River Rother – Fair Oak Estate – Habin to Trotton

Advisory Visit April 2018

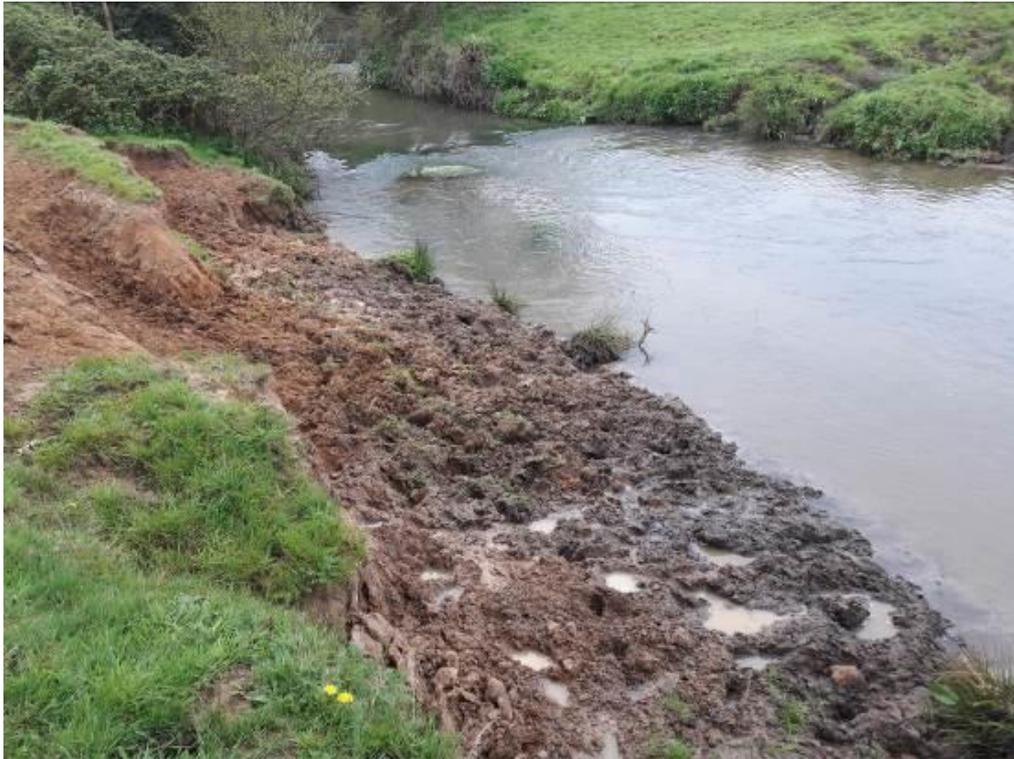
Although not considered to be a serious issue at Fair Oak, there were examples of excessive bank poaching, particularly towards the Habin Bridge end of the fishery (photo 26). Bank trampling on this scale results in the input of fine sediments into the channel. This is of particular concern when the bank poaching is occurring immediately upstream of potential spawning sites, where

the presence of fine sediment particles can infiltrate into spawning redds, reducing egg viability and impacting on wild trout recruitment.

Photo 26. Heavy bank poaching can potentially result in reduced egg to fry conversion rates in any spawning sites located in the downstream vicinity.

Re-grading the bank and lining the bed with importing cobbles and gravels to make purpose built livestock fording and drinking bays would definitely help to reduce sediment input in this area. DEFRA have recently released new guidance relating to bank poaching pressures.
