## **The Pagham Rife at Runcton**

**Advisory visit February 2016**

## 1. Introduction

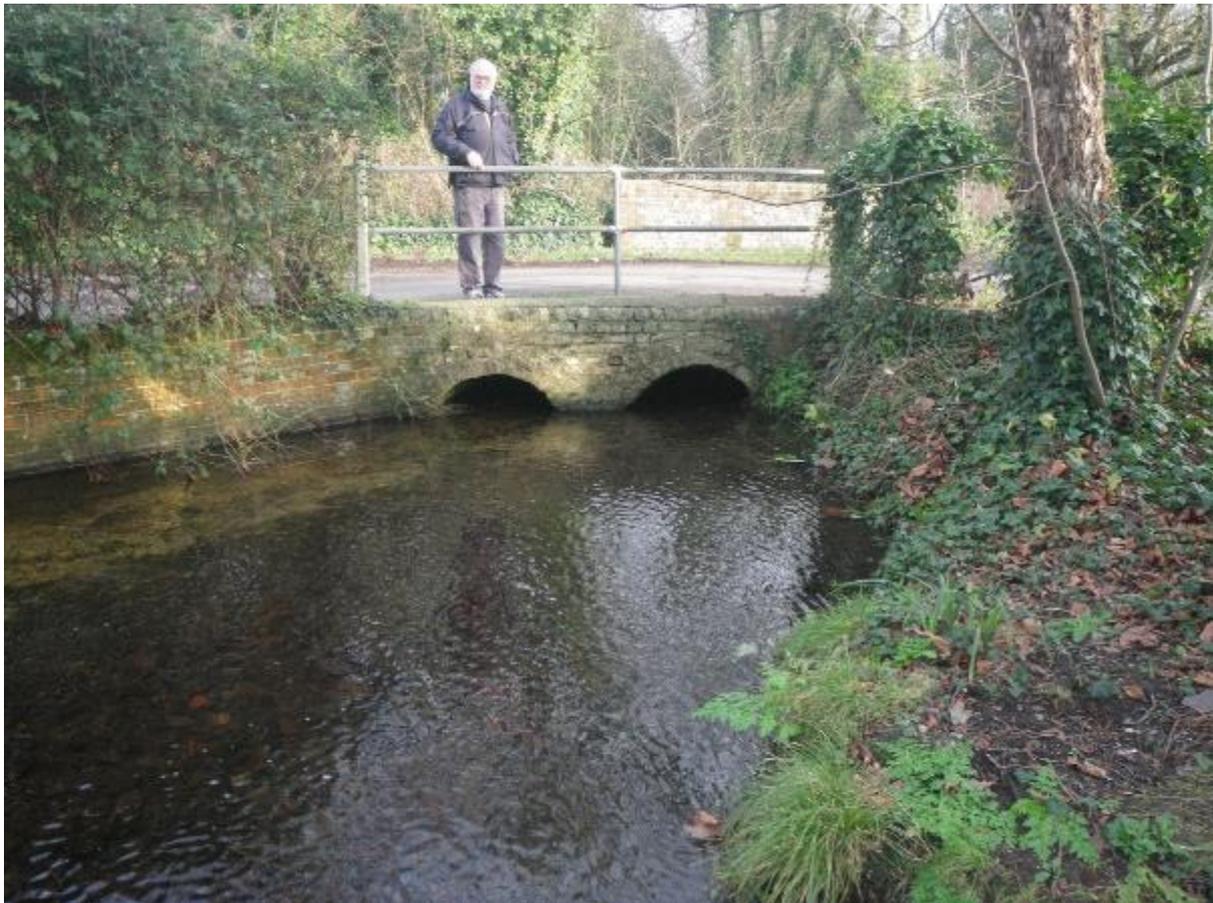
The section of channel downstream of the mill building and on to the bottom boundary consists of a wide, shallow channel flowing over a mainly flat bed. This section has potential for providing opportunities for trout spawning but currently supports very little cover for trout of any life stage. Habitat for trout fry, parr and adult fish was very limited and mainly restricted to the arches of the downstream road bridge shown on the cover photo.

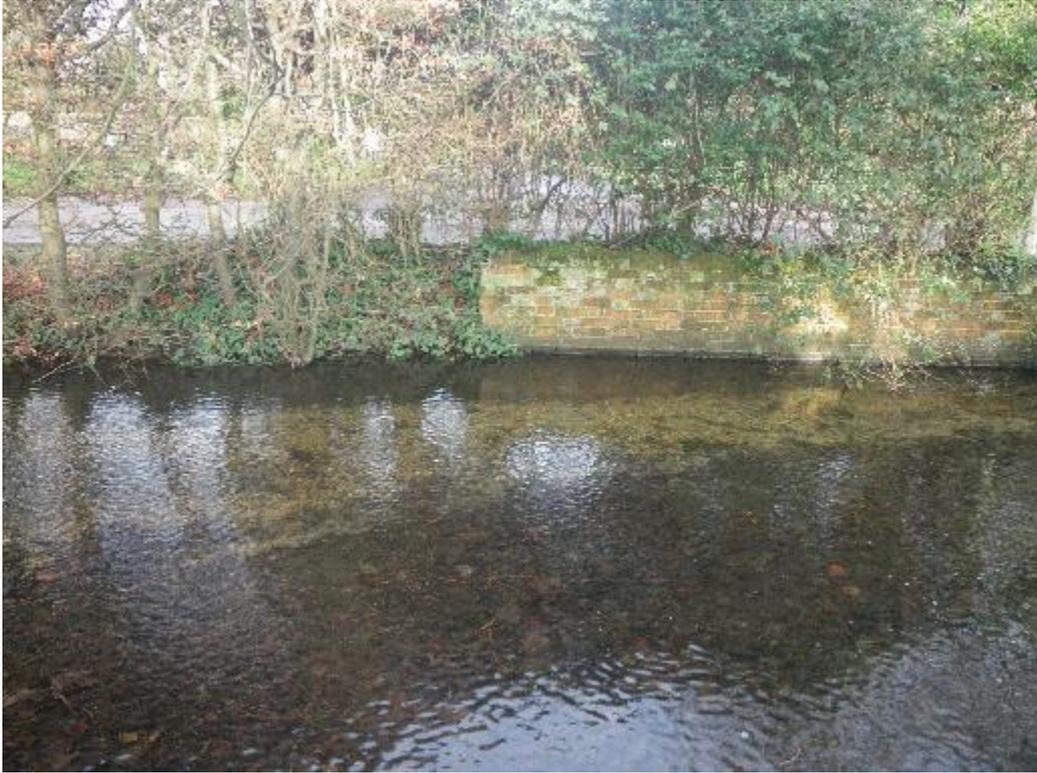
The downstream section of the LB margin is boarded by a vertical wall (photo 2), with the RB constructed of earth banks forming part of the curtilage of the property. A tiny amount of cover is provided by some trailing vegetation and overhanging branches located just upstream of the walled section.

There is also a modest plunge pool that has formed at the exit from the mill race which could potentially provide some refuge for an adult fish but the lack of any low, overhanging cover seriously compromises its ability to hold fish comfortably.

Photo 2. Broad, shallow channel with very little cover for fish

'Cover' logs popped in parallel to the flow and adjacent to the toe of the bank can also encourage trout to take up residence in open, shallow environments. The section of channel immediately downstream of the mill looks ideal for one or two cover logs.

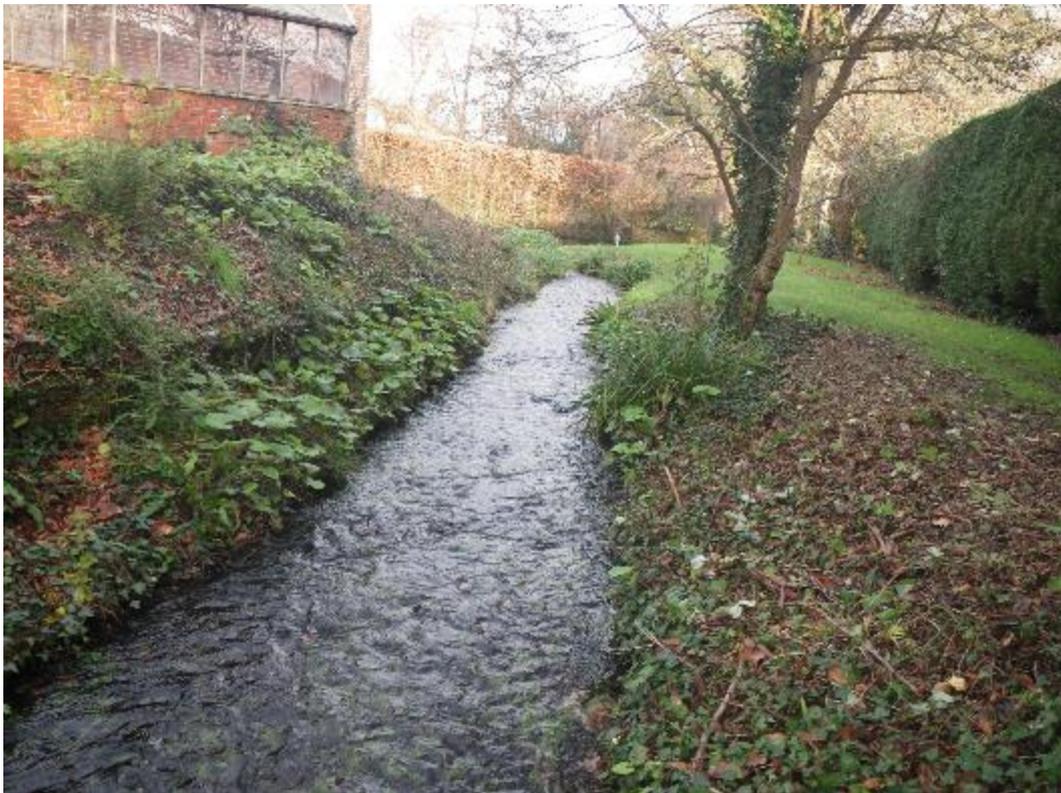
Bypassing the mill is a 100m plus long by-wash channel (photo 3 and 4). The steep gradient and narrow channel has maintained a clean gravel bed and appeared to potentially be an ideal spawning and nursery site. This was confirmed with what appeared to be at least two definite trout redds (nests of trout eggs) shown in photos 5 and 6.

Photo 3 By-wash channel.

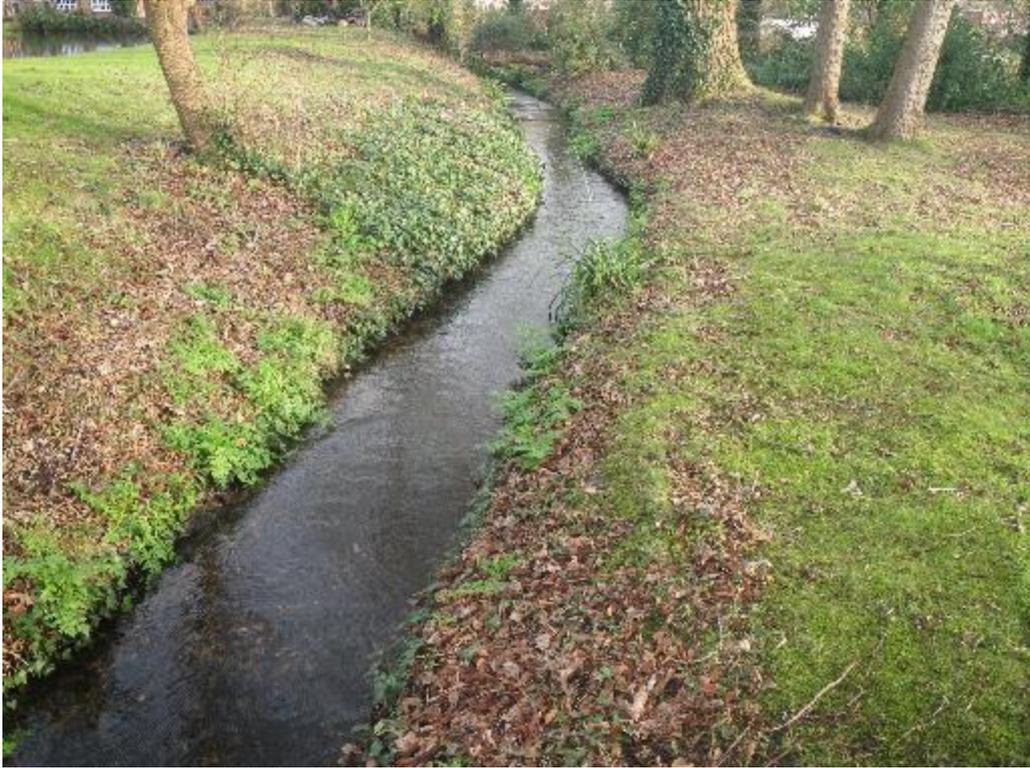
Photo 4. By-wash channel. Gravel rich but lacking cover and diversity.

The by-wash channel is man-made and although supporting rich seams of gravel and a vigorous flow velocity, ideal for trout, the overall topography of the stream bed was comparatively flat, with precious little variation in channel depth or width and chronically lacking any significant cover. Any trout utilising this site for spawning is highly likely to run up in darkness, or possibly down from the well covered site above, spawn, and then return to areas affording more cover from the attention of predators.

If this site is indeed being used for spawning by either resident brown trout or migratory sea trout, then its productivity could be greatly improved via a range of simple measures. These might include changes to the riparian maintenance regime and the provision of cover for both pre and post spawning adults, as well as for fry and parr. A prescription for managing the by-wash channel is highlighted in more detail in the conclusions and recommendations section of this report.

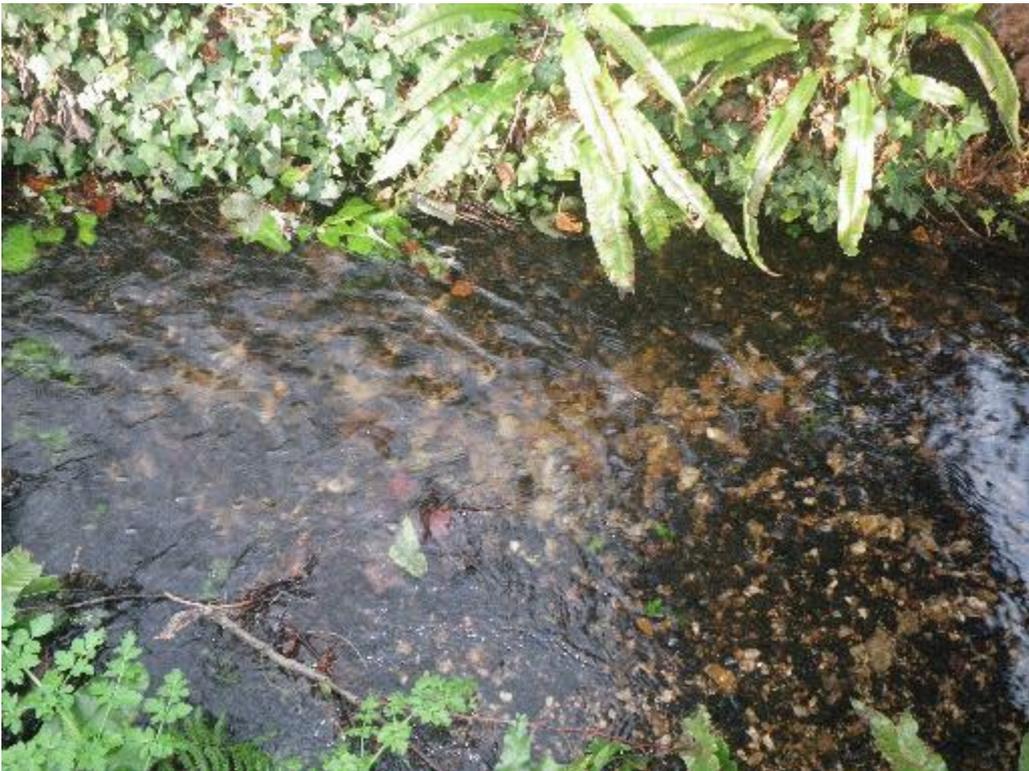
Photo 5. The light mound of gravel appears to indicate trout spawning activity.

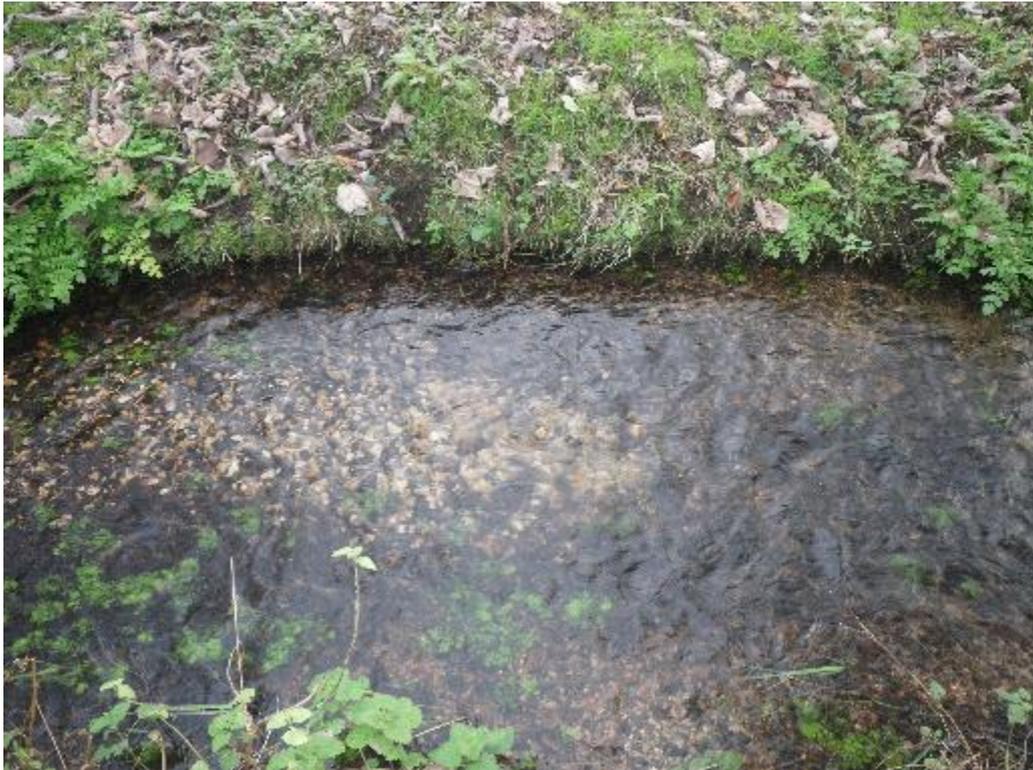
Photo 6 A more obvious "redd" in exactly the type of location where trout spawning would be expected. The size of this redd would indicate brood stock of a significant size, a possible indication of the presence of sea trout.

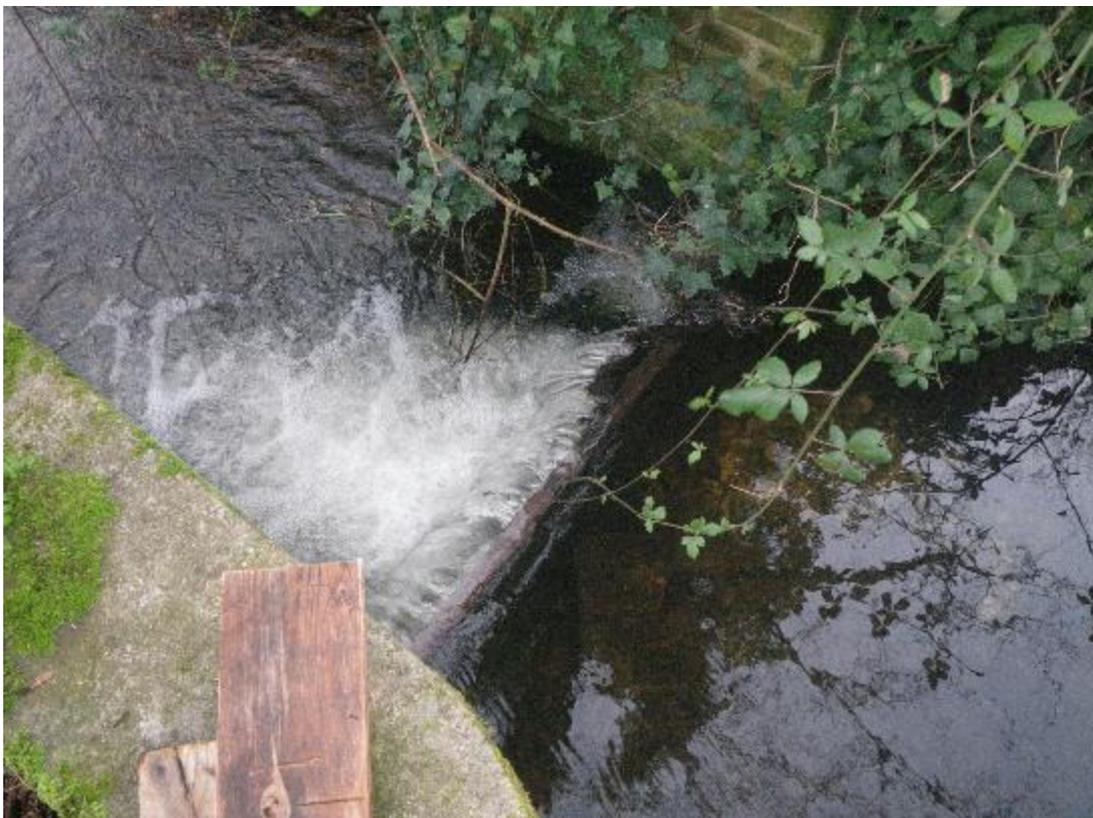
At the head of the by-wash channel is a water-level control structure consisting of a drop-board arrangement (photo 7). A similar structure is in place on the parallel channel that forms the neck of the mill pond, which also has a grill or grate designed to contain stocked trout which are to be introduced into the mill pond.

Photo 7. Water level control boards at the head of the by-wash channel.

In many ways, prioritising flow splits into the by-wash channel by lowering the drop boards at this location will have two direct benefits for the site as a whole.

Increased flow via this route could be harnessed to create some modest pool habitats in the by-wash channel itself, thus creating some holding habitat for adult trout. The extra flow would also benefit invertebrates and gravel quality and potentially boost spawning success.

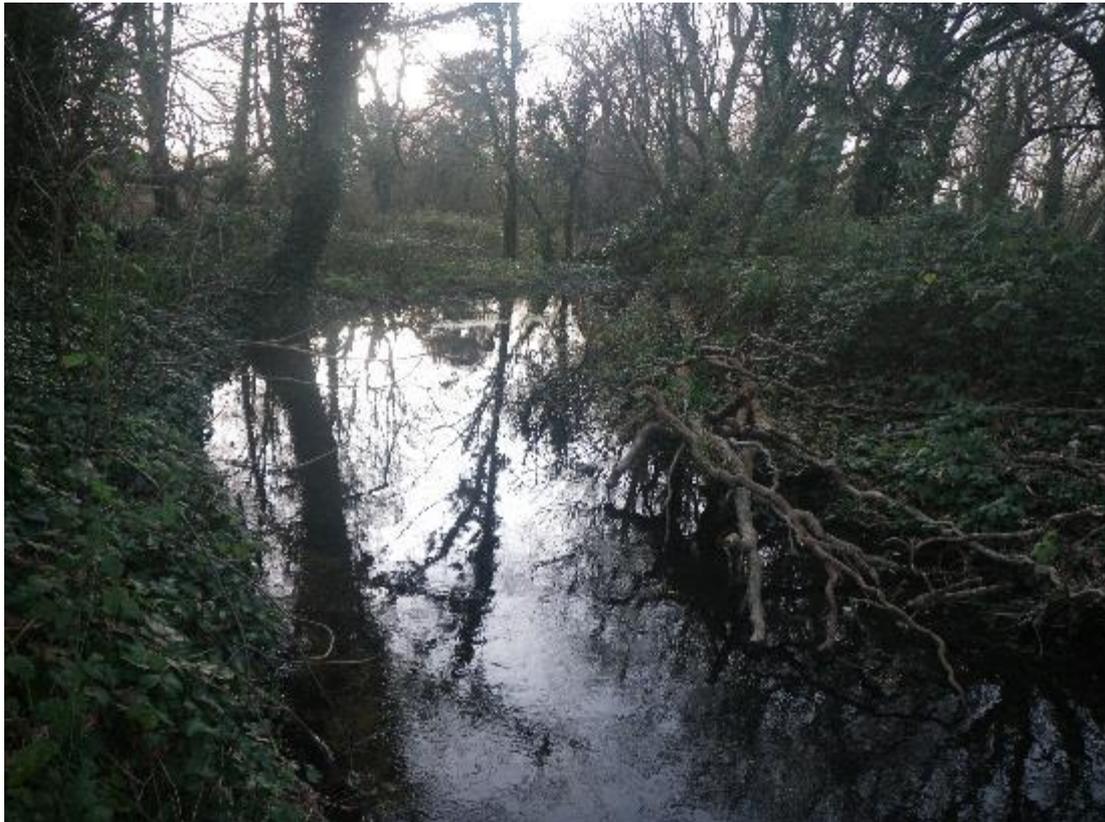
Currently the impounding boards placed into both channels are having an adverse impact on the section or Rife running upstream above the flow split (photo 8). Reducing the height of the impounding boards on both the by-wash channel and the mill pond channel will result in improved habitat developing on the upstream reach.

Photo 8. The Rife upstream of the mill pond is adversely impacted by the impoundment. If run slightly lower and faster, better quality habitat would eventually establish.

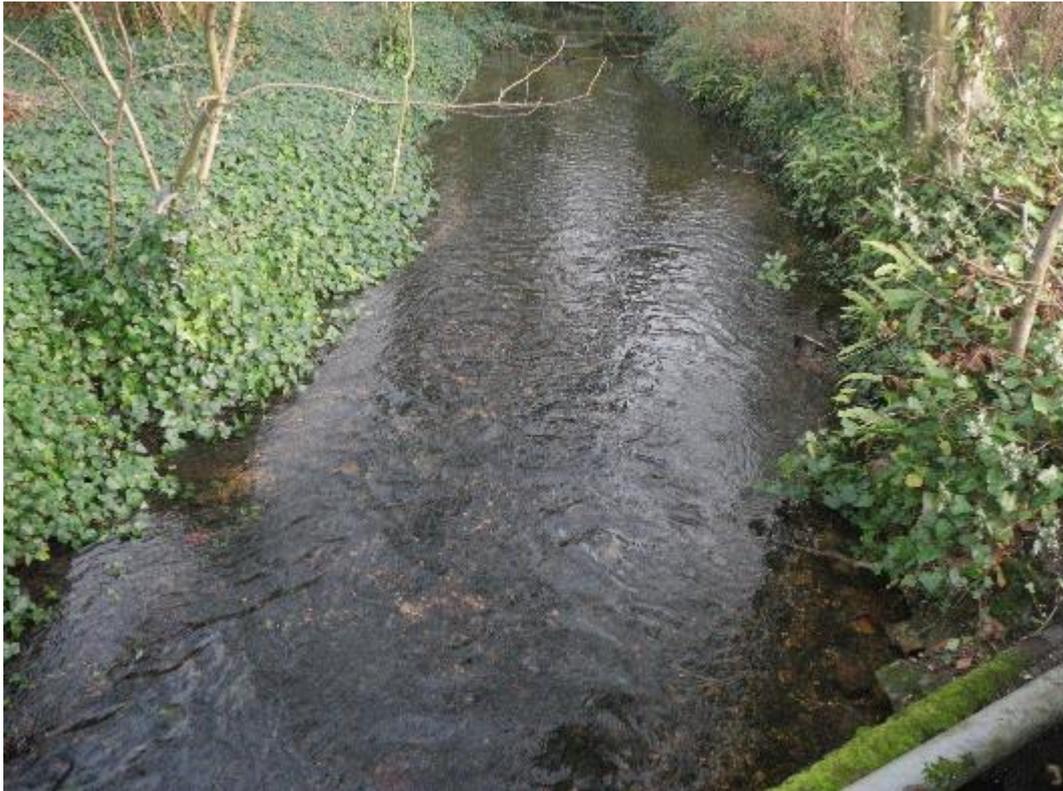
Photo 9. Section of good juvenile trout habitat downstream of the road bridge.

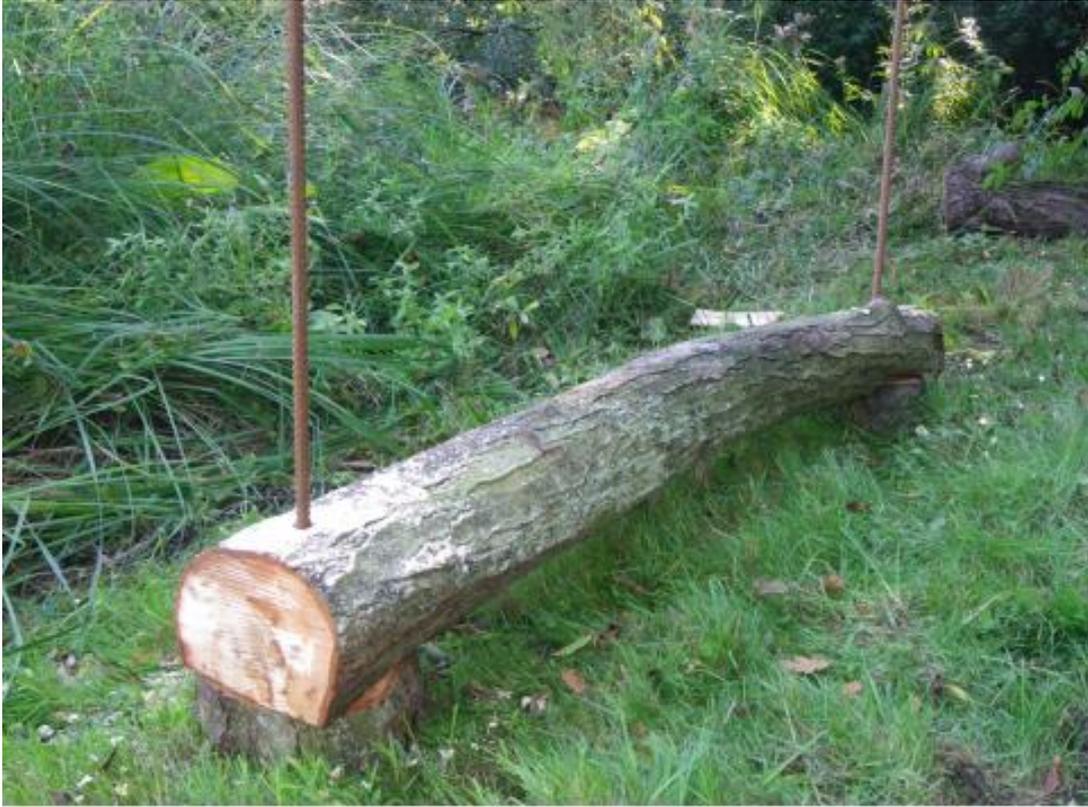
The principle of the cover log is that there is a gap underneath where trout can safely hide from predators but also safely nip out into the flow to intercept passing food items. To be effective they need to be positioned adjacent to the margin that carries the majority of the flow velocity. A cover log is shown up on the bank ready for deployment in photo 10 and how they should look once installed into the channel, mimicking an undercut bank (photo 11). Simple brushwood bundles installed (photo 12) in similar fashion are also hugely effective, especially on sections immediately downstream of known spawning sites.

Photo 10. Cover log sat up on two woody rings cut from the end of the log, drilled and ready to be pinned to the bed with steel re-bar.

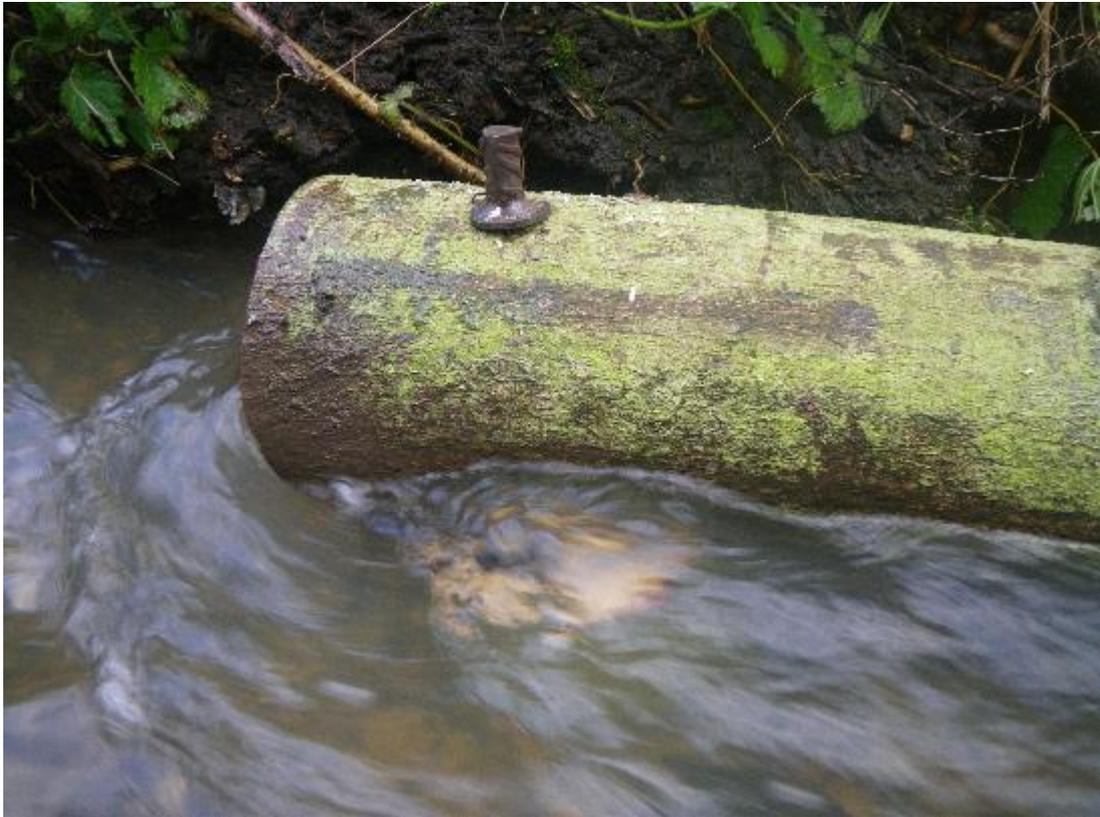
Photo 11. Correctly installed parallel to the flow and tight against the river bank.

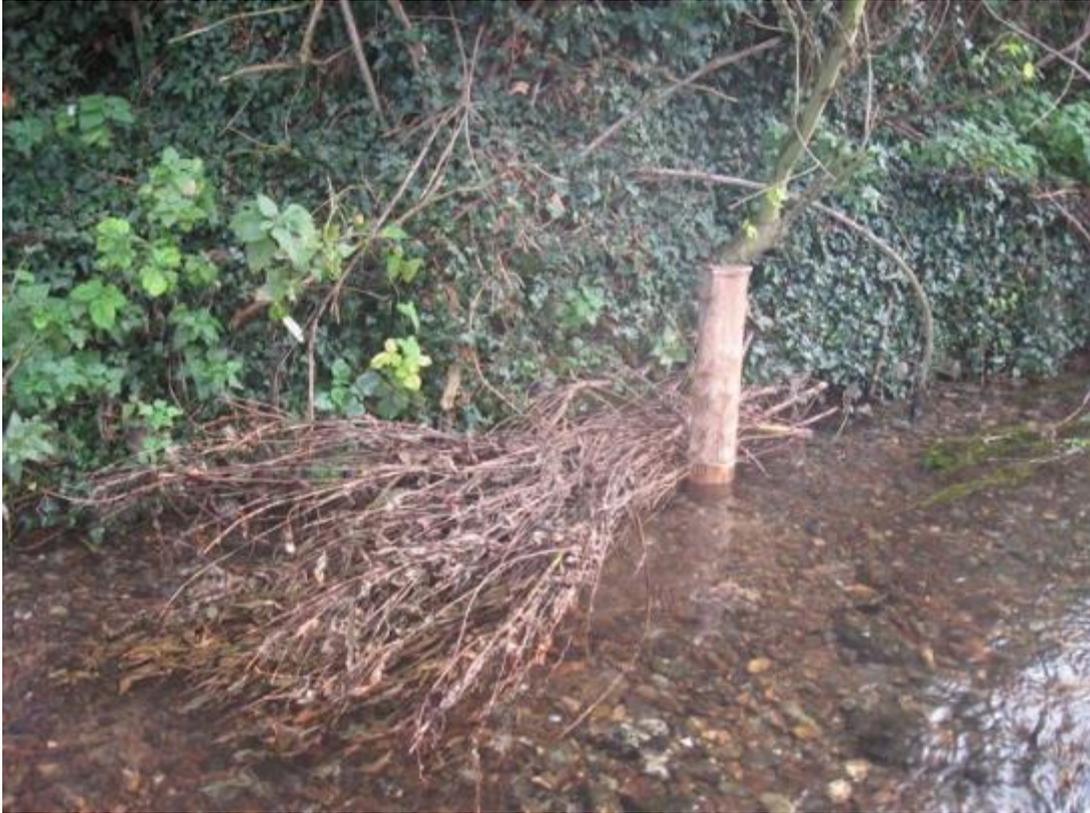
Photo 12. A simple brushwood bundle wired to a driven chestnut post providing cover for newly hatched trout fry in a shallow gravelly margin.
