**Advisory Visit for the Scrainwood Estate**

**Scrainwood Burn**

**(Wreigh Burn - Source to Netherton Burn - GB103022076760)**

**Date 20/07/2012**

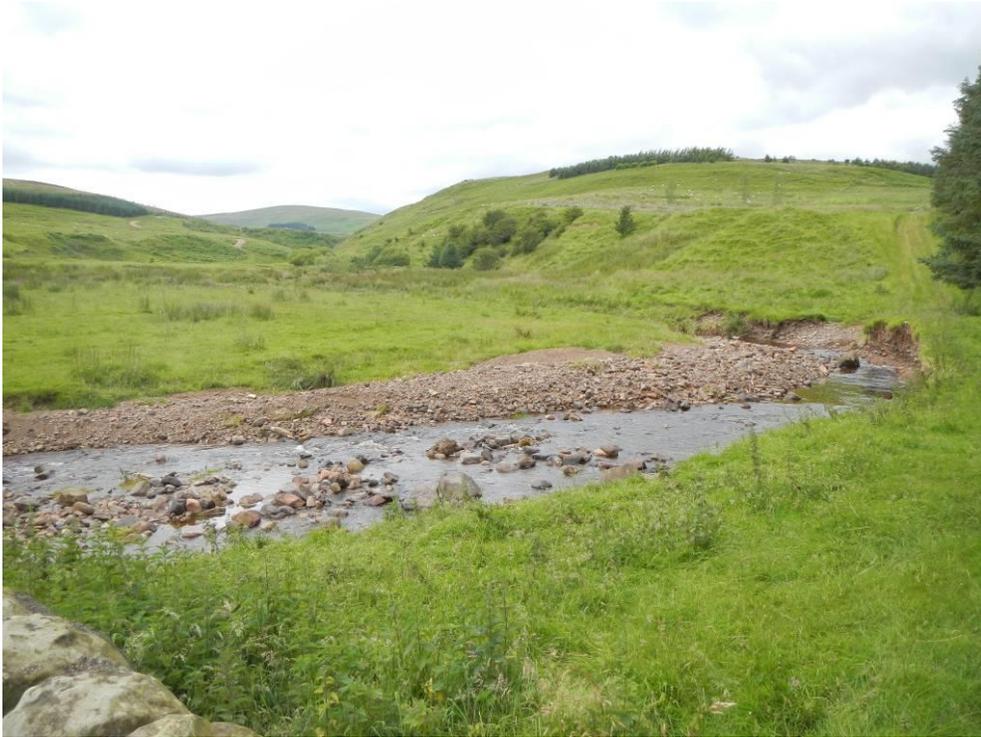
The first thing that became apparent upon arrival at the Burn was a general lack of the marginal vegetation and trees along the bank that would usually be associated with high quality trout habitat (Picture 1). This is almost certainly a legacy of the sheep grazing in this area, the result being a reduction in the tree species diversity and prevention of natural regeneration through self-set trees, meaning that as older trees reach the end of their lifespan they are not replaced.

**Picture 1. Very open river valley with a lack of marginal tree and vegetation cover along the watercourse, typical of the area.**

This creates a very open valley, with little aerial cover to provide secure lies for fish. The lack of woody material along the banks also means that the older trees that would normally supply beneficial woody debris (WD) to the channel as the trees die are also absent. Both of these features are vital in producing high quality habitat, particularly features capable of supporting larger resident trout.

1. Contact Natural England to begin detailed discussions on how CSF and HLS monies may be available to facilitate creation of a generous buffer strip along the Burn.

2. Exclusion of livestock from the river and river banks. Note that ongoing fence maintenance will be required to ensure that livestock cannot access establishing buffer areas.

5. Once fenced and stock is excluded, kick-start the regeneration of bank side trees through planting of locally native species such as willows (*Salix cinerea* & *Salix caprea*), alder (*Alnus glutinosa*), ash (*Fraxinus excelsior*), and hawthorn (*Crataegus monogyna*).

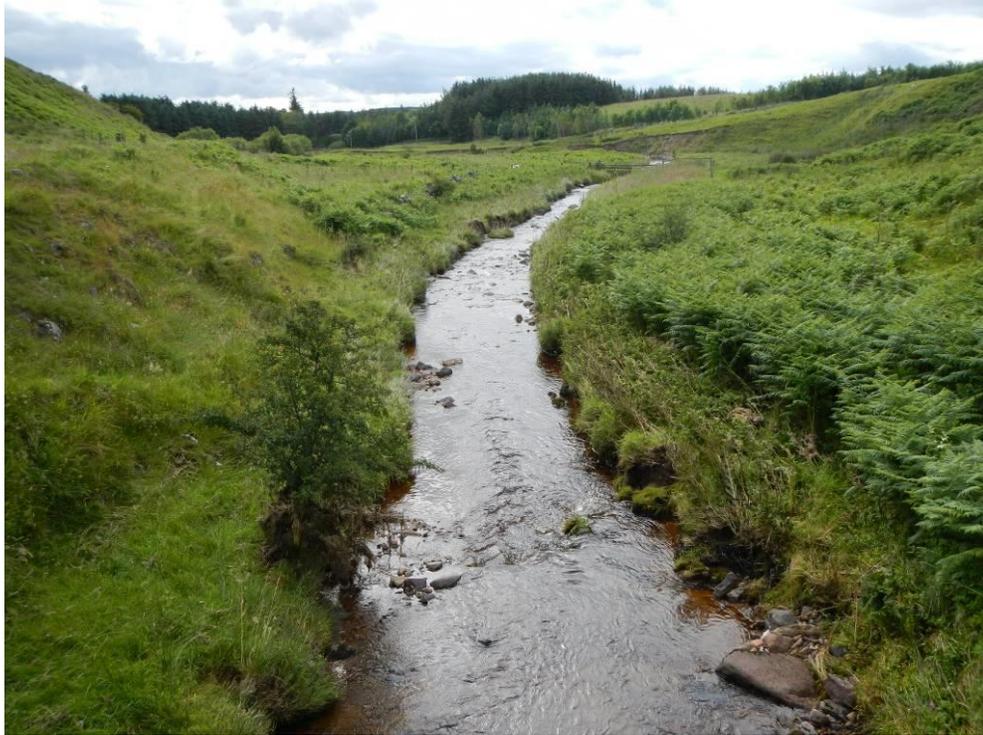
Grazing, even where it is relatively low density, tends to greatly reduce the abundance and diversity of bank side vegetation, also leading to a greatly reduced root mass within the soil. This is because different plant species have different root systems, which provide various combined benefits for soil stabilisation and bank protection. Furthermore, where vegetation is grazed, much of the growth is replacement of the material eaten above ground, rather than extending root growth within the soil. It is also unfortunate that as watercourses often act as barriers to livestock, the banksides tend to be grazed harder than other areas (as often occurs along fence lines for the same reason). Consequently, where grazing pressure is removed, trees and greater diversity of vegetation re-colonise, providing greater protection to the bank and increased cover within the channel for fish and invertebrates (Picture 2).

**Picture 2. Increased vegetation where grazing has been reduced. This could be improved further through complete stock exclusion and increasing the number of bank side trees. These would increase cover and some could be laid into the channel to provide structure and flow diversity.**

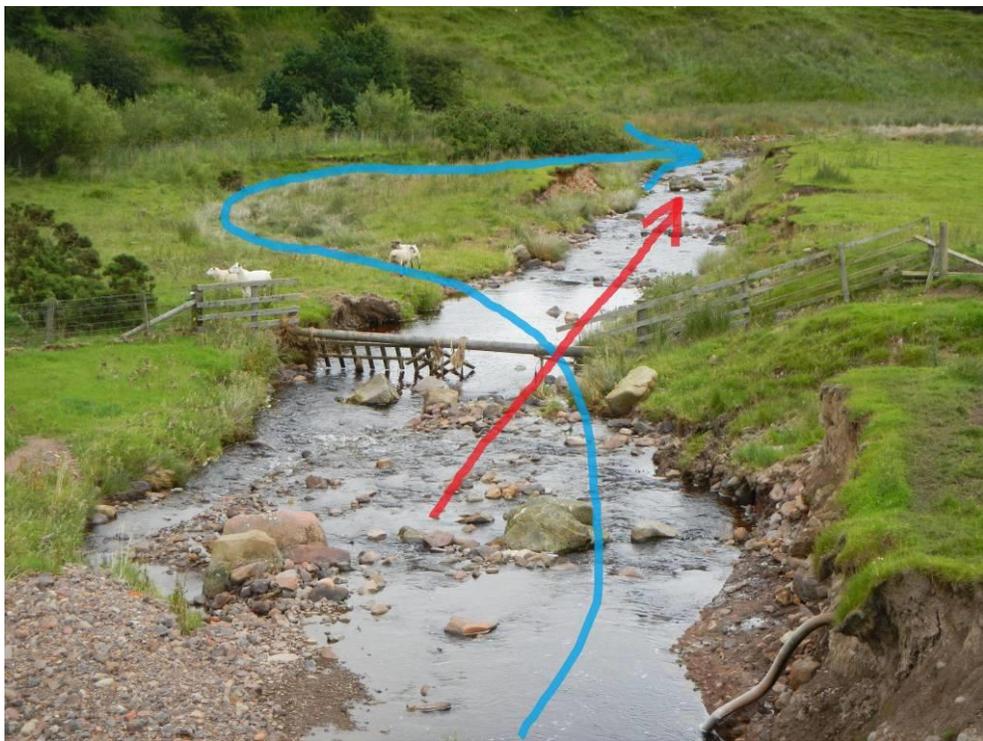
In areas where the channel has been straightened, the gradient of that section is increased as the distance the water has to travel down the slope is decreased. This can have multiple negative effects upon the function of the channel (Picture 3):

- The velocity of the water is increased due to the steeper gradient, increasing the Burn's power to erode its bed and banks;

- A reduction in the number of bends and slower, wider areas to store bed materials transported from upstream, meaning that bed material is more likely to be transported downstream and accumulate in problem areas like bridges and wider channel areas, also filling in pools;
- This lack of deposition means that there is a constant loss of bed material within the straightened section, leading to progressive incision/lowering of the bed. The banks then become undercut or perched, leading to greater erosion, further exacerbating the problems with over supply of bed materials downstream.

**Picture 3. The blue line represents the original channel the red line represents the shorter, steeper, straightened channel. Note the bank erosion in the background due to the lowered bed level and increased velocities within the straightened channel. This will undoubtedly have also exacerbated erosion on the bend upstream (foreground of the picture) due to the lowered bed downstream taking and transporting bed material away from areas upstream.**

3. Cessation of dredging work within the channel other than limited work around bridges (if absolutely necessary). Ideally, any material removed should be returned to the channel downstream of the bridge.

4. Allow the reinstatement of a more natural channel morphology with bends (where pools can become established) and bars (where sediment and bed materials can accumulate throughout the reach, rather than individual problem points).

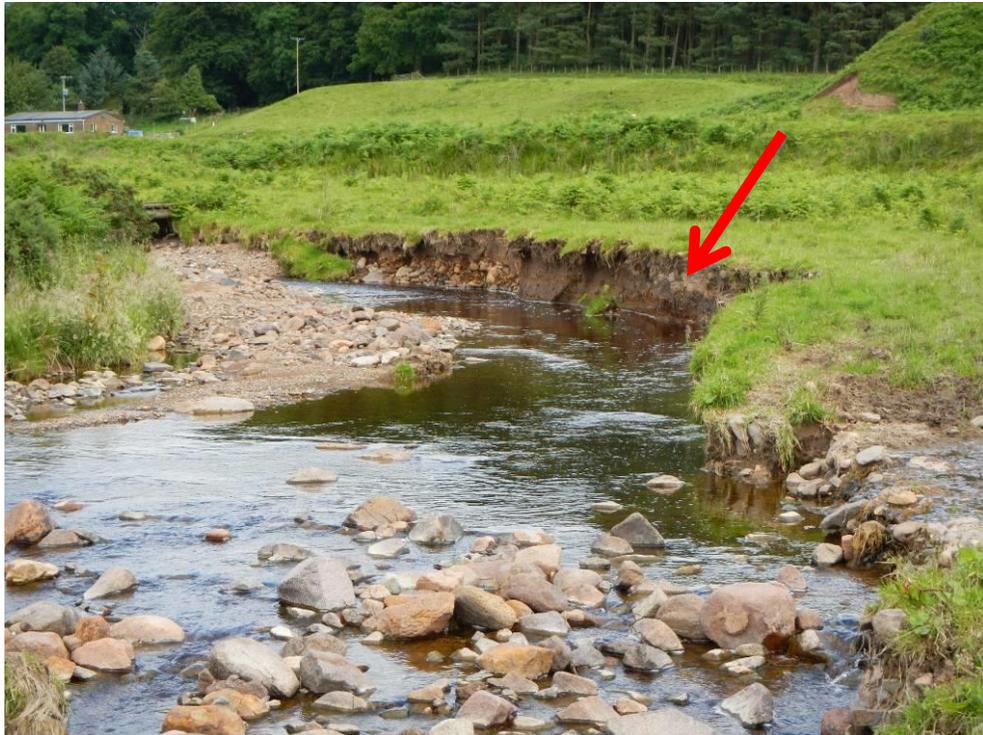
Dredging can have similar negative impacts upon on the river channel (Picture 4):

- The river often becomes over wide or deep for the volume of water it usually carries and the lower velocity within the pools encourages greater deposition of materials supplied from upstream that would

ordinarily be transported through or stored on the inside of bends downstream, leading to increased deposition in that area;

- The dredging inevitably lowers the bed level, leaving the banks perched and more susceptible to erosion;
- The lowered bed encourages back cutting upstream of the dredged area, increasing erosion further upstream.

**Picture 4. The foreground of this picture is the location of a recently dug pool that has filled in with material from upstream. This is primarily because the pool was over wide and deep, and effectively acting as a silt trap. The rock weir created at the tail of the pool also exacerbated this and is likely to have increased erosion around the weir. Also note the increased erosion upstream in the centre of shot (arrowed), resulting from the bed material upstream moving downstream to fill the void created by the pool.**

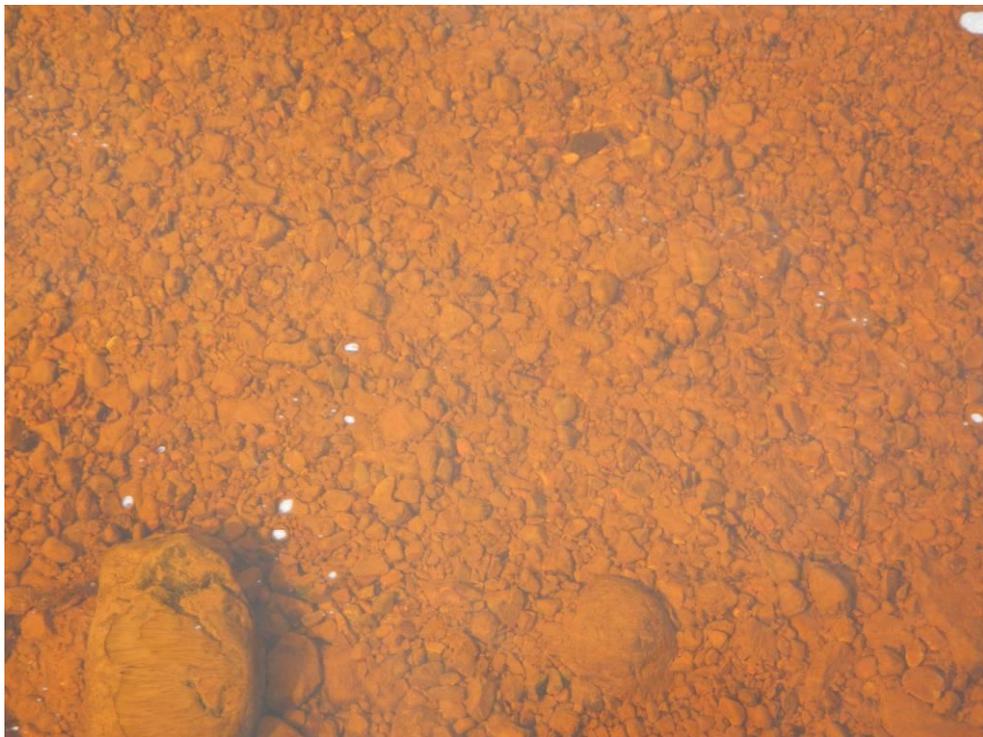
Currently, it is not surprising to see that there are good numbers of juvenile salmonids in the burn. There are sufficient areas of suitable spawning areas present, even if many of them are compromised to an extent by sediment deposition (Picture 6). Habitat for juvenile salmonids is definitely sub optimal, due to a lack of cover and refuge, but there are sufficient areas of natural flow diversity and slightly deeper water to support a reasonable population. There was, however, a significant lack of habitat for any fish past the parr stage, due to a lack of deeper water, but more significantly the lack of aerial cover.

**Picture 6 Silt-laden gravels typical of many areas of the Scrainwood Burn bed, lying outside the main flow. In most areas where the flow is low enough to accumulate smaller gravels suitable for resident trout, low flows and high sediment loading render them of poor suitability for spawning.**

As the triggers for migration to sea within trout are known to be both genetic and environmental, it is therefore not surprising that a large percentage of the trout population within Scrainwood Burn do currently go to sea. The lack of deeper pools, clean areas of smaller gravels (c. 10-30mm, suitable for smaller river resident trout spawning), lack of cover, high summer temperatures (due to a lack of shade) and the lack of individual lies
