River Semington – West Lavington

An advisory visit carried out by the Wild Trout Trust – December 2009

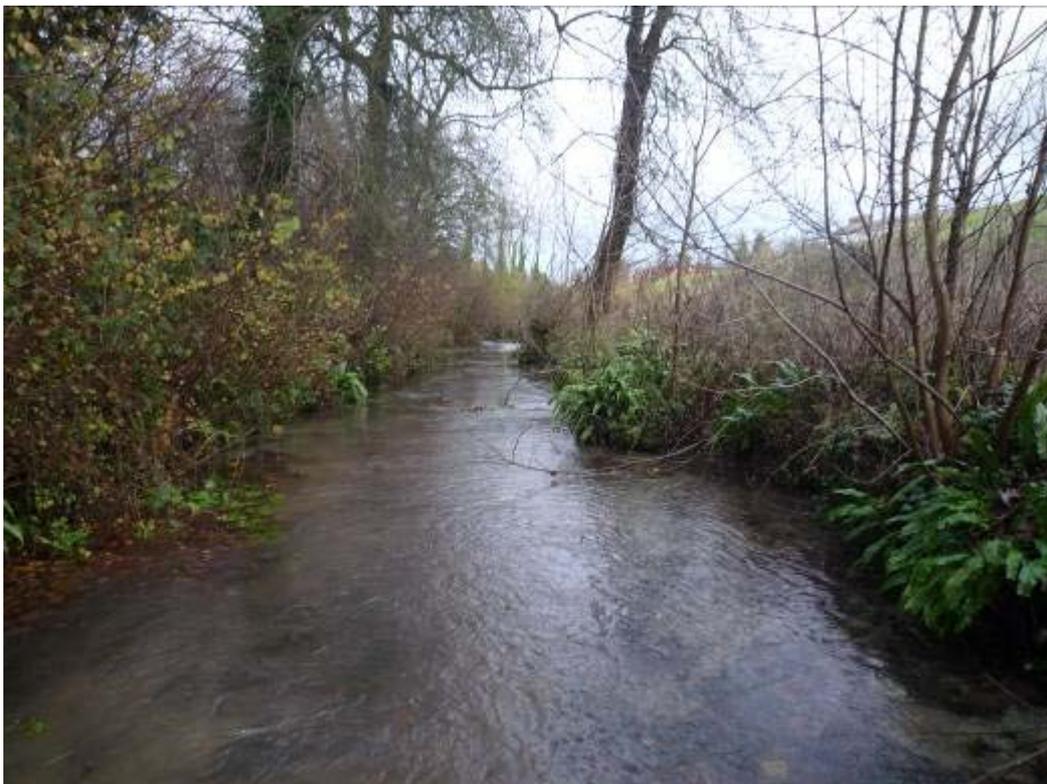
At the outlets to the bottom pond the Semington Brook is properly formed into a small stream (cover picture). Habitat quality on this section for trout was considered to be good, with the stream providing a nice range of habitats for all life stages. A particular feature of the bed substrate was the presence of the colonial algae (*Hildon brandia*) (pic 4). This red algae is closely related to a marine species and from my observations of southern rivers is a comparatively rare find.

The lower section, where the stream exits the bottom pond has lots of scope to provide a sustainable habitat for wild brown trout. This section could be improved further with a focus on providing good quality holding and spawning habitat. The introduction of more large woody debris (LWD) is recommended. The presence of LWD has been shown to be extremely important in several respects:

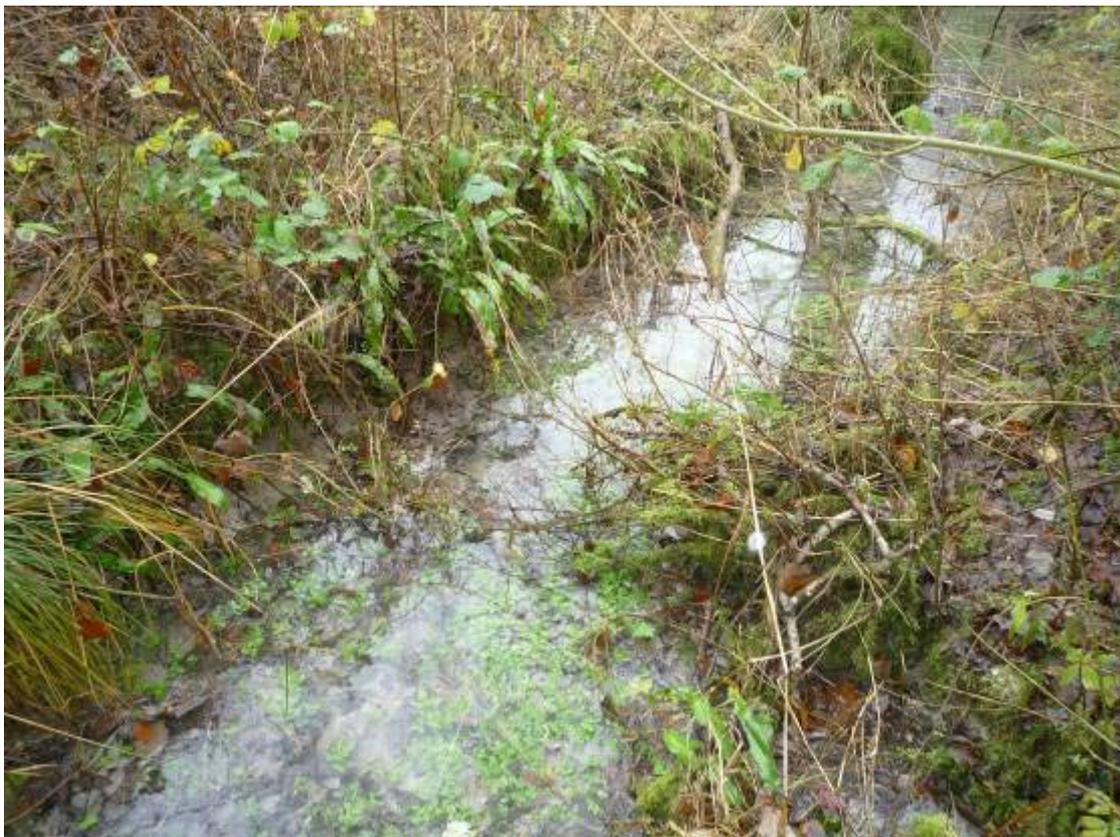
Springs at the very source of the Semington are ephemeral and at the time of the inspection had only recently started to flow. Two interconnected lakes have been constructed virtually on the source of the springs. Both lakes essentially dry up following drought conditions and there is little scope to restore any functioning stream at this location. Indeed the main value of the site is probably associated with the transitional nature of the lakes back to a marshy bog. This type of habitat is comparatively rare, particularly in lowland southern England and will support a specialised community of plants and invertebrates as well as providing a valuable habitat for a range of bird species. The unreliable and ephemeral nature of the water supply means that this top section has no scope to develop any sustainable fish populations.

Pic 1. Source of the Semington Brook just above the first of the series of on-line lakes

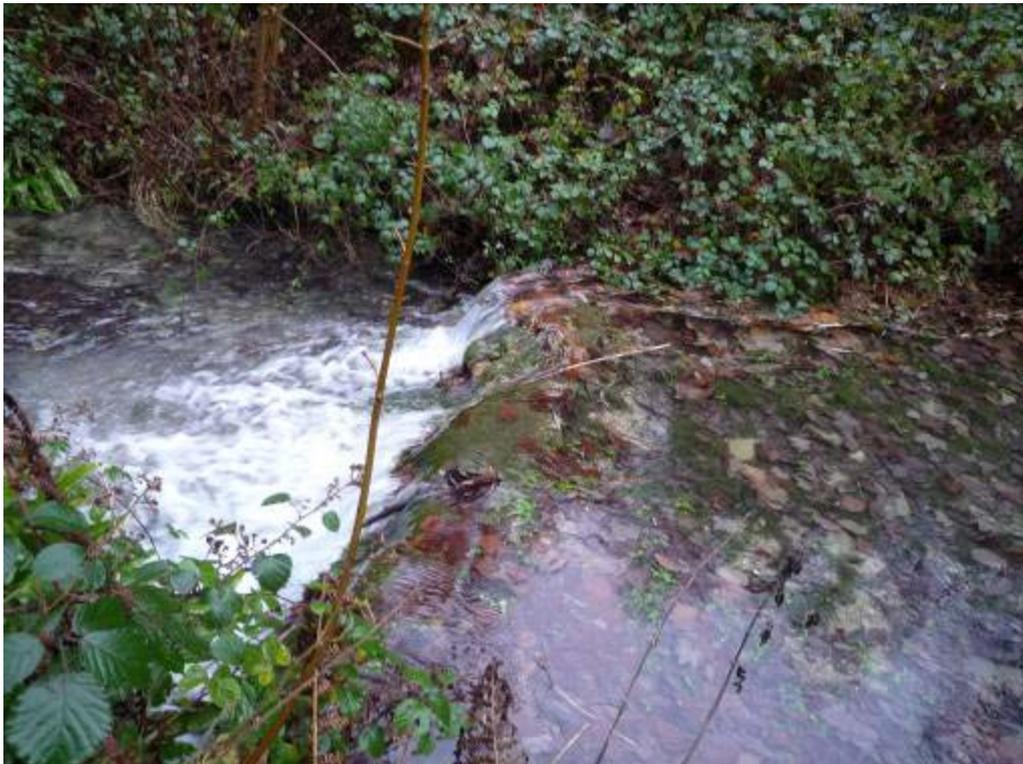
Below the first two interconnected ponds the stream drops down a steep gradient and over several stone weirs (pic 2) that look to have been installed to push the water down parallel channels before dropping into the neck of the next pond. The whole site is set down in a steep-sided valley and was probably part

of a large ornamental garden. The stone weirs are in places backing up the stream and restricting the development of any natural morphology by slowing down upstream water velocities. Consolidating the flow into a single channel and lowering or removing the central sections of the weirs would help to improve habitats for flow-loving species within the stream, however, the heritage value of the structures should be explored further before undertaking any modifications. Carrying out this work at this precise location is unlikely to benefit trout populations unless the habitat connectivity issues are addressed further downstream as well. There are two further substantial dams a short distance downstream that will restrict any significant upstream migration for trout and other flow-loving fish species so carrying out improvement works here in isolation from the rest of the site will not improve the fishery potential of the stream as a whole.

Pic 2. Stone weir below the top lakes. Removing the central stone will improve habitat quality in the stream above.

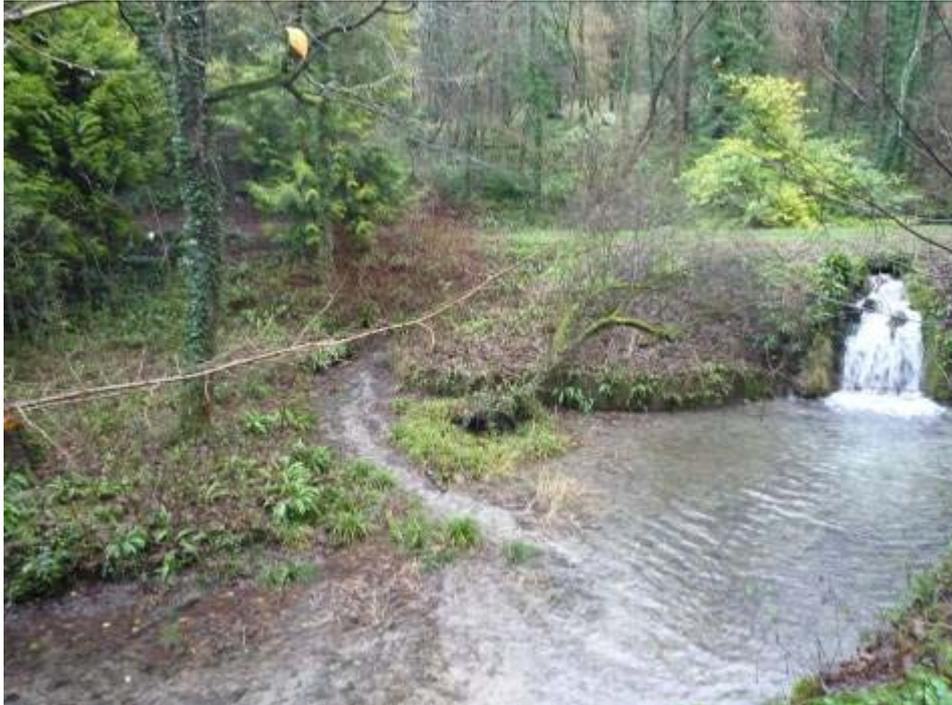
Further downstream the channel starts to widen and the stream again loses all velocity as it melts into the neck of a third lake. This particular lake does not completely dry up but does shrink to a small area of open water just above the dam. The dam itself is a large structure (pic 3) of at least 3m in height. Set into the dam is a culvert with a sluice gate which is drawn following heavy rainfall events to prevent overtopping of the structure. Below the dam the stream forms a nice shallow channel.

Two brown trout were observed attempting to spawn on a thin layer of gravels just a few metres downstream. These fish looked to be sizable wild fish which probably reside in the bottom lake below. Although migration is possible to this point an assessment of the bottom dam downstream suggested that only large

fish under exceptional circumstances could negotiate the structures to reach the point where the fish were observed.

Pic 3. The large dam of the third lake has a sluice to prevent the dam from over topping. Two trout were observed getting ready to spawn on the shallow gravels in the foreground.

- Consider the installation of emergency spillways on the dams of the lower ponds to negate any requirements for sluice operation. This action will provide better flow stability and avoid the mobilisation of sediments settled within the ponds.

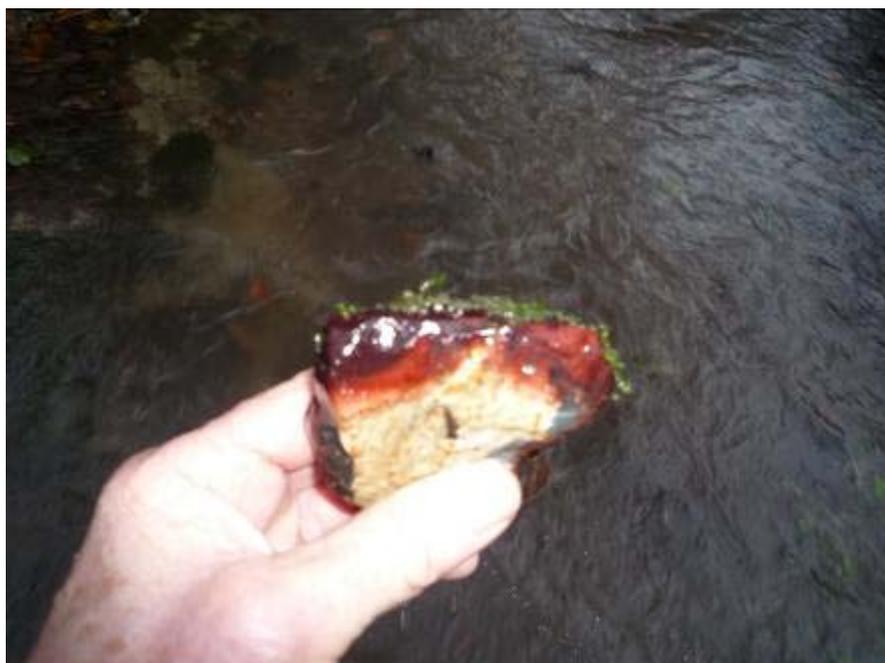
Colonial red algae *Hildon brandia* with a fine coating of water moss *Fontinalis*

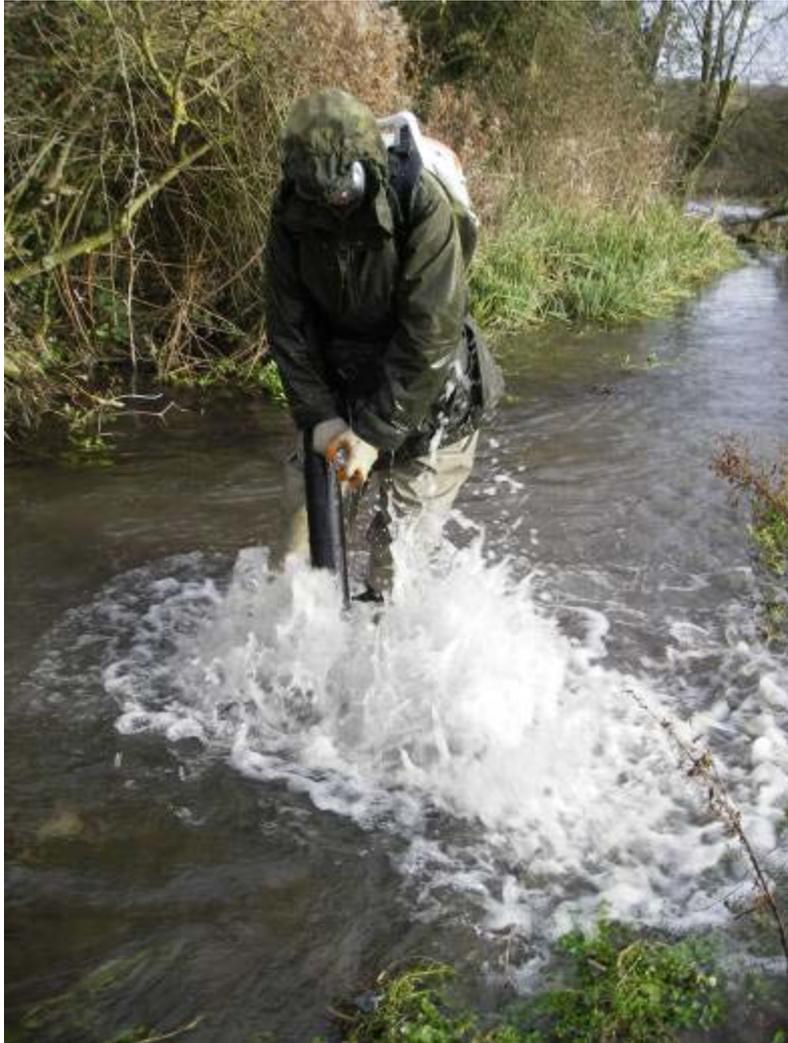
[Gravel cleaning using a backpack leaf blower](#)

Where spawning gravels currently exist it may help to boost trout production by breaking up and loosening the gravels each autumn before trout spawning commences in the November to January period. This work can be undertaken using hand tools such as fencing spikes and rakes or by using hand held pressure pumps to blast the sediments out of the gravels. This creates optimum conditions for spawning and will ensure that a much higher percentage of eggs survive to become fry. A demonstration of gravel cleaning techniques can be arranged via a Wild Trout Trust Practical Visit (details in the "Make it Happen " section).
