Advisory Visit

River Sence, Wistow, Leicestershire

September 2017

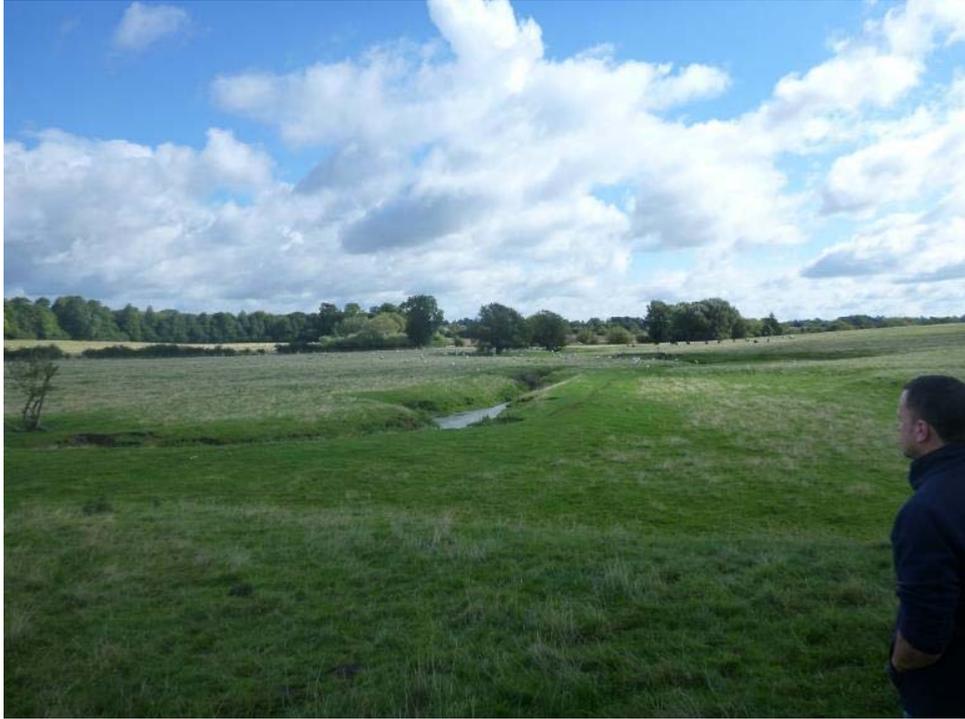
Photo 1 Wide view of the upper section of the fishery.

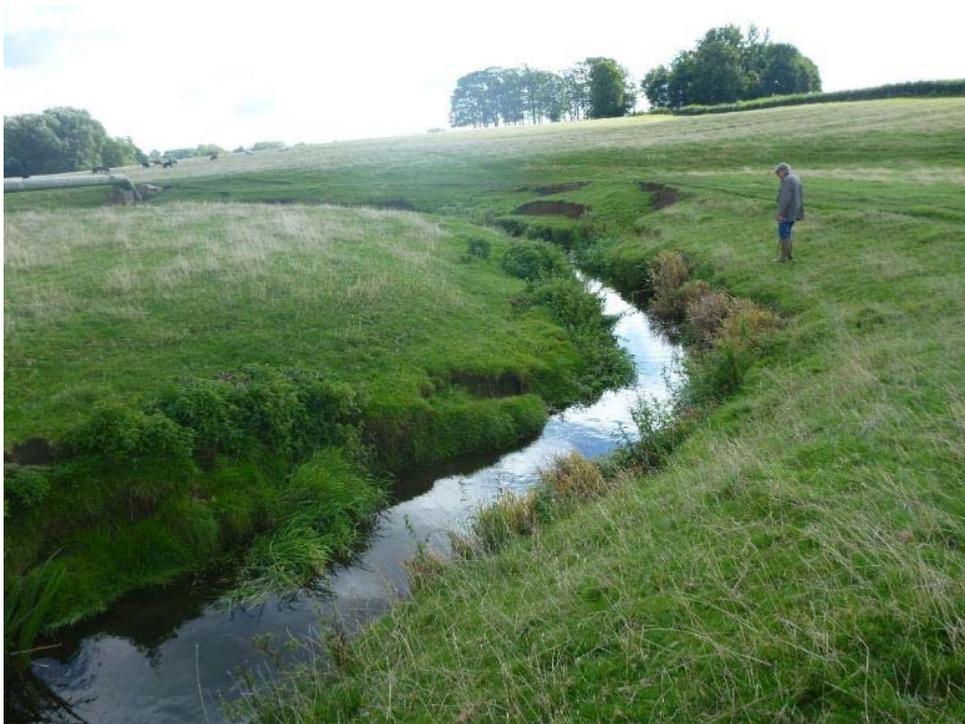
The main impacts on river habitat quality remain the same as in 2002/03 as noted above. The past land drainage works have lowered the river bed by around 2 metres, leaving a deeply incised channel which largely lacks a pool-riffle sequence and is disconnected from its floodplain. There is a lack of diversity of depths, with few deeper pools or wider, shallower riffles, limiting availability of fish habitat. At high flows, the over-sized channel has a far greater bank-full flow than would naturally be the case, making it a hostile environment for fish, particularly juveniles. In a less altered channel, the high flows would overtop into the floodplain more frequently, leading to a lower maximum stream power and providing calmer refuge areas for fish.

Photo 2 Closer view of the river showing a typical section with a deeply incised, uniform channel from past land drainage works.

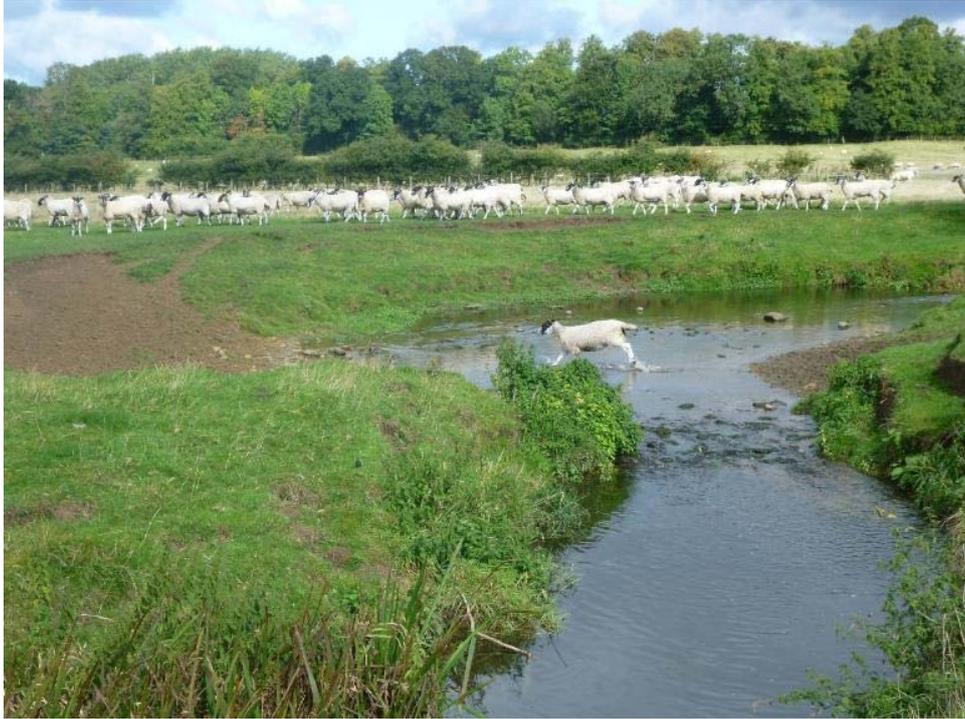
Photo 3 Livestock access has widened the wetted channel and lowered the banks in some areas, leading to the retention of bed substrate (gravel) and formation of riffles, repairing to some degree the adverse impacts upon habitat of river engineering. However, this now needs to be built upon by improving riparian habitat and vegetation, by limiting grazing (fencing).

On straighter sections of channel, the widening of the wetted channel and lowering of the banks by livestock trampling has alleviated some of the habitat damage caused by historical channel engineering; the effect has allowed gravel to be retained on the river bed forming a riffle (Photo 3). In areas where meanders occur, the same effect has had a less positive outcome (Photo 5); these areas are where deeper pools should naturally form, so retaining a narrower wetted channel and stable bank on the outside of the bend is desirable.

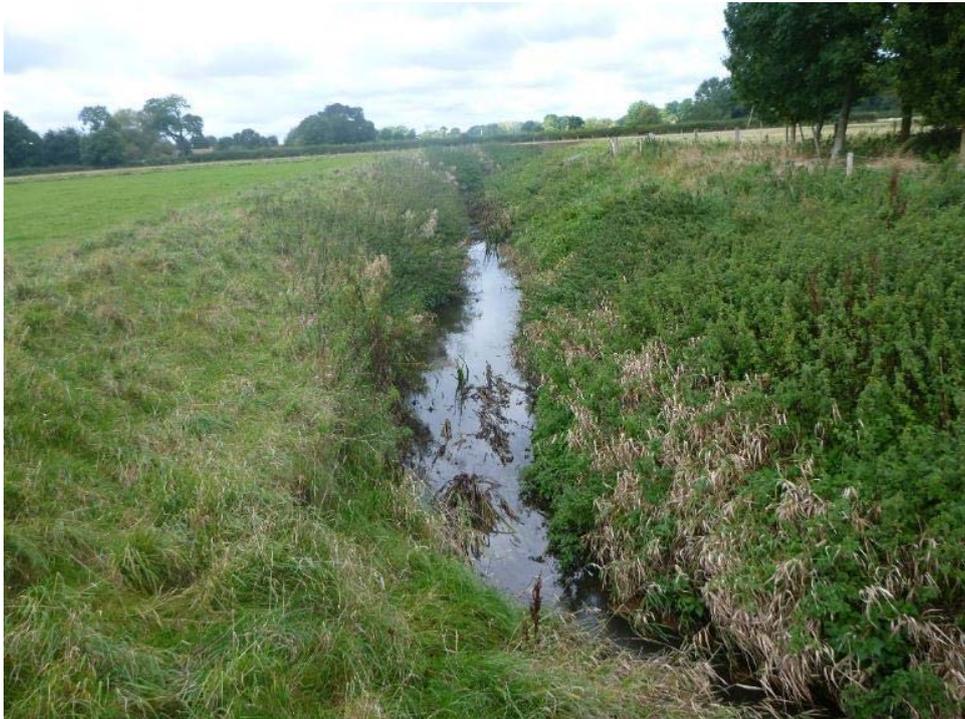
Photo 4 In contrast to Photo 3, the deeply incised character of the channel caused by river engineering persists in many sections. In straight reaches such as this, re-grading the banks to form an inset floodplain and widening the wetted channel in selected areas would promote riffle formation.

- Re-profile the river banks with the aim of creating an inset floodplain (Figure 1). Seek advice from a fluvial geomorphologist on the dimensions of the channel and floodplain level.
- Fence livestock out of the river wherever possible. If long lengths of fencing are not possible, create exclosures and plant trees, similar to the existing areas (Photos 6 & 7). A mixture of native tree species should be used, avoiding the more vigorous willow species. Sallows (*Salix cinerea* and *S. caprea*) are appropriate close to the water. Elsewhere appropriate species include hornbeam, oak, wild cherry,

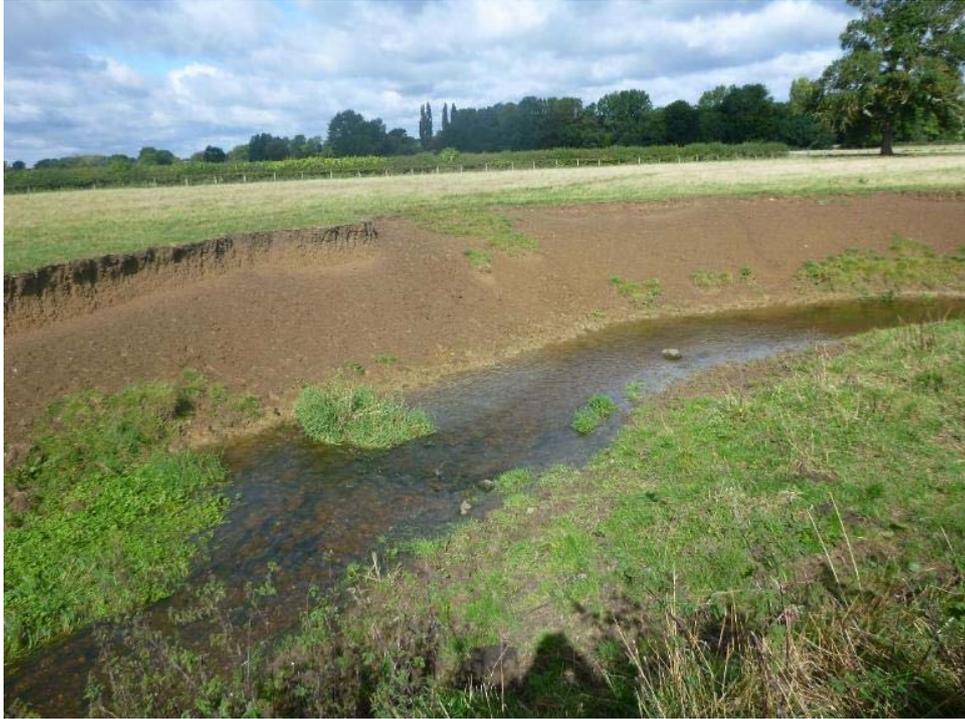
Photo 5 A typical area where livestock are accessing the river and poaching the banks. In this case it is preventing the establishment of a pool on the outside of the bend. Preventing grazing and establishing trees on the outside of the bend should promote pool formation.

The second major impact on habitat quality is grazing by livestock. These are accessing the river in many areas causing bank poaching which widens and shallows the river and inputs excessive amounts of fine sediment.

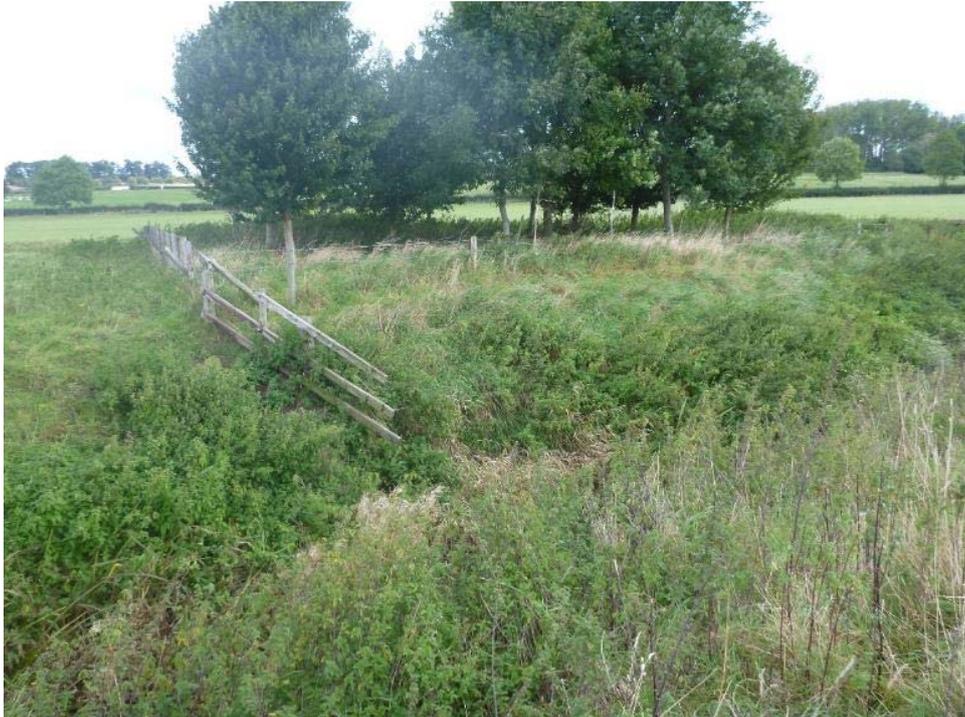
Photo 6 An enclosure with planted trees on the lower river section.

Establishing better riparian habitat, including trees, means fencing out livestock. Members of the club indicated during the visit that the landowner is unlikely to agree to long lengths of fencing and tree-planting because of the increased maintenance burden created. However, it may be possible to create smaller, targeted stock exclosures, following the example of existing areas (Photos 6 & 7) and the area at the upstream end of the fishery which was fenced in 2003.

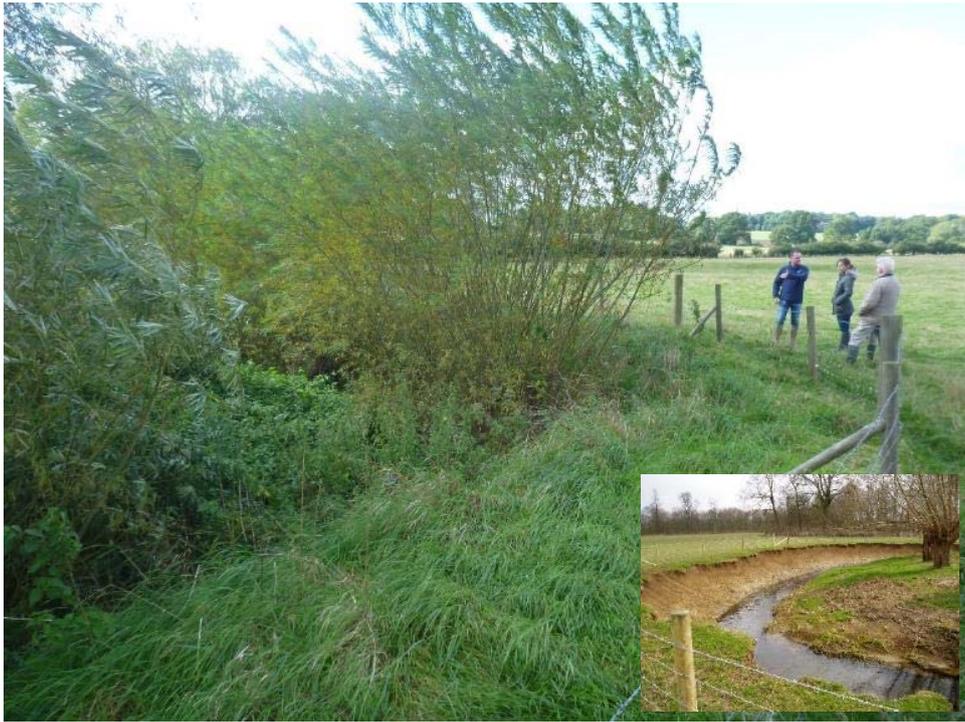
Photo 7 Area which was fenced and planted with willow whips in 2003 (inset). In retrospect, a variety of tree species should have been planted including less vigorous sallows.

- Ensure the existing fencing in the area of Photo 7 remains stockproof. Thin out the willow trees in this area by partially cutting and laying (like hedge laying). “Singling” (cutting to retain just one main stem) of some the willows is recommended to avoid a proliferation of multi-stemmed regrowth; the remaining stem can be subsequently managed as a pollard.

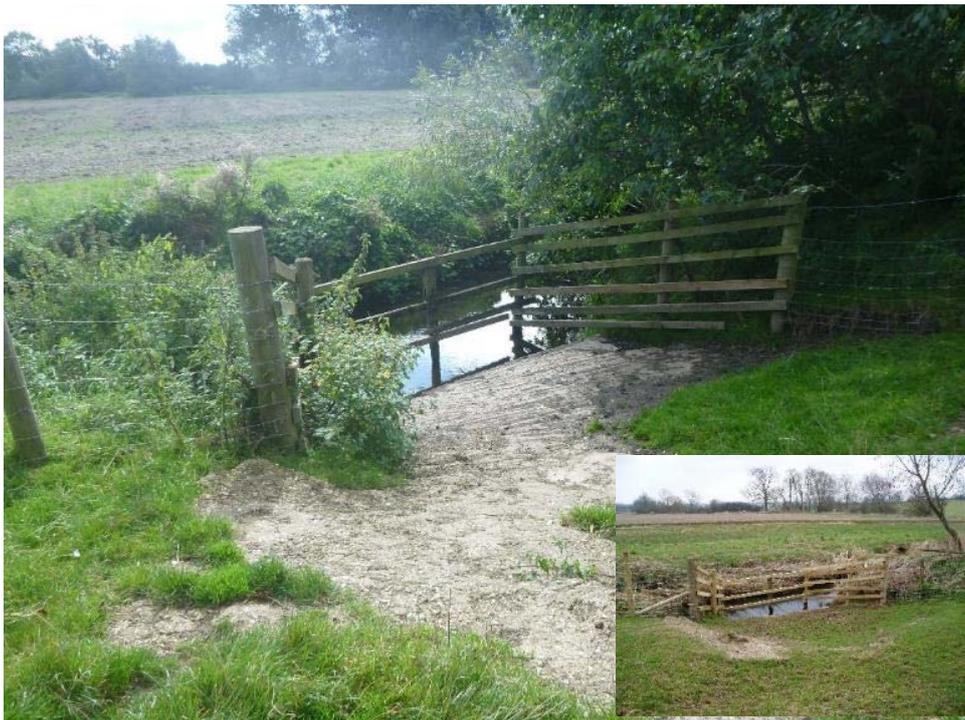
Photo 8 Cattle drink installed in 2003 (inset).

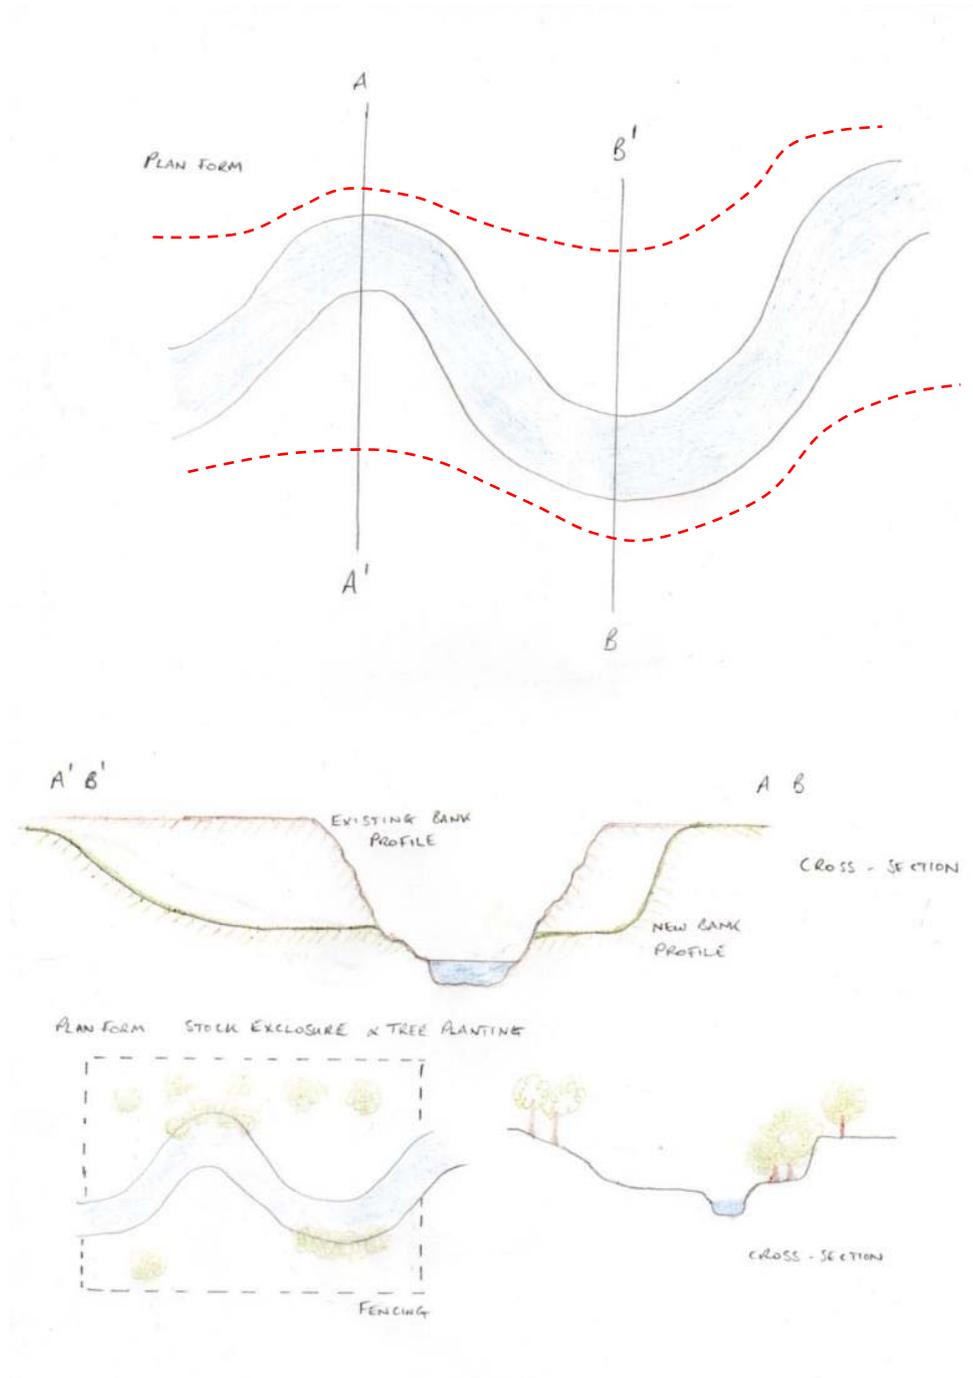
Figure 1 Indicative diagram of bank reprofiling. An inset floodplain is created (at a level based on geomorphologist's advice). On meanders, the inside of the bend is pulled back more than the outside. On straighter sections, the re-profiling is more symmetrical and could be combined with widening the wetted channel to retain gravel and create riffles. Stock enclosures and tree planting could be located in meander areas to provide cover and bank stability on the outside of the bend. Fencing on both banks will be required to prevent stock crossing the river via the lowered banks.

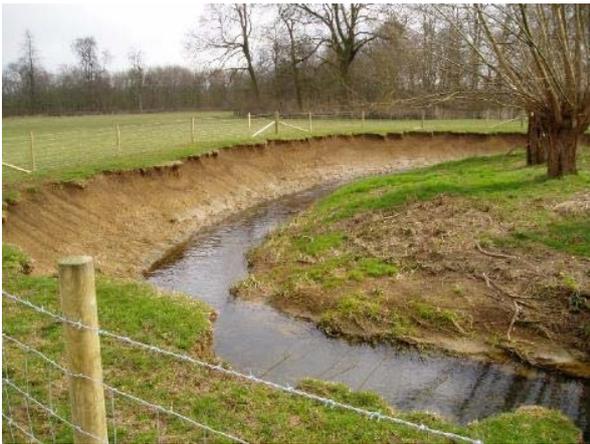
Left:

Poached and eroded banks fenced off, with low growing willow whips planted into the banks.

Right:

Livestock drinking area.
