Advisory Visit

River Seven, North Yorkshire

11th November, 2008

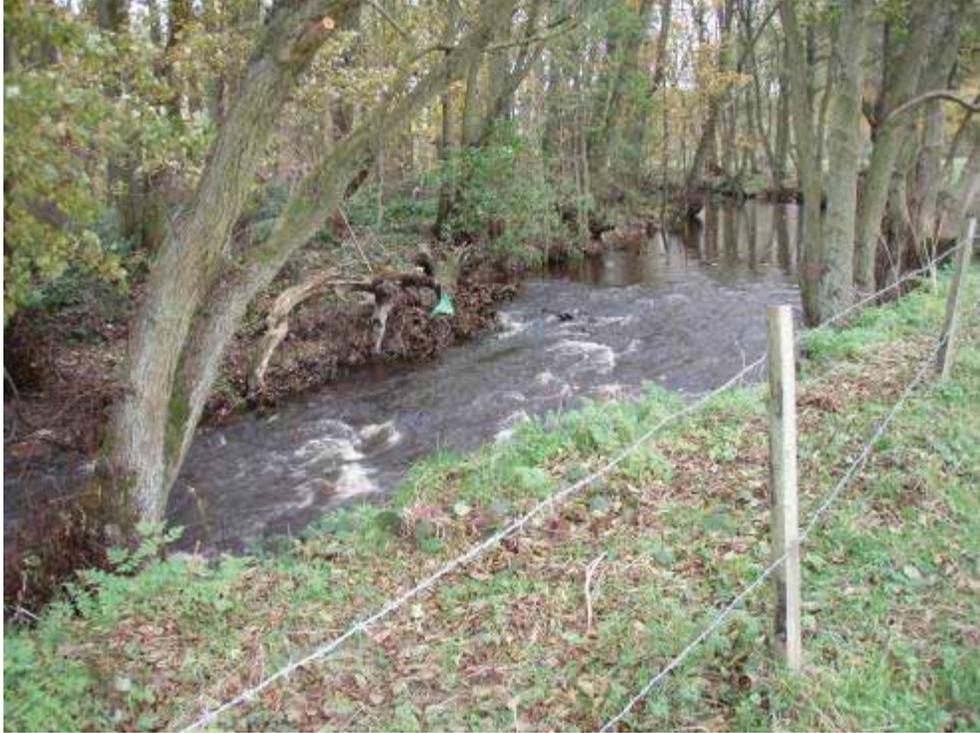
Photo 1 Pool and riffle habitat

The River Seven is an upland rain-fed river running off a moorland catchment area. The instream habitat is generally very good with a natural pool-riffle sequence and a wide variation in depths. There are deep pools, glides, gravel shoals, and broken shallow runs – a good balance of habitat for all life stages of trout. Apart from the more open upstream sections the banks are lined with mature trees, mostly alder, but also ash and some hawthorn (Photos 1 and 2).

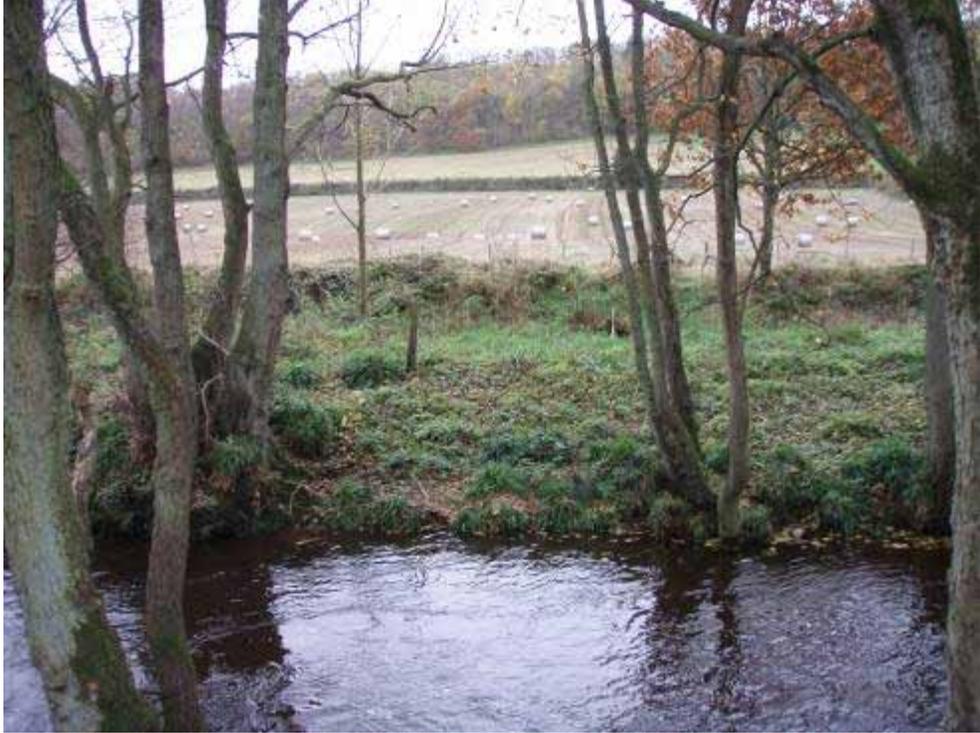
Photo 3 Arable field on the RHB below Seven Bridge with a nice wide buffer zone

alongside the river. In the field on the right bank wheat had been cultivated, and there is a wide margin between the crop and the river (Photo 3).

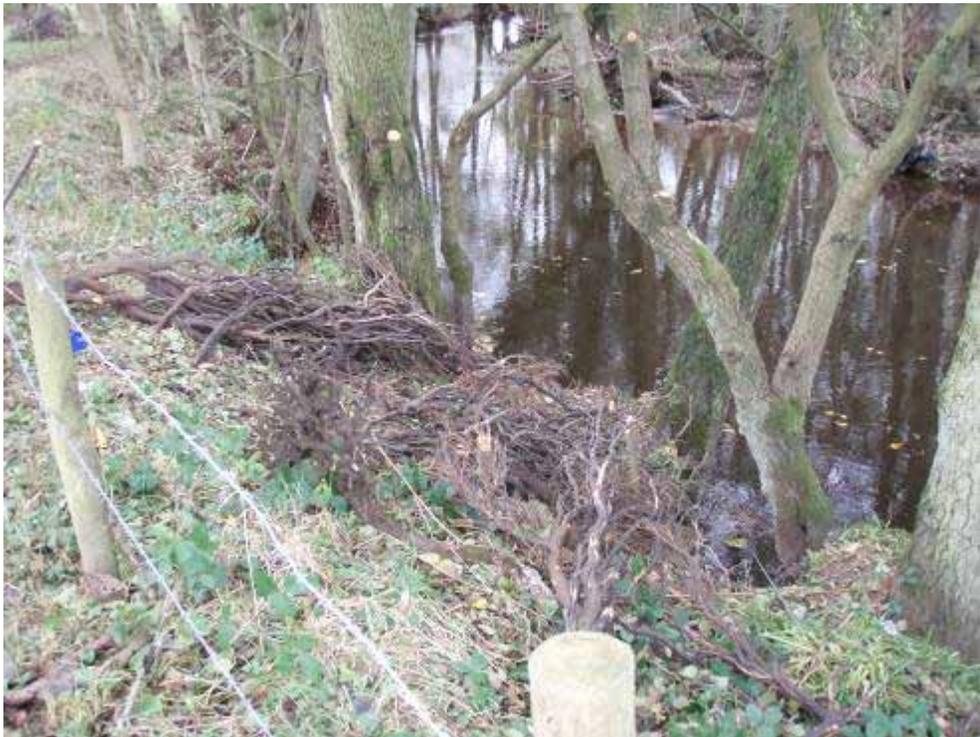
Photo 4 Removal of submerged alders roots – this is undesirable as they are great habitat for trout and crayfish

Ken and Brian have done a tremendous amount of work along the left bank clearing brambles and briars and thinning out the lower branches of trees to allow more light to reach the river channel. This should benefit the river banks by encouraging growth of tall grasses and other low, fringing vegetation. Unfortunately the submerged roots of some alder trees have also been removed; these are very valuable habitat for trout, crayfish and other species (Photo 4). Adult trout in particular will use submerged tree roots as a safe refuge, and establish territories in their vicinity. Removal of the tree roots will cause fish to move elsewhere and generally reduce the carrying capacity of the river for trout.

- Retain alder roots in the watercourse – these are valuable habitat for a range of species including trout and crayfish.
- Take part in the anglers' invertebrate monitoring initiative instigated by the Riverfly Partnership. Regular invertebrate samples provide a quick water quality "health check" and can provide an early warning of pollution problems, such as sheep dip. Details of sampling strategies and training days can be obtained from the Riverfly website at www.riverflies.org . Contact Bridget Peacock riverflies@salmon-trout.org for further details. Suitable nets for sampling macroinvertebrates can be obtained from Alana Ecology www.alanaecology.com Tel: 01588 630173

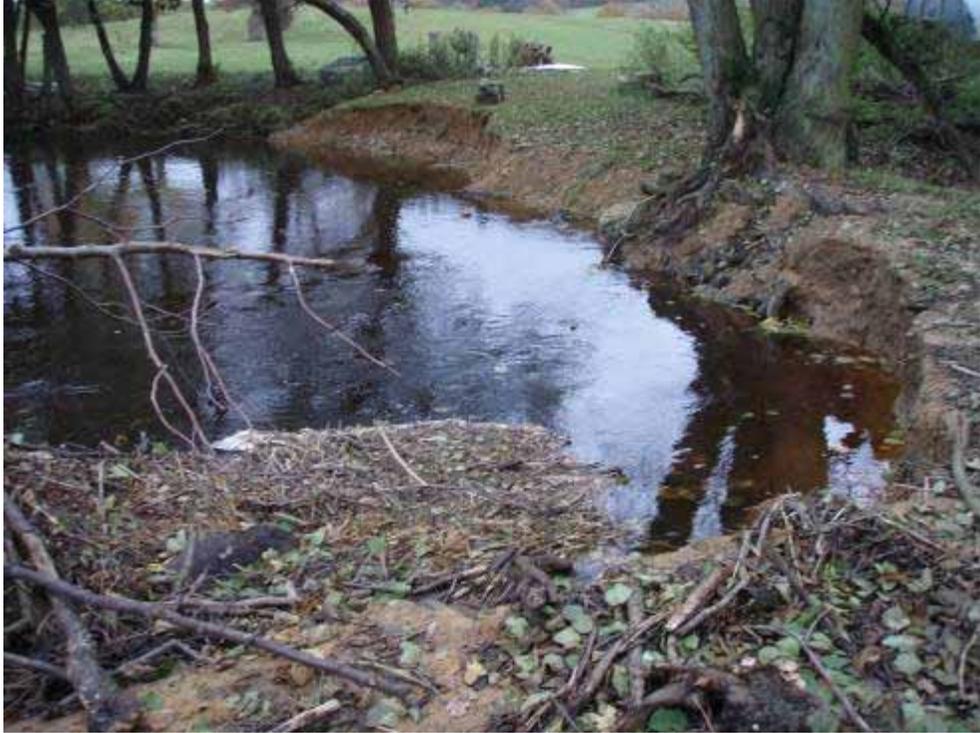
Photo 5 Rapidly eroding banks, cutting behind trees.

Generally the banks of the river are in good condition with little damage caused by grazing livestock. One exception to this was on a sharp bend in the river about halfway between Seven Bridge and Cropton Mill. Here the outside of the bend was eroding quickly leading to the loss of trees (Photo 5).

- The bank erosion observed on the bend between Seven Bridge and Cropton Mill should be addressed to prevent it getting worse. This could be achieved using techniques such as a tree kicker (Figure 1) or brushwood mattresses (Photo 14), in combination with fencing out livestock. Arisings from tree work could be used for this work.

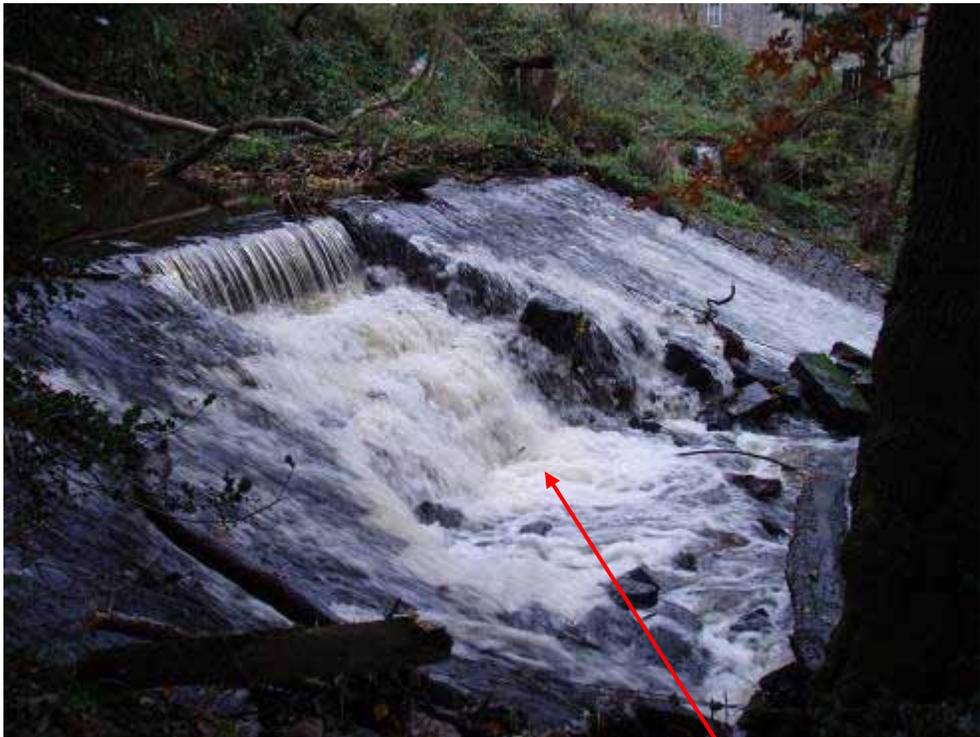
Photo 6 Weir at the mouth of the beck (the mill can be seen in the background). Trout were observed leaping to ascend the weir (unsuccessfully), at this point

At the confluence of the Cropton / Sutherland Beck, there was an old weir across the Beck with a head difference of about 2 metres (Photo 6). Two trout were observed leaping at the weir during approximately five minutes observation, and Ken has subsequently observed many further attempts by trout to ascend the weir. The structure appears to be impassable to fish, certainly at the flows observed on the day, and probably at higher flows as well. The weir appears to have been associated with Cropton Mill, although the leat is now blocked and in-filled.

- The possibility of removing or lowering the weir at end of Cropton / Sutherland Beck should be explored. This will increase access for trout to good quality spawning and juvenile habitat and contribute to improved fish stocks. Consultation with the Environment Agency and NYMNPA is recommended to check what constraints there might be on weir removal, including rights of water abstraction, flood risk issues, archaeological interest and ownership of the structure.

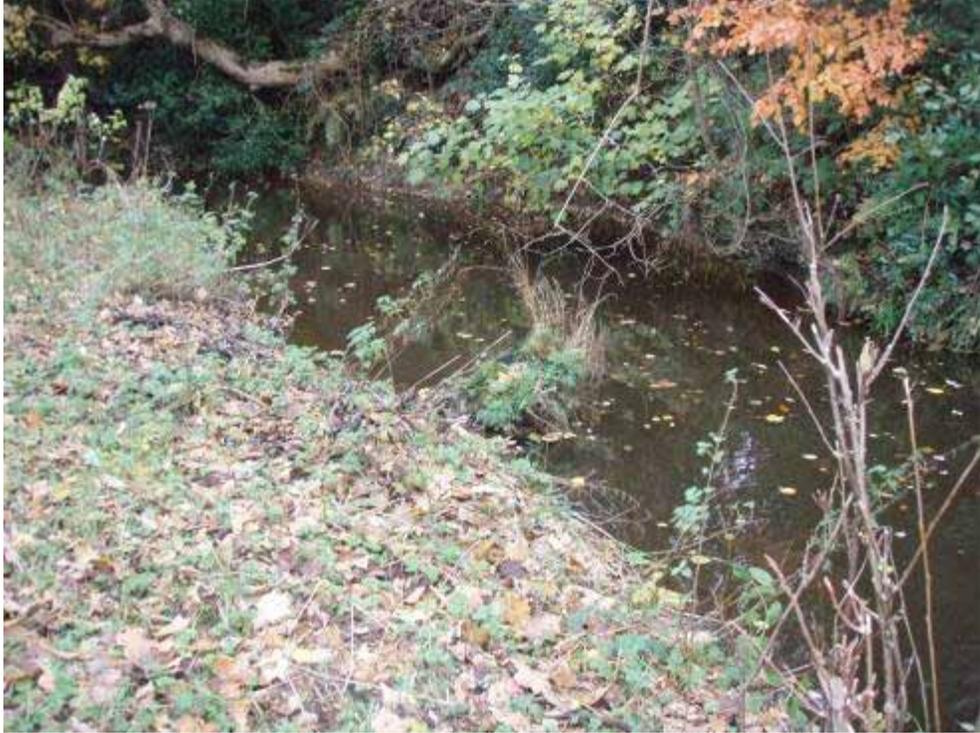
Photo 7 Slow water in the impounded section above the weir

Above the weir, the beck is impounded, slow-flowing and has an accumulation of fine sediment on the bed (Photo 7). There are some good examples of submerged alder roots in this section (Photo 8). Above the backwater effect of the weir the beck has some very good in-stream habitat; there is a pool-riffle sequence with a good balance of adult and juvenile trout habitat. There were one or two areas where livestock had access to the beck for crossing and drinking where the banks were poached – an undesirable source of fine sediment which can impact on trout egg survival – but generally the high banks restricted livestock access (Photos 9 and 10).

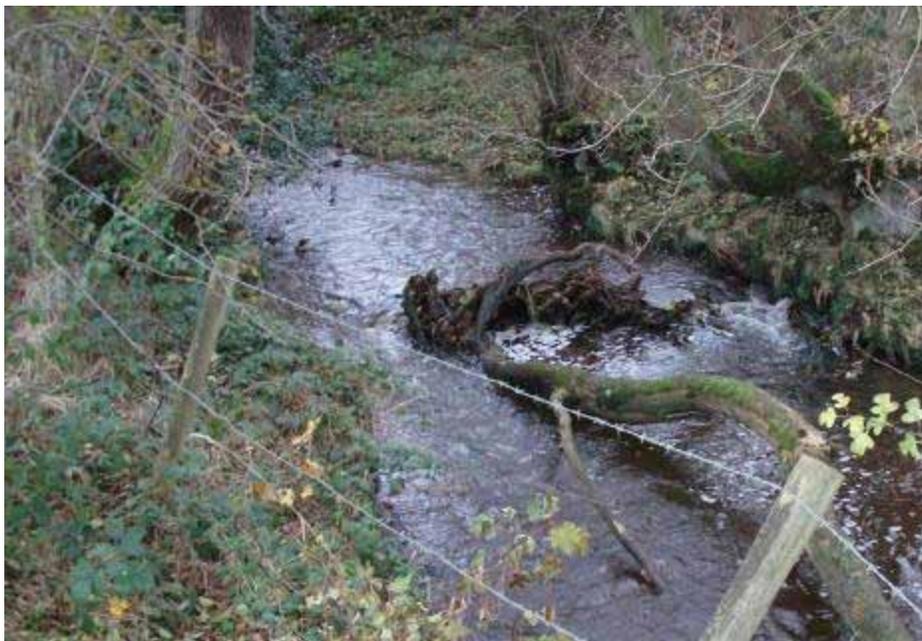
Photo 11 One of the few examples of large woody debris seen during the visit – good habitat that should be retained.

On both the River Seven and the beck, there was generally a lack of large woody debris in the river channel (Photo 11). The presence of LWD has been shown to be extremely important in several respects:

- Adopt a policy of retaining LWD in the river channel wherever possible. The West Country Rivers Trust provides a useful guide to the management of natural LWD:

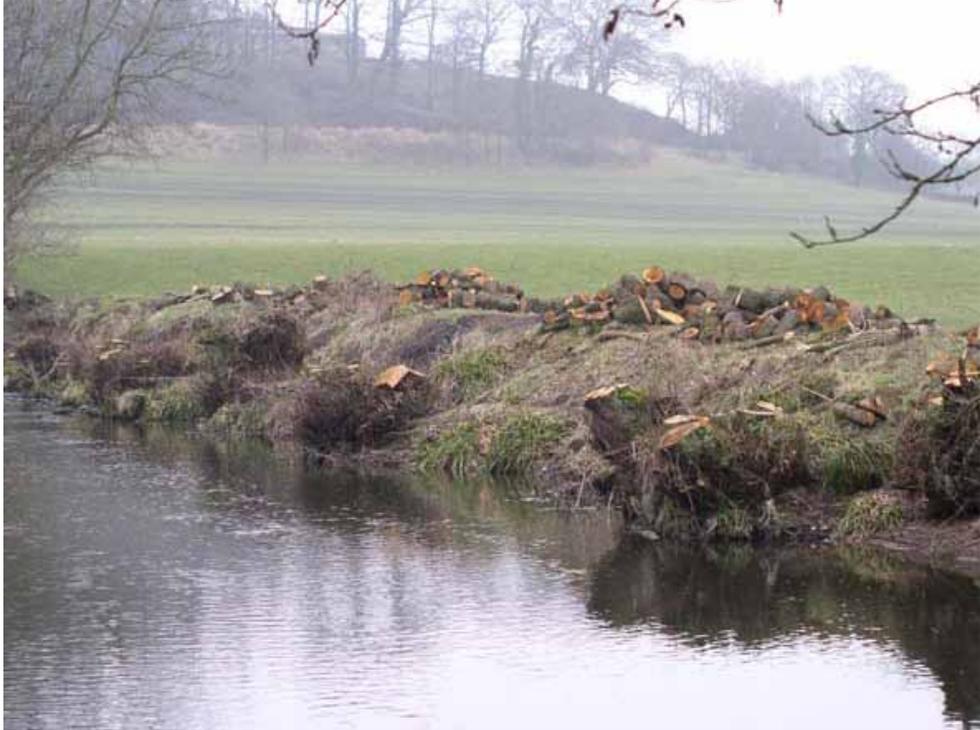
Photo 12 Alders coppiced on the River Dane, Staffordshire, in 2004...

- Selectively coppice the trees along the more heavily shaded sections of the river to encourage a diversity of size and maturity amongst bankside trees, and increased light penetration to the river and banks (Photos 12 and 13). Careful rotational coppicing of selected trees, particularly alder, would enhance the growth of valuable fringing vegetation. Ideally the channel
