## **Sherford Stream, Taunton**

**An Advisory Visit Report by the Wild Trout Trust**

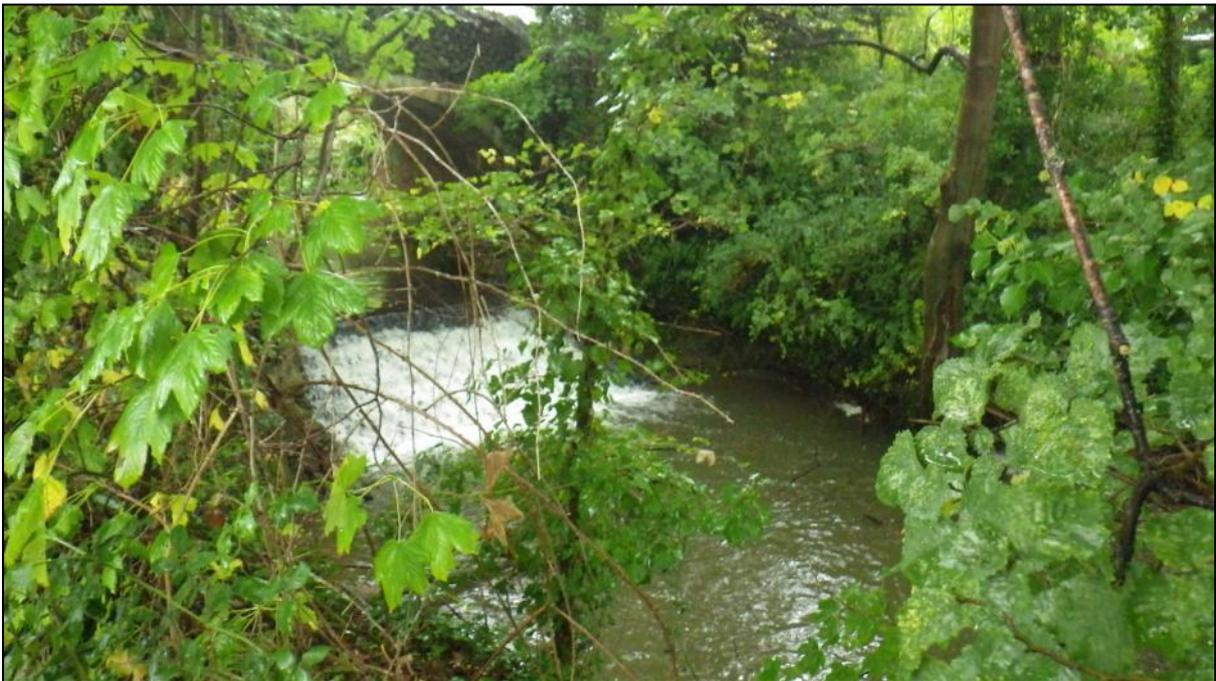
The upstream extent of the section of the Sherford Stream visited was at NGR: ST223230 near Pikes Crescent. The stream is heavily impounded by a tall stepped weir that slackens flows upstream and fragments the river habitat by acting as a barrier to fish passage.

**Figure 2: A tall stepped weir at ST223230 is impassable to fish**

It is strongly recommended that a feasibility study be undertaken by the Environment Agency to assess the possibility of removing weirs along the Sherford Stream. If for any reason a barrier cannot be removed i.e. for reasons of flood defence, disproportionate costs or planning constraints; then a secondary substitute may be to ease fish passage over the structure.

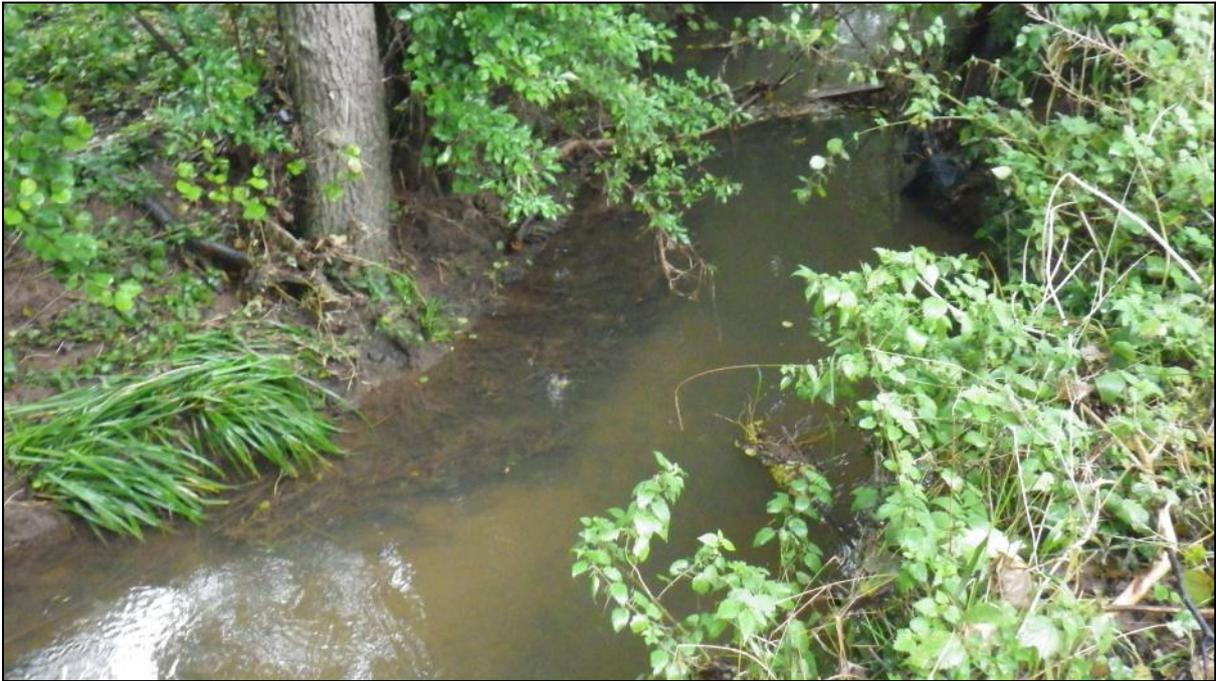
Downstream of the weir, natural geomorphology has shaped the stream into a physically diverse habitat that follows a sinuous meandering path through a tree-lined river corridor. Naturally-formed pools and riffles provide a wide range of water depths and woody debris and tree roots have helped to provide a diverse variety of habitat features. It is these very features that are prevented from forming *upstream* of the weir due to the impoundment of flow.

**Figure 3: Tree roots and woody debris enhance a pool habitat**

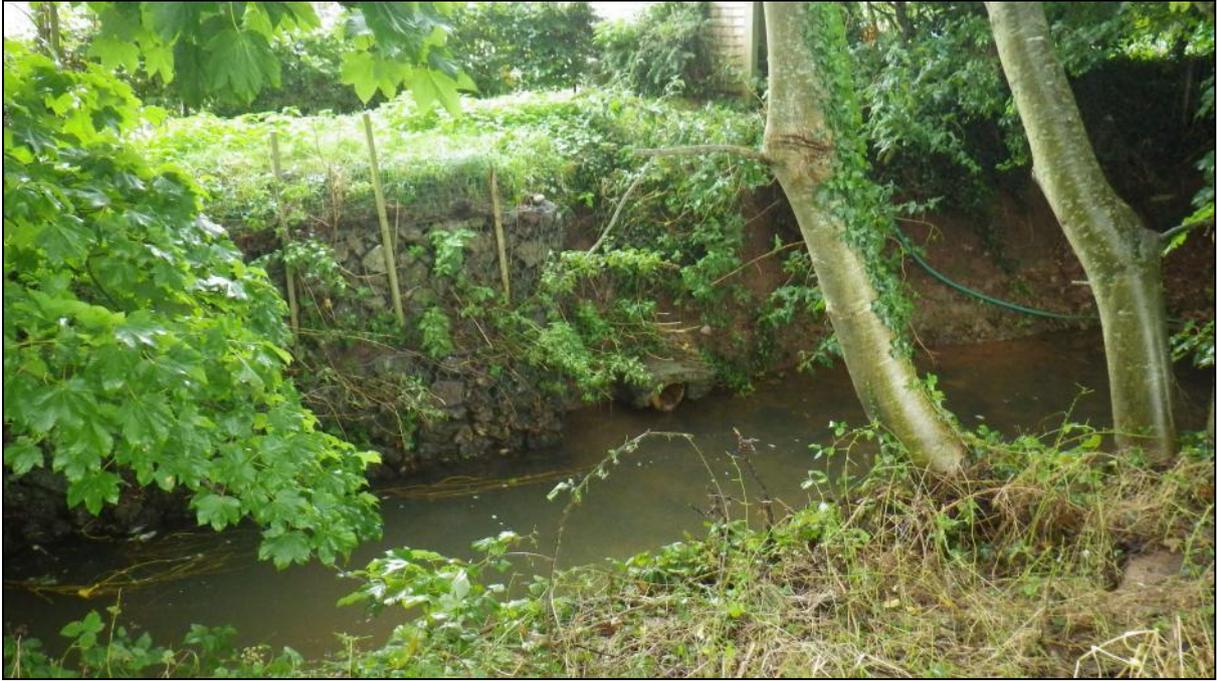
The quality of bankside habitat varies considerably along the reach depending on the proximity of private properties and infrastructure, and the consequent engineering works installed to control erosion. Where the banks are heavily modified, small outfalls were frequently observed discharging into the stream. Further investigation may be required to ascertain whether or not such discharges are affecting water quality.

**Figure 4: An engineered gabion basket bank revetment and small outfall**

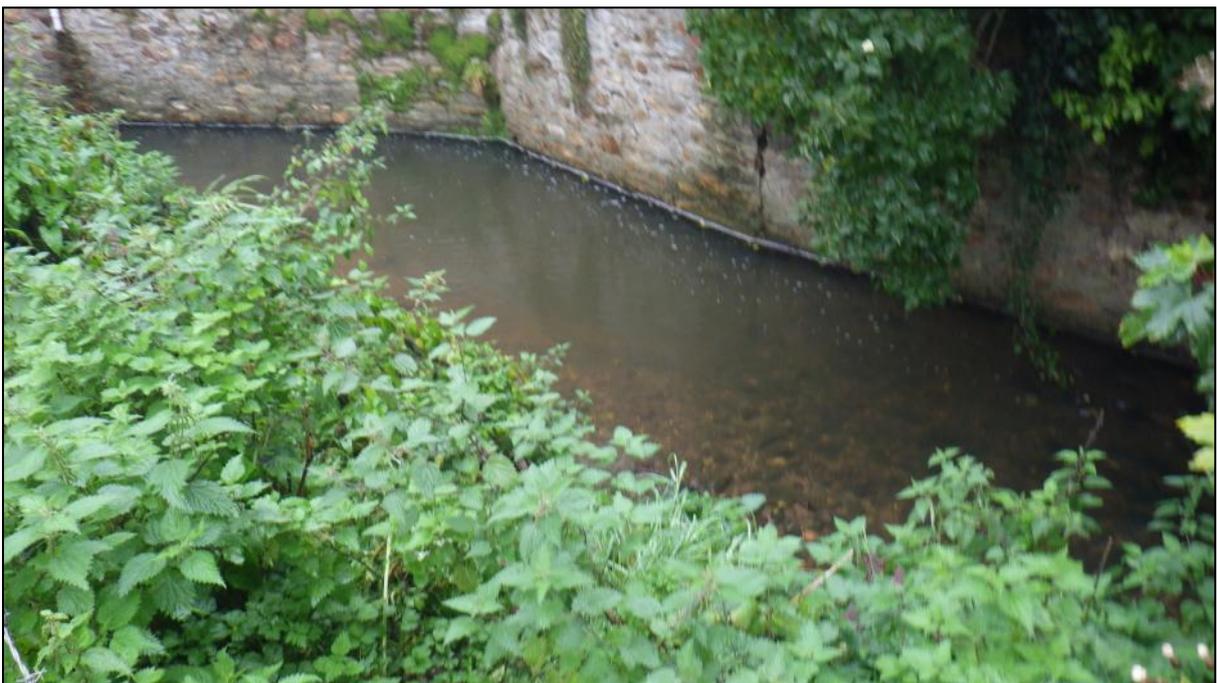
Fortunately, in some locations where the banks are heavily modified, the flashy nature of the catchment means that sudden energetic flows have scoured a sequence of pools and riffles on the bed, retaining a level of physical diversity.

**Figure 5: A scour pool against a heavily engineered bank**

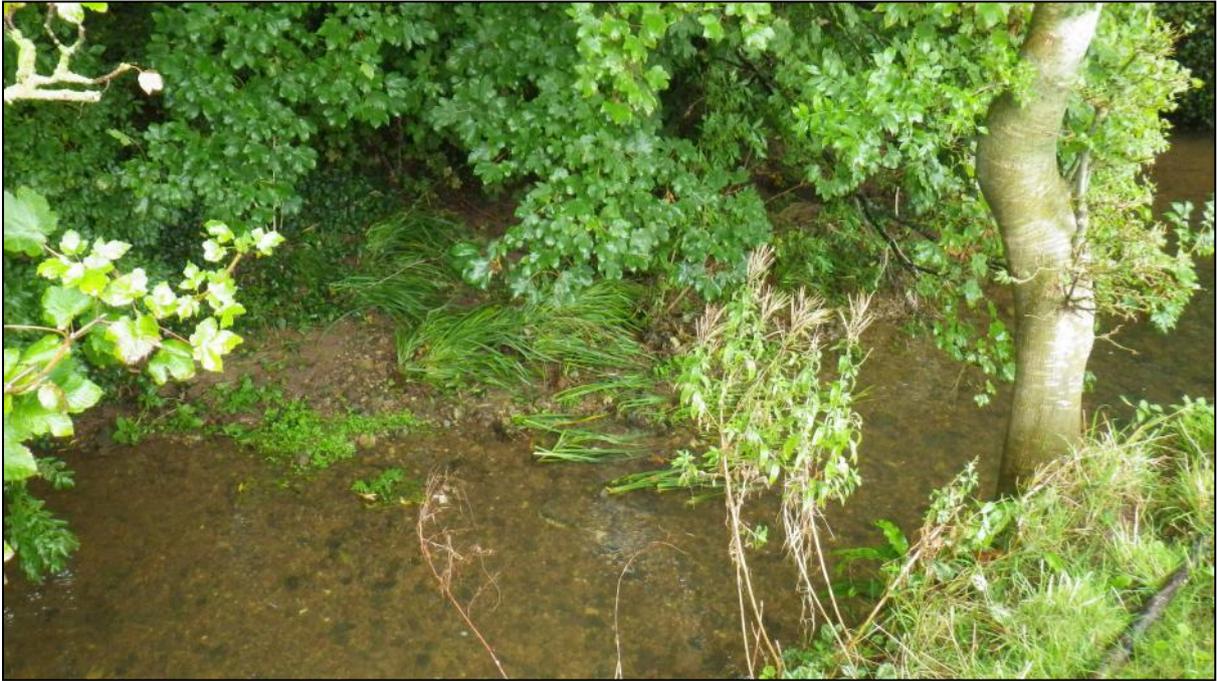
Sudden high-energy flows have augmented geomorphological processes creating occasional small, sandy gravel shoals that provide marginal habitat for plants unable to colonise the steep, shady banks.

**Figure 6: A sandy gravel shoal provides marginal habitat**

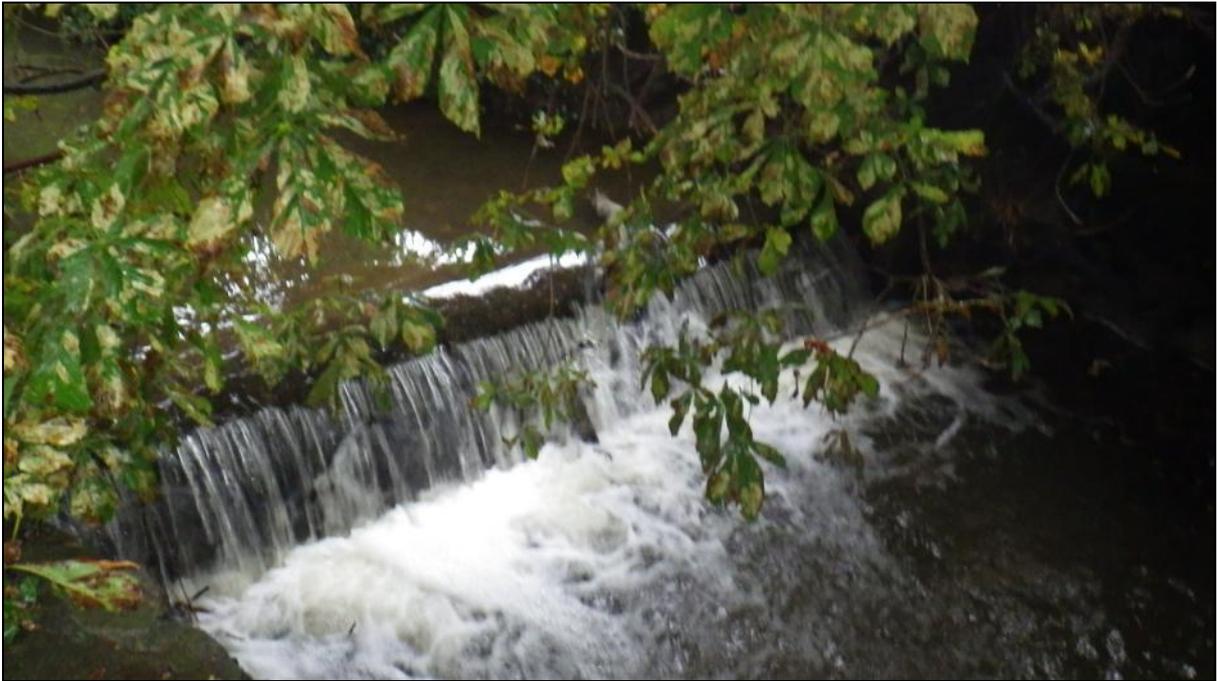
Natural processes have shaped a diverse brown trout habitat. Resident fish populations are however fragmented by impassable weirs that obstruct access to the full range of available habitat.

**Figure 7: One of the smaller weirs on the Sherford Stream**

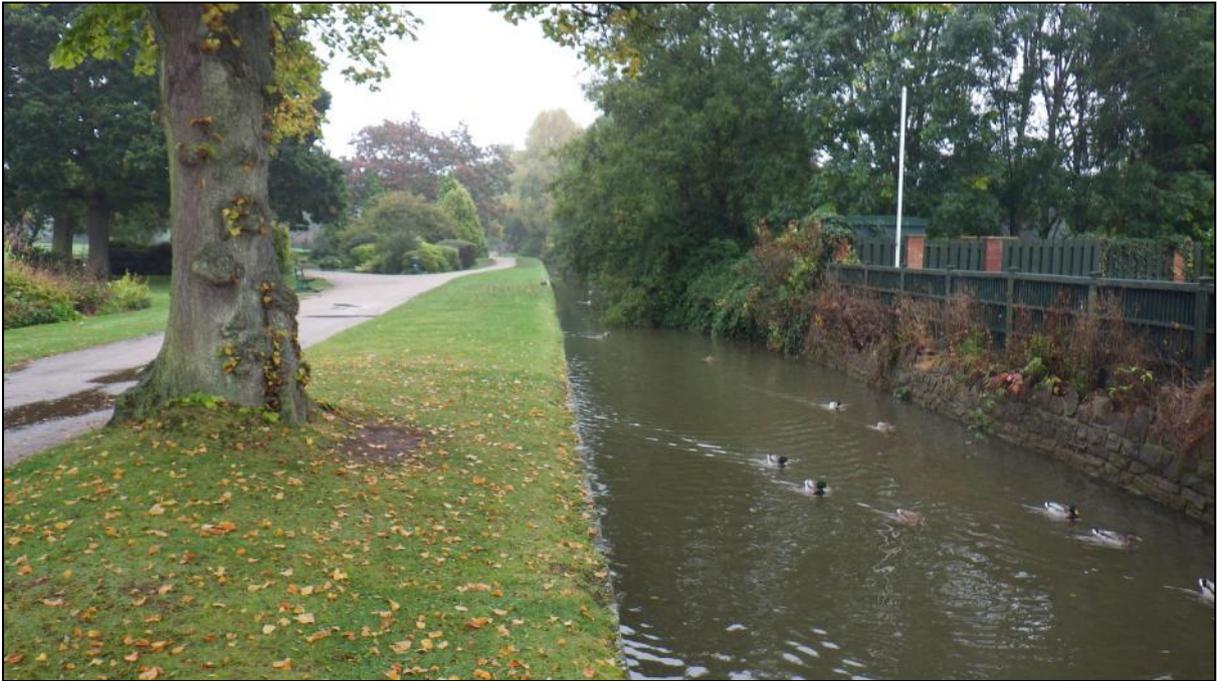
**Figure 8: A straightened section known as Sherford Leat runs through Vivary Park**

The straightened leat is a homogenous habitat. The over-wide channel has caused flows to be sluggish, allowing fine sediment to drop out of suspension and uniformly smother the bed. Natural geomorphology no longer functions and there is a paucity of marginal wetland habitat. Some cover is provided by overhanging branches and brambles on the left bank.

Sherford Leat would benefit from the introduction of some physical variation in terms of both flow diversity and habitat features. In particular, the introduction of some marginal cover would greatly enhance the habitat for adult trout.

A sweet chestnut post revetment back-filled with brushwood and topped with a geotextile 'grow bag' filled with dredgings from the leat; could be planted with marginal plants. Occasional branches protruding from the brushwood structure could be wired to the posts to provide sub-surface marginal cover for trout.

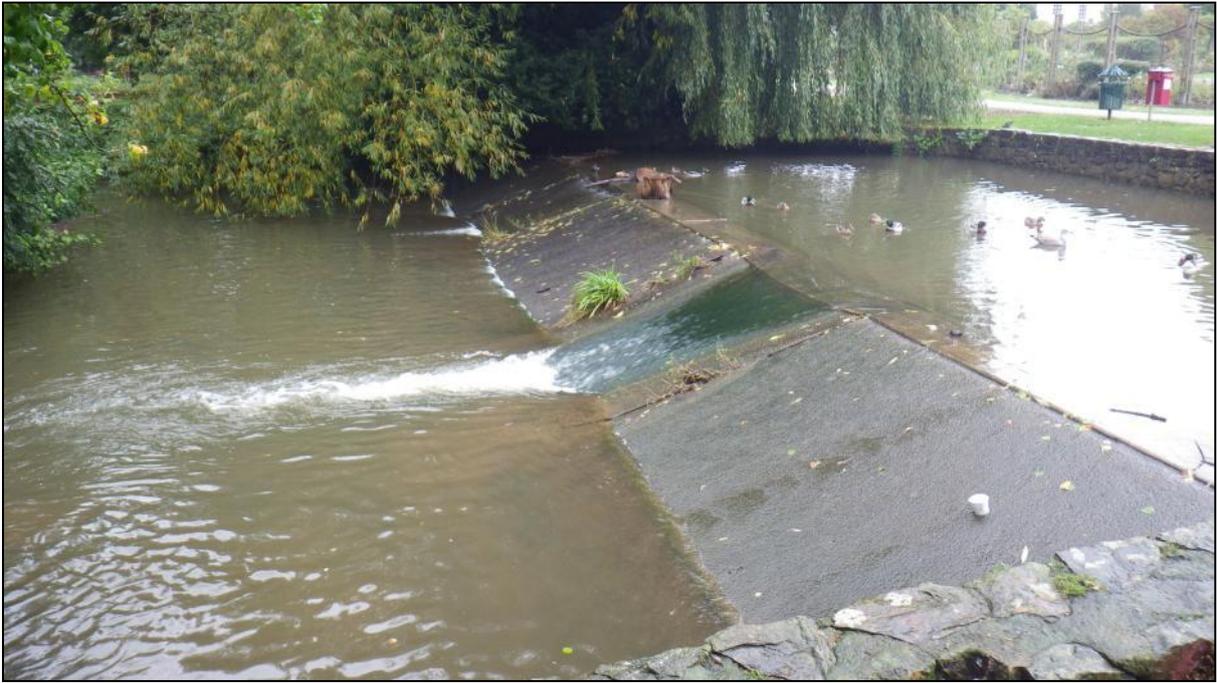
In the past century, the lower end of the leat has been filled-in and the stream diverted west and then northeast to join the Tone. The diversion consists of a large sloping crest weir on the LB. This structure is a severe barrier to fish passage.

**Figure 9: A sloping crest weir diverts the stream west through an online lake**

The sloping crest weirs within the ornamental lakes at Vivary Park are a major barrier to fish passage. It may be possible to bypass the weirs by creating a new sinuous stream around the lake. Bypassing the weirs with a new naturalistic channel would be an opportunity to create some high-quality habitat amidst a heavily modified section of the river that would

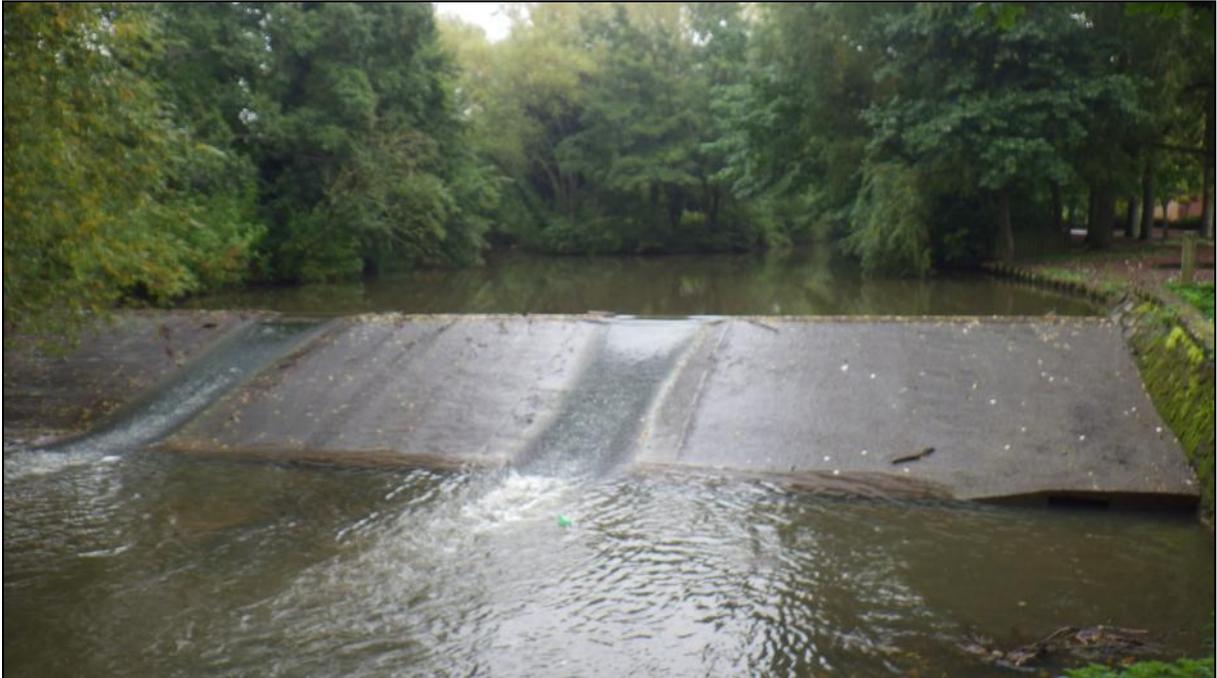
The weir diverts water into an ornamental online lake retained by an even larger sloping crest weir.

**Figure 10: A larger weir holds water in the ornamental lake**

Even in high flows it is very unlikely that either of these weirs is passable for fish.

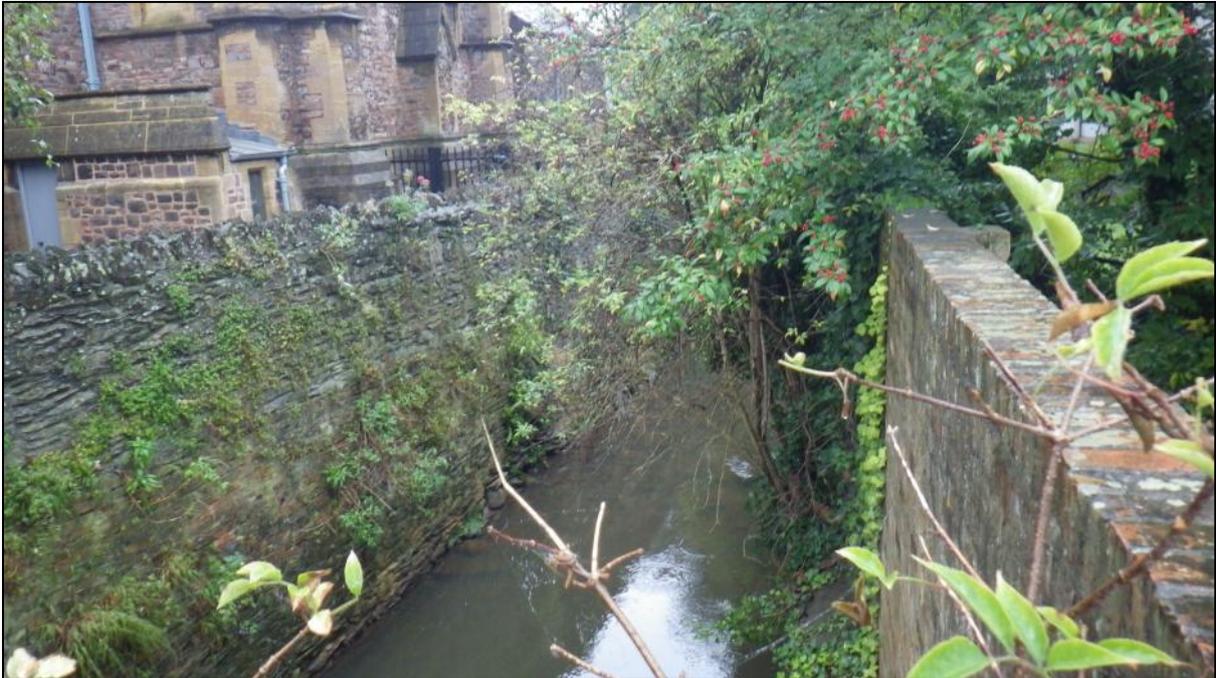
Downstream of the lake the stream resumes a more appropriate width but flows through a heavily-engineered, canalised channel. A small weir poses an obstruction to fish passage but is probably passable during high flows. The stream flows between vertical brick and stone flood walls and is virtually inaccessible.

**Figure 11: The stream is canalised by tall brick and stone walls**

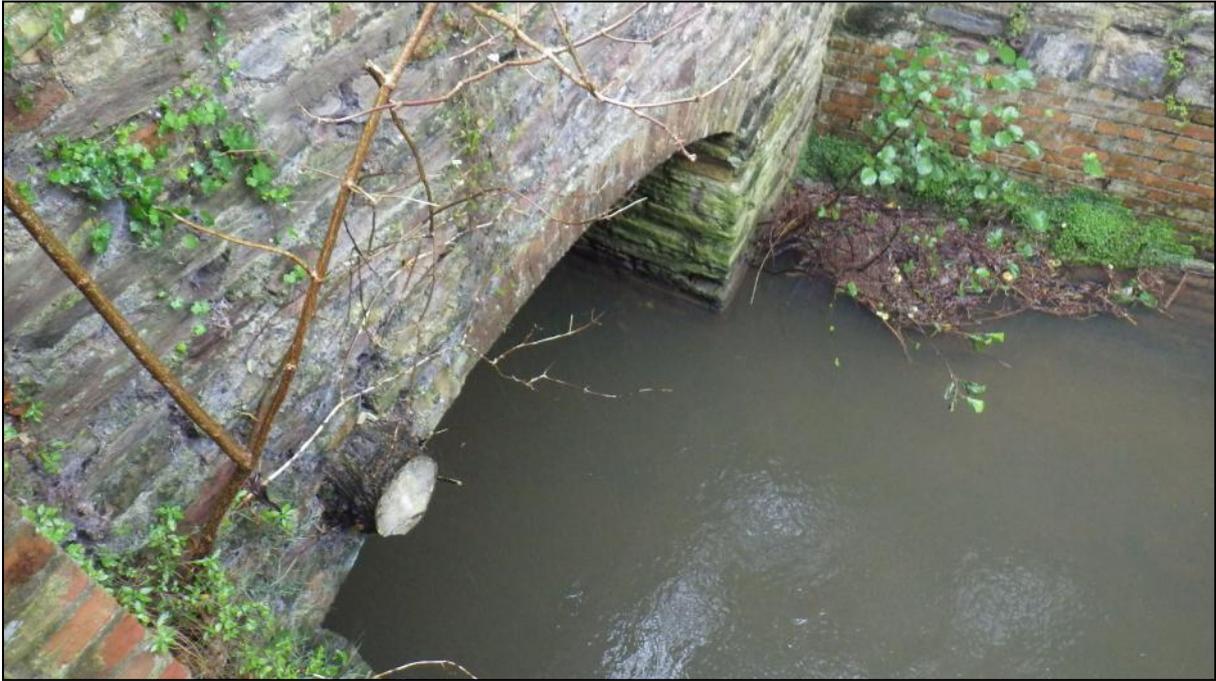
Near the police station at NGR ST224241, the stream enters a very long culvert passing under the A38 and the County Court building.

Culverts are often barriers to fish migration. Excessive water velocity or turbulence, drops at culvert outlets, physical barriers inside the culvert such as debris caught in the culvert barrel, and low flows can all make culverts difficult to traverse. In addition, the longer the culvert, the greater the energy exertion required for fish to swim through.

Even if none of these issues affect the culvert, the sheer length of the structure means that the stream is kept in perpetual darkness. Research suggests that salmonids may be dissuaded from entering dark culverts (Kemp *et al.*, 2006), (Weaver *et al.*, 1976).

**Figure 12: The downstream end of a roughly 180-m culvert**

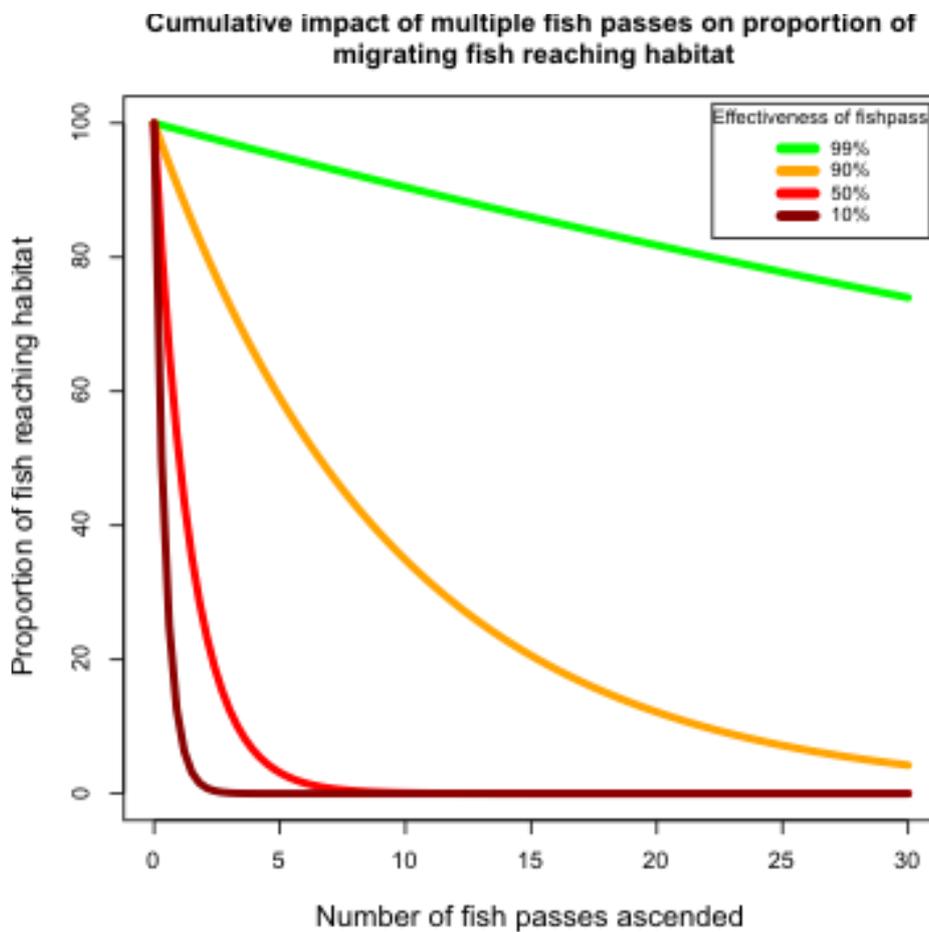
The number of impassable weirs on the stream makes it highly unlikely that the trout populating the stream have migrated upstream from the River Tone. Research suggests that even the most passable of obstructions can have a considerable impact on fish migration, particularly if fish must overcome consecutive obstacles to reach an upstream habitat.

Figure 17: Graph showing the cumulative effect of multiple obstacles to fish passage on upstream migration (courtesy of Dr E Shaw, Catchment Science Centre, University of Sheffield).

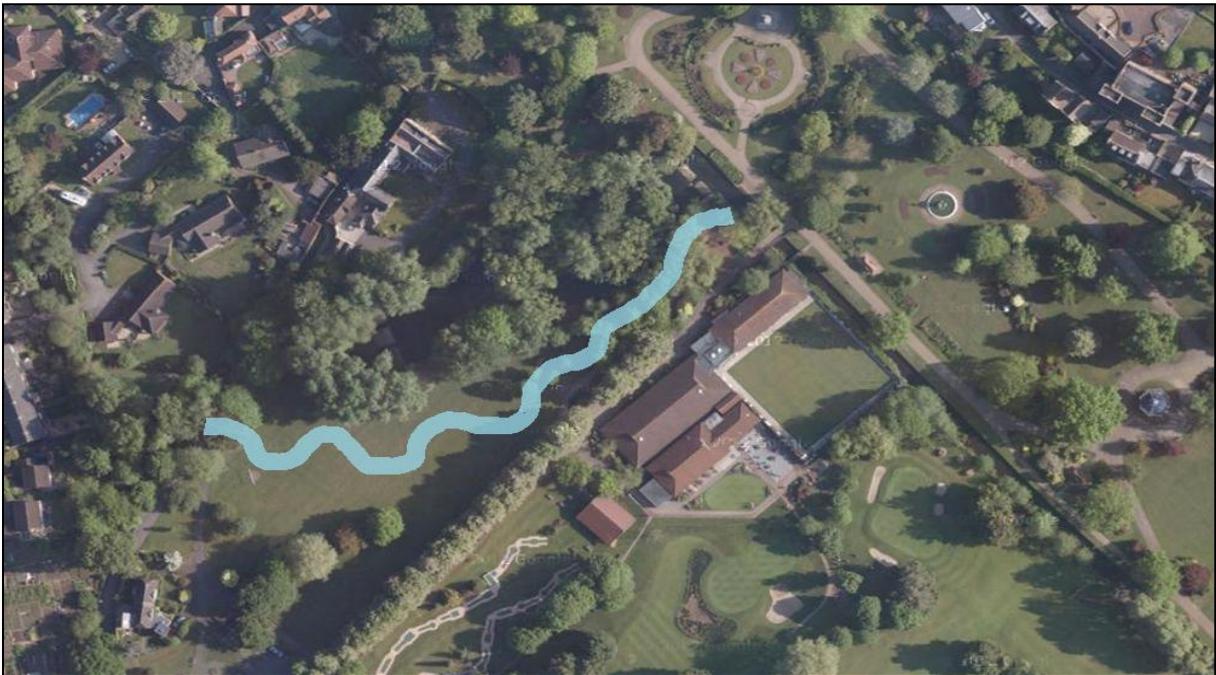
**Figure 18: A possible location for a naturalistic bypass channel around the lake at Vivary Park**

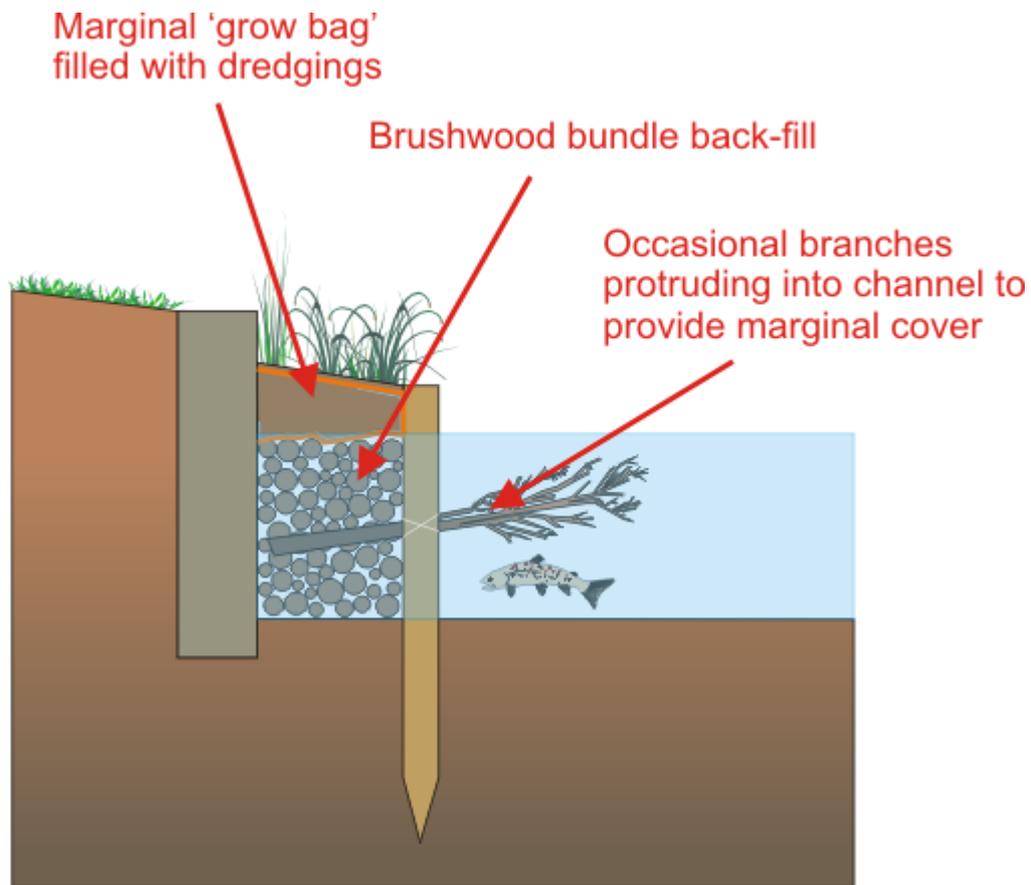
Figure 19: An example cross-section of a marginal revetment with sub-surface cover for trout

This structure would enhance the biodiversity and visual aesthetics of Sherford Leat without clashing with the manicured character of Vivary Park. The brushwood marginal cover would be barely visible below the surface and the marginal vegetation could provide nesting habitat for local waterfowl.
