Advisory Visit

Skeeby Beck, North Yorkshire

2nd November, 2009

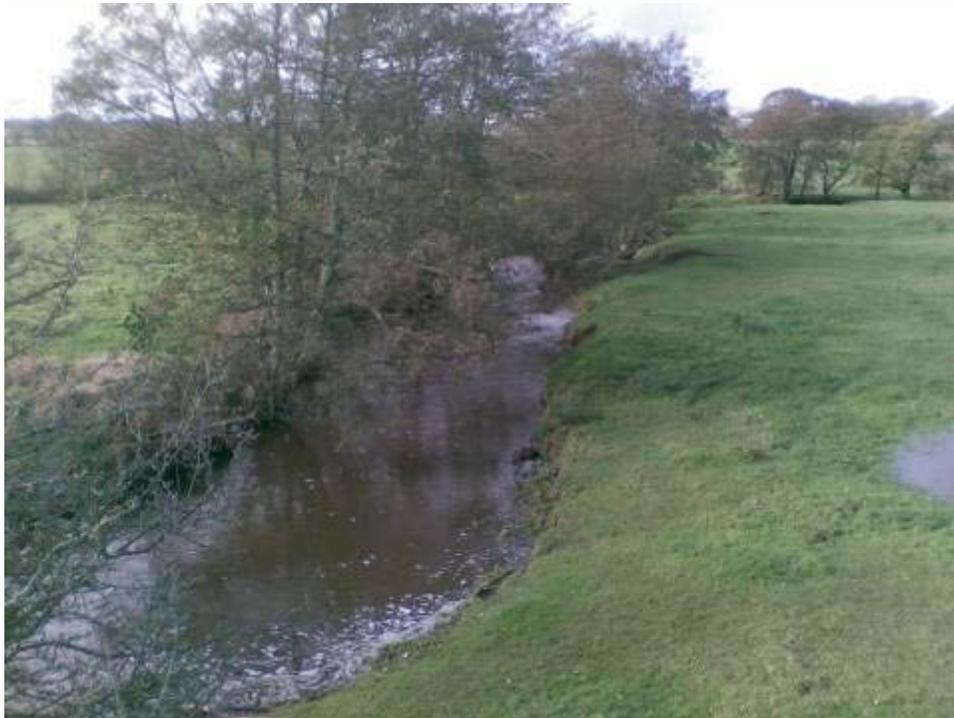
Photo 2

Riparian land use alongside the beck was largely grazing for horses, with some arable (rape) cultivation towards the downstream end of the fishery. It is preferable to have pasture rather than cultivated land alongside watercourses to minimise sediment run off into the river which damages fish spawning habitat. All the land is within the Entry Level Stewardship scheme (ELS). The arable fields have a generous headland alongside the river, which promotes a strip of 'shaggy' marginal vegetation alongside the river – this is good habitat which provides excellent cover for fish where it overhangs the river margins. In contrast, the grazing fields have unfettered stock access to the river, and here marginal vegetation tends to be closely grazed (Photo 2).

The grazed banks would benefit from reduced grazing pressure to promote the growth of 'shaggy', overhanging marginal vegetation. However, there is a caveat, in that the invasive non-native plant Himalayan balsam is present. Grazing pressure may currently be limiting the spread of this species, so some alternative means of control may have to be instigated if grazing is reduced. The use of temporary electric fencing, or fencing with gates to allow controlled grazing access, could be used to achieve a balance between a healthy riparian zone and controlling balsam. If the manpower is available, two or three working parties can effect reasonable control by hand pulling before the balsam flowers in late June.

- Create a buffer strip alongside the river to reduce grazing pressure and promote growth of a shaggy riparian fringe and encourage tree succession.
- Consider becoming involved in the Riverfly Partnership invertebrate monitoring scheme.

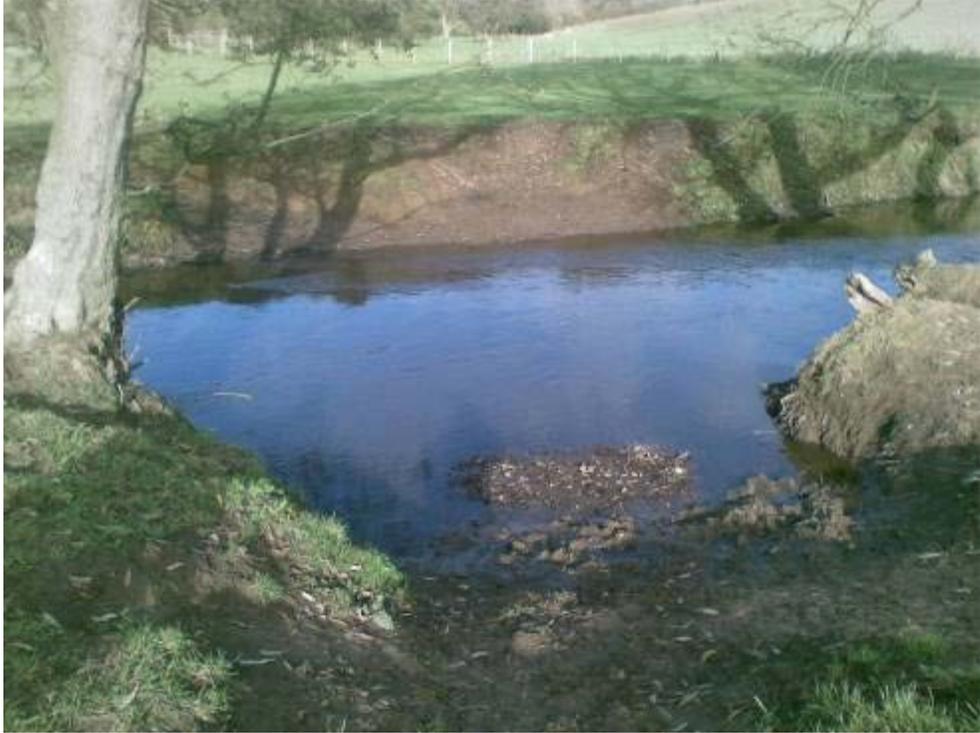
There are a number of crossing points for farm vehicles and animals along this stretch of the beck. These create pathways for sediment to be washed into the river. Fine sediments can clog riverbed gravels and smother incubating trout and grayling eggs, which require a constant flow of water through gravels to provide oxygen and remove metabolic waste. Trout eggs are particularly vulnerable, as they can spend around 5 months within the gravel (November – March). Measures to reduce the risk from these access points include reducing their number and reinforcing the approach / standing areas.

Photo 3 River crossing point – a source of fine sediment

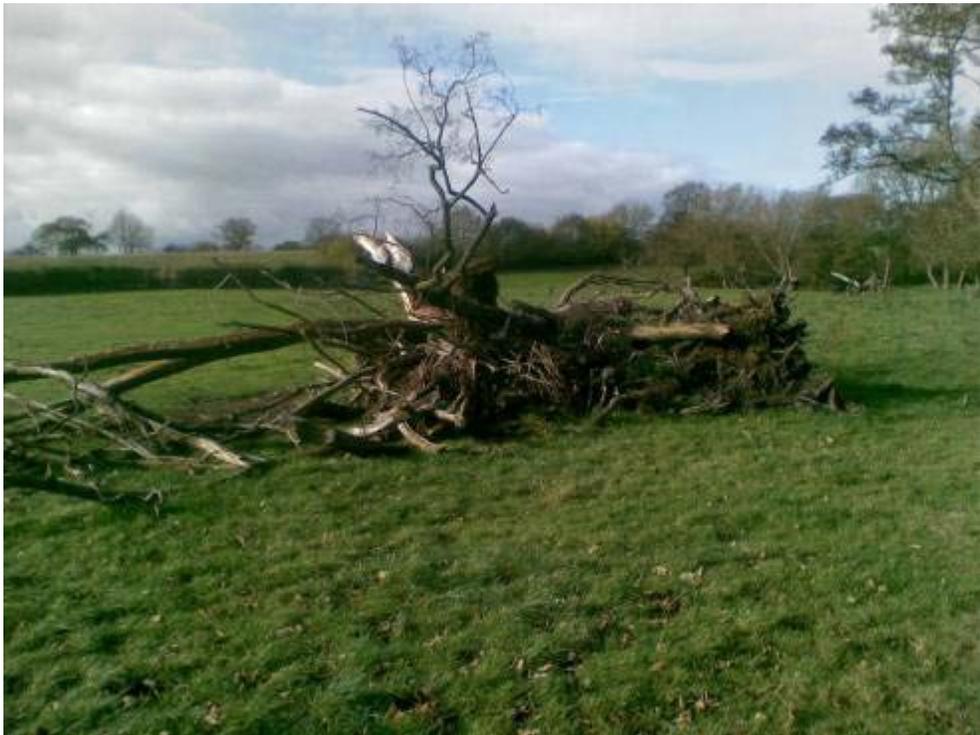
Photo 4 Large woody debris removed from the beck

In a number of areas, fallen trees and debris dams had been removed from the beck. 'Large Woody Debris' (LWD) is a general term referring to all wood naturally occurring in streams including branches, stumps and logs. Almost all LWD in streams is derived from trees located within the riparian corridor. Streams with adequate amounts of LWD tend to have greater habitat diversity, a natural meandering shape and greater resistance to high water events. Therefore LWD is an essential component of a healthy stream's ecology and is beneficial by maintaining the diversity of biological communities and physical habitat.

Traditionally many land managers and riparian owners have treated LWD in streams as a nuisance and have removed it, often with uncertain consequences. This is often unnecessary and harmful: stream clearance can reduce the amount of organic material necessary to support the aquatic food web, remove vital in-stream habitats that fish will utilise for shelter and spawning and reduce the level of erosion resistance provided against high flows. In addition LWD improves the stream structure by enhancing the substrate and diverting the stream current in such a way that pools and spawning riffles are likely to develop (Figure 1). A stream with a heterogeneous substrate and pools and riffles is ideal for wild trout and a range of other species.

If a tree trunk or branch is causing a severe problem then by all means move it but try and retain as much within the channel as possible, or reposition it to a more favourable location. LWD may make some sections of river unfishable, but the chances are its retention will increase trout stocks; it is without doubt the simplest and easiest way to promote improved habitat on a stream like the Skeeby Beck. Further advice LWD retention is available from the Wild Trout Trust.

- Adopt a policy of retaining natural LWD in the river channel unless it is causing significant problems. The West Country Rivers Trust provides a useful guide to the management of natural LWD:
 1. Is the debris fixed, if yes then continue to 2, if not continue to 5.
 2. Is the debris causing excess erosion by redirecting the current into a vulnerable bank? If yes then go to 5 if not then go to 3.

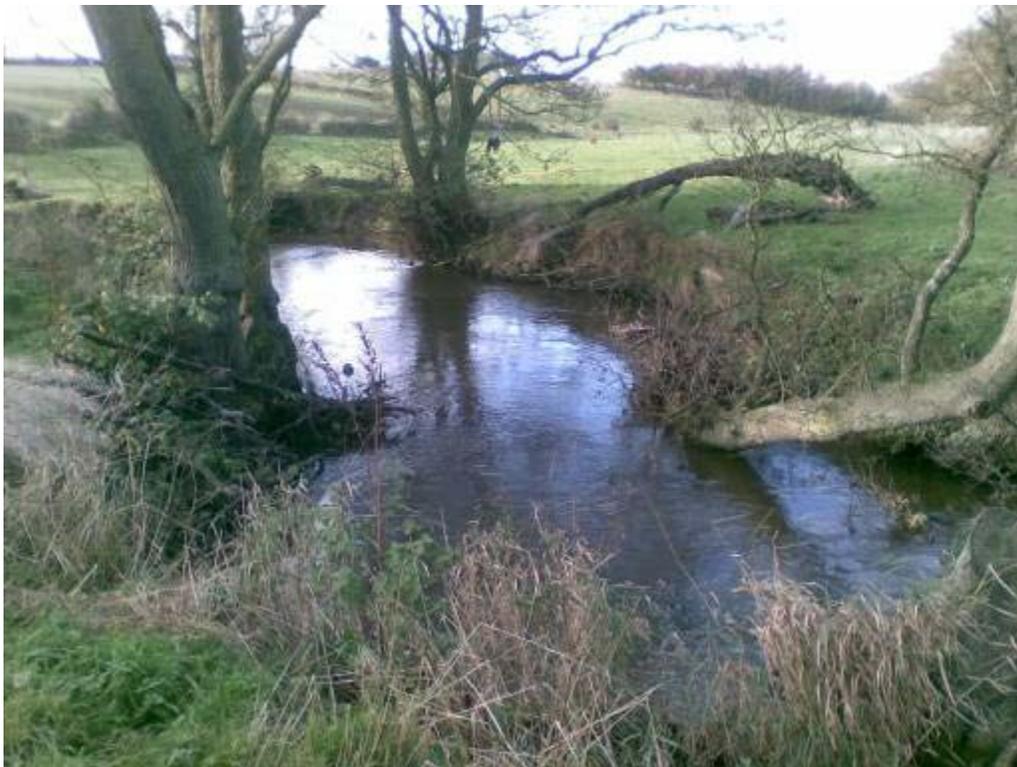
Photo 5 Retained LWD (foreground) and removed (background, left) – the former is most beneficial to fish stocks

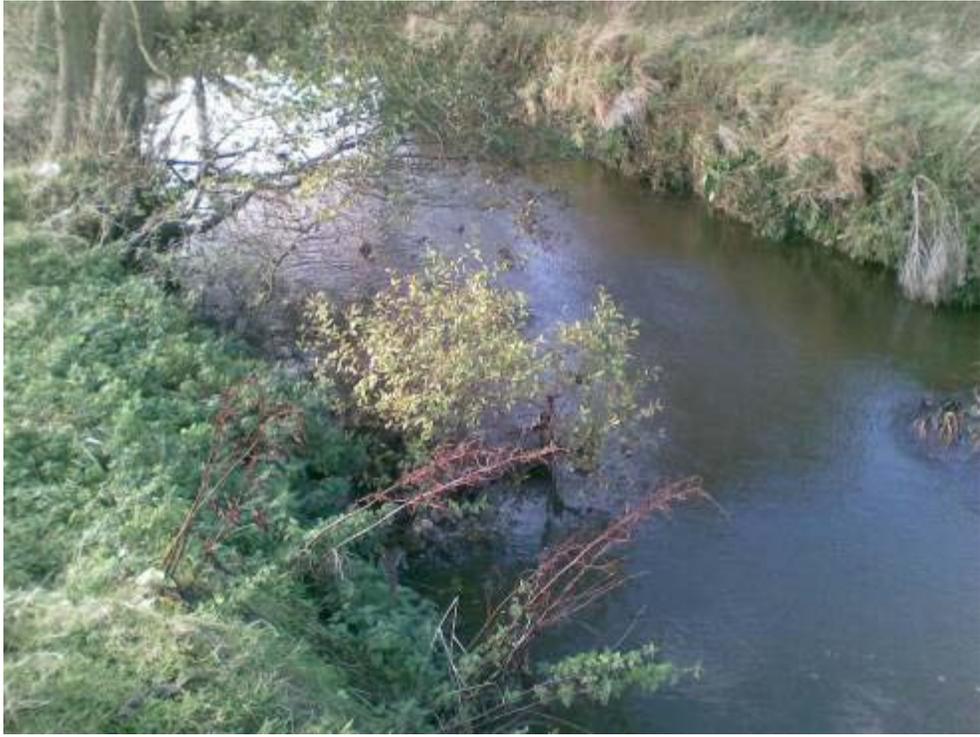
Trimming of trees and branches is being contemplated to improve angling access to the beck. This is not a problem as long as it is done carefully, and the importance of **low level** cover is appreciated. Branches, tree trunks, tree roots, overhanging vegetation, etc. in the water or within 18 inches of the water surface are very valuable habitat, providing cover which retains fish; its removal will directly reduce the numbers of fish within the reach. Higher level vegetation is far less critical, and can be safely pruned although due consideration should be given to channel shading and leaving some refuge areas for fish.

Photo 6 Low cover over the water (a small willow bush) – valuable fish holding habitat that should be retained

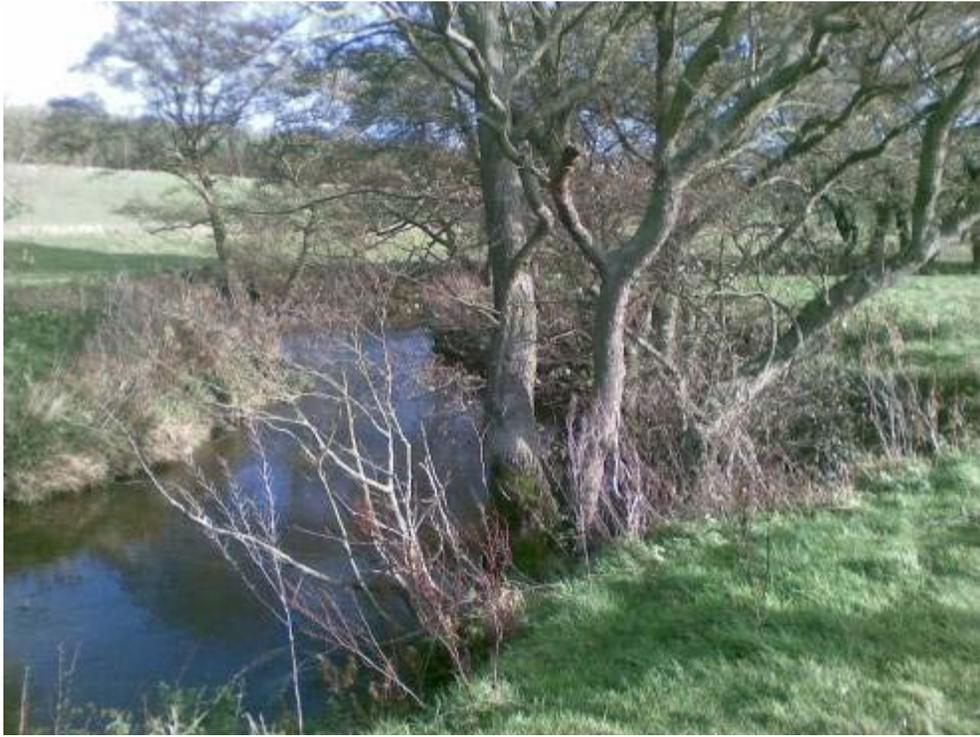
Some of the alder trees have tarry spots on their trunks; this is a sign of the fungal disease *Phytophthora* which will eventually kill the tree (<http://www.forestresearch.gov.uk/fr/INFD-737HUN>). Coppicing such trees will reduce the risk of losing the entire tree from the river bank and exposing the bank to accelerated rates of erosion. A programme of rotational coppicing as outlined in the *Wild Trout Survival Guide* (provided during the visit), should be implemented, selecting the worst affected alders first. A best practice guide for coppicing is included in Appendix 1. Note that coppiced re-growth needs to be protected from grazing animals.

Photo 7 Diseased alders on the outside of bends are vulnerable to loss leading to accelerated bank erosion – these are prime candidates for coppicing.

- Start a programme of rotational coppicing of riverside trees with the long-term aim of producing a mosaic of trees in different stages of re-growth. Focus on coppicing the alders showing signs of *Phytophthora* infection.

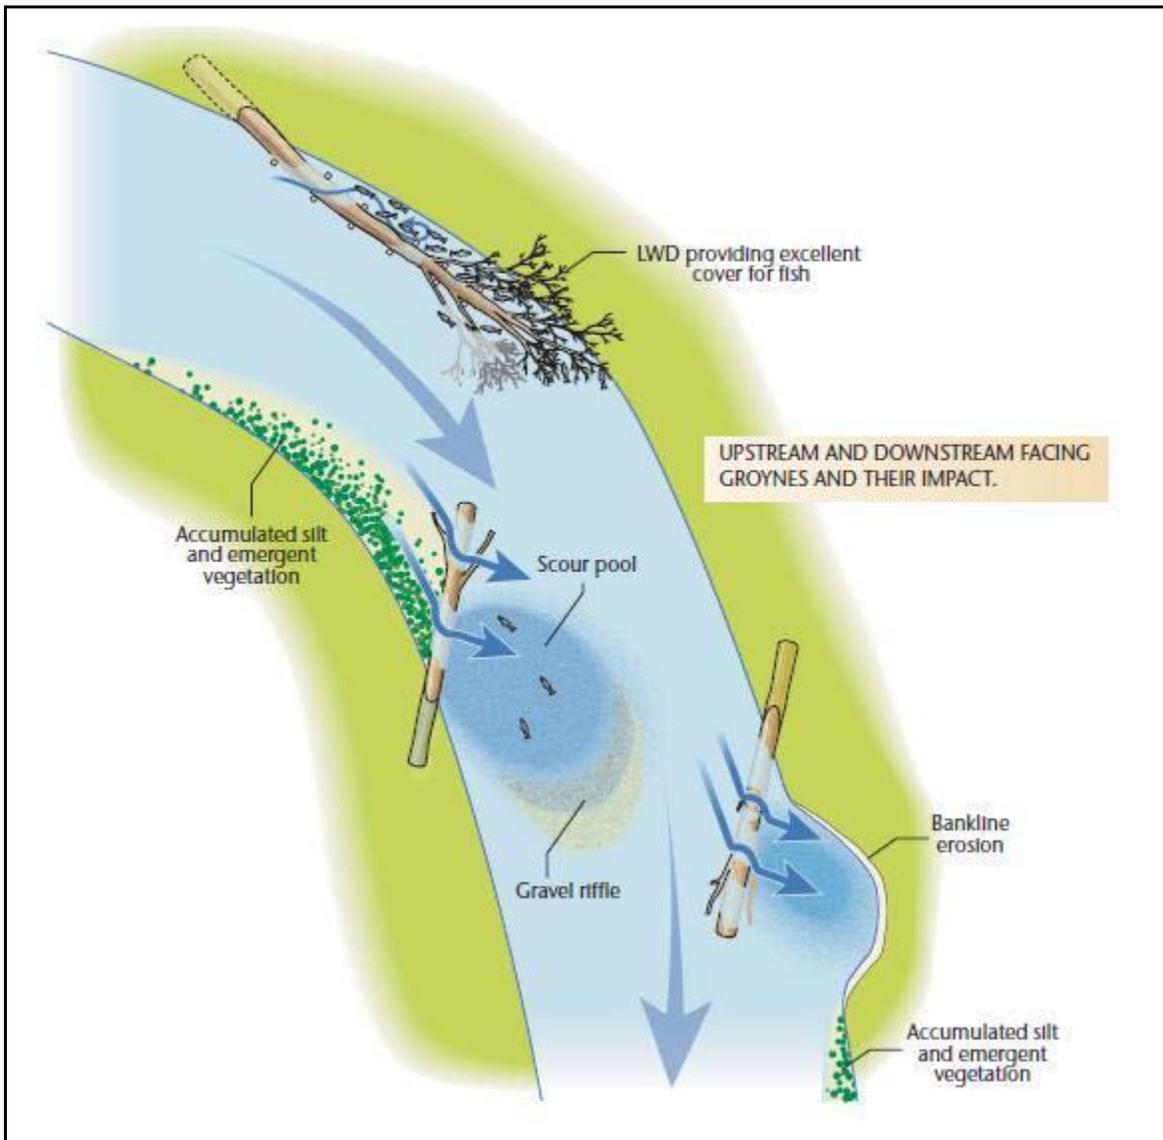
Figure 1 Large Woody Debris (LWD) and its effects. Upstream pointing groynes are preferable to downstream, to avoid bank erosion.

- Deliberately introduce LWD to the river in selected areas to improve habitat diversity and cover for fish. Whole trees or logs can be fixed by a variety of means to achieve this, and WTT can advise further on these techniques (see Figure 1).

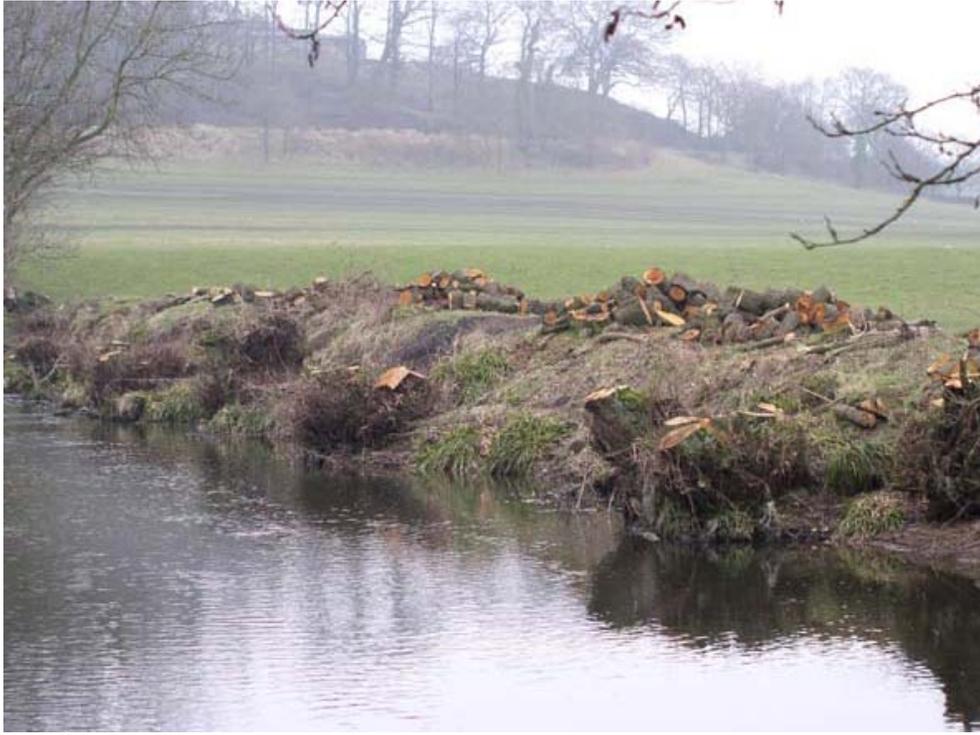
Photo 8 Alders coppiced on the River Dane, Cheshire in 2004

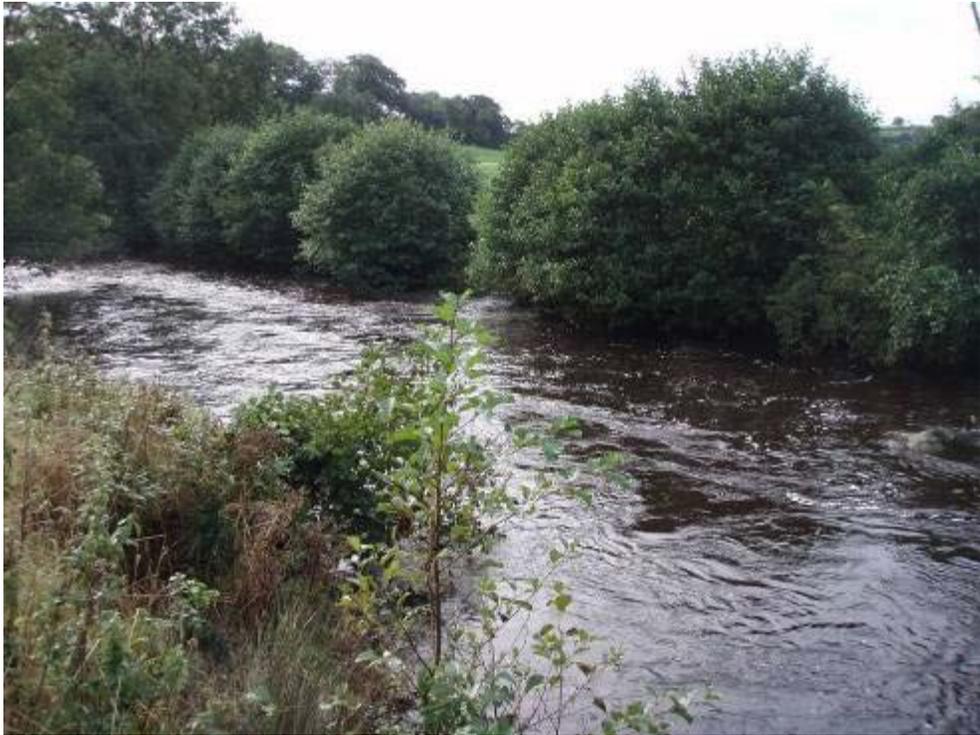
Photo 9 The same site in 2008. It is preferable to coppice more widely spaced trees rather than blocks like this, and to plan a rotation to achieve different heights of regrowth.
