WILD TROUT TRUST

Project Proposal

Amerdale Estate, River Skirfare & Cosh Beck

September 2020

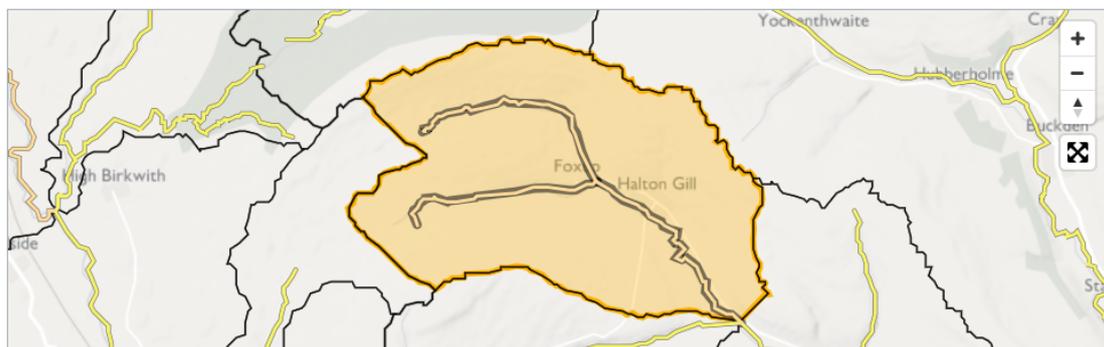
Fig 1. <https://environment.data.gov.uk/catchment-planning/WaterBody/GB104027069250>

Skirfare from Source to Heselden Beck Overview

Overall classification for 2019
Poor

Id	GB104027069250
Type	River
Hydromorphological designation ⓘ	not designated artificial or heavily modified
NGR ⓘ	SD8609877971
Catchment area	1872.649 ha
Length	11.043 km
Surveillance Water Body ⓘ	No
Catchment area	18.726 km ²

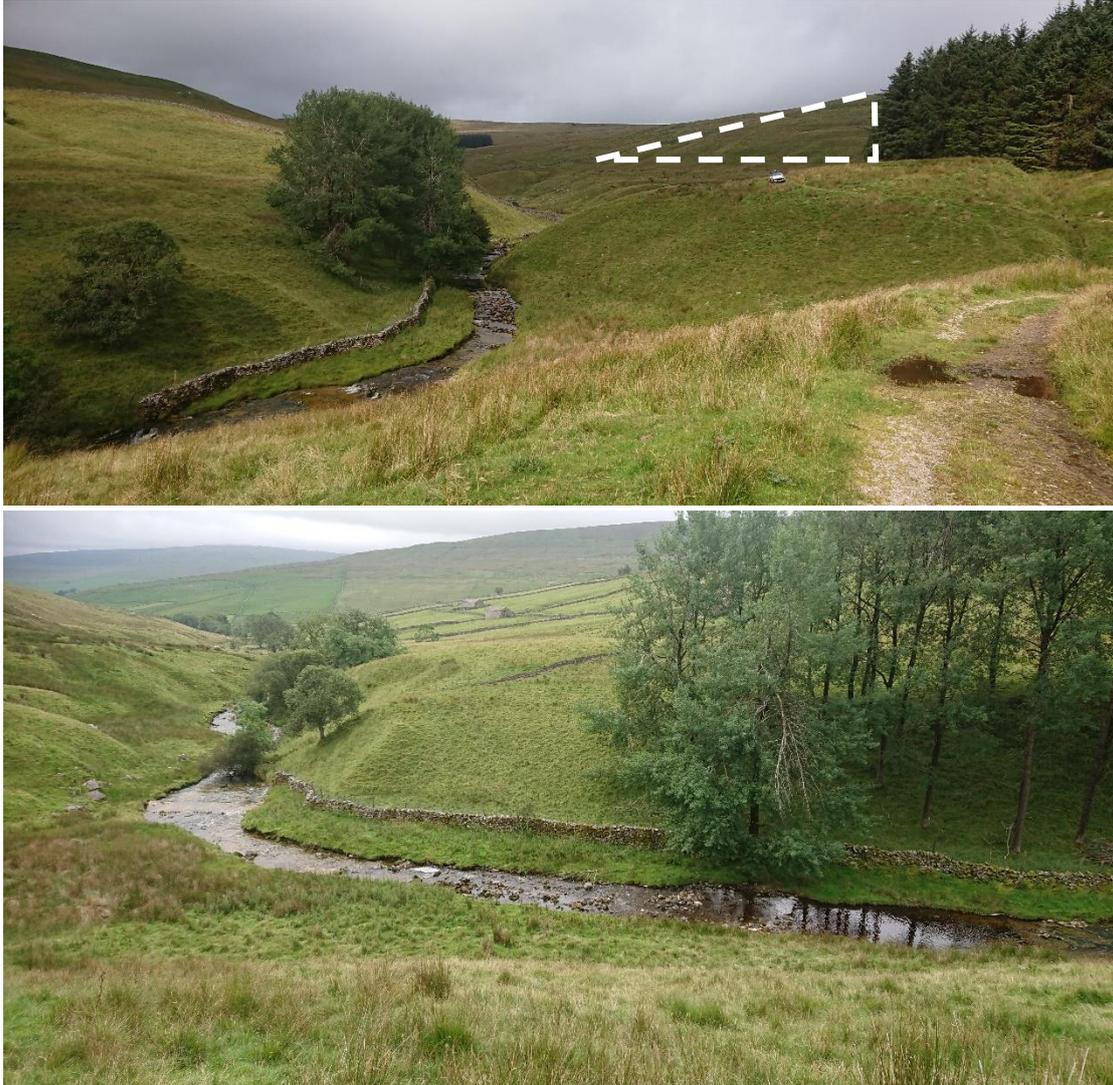
Fig 2. Looking u/s (upper) and d/s (lower) along Cosh Beck nestled in a naturally narrow valley. There was scant shade provided by a small copse of mature aspen (on the southern RB) and a handful of goat willow and ash at the bank edge. Grazing / browsing is preventing the natural regeneration of tree cover and reducing diversity of herbage along the banks. The channel was dominated by pool-riffle-cascade sequences.

There are advanced plans for a mixed plantation of 300 acres across the upper moorland from the Estate boundary to the watershed and extending behind the conifer plantation in the upper image (lowest extent indicated by the dashed white triangle) which will certainly slow the flow and improve hydrology from that part of the catchment. However, that planting regime will not extend to the beck bank.

Trout (2+) and bullhead were captured here.

Opportunities: The drystone wall on the RB forms the boundary with a neighbouring property. Fencing off the LB for this ~750m reach to at least 10m or where there is an appropriate contour to ease access for machinery, and subsequent planting with appropriate native and locally sourced trees will provide multiple ecosystem benefits (shade / shelter / cover / leaf litter input and eventually wood / natural flood management).

Due to the naturally steep, narrow and unmodified nature of the channel here (Fig 2), and the existence of a drystone wall extending the full length of the RB, the proposal for Plot 1 is relatively simple. Installation of livestock exclusion fencing along the full length of the LB combined with tree planting on both banks, thereby extending the planned creation of the mixed plantation at Eller Carr to benefit the beck. The minimum width considered should be ~10m but given the poor nature of grazing, perhaps consider extending to the track which would make installation and maintenance of fencing considerably cheaper / easier. Requirement for gated access to remove any straying stock and for planting.

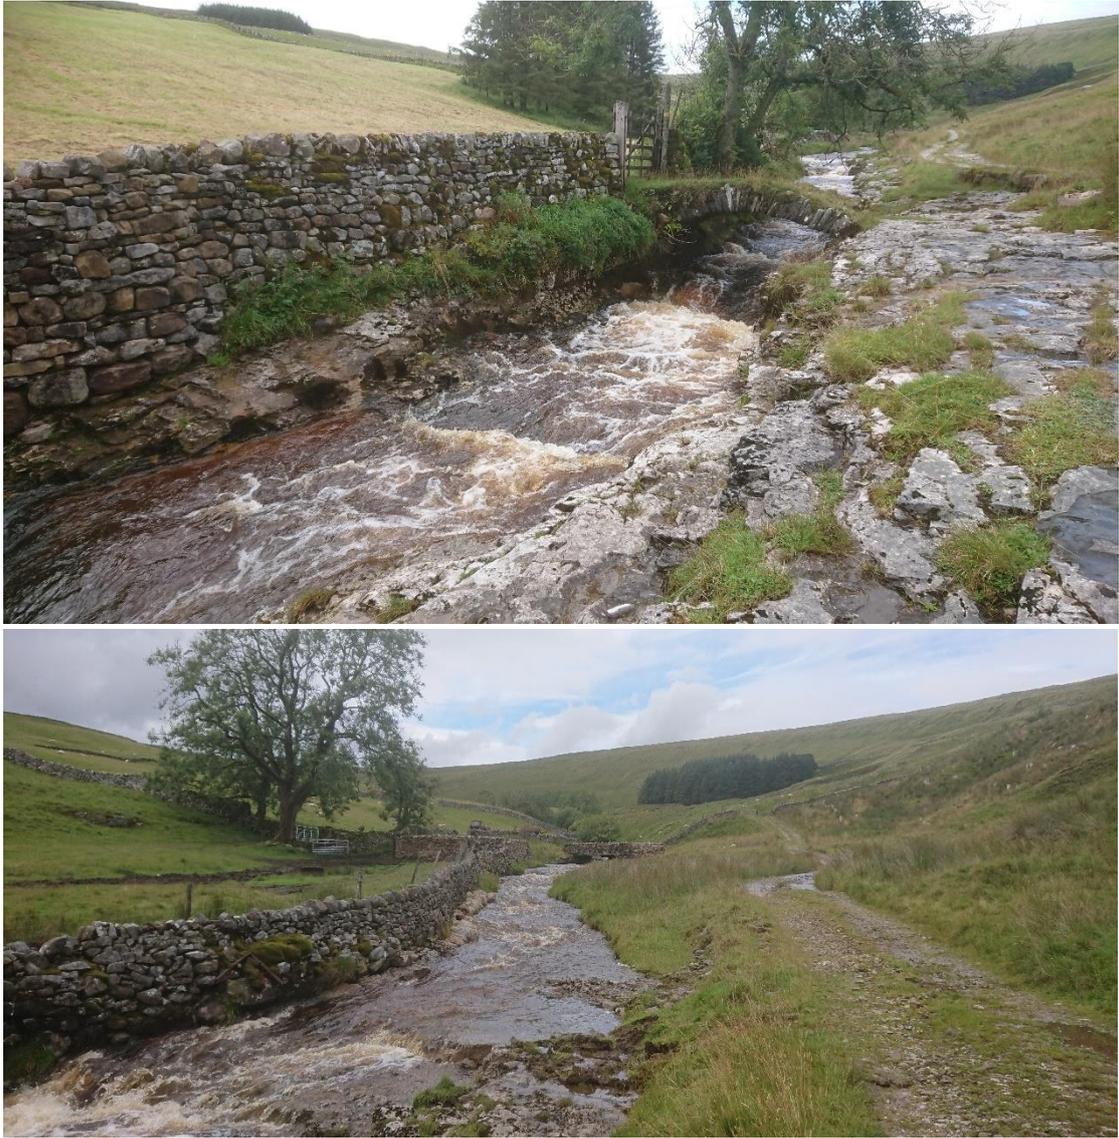
Fig 3. A reach of Cosh Beck in between those owned by the Estate, used here to exemplify the exposed nature (lack of shade) especially where it was running across bedrock. During summer low flows and warmer temperatures, the limestone slabs have the capacity to warm the water markedly, and climate change scenarios predict that this will only increase in the next few decades.

Any opportunities to encourage planting of tree cover (see Fig 4), even along a very narrow riparian strip such as between the track and the channel, should be explored as the benefits will accrue primarily d/s. However, increased cover throughout this reach might embolden more trout to use it or move through it.

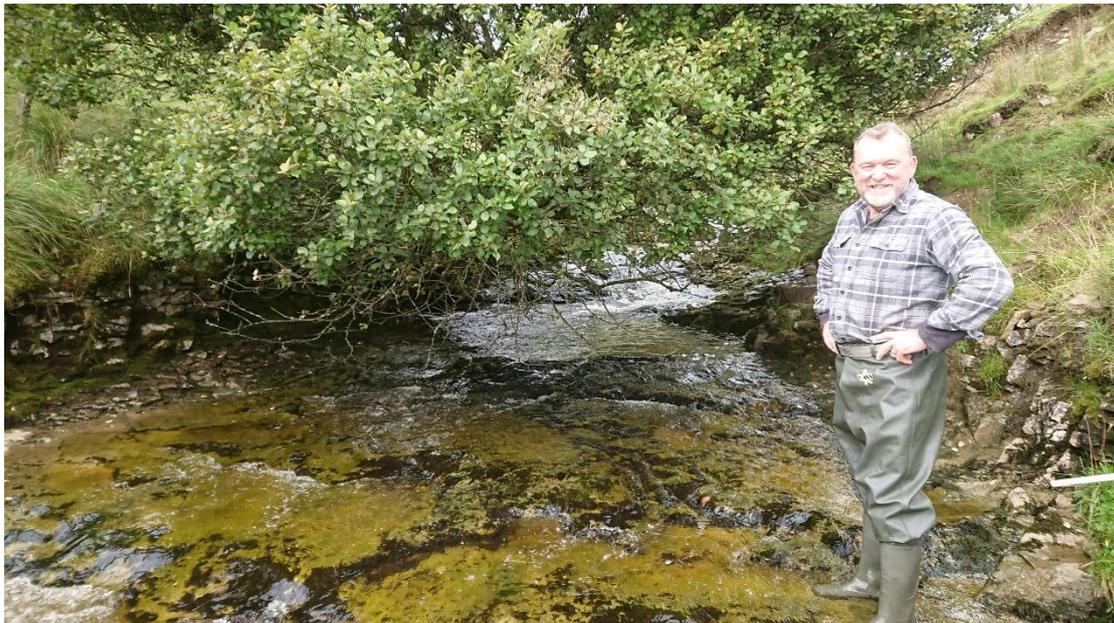
Fig 4. Haithwaite's Tree – an example of how a single goat willow can fully span the channel on these reaches, providing important shade and low cover, intercepting debris during spates and introducing leaf litter during the autumn. Here, the channel was dominated by limestone bedrock, highly susceptible to warming.

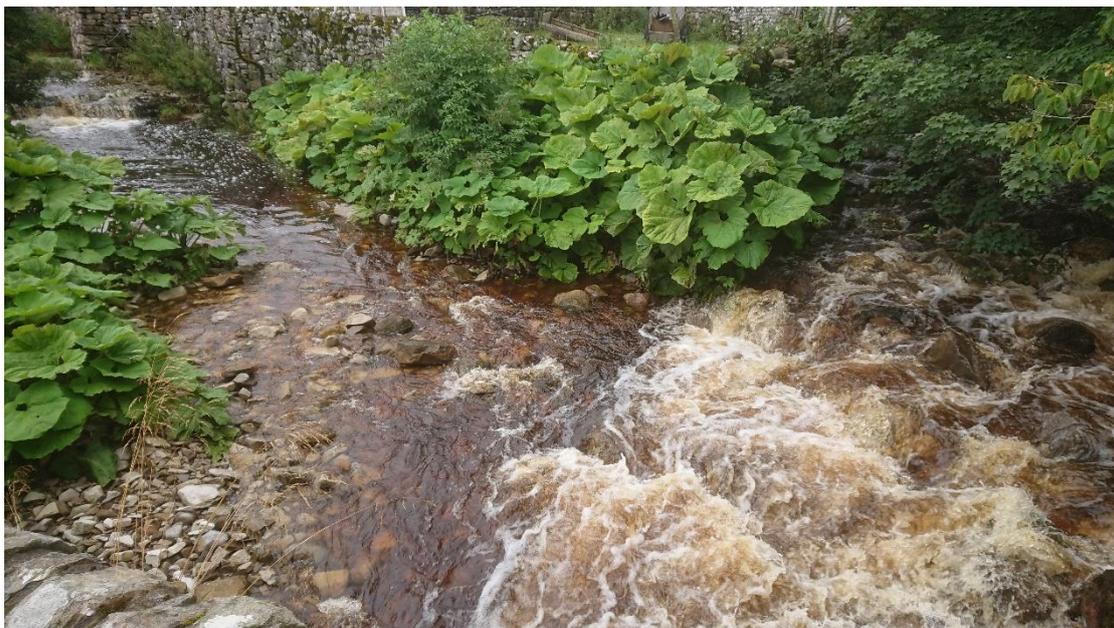
Fig 5. The confluence of Foxup (LHS) and Cosh Becks to form the Skirfare. The appearance of dense stands of butterbur and nettle at Foxup Farm suggests a source of nutrient enrichment which should be investigated and curtailed. There were no access issues for fish passage on either tributary at the confluence.

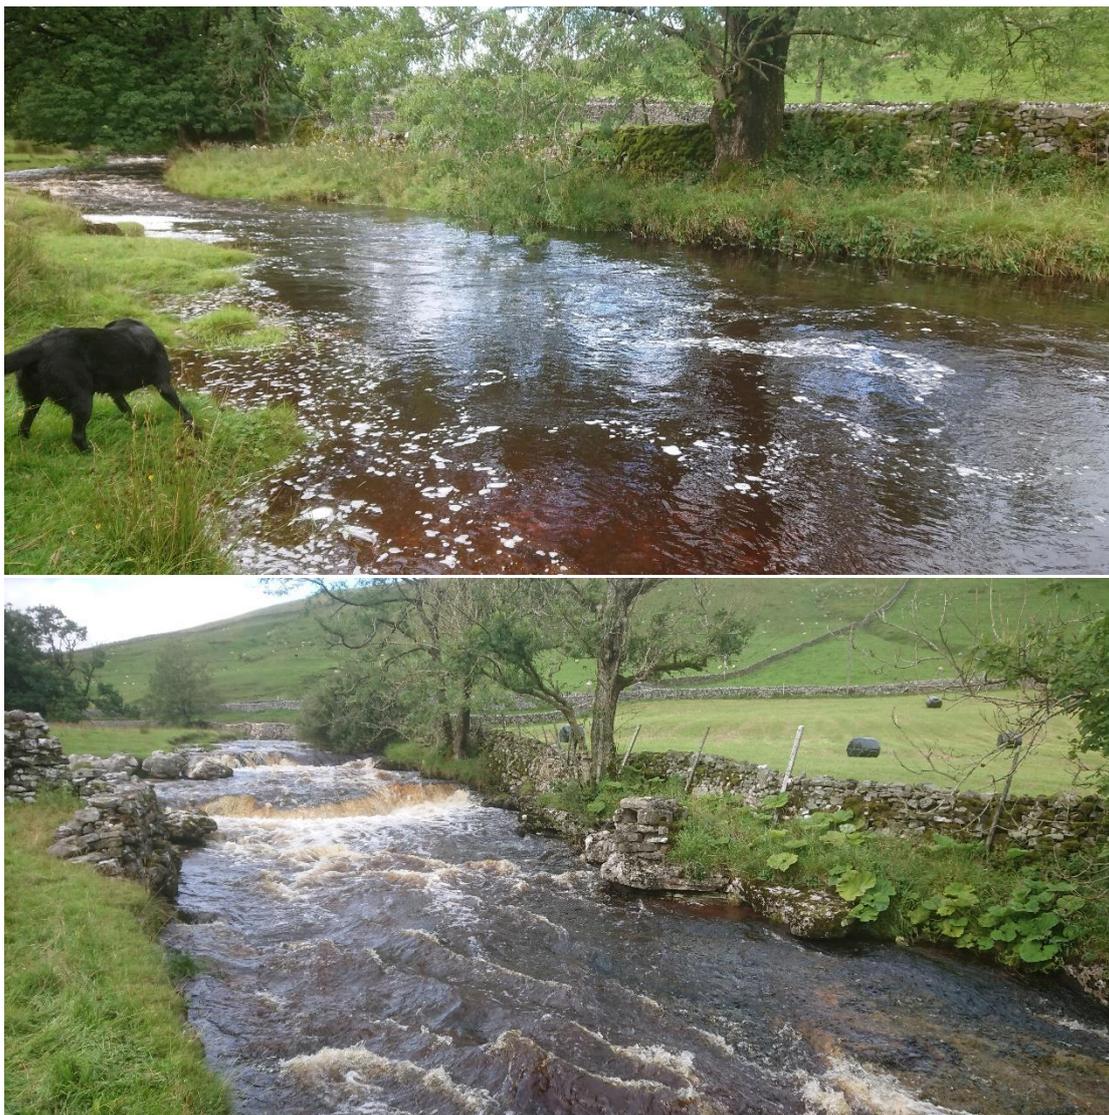
Fig 6. From the confluence for $\sim 580\text{m}$, the LB of the Skirfare was better protected from grazing than the RB, albeit by a rather narrow riparian buffer or in some places directly by a drystone wall. Mature trees were mostly sycamore with occasional lime and ash, some of which were exhibiting signs of *Chalara* (ash dieback).

- Bolster the riparian tree fringe on the LB to diversify the composition, size and age structure
- Keep a watching brief on the ash trees to ensure they do not compromise existing walls or fences, and potentially be prepared to fell & retain *in situ* (via cabling) to maximise benefit at that location.

- Fence the RB for the full extent ($\sim 700\text{m}$) with a minimum buffer of 10m, taking advantage of any existing walling and fencing framework but ensuring its integrity is sound to prevent livestock access. Gated access will be required along the public footpath, but superb opportunities for engagement re the conservation enhancements via discrete signage.

- Extend new fencing on the LB ($\sim 200\text{m}$) to the Estate limit above Halton Bridge.
- Plant small copses of native trees within the newly protected buffer zones.

- Full protection for the riparian buffer strip will negate the requirement for many of the watergates on each field boundary which otherwise require regular upkeep / replacement.

Ref to Figs 6&7. Extension of a buffer fence along the majority of the RB of minimum width 10m to encompass public footpath, which will require new gates to retain access, plus removal of short sections of defunct fencing and watergates. Installation of buffer fence on shortish section of LB to take advantage of the wall position and to reduce the rate of (currently) excessive erosion. Protection of the two spring-fed tributaries on the RB from source to confluence will require livestock exclusion plus two small clear-span bridges to accommodate the footpath.

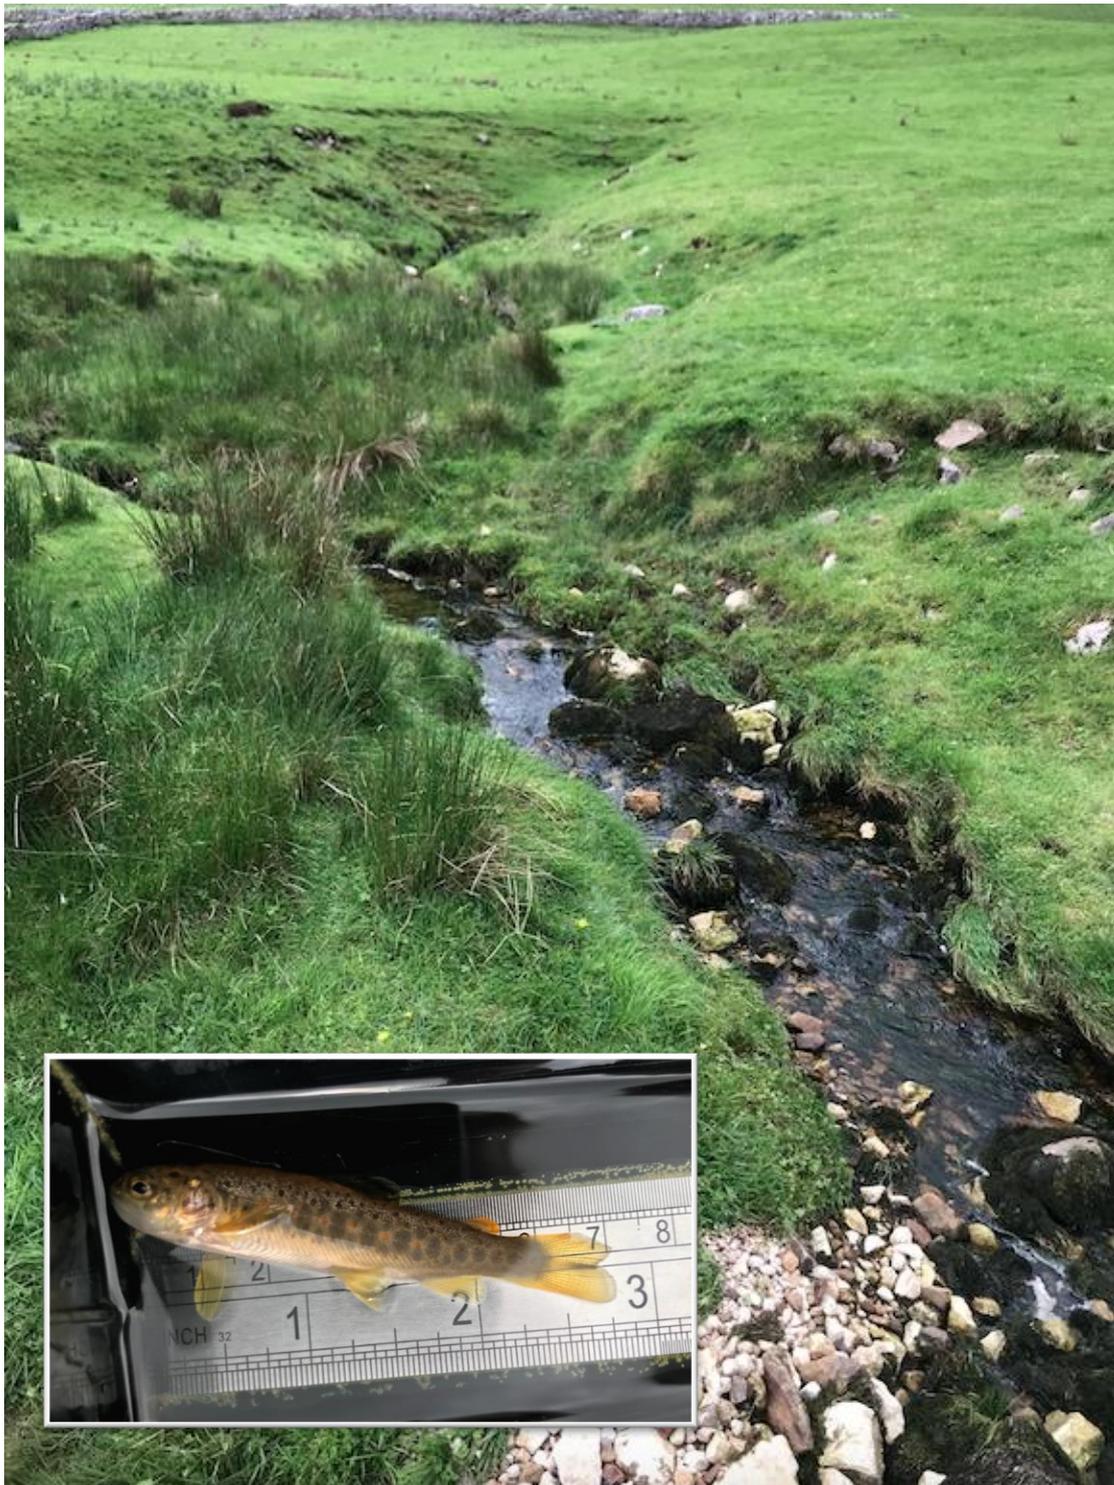
Fig 7. El Dorado. On the RB at SD 87639 76387, two parallel spring-fed tributaries emerged from the hillside and flowed ~120-150m to the mainstem Skirfare. The channel forms were naturally sinuous and contained gravel of an appropriate size (15-40mm) for spawning but were clearly exposed to the influence of sheep grazing, poaching and silt / nutrient enrichment.

Despite being <1m in average width, electric-fishing revealed 7 young-of-year trout (inset) and a 2+ individual, indicating potential as a nursery beck.

- **To bolster fishery potential, these seemingly insignificant becks need protection as there is generally a dearth of good spawning / fry habitat in the mainstem Skirfare.**
- **Fencing to exclude livestock, planting with low scrubby species to provide shade and shelter, and the introduction of some large woody debris to help retain and sort gravel substrate.**

Planting of a greater diversity of trees as copses throughout the buffer zones (aspen, alder, bird cherry, blackthorn, hawthorn, rowan & spindle) to counter the predominance of ash, plus the addition of goat willow specifically along the two springs to get low, bushy cover *in situ* rapidly will be required to kick-start renaturalisation.

Introduction of large woody material within the tributaries by pinning in locally sourced boughs / trunks (See 'How to' videos from WTT: <https://www.wildtrout.org/content/how-videos>) to maintain and increase sinuosity, as well as to retain and sort gravels, can be achieved easily. Both becks would benefit from addition of appropriately sized gravel (15-40mm) to compensate for that stripped out historically.

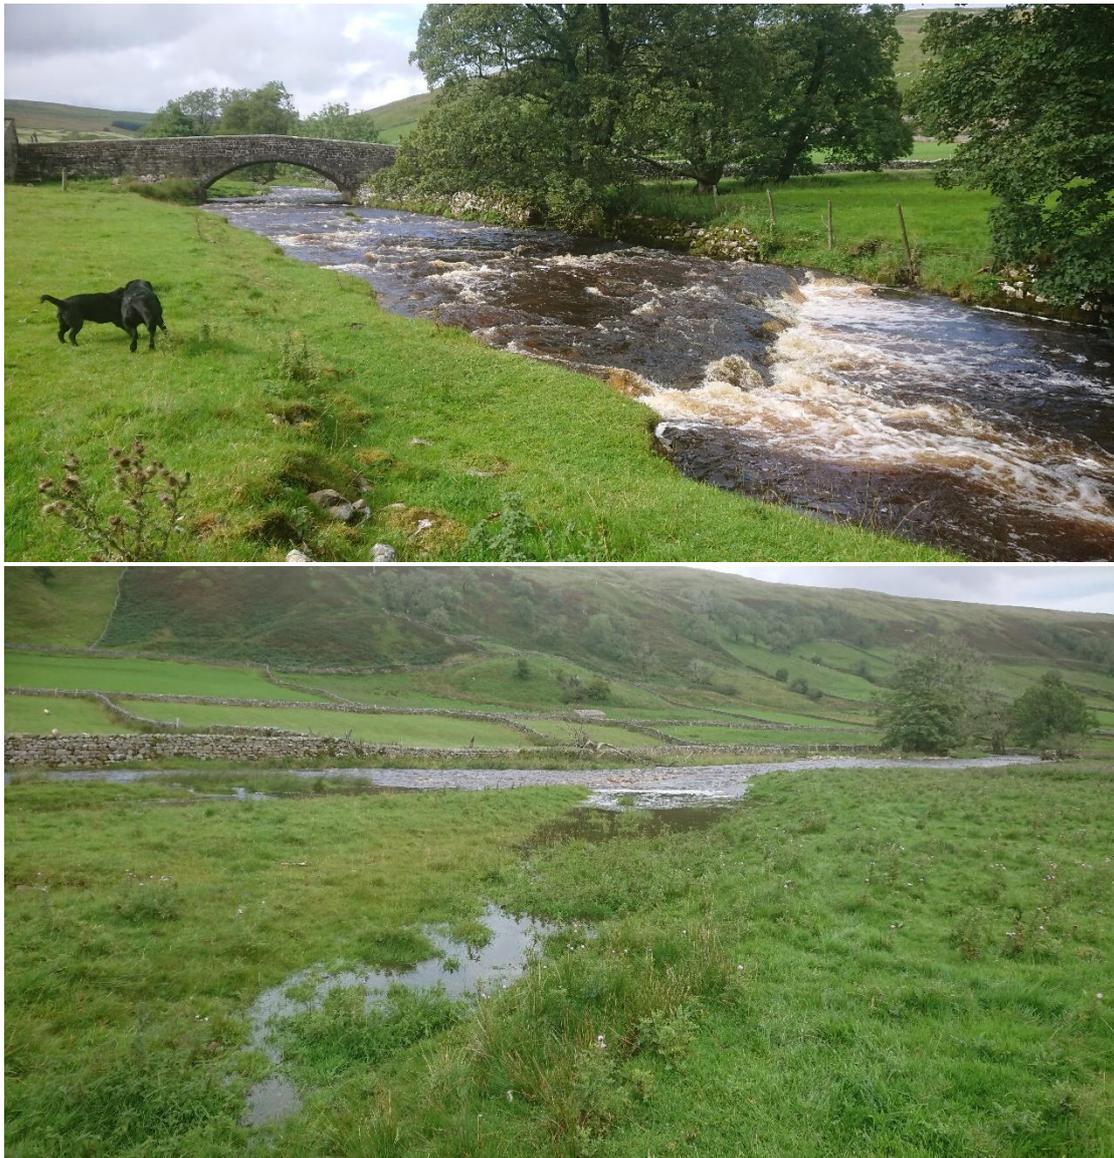
Fig 8. From Halton Bridge d/s, there was significantly more evidence of the Skirfare having meandered but then being prevented from doing so by walling, certainly of the LB. The lower image shows a paleo channel returning back to the extant channel – the continuation of which was visible in the field beyond the drystone wall.

These lower reaches were almost devoid of any cover except for ~12 mature sycamore and ash trees. A much wider floodplain incorporated a substantial area of spring-supplemented marsh on the RB.

The channel in the straightened sections was steeper and hence flow was more powerful and uniform in character (continuous riffle or glide), and with a lack of stabilising roots from trees and diverse herbage in the banks, had eroded laterally to become consistently wider and shallower than would naturally occur. The only variety in channel substrate was provided by occasional contact with seams of limestone bedrock near to the bridge (upper image).

Not visible in these images, but there were two becks that had been condemned to 'drains' via straightening, partial culverting and perching, crossing the fields of the LB in the lower image.

The most d/s area incorporates more elements – ref to Figs 8&9. Reconfiguring field boundaries and complete removal of stock access to the flood plain area will be required to achieve most benefit.

Removal of the drystone wall and revetments constraining the LB of the Skirfare (and either rebuilding it or replacing it with fencing set back and parallel to the true edge of the floodplain as determined by gradient) will release the main channel to re-meander as well as allowing for the deculverting and return of two small tributaries to their paleo-channels. Minor plant work will be needed to encourage the reconnection of the current channels with the paleo-channels. The tributaries will benefit from addition of woody material and gravel as previously described in Plot 2.

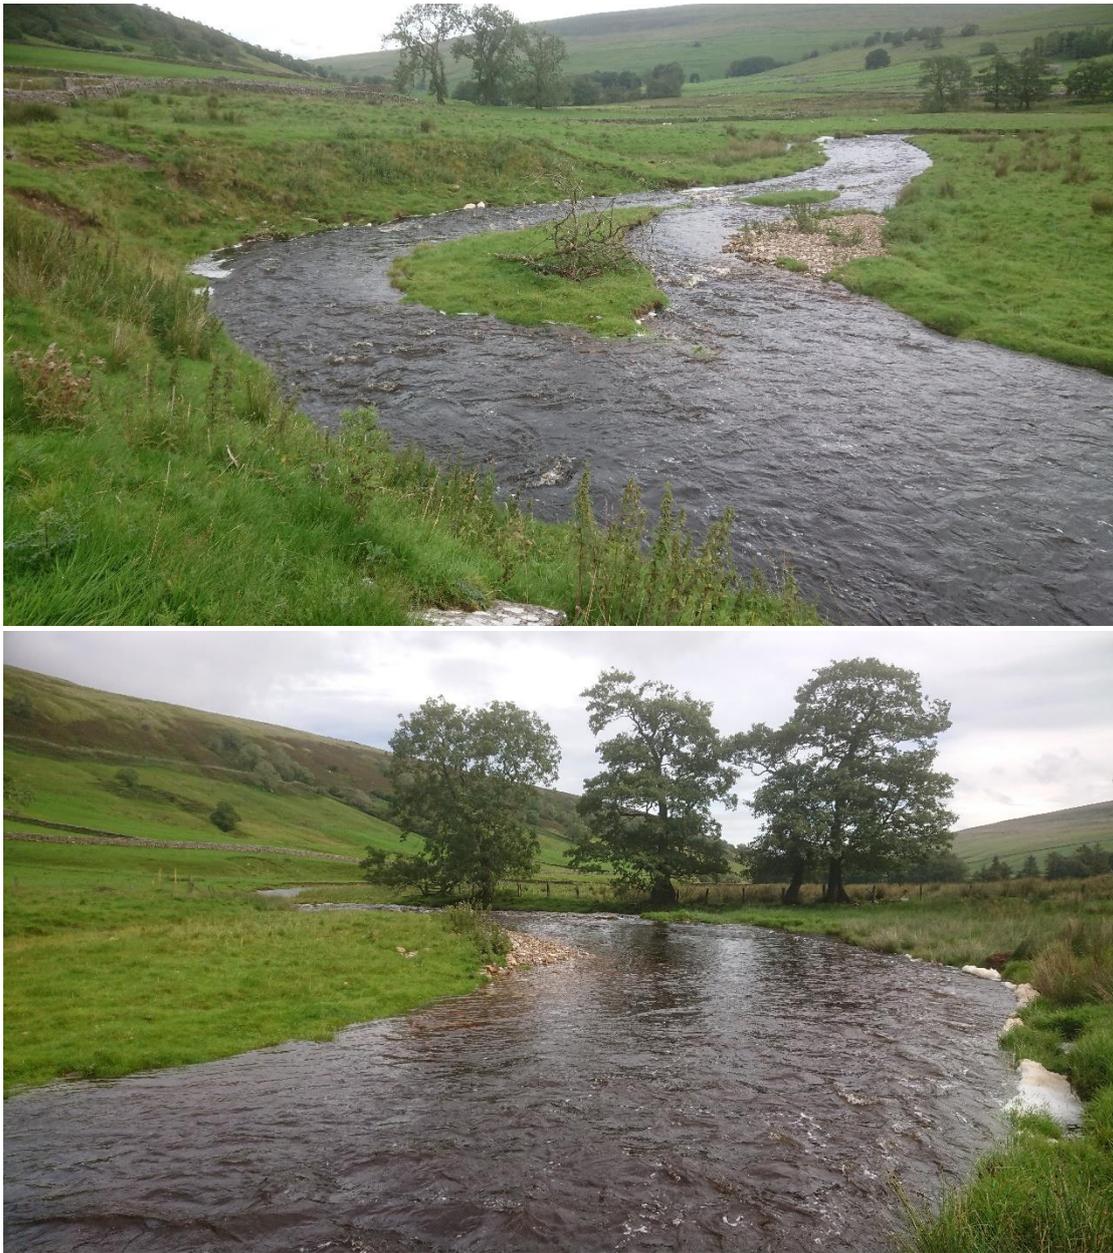
Fig 9. Sinuosity in the Skirfare channel. As the channel has regained some dynamism and been allowed to meander, the natural processes of erosion and deposition have created a series of deeper pools on the outside of the bends complemented by bars of cobble and gravel on the inside. These bars are vital habitats for specialist fauna, particularly ground beetles and spiders, while the deeper pools give ample cover to the larger trout.

Sheep and cattle currently have unfettered access to both banks for the majority of this reach (the three trees in the lower image indicate the d/s Estate boundary), and the vegetation was depauperate as a result. In addition, there was evidence of slumping and erosion scars forming caused by trampling and tracking of animals across the steeper slopes (top left of upper image)

- **Removal of all grazing pressure on this parcel of land to allow excessive erosion to recover and facilitate the recovery of the marsh area which was heavily poached.**
- **Removal of the walling revetment on the LB to facilitate full and natural recovery of the channel by giving it the freedom to move where it wants. Additional reduction of material at the head of other paleo-channels, to better reconnect the channel with the floodplain and to allow dissipation of energy under spate flow.**
- **De-culverting and re-wiggling of the two small becks to restore natural characteristics and extend potential for spawning, akin to El Dorado in Fig 7.**
- **Woodland creation on the floodplain beyond just a riparian 'strip' – this could be quite diverse encompassing wetter hollows as well as drier bank tops and hummocks.**

Installation of a fence-line on the true edge of the floodplain on the RB will retain the better-quality grazing but leave the nascent marsh and floodplain to develop. This will require consideration for footpath access.

The widest point (southern and eastern sides) of the floodplain would benefit from planting with relatively dense coverage of native trees, with the marsh area and the more classical buffer strip on the RB (western side) remaining open and with small copses, respectively.

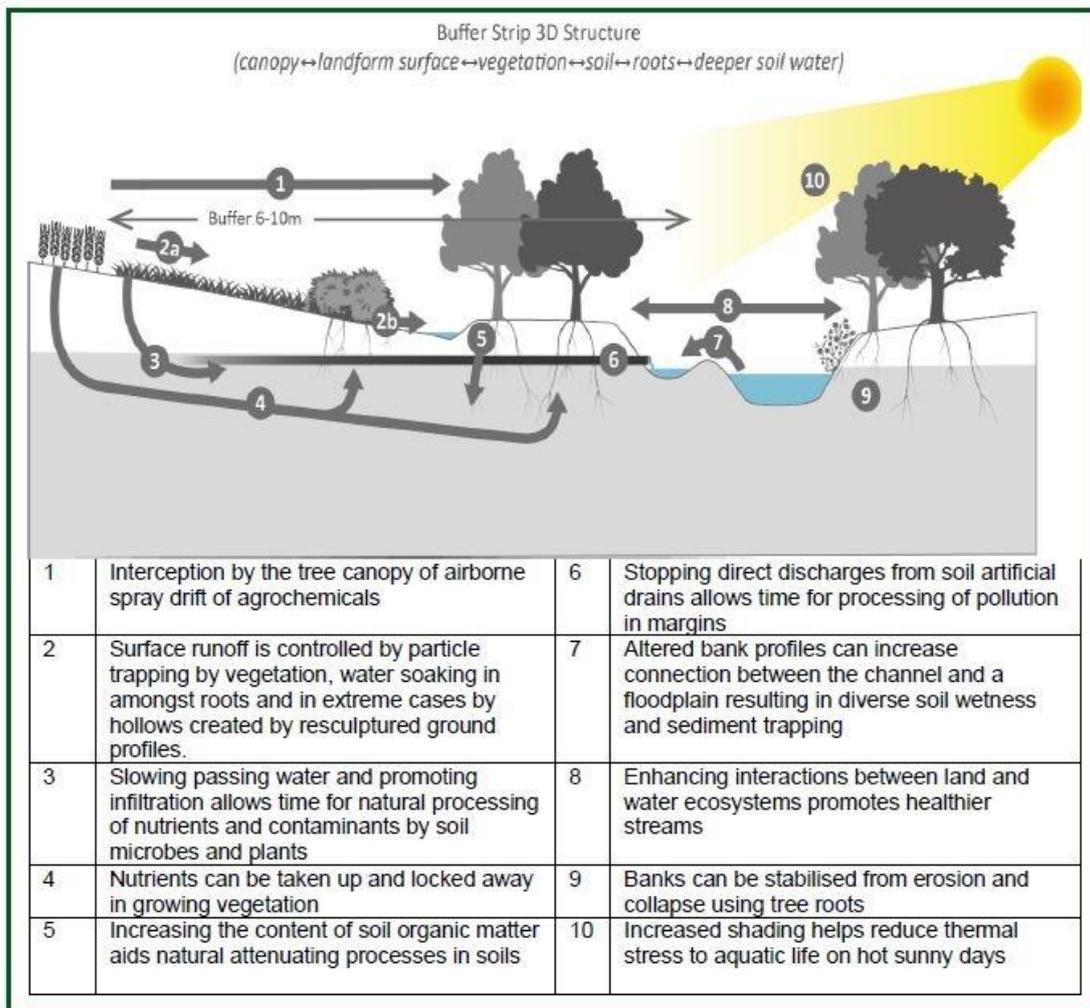
Fig 10. Potential elements of a 3D-buffer structure (reproduced with permission: <https://www.gov.uk/government/publications/3d-buffer-strips-designed-to-deliver-more-for-the-environment>)

A useful summary figure of the 3D-structure of buffer strips and the main processes and functions involved has been produced recently by the Forestry Commission and the Environment Agency; see Fig 10 overleaf.

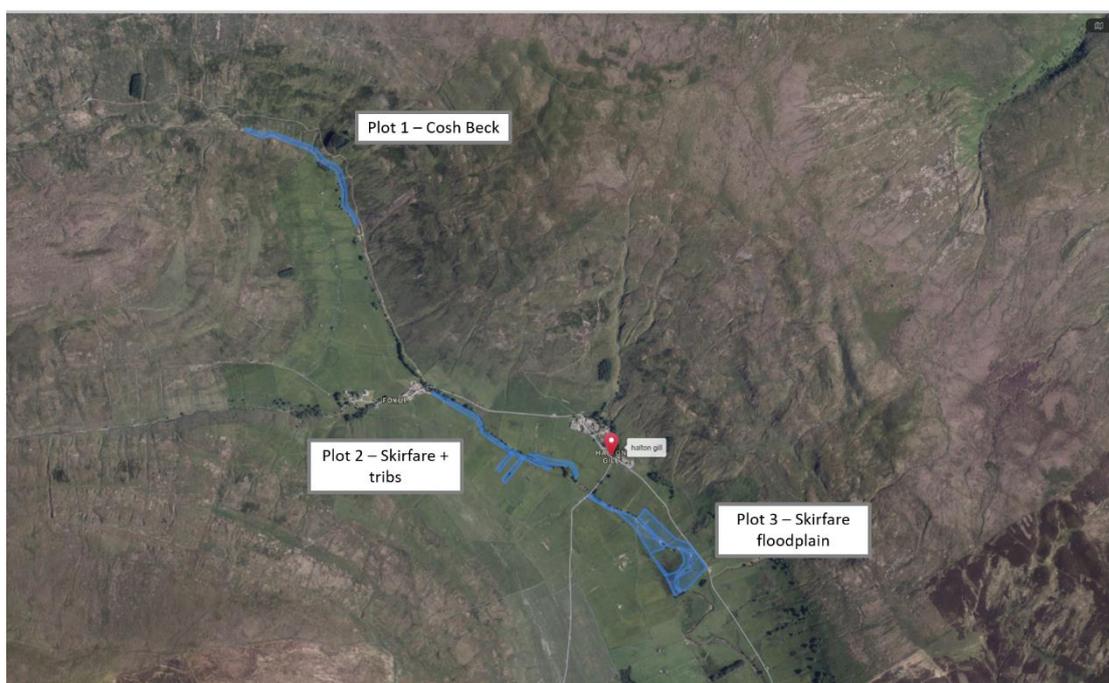
Fig 10. Overview of potential buffer strip creation for the Amerdale Estate outlined in blue.

The proposal effectively covers three separate plots as depicted in Fig 10 above and which will be summarised below.
