**Advisory Visit**  
**Skitwath Beck – River Eden Catchment**  
**9<sup>th</sup> March 2016**

## **1.0 Introduction**

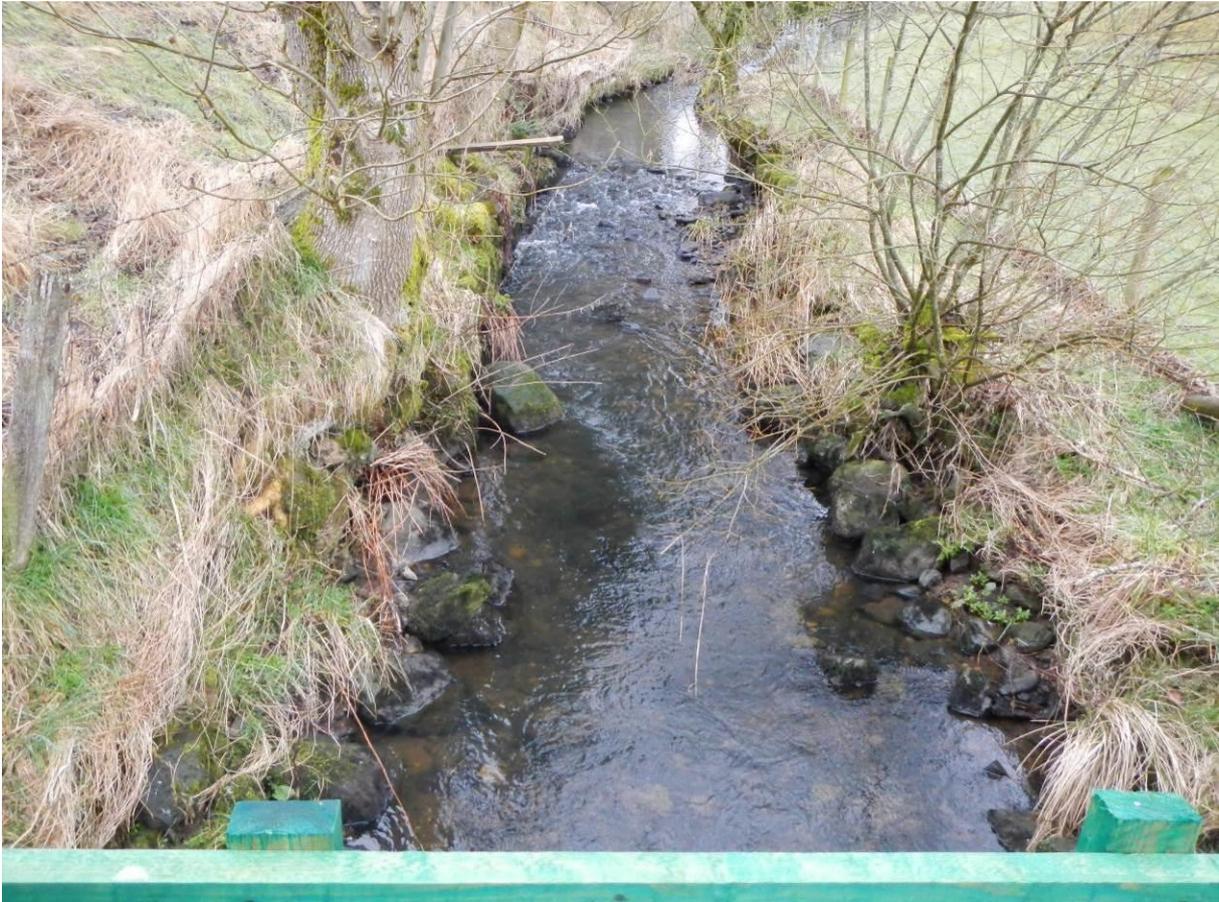
The relative uniformity and low sinuosity of the channel is immediately apparent on the Beck, as is the hard bank revetment that has been installed to try and keep the channel entrained, although fortunately, some of the revetment is now beginning to fail (Fig. 1). While this area of the Beck is within a steep sided valley and so would naturally be less sinuous than a lowland watercourse, the straightening and dredging has accentuated this factor, producing a channel with elongated pools and riffles and a reduced number of those features. The lack of sharp bends also limits the depth that pools can achieve, with many areas between riffles forming little more than deep glide habitat (Figs. 1 & 2). The lack of flow energy dissipation within

the relatively uniform depth, width and planform of the channel also reduces the amount of finer substrate that can be retained, with smaller gravel in short supply.

**Figure 1. Straightened channel section, the lack of sinuosity and sharp bends leads to a lack of discrete areas of bed scouring and a lack of deeper pool habitat.**

It would be greatly beneficial to re-meander the beck channels and reinstate a more natural gradient, planform and geomorphology to the reaches inspected. Wherever adjacent land use allows, bank revetments should be removed, allowing natural erosion to reinstate a more sinuous channel with a greater diversity of width and depth. This is particularly true in the area of the first conifer plantation (Fig. 4). In this area, it may be beneficial to place some of the boulders (or woody material deflectors) in locations within the channel that will help to divert flows into the banks and / or, possibly, undertake some light touch excavation to encourage the Beck into its new course.

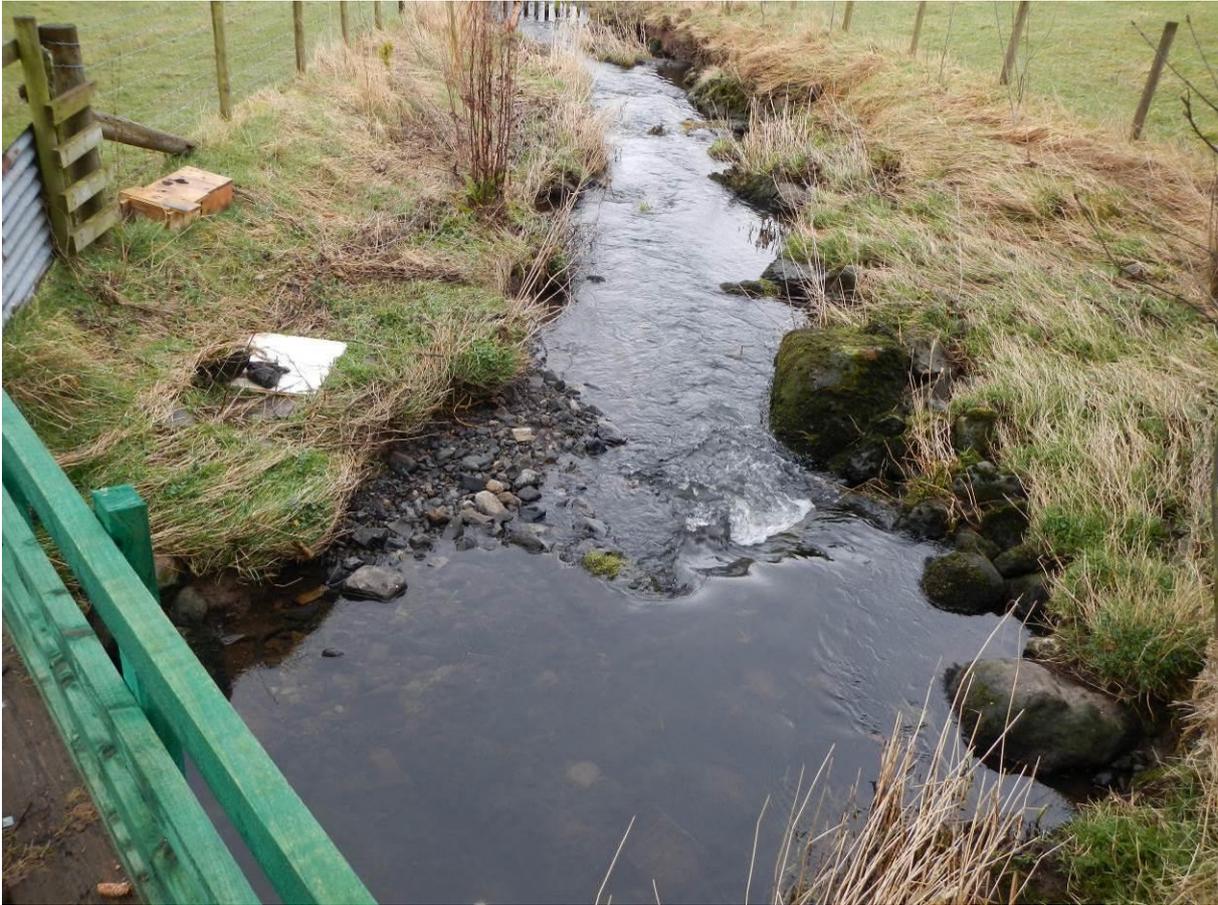
Much of the Beck is buffer fenced allowing beneficial rank grasses and herbaceous vegetation, as well as planted and self-set shrubs to become established. These will greatly increase the stability of the banks above that of grazed areas and provide vital habitat along the banks and within the river margin (Fig. 2). By preventing livestock access to the banks, the associated reduction in soil compaction will also increase water filtration into the soil and help to intercept surface run-off, forming additional protection against siltation and nutrient input to the Beck.

**Figure 2. Buffer fences support the development of healthy bankside vegetation and improve habitat quality.**

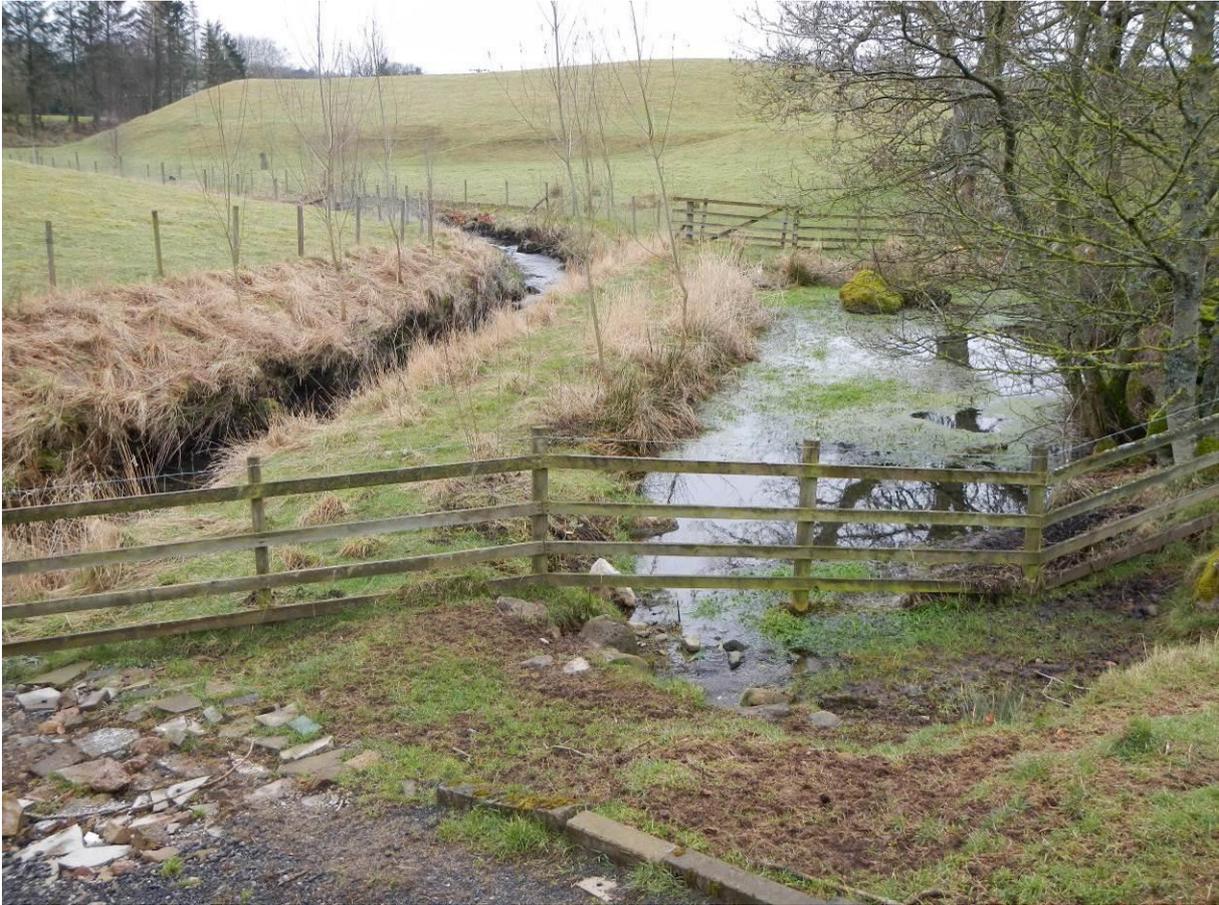
Another issue with the dredging of a watercourse is evident in the level of channel incision which occurs, lowering the current river bed well below that of its original condition. This factor is well-demonstrated in Figure 3 where straightening of the channel has resulted in the bed level over a metre below that of the relict channel, which now forms a perched pond. A long-term aspiration for this area should be to reinstate the old channel, thereby greatly reducing the gradient of the reach and facilitating the retention of finer substrate.

**Figure 3. The Beck (left of shot) and relict channel that forms a pond (right of shot) with the addition of water from a smaller side tributary.**

Long-term, it would also be beneficial to look at the possibility of reinstating the meander that was lost through straightening (Fig. 3). However,

reinstating this section will ideally require utilisation of some of the adjacent field at the u/s end.

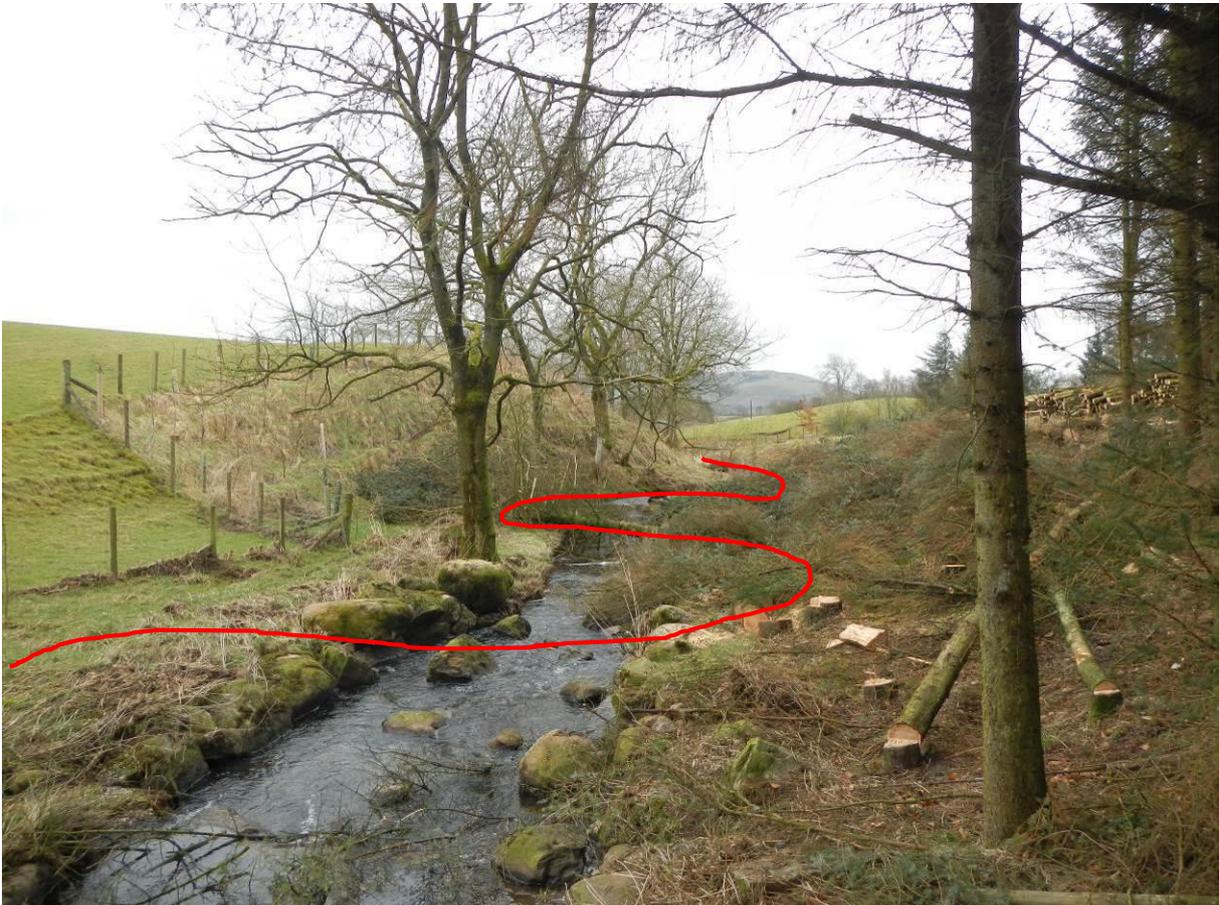
Similarly, the next reach d/s presents an ideal opportunity for assisted natural channel recovery where, if the hard bank revetments are removed, the Beck could be allowed to develop more sinuosity naturally, or with assistance from some simple in-channel structures.

Tree felling work underway in the area by Eden Rivers Trust (ERT) to remove the coniferous trees also highlights an additional action that could be undertaken, utilising the tree materials won. Pinning the conifer tips across the watercourse would help to slow flows d/s by increasing the transition time through the site. This would dissipate flow energy locally, helping to retain finer substrate and is also a technique that, when undertaken at a catchment-scale, has been shown to reduce peak flood events d/s. The additional in-structure and areas of lower flow also provides excellent habitat for invertebrates.

**Figure 4. Possible site for assisted river restoration by removal of the hard bank revetment (schematic representation of proposed new channel course in red).**

In a similar manner to what has occurred during the felling of conifers in Figure 4, conifers or other trees could be pinned in place over the Becks in locations where flood water can be encouraged to back up behind them (e.g. where there is no risk to surrounding infrastructure such as fencing). The technique simply involves pinning the trees in place across the channel; however, it is important to ensure that, particularly with conifers, only the d/s facing branches are left attached to the tree. This prevents too great a blockage from occurring, as accumulated debris will be forced underneath as the pressure increases. Owing to their orientation, u/s facing branches tend to get trapped against the bed, accumulating more debris and can create problematic blockages.

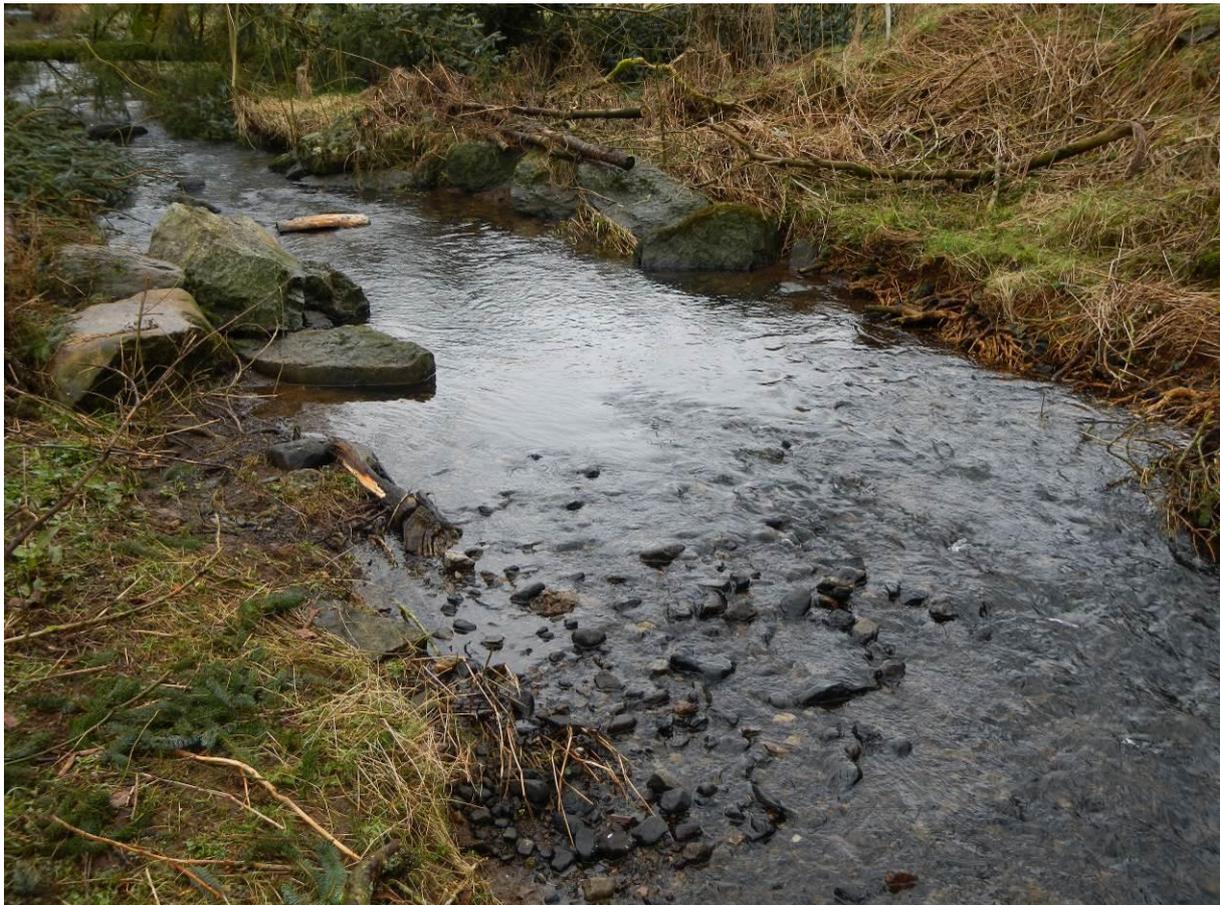
In areas where the gradient is lower and the channel wider, areas of gravels were present and provide some salmonid spawning habitat. The material is still quite large in diameter and therefore better suited to large resident trout and migratory salmonids. Increasing the occurrence of finer gravels would be greatly beneficial for smaller resident trout spawning. It should also be noted that in many areas the coarse substrate present is the product of natural sediment transport post cessation of dredging as, in many areas, the bed was regularly dredged right down to clay (D Teasdale 2016, pers. comm., 9 March). This highlights the potential for further natural recovery with material supplied from u/s if the channel morphology and can be improved.

**Figure 5. Where gravel is present it tends to be on the larger side of what resident trout can utilise.**

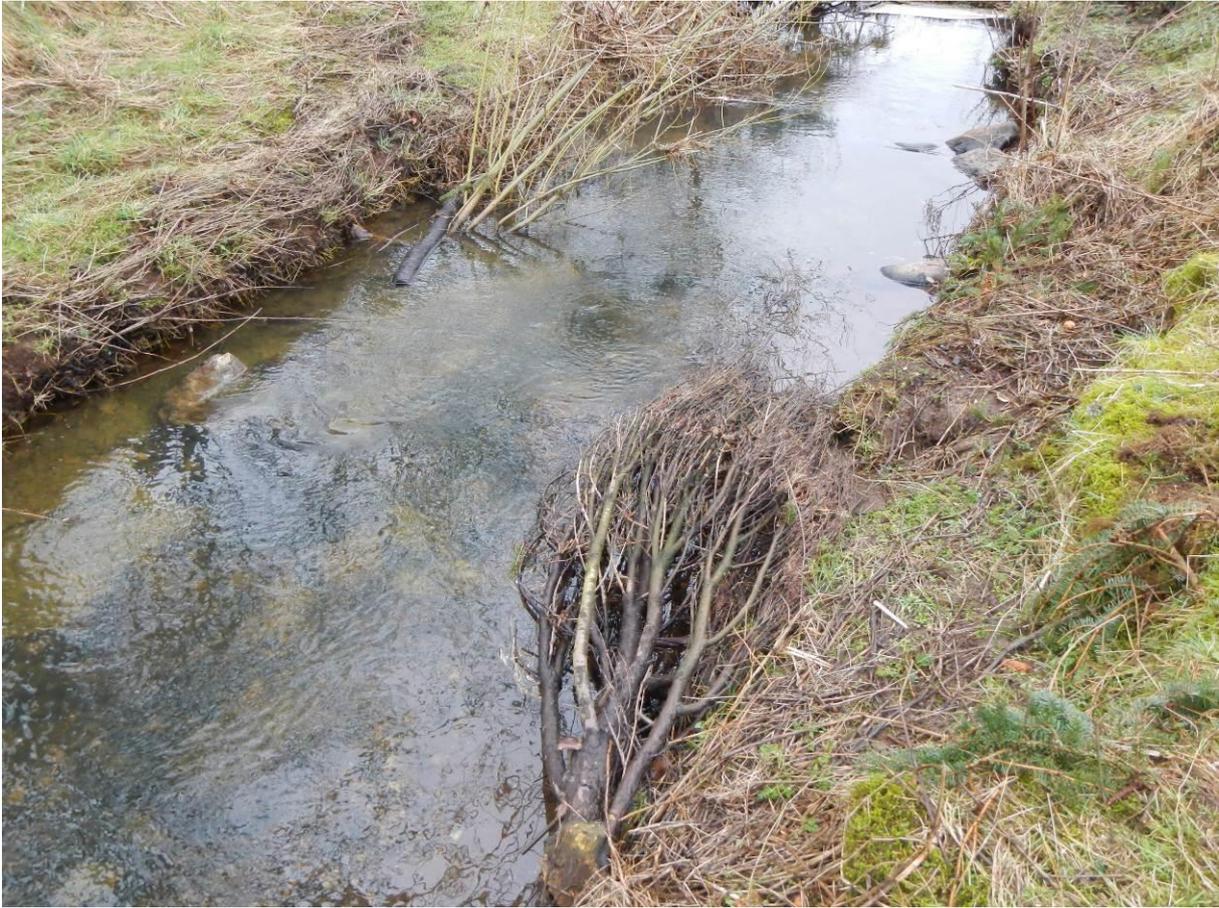
Beneficial improvements to in-channel habitat quality have already been undertaken on the Beck, employing small brush/kicker type techniques and willow laying and additional work in this vein will be greatly beneficial alongside any more significant channel improvements (Fig. 6). These provide valuable flow dissipation that increases sediment deposition in their lee, along with valuable cover for fish.

**Figure 6. Simple in-channel habitat improvement techniques provide valuable dissipation of flow energy and provide additional cover.**

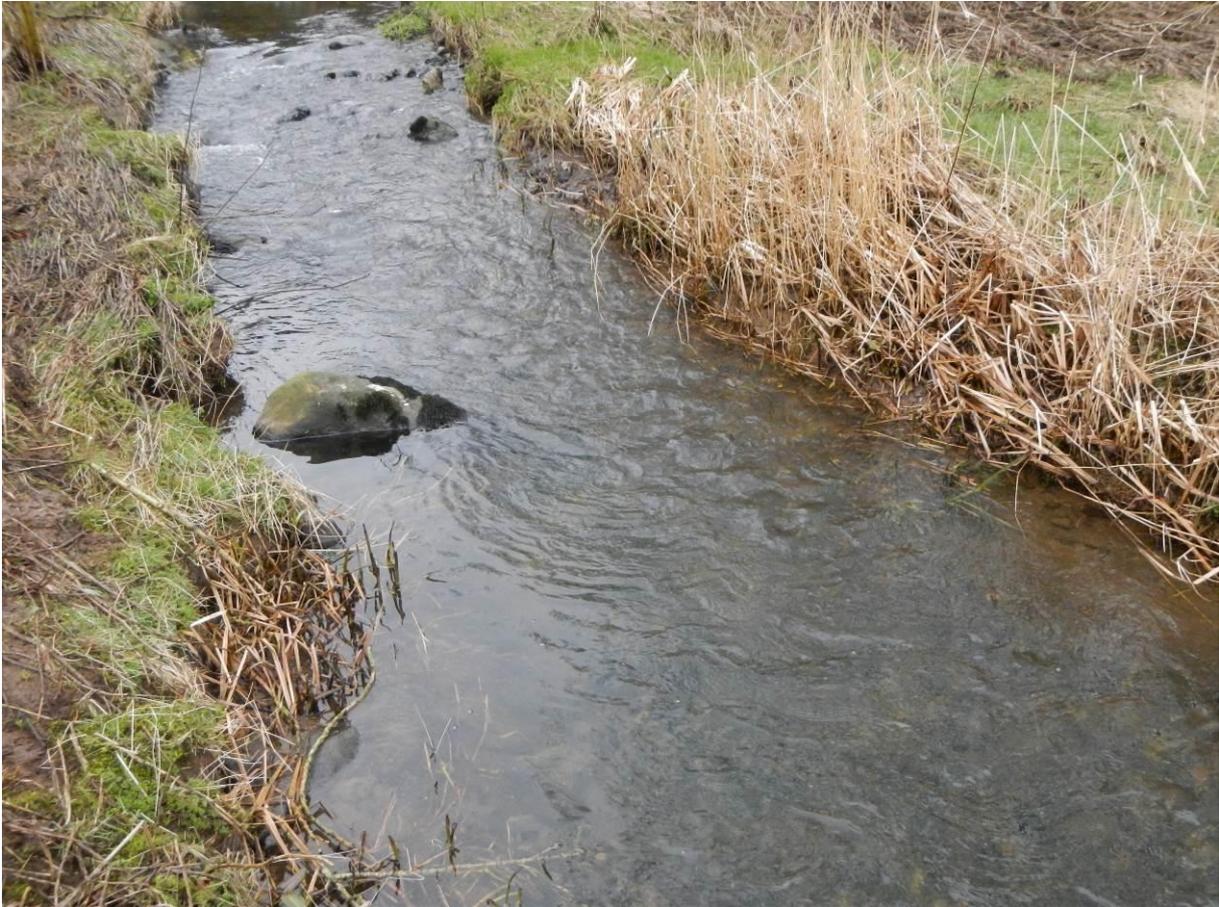
Being outside the influence of grazing, bankside and emergent vegetation encroaching into the channel provides natural improvements in width variation, with the narrower channel creating discrete areas of accelerated flow, driving bed scour to maintain deeper water refuge (Fig. 7). Narrower areas also help to retain depth in low flow conditions.

**Figure 7. Natural channel narrowing facilitating some bed scouring and creating deeper water habitat.**

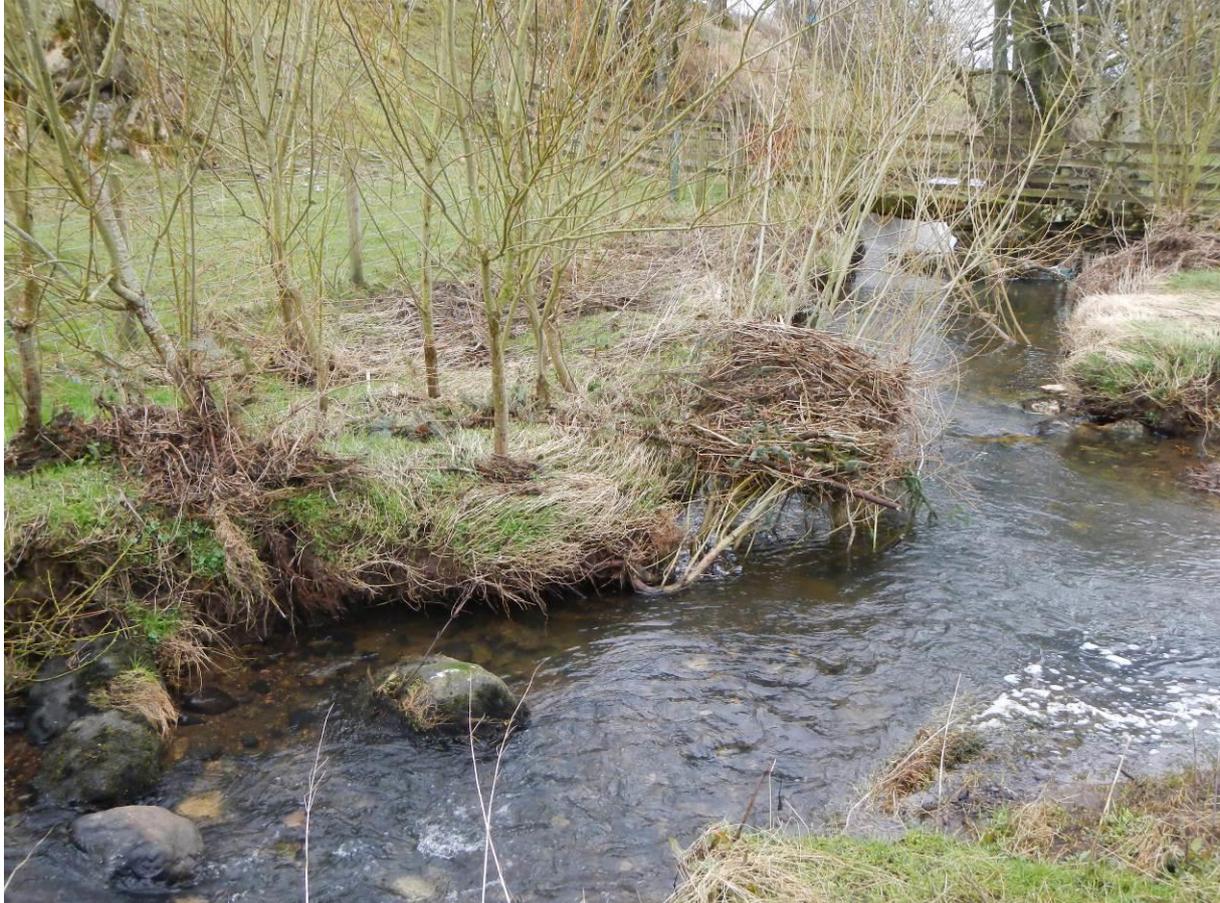
About 2/3rds of the way along the length visited, Swinescale Beck joins and with the increased flow, a slightly larger pool has formed with good cover provided by bankside willows and undercut banks (Fig. 8). At the d/s end of this pool, a pinch point at small footbridge that accelerates flows, creating another wider, although not particularly deep pool in which some finer substrate is retained.

**Figure 8. The confluence of the Swinescale Beck and Skitwath Beck provides some deeper water refuge and overhanging cover.**

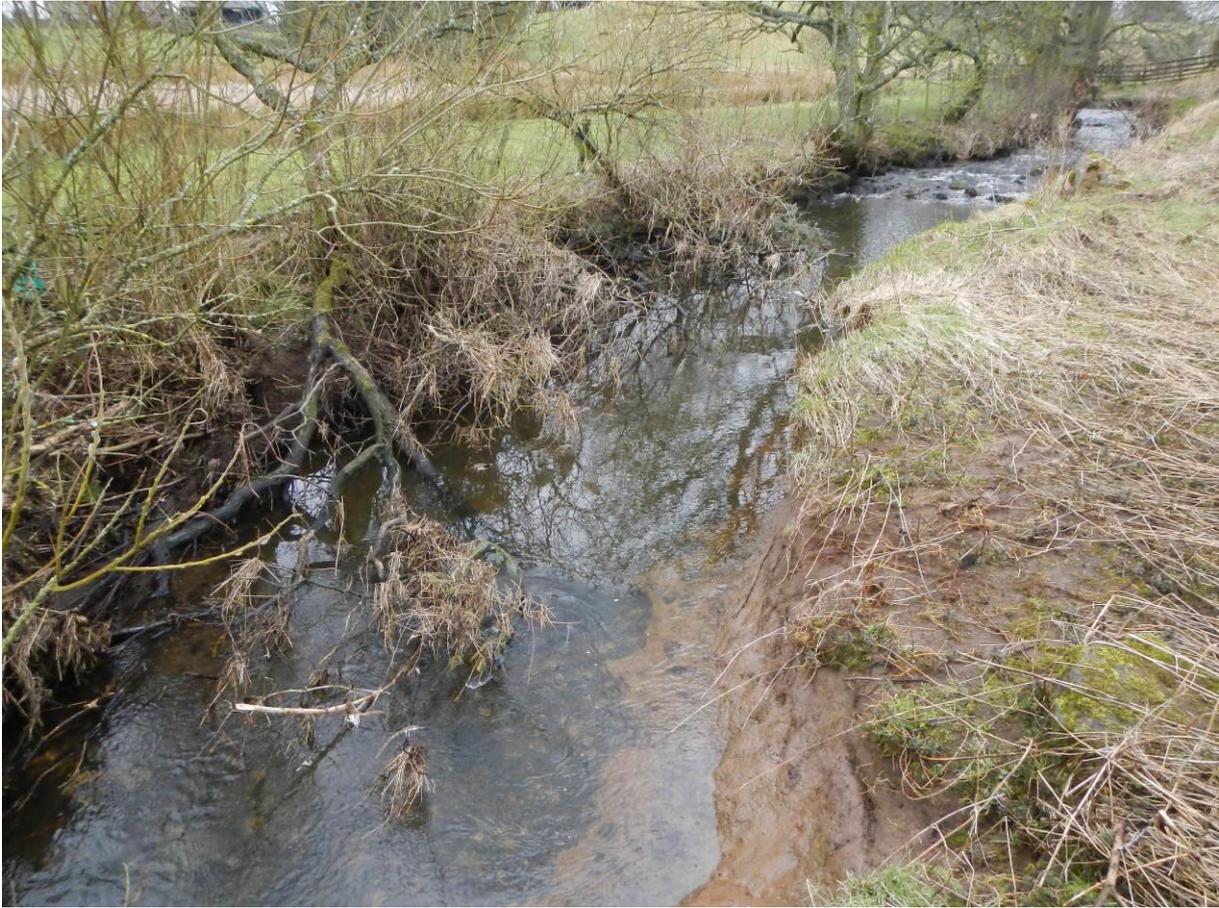
Proceeding d/s of the pool, the character of the Swinescale Beck changes markedly, with the channel becoming noticeably larger and supporting a far greater extent of deeper pool habitat, capable of supporting a healthy population of adult resident trout (Figs. 9, 10 & 11). Bankside willows help protect the bank and provide high quality cover and refuge for fish from high flows and predators (Fig. 9).

**Figure 9. Excellent overhanging and trailing willow cover over deeper pool habitat.**

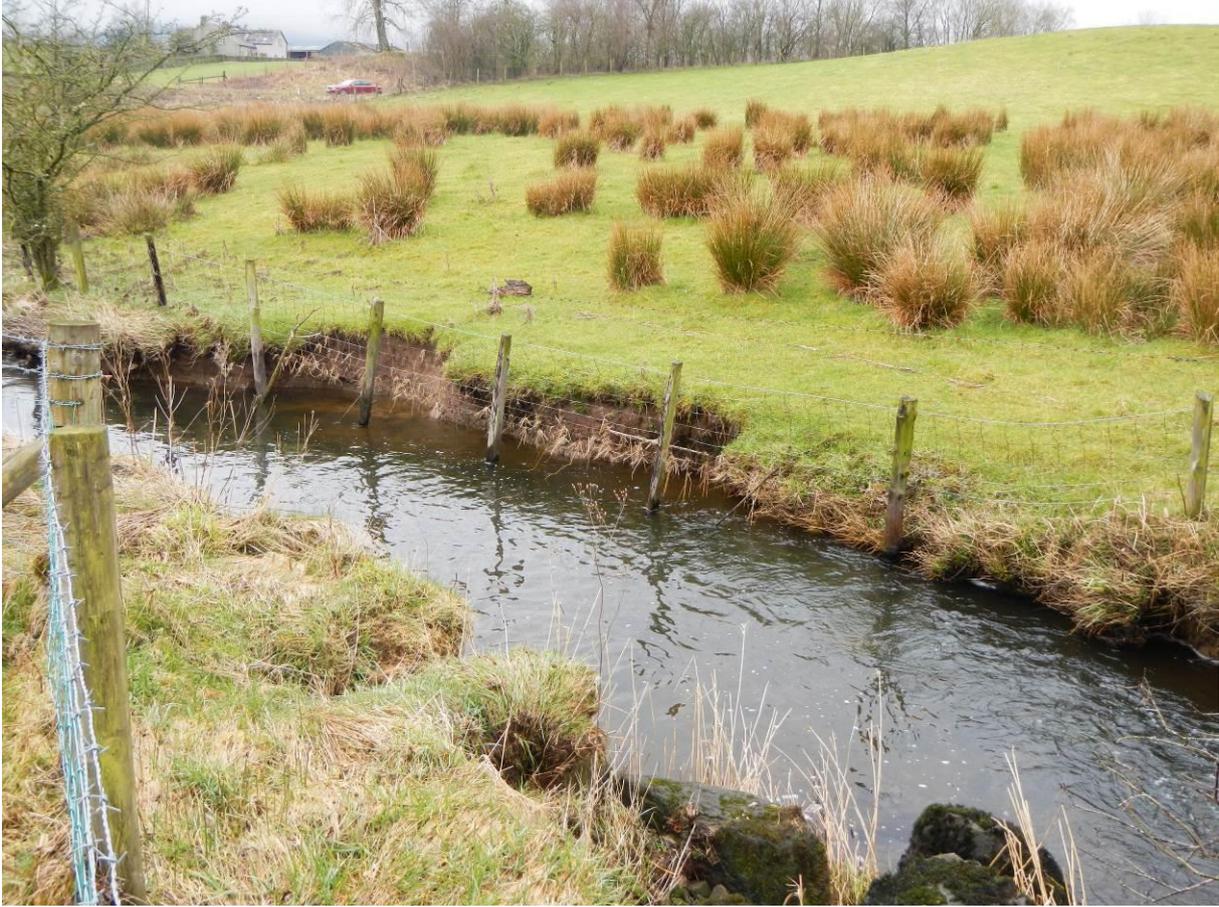
Figure 10 depicts good pool habitat but with a lack of tree cover (as in Fig. 11) which is likely a partial cause of the bank erosion that has now undermined the fence. Setting the fence line back a few metres would allow the bank to revegetate and facilitate planting of willow that will help to bind the bank together and reduce the rate of erosion. The added cover then provided would also enhance the habitat quality of the pool.

**Figure 10. Deeper pool habitat with eroding, undercut bank.**

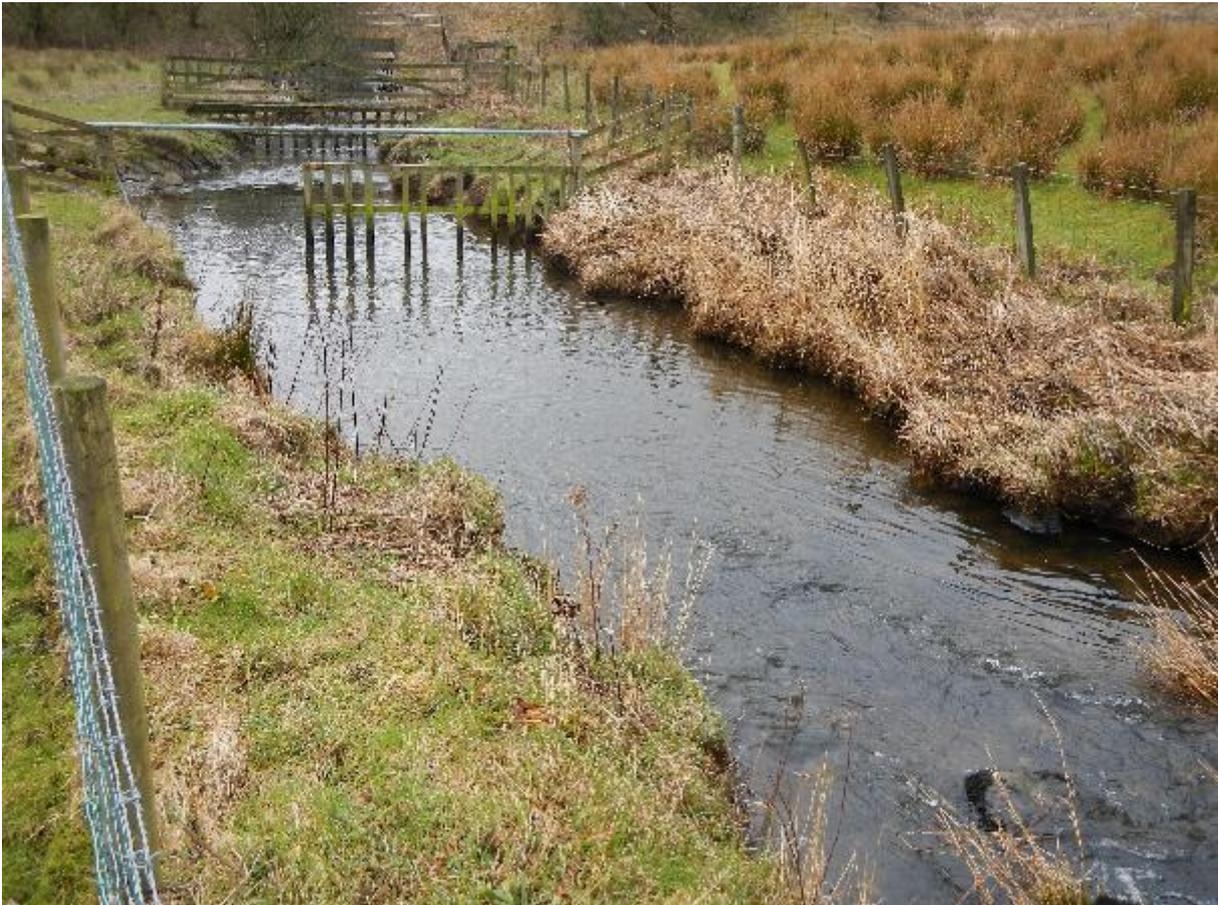
Immediately d/s, a straight pool again provides some good deep water habitat but is lacking in aerial cover (Fig. 11). Interestingly, the fixed bed level d/s (the u/s extent of the A66 road crossing structure) is likely to be retaining some of the depth within the straight pool but causes its own additional issue through the impediment to fish passage created by the shallow flows over a smooth concrete bed (Fig. 12). It is understood that rectifying the issue of fish passage at the A66 road crossing is being looked into by the council's highways department and ERT. Depending upon how far u/s along the concrete bed the easements are installed, additional improvement may be possible through willow planting to provide additional shrubs that could be laid into the channel to dissipate flows and provide resting areas that will assist fish past the section.

**Figure 11. Straight but reasonably high quality pool habitat though lacking tree/aerial cover.**

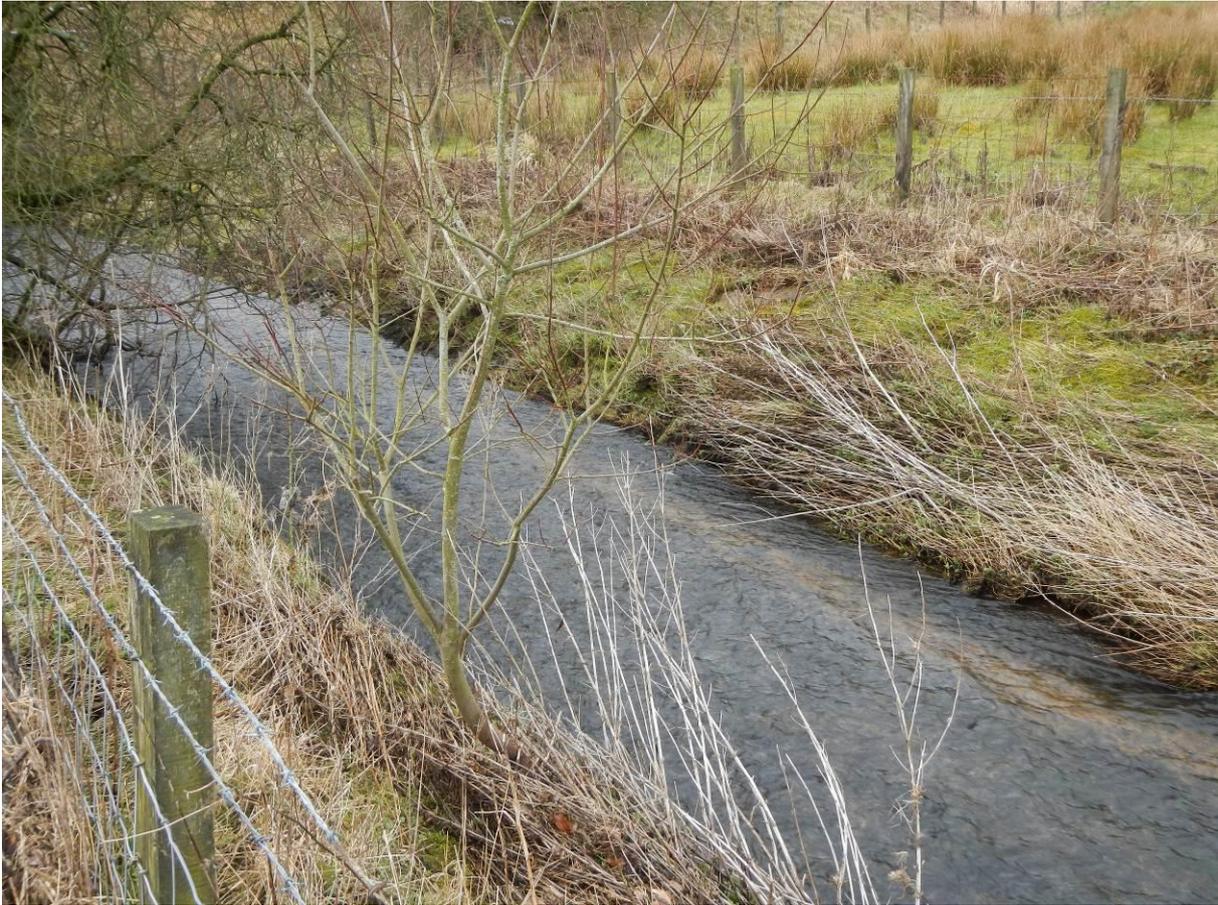
**Figure 12. Shallow water and fast flows over concrete-lined channel (part of the A66 road crossing structure) creates an impediment to fish passage. Laying more of the willows into the channel and planting more to be laid in future could assist fish passage.**

It is important to address all barriers to fish movement as far as is practicable, no matter what the size or extent, as all sizes require the ability to migrate both u/s and d/s to make use of different habitats. For this reason, it is recommended that improvements to passage through the culvert/concrete lined sections is supported however possible. It will be important to first identify what the Council and ERT have planned and then, if required, undertake additional measures such as planting and laying willows along the poorly passable channel sections.

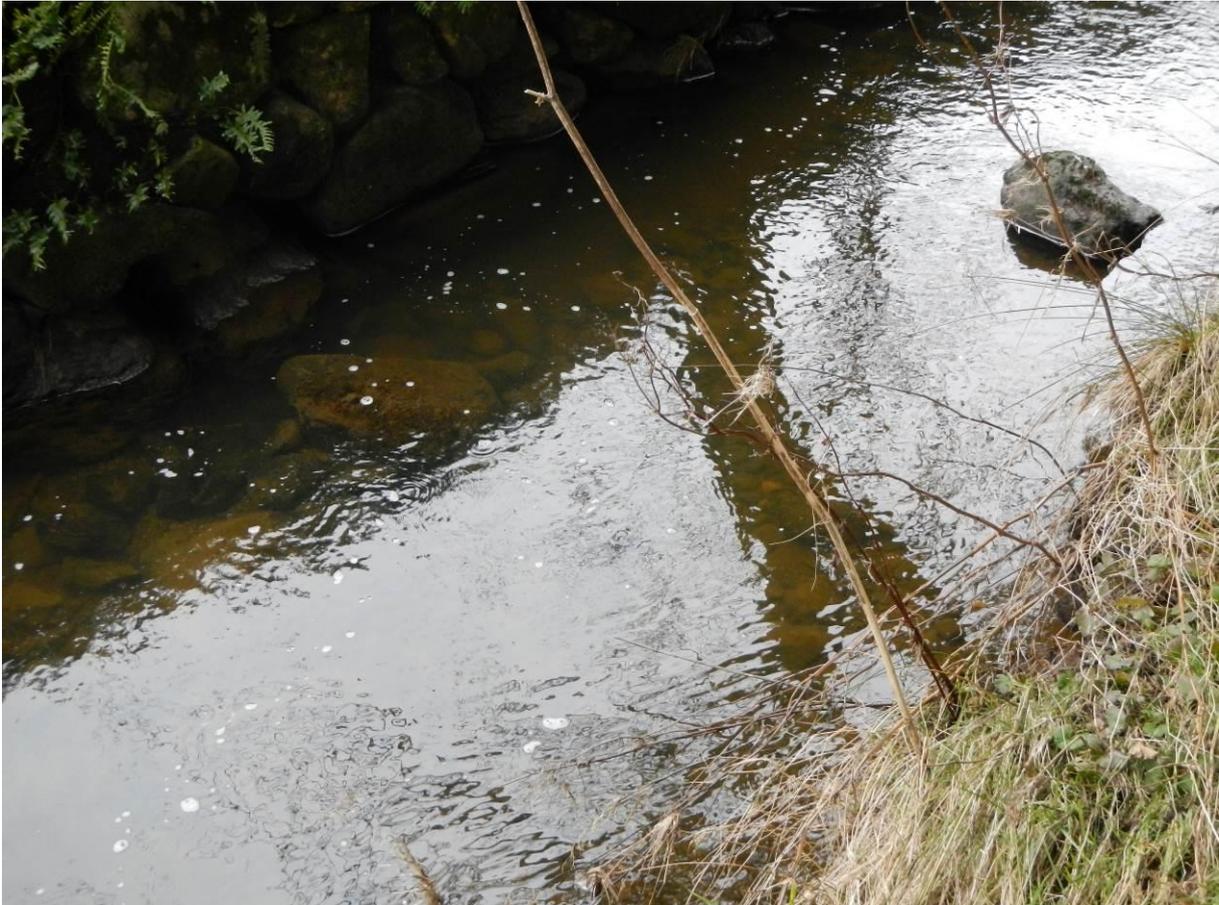
A short section of Swinescale Beck was walked u/s from its confluence with Skitwath Beck. In this section it became apparent that Swinescale Beck carried a higher fine sediment loading than Skitwath Beck, as evident by the silt deposition on the bed (Fig. 13). It was thought that this is due, at least in part, to forestry practices u/s (D Teasdale 2016, pers. comm., 9 March), although the presence of any unfenced, grazed sections of the Beck u/s could also contribute.

As with Skitwath Beck, much of the channel is artificially straight and revetted, limiting the development of natural geomorphological features, although some smaller resident trout habitat (Fig. 13) and good juvenile habitat (Fig. 14) is present. The hard nature of the armoured banks does limit the availability of cover and refuge, however, as bankside shrub and vegetation growth is limited in those areas (Fig. 13).

**Figure 13. Some deeper pool habitat suitable for smaller resident trout is available on Swinescale Beck but deeper, slower areas facilitate deposition of fine sediment indicating issues from input u/s.**

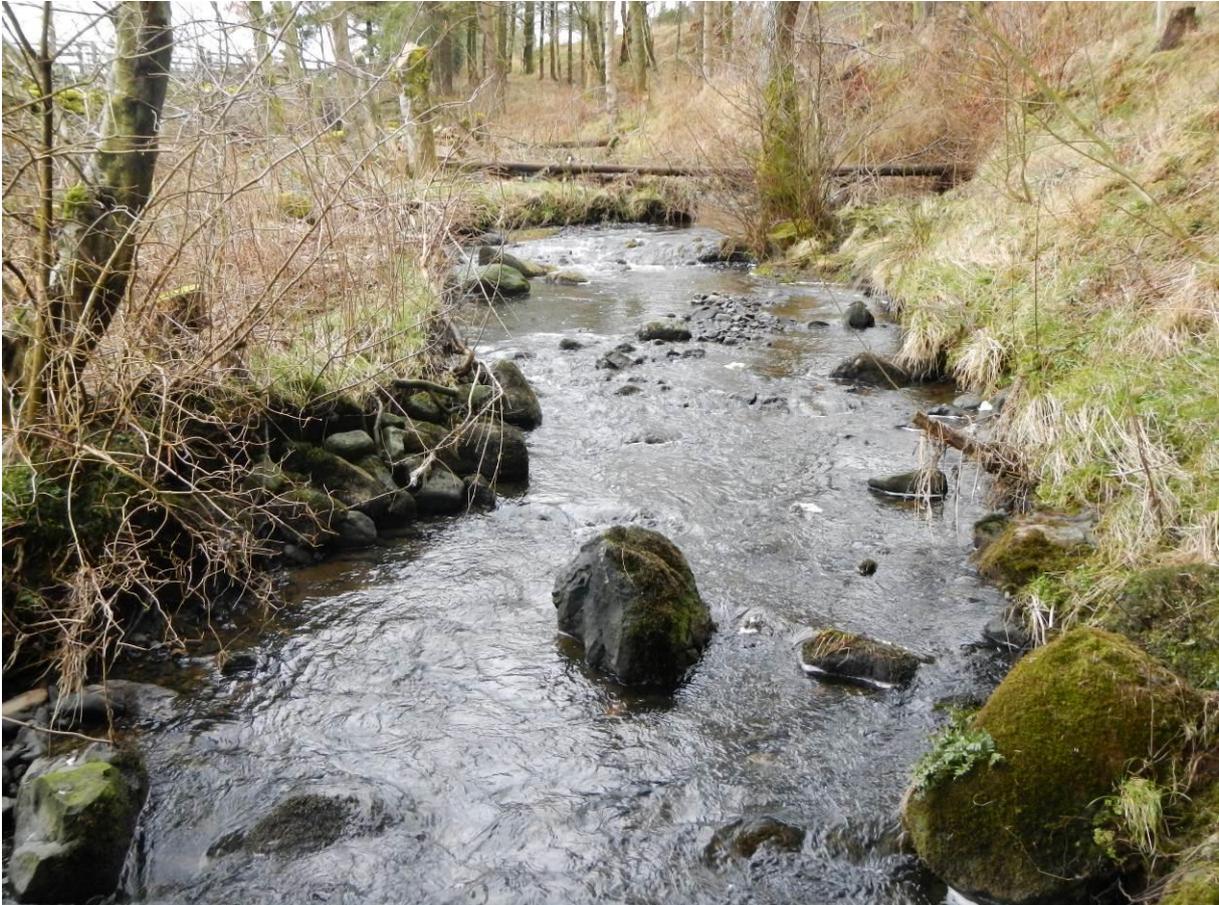
**Figure 14. Good juvenile salmonid habitat on Swinescale Beck.**

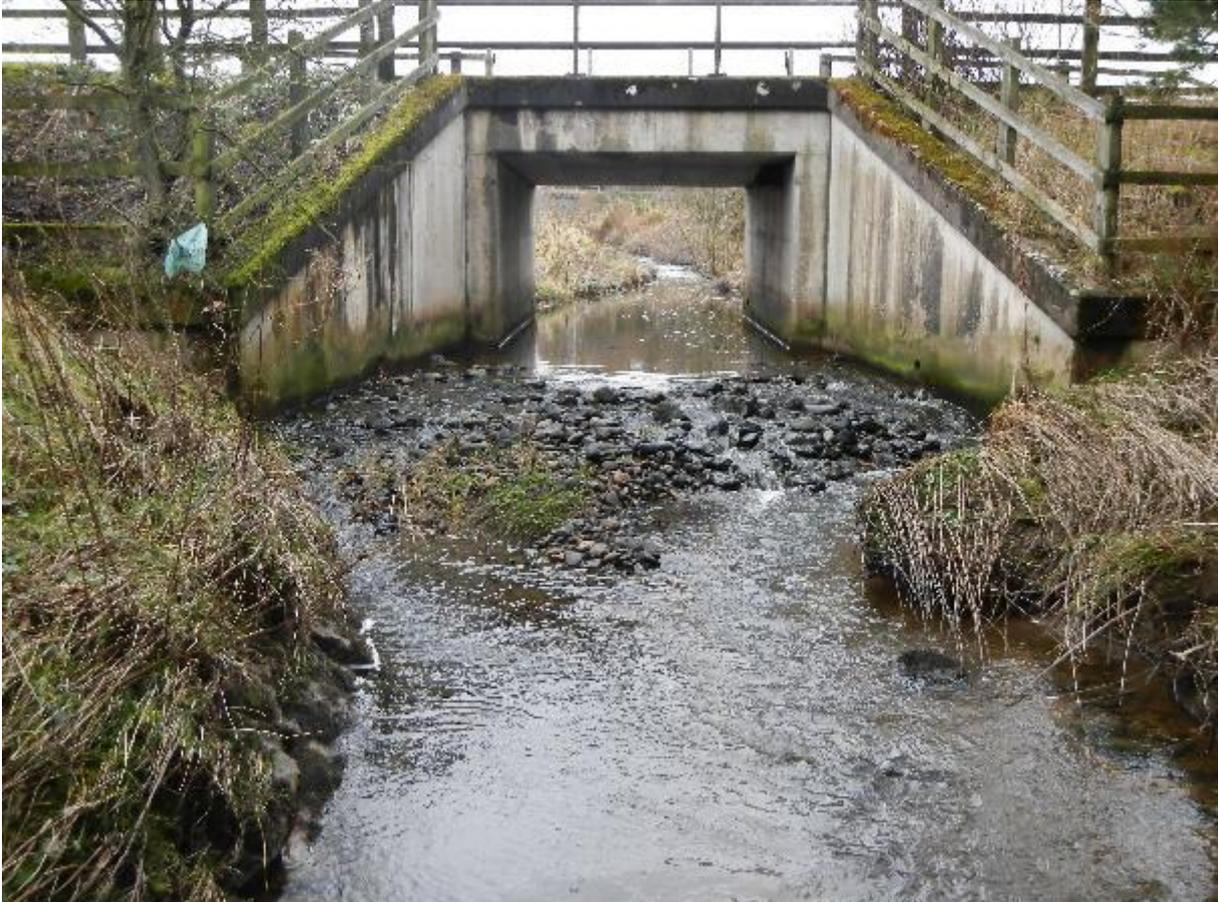
A suitably oversized culvert provides farm access over the Beck and nicely demonstrates the issue of sediment transport on straightened and over-wide watercourses (Fig. 15). Owing to the straightened, steepened nature of the realigned channel u/s, much of the smaller substrate is being washed through the section, with little retained. This material is then deposited within the channel where it becomes overly wide at the d/s side of the culvert. As this deposition posed no real issue for flood risk it is recommended that it is retained in place as valuable substrate.

**Figure 15. Over-wide culvert has facilitated retention of much of the gravel and cobble substrate that cannot be retained within the straight, steep channel u/s.**

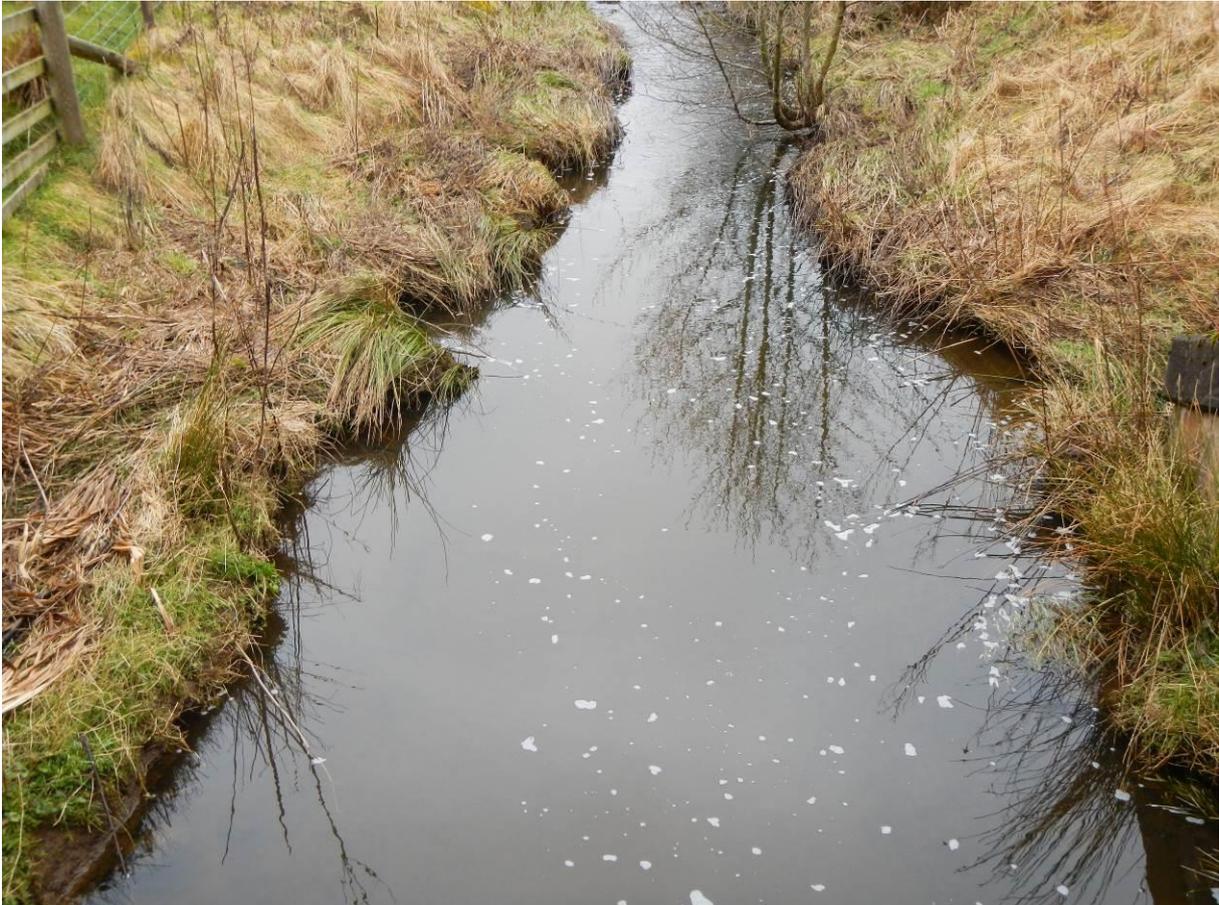
**Figure 16. Pool habitat over a smooth concrete bed. Increasing cover with bankside tree planting would be beneficial.**

Directly u/s of the culvert, deeper water pool habitat could be enhanced as by planting willows at the water's edge (Fig. 16). In most cases, goat willow (*Salix caprea*) will work best, being a smaller shrub species. Crack willow can also work well as it is a fast-growing species which collapses under its own weight and provides a natural input of woody material to the channel; however, the fast growth means that it may require additional maintenance and so be unsuitable in some locations. Once established, laying some of those shrubs into the channel would further enhance the cover habitat and may also assist in retention of natural substrate in at least some areas of the smooth concrete bed. Planting of willows on alternating banks through the straightened section u/s to push the flow from one bank to the other would also be beneficial (Fig. 17). As on Skitwath Beck, planting and laying of willows along the concrete-lined section, around the A66 road crossing, would also assist fish passage (Fig. 18).

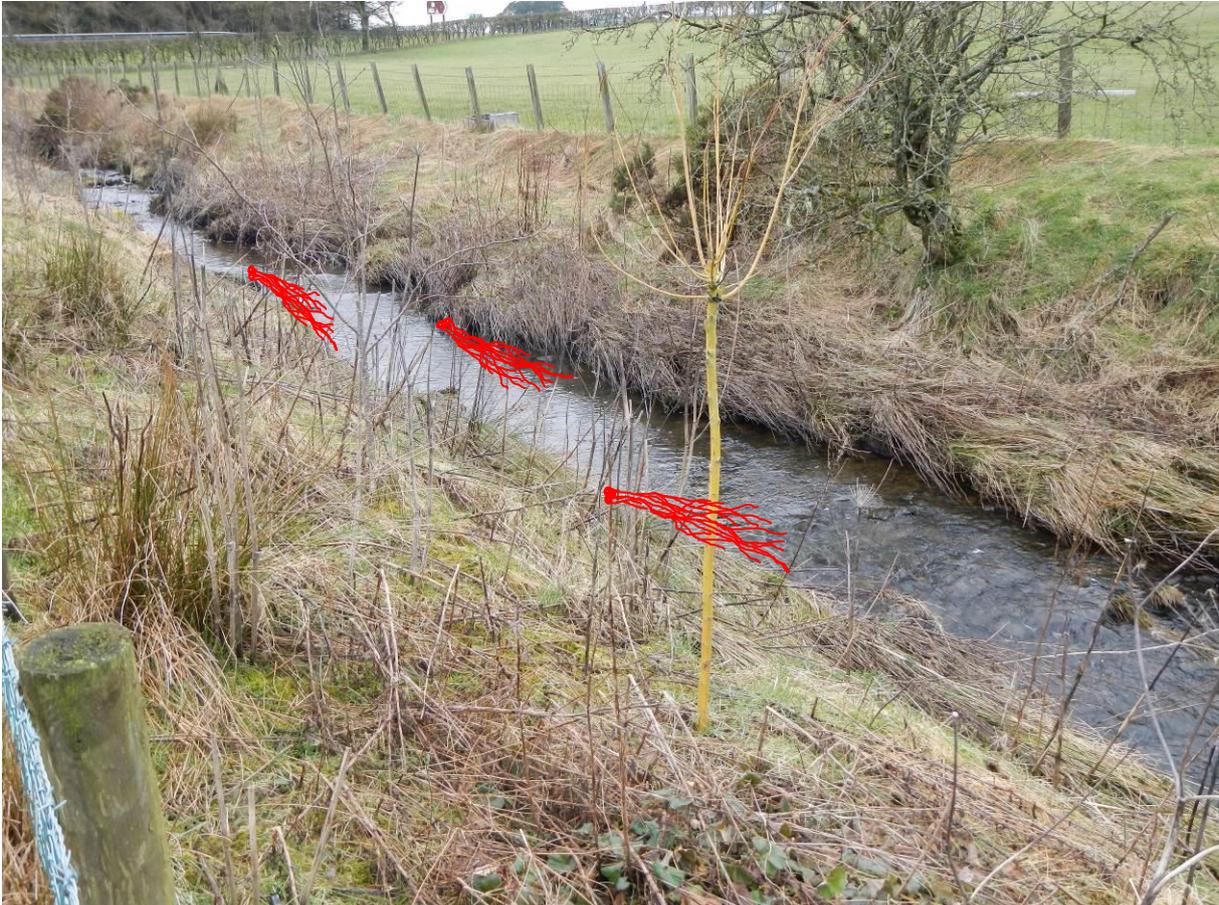
**Figure 17. Planting trees alternately along each bank could help to diversify flow in the straightened section once they have grown up and been laid in.**

Planting a mix of native, deciduous tree species would be beneficial in any areas where the channel is lacking cover and can also be used to help increase bank stability in areas of erosion. Smaller shrub willow species would be particularly beneficial on straight sections where they can be laid in to increase flow diversity.
