**Advisory Visit**  
**Skitwath Beck – River Eden Catchment**  
**9<sup>th</sup> March 2016**

## **1.0 Introduction**

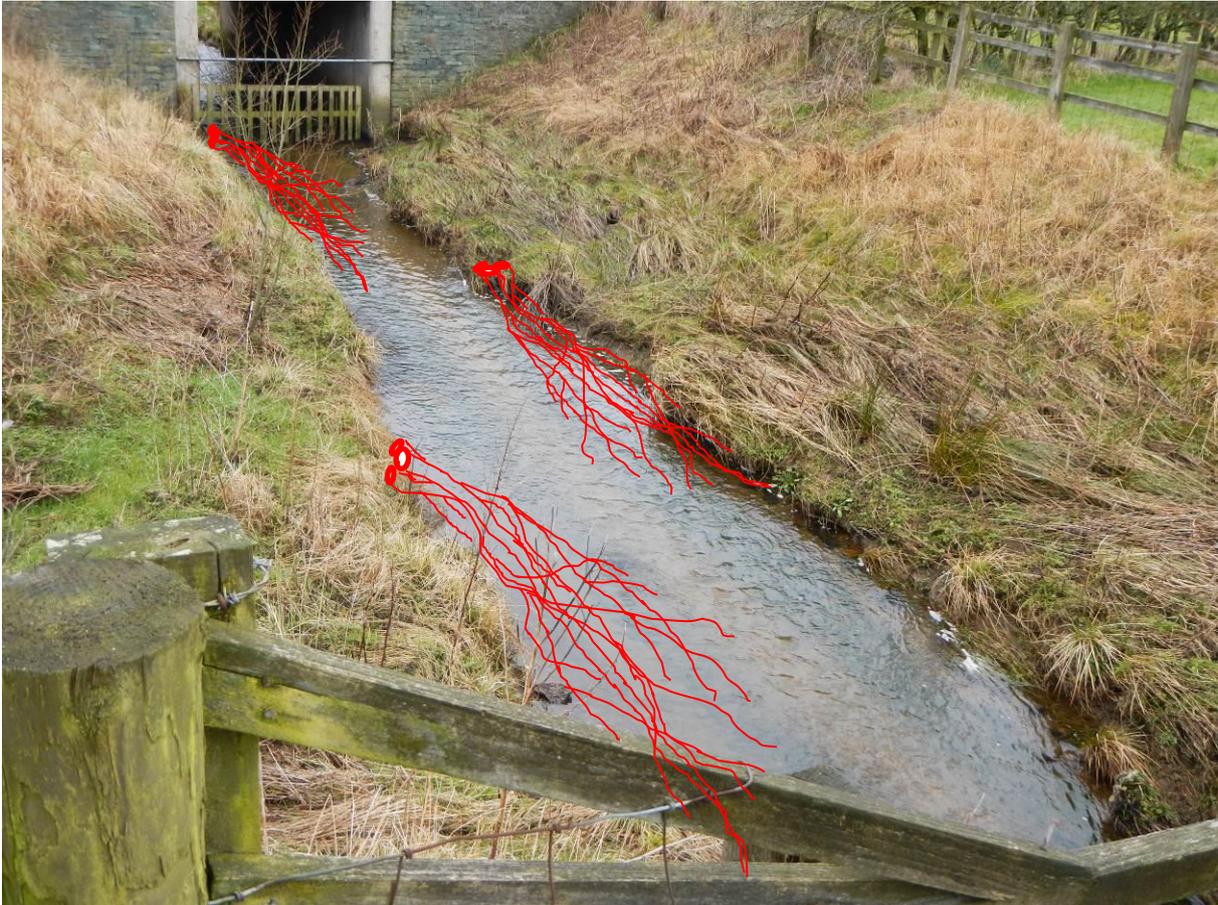
**Figure 18.** As on Skitwath Beck, bankside trees planted and laid into the channel (red) could help to dissipate flows and assist fish passage.

It is important to address all barriers to fish movement as far as is practicable, no matter what the size or extent, as all sizes require the ability to migrate both u/s and d/s to make use of different habitats. For this reason, it is recommended that improvements to passage through the culvert/concrete lined sections is supported however possible. It will be important to first identify what the Council and ERT have planned and then, if required, undertake additional measures such as planting and laying willows along the poorly passable channel sections.
