Habitat Advisory visit to the River Slate, Co. Kildare,
Eire.

Undertaken on behalf of Rathangan District Angling
Association by Vaughan Lewis, Windrush AEC Ltd

June 2008

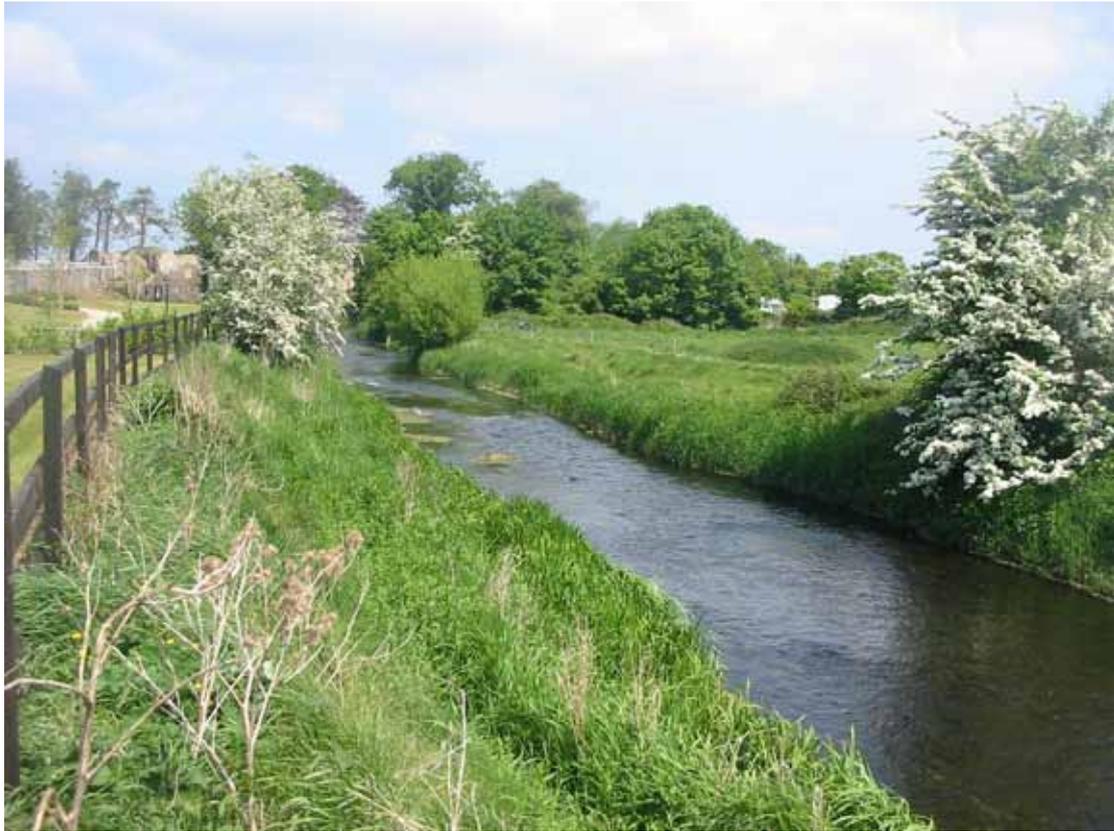
River Slate at Rathangan. Note steep gradient, well-fenced banks and clumps of filamentous algae in the background

Habitat quality in this reach was generally good. The river had a relatively steep gradient, with abundant shallow gravel runs suitable for spawning brown trout *Salmo trutta* and Atlantic salmon *Salmo salar*. However, pool habitat was relatively limited, largely due to repeated removal of any Large Woody Debris (LWD) from the channel by the drainage authorities. One large tree had recently been removed from its stable position in the channel where it had scoured a pool of some 1m deep. This was a good example of both the benefits of LWD (several trout were visible in the scoured out pool) and the regrettable policy of the removal of woody debris from the river.

There were some small clumps of water crowfoot *Ranunculus* Spp. present, although the abundance of this species had also apparently declined during the past 5 or so years. Previous to this, the local council had to undertake an annual cut of the weed to maintain a free channel within the river. There were patches of unbranched bur-reed *Sparganium emersum* present in the channel, indicating slower, more nutrient rich conditions. The banks were fenced on both sides, preventing access to the river for grazing stock.

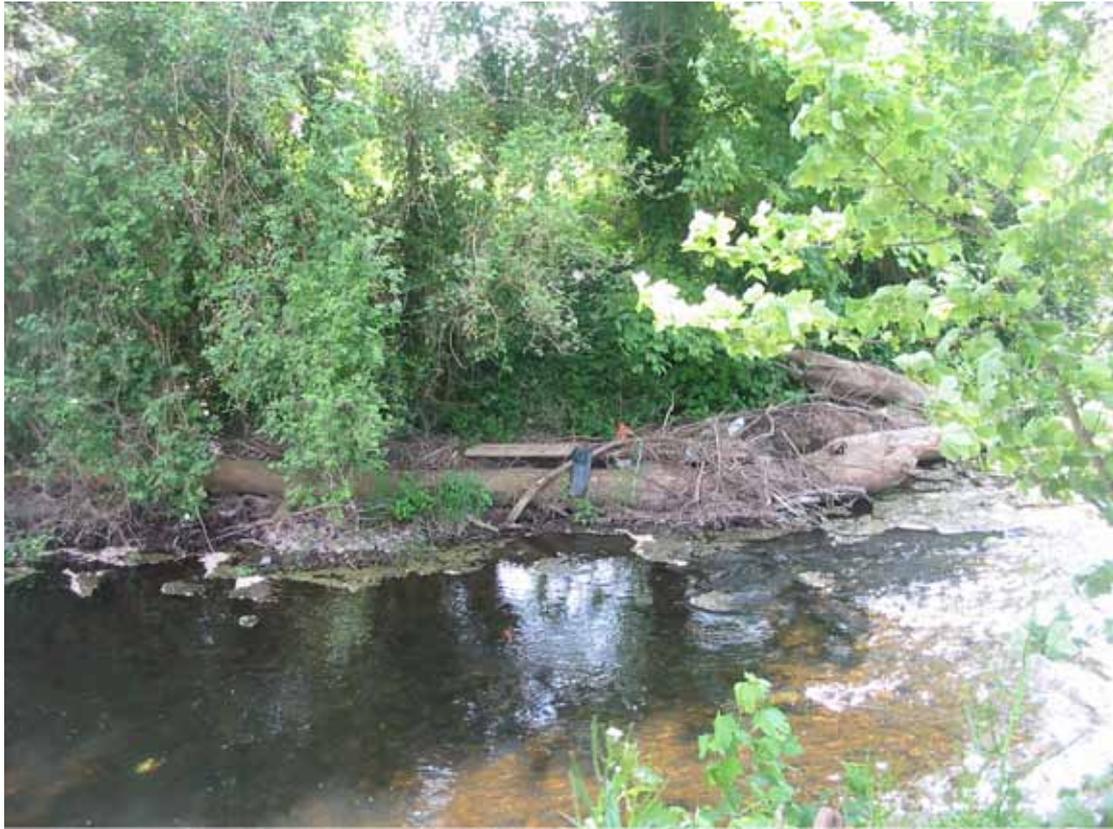
LWD removed from the channel recently

- The regular dredging of the river undertaken by the drainage authorities is entirely counterproductive to the development of strong populations of both brown trout and Atlantic salmon. There is no doubt that this management has reduced and impoverished habitat diversity in the Slate. Regular extraction of LWD from the channel has removed an important structural element from the channel, and largely eliminated instream cover for fish.

- There was a general dearth of Large Woody Debris (LWD) in the river, leading to a lack of cover and a paucity of deeper pool areas suitable for adult fish in some sections of the river. The simplest and most robust method of increasing local scour of the bed, and hence increasing habitat diversity, is by felling carefully selected bankside trees into the river. The selection of suitable trees requires consideration of a number of issues including:

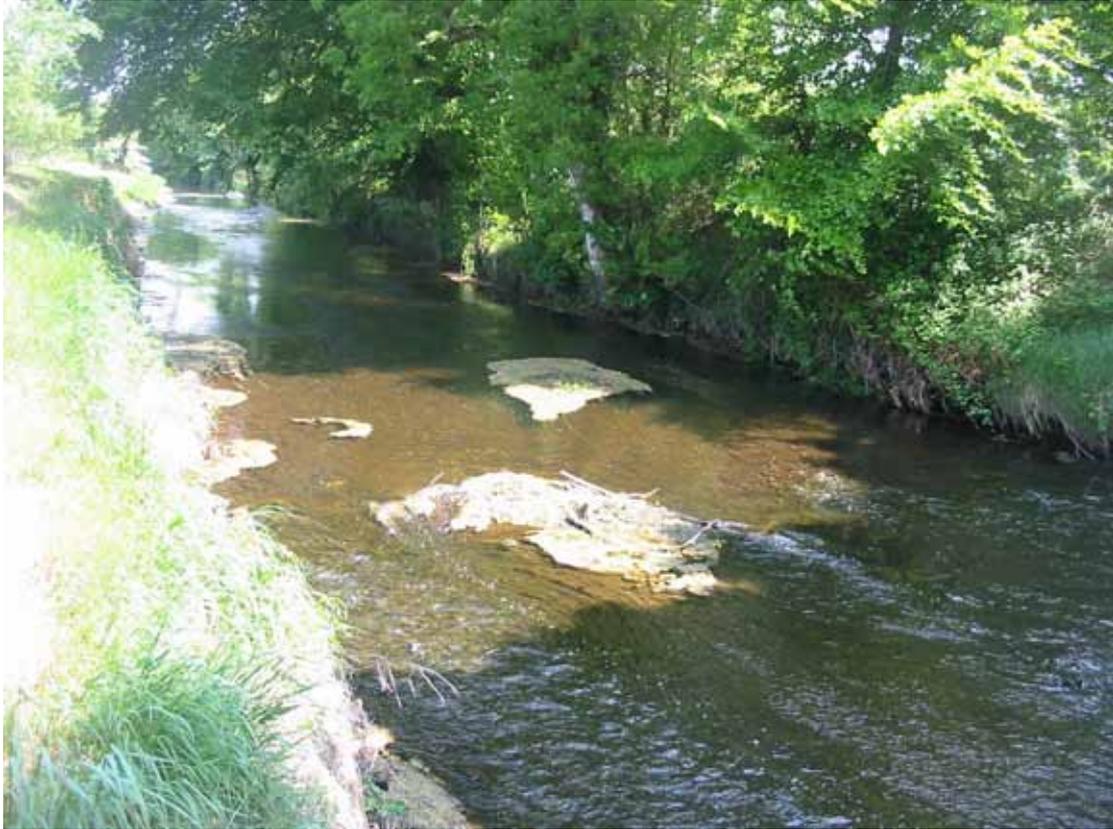
The Town Stretch running upstream to Murphy's Bridge was generally quite open on the RB, with some shading provided by LB trees. The channel was generally shallow, with a dense growth of filamentous algae and diatoms over much of the riverbed. This reach used to sustain high numbers of Trichoptera (caddis flies), with spectacular evening hatches of sedge. This is apparently no longer the case. A handful of small brown trout were observed in this reach. These were generally around 20cm-30cm in length.

Dense beds of filamentous algae and diatoms in the Town Stretch

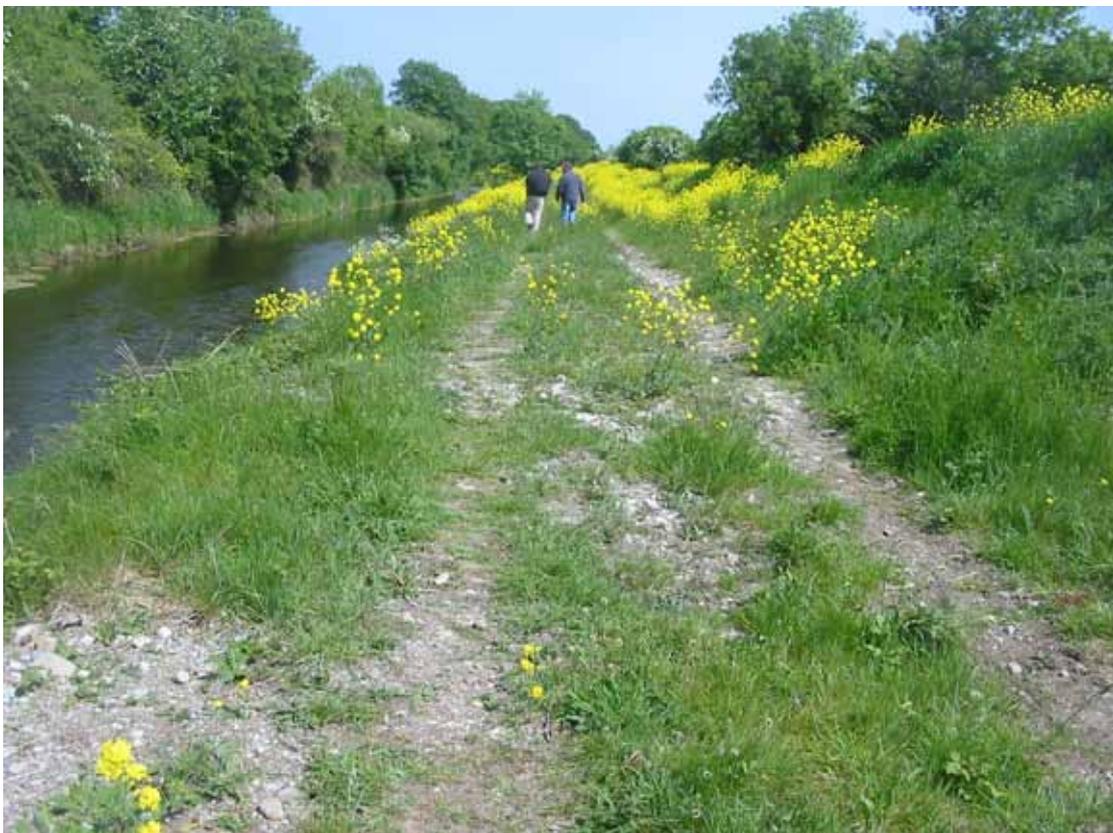
The Iron Bridge reach was traditionally an excellent spawning area for both trout and salmon. However, recent dredging work has severely reduced the instream habitat quality. Large volumes of gravel and stone were removed from the channel, leaving it overwide, uniform and lacking in shallow riffle areas vital for spawning and juvenile salmonids.

Recently excavated gravel used to make up a track on LB u/s of Iron Bridge.

Future dredging work would ideally be undertaken in a more sensitive manner, with greater regard to both the necessity for the work and its impact on the river's ecology. Given the greatly incised nature of much of the Slate's channel, it seems doubtful whether much of the work that has been undertaken in the recent past actually delivers real benefit for flood defence purposes. Recent changes in agricultural economics, particularly with regard to the EU payments system, also cast doubt on the need for regular dredging to take place for farming purposes. It would be instructive to undertake some quantitative hydraulic modelling of past and proposed dredging work in order to fully understand its impact on the river's flood dynamics.

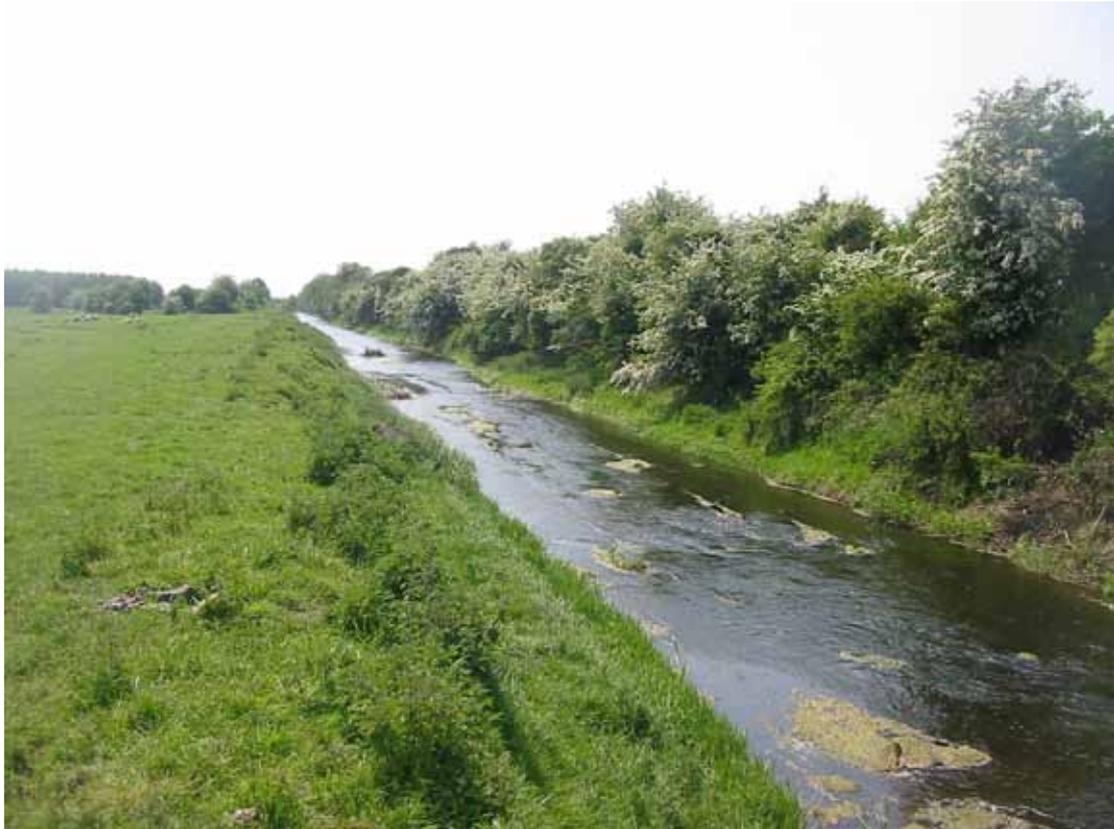
Filamentous algae was again very visible in this reach, with stock grazing also an issue. The LB of the river was overgrazed by sheep in places, with very little cover remaining. The RB was shaded by extensive bankside growth of shrubs and trees, particularly hawthorn. There was a large raised berm visible on the LB indicating where the dredged spoil had been deposited historically.

Below Aga Bridge. Note grazed LB, tree covered RB and extensive algal growth instream.

- Where stock had unrestricted access to the banks of the river, there was little cover, or shade, with the banks physically damaged in some reaches. Erection of temporary (electric) or permanent (post and wire/netting) fencing would prevent this

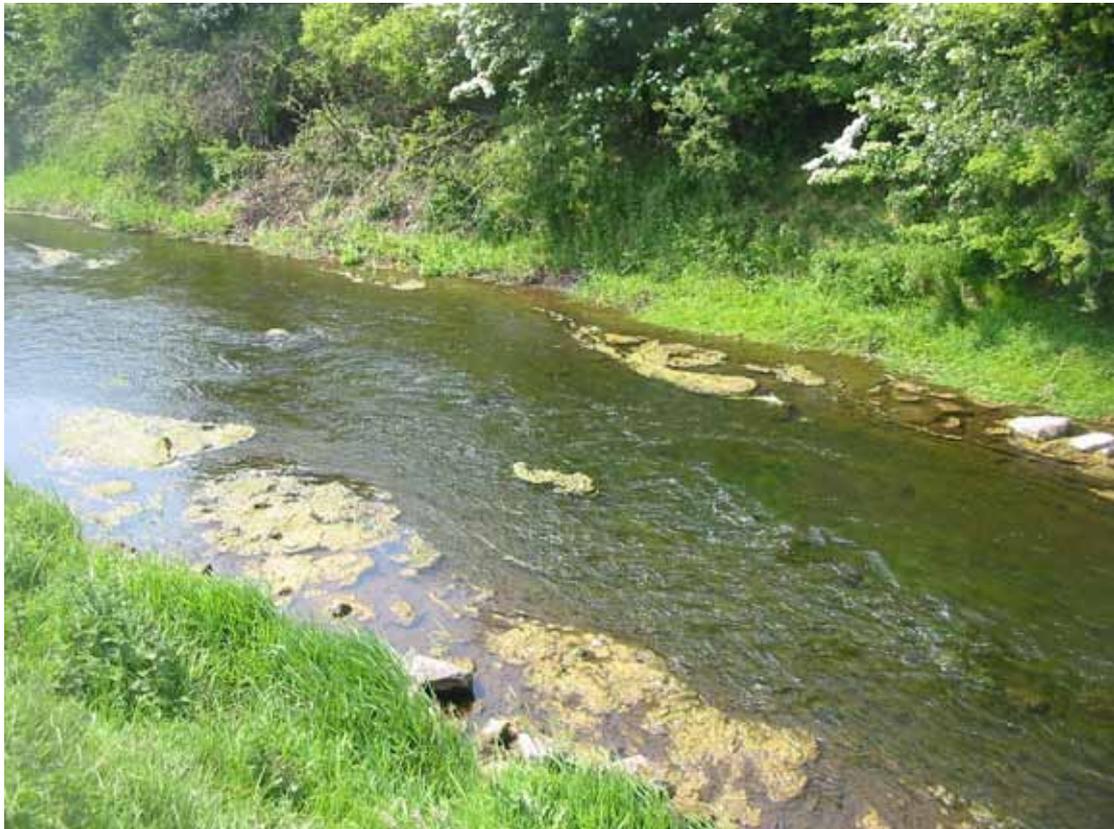
There is little doubt that the apparent decline in the fishery status of the Slate can, in part, be attributed to its moderate to poor water quality. Visually, the impacts of elevated organic and nutrient enrichment were very apparent. There were considerable accumulations of sediment overlying the hard bed of the river, whilst the abundant growth of filamentous algae and diatoms was all too obvious.

Extensive growth of filamentous algae, both on the river bed and the water surface

It is important that a full audit of likely inputs of organic enrichment is undertaken. This should include the obvious point source inputs, including drainage and wastewater treatment discharges, along with diffuse source inputs. Once identified, actions should be put in place to reduce their impact on the river. These actions might include the enforcement of planning conditions with respect to sewage discharges from single or multiple development sites, the installation of a phosphate stripper at Rathangan wastewater treatment plant, and the implementation of good agricultural and forestry practice to minimise diffuse source inputs.

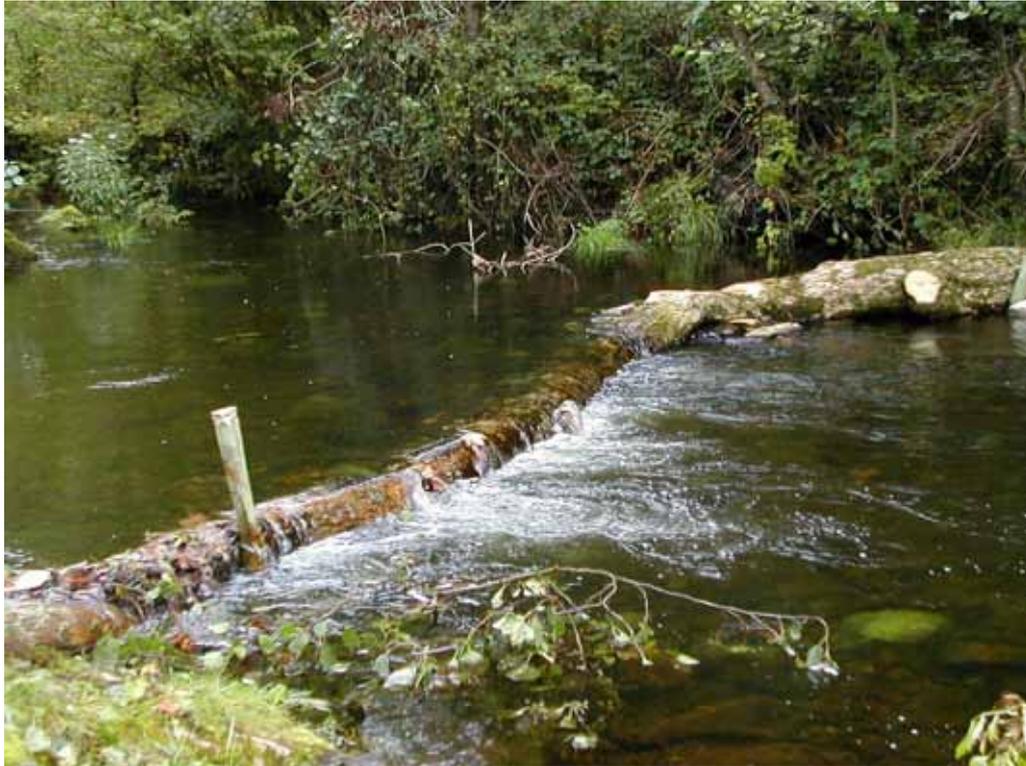
LWD deflector staked in place in an upland stream.

Ø Fixing of the felled timber. By far the best fixing can be obtained by partially cutting through the selected tree and 'hinging it' into the water. By locating the end of the hinged timber behind and upstream of an existing tree on the opposite bank, a very firm fixing is thus obtained at both of its ends. A Tirfor winch is a very useful tool for this type of operation. Short of the impact of a massive flood event, the stability of the felled tree will then be assured. Further security can be obtained by drilling through the trunk of both ends of the felled tree and securing them to standing trees using cable laid wire.

- As an alternative to LWD, simple groyne could be constructed from locally derived rocks. These should extend approximately one third of the way across the channel, and should be set facing upstream in order to reduce the risk of bankside erosion. Further details on groyne construction and the use of LWD are provided in the Wild Trout Survival Guide that has been sent to the club secretary following the advisory visit.
