WILD TROUT TRUST

Advisory Visit

River Smite, Nottinghamshire

September 2020

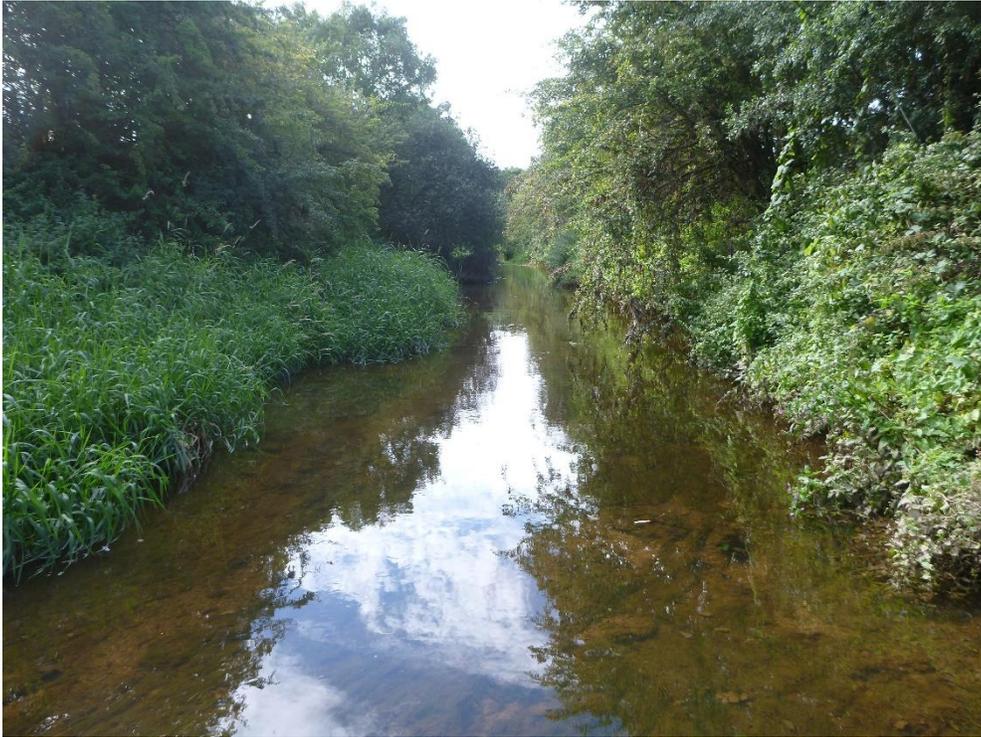
Examples of the above were evident during the visit to the Smite. Figure 6 shows the typical habitat downstream of the road bridge – uniformly shallow (around 10 – 15cm), but within a channel which contains flows up to approximately 4 metres deep before spilling onto the floodplain. Wrack levels in the bankside bushes showed a recent rise in levels of about 0.5m after summer rainfall and rises exceeding channel capacity in recent winters were reported by the landowner. The channel is moderately shaded by hawthorn bushes here, but the north-south aspect allows sufficient light for emergent vegetation to colonise the margins, pinching the channel at low flow levels; encouraging this process by creating brushwood 'berms' (low shelves) is a way of improving in-stream habitat (see Recommendations).

Figure 6 Downstream of the road bridge.

- Create a narrower, sinuous low-flow channel by installing brushwood berms on alternate banks (Figure 10 and Figure 11). This would be a suitable technique upstream of the footbridge and downstream of the road bridge. Existing bankside bushes could provide a source of brushwood and an opportunity to manage the riparian tree cover and introduce a greater variety of native tree species.

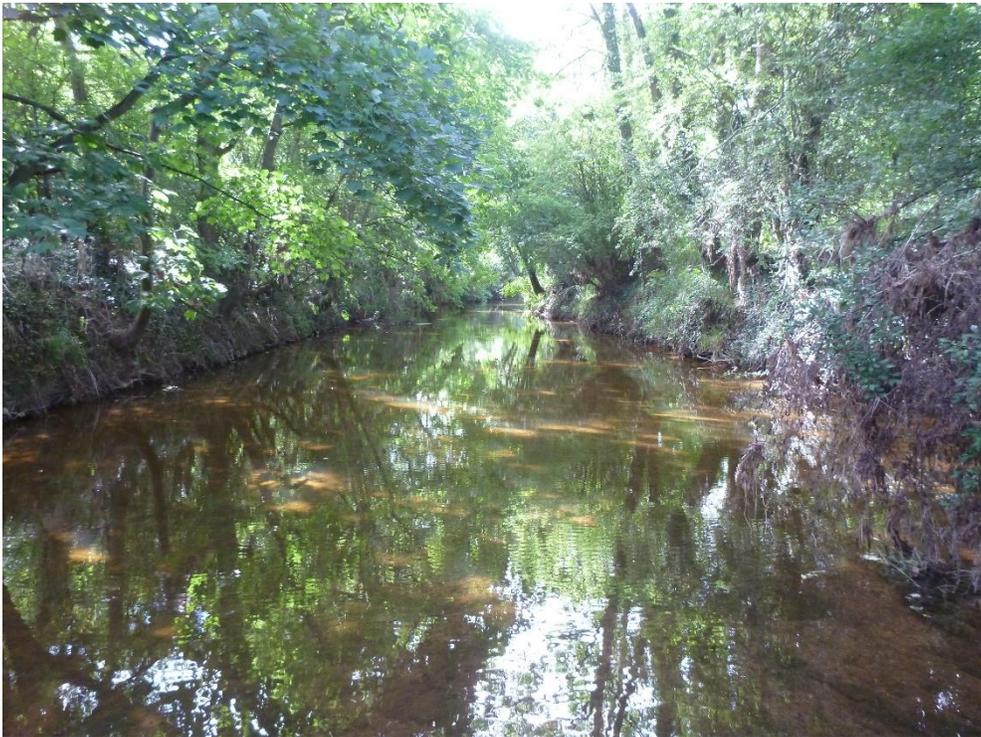
Figure 7 shows the section upstream of the road bridge, which runs through Fishpond Plantation (right bank) and the village Millennium Green area (left bank). This section is impounded by the bridge culvert (Figure 8) and is shaded by mature trees, the result of which is an over-wide, shallow, low-energy reach with poor in-stream habitat. Attempts to improve in-stream habitat here with brushwood berms or flow deflectors are likely to be frustrated by the shade (preventing aquatic vegetation from establishing and pinching the low-flow channel) and the impoundment (low flow energy, hence less bed scouring effect).

Figure 7 Upstream of the road bridge.

Thinning of some trees (particularly the uniformly-sized sycamores on the left bank) may reduce shade and provide material for in-stream structures, but this must be carefully considered given the known presence here of an important bat community.

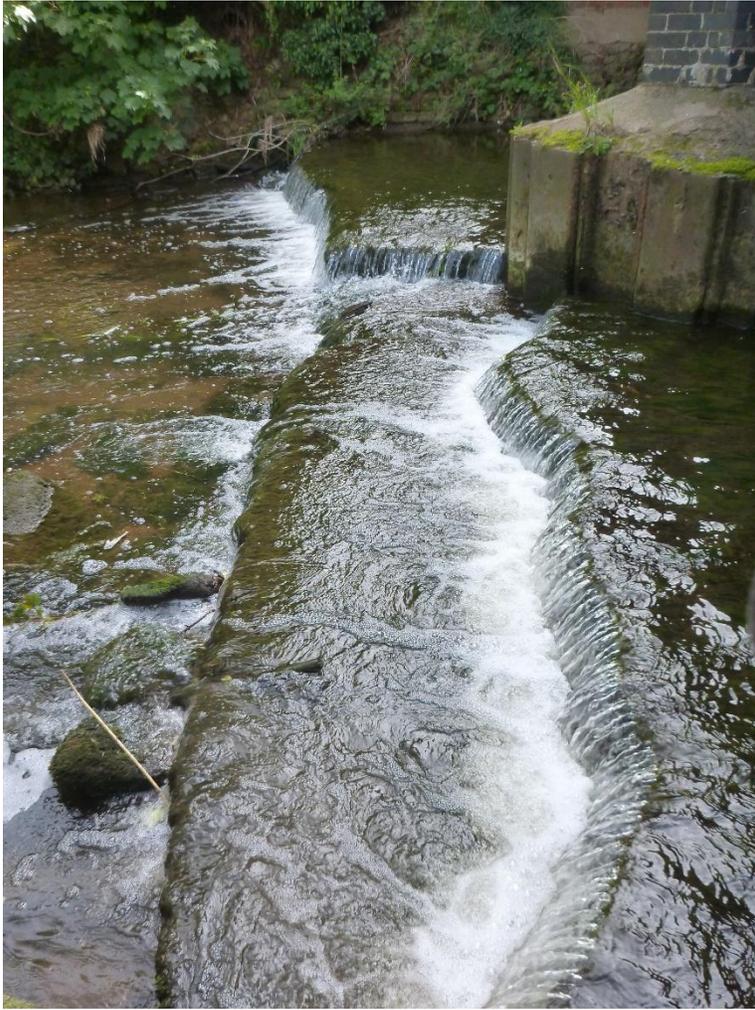
At lower flows, the weir at the road bridge is an obstacle to fish movement (Figure 8). It would be possible to improve this with relatively simple techniques (see recommendations), but the priority on this reach would be to concentrate on in-stream habitat improvement in the first instance.

Figure 8 Obstacle to fish migration caused by the bridge culvert.

- The weir under the bridge could be improved for fish passage. The simplest way to do this would be to raise downstream water levels to drown out the drop over the weir. Two or three areas of the river bed downstream of the weir could be raised to create artificial riffles and step-down the water levels. These could also have the benefit of scouring pools downstream of each riffle. Installation would take around 2 – 3 days with an excavator and cost around £10K. Flood risk implications would be neutral given it would simply extend the existing water level at the bridge a short distance downstream.

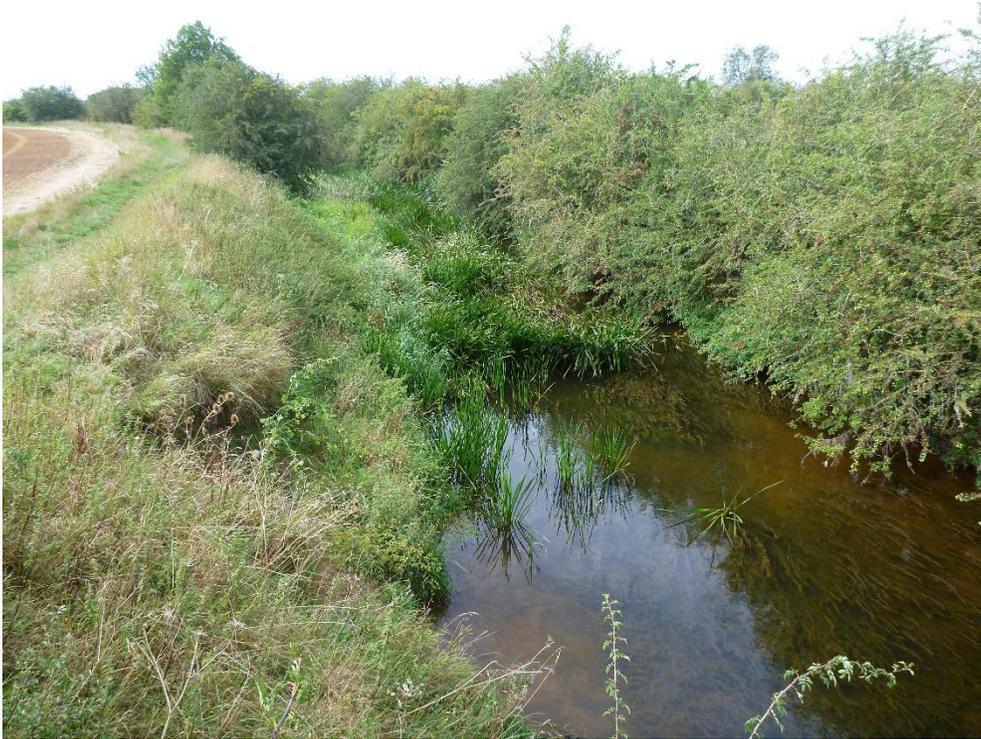
Figure 9 shows the section of river upstream of the footbridge. In contrast to the previous section, the channel here is choked with burr-reed with only small areas of open water, or narrow channels where shade is present from bankside hawthorns. The uniform size of the hawthorns suggests they are periodically trimmed to the same size; allowing some to develop into larger trees along the right (southeast) bank would provide more shade and reduce the prevalence of burr-reed. Similarly, planting and protecting other native tree species along this bank is recommended for the same reason. Brushwood berms could be installed here to create a low-flow channel closer to the natural width of the river, which should have enough energy to restrict burr-reed to the margins (see recommendations).

Figure 9 Upstream of the footbridge.

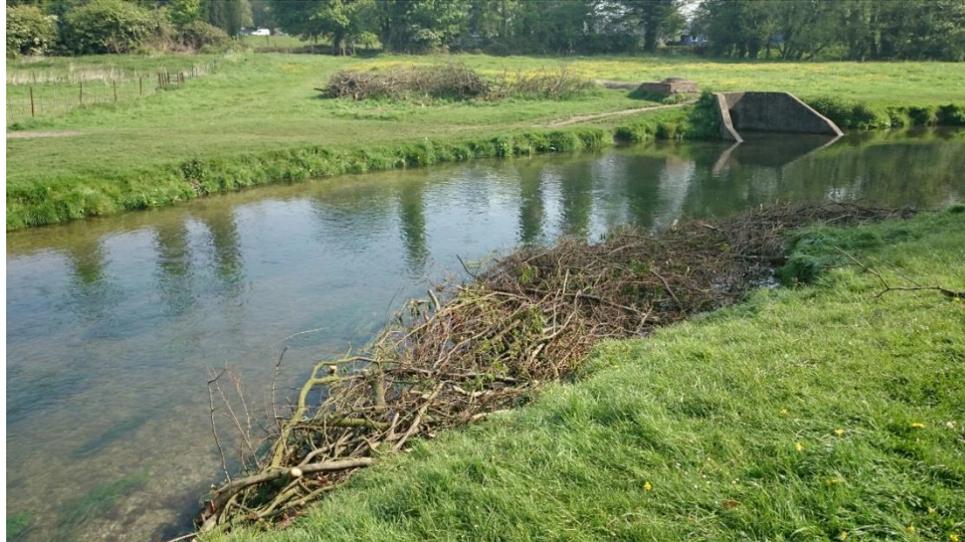
Figure 10 Brushwood berm created by packing brushwood between stakes driven into the river bed and battening over the top.

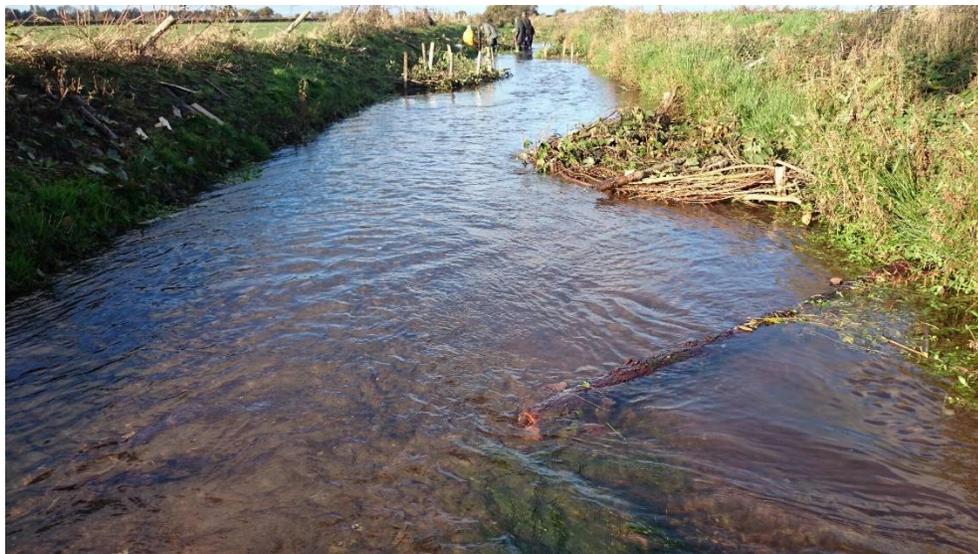
Figure 11 Brushwood structures on alternating banks to create sinuosity.

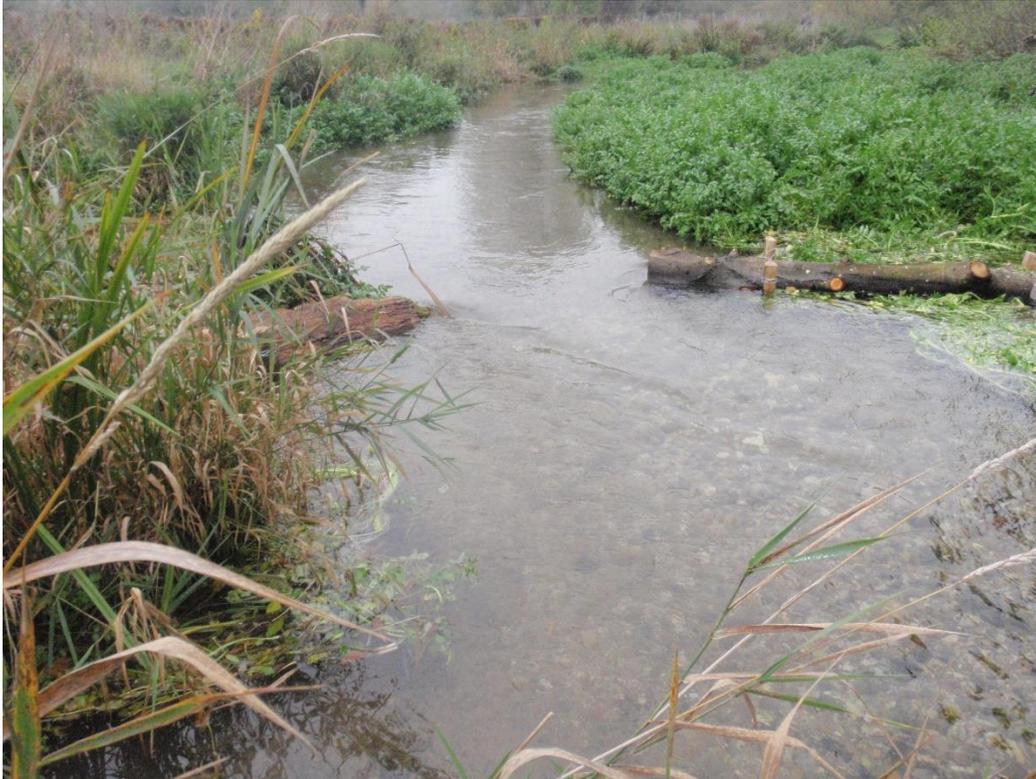
Figure 12 Log flow deflectors arranged into an upstream-V shape to deflect flow into the centre of the channel, scouring a deeper hole and throwing up sorted gravel downstream (river flow towards the camera).

- Introduce some log flow deflectors to create localised bed scour. This should create some deeper areas and also grade the river bed substrate making it more suitable for fish spawning (Figure 12). Logs could be sourced from the sycamore trees on the left bank upstream of the road bridge.

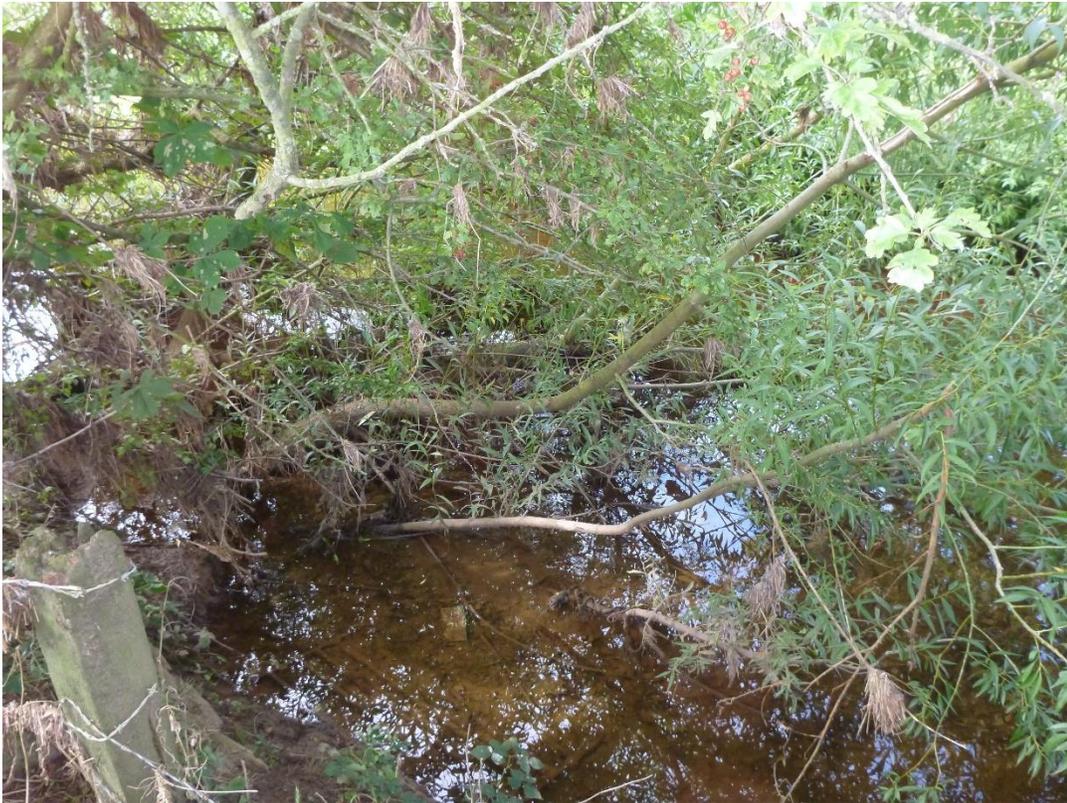
Figure 13 Willow growing out into the channel downstream of the road bridge. Retaining cover of this kind is the most beneficial habitat option, but if management is required trimming the higher level branches and retaining those in and just above the water is recommended.

- If overhanging trees need to be managed, do so in a way that retains low cover (in or close to the water surface), as discussed on site regarding the crack willow on the right bank downstream of the road bridge (Figure 13).

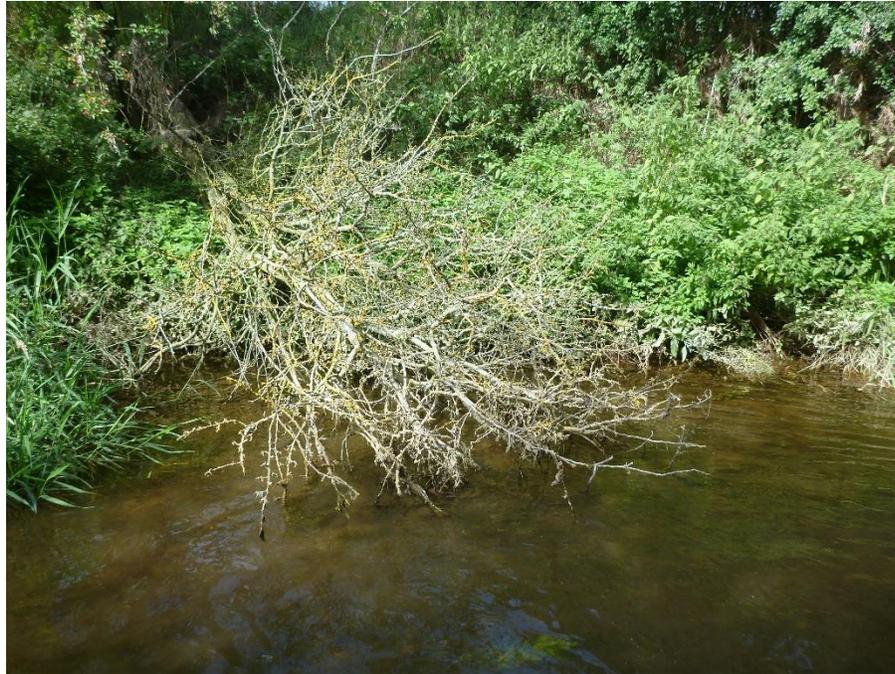
Figure 14 Natural cover provided by a fallen hawthorn.

- Retain natural features such as fallen timber, tree stumps etc. The more structure within the channel to provide cover and flow variation, the better (Figure 14). Similar features could be created by partially cutting and laying over suitable trees into the river margins in a similar manner to hedge laying (Figure 15).

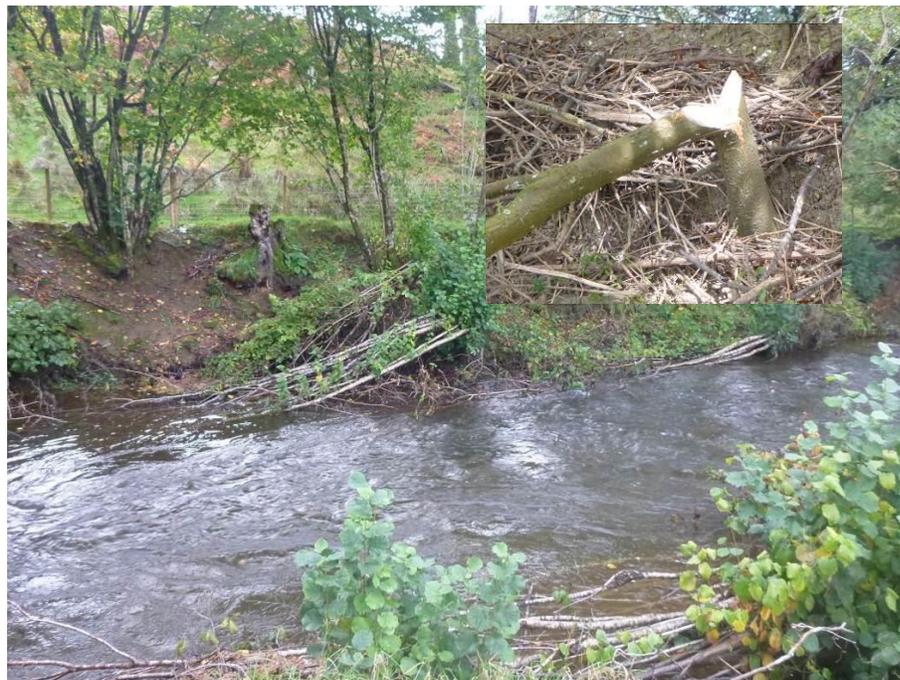
Figure 15 Bankside trees cut and laid to create good cover. Inset: example of steeply angled back-cut to create a hinge.

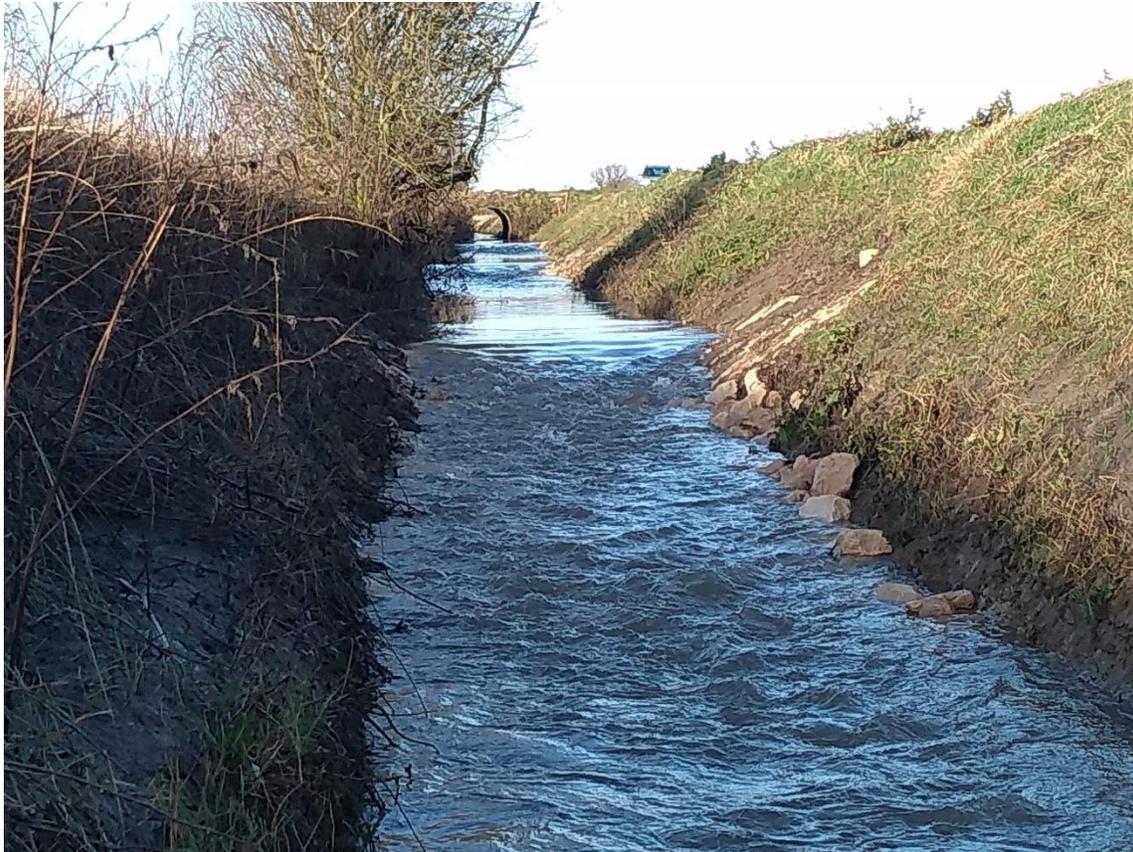
Figure 17 Example of a series of three rock ‘riffles’ installed to step-down water levels downstream of a culvert which was perched above previous water level. NB the perspective – the distance to the culvert from the camera is c.100m.
