**ADVISORY VISIT TO ST MARY'S BURN, HOLM,  
ORKNEY ISLES  
August 25, 2008**

**By Dr Andy Walker, Ellwyn, Moulin, Pitlochry PH16 5ER**

**On behalf of Windrush AEC Ltd, The Cottage, Fordwells, Witney,  
Oxon OX29 9PP**

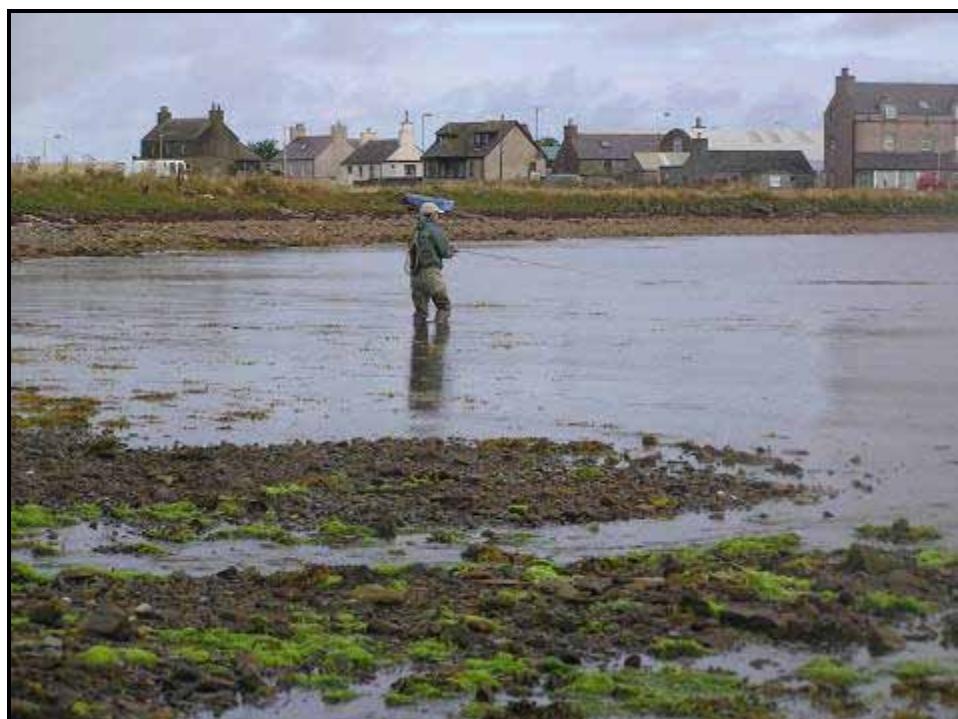
**Plate II: Malcolm Thomson fishing for sea trout in St. Mary's Burn outflow in the Bay of Ayre  
(OS Ref. HY 470 012)**

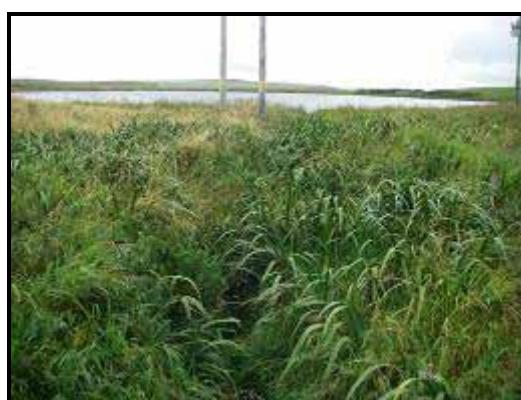
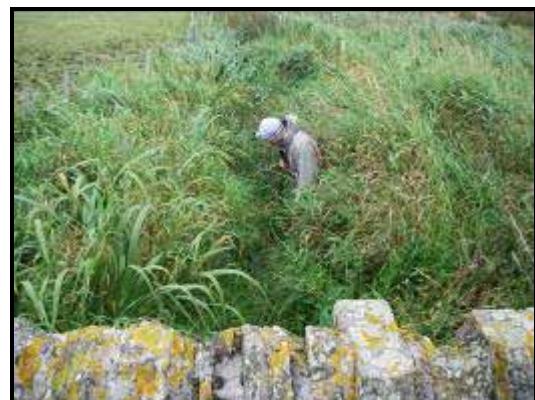
**Plates III&IV: Choked lower reaches above the loch**

The channel is protected on both sides against overgrazing of the banks by cattle and other farm stock, but the vegetation has grown so thickly under zero grazing pressure that it chokes the stream. On the other hand, most of the sections we looked at held clear water under the vegetation and the substrate, while heavily silted in many places, contained gravel in places that could be suitable for spawning of trout. Invertebrates (water snails, caddis and small mayfly larvae) were common under the flattened stones, indicating good water chemistry (high level of calcium) with sufficient oxygen for juvenile fish, although none were seen. Conditions were very difficult to see fish and further electrofishing would be recommended in autumn or early winter when the vegetation will have died back and flows should be enhanced by rainfall. There had been very little rain for several weeks before the advisory visit. The burn receives some spring water here and there and we saw evidence of this in the upper reaches. The only point sources of pollution that we encountered were a small pipe discharging from a farm in the lower reaches (right bank – looking downstream) and a red-stained discharge from an old landfill tip. Neither of these discharges seemed to affect the stream for more than a few metres. We wondered whether willow bushes and reeds growing luxuriantly in the landfill tip site may have

- The next stage would be a targeted removal of large amounts of instream silt by mechanical digger and clearance of the much of the surrounding vegetation to expose the water surface to daylight. Some of the more vigorous vegetation may need to be sprayed periodically with herbicide (probably glyphosphate – consult with SEPA). Desilting and partial weed removal will promote stronger scouring action and hopefully expose gravel that may be used by spawning trout. Gravel and larger stones should be retained whenever possible. It may be necessary to import quantities of both materials to create better habitat for spawning and sanctuaries for parr and larger trout. Deeper sections also should be retained as cover for larger juveniles and ascending adults. Sections with stepped falls, providing they are passable by trout, should be retained for channel and biological diversity and oxygenation. Simple upstream pointing V groynes of wood beams or stones may be used to break the current in flatter sections, again promoting varying depths and flow patterns to the benefit of invertebrate diversity and trout (see The Wild Trout Survival Guide provided by WTT).

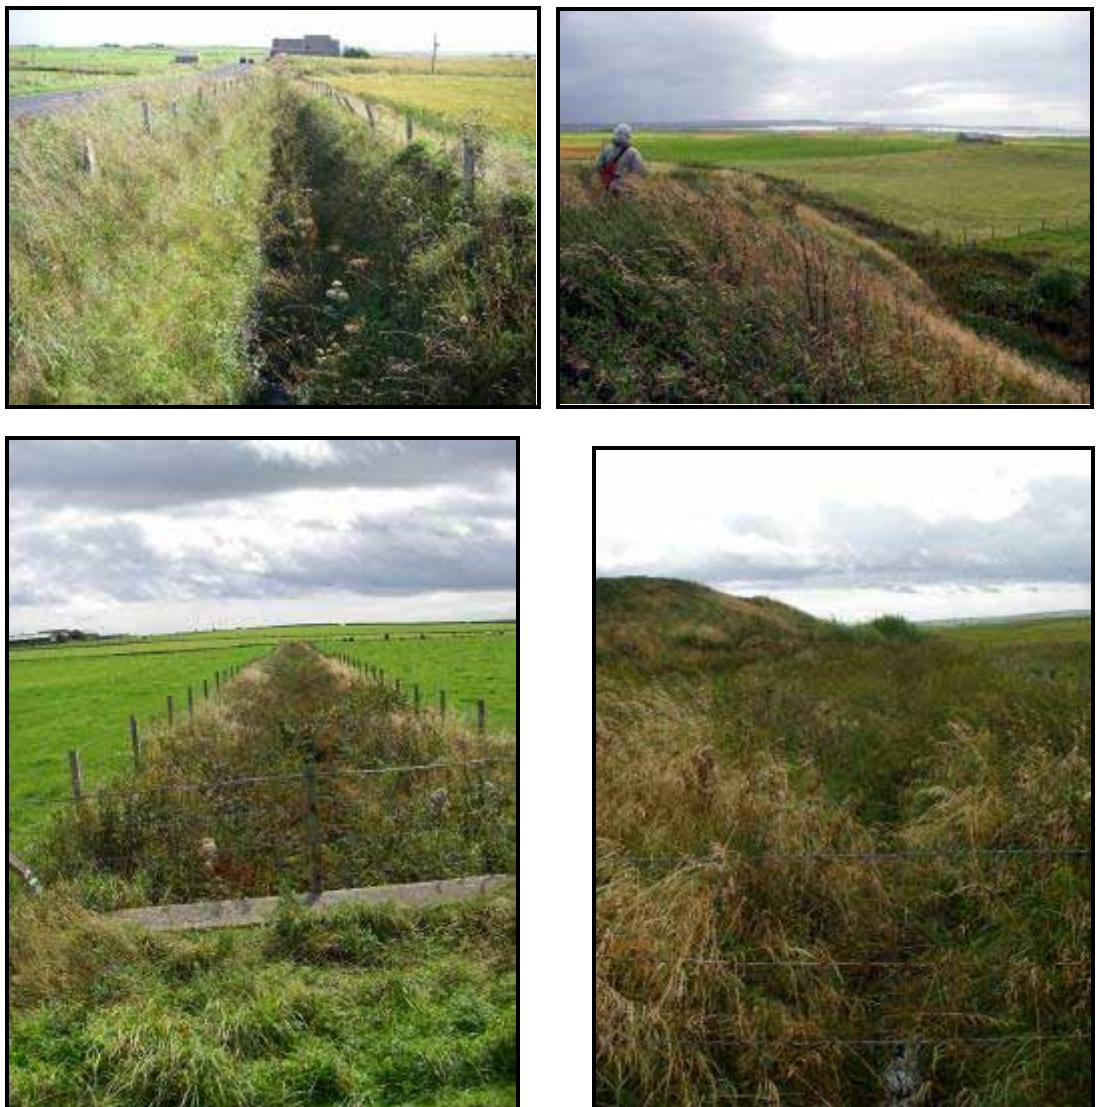
**Plates V-VIII: Middle reaches including old landfill tip area showing willows**

been planted to assist nutrient uptake. Diffuse pollution in the form of farm slurry or fertilisers would be expected to reach the stream from the surrounding fields during wet weather. SEPA may be able to advise on water quality and effects of local farm practices, although they may not have sampled there because of the small size of the catchment.

- Willow cuttings may be placed at points along the banks where additional cover for trout in the form of rootballs would be useful as hiding cover for larger fish. Willows already present in the area around the old tip can be used as sources of cuttings. However, there needs to be a regular maintenance programme to ensure that the willows are cut and dug back if they become over-rampant.

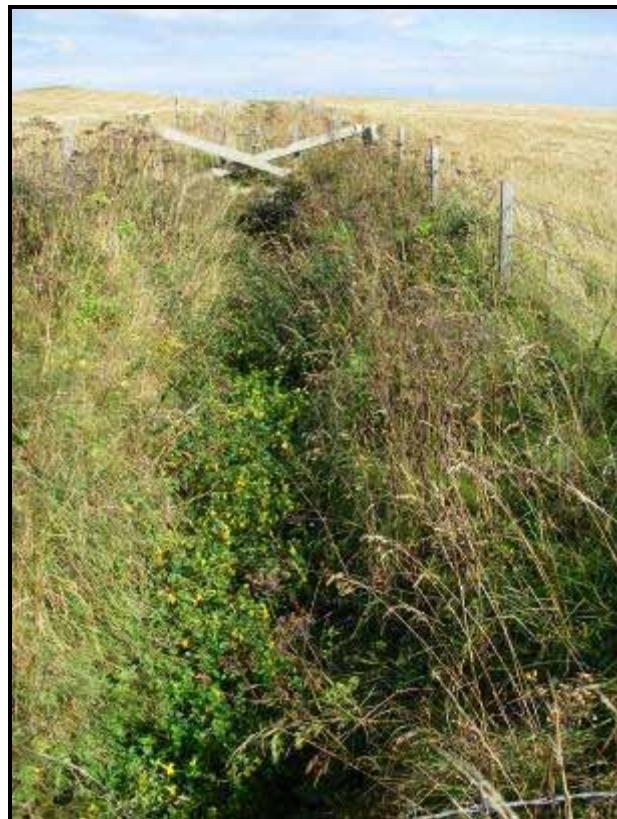
**Plate IX: Steeper section nearer the top of the burn**

- Also, if natural gravel sites are found to be inadequate for spawning, streamside ova incubation boxes may be used where there is enough slope to provide a head of flow (see The Wild Trout Survival Guide). These provide a constant flow with clean gravel from which fry emerge and drop into the burn volitionally in spring. The steep section of burn shown in Plate IX (OS Ref 469030) may provide a suitable site.

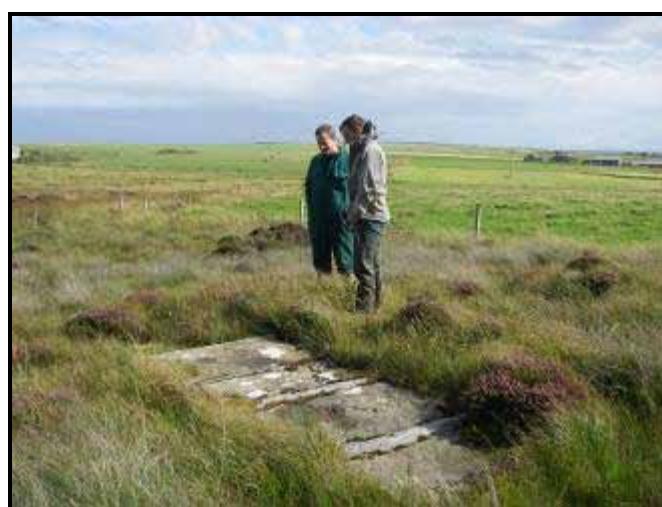
**Plate X: Covered springwater source by Hilltoft/Quoylobs**

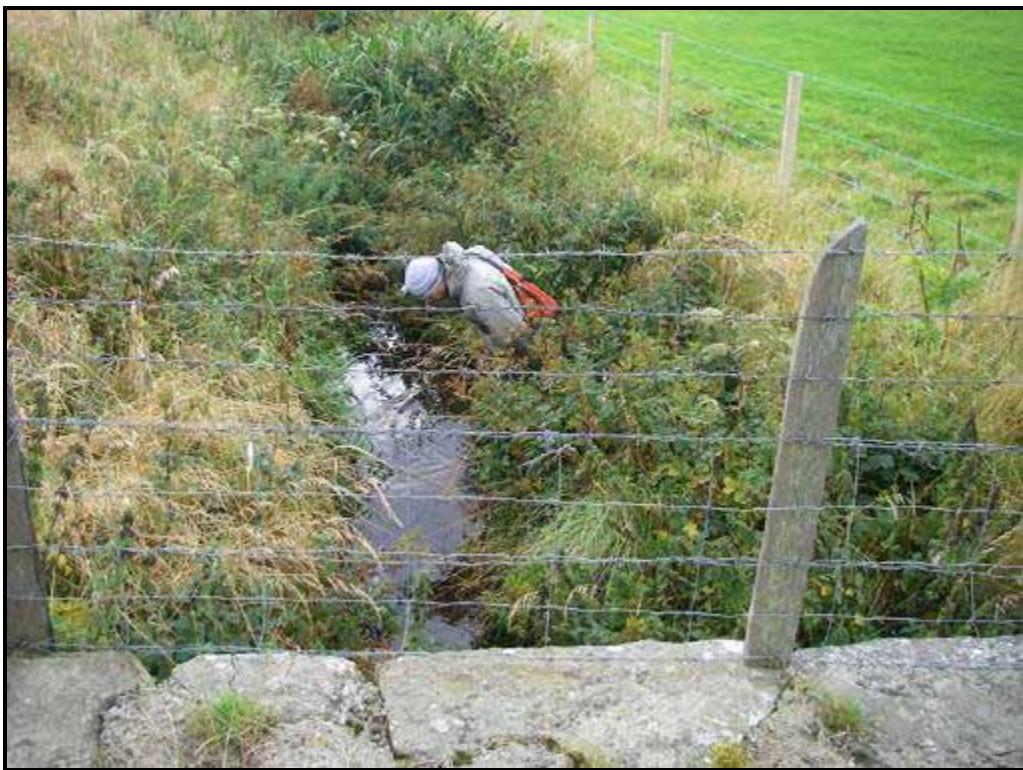
**Plate XI: A little clearance of bankside vegetation exposes clean water**

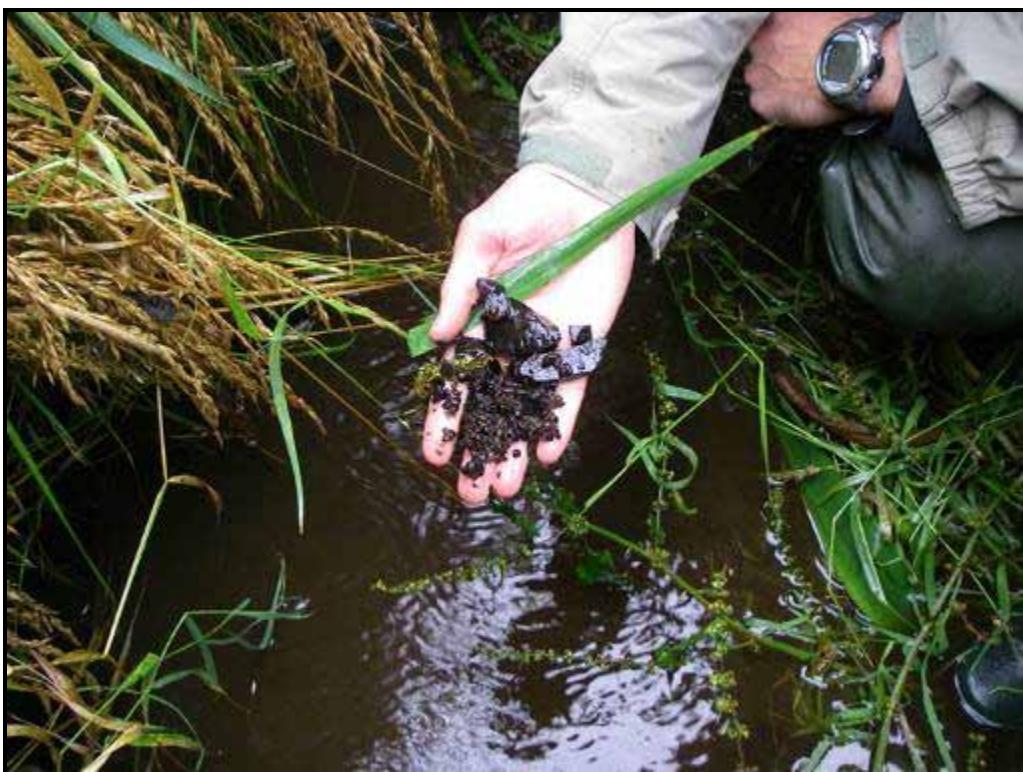
**Plate XII: There is some mixed gravel which could be used by trout for redds, although the bottom was fairly silty and choked**

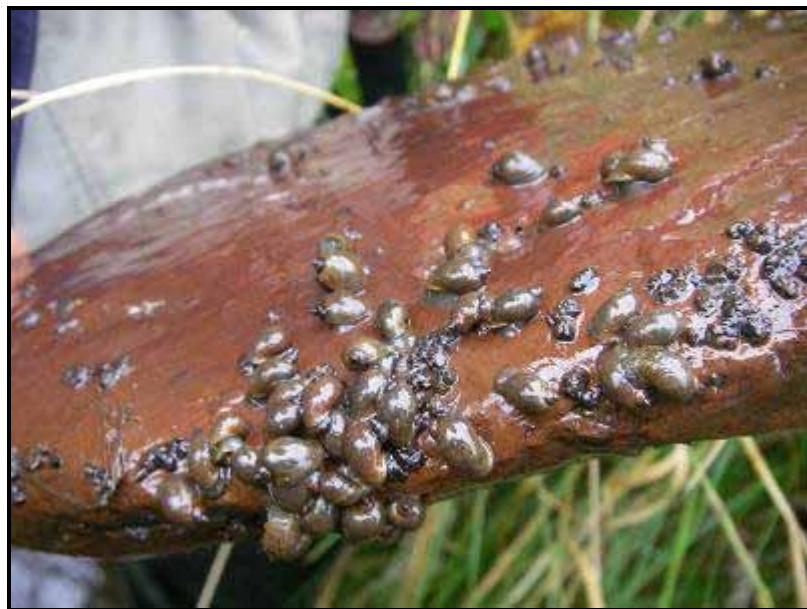
**Plate XIII: The underside of stones shows good invertebrate production**

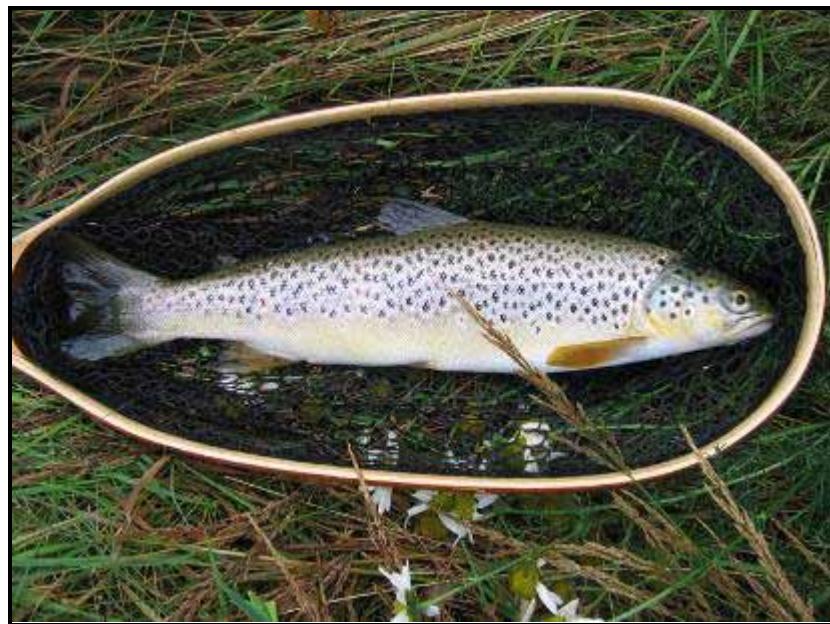
**Loch of Ayre (St. Mary's Loch)** was found to be strongly brackish and contained a lot of marine or estuarine algae (e.g. *Enteromorpha* spp.). It was being grazed by a group of whooper swans. Large flounders were seen as we waded around the margins. Two finnock (0+ sea year sea trout) and a brown trout were seen to jump. Malcolm later caught a brown trout weighing 480 g (1lb 1oz), which proved to be a maturing female. It had eaten small mysid shrimps, indicative of estuarine conditions and might fairly be termed a 'slob' trout.

**Plate XIV: Loch of Ayre Trout (310mm, 480g) 27.8.08**

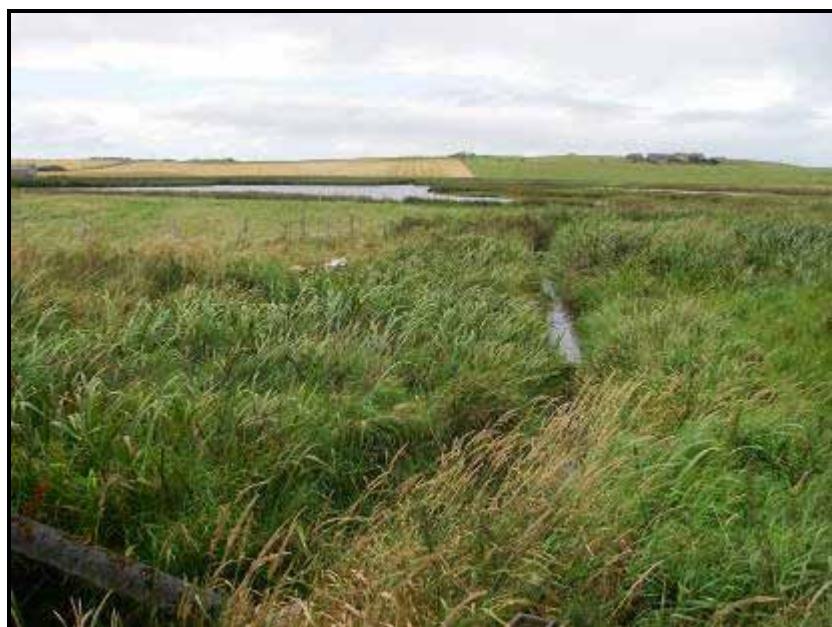
**Plate XV: Graemeshall Loch and outflow burn**

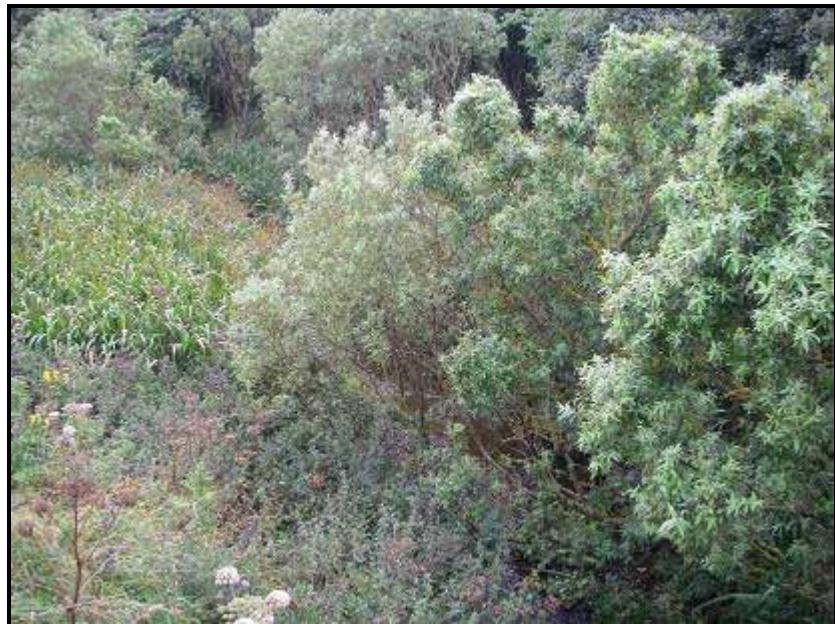
A quick visit was made to the neighbouring **Graemeshall Burn** which runs parallel to St. Mary's Burn. According to Malcolm Thomson, both are fairly typical of small Orkney streams. Graemeshall Burn is like a larger version of St. Mary's Burn and also is quite heavily overgrown, although the water is much more visible in the channel. Trout were seen from a bridge near Millhouse and the spawning and nursery habitat seemed good, although the habitat and the fish population should be surveyed in greater detail to assess whether a management programme could help. The St. Mary's Burn project has been prioritised at present. It seems very likely that some of the productive capacity of both spawning burns has been lost by channel drainage and straightening and through progressive sedimentation, especially of the St. Mary's Burn.

**Plate XVI: Graemeshall Burn near Millhouse, overgrown with willows at this site but trout were seen in the open water**

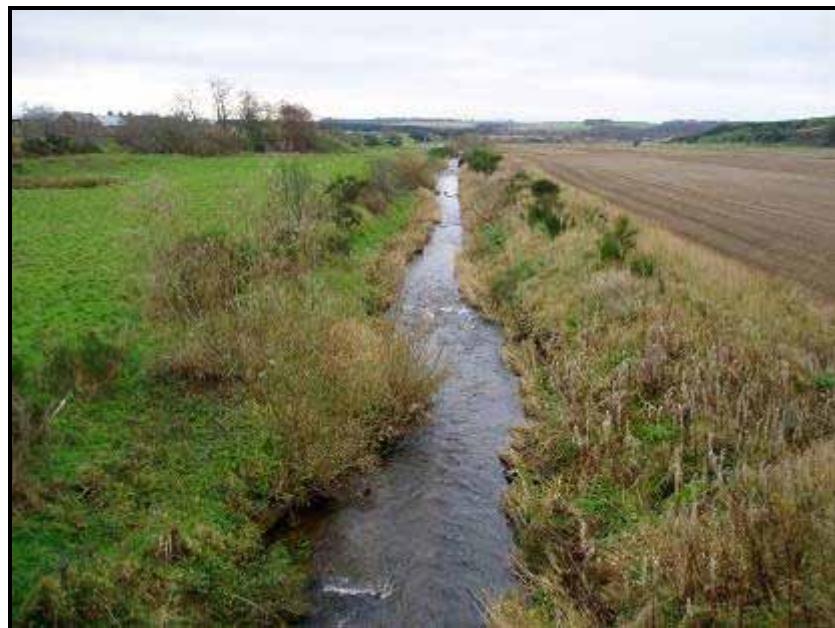
Streams and rivers flowing through relatively flat, erodable areas form unstable meanders that move across flood plains over time. These winding, natural streams exhibit a repeating sequence of shallow riffle sections and pools at regular intervals of about five to seven channel widths. Artificially straightened channels, on the other hand, tend to return gradually to a sequence of pools and riffles as the bed and banks become eroded by spates and materials are deposited according to their relative density and the extent of flows (see **Plate XVII**).

**Plate XVII: Straightened burn in the River Deveron catchment showing gradual return to riffle/pool sequence**
