Advisory Visit

St. Mary's Loch, Scottish Borders

18th August, 2010

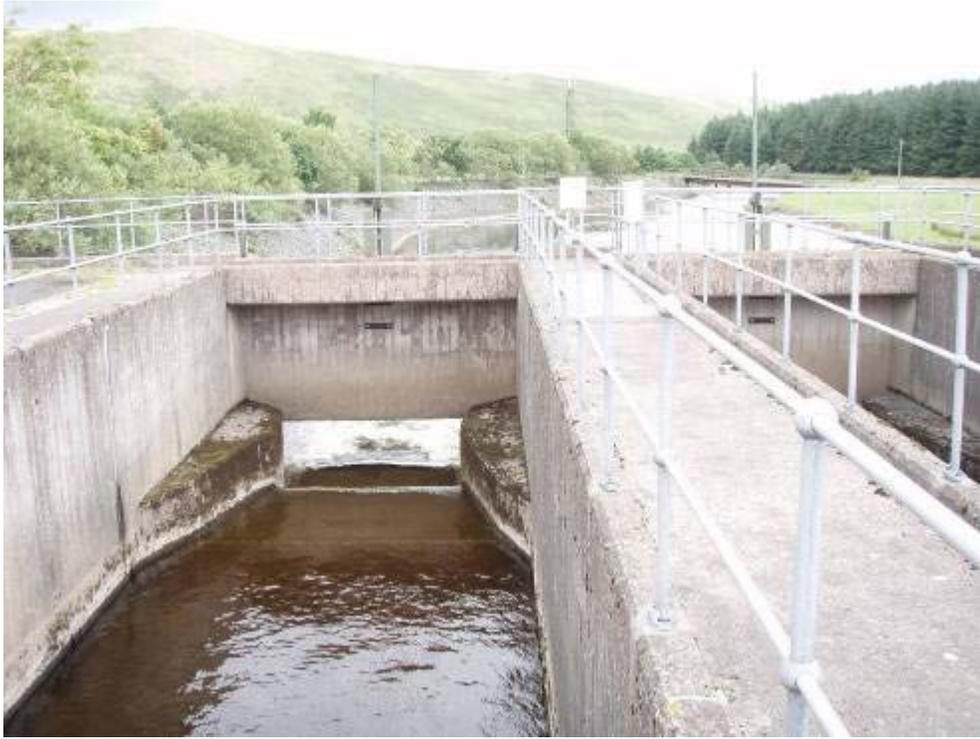
The outflow from St. Mary's Loch to Yarrow Water was inspected. This consisted of two concrete culvert spillways with flow control and gauging apparatus (Photos 1 - 3). Alongside these was a wider channel with a series of low weirs with sloping and dished crests (Photo 4); at the time of the visit there was no water flowing through this channel. Although the loch and river levels were low at the time of the visit, the arrangements for fish passage across the outflow appeared less than ideal. The water level in the loch at which this fish-pass channel works is known and it is therefore possible to work out how many days in a year the fish pass has water in. However there is also a large amount of gravel in the pass, reducing the depth of water in the pools and hence the passes effectiveness.

Photo 1 Outflow to Yarrow Water, looking downstream

The St. Mary's Loch outfall arrangements and their operation should be reviewed to assess their current impact upon migrating fish, and whether improvements can be made. Salmon currently run upstream from Yarrow Water, as shown by the presence of salmon parr in the lochs' tributaries. However, consideration should be given to the potential for other species to pass the outfall structure in both directions.

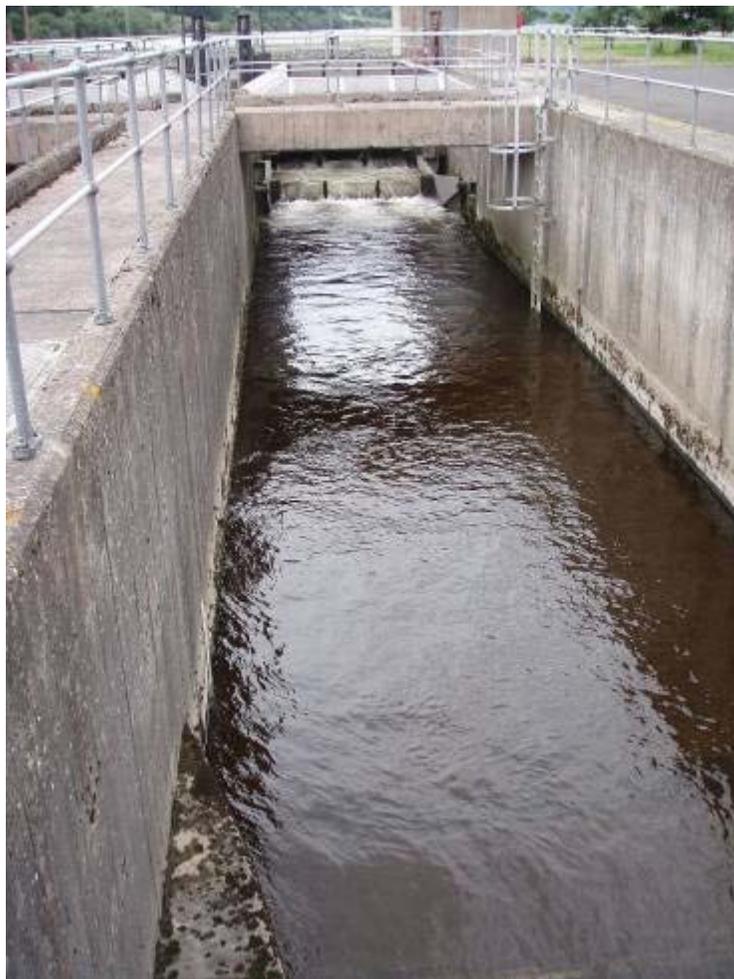
Photo 2 As per Photo 1, looking upstream

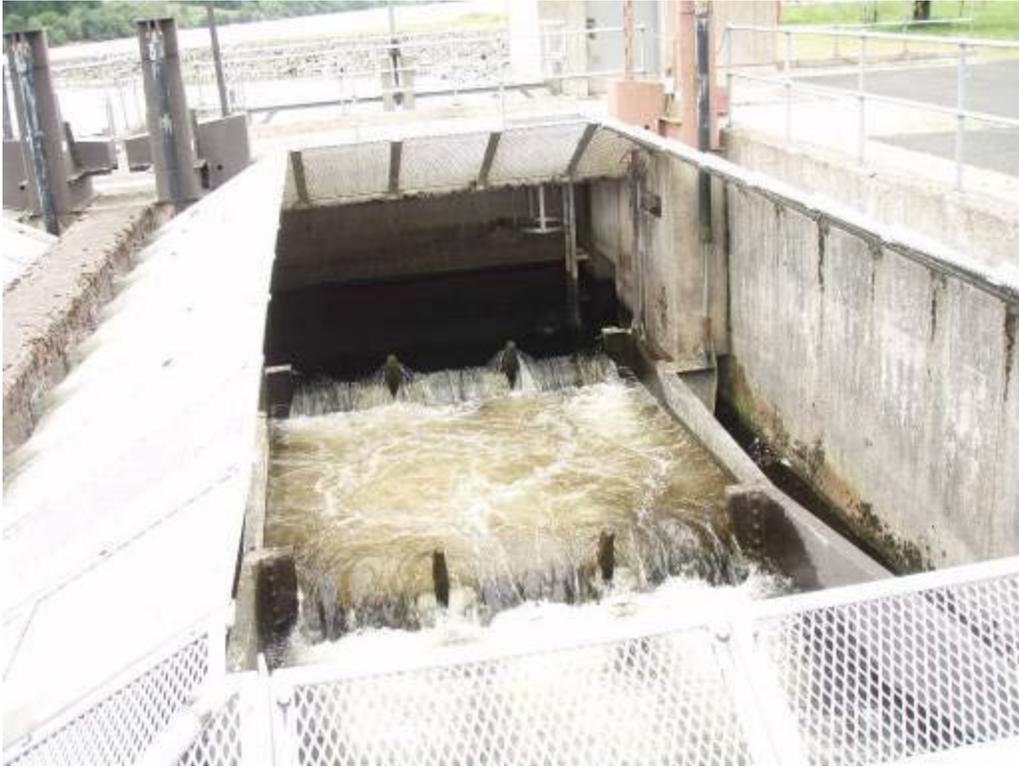
Photo 3 Outfall arrangement at head of one of two concrete culverts (loch in background)

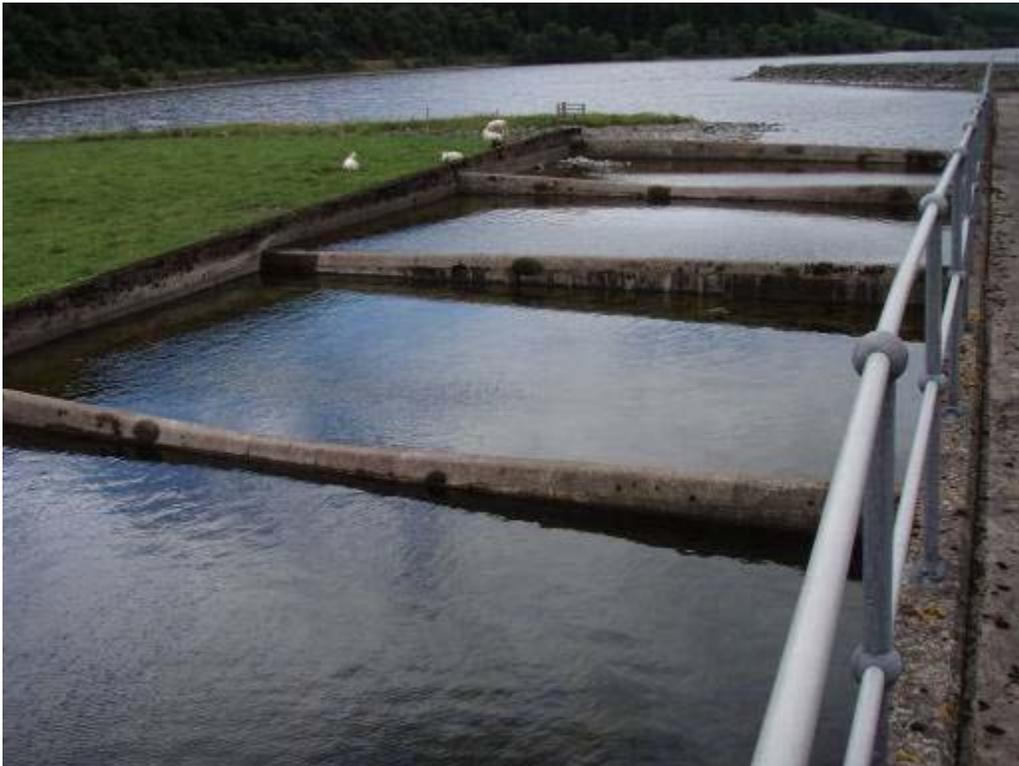
Photo 4 Channel with low weirs, not flowing at the time of the visit

Eels are another species which are vulnerable to barriers to migration. Their precipitous decline in recent decades provides an impetus to consider this species whenever improving fish passage is being considered. The migration of young eels (and possibly also of the young of outlet river spawning trout) is a much more gradual process than, for example, the spawning migration of adult salmon and trout or the downstream migration of smolts. A migration route with a year-round flow which is passable to smaller fish would be a valuable addition to this site. A nature-like channel (Photo 15) designed to pass fish at various stages of flow (including a set minimum level) would be a great improvement over the existing channel with weirs (Photo 4).

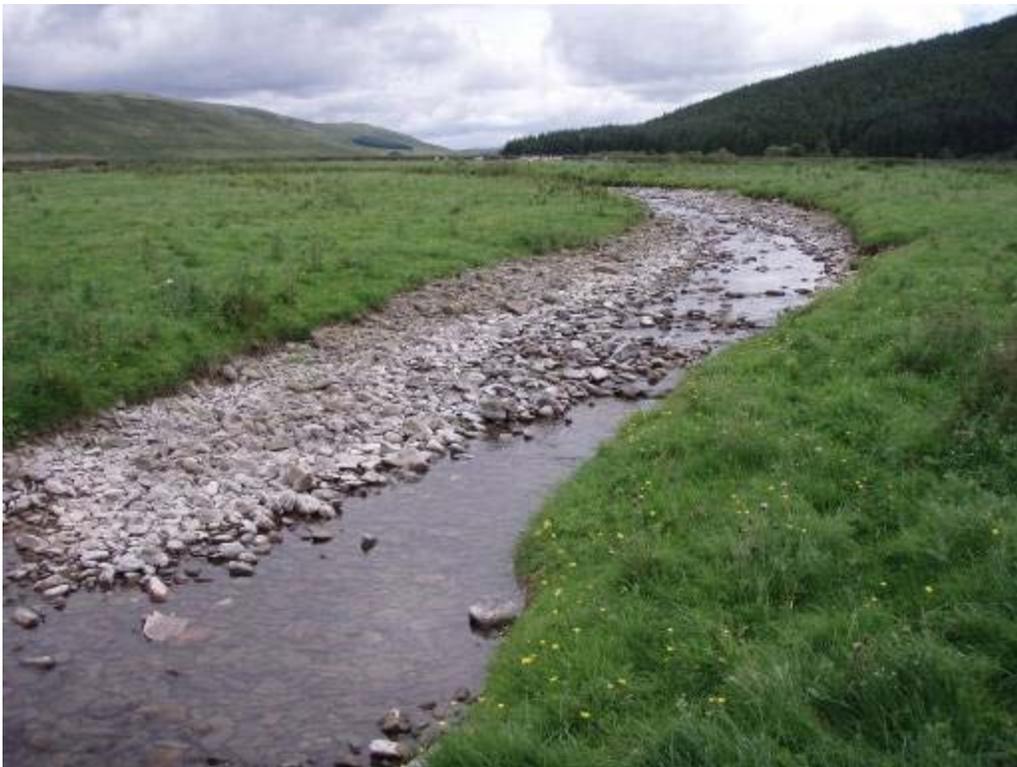
Habitat quality in the feeder burns was generally quite poor, the common problems being over-wide, uniformly shallow channels with no defined thalweg (line of maximum depth within a channel). The main reason for this is grazing of the banks which restricts the diversity of vegetation along the burn margins and reduces their resistance to erosion; hence the banks are gradually pushed back leading to a wide, relatively featureless channel. In some cases the channels have been modified in an attempt to increase the flood conveyance capability or protect the banks from erosion; this has further damaged the in-stream habitat and reduced the capacity of the burns to produce trout. Photos 5 – 14 illustrate the factors affecting the habitat within and alongside the burns.

Photo 5 Lower end of the Kirkstead Burn – an over-wide channel with little depth variation (no pools). The banks lack a variety of vegetation and there is no low overhead cover.

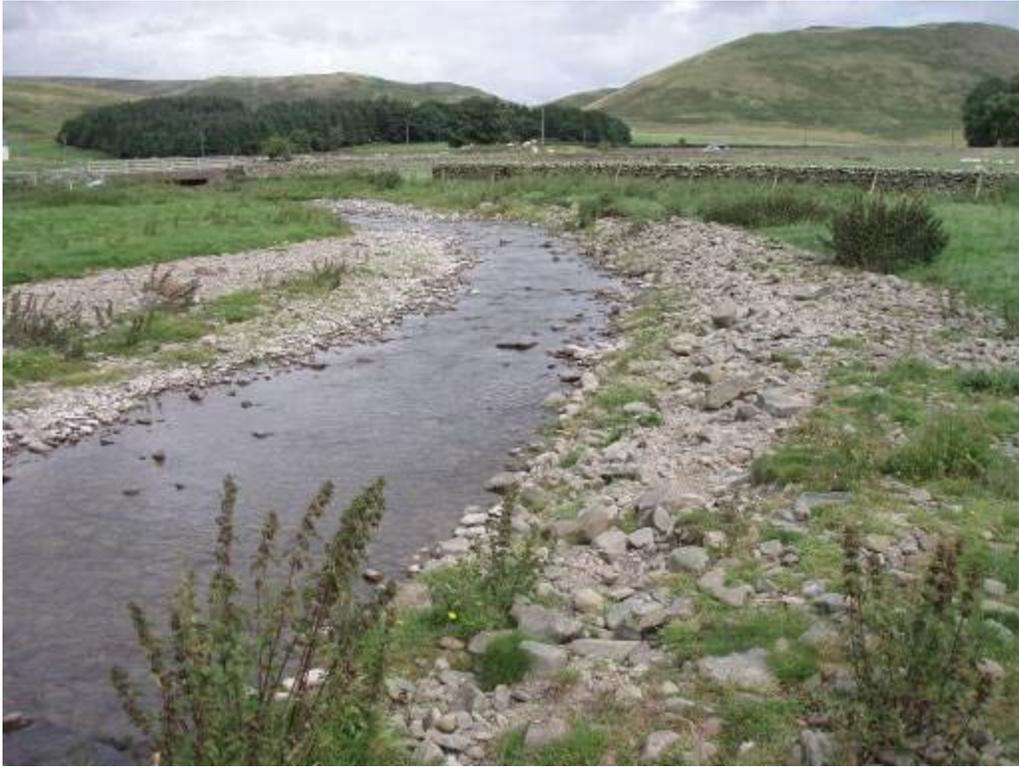
Photo 6 A little further upstream from Photo 5 (Kirkstead Burn). The channel bed has been scraped back against the outside of the bend, reducing the habitat quality of the channel still further.

Where some of the burns have been modified to increase flood capacity there is scope for habitat rehabilitation. Again, liaison with landowners / farmers is crucial to get them on board with any proposals. On stretches such as those shown in Photos 6, 8, 10 and 12 the channels could be narrowed using alternate low D-groynes (Figure 2, Photo 16) and deeper areas created with low weir structures (Figures 3 – 5). The latter are designed to create depth and scour downstream of the structure, not impound water upstream. Subsequent fencing of the watercourse is vital to reduce grazing pressure and allow vegetation to develop.

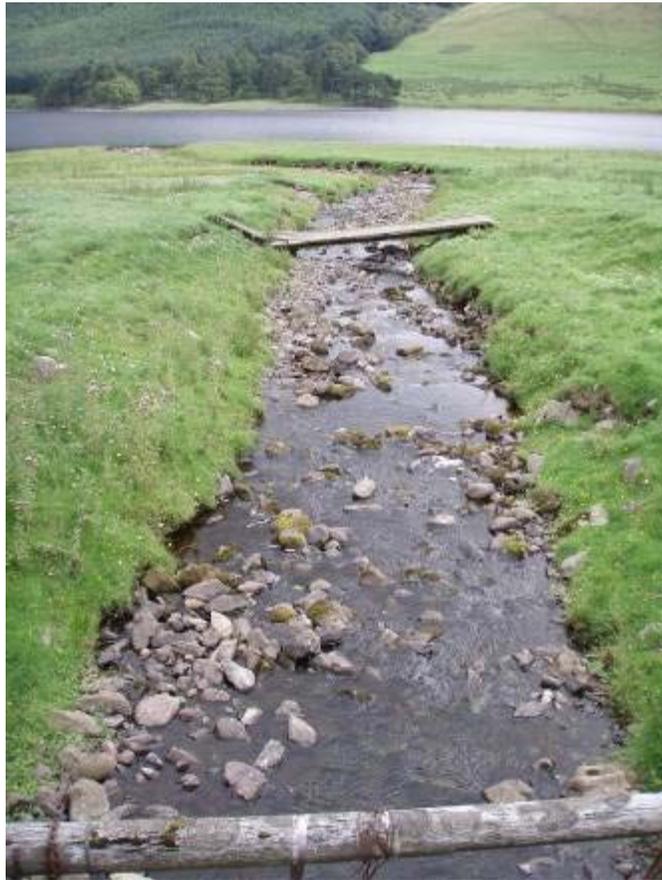
Photo 7 Summerhope Burn – better in-stream habitat in the form of a narrower channel with more depth variation, but riparian vegetation could be improved by reducing grazing pressure.

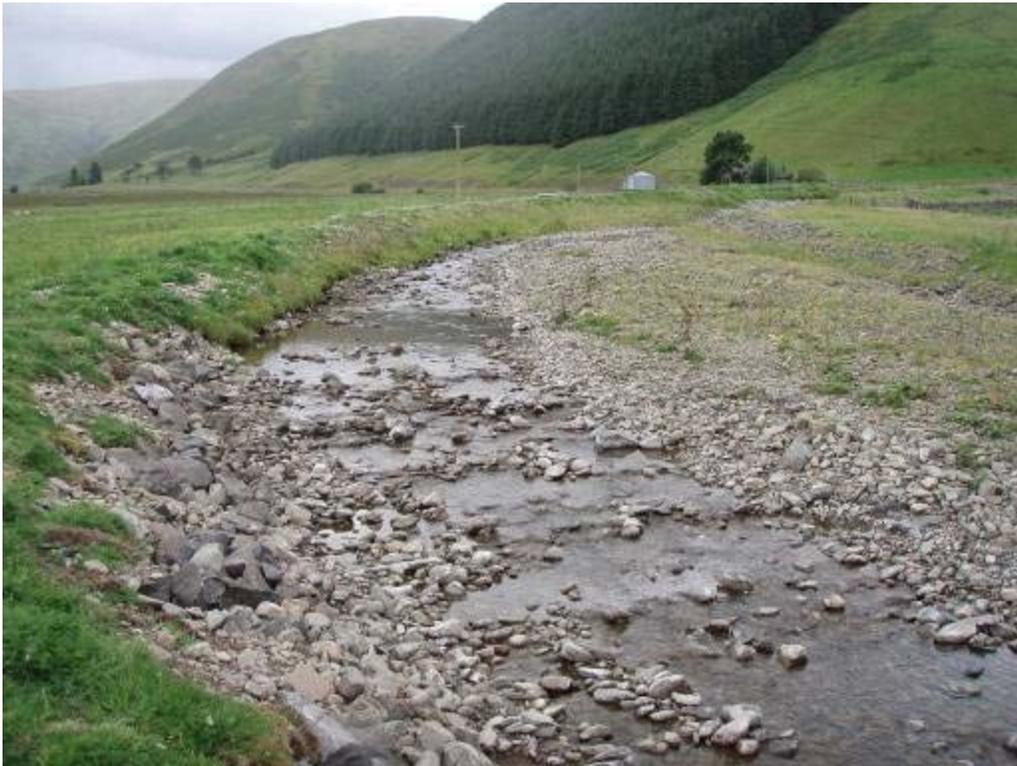
Photo 8 Chapelhope Burn has recently been extensively modified, with the bed dug out and used to create embankments. Habitat here is very poor and will not produce or support much in the way of juvenile trout or salmon.

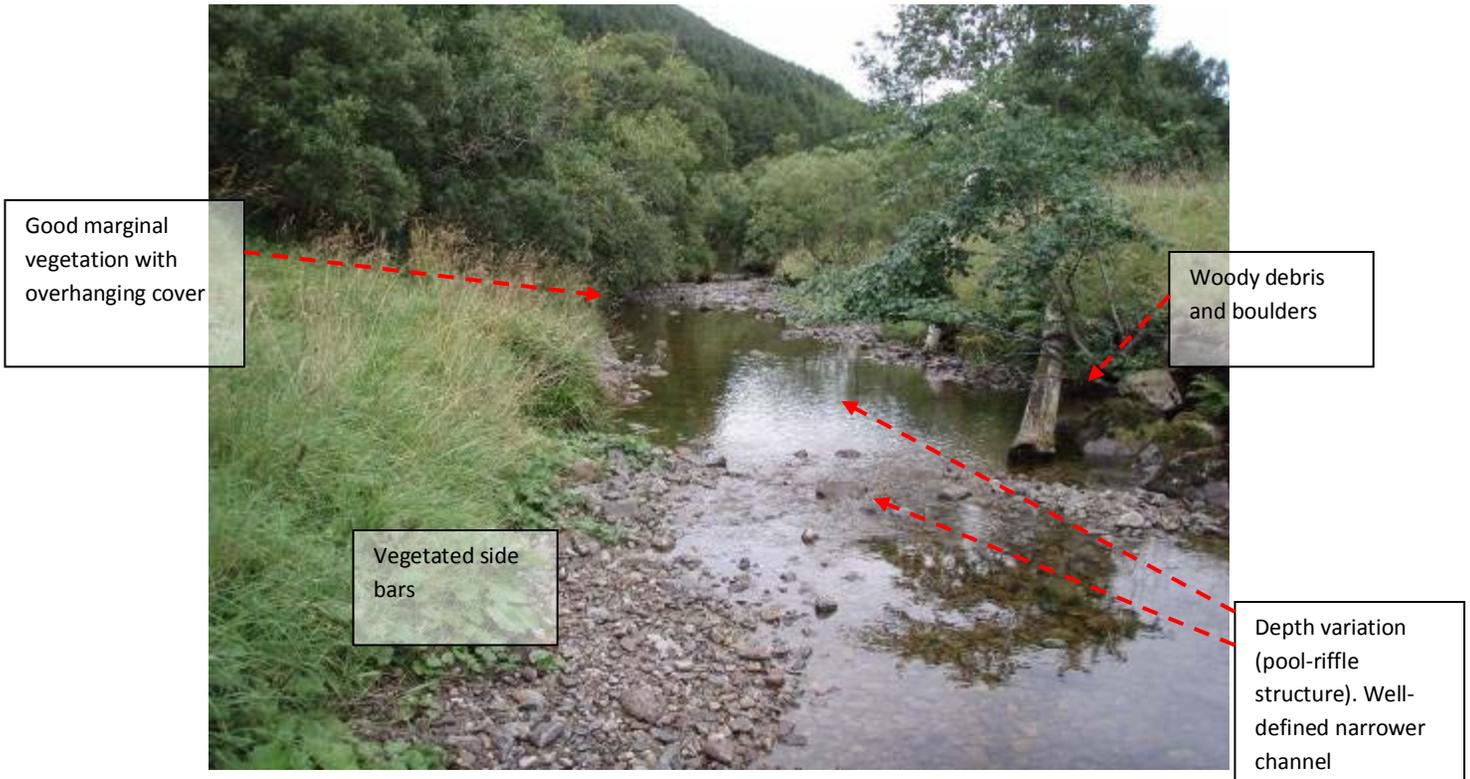
Photo 9 Chapelhope Burn just downstream of the section in Photo 8. Good habitat is present in this unmodified section.

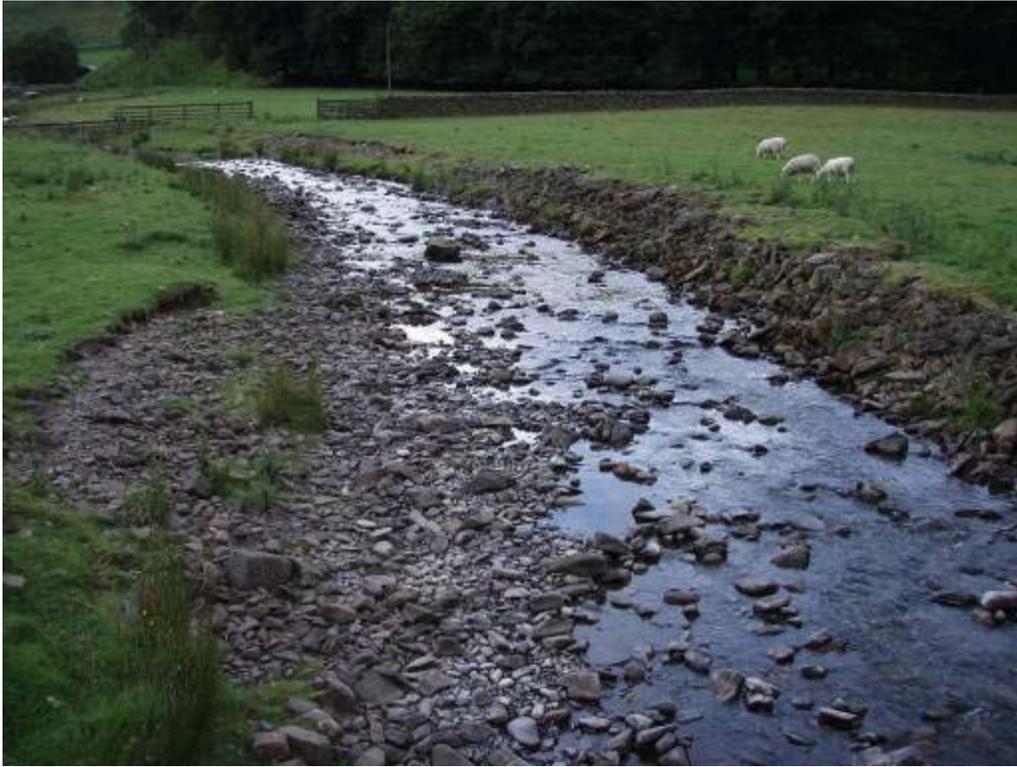
Photo 10 Crosscleuch Burn. Overwide channel, modified to provide bank re-inforcement. Lack of depth variation and no pool structure.

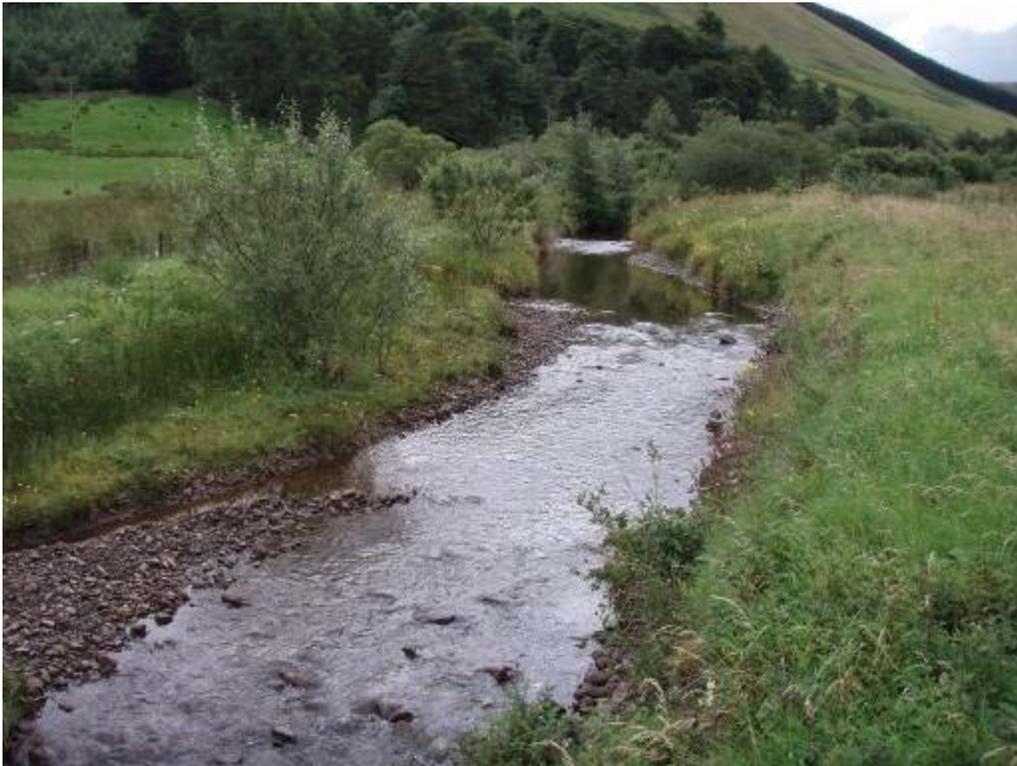
In contrast, the Little Yarrow has reasonably good habitat resulting from a habitat enhancement and protection project previously carried out by the Tweed Foundation. This burn has a good width of margin fenced from grazing and a diversity of vegetation has developed; the channel also tends to be relatively narrower and has a greater variety of depths (Photo 11)

Photo 11 Little Yarrow in the Tweed Foundation project section. Fenced margins have allowed a diversity of riparian vegetation to develop, the channel to narrow (as side bars vegetate) and a pool-riffle structure to develop. Overhanging marginal vegetation provides good low cover for juvenile trout and salmon.

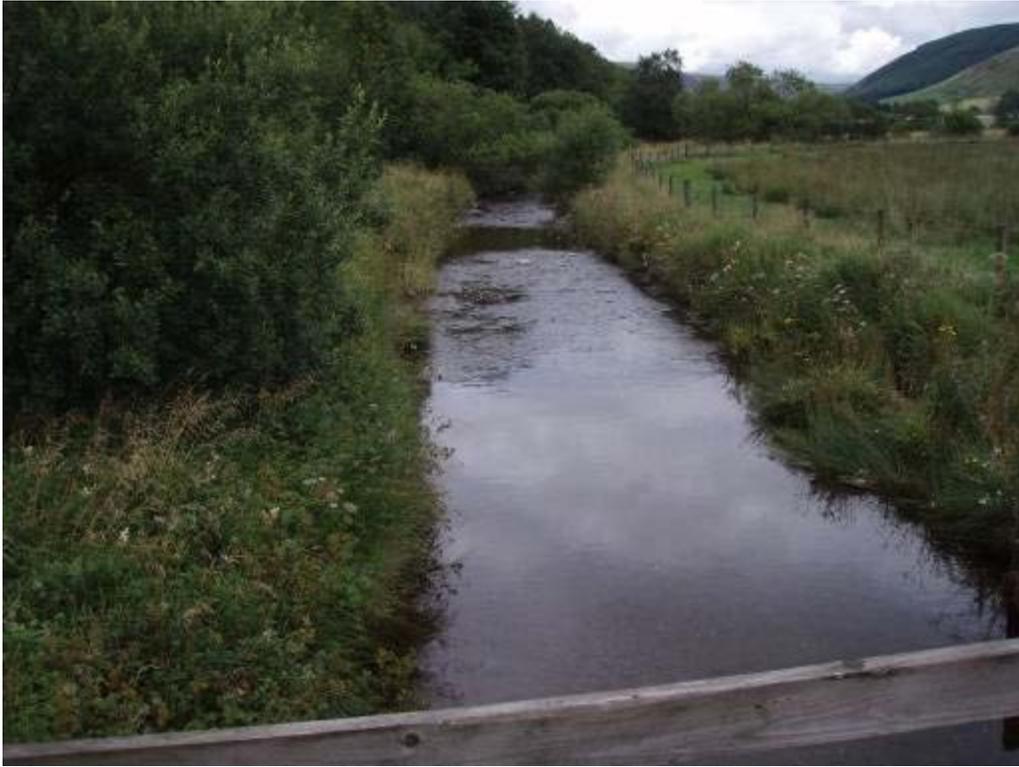
Photo 12 Little Yarrow (looking downstream from same point as Photo 11). Good riparian vegetation, but the channel has a relatively uniform cross-section and could be improved.

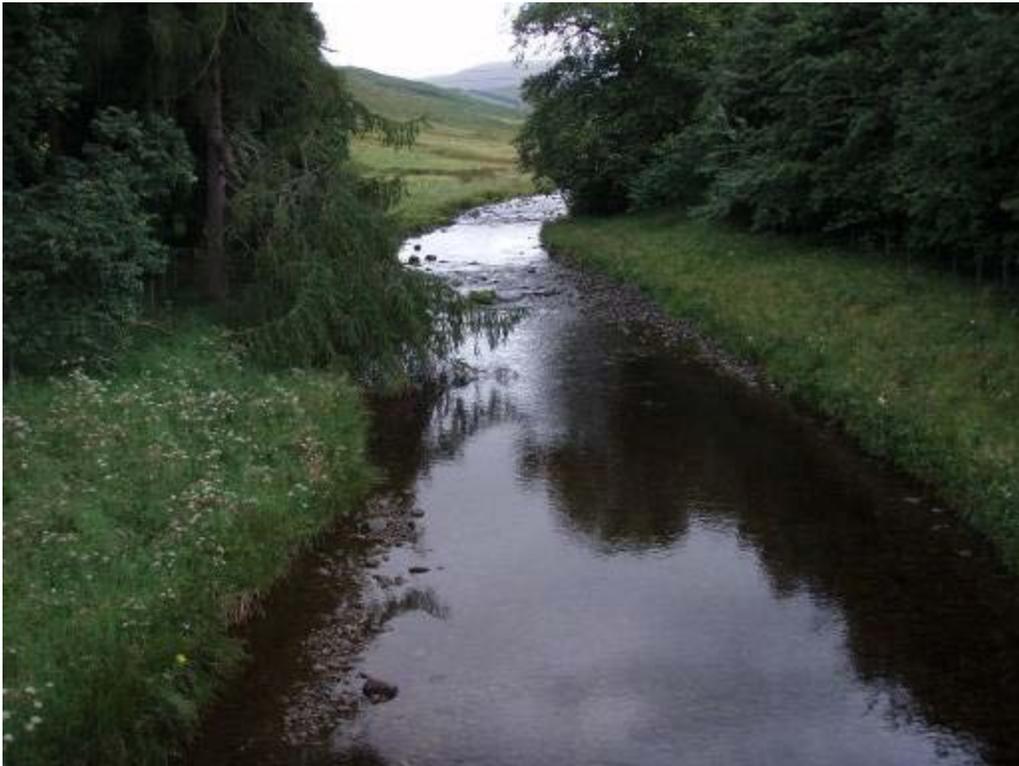
Photo 13 Megget water just upstream of the main road bridge

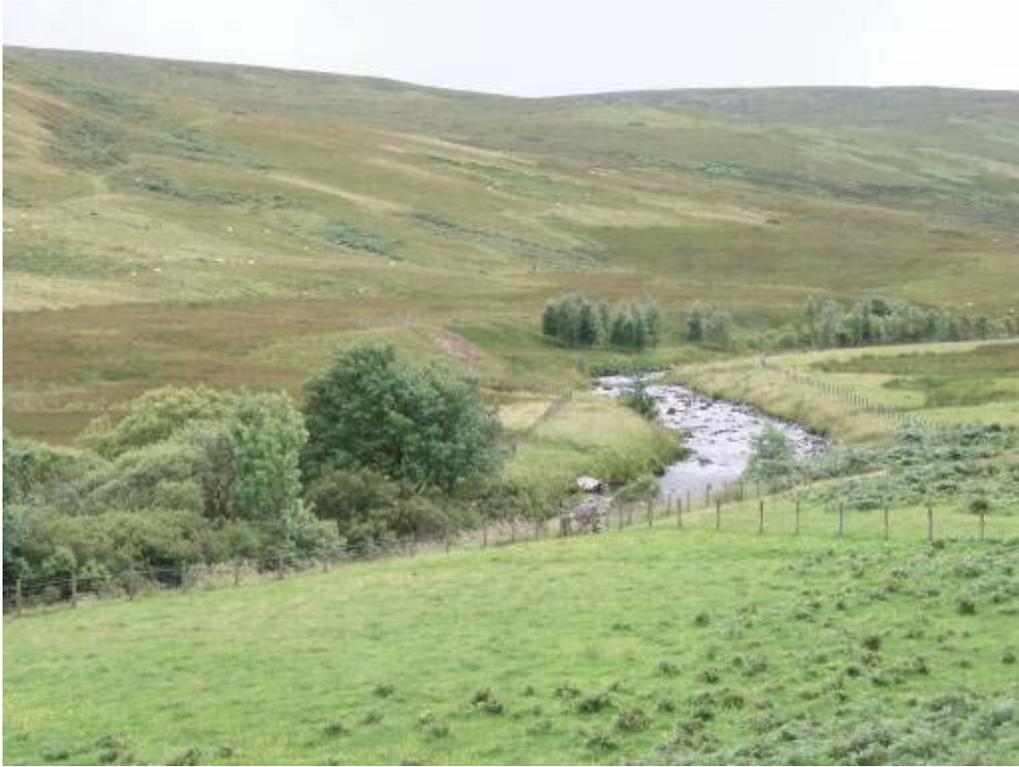
Photo 14 Megget Water further upstream appears to have good riparian habitat (fenced) and reasonable in-stream habitat, although this was not closely inspected. The possible effects of the reservoir upstream on trout and salmon recruitment remain to be investigated.

The impact of Megget Reservoir on Megget Water and its production of juvenile trout and salmon should be investigated further, with consideration given to potential effects on water quality and sediment supply and transfer. The subject could form the basis of an undergraduate or post-graduate research project. If lack of supply of spawning gravel is an issue, then consideration could be given to gravel augmentation; further information on this subject is available at <http://87.84.223.229/FCERM/en/SC060065/MeasuresList/M1/M1T2.aspx?pagenum=2> .

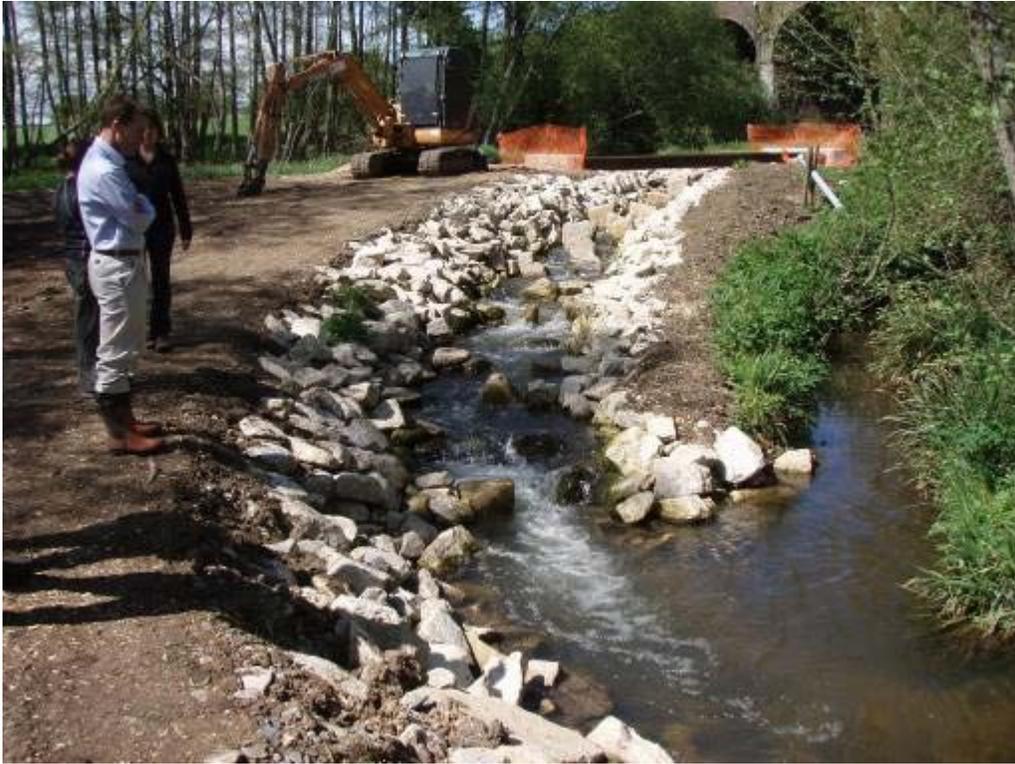
Photo 15 Nature-like fish bypass channel. A scaled-up version designed to work at different flow stages would be an improvement on existing arrangements at St. Mary's Loch outflow.

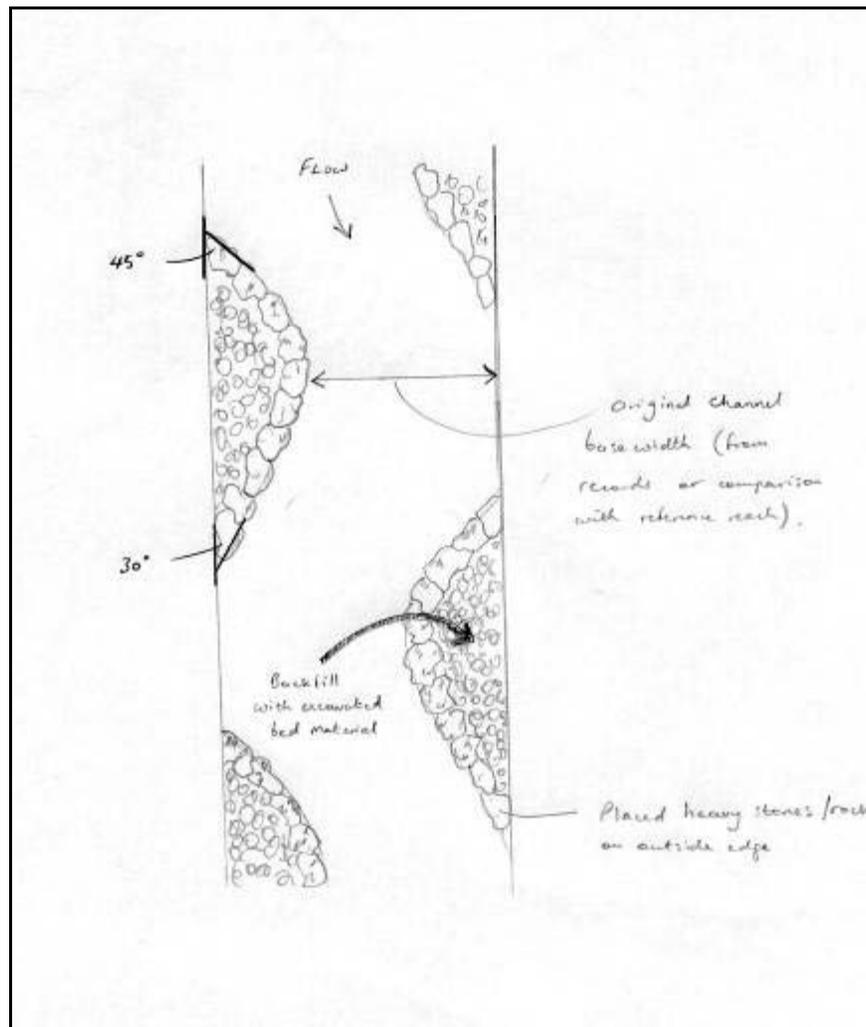
Figure 2 D-groynes on an over-widened channel to restore a natural channel base width.

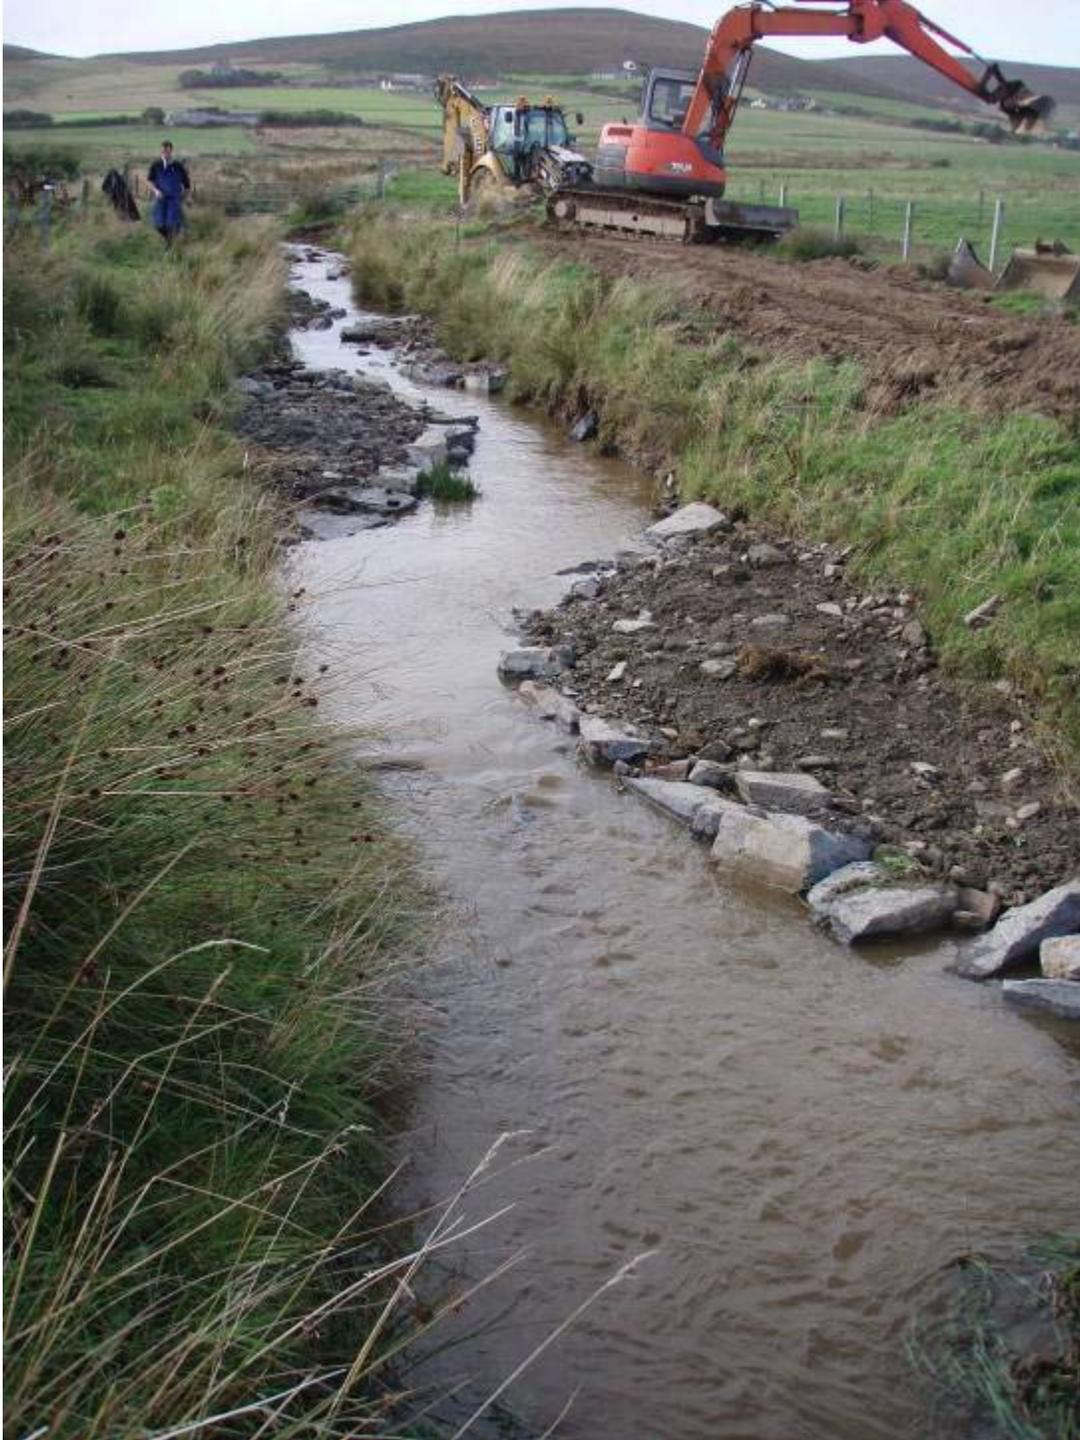
Photo 16 D-groynes installed on an burn on Orkney. In the absence of grazing, these vegetate quickly. Their low profile allows flood flows to overtop the structures.

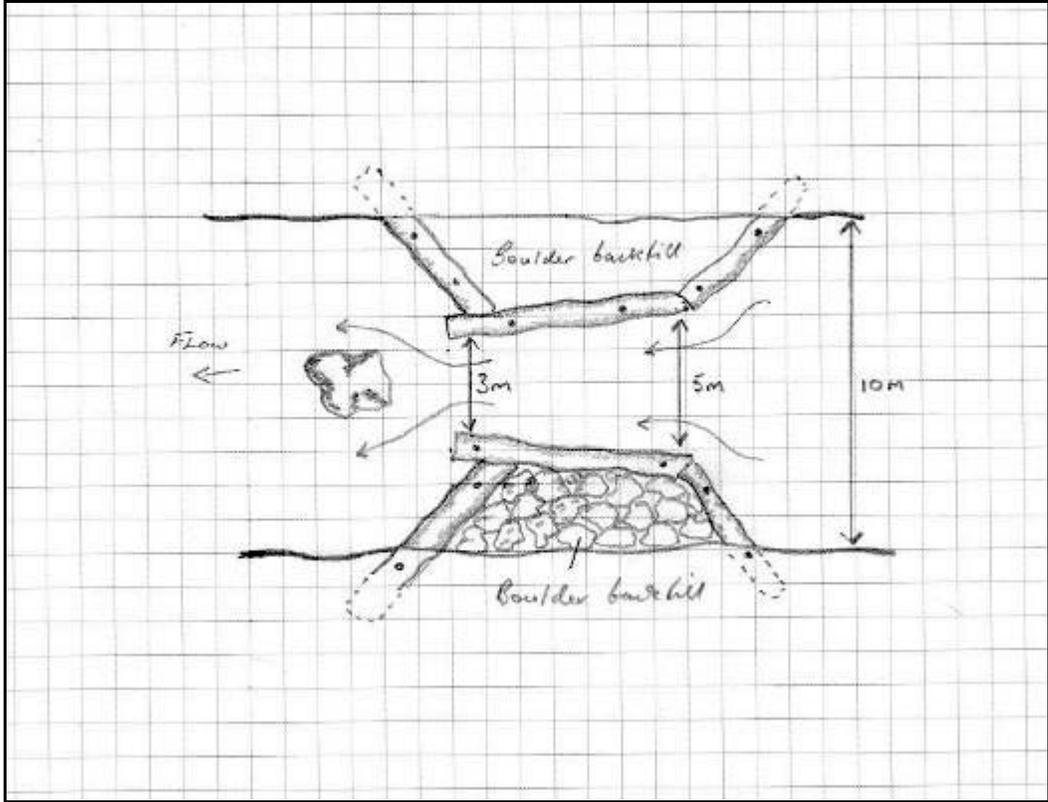
Figure 3 Channel constrictor. For illustrative purposes (dimensions can be ignored)

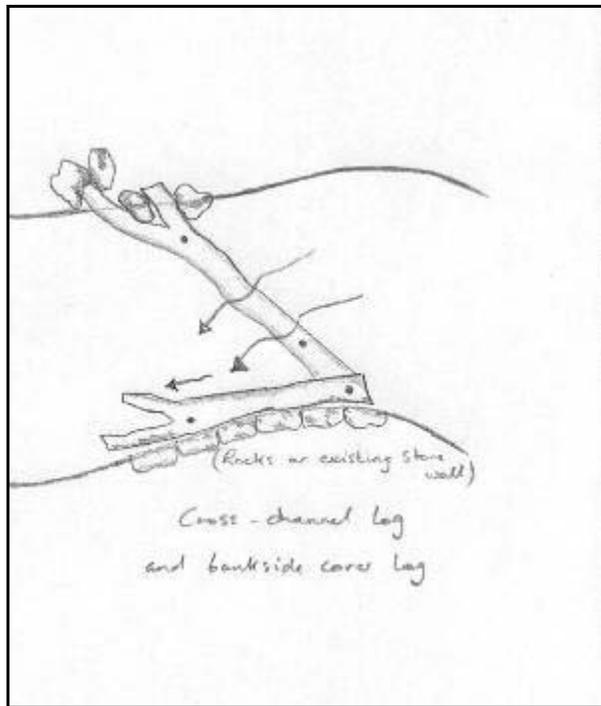
Figure 4 Cross-channel log and cover log

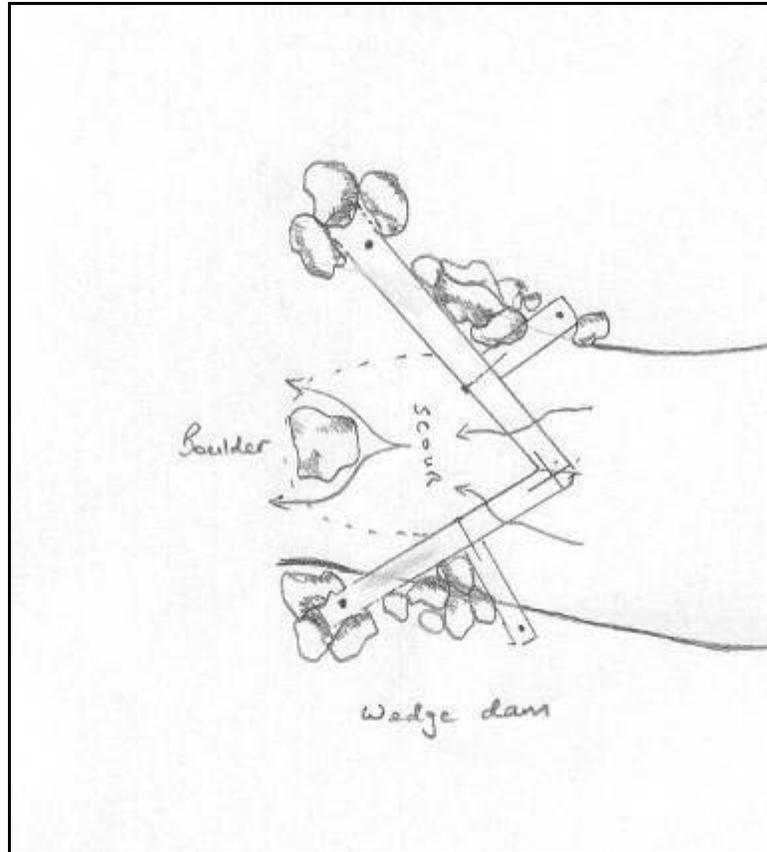
Figure 5 Wedge dam
