## **River Rother – Stedham Weir**

**A Project Proposal by the Wild Trout Trust – November 2014**

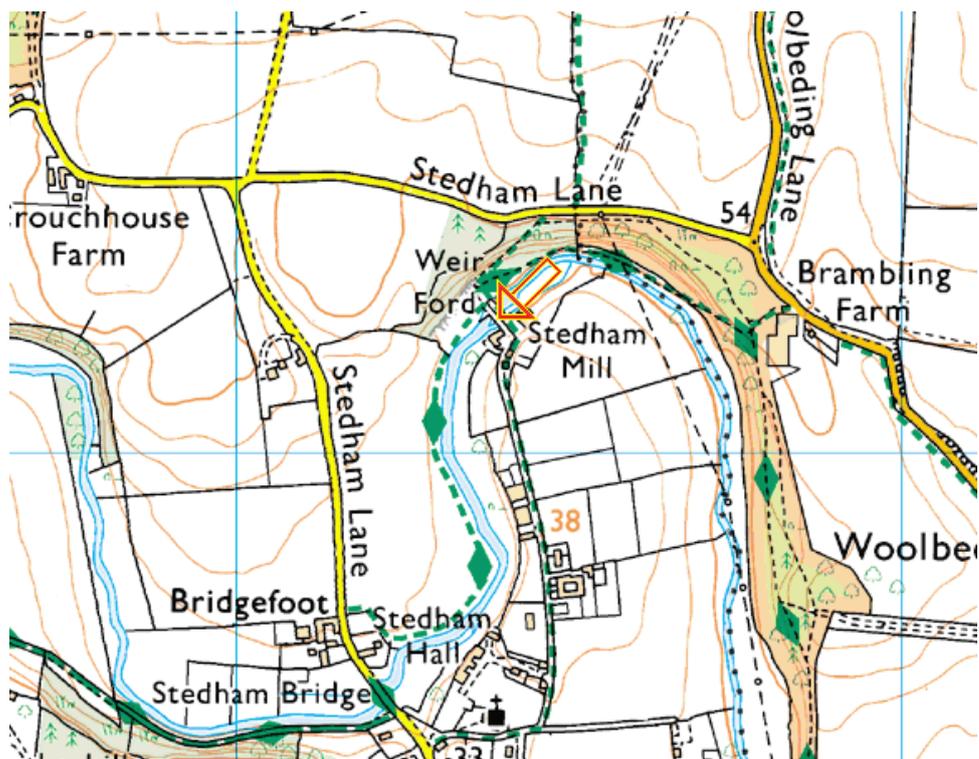
Map 1 River Rother Stedham

The reach inspected ran from Stedham Bridge at NGR SU 862226 down to Stedham Mill at SU 863232. The Rother (Waterbody ID GB107041012810) has been assessed as being in 'poor status' under the Water Framework Directive.

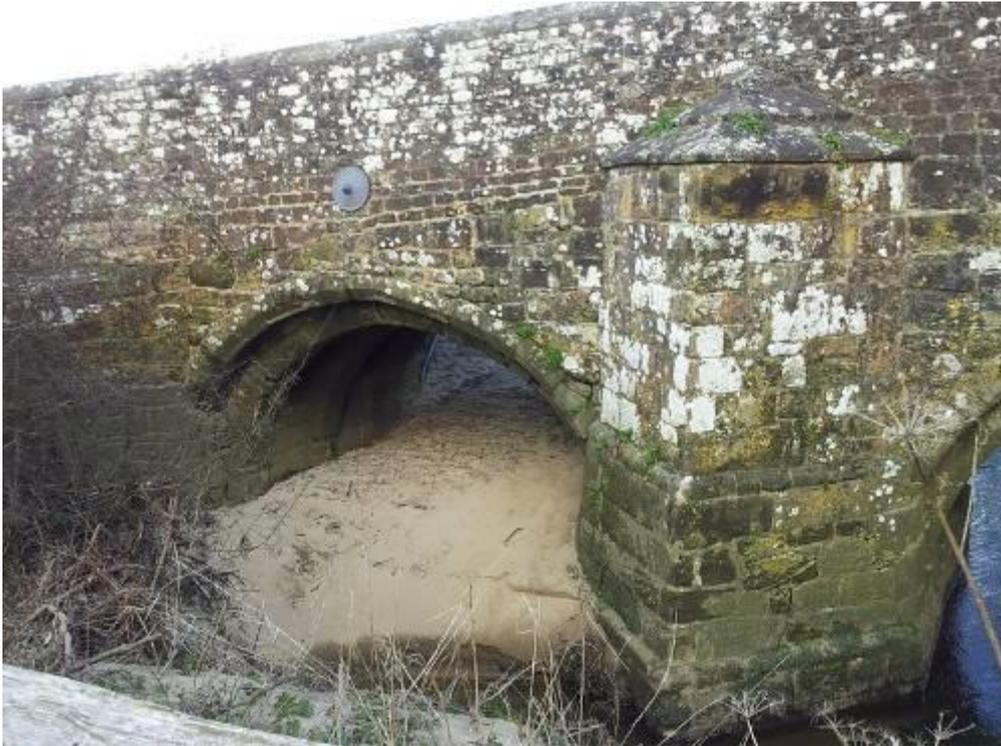
Photo 1. Sand deposited under Woolbeding Bridge. A Rother speciality!

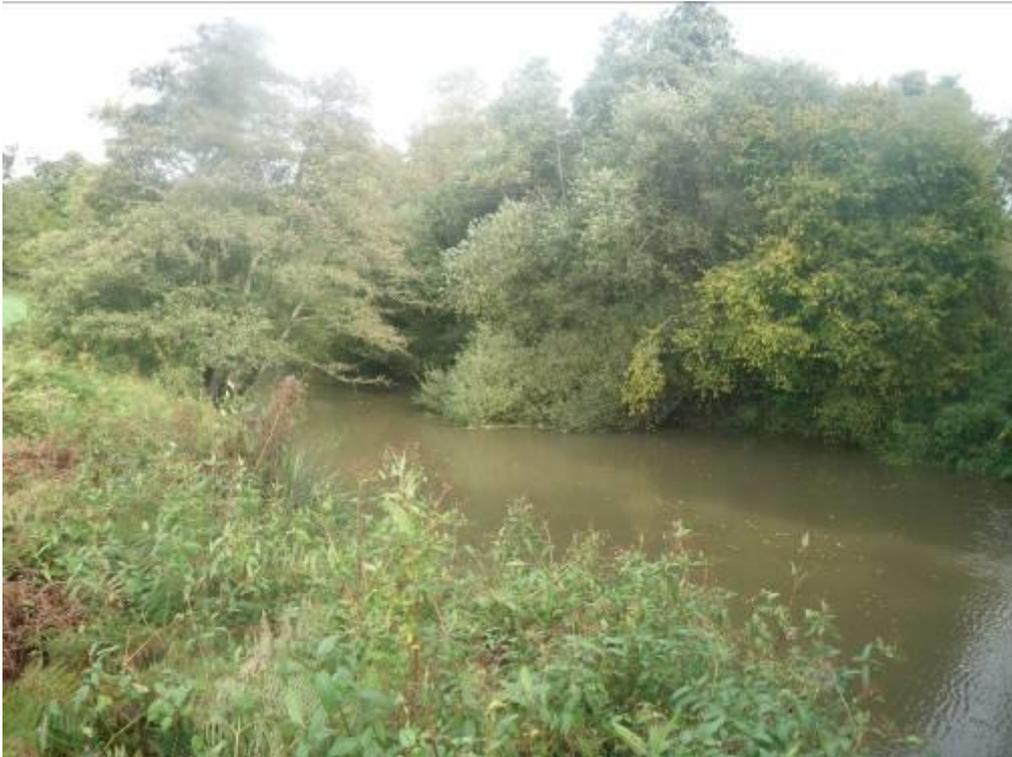
Photo 2. Section of impounded water between Stedham Weir and Stedham Bridge. Slow, impounded water providing poor habitat for fish like chub, dace, grayling, trout and bullhead.

It might be possible to improve fish passage opportunities at Stedham by building technical fish passes. This would, however, be a missed opportunity. In-channel habitat quality within the reach upstream from Stedham Bridge to Stedham Mill (photo 2) is considered to be very poor. This section of channel is heavily influenced by the impounding effect of the weir structure, which has drowned out the natural gradient of the upstream channel, promoting 'canal-like' habitat in what once would have been a much more varied habitat.

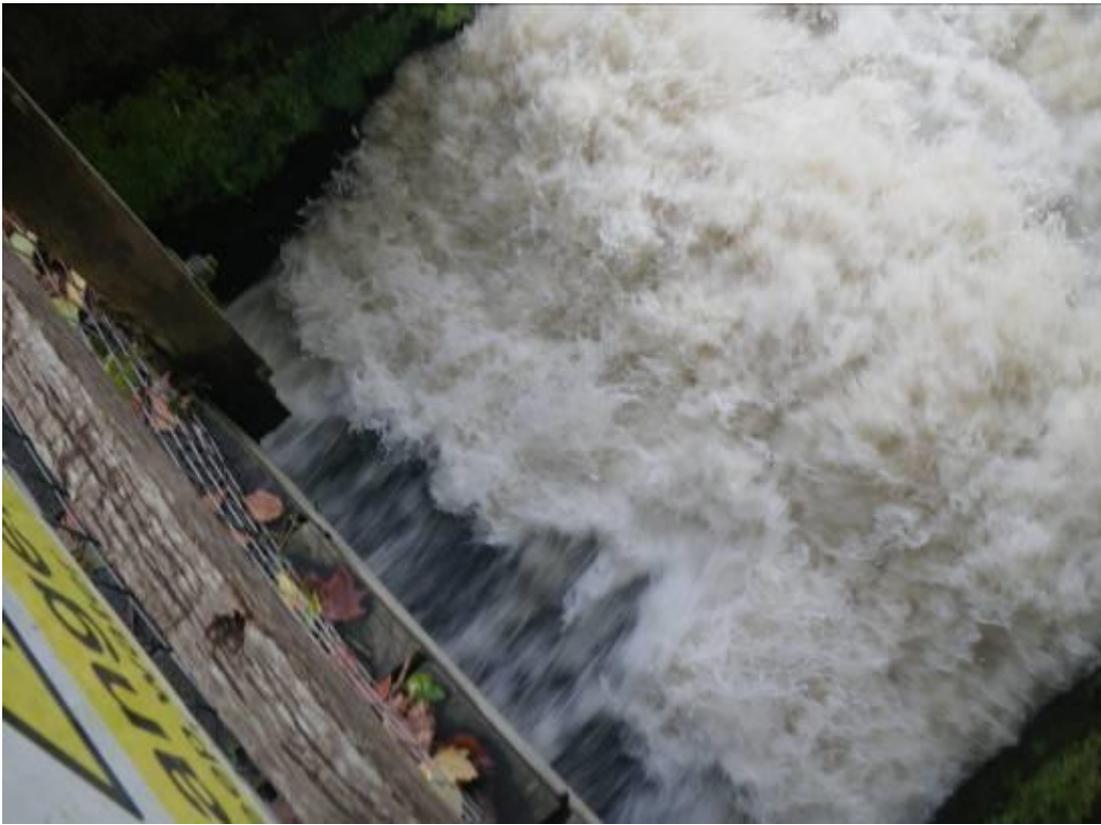
The weir structure at Stedham poses an unacceptable environmental burden on the River Rother. The water head-loss at the structure is in excess of 1m high. As already discussed, it is possible for large sea trout to make some progress up and over the structure during exceptionally high flow conditions. Some upstream passage for migrating eels (*Anguilla Anguilla*) might also occasionally be possible, where elvers can creep up via wet areas of rough stone or brickwork. For the majority of the time, Stedham Weir is a major blockage for upstream migration for trout and eels and represents an impenetrable barrier for coarse fish species at all times.

For small trout and all coarse fish, the weir at Stedham is a one-way valve, with any fish washed over the weir in a flood event being unable to migrate back upstream. The cumulative impact of structures like Stedham Weir on wild fish populations is likely to be huge and is a major reason why the Western Rother and other similar rivers are failing to meet Water Framework Directive targets for healthy fish populations.

Photo 3. Under shot weir gate at Stedham. A sea trout was observed jumping at this structure on the day of the visit and failing hopelessly to make any upstream progress.

4. Resolve fish passage issues by reducing the head created at the weir by removing the automated gate. This option potentially provides the best solution for improved fish passage, but crucially, also provides an opportunity to restore a substantial length of channel up to and possibly beyond Stedham Bridge. In

Option 4 is the only option that provides a combination of tangible flood defence benefit, habitat creation opportunities and resolves fish passage issues. It is also likely to be the cheapest of the four options considered.

If a broad agreement can be reached, the first phase of the project could simply be lifting the gate during winter spate conditions and leave it up in the fully drawn position. A full topographical survey of the structure and long-section of the upstream channel is required. Once the information is gathered, work to lower and stabilize the bank, create new fishing stations and create a series of high quality holding pools using a combination of flow deflectors and possibly a redistribution of river bed substrate could take place the following

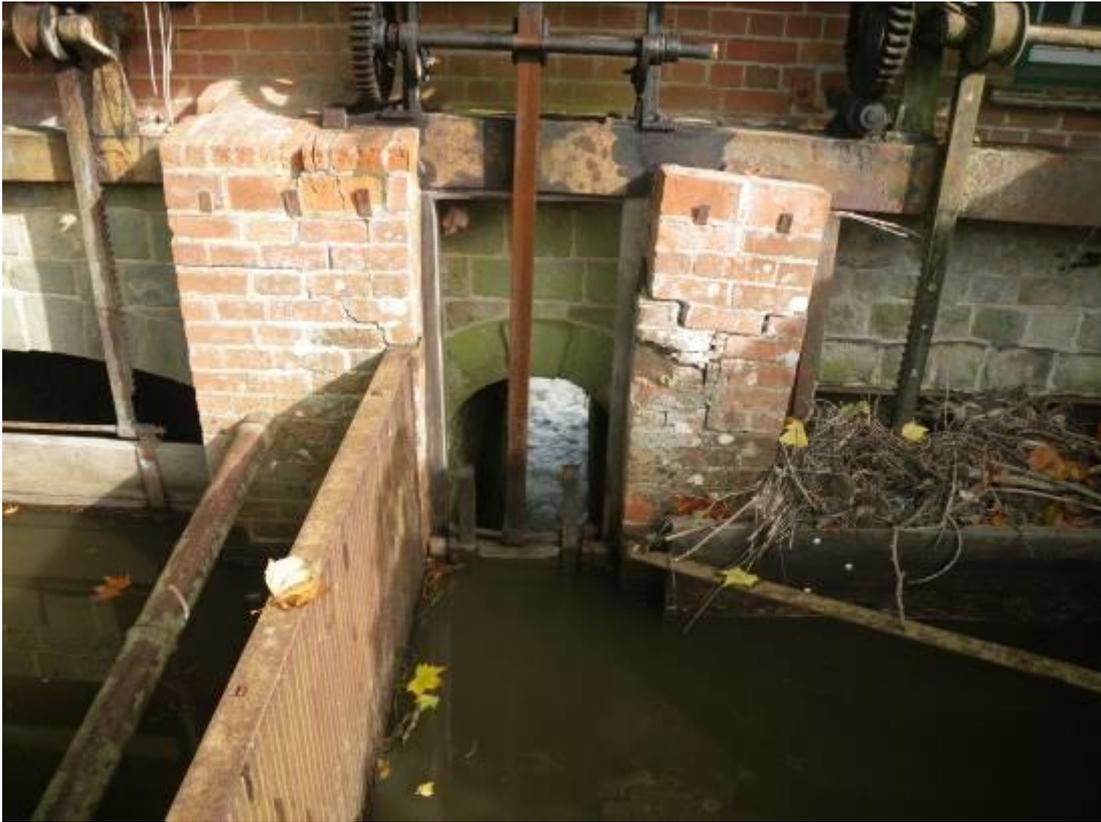
Photo 4 Eel house sluice.

The structural integrity of the eel house and sluice arches looks to be very poor. Constructing a technical fish pass at this location is likely to be very expensive. An additional issue would be creation of sufficient attractant flow via the bypass channel to ensure that fish pick up the passable route, rather than running up to the main impoundment. Currently this RB bypass channel runs a long distance downstream before rejoining the main river. It is likely that a bypass channel discharging at this particular location is going to be very inefficient, unless it takes the majority of the flow. This would require significant remodelling of the existing bypass channel to take the extra flow required. Possible project costs estimated to be in excess of £150k.

1. The construction of a new bypass channel to be taken off the LB and rejoin the main channel approximately 50m downstream of the existing impoundment. This option would involve the construction of a new off-take structure approximately 100m upstream of the existing weir and taking the flow through a meandering, naturalistic channel running parallel with the existing channel. Due to the land take required and potential project costs (£100k plus) this option was not favoured by the group and in particular by the property manager.
2. Utilise an existing by-wash channel that runs down the RB through the garden of Stedham Mill, rejoining the main river approximately 150m downstream of the existing impoundment. This option will still require a technical fish pass to overcome a differential headloss through the old eel trap sluice (photo 4).
