River Stor – Storrington (Meadowside)

A Project Proposal by the Wild Trout Trust - June 2015

1. Introduction

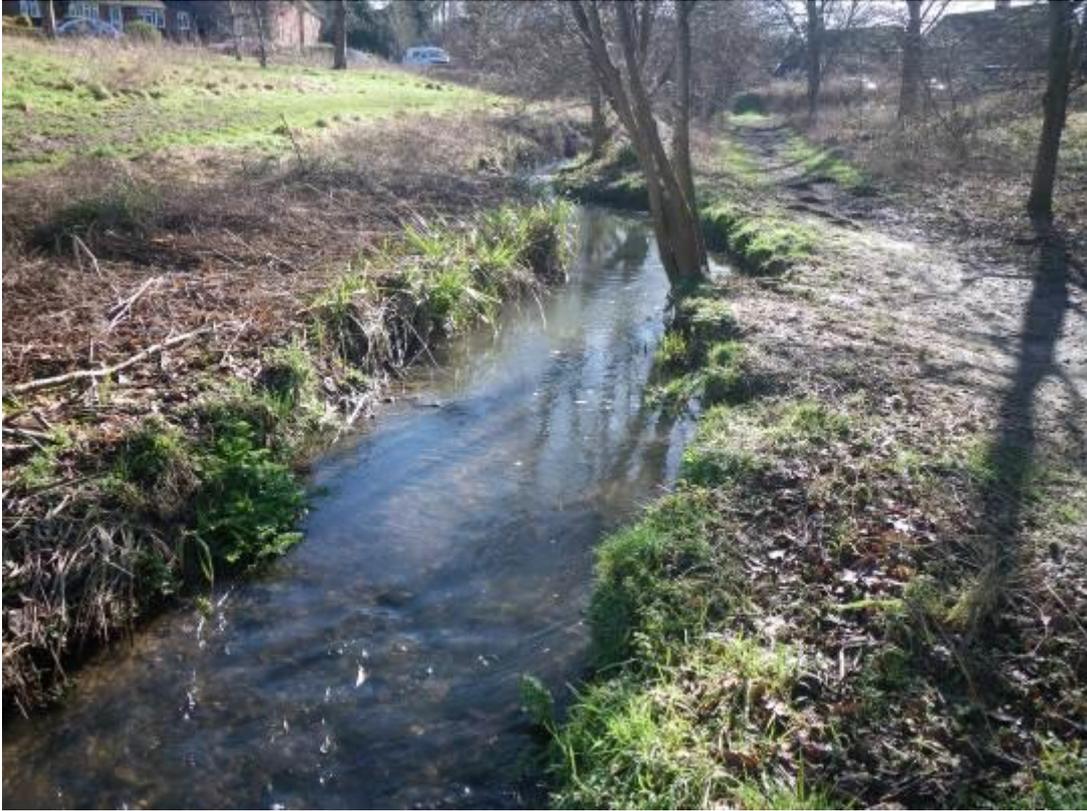
The majority of the chalk rivers of England are heavily modified with structures and man-made channels, having been utilised for agricultural irrigation or power generation for hundreds of years. The Stor too has been heavily modified and the channel appears to be slightly perched above the valley floor, albeit through a gently meandering planform (photo 1). Deeper pool habitat was at a premium and might constitute a habitat bottleneck for large fish species.

Photo 1. Suggests that the channel is perched above the valley floor, possibly to create a head of water for milling downstream.

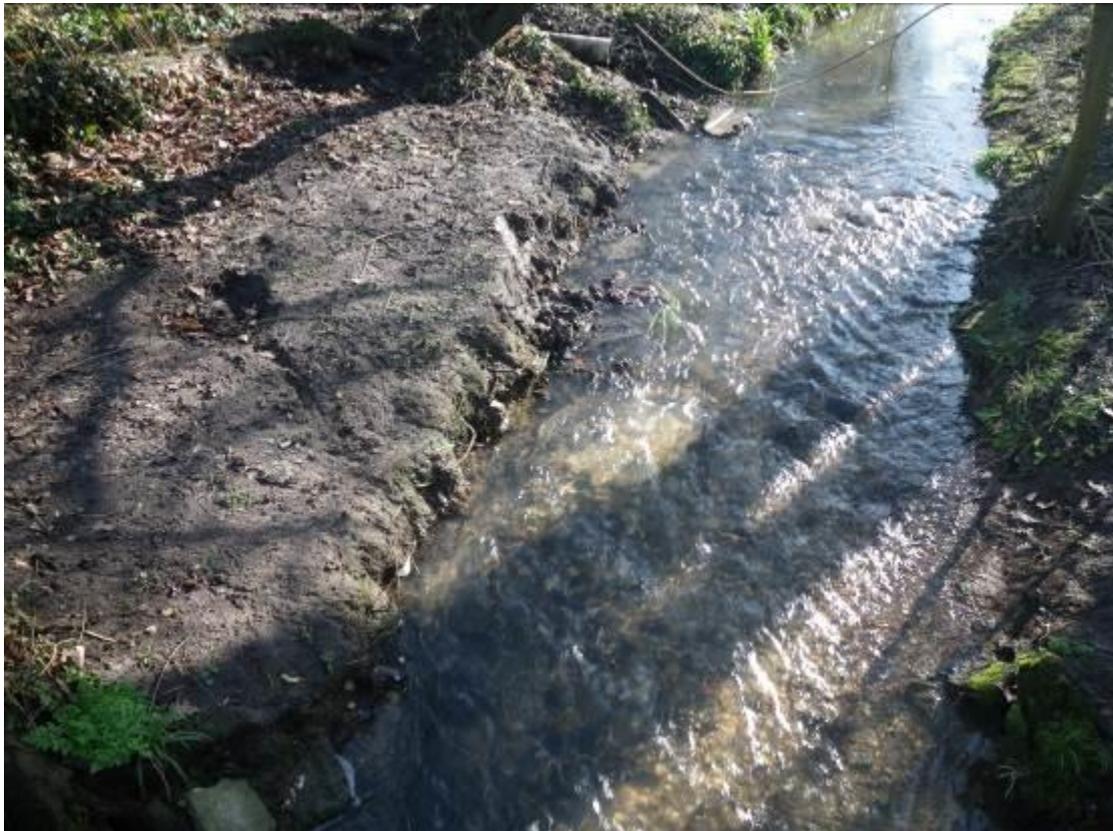
The margins are studded with valuable emergent plants such as sedge *Carex* spp. and support occasional stands of alder trees *Alnus glutinosa* with both tree root systems and emergent plants performing a useful role in defending the banks from excessive erosion. That said, bank erosion would appear to be a key issue for the Stor in several locations. These pressures are generated mainly via footfall and dog swimming on the bank tops, rather than any major concerns associated with flow generated bank erosion (photo 2).

Photo 2. Banks and river margins eroding via heavy foot fall/dog slides.

A number of key improvements could be undertaken using simple methods associated with winning locally available woody debris and using it to promote vertical bed scour and arrest bank erosion pressures. The lack of deeper pool habitat could be addressed using large woody debris flow deflectors to locally squeeze the channel and drive flow velocities downwards to promote river bed scour. Slightly deeper pools and the creation of ramps of clean loose gravel suitable for fish spawning (drawings 1 & 2) will benefit local fish communities.

A combination of a single flow deflector, keyed into the RB and angled to kick the flows away from the eroding bank, coupled with packing the eroded bank face with brushwood is an ideal method for addressing the issue as well as creating favourable habitat.

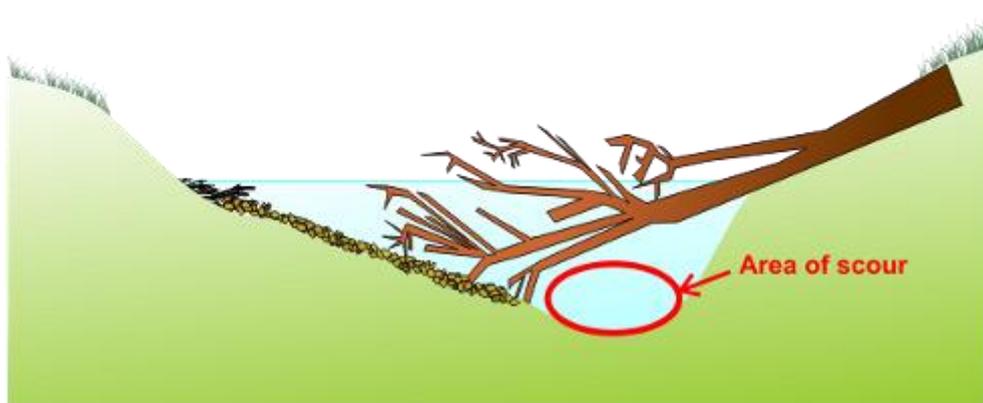
Drawing 1. Naturally fallen woody debris can promote downward bed scour.

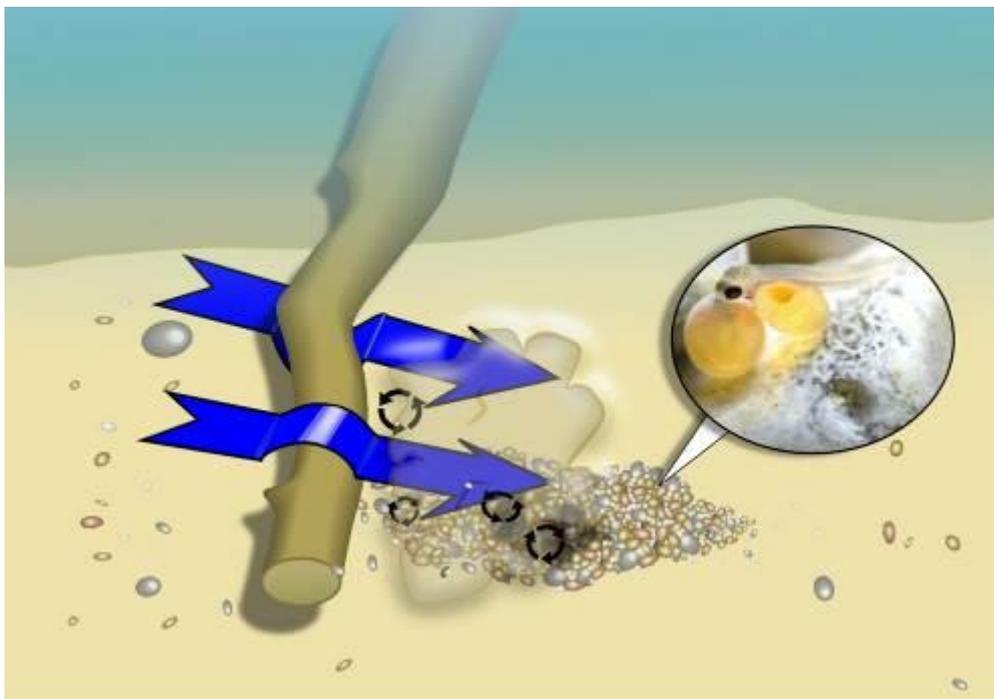
Drawing 2 Managed woody debris pegged into the channel can have the same effect by eroding the bed and blowing eroded river bed gravels into sites ideal for fish spawning.

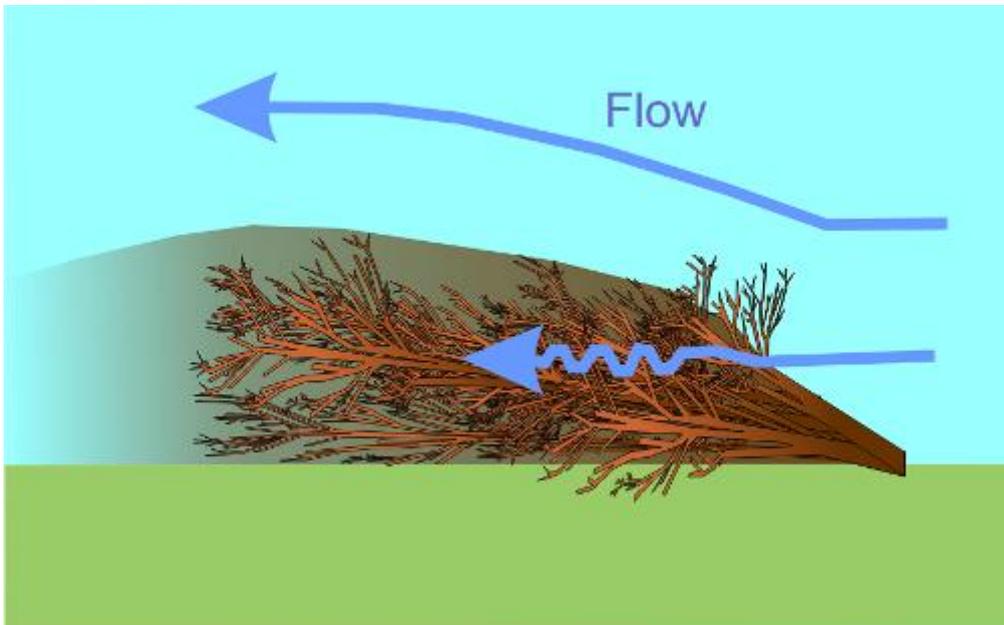
Drawing 3. Depicts a brushwood bank toe designed to slow down erosive flows and collect sediments.

Where unwanted lateral bank erosion occurs, coarse woody debris (brushwood or brush) can be used to peg into the toe of the bank and against the eroding bank face (Drawing 3). Photo 3 depicts a typical piece of eroding bank that has been packed with secured brushwood designed to reduce erosion pressures and provide improved in-channel habitat for fish and invertebrates.

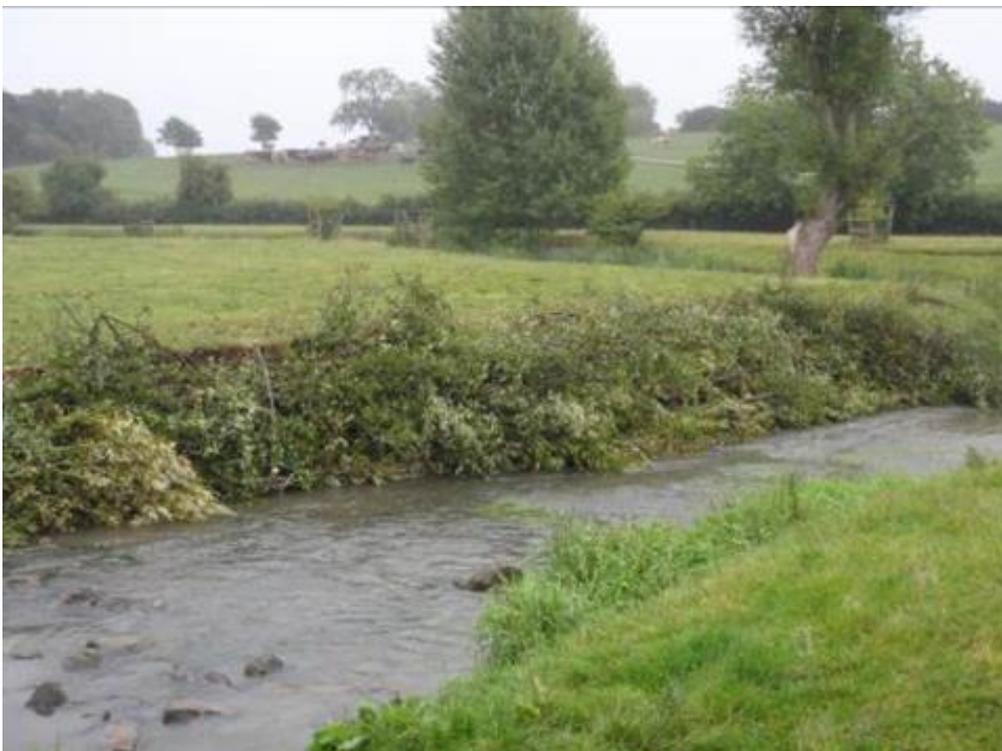
Photo 3. Depicts an eroding bank packed with brushwood.
