River Stour, Stourhead, Wiltshire

An Advisory Visit by the Wild Trout Trust November 2014

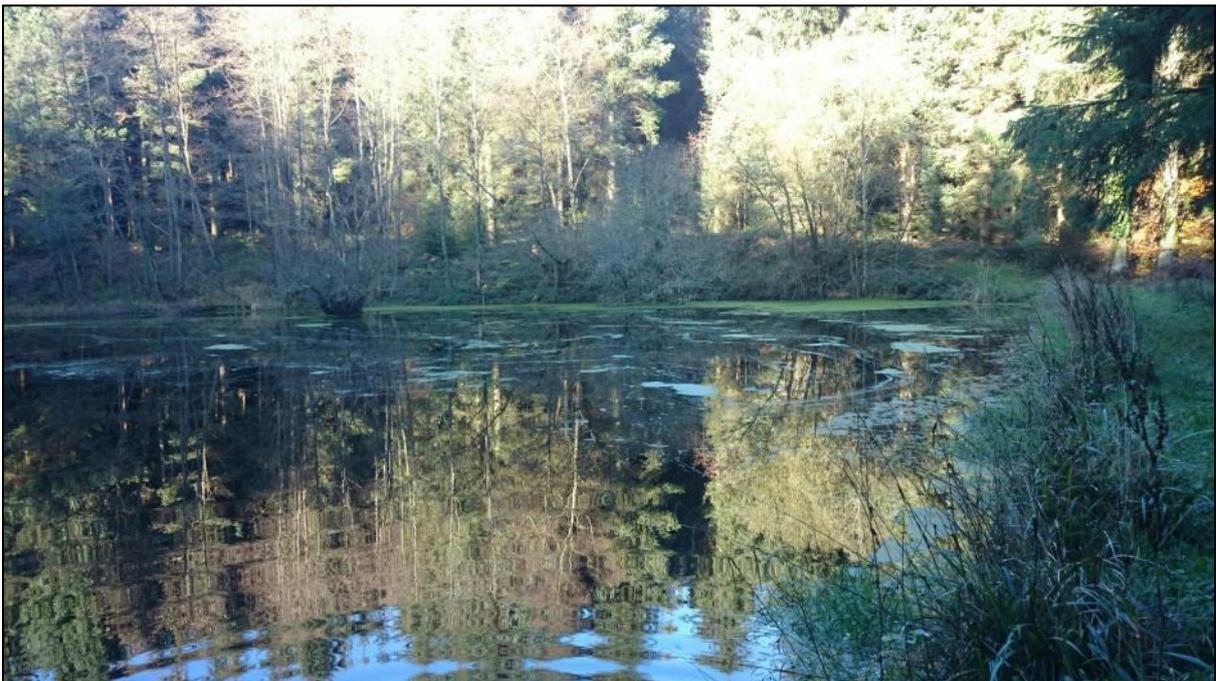
The upstream-most lake visited, Convent Pond, is heavily silted with an infestation of duckweed (Figure 2). The silt in the pond is most-likely a build-up of decaying leaf litter. Eutrophication (an excess of nutrients) arising from the annual input of leaf litter is likely a significant factor in the duckweed infestation. Other factors include the lack of other aquatic plants to compete with the duckweed and the sheltered location of the pond reducing wind-blown movement of the water.

Figure 2: The upstream-most lake is heavily silted with an infestation of duckweed

4. Duckweed on Convent Pond can be initially removed by skimming the surface with a boom to collect it in one location and netting it out with a large hand net. An alternative technique is to pump water from the surface and letting it drain back into the pond from a short distance from the bank edge (so that the duckweed remains on the bank). Reducing the volume of sediment in the pond also will help to reduce concentrations of excess nutrients, in turn helping to control the duckweed. It is worth remembering, however, that aquatic weed treatment such as this has to be an ongoing job because the duckweed will return. It is rather similar to maintaining a garden lawn where regular cuts through the growing season are needed to keep the grass short.

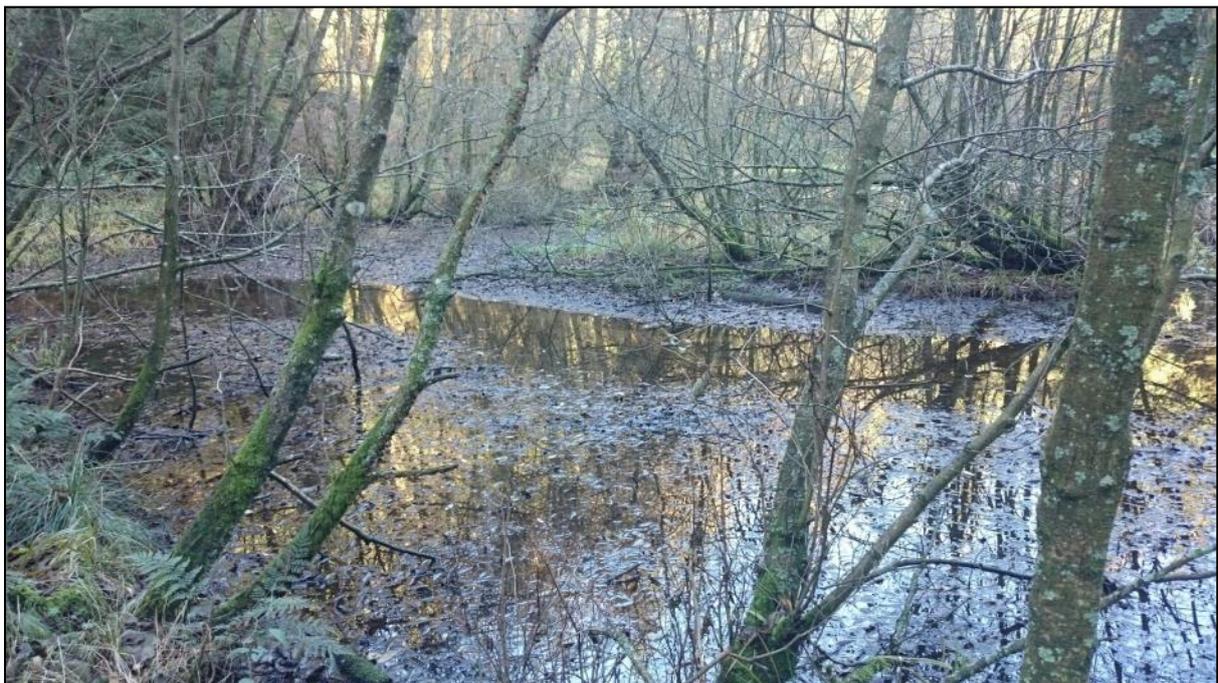
The siltation is most acute at the upstream (western) end of the lake (Figure 3). The natural river upstream has a clean gravel bed but sedimentation in the lake is inhibiting fish passage, potentially depriving fish in the lake from access to spawning habitat.

Figure 3: Siltation is most acute at the upstream (western) bank.

2. Initiate a programme of silt removal from the lakes. There are a number of techniques available to achieve this goal, the right ones for each lake will depend heavily on access and associated costs. Chemical treatment of the organic component of silt (e.g. with chalk-based products such as Siltex) may be the most cost-effective solution where poor access makes mechanical removal options impractical. It is understood that discussions between Mr. Parfitt and Shaun Leonard of WTT highlighted the options for treatment of the siltation issue and concluded that some partial Siltex treatment may be attempted on the lakes. Mr. Leonard described the likely annual reduction in silt depth from Siltex treatment (perhaps only 1 or 2 cm), that these treatments work only on the organic fraction of any silt load, that there is a need for annual retreatment if some benefit is observed and that there is a risk of algal blooms in ponds that are effectively fertilised by the Siltex treatment. However, there are many modern technical innovations in silt removal and it is recommended that quotations for mechanical removal are obtained from companies that specialise in aquatic management.).

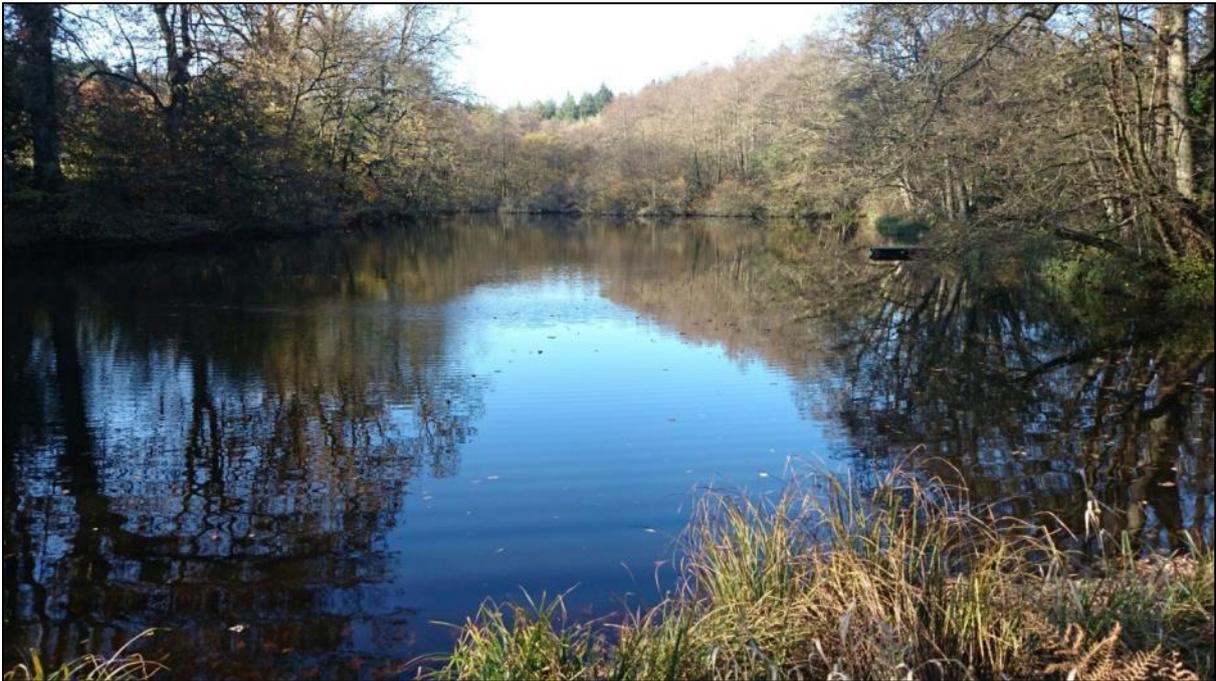
abundance of bankside cover in the form of low branches on the southern and northern banks, sedge beds on the eastern bank (Figure 4) and a cluster of overgrown and partially-submerged willows on the western bank (Figure 5).

Figure 4: The upstream-most lake from the eastern bank.

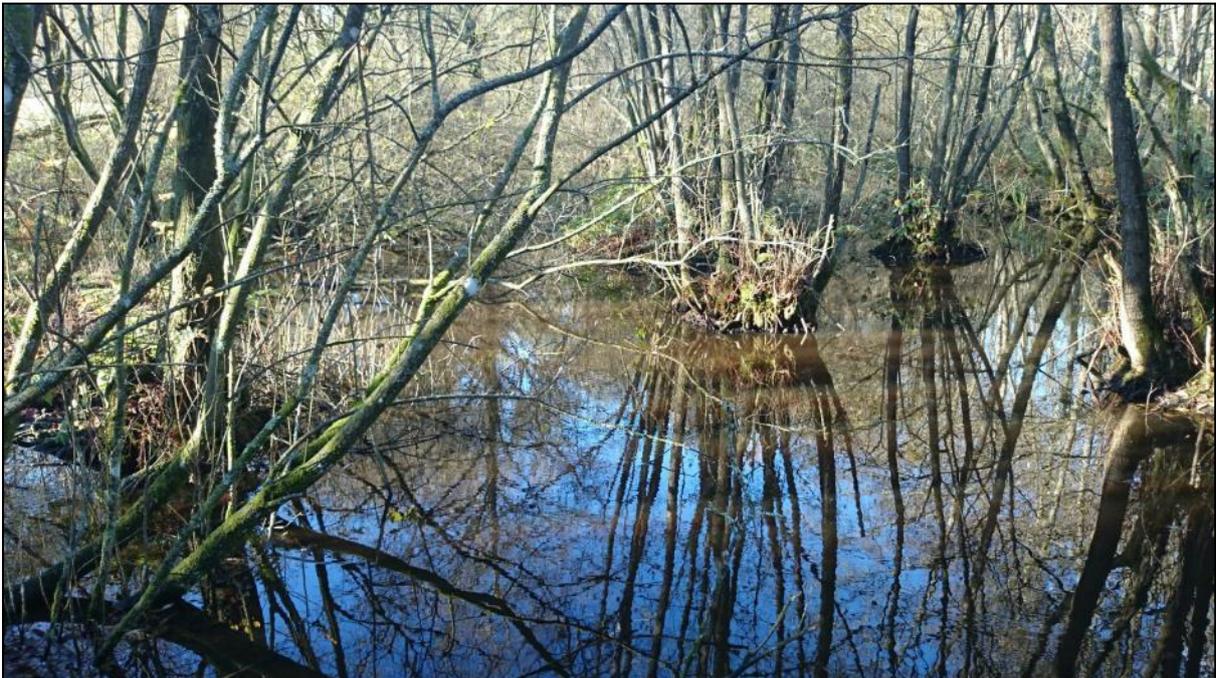
Figure 5: Willows growing in the shallows of the western bank.

trees also means an abundance of leaf litter which will be a major contributor to sedimentation. Trees also provide shelter from the wind. Some clearance of the willow thicket dominating the western (upstream) end of the lake would improve angler access and also help to increase the lake's exposure to the prevailing wind.

1. Commence tree works around the top two lakes to help control the annual volume of leaf litter and to expose the lakes surface to prevailing (south-westerly) winds. Care should be taken to ensure that adequate shade and low-growing branches over the water are retained.

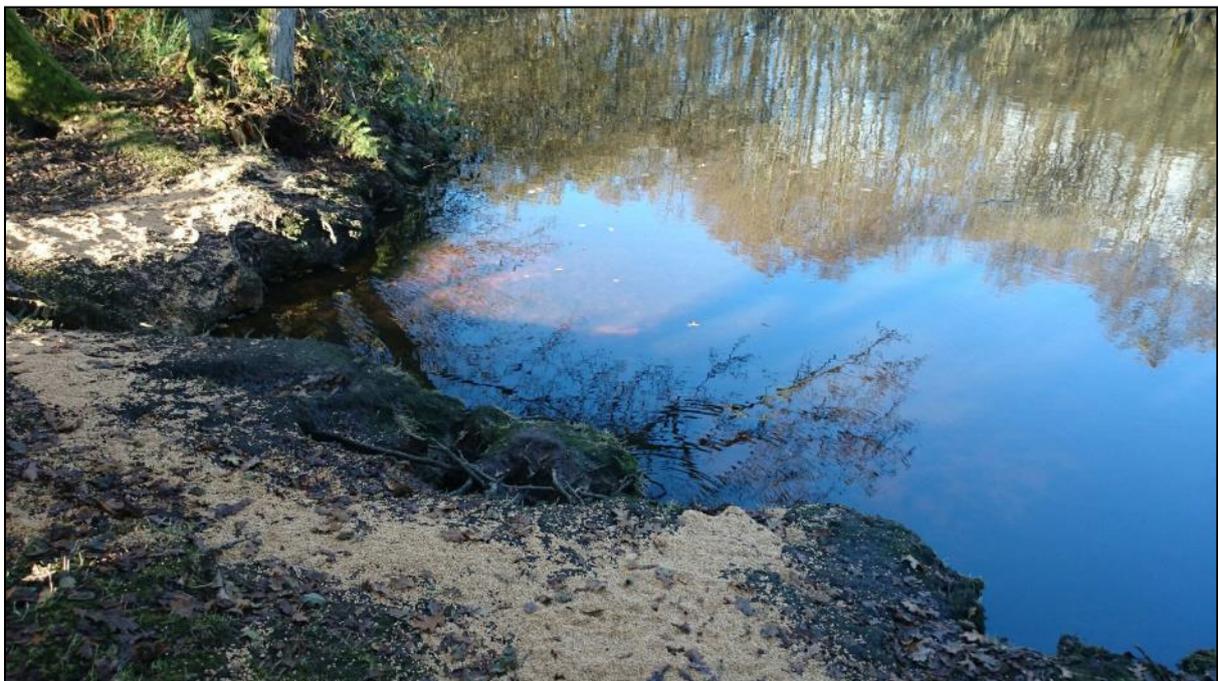
In addition to the fishery, the lake is also used to feed ducks for an annual shoot. A substantial volume of grain was observed on the southern bank and in the margin of the lake. The bank was also heavily eroded by waterfowl footfall (Figure 6). The volume of grain observed and the severity of the erosion suggests that feeding is over-intensive. Over-feeding ducks could have negative impact on water quality. Birds have a relatively fast metabolism and consume and excrete relatively large volumes of organic material. An increased density of wildfowl can contribute to eutrophication in the lake. Bacterial decomposition of submerged grain could also impact on water quality and the bank erosion is contributing to the lakes fine sediment load.

Figure 6: Wildfowl feeding could be having a negative impact on the quality of the fishery.

3. Engage with the Estate owner and explore the possibility of ceasing duck feeding on Tucking Mill Lake. The potential impacts on the fishery of an

increased wildfowl population in the general area may not necessarily be limited to the lake where feeding occurs.

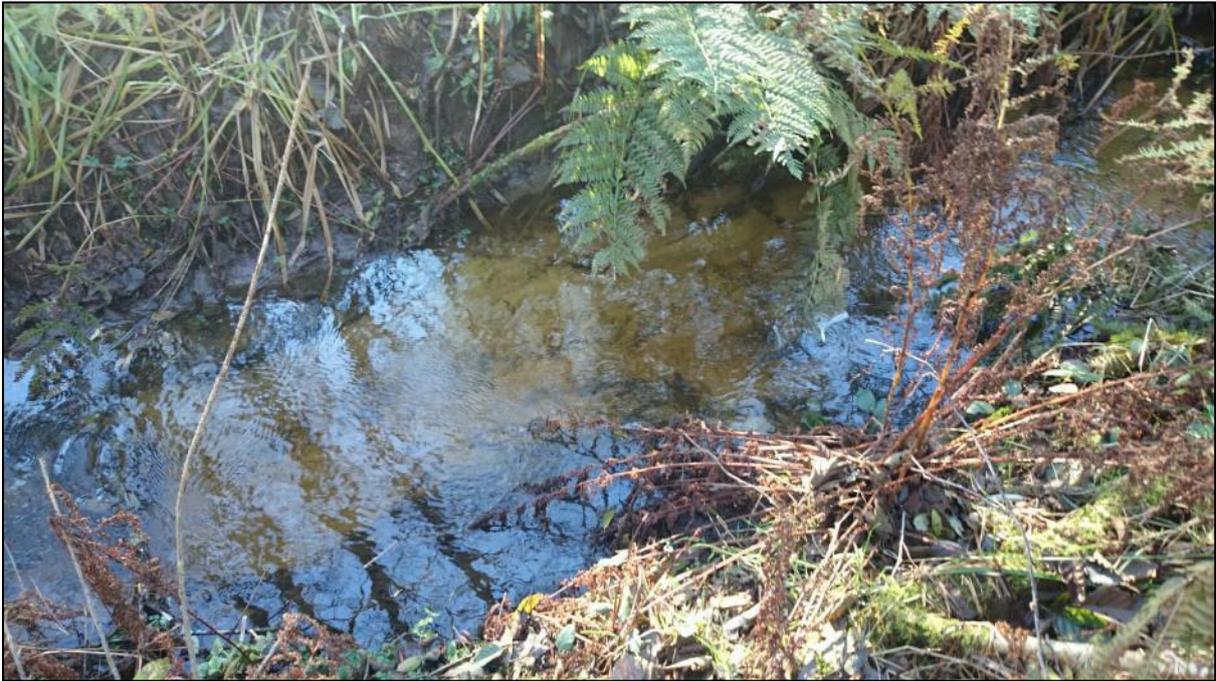
The lake is fed by a small stream which flows out from a culvert to the west. The gravel bed of the stream is smothered with fine sediment for approximately 60 metres upstream (Figure 7), probably as a result of the impoundment at the lake slowing flows and allowing fine sediment to drop out of suspension. Near the culvert outfall a small patch of clean gravel was observed (Figure 8). The

Figure 7: Fine sediment smothering the stream bed

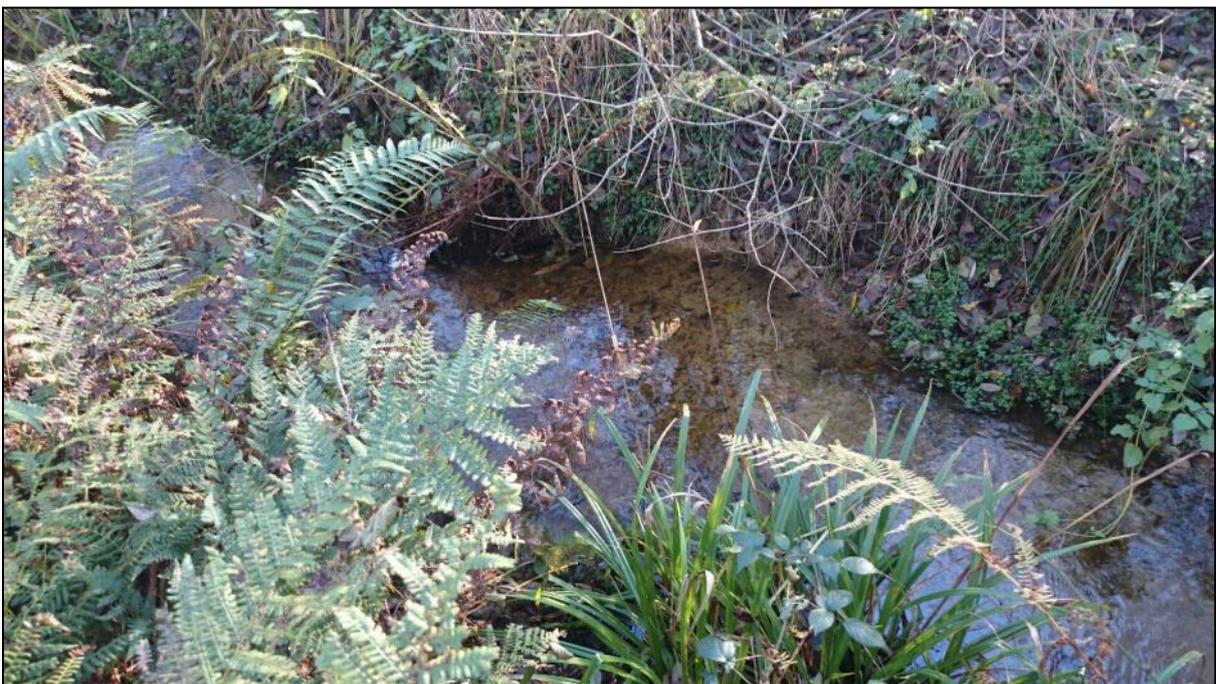
Figure 8: A small patch of clean gravel near the culvert outfall appears to be the only available spawning habitat.

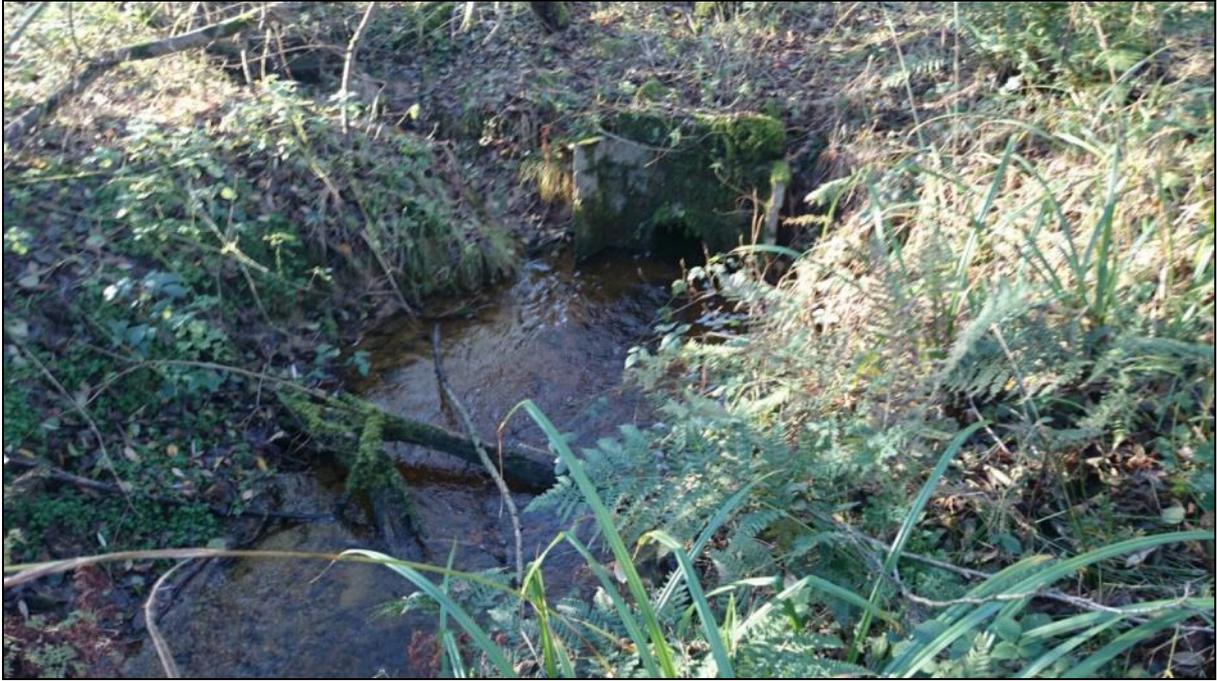
culvert (Figure 9) is over 100 metres long. Traversing upstream through the culvert would require a prolonged period of physical exertion which makes it a significant obstacle to fish passage. The culvert is also probably a behavioural barrier (research suggests that salmonids may be dissuaded from entering dark culverts (Kemp *et al.*, 2006, Weaver *et al.*, 1976). Therefore this small patch of gravel may be the only viable spawning habitat available to the trout population.

Figure 9: The outfall of the culvert is not a barrier to fish passage but the length of the culvert makes it a significant obstacle which trout are unlikely to successfully traverse.

5. Better connect the Tucking Mill Pond with the river upstream by removing the culvert and replacing it with a clear-span bridge where farm access between the fields is required. Excavating the pipe should be a relatively simple task that can be undertaken with a small 360 excavator or tractor equipped with a digging bucket. At present the pipe is in a straight line and so once removed, a more sinuous plan form will need to be created. The new channel will need to be shaped to closely resemble the depth, width and sinuosity of the natural channel upstream and downstream of the culvert. It is possible that a natural gravel seam is present at the depth of the pipe but it may be that new gravel will need to be introduced. This will provide an opportunity to shape a sequence of riffles and pools into the channel. In addition to new gravels, introducing some fixed woody features such as small logs will help to diversify flow patterns and keep gravels scoured clean of fine sediment.

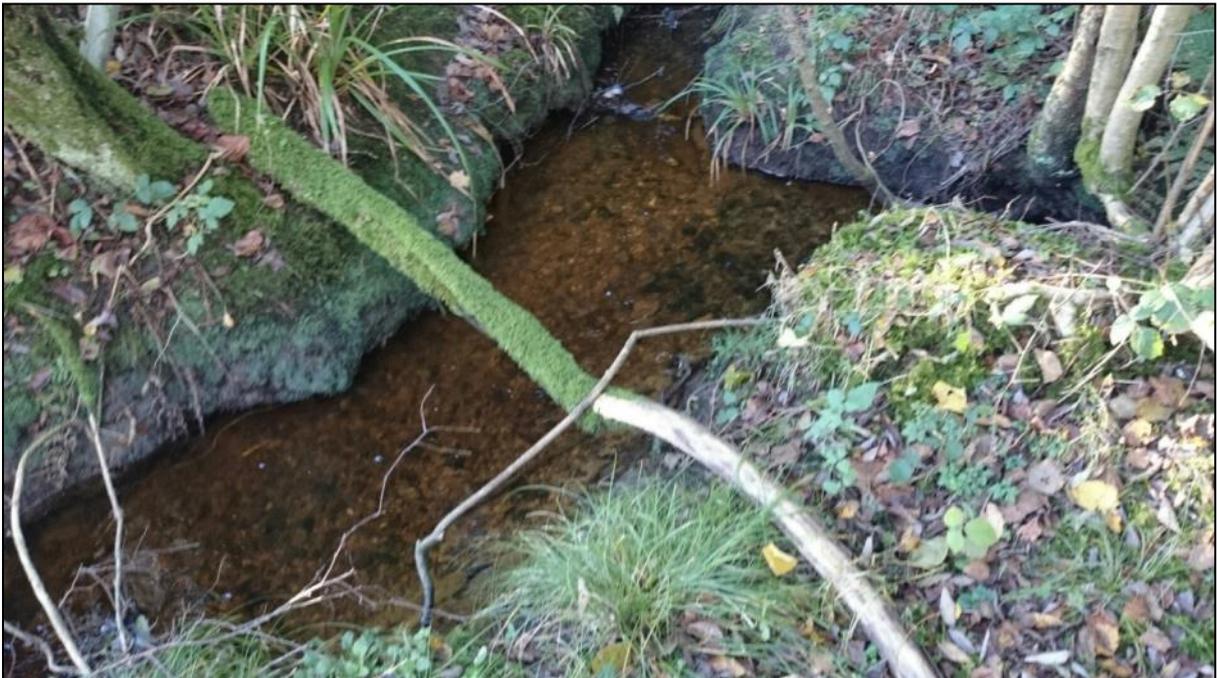
Upstream of the entrance to the culvert the stream is relatively fast-flowing over a clean gravel bed (Figure 10). Improving connectivity between this habitat and the lake downstream could significantly boost trout recruitment.

Figure 10: Upstream of the culvert the stream exhibits some very good quality spawning habitat.

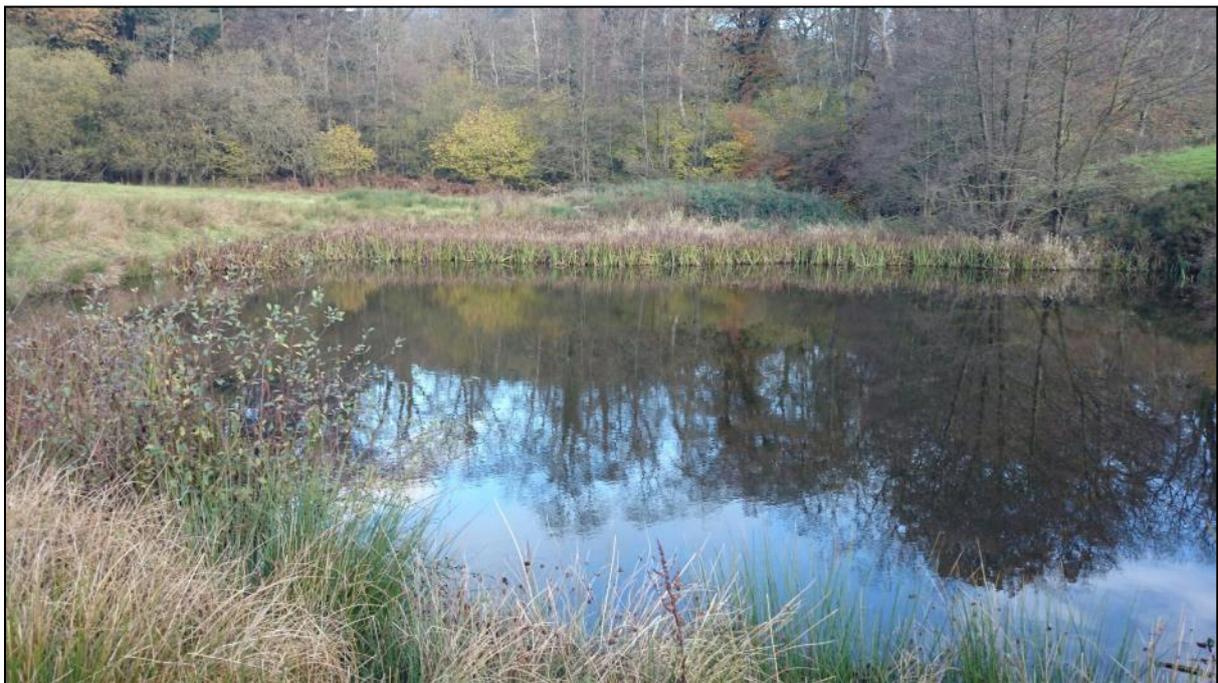
The third lake downstream, Lynch Pond, is relatively open to the elements compared to the two lakes upstream. The reduced tree cover and the silt trap effect of the upstream lakes appeared to have reduced the volume of leaf litter, and the resulting rate of sedimentation. The lake appeared to have a good depth and trout were observed rising on the day of the visit. However, sedimentation at the upstream (northern) bank is a classic sign of stream-fed siltation. The sedimentation has caused bankside vegetation to encroach on the lake, reducing the size of the lake over time and potentially impeding upstream access for trout (Figure 11). It is possible that although the inflow from the stream is relatively small, it may be a point source of leaf litter and fine mineral sediment.

Figure 11: Lynch Pond with a dense bed of marginal plants at the inflow (background).

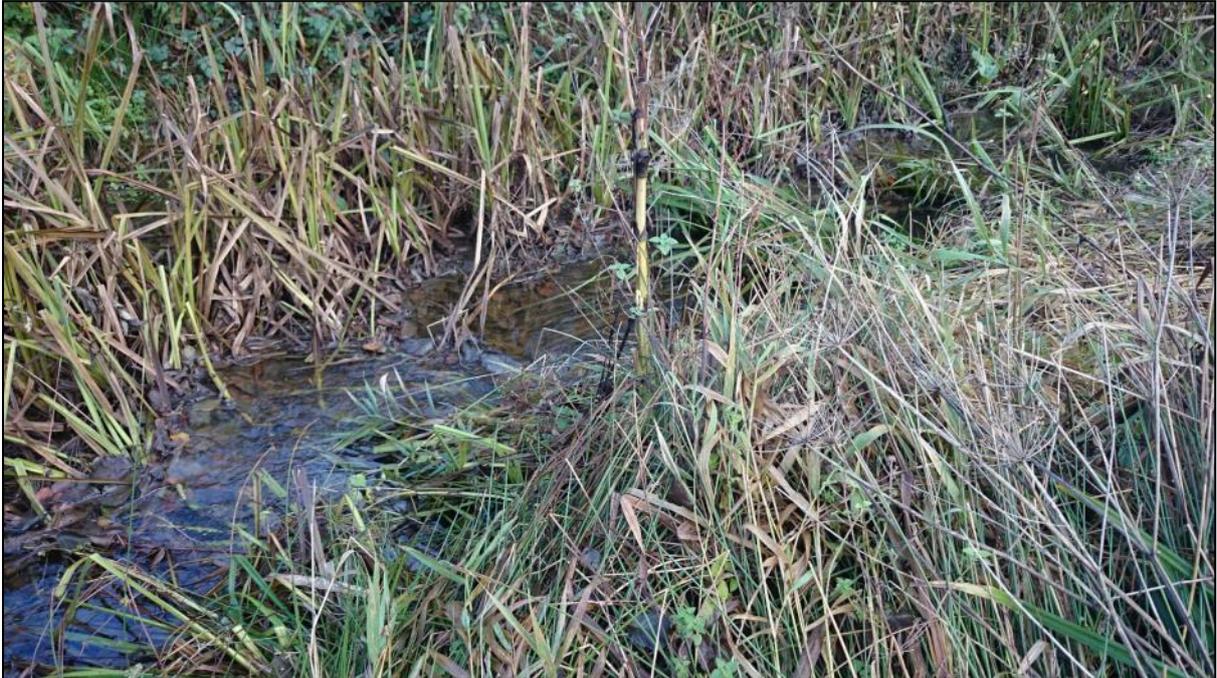
Above the lake the stream has an abundance of good quality spawning habitat but the encroaching vegetation, a mixture of branched bur reed (*Sparganium erectum*), sedges (*Carex* spp.), rushes (*Juncus* spp.) and common reed (*Phragmites australis*), choke the in-flow and trap leaf litter washing downstream (Figure 12). Annually removing trapped leaf litter at this location will help to reduce the rate of sedimentation and could improve upstream access for fish. Another alternative could be to divert the stream through an existing secondary high-flow channel (Figure 13). The advantage of diverting the flow could be that the high flow channel may require less annual maintenance as it is more shaded and less likely to become choked with vegetation. However, the

Figure 12: Leaf litter trapped in encroaching vegetation

Removing the existing reed bed is not recommended as it probably provides important juvenile trout habitat and boosts biodiversity as well as helping regulate nutrient levels. Instead, de-silting the pond and increasing depth at the western bank, near the existing vegetation (so the depth rapidly increases to

approximately 1 metre) could help to reduce the rate of any further encroachment.

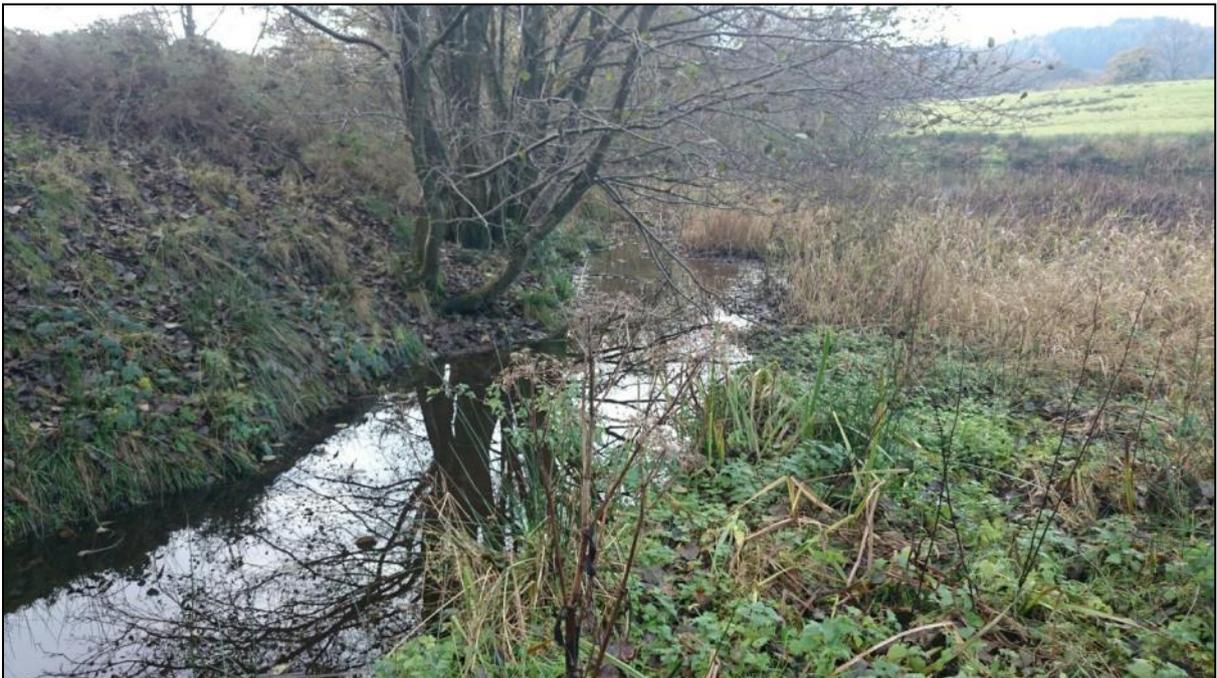
leaf-trapping action of the reed bed will be reduced if the main flow no longer passes through it, potentially making management of silt more difficult.

Figure 13: Diverting flow through the secondary in-flow channel could be an alternative action

6. Clear the inflow of Lynch Pond to facilitate access to spawning habitat upstream. Alternatively, consider diverting the inflow through the secondary channel (Figure 13). This channel is less likely to become

encroached by marginal plants, reducing annual maintenance, but the lack of vegetation could also allow more leaves into the pond, potentially accelerating the rate of sedimentation.

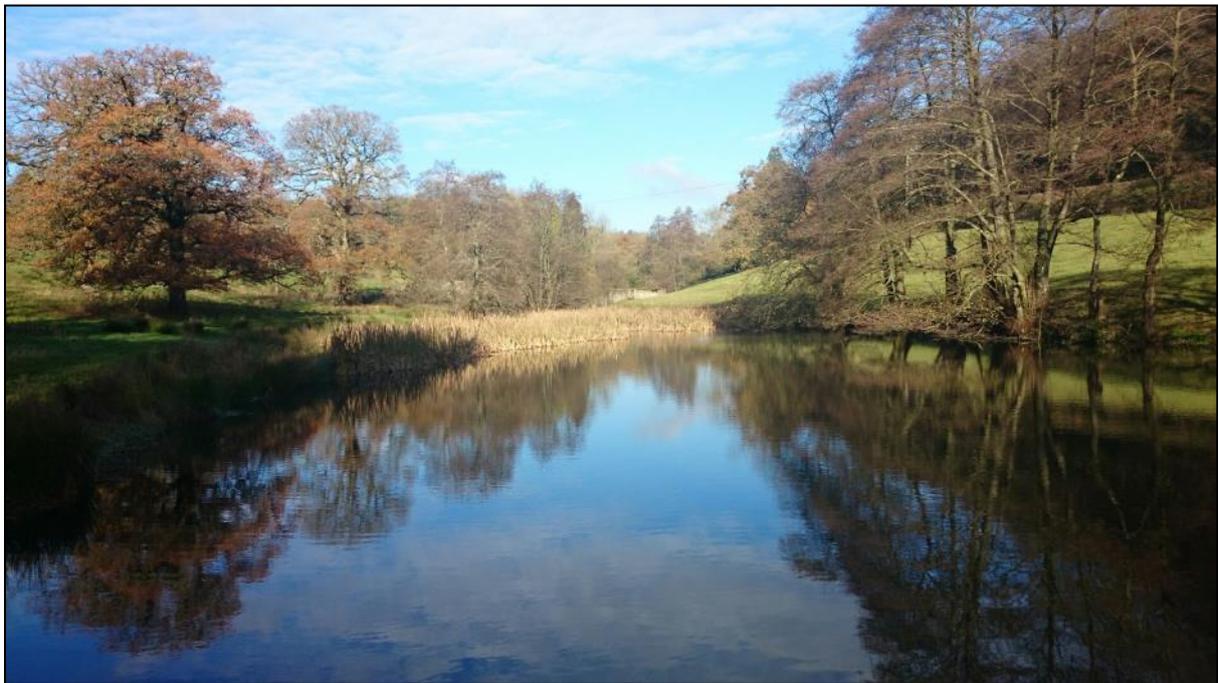
The final lake downstream, Lower Kennels Pond, is also relatively exposed but some good cover is provided by low branches from bankside alders (Figure 14). Access is relatively good compared to the other waters visited, potentially making some mechanical de-silting options more practicable. Unfortunately, habitat connectivity is poor both upstream and downstream. Upstream fish passage is blocked by an impoundment at a small pond on private property and the outflow from the lake is also a complete barrier to fish passage. The lack of access to clean gravel habitat presently prohibits the lake from supporting a self-sustaining wild trout population. Whilst the best long-term scenario is to fully reconnect the lake to the river, options to achieve this are likely to be prohibitively expensive in the short term.

Figure 14: Lower Kennels Pond from the Southern bank

7. Consider establishing a stocked catch-and-take day-ticket fishery at Lower Kennels Pond. Profits from day tickets could help towards covering the cost of managing sediment and habitat works throughout the rest of the fishery. Further advice should be sought on the viability of the lake to support a commercial fishery. A good starting point would be to review Environment Agency fishery management advice (https://www.gov.uk/government/uploads/system/uploads/attachment_data/file/290646/sw2-045-tr-e-e.pdf)
