**Advisory Walkover**  
**Powmillon Burn, Strathaven**  
**March 2019**

## 1.0 Introduction

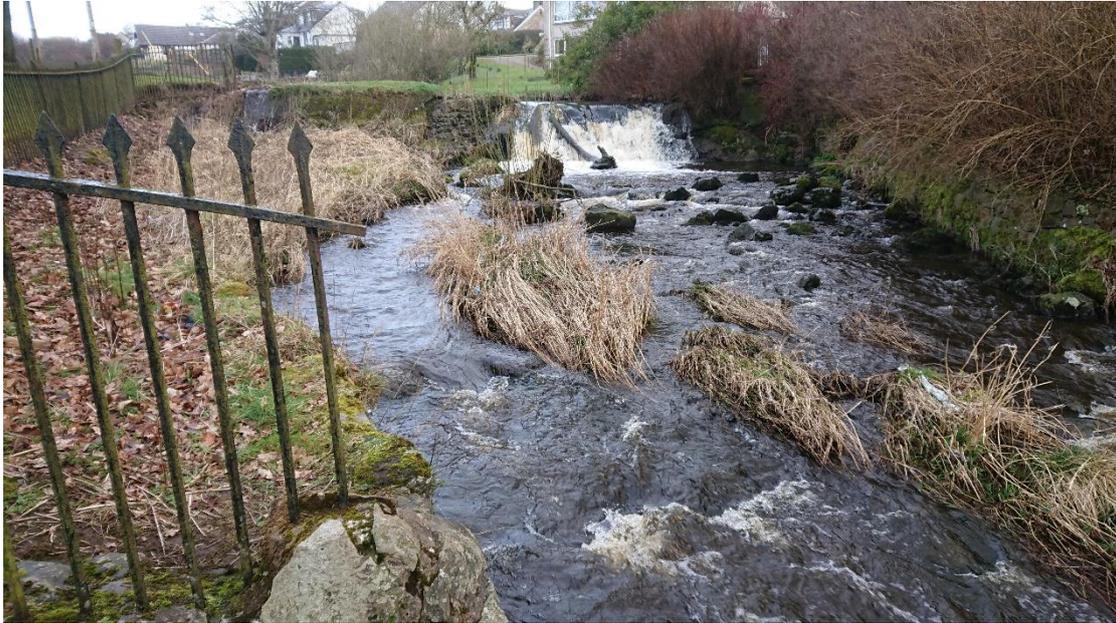
**Fig 1. Effectively the u/s limit of the Powmillon Burn under consideration, the weir impounds water to provide an offtake / lade for former milling and currently supplies the lake. It can be considered an impassable barrier to upstream fish migration.**

**Upstream, the impounded reach was relatively short and aerial imagery of the channel within the pastures shows a naturally meandering channel. Throughout the park, as will be seen in the following images, the banks have been heavily formalised with walling and the channel straightened, thereby increasing the gradient and creating very uniform width, depth, and substrate characteristics.**

**Here, the LB was walled but the RB was less constrained. As a consequence, and in response to the weir and large boulders disrupting the flow of water, the channel has diversified and created good habitat for many life-stages of trout: deep water for holding adult fish; shallow streamy runs for juveniles; trailing, 'shaggy' vegetation to provide refugia from spate flow and predation; and sorting of substrate into size classes, creating some small pockets of gravel where trout may spawn.**

**Opportunities: some low growing, shrubby trees like bird cherry, goat willow (sallow) or dogwood could be planted on the RB beyond the fence, to add more overhead cover. These would be easy species to manage by coppicing, and provide excellent resource for pollinators, as well as enhancing aesthetics.**

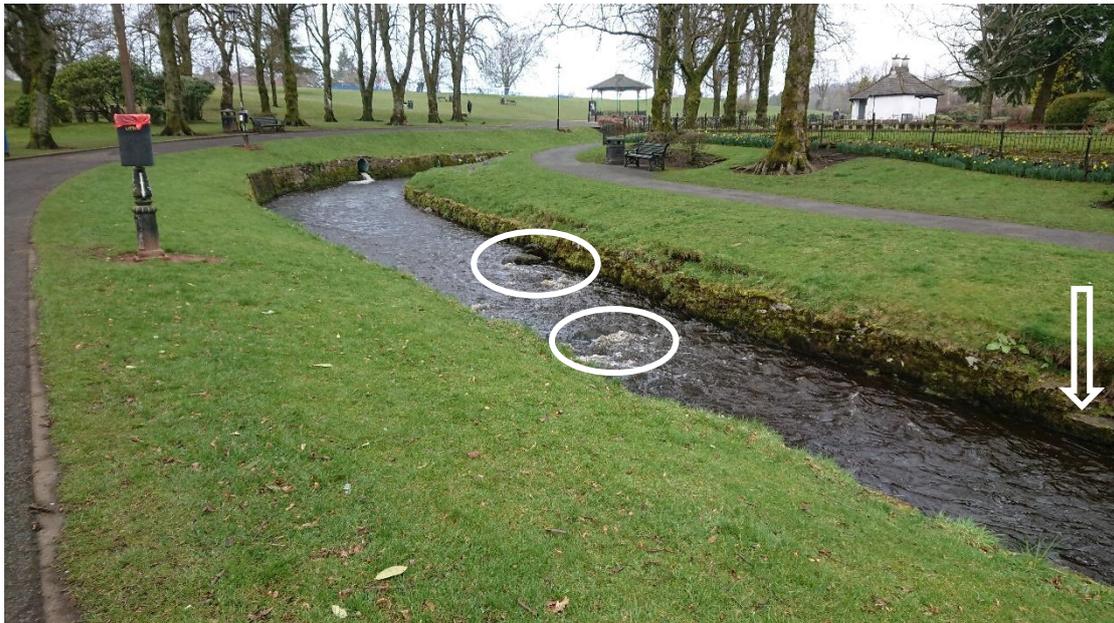
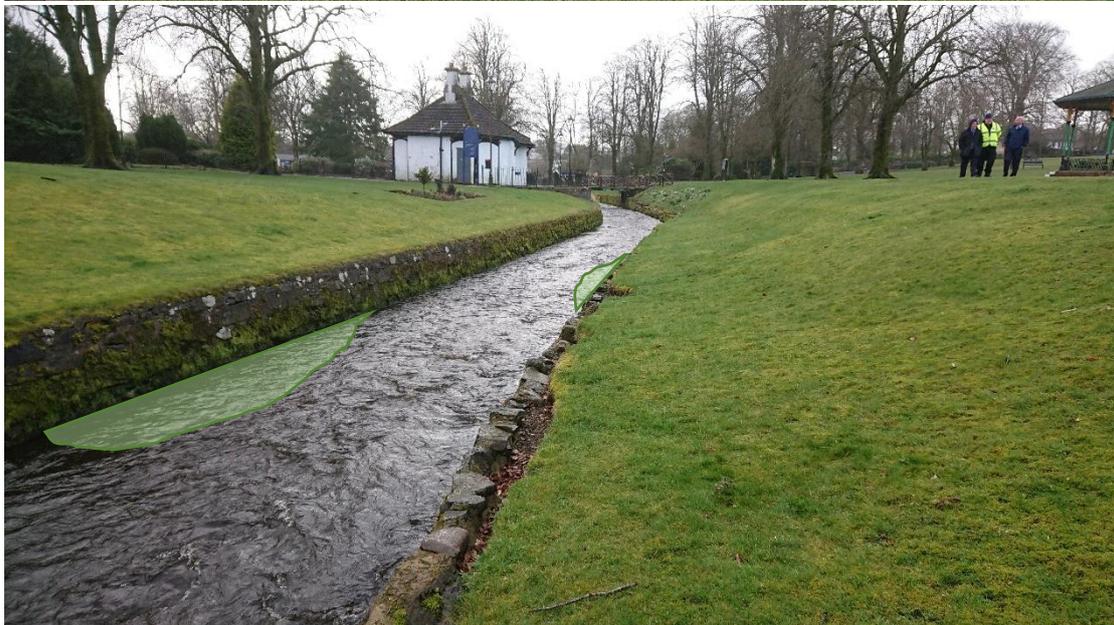
**Fig 2. A heavily formalised reach near to the bandstand. The channel has been designed to a constant trapezoidal proportion relative to a fixed width. The straightening and long sweeping bends have caused a steepening of the gradient and, hence, the instream habitat was dominated by continuous shallow riffle. Substrate was mostly distributed evenly across the channel. The few features of note were caused by larger boulders within the channel disrupting the flow**

The banks were maintained as short sward grass and therefore there was no cover, the walling effectively severing any ecological tie between the land-water interface.

**Opportunities:** This is a very 'visible' area of the park with paths on both banks; dogs were being encouraged to play in the water from the inside of the bend where the channel bed was more accessible (white arrow).

- Diversifying the flow by enhancing the effects of the boulders already *in situ* (upper image, white ellipses), and recreating similar enhancements upstream on the straightened section.
- Installation of alternating low-level berms to encourage a more natural sinuous flow path (e.g. green hatched areas in lower image; see Fig 3).
- Judicious planting of some trailing vegetation such as native ivy, honeysuckle or bramble in association with the instream structure to provide low cover. This would be of most benefit where the trailing vegetation would cover deeper water.

The use of structure to impede flow and hence diversify flow patterns around that structure has knock-on effects to the surrounding substrate via scour and deposition (visible in Fig 2). Physical habitat diversity begets biological diversity, be it microbial, plant, insect or fish. Different life-stages also require different habitat characteristics.

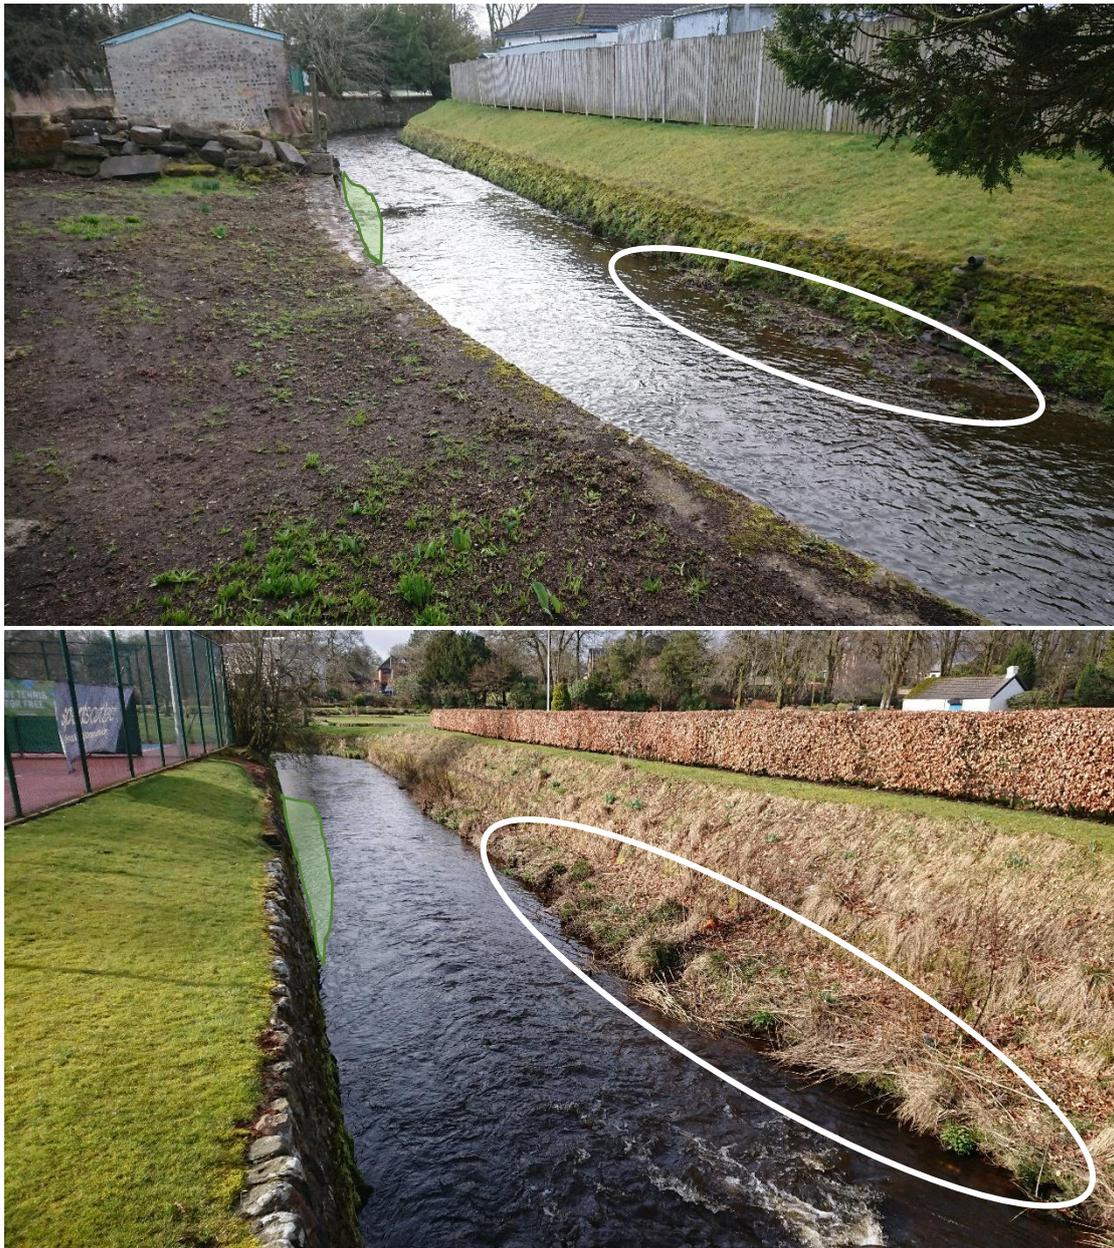
**Fig 3. The back and side of the Bowling Club, upper and lower panels, respectively. The two ellipses, both to the RB, highlight naturally developing features that would be good to create / encourage / enhance elsewhere.**

**Upper:** finer sediment has been deposited on the inside of the slight bend, slightly narrowing the wetted channel, i.e. the remaining wetted cross-section must be slightly deeper to the outside of the bend. The regular mowing of the grass is removing much beneficial biodiversity – this is despite the fact that the area is not accessible or particularly visible to the public.

**Lower:** a low berm has developed at the toe of the wall and been colonised by native vegetation; this area appears to be benefitting from 'benign neglect'. The vegetation at water level provides a much more natural land-water interface and good low cover for fish and insects.

**Opportunities:** with limited public access to this part of the park, any enhancements should provide even greater benefits to fish populations because of lower disturbance. Work here could form part of an experimental study for Clyde RF.

- Enhance and exaggerate the current berm / deposition bar development.
- Increase sinuosity with a complementary berm on the opposite bank (LB) downstream.
- Planting of trailing species at judicious points along the wall tops.
- Introduction of several individual boulders mid-channel to disrupt flow.

Currently, the trapezoidal channel is overly straight and uniform. In some areas, deposition of fine sediment and colonisation with plants (generally on the inside of the bends) has already led to a natural recovery of the channel to more appropriate dimensions (e.g. Fig 3). However, under typical flow conditions, the channel is over-capacity: too wide and hence the water depth generally too shallow; see Fig 7.

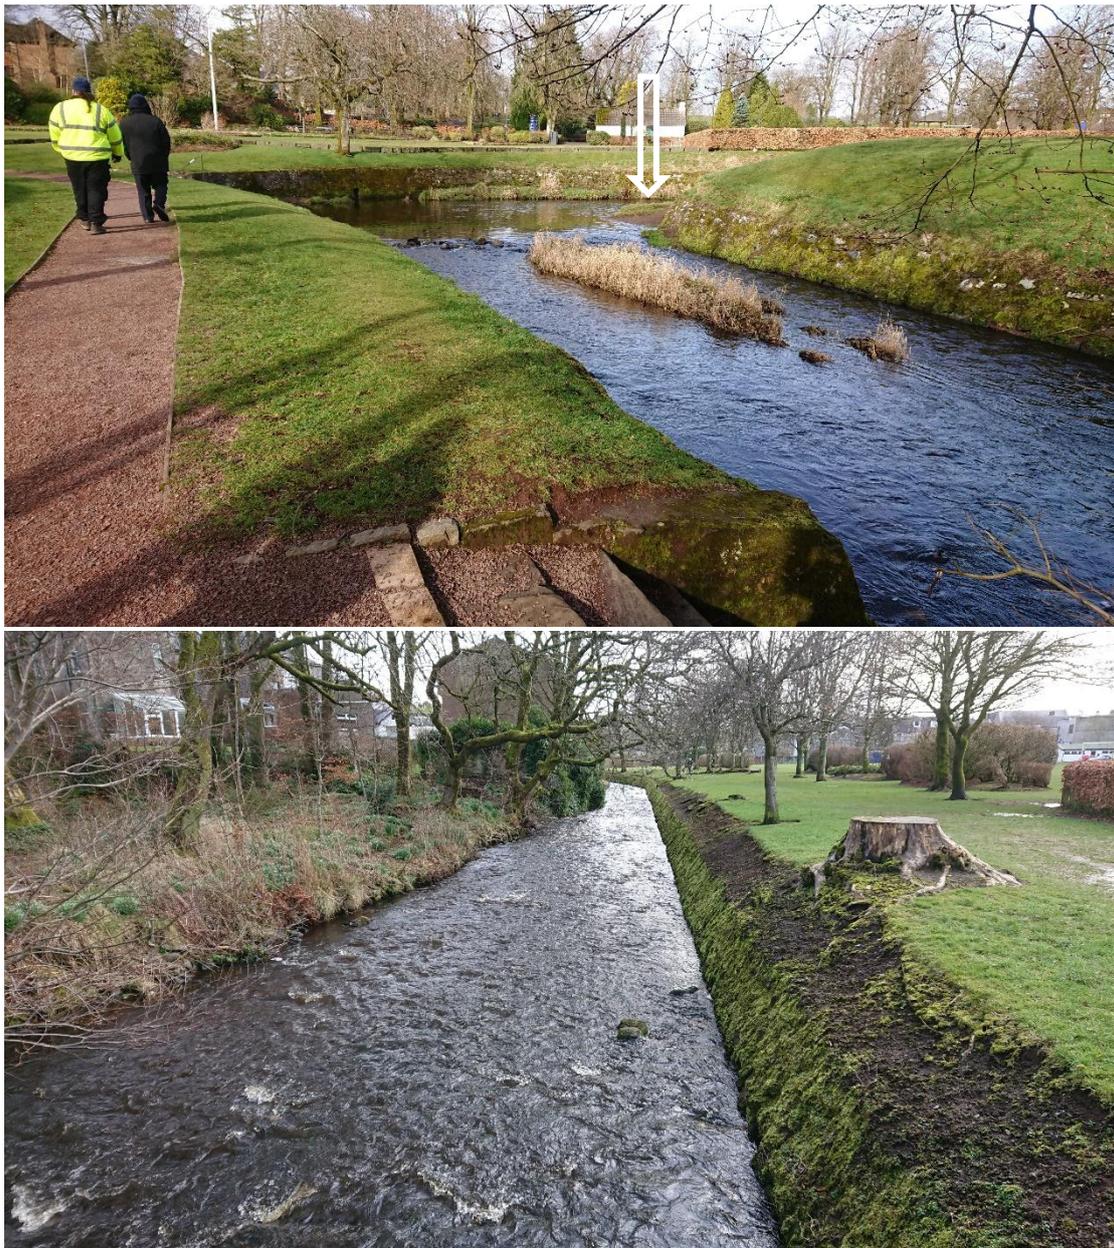
**Fig 4. One of the few locations within the park where the channel width varies, the left-hand bend downstream of the Bowling Club. The pool was actually deeper through the centre of the bend; there was evidence of a berm of vegetation at the toe of the wall around the outside and a notable deposition of finer sediment on the inside (arrow). In a similar fashion to the weir in Fig 1, the greater width afforded between the walls, and the disruption of the flow has led to the development of a point bar mid-channel which has been colonised by plants. Steps down to the water, and a footbridge, make this an ideal demonstration reach (currently exploited by Clyde RF). The relatively natural LB in the lower image offers a clear contrast in habitat to the walled RB.**

**Opportunities: downstream from the footbridge presents ideal study location for contrasting natural v unnatural banks, but as the LB (natural) is under private ownership, there is little to consider in this report. Upstream of the footbridge, there is scope for enhancement.**

- **Exaggeration of the deposition bar, encouraging it downstream.**
- **Placement of individual boulders to disrupt flow.**
- **Pinned logs, placed parallel and tight to the bank to provide cover for fish.**

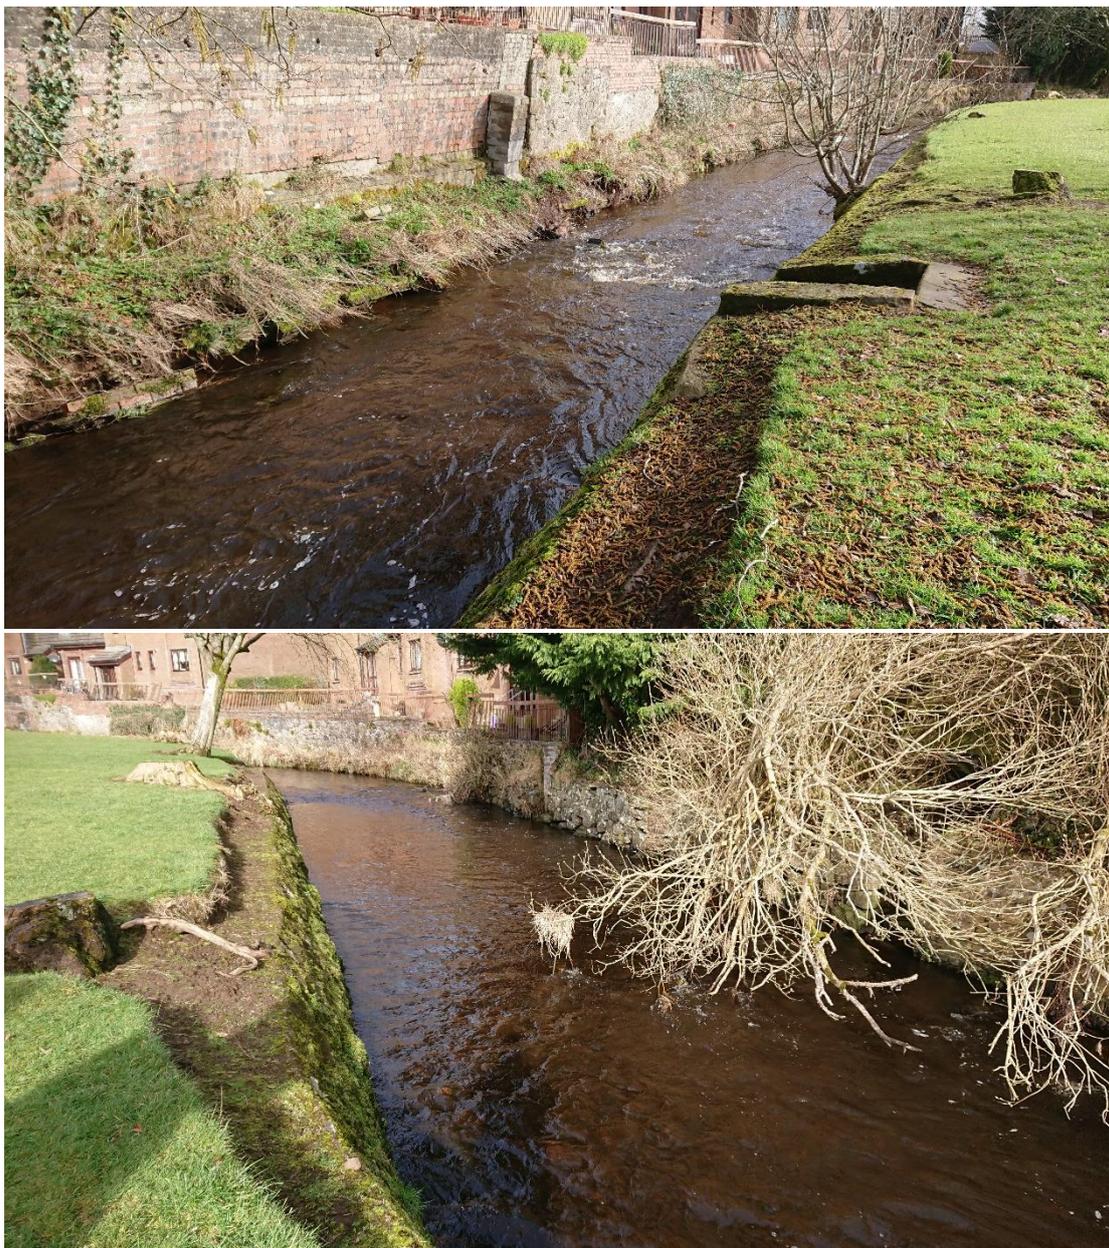
**Fig 5. The lower reaches within the park appeared to be slightly narrower and hence retained a greater depth of water. The integrity of walling of properties to the LB was suspect. A slight step in the walling of the LB had allowed some natural vegetation to colonise and this provided some low trailing cover (upper). Indeed, in the lower image was evidence of some of the only low-branched cover along the whole reach, especially beneficial as this was over deeper water and hence good habitat for larger adult fish.**

Maintaining a short sward of grass along the RB top has clearly reduced resilience to spate flow and led to erosion scalloping (both images). Continually cutting grass shoots means more energy is invested in replacing those shoots rather than roots. Allowing a more diverse 'buffer' of native wildflowers to develop would diversify the root matrix and bind the soil together more effectively, plus better for the wider ecology e.g. pollinators. It can be managed as an attractive feature without becoming too formal, and reduce footfall right to the edge of the bank top (also a contributor to the erosion issue).

**Opportunities:**

- Low berms (as previous) on the straight sections using the current depth profile of the channel as an indicator for where to position them to best effect. This section might also present an opportunity to site two narrow berms opposite each other to 'pinch' the channel, rather than create meanders by placement on alternating banks.

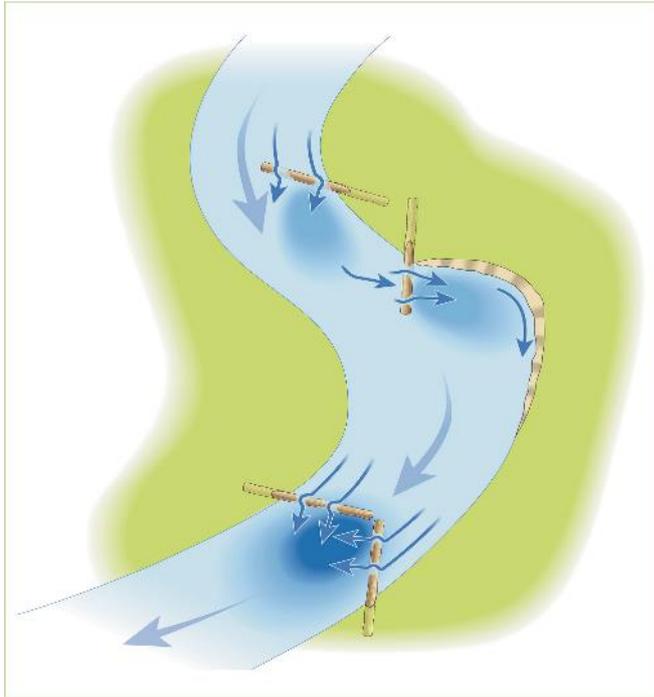
**Fig 6. Conceptual diagram of use of woody material as deflectors, but boulders can achieve the same effect. From the top of the figure:**

**Upstream angled – diverts flow to the centre of the watercourse, and creates localised scour; locating deflectors on opposite banks of a straightened section, but off-set in position can create sinuosity of flow without eroding the banks.**

**Downstream angled – diverts flow toward the bank, increasing likelihood of erosion and can be used to increase sinuosity of the entire channel. NOT TO BE USED HERE.**

**Paired upstream angled – focuses more flow to the centre and creates a deeper scour pool with associated ramp of sorted substrate further downstream.**

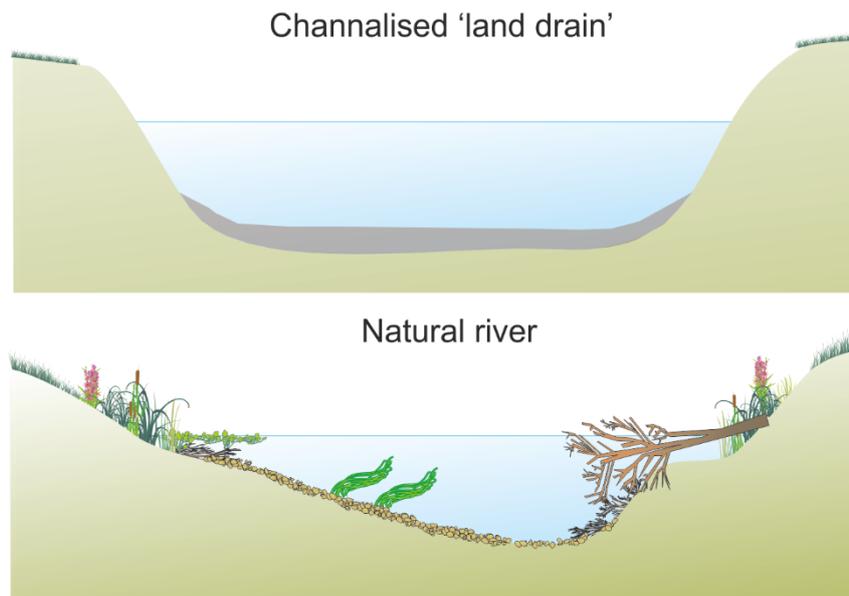
**Fig 7. Simplified, uniform dimensions of a trapezoidal channel designed for conveyance of water, as compared to the diversity found in a natural channel.**

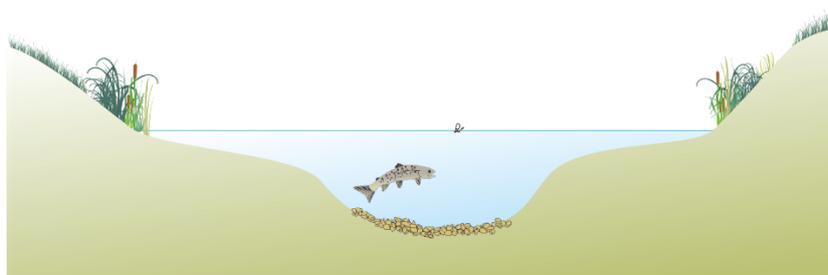
Two-stage channel

Creation of a two-stage channel, i.e. a meandering low flow channel within the confines of the engineered walls significantly improves opportunities for biodiversity while not increasing flood risk (in cross-section profile - Fig 8, and in creation – Fig 9).

**Fig 8. Cross section of a watercourse with a two-stage channel wherein water is confined to the deepest point during low flows but can accommodate a much greater volume under spate conditions.**

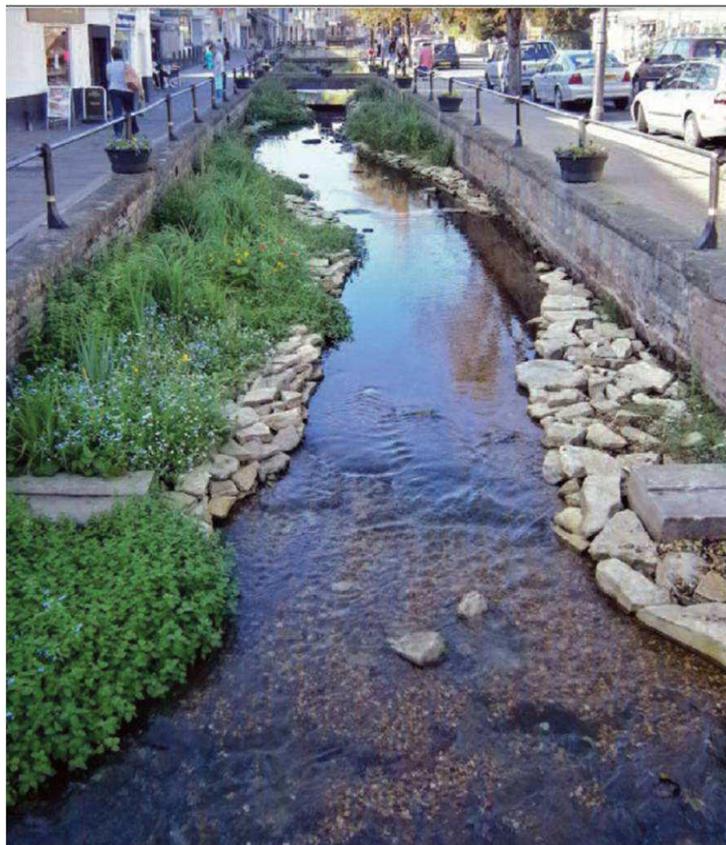
**Fig 9. A constructed two-stage channel creating a sinuous low flow-path. The low berms on either side are quickly overtopped during spate flow and hence do not significantly reduce the carrying capacity of the channel.**

Low berms on spate streams like the Powmillon Burn can be created and quickly stabilised using rock rolls and pre-planted coir rolls or pallets pinned into position using rebar (see links and videos of a project conducted successfully on a similar sized and similar gradient waterbody, the Porter Brook, in the Appendices). In such an
