Advisory Visit
Sutton Brook, Derbyshire
April 2013

1.0 Introduction

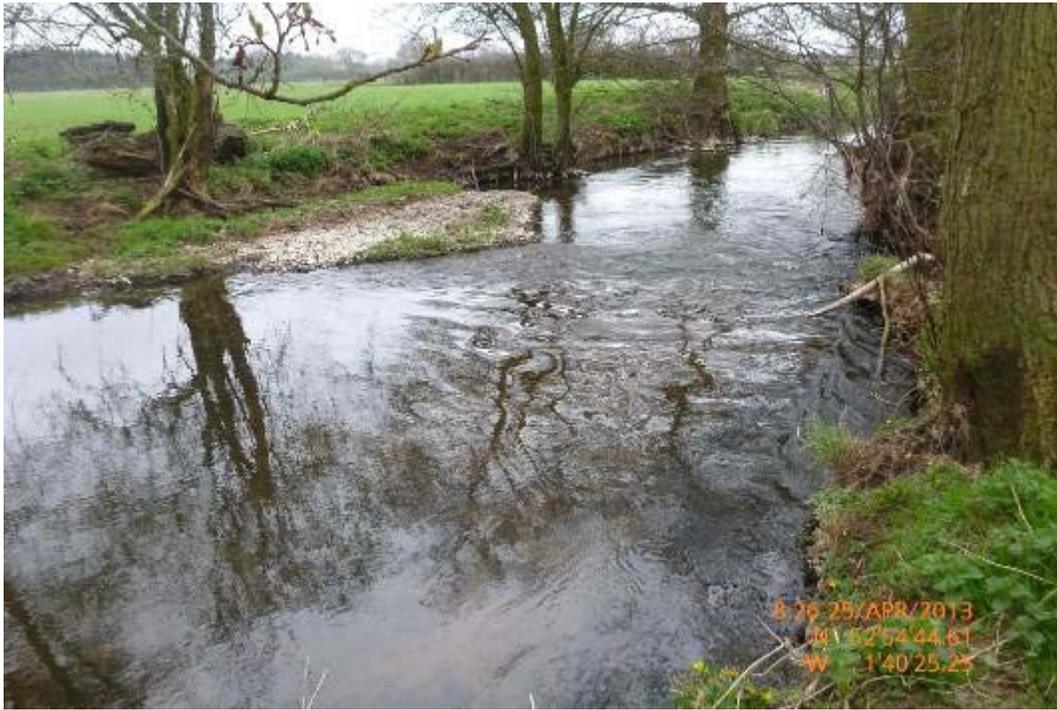
Photo 1 A gravel bed and gradient changes in the river bed like this make ideal trout spawning areas

and a channel structure that allows water to percolate through the gravel. Typically, trout redds (nests) are found at the tail of pools before the water breaks into a riffle; this is where the gradient of the river bed increases and water flows through, as well as over, the gravel (Photo 1). Hence eggs buried in the gravel in the autumn and winter can survive and hatch the following spring because they have an adequate supply of fresh water.

This section of the Sutton Brook has abundant spawning habitat. The bed is comprised almost entirely of suitably-sized spawning gravel and there are numerous gradient breaks on the river bed which provide good locations for trout to make redds. It would be a useful exercise to walk the brook during the autumn and winter and observe where trout choose to spawn; this would inform efforts to protect these areas and to provide better juvenile habitat in the right areas.

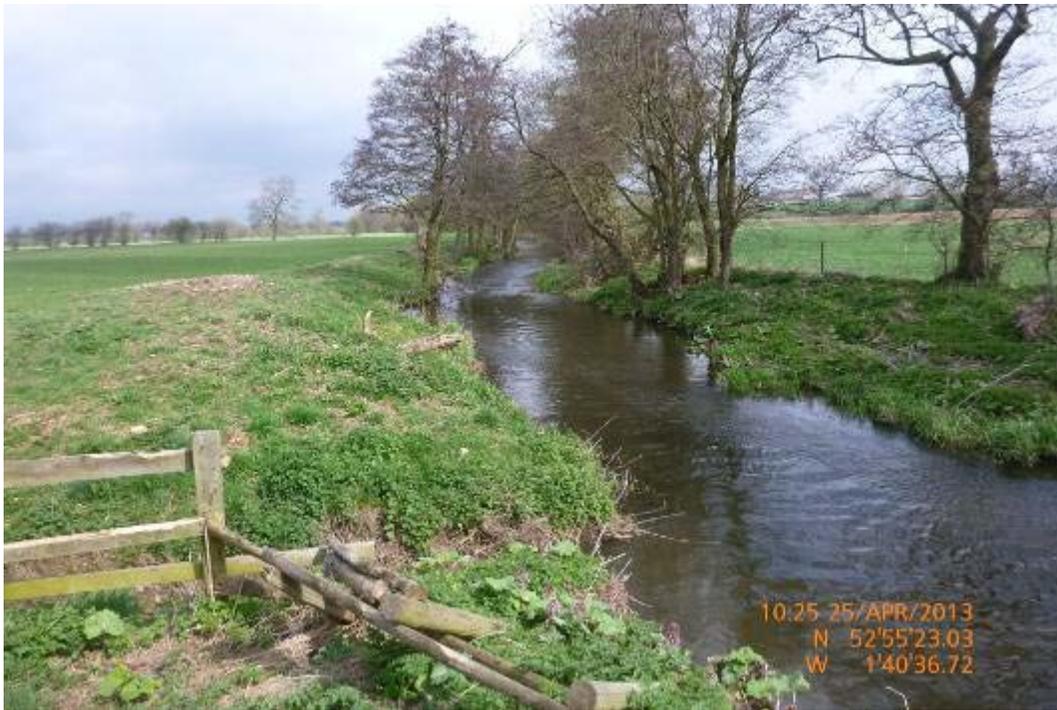
Photo 2 The brook channel has been historically straightened for much of its course and probably dredged in some areas such as this (a gravel spoil bank is present on the true right bank, left of picture). This has caused to a relative lack of pool habitat.

The deeper pools which provide adult trout habitat tend to occur on the outside of meanders where 'lateral scour' takes place, whilst riffles occur in the straighter sections between bends (Figure 2). The number and quality of pools (and riffles) can be heavily influenced by channel engineering and maintenance. For example, straightening the river reduces the number of bends and leads to a shallower, steeper gradient channel, lacking pool habitat (hence holding fewer adult trout). The Sutton Brook appears to have been extensively straightened in the past (probably by the then River/Water Authority), as evidenced by the plan-form on the map (Figure 1) and the presence of bunds of dredged material and a stone toe to many banks (Photos 2, 4). The brook narrowly avoided a major land drainage scheme to lower the river bed in the 1980s (A. Crawford, pers.comm.). More recently a localised area of river has been straightened by the landowner (Photo 3).

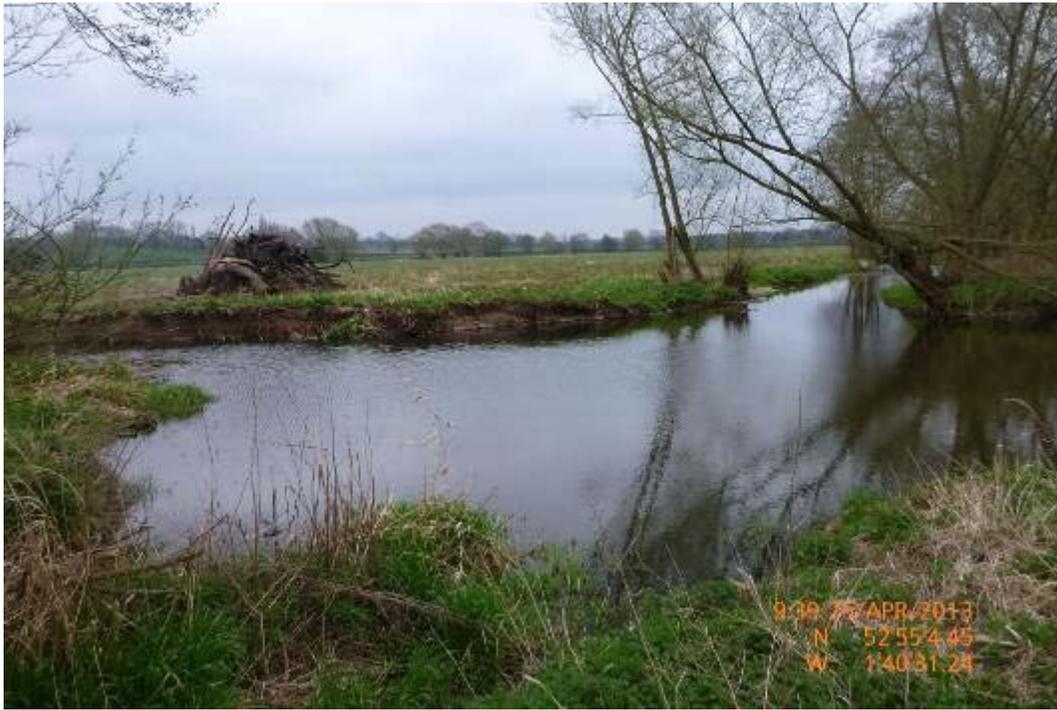
Photo 3 More recent river engineering where the inside of a meander has been removed (far bank), further straightening and over-widening the channel to the detriment of in-stream habitat.

- Avoid further straightening of the river channel to preserve existing pool habitat. Constructive dialogue with the landowner is essential for this and a trial of the soft revetment and tree establishment approach may help.

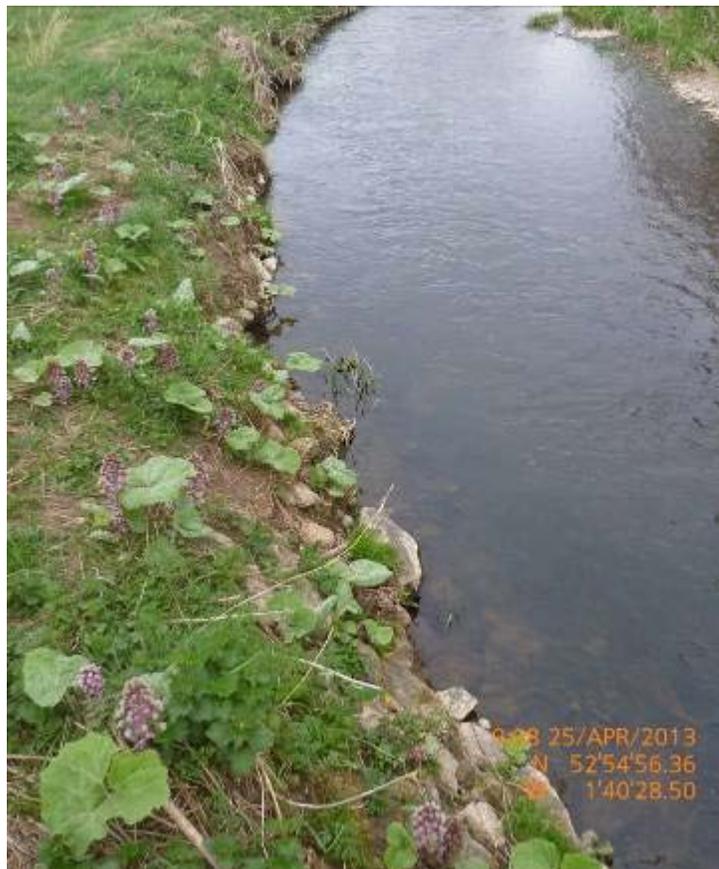
Photo 4 Stone pitching at the toe of the bank – common to many watercourses in this area and dating back to River / Water Authority land drainage works.

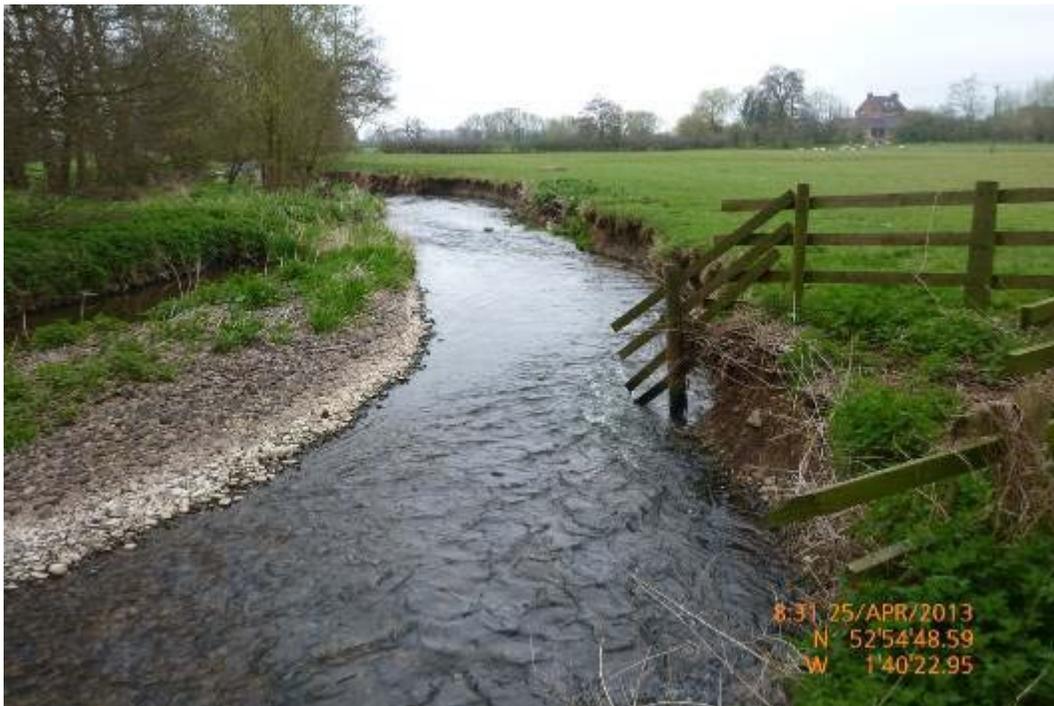
Photo 5 Different land use on each bank resulting in differing resilience to erosion. An ungrazed, uncultivated zone on the left bank with plentiful tree growth provides good erosion resistance and good habitat.

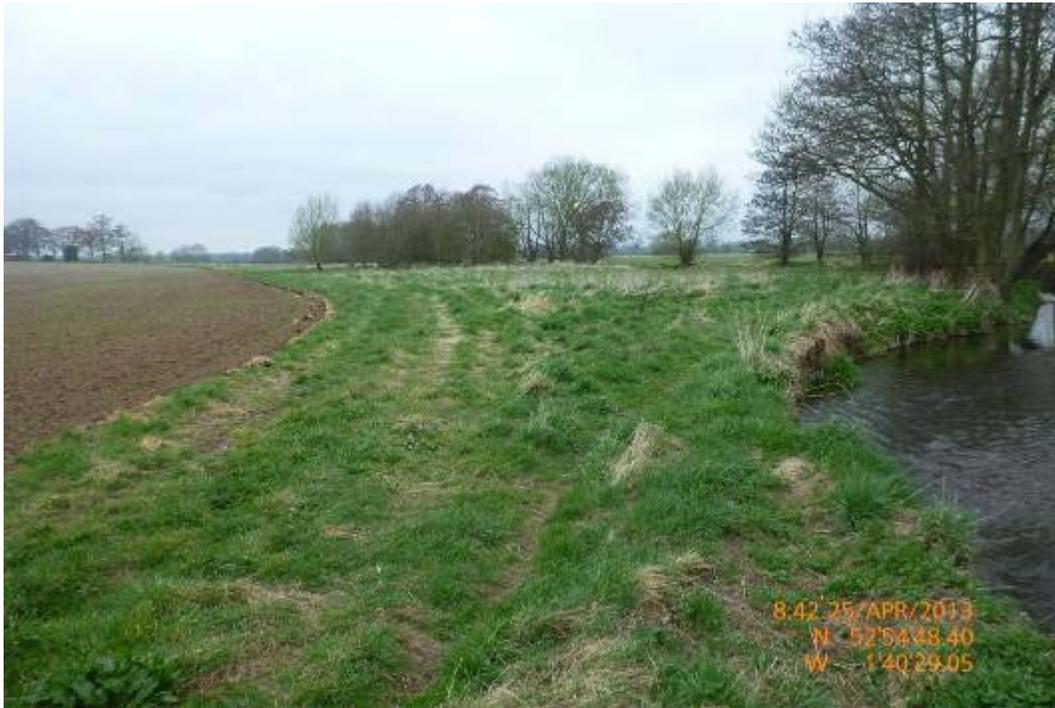
Photo 6 A wide, uncultivated strip alongside the river is very beneficial. Establishing trees within such an area would provide even more long-term protection from accelerated rates of bank erosion.

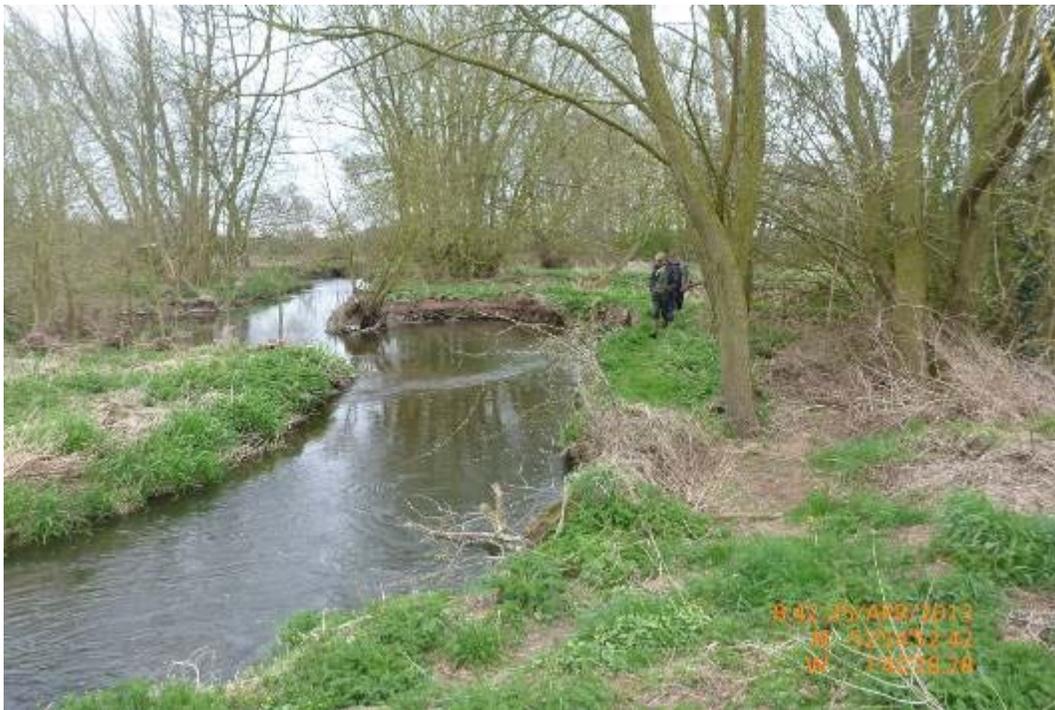
Photo 7 The ideal river corridor – a wide buffer zone of uncultivated land with plentiful trees, providing good bank resilience and good habitat. If protected from grazing, the trees could be rotationally coppiced to provide materials for bank protection works or firewood.

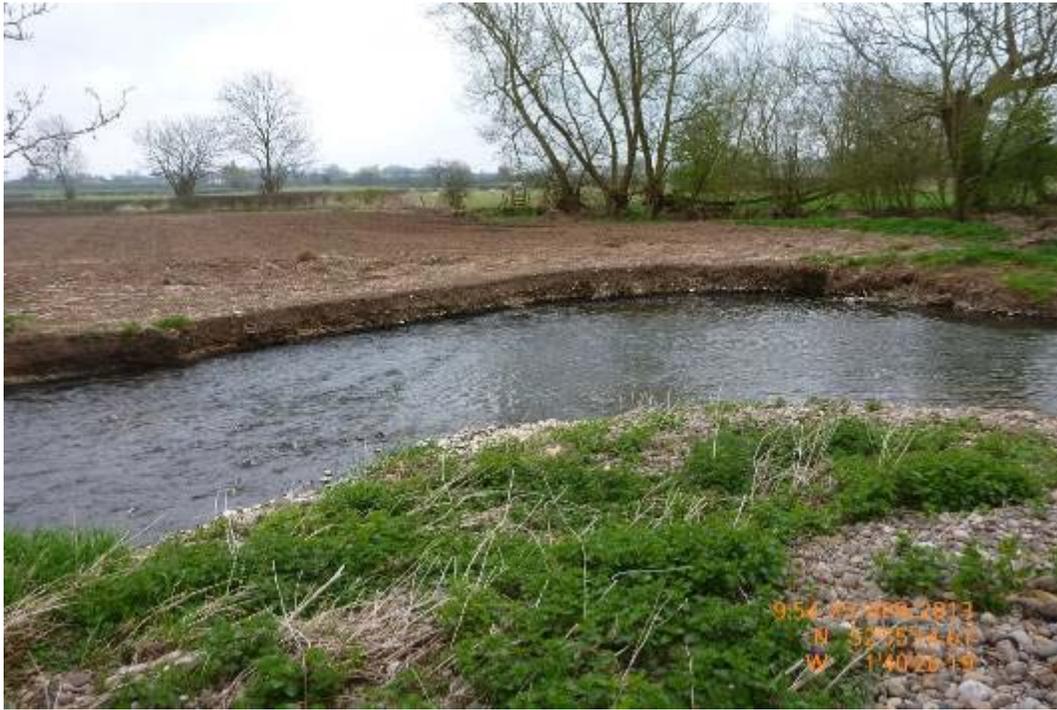
Photo 8 The absence of any kind of buffer zone between the river and agricultural land here is leading to greatly accelerated rates of erosion. This bank needs protection with brushwood revetment and a wide, uncultivated field margin establishing.

- Extending the good management of the banks that is currently taking place to the whole of the stretch. This includes a wide buffer zone between the river and fields, ideally where trees are allowed to establish (or be planted).
- Carrying out 'soft' revetment using brushwood against eroding banks (Photo 12). This technique has the advantage of both slowing the rate of erosion and providing very good cover for juvenile fish (see www.wildtrout.org/sites/default/files/library/TJ%20Looking%20after%20you%20ngsters18-19%20SALMO%2011.pdf).

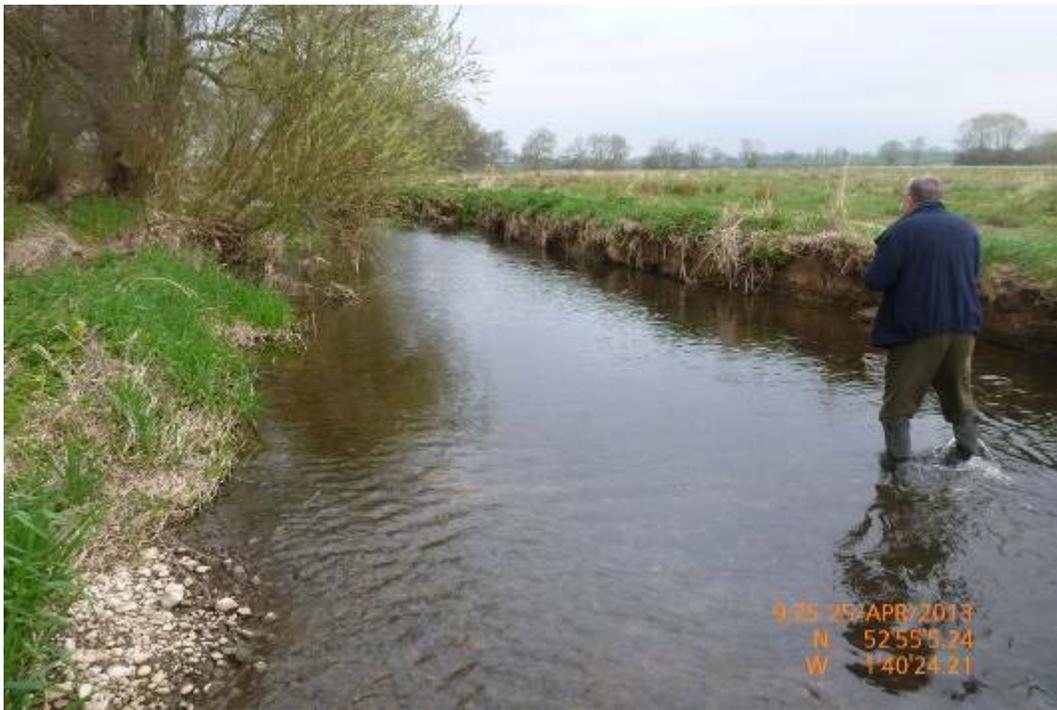
Photo 9 Another example of the differing land management on each bank and the resulting effect on stream habitat. Land managed as woodland on the left of picture creates a soft, vegetated margin, whereas the treeless, grazed bank on the right has a steep earth face which provides little trout habitat value.

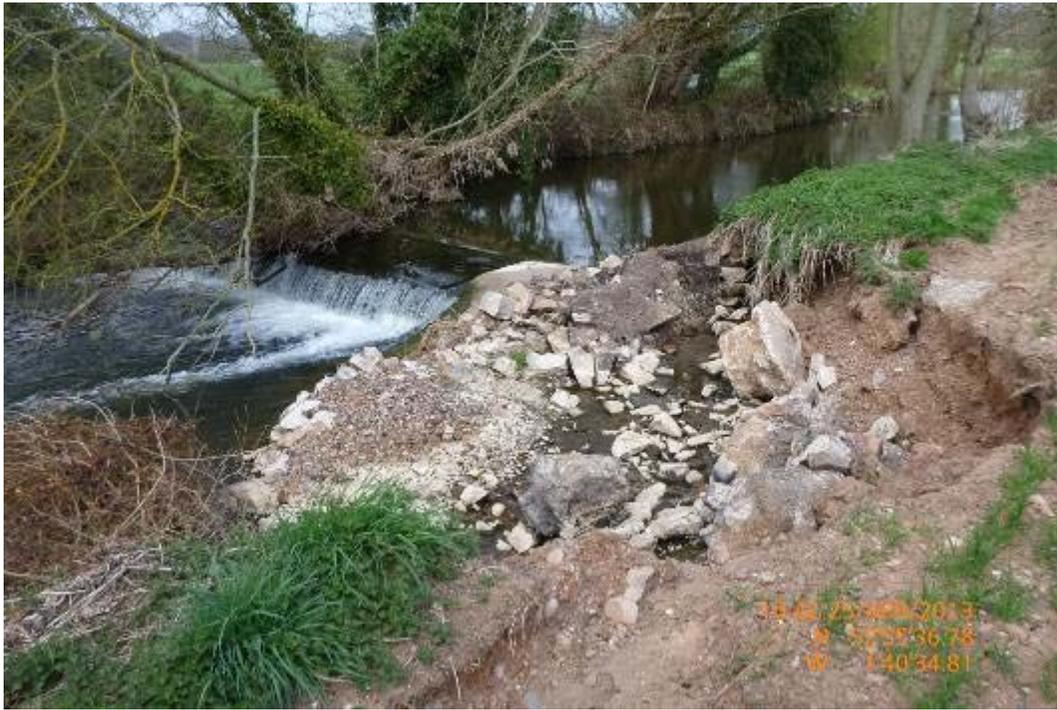
At the upstream end of the reach visited are two weirs. The lower has been breached by erosion to the left bank and partially repaired. Whilst weirs may provide some attractive habitat in a localised area downstream of the structure, this is at the expense of the habitat upstream where flow is impounded and sediment settles out (See www.wildtrout.org/sites/default/files/library/weir%20experiment%20comp.pdf). Weirs are also a barrier to the free movement of fish, for example preventing access to upstream spawning grounds. As in this case, weirs are prone to failure and washout around the side of the structure; if the head of water impounded by the weir is no longer needed, the best course of action would be removal.

Photo 10 Breached weir – removal of the weir is probably the best option here.

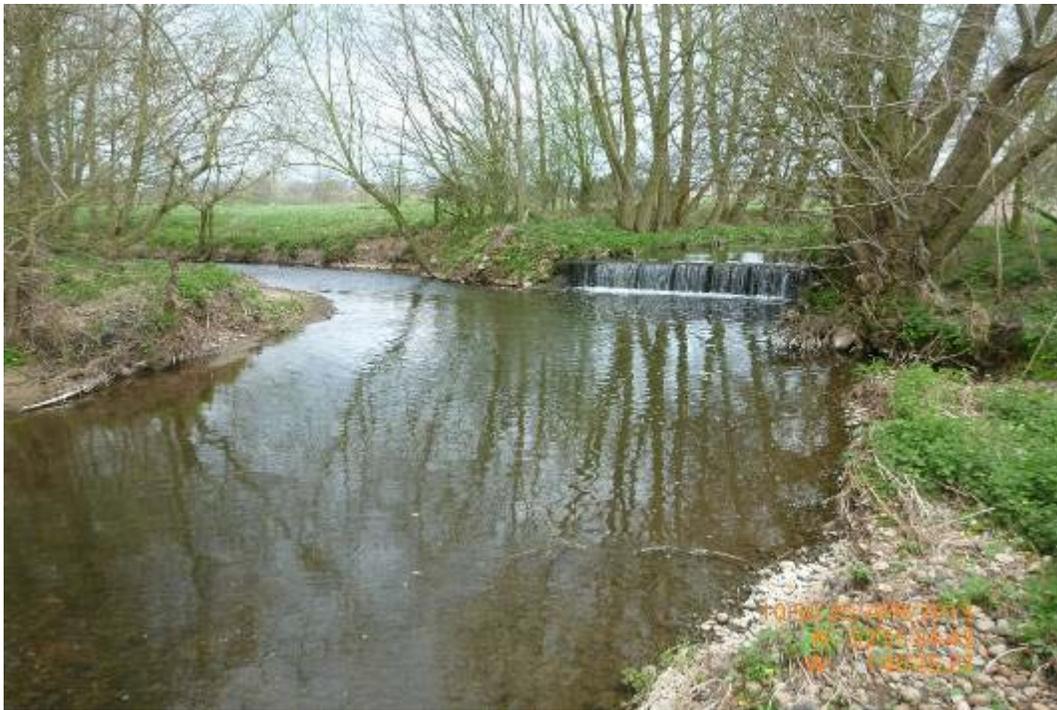
The upstream weir is located at the confluence of two channels (SK218368), the left (east) channel falling over the weir to join the right (west) channel. These channels originate from the mill pond at Longford, the right channel also containing the flow from the Alkmonton Brook. Further investigation of upstream water levels and flow diversions would be required before any alteration to this structure could be contemplated; also the benefits for fish passage would be limited unless the barrier presented by the mill pond at Longford was also considered.

Photo 11 Weir at the confluence of two channels near the upstream extent of the visit.

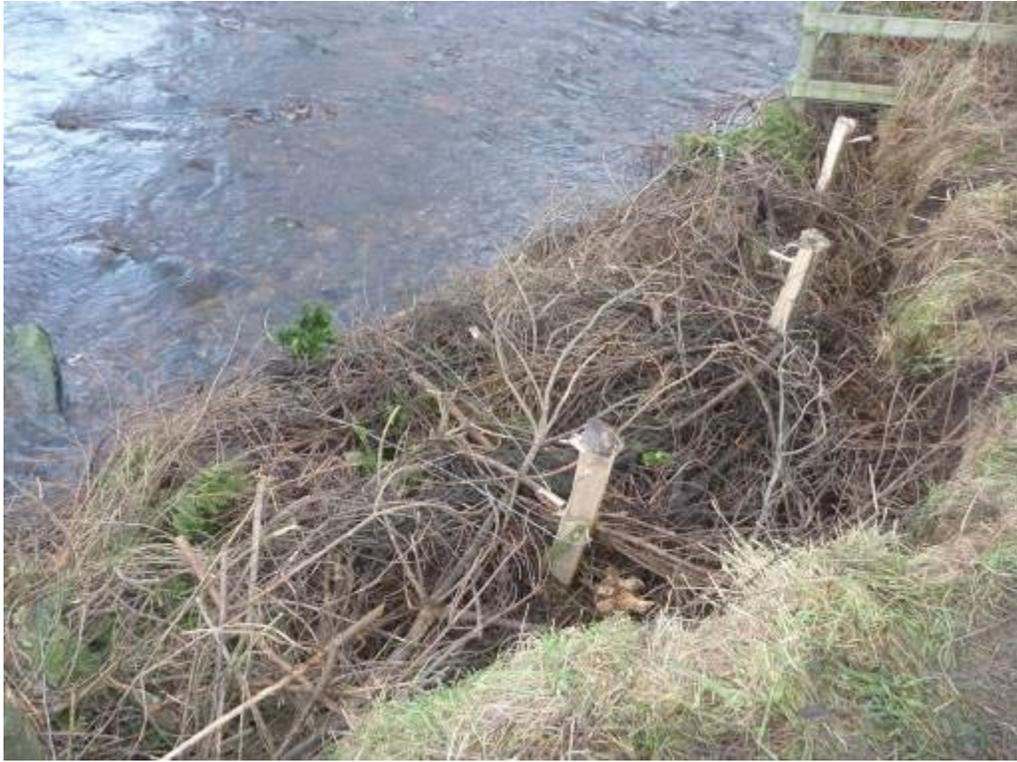
Photo 12 Example of brushwood revetment.

The brushwood forms a matrix which absorbs the energy of the flow and encourages deposition of sediment, allowing the bank to consolidate and vegetate. Combined with the creation of buffer zones and tree establishment (Figure 3), this approach could greatly improve bank stability, habitat quality and reduce land loss.
