## **Tadnoll Brook (Dorset Frome Catchment) Warmwell Estate**

**An Advisory Visit by Nick Lawrence on behalf of the Wild Trout Trust  
January 2016**

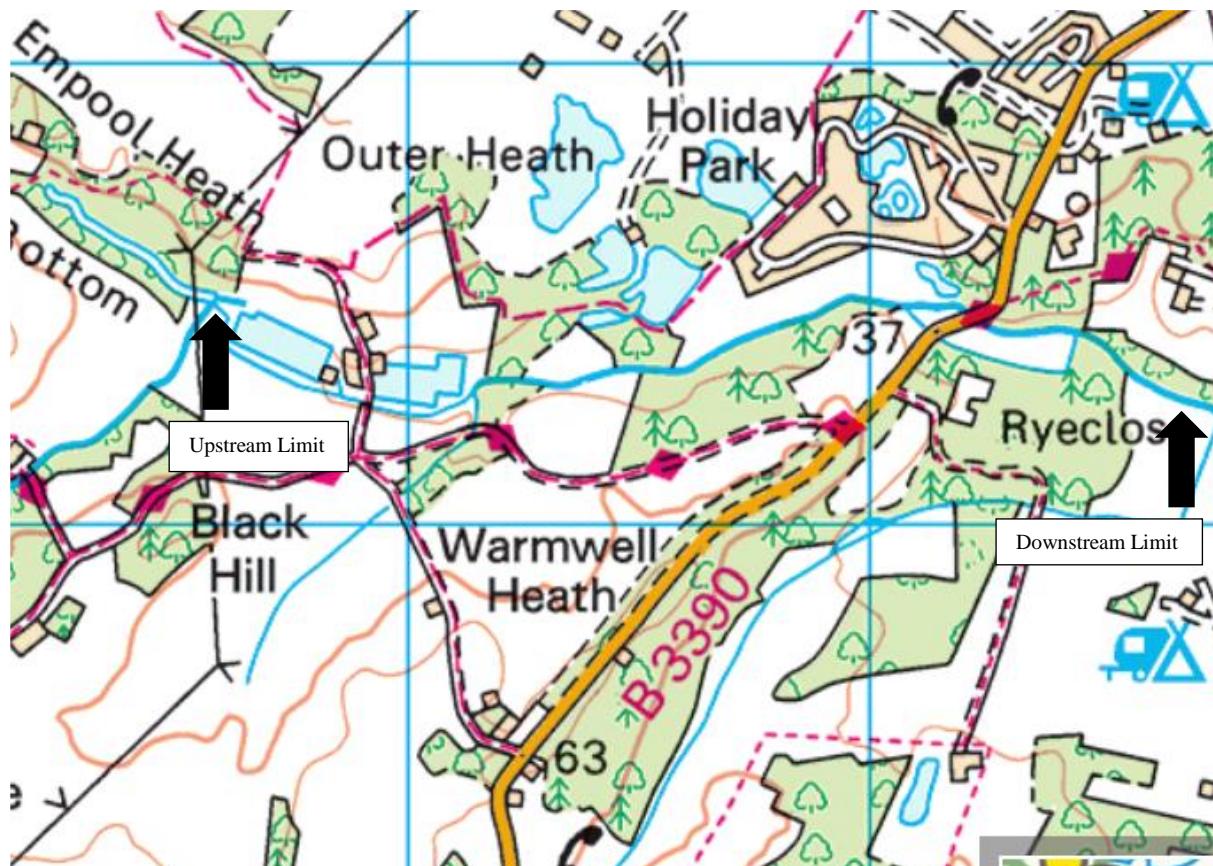
Map 1 Warmwell Estate stretch on the Tadnoll Brook.

The Warmwell Estate reach lies just downstream of West Knighton. It is approximately a mile from the source. The upstream boundary of the fishery is just above Warmwell Mill watercress farm [SY7458675](#) and runs around the watercress farm then down into an oasis of heathland and woodland, finishing just upstream of Moigne Combe at [SY767872](#).

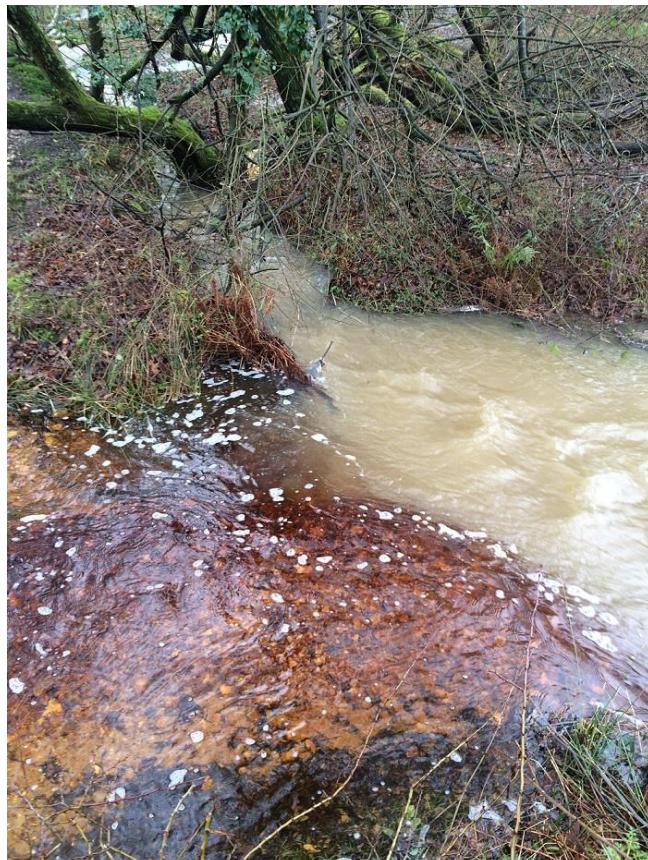
Photo 1. Heathland water (left) meets run off from roads and agriculture on one of the feeder streams to the Tadnoll Brook. (right).

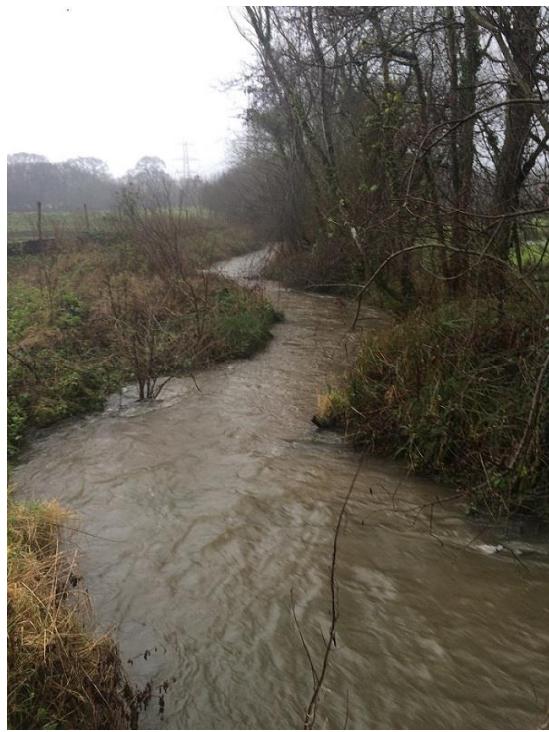
Photo 2. Unmodified beautiful meander amongst woodland.

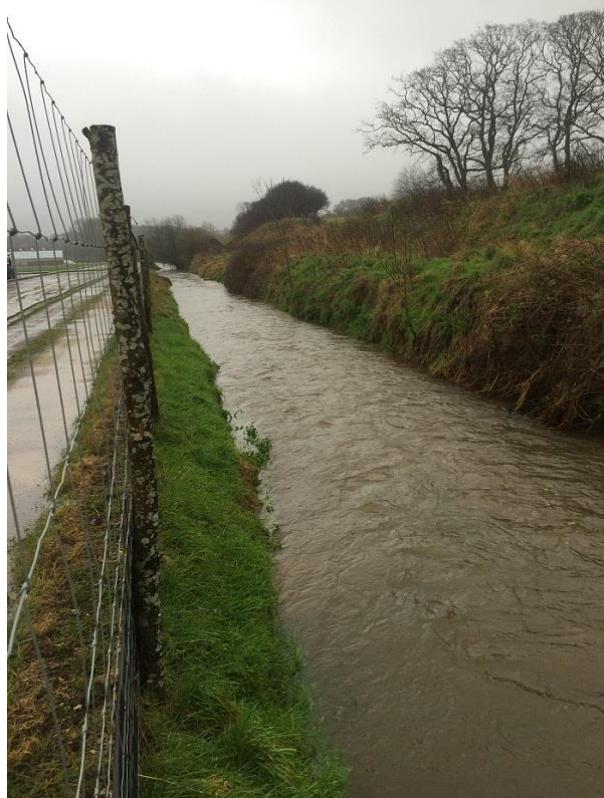
Only 100 yards below this fantastic example, is heavily modified channel, which has been canalised for the watercress farm at Warmwell Mill (Photo 3). This section could be improved fairly easily with an introduction of staggered woody debris, to kick the flow around and locally scour the riverbed.

Photo 3. Heavily canalized channel due to the industrial nature of the watercress farm.

- To complement the weir removal, large woody debris could be installed into the canalised section above to accommodate the new flow regime. If the watercress farm has an issue with this, some short stub deflectors to create pinch points and some raised logs to provide undershot/ overshot scour would be beneficial. On the right bank encourage some more low scrubby covers to make up for the lack of cover on the watercress farm bank.

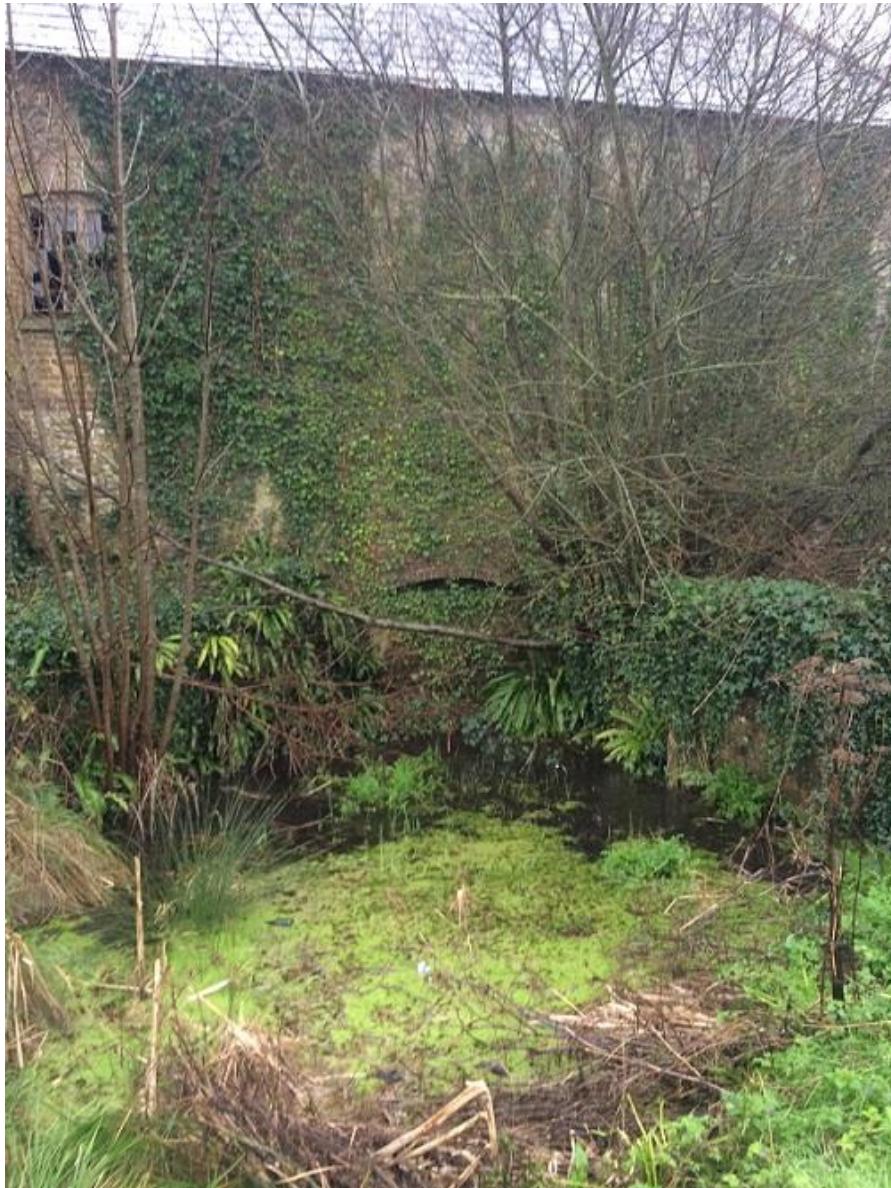
There was evidence that the river used to flow under Warmwell Mill (Photo 4), but as the watercress farm has expanded, it is possible that the channel was moved as it interfered with the farming. The farm is 12 acres in size and would have had some negative effects on the little brook over the years with channel modification and effluent most notably from phosphates.

Photo 4. Warmwell Mill, is this the historic course of the river?

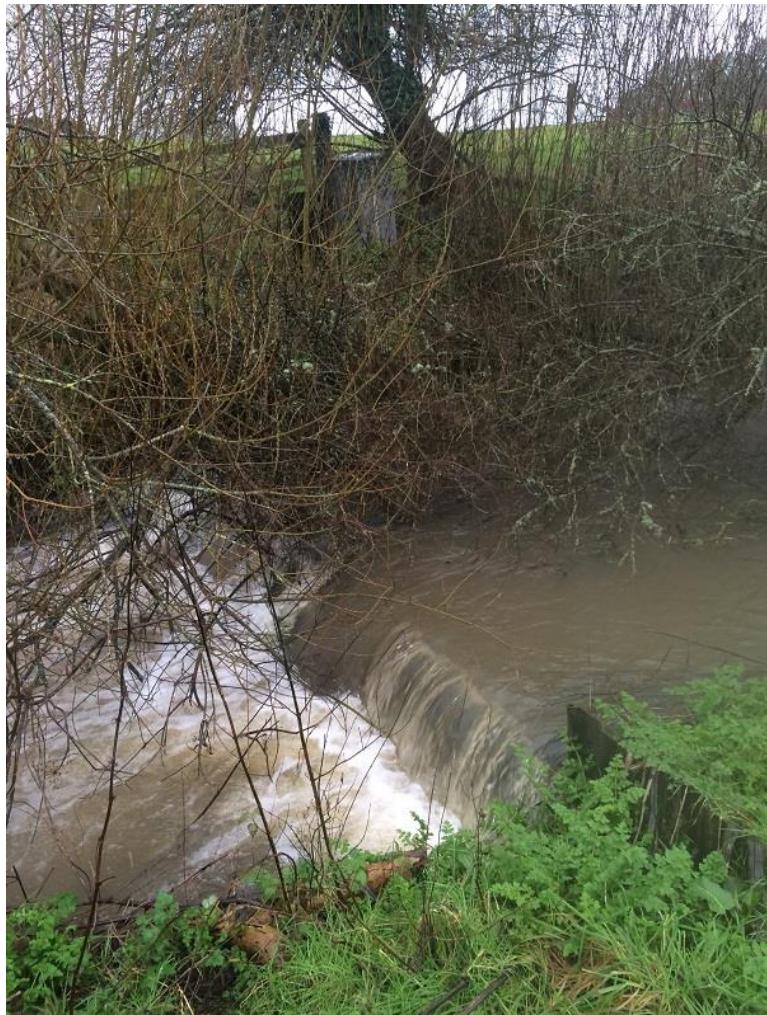
As well as the canalisation of the river, there is a large steel piling structure (Photo 5) near the bottom of the watercress farm. This is impounding the flow and also impeding fish movements; if removed, it would reinstate fish passage and definitely improve the habitat of the section above, though its current function (if any) would need investigation.

**Photo 5. Steel piling weir, impeding fish movements and impounding flow.**

The Warmwell Estate reach of the Tadnoll Brook has fantastic potential in terms of habitat. However, there is one significant impoundment by the watercress farm at the top end of the fishery (Photo 5). This could drastically change the reach above (Photo 3) if this structure was removed and also improve fish passage, with the addition of woody debris in the canalised section adjacent to the cress farm to accommodate the new flow conditions. This could be a small and very worthwhile project.

- The steel piling weir towards the top of the reach should be removed to allow free fish movement and improve the habitat upstream. This is as long as there is no reason for it still being there.

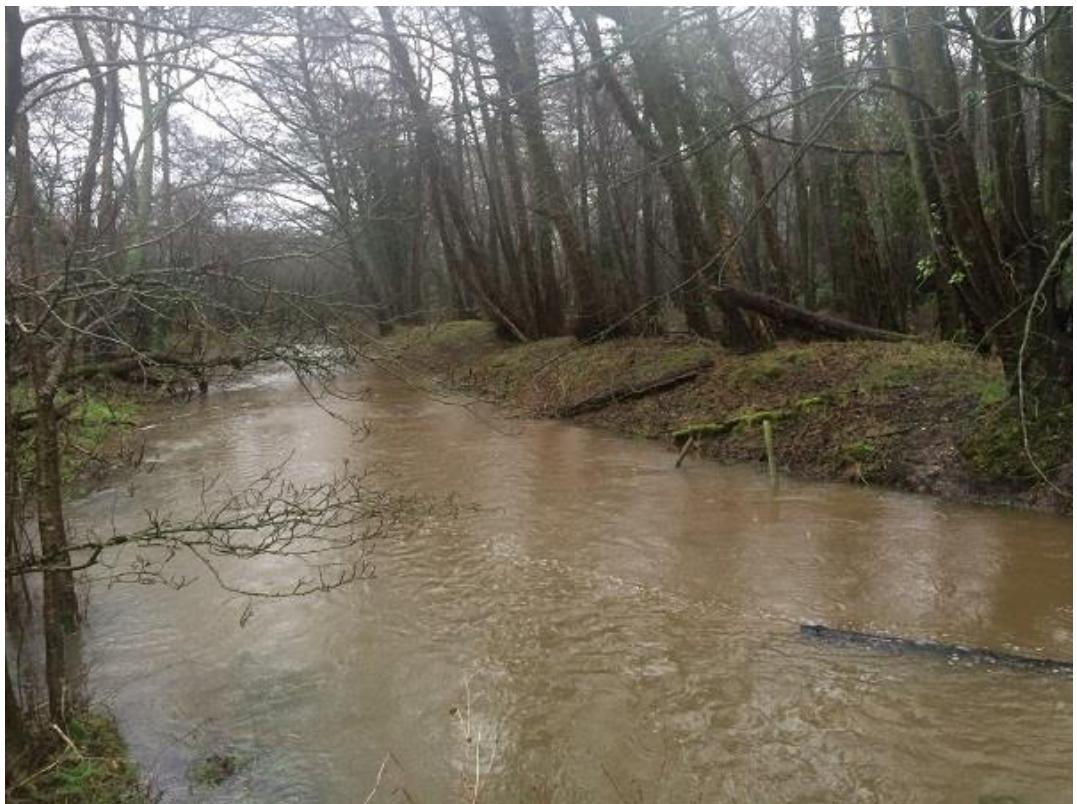
Directly downstream of the watercress farm there is a lovely wooded section that is habitat rich in terms of naturally occurring woody debris, there are a few sections that are heavily shaded (Photo 6 and Photo 7, but as a whole this isn't an issue as there is plenty unshaded areas to compliment the shaded areas. A coppicing action plan is needed in some selected areas to give the brook back some much needed light.

Photo 6. The reach directly below the watercress farm. Great natural woody debris but heavy shading on the right bank.

- Consider a coppice management plan to ensure that much needed light is brought to the shaded sections, especially on the southern bank. This could be on a 10 year rotation, coppicing 10% each year to retain a good ratio of direct sunlight to dappled shade.

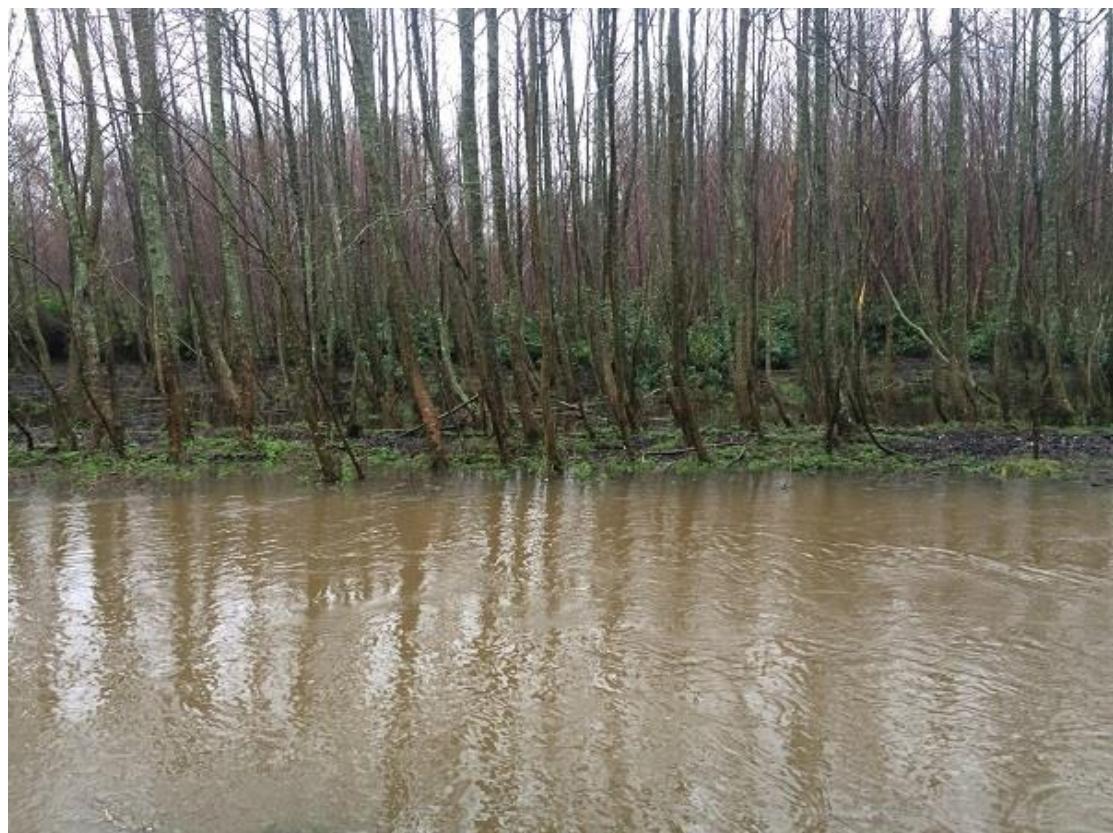
Photo 7. This area requires some re-coppicing, again heavily shaded on the south side of the brook.

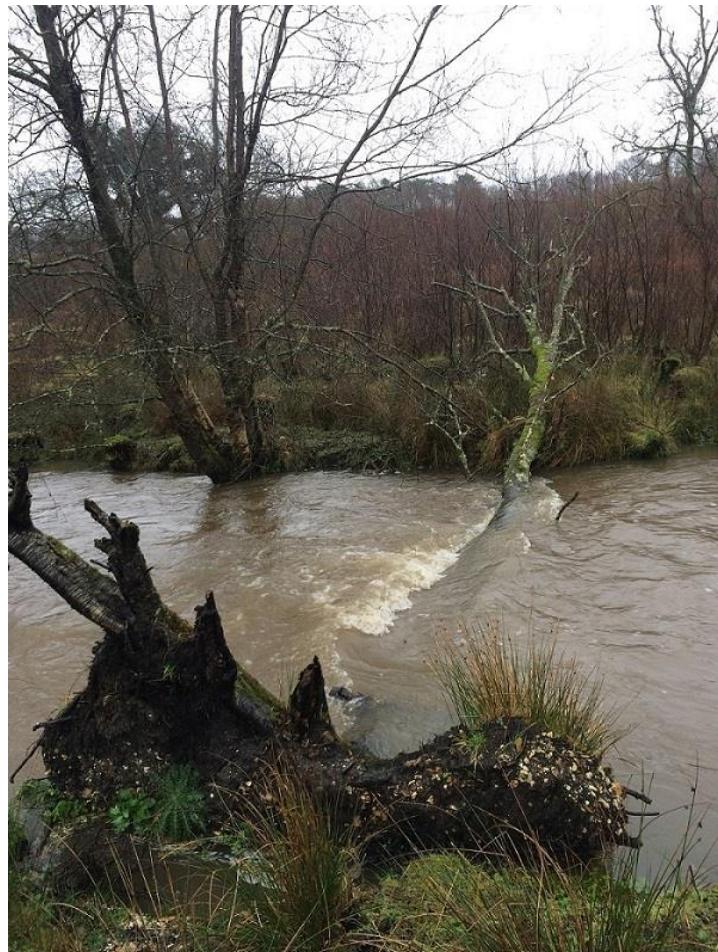
The lack of management of these wooded sections has led to some interesting habitat features of fallen wood and collapsed willows. These features (although the full effect couldn't be seen on the day due to the weather) will definitely be having a positive effect on the river. Natural fallen wood, as seen in Photo 8, can produce valuable scouring and sorting of gravels. The scouring will create different habitats for a greater diversity of invertebrates as well as giving the river bed a variation in depth, creating pools for adult trout to lie in. This scour and sort will also give good oxygenating potential spawning habitat for fish.

Photo 8. This is one of many fantastic examples of fallen woody debris. It will be producing a good scour and sorting of gravels downstream.

- Continue to employ light touch management, e.g. leave fallen trees in the river if they are not impounding the river or causing excessive bank erosion. If a fallen tree does fall in a place where it might cause a problem, simply adjust its placement into a more favourable position and secure it with posts and wire to retain the ecological (and fishery) benefit. Information for work like this can be found on the WTT page.  
[http://www.wildtrout.org/sites/default/files/library/Large\\_Woody\\_Debris.pdf](http://www.wildtrout.org/sites/default/files/library/Large_Woody_Debris.pdf)

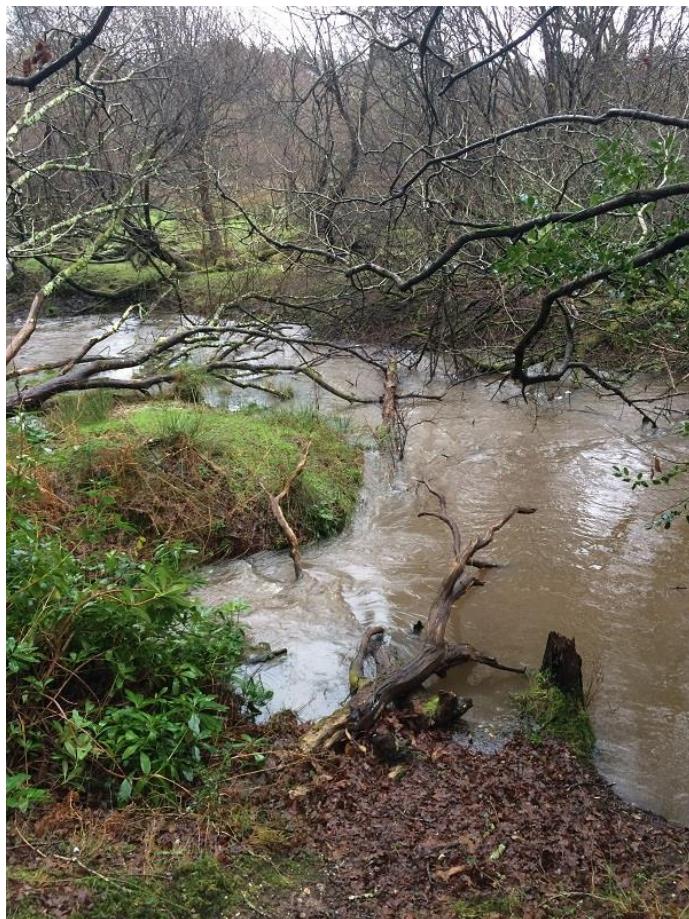
Photo 9 sums up the advisory visit in terms of naturally occurring woody debris. The photo details a tangled matrix of woody debris, diversifying the flow and sorting river gravels. These areas are perfect places for all ages of trout. The brook here has a naturally braided channel; the island can be seen in the picture too. This is how the majority of our rivers would look without human intervention.

[Photo 9. A prime example of naturally occurring woody debris, a gift from nature!](#)

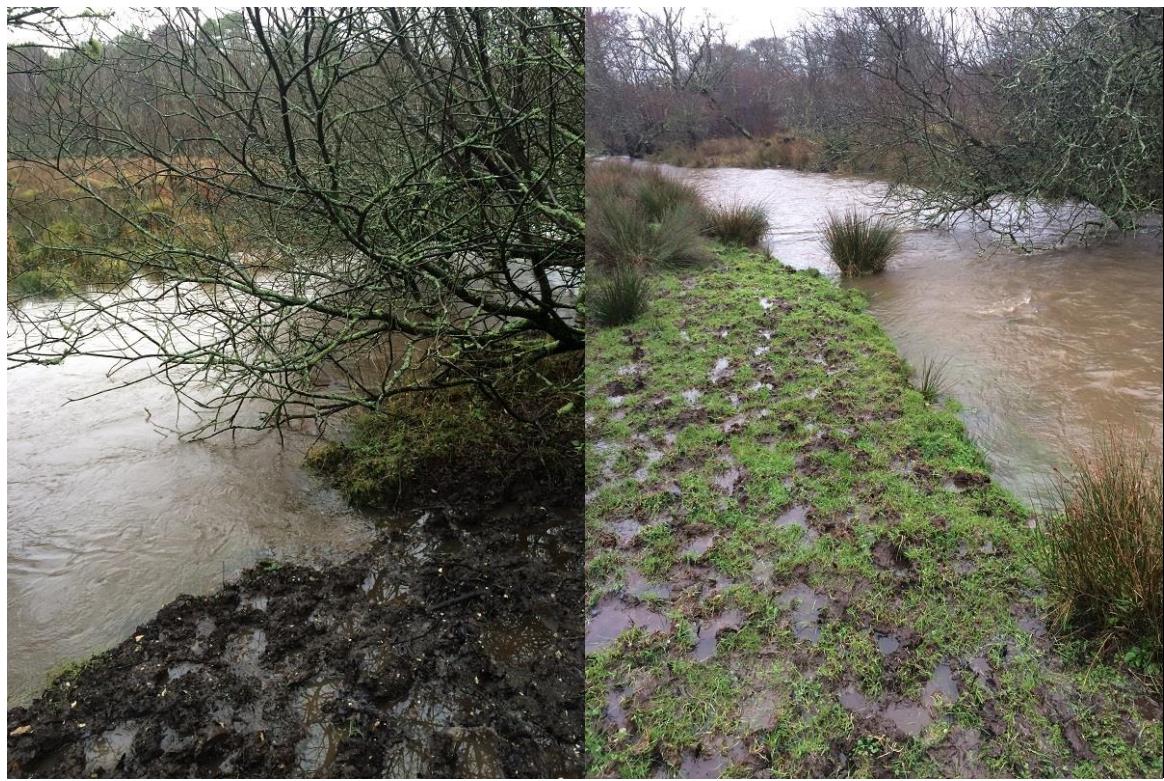
One of the biggest issues of note is that the river is not fenced, which has led to some bank erosion from cattle poaching (Photos 10 / 11). There are areas which are unaffected (within the woodland), but for the majority, where it is open ground, there is heavy pressure from livestock access. This overgrazing and poaching leads to fine sediments washing into the brook and can be a reason for a decline in salmonid recruitment. Cattle grazing/ poaching in these unshaded areas has also led to poor marginal plant growth and will progressively widen the brook as the banks are trampled. Disturbance from heavy grazing livestock can produce an overall increase in biodiversity, but here there is excessive pressure on small areas, to the likely detriment of the brook and its wildlife.

Photo 10 & 11. Strong evidence that the banks are heavily used by cattle (leading to little or complete cessation of marginal growth in the unshaded areas).

- Explore the possibility of stock fencing with a large buffer area 20 metres wide, if 20 meters is too large the minimum would be 5 metres. It was mentioned that the grazing was needed both sides of the brook, so cattle crossing points might need to be incorporated; these can double up as drinking areas. If not, then the possible use of pasture pumps to ensure adequate watering for stock (photos 14 and 15).

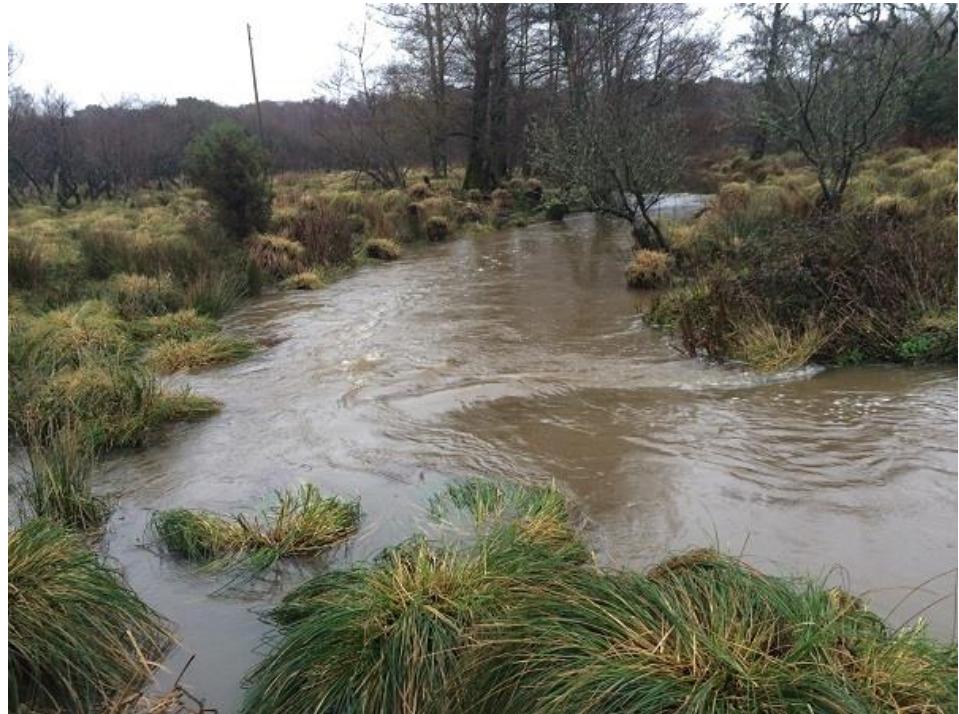
There are still areas unaffected by cattle poaching, but they are towards the bottom of the fishery (ref to Photos 12 / 13). These areas show how a fenced buffer area could be a potential way forward for restoring more natural and diverse marginal and riparian vegetation along the Tadnoll Brook. Of course fencing will need a provision for drinking areas and/or crossing points. This will create work for the estate with the upkeep of the fence and the area inside it.

Photo 12. A beautiful natural meander with a pinch (possibly due to large woody debris that can't be seen) with lush marginal growth.

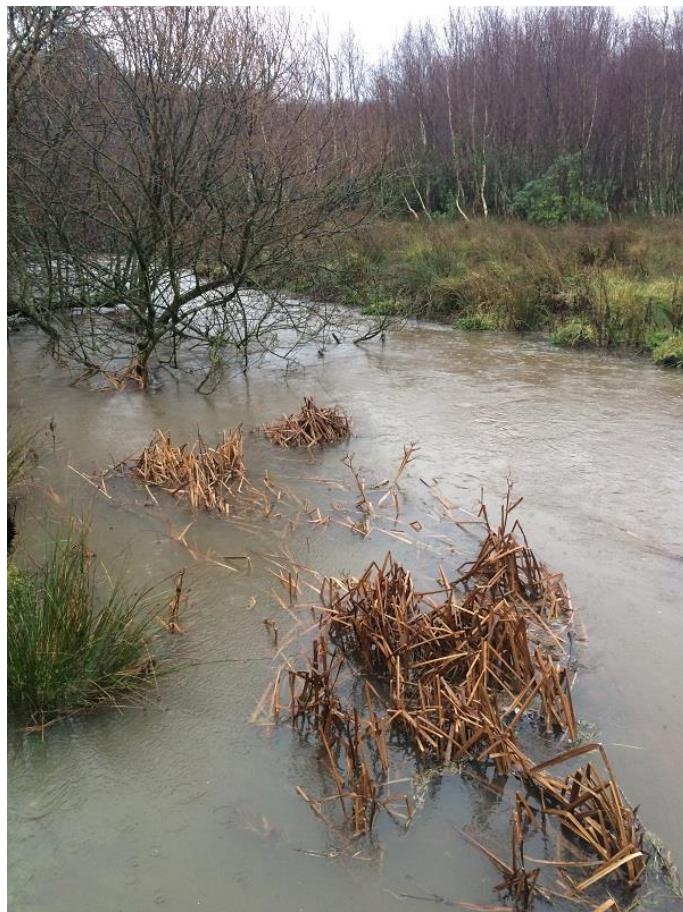
Photo 13. A rare reed bed margin, lack of habitat like this is possibly due to shading and cattle grazing.

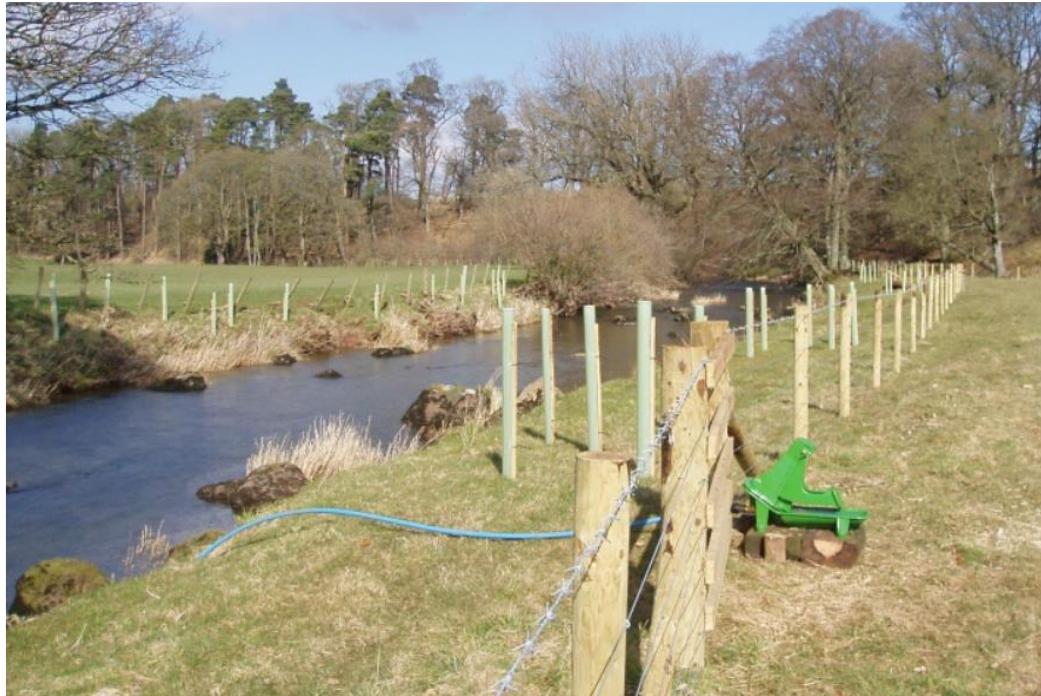
Photo 14. An example of a pasture pump on the river Lyvennet in Cumbria

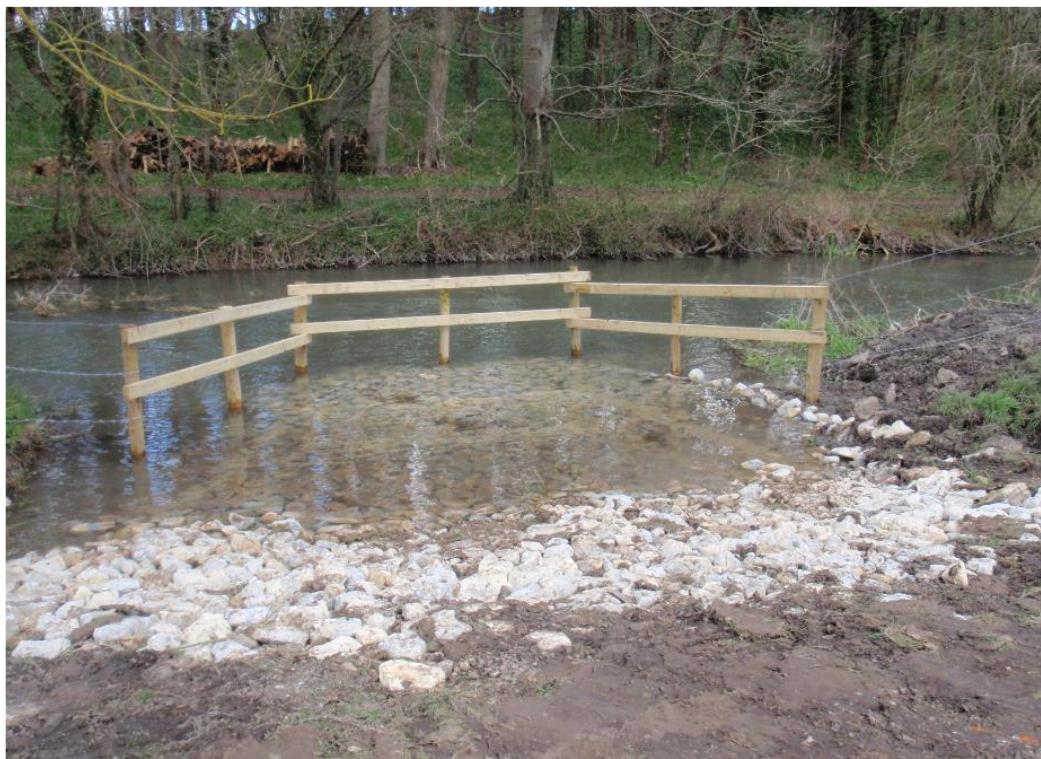
Photo 15. An example of a fenced cattle drinker on the river Coln in Gloucestershire.
