Advisory Visit

Tapster Brook, Preston Bagot, Warwickshire

15th June, 2009

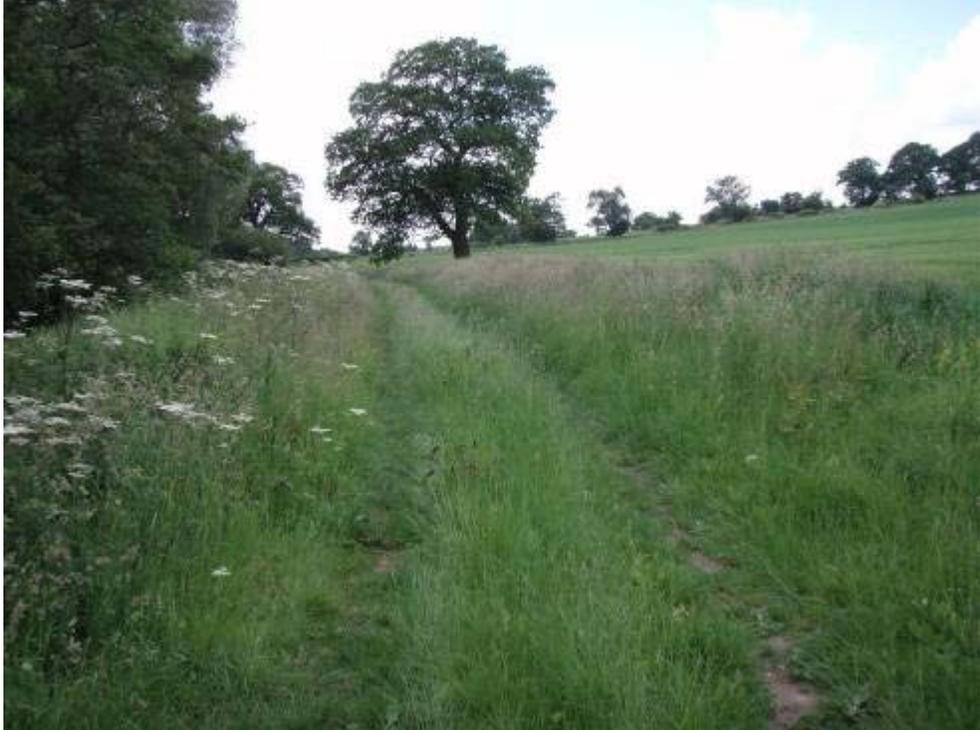
Photo 1 Sensitive land use alongside the brook via Countryside Stewardship – a wide, grassy margin between the field and brook.

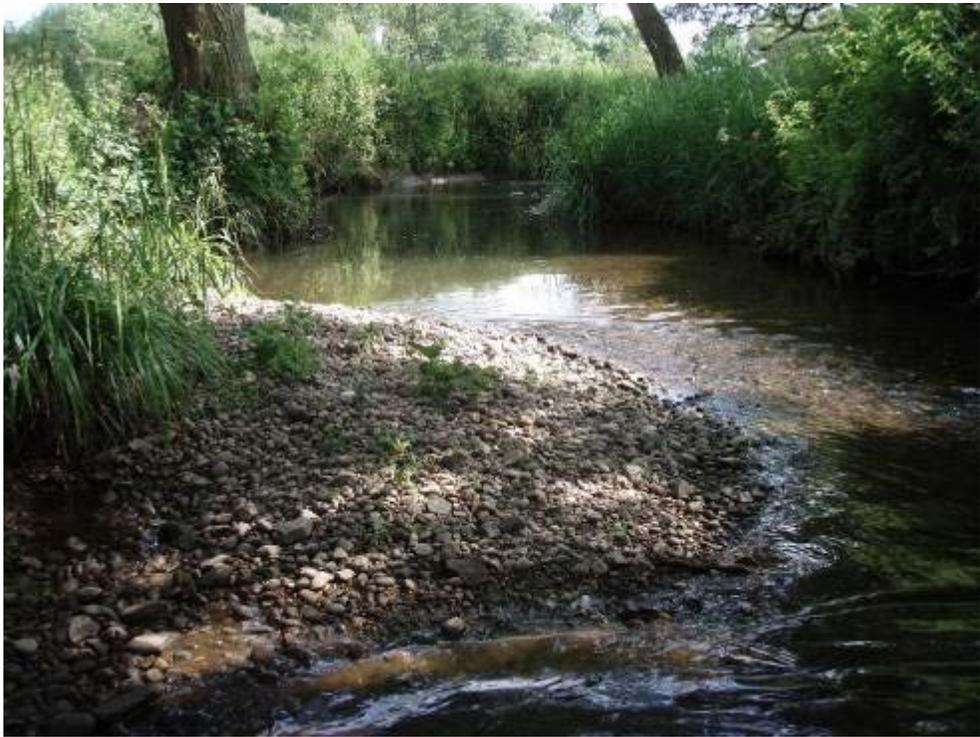
Photo 2 Excellent natural instream features – pool, riffle and gravel side bar

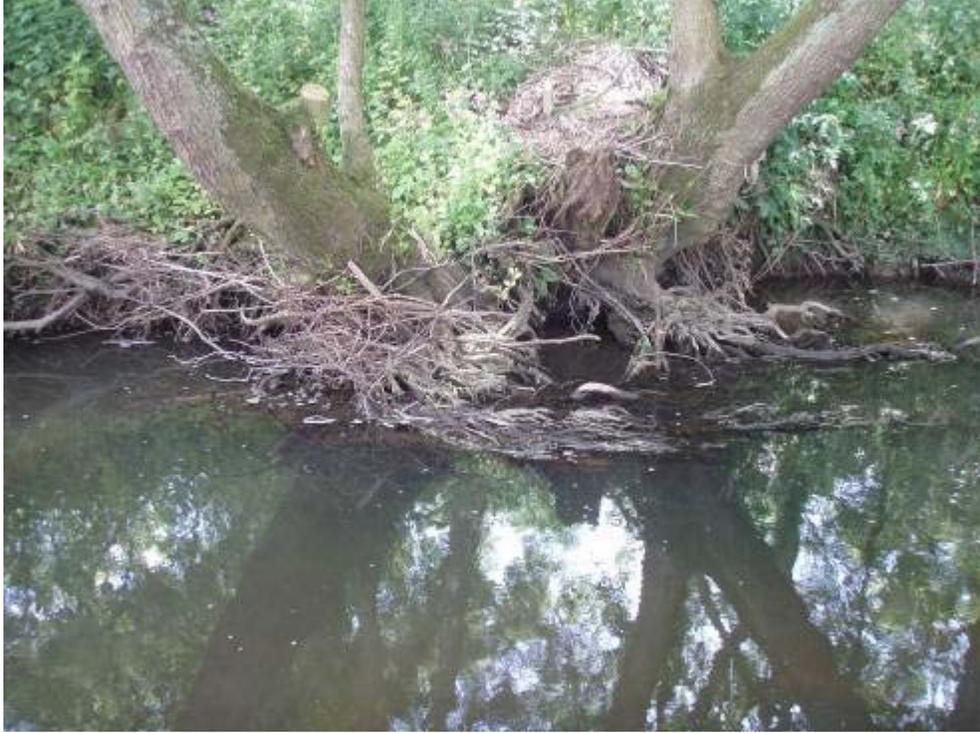
Photo 3 A tangle of submerged tree roots provide vital cover for trout – excellent habitat

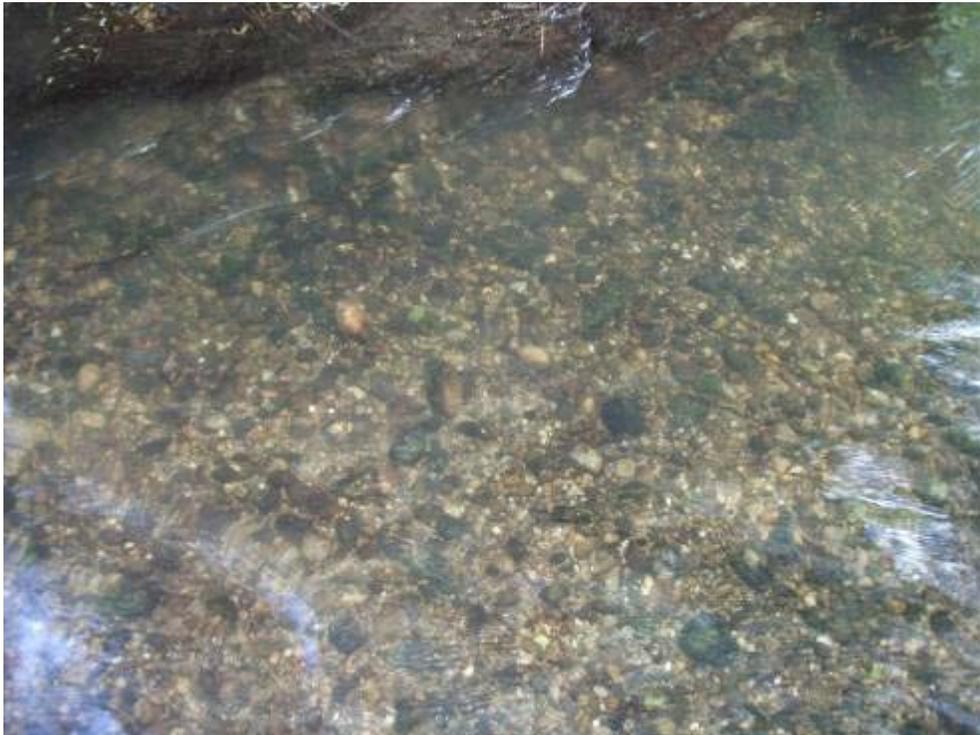
Photo 4 Good quality gravel suitable for trout spawning

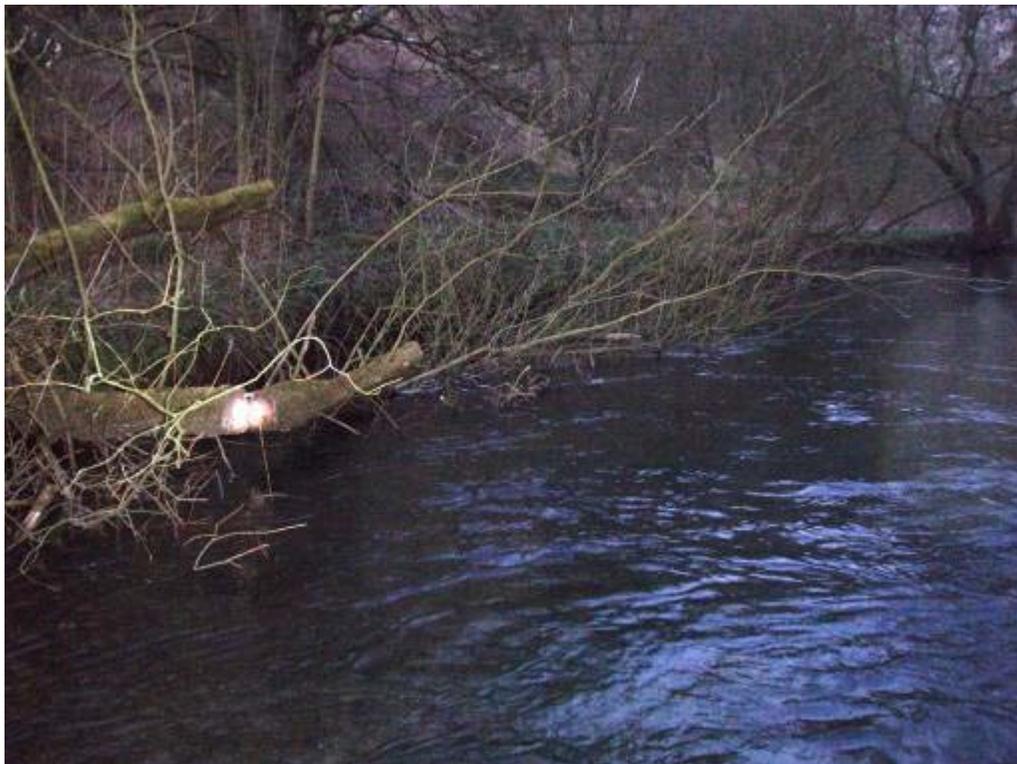
Photo 5 Willow hinged and staked alongside the bank (R. Wye, Derbyshire)

The reason why some pools hold trout whilst others don't was discussed and it seems that the key factor is the presence or absence of cover. Pools with submerged alder roots or undercut banks are favoured by adult trout, whereas areas of a similar depth but lacking in cover tend to be avoided. There are ample opportunities for improving this situation by 'hinging' tree trunks or branches into the water, or staking tree trunks in position alongside deeper water.

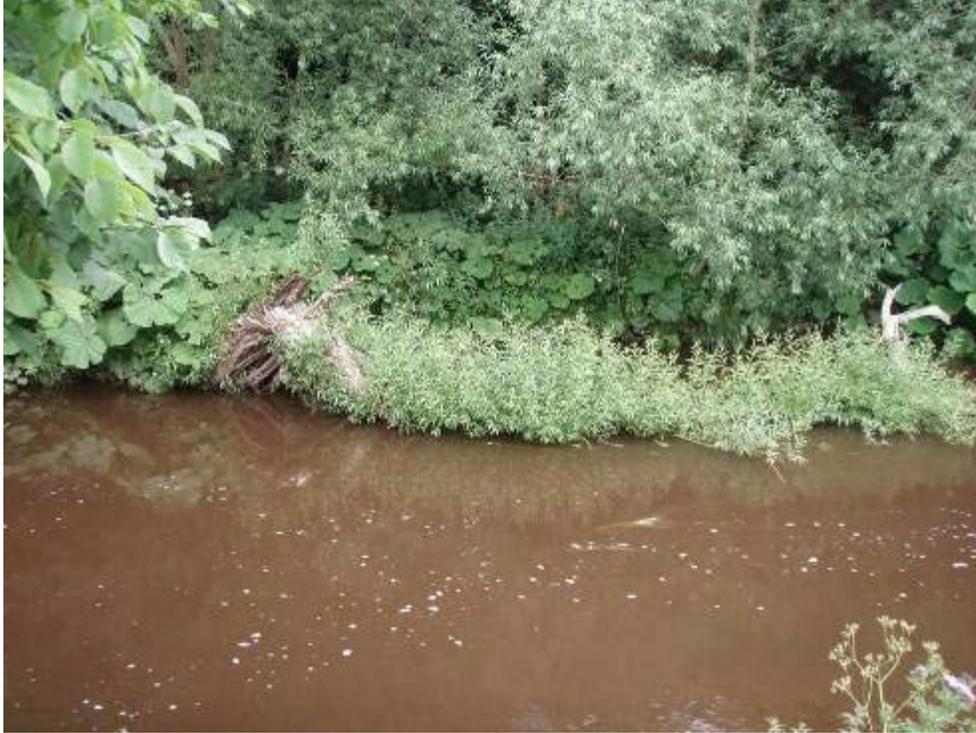
Photo 6 Good example of a willow still attached to its stump, but laid along the bank providing great cover for fish (R. Dane, Cheshire).

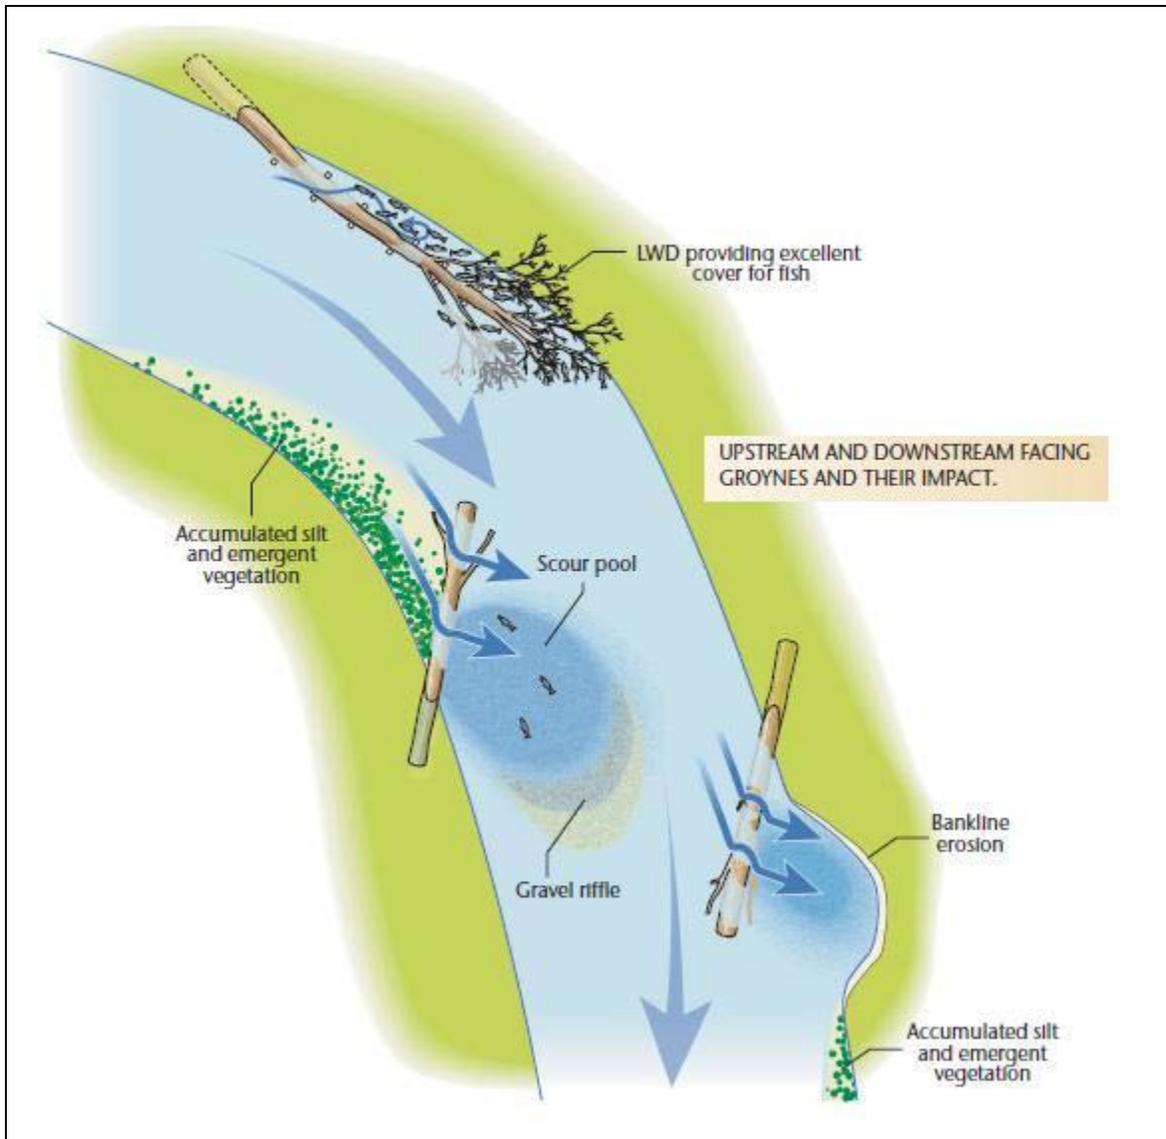
Commander Onslow has considered removal of this weir, and this would benefit the brook overall by re-energising the section upstream. In the short term (1-2 years) the river bed would regrade, and become narrower and deeper; over a longer period the channel may become more sinuous as meanders start to re-develop. This could be promoted by using flow deflectors to create scour of the river bed and/or banks (see Figure 1 for the effects created by differently positioned flow deflectors).

Although downstream pointing deflectors are generally not recommended because they promote bank erosion, they could be useful in this situation. The hard clay banks here seem quite resistant (see Photo 9 where a broken weir structure has obviously deflected flow against a bank for some time), so the use of downstream deflectors could help to recreate meanders on the straightened section, ultimately leading to lateral scour pools and riffles (similar good habitat to that present downstream).

The selection of trees for felling should be done in conjunction with plans for introducing LWD to the channel, for example to recreate the effects in Photo 17, or provide structures such as those in Figure 1.

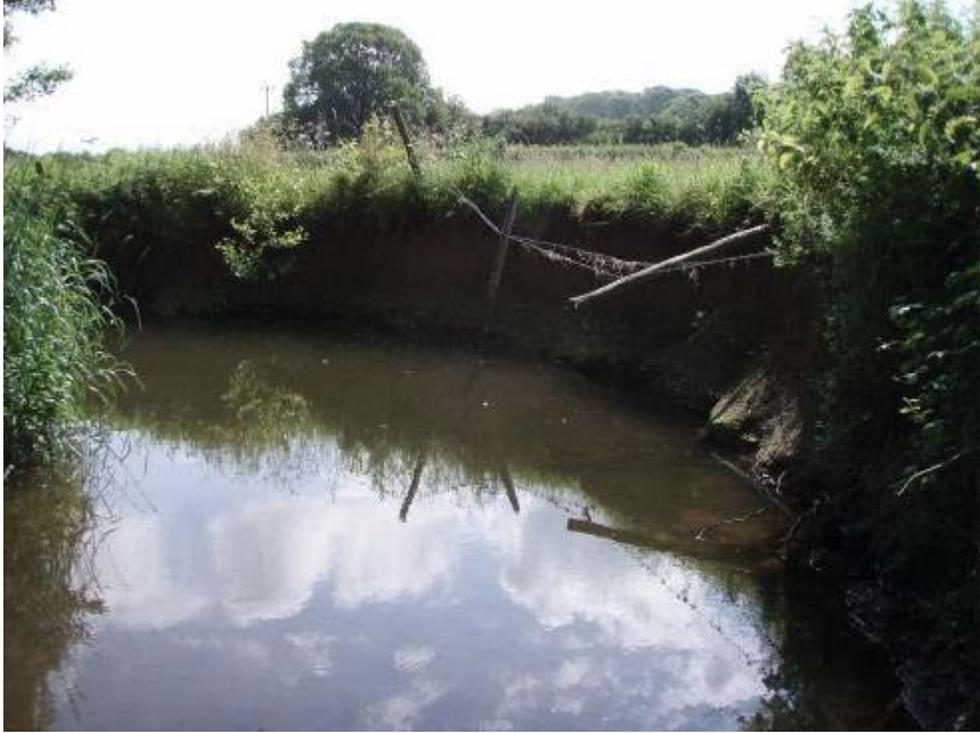
Photo 7 Pool where installation of LWD and brushwood bundles on the outside of the bend would be beneficial, providing cover and erosion protection

- Install cover logs alongside deeper water by hinging tree trunks and branches and pinning them to the bed and banks. Brushwood bundles (faggots) made from hazel coppicing could also be used to provide cover and protection of eroding banks (e.g area in Photo 7). Good examples of techniques and principles can be found in the Chalkstream Habitat Manual (*Use of Large Woody Debris* section) (http://www.wildtrout.org/index.php?option=com_content&task=view&id=324&Itemid=315).

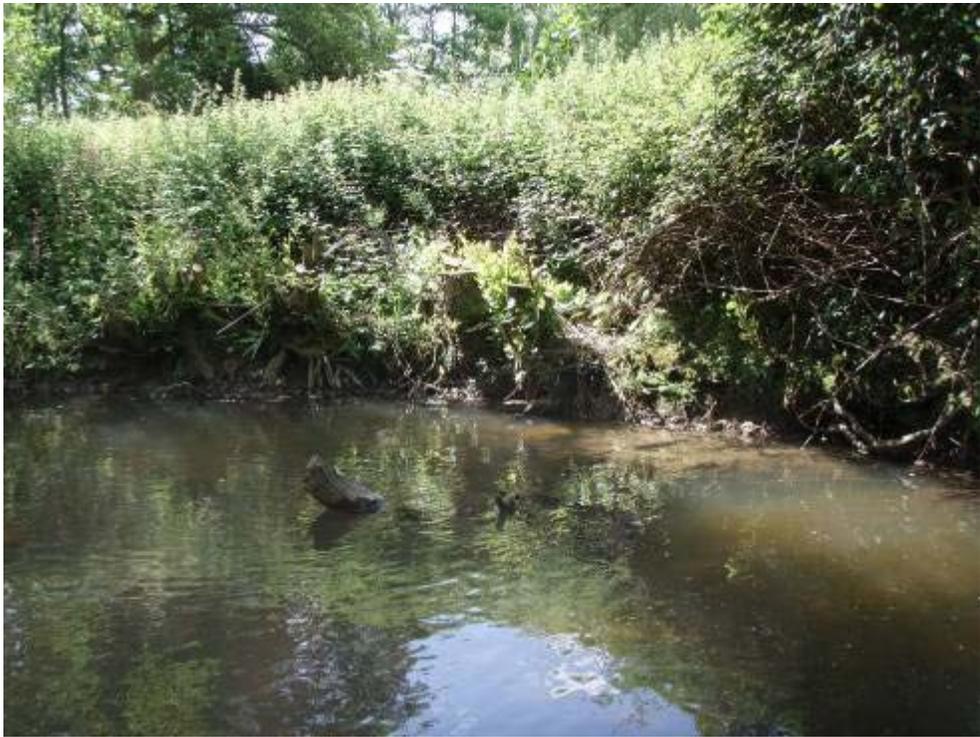
Photo 8 Coppicing of trees alongside the deep pool. Installation of log cover along this bank will improve the holding capacity for trout.

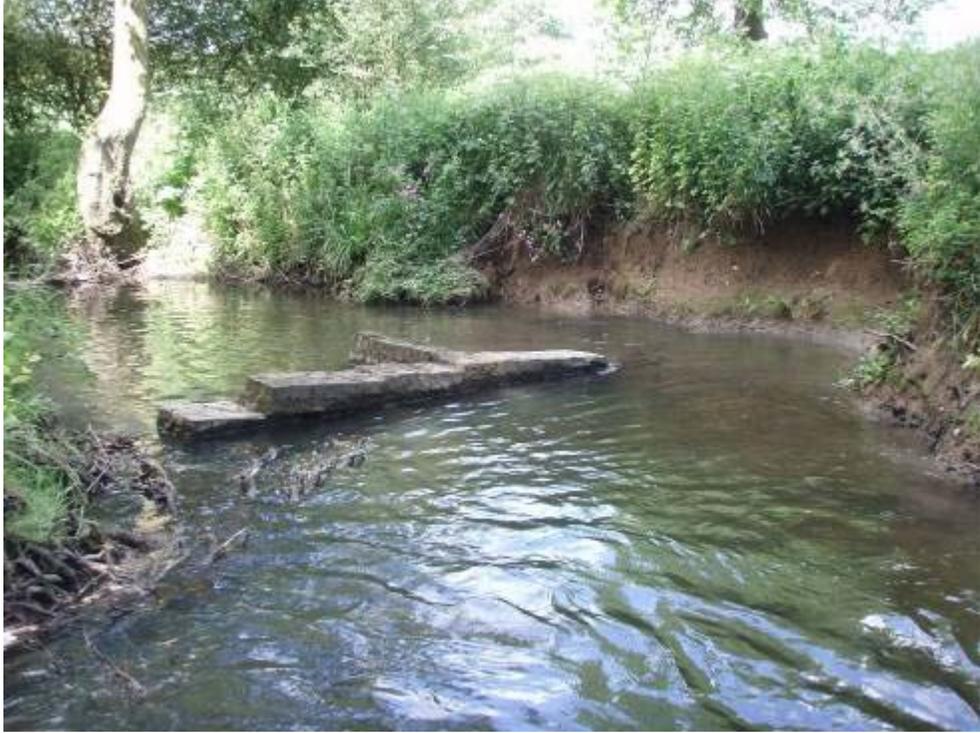
Photo 9 Old weir structure deflecting water against the hard clay bank causing moderate erosion

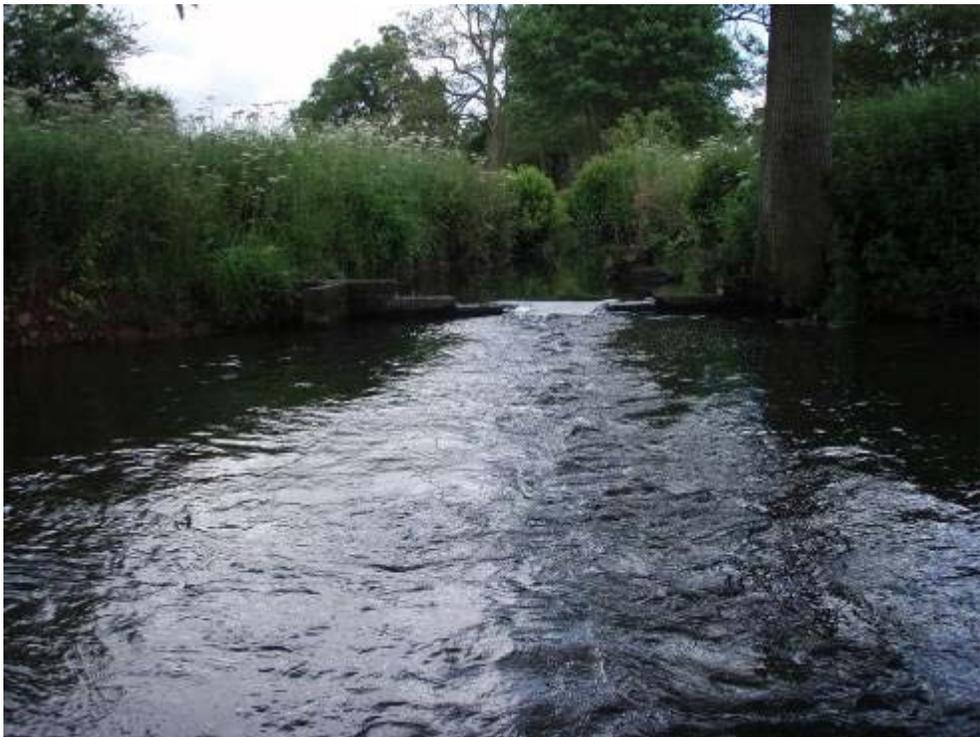
There were four weirs on this section, two of which were in disrepair; the others were low structures which could be easily by-passed by fish. Although fairly low in crest height, the weir below the road bridge (close to the field boundary between second and third Reeves Ground) was causing a backwater effect for about 40 metres upstream; along with the straightened nature of the channel here (second Reeves Ground / Coney Close) this was relatively poor habitat compared with that downstream. The brook here is overwide, slow-flowing, lacks diversity of depth and has poorly sorted bed substrate.

Photo 10 Intact weir, downstream of A4189 road

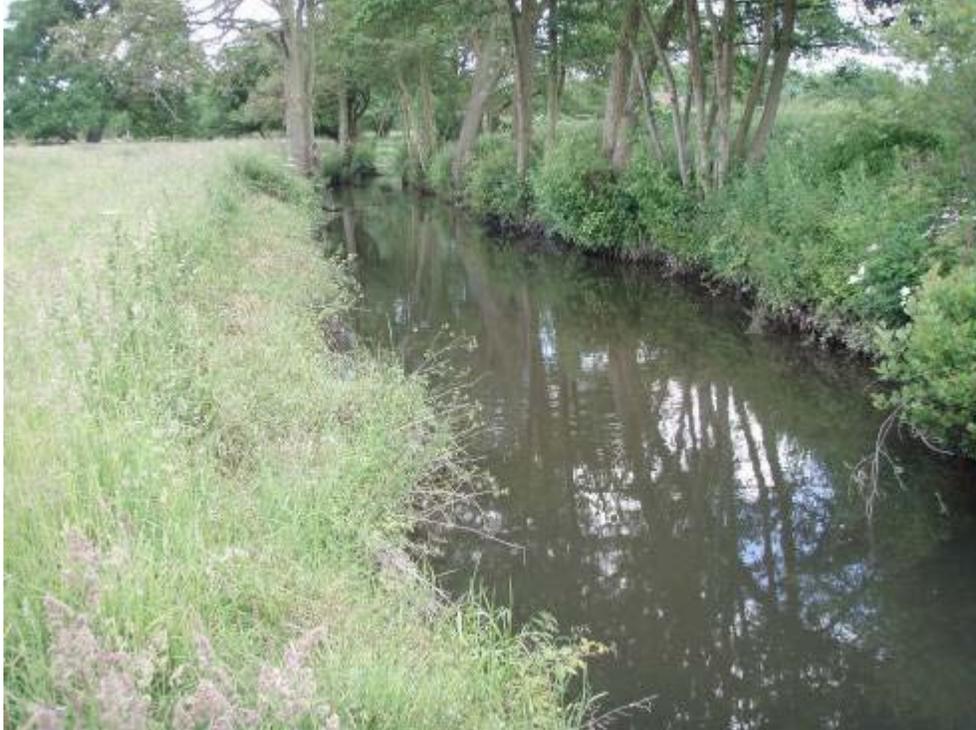
Photo 11 Impounded section of brook upstream of the weir in Photo 10 – poor habitat

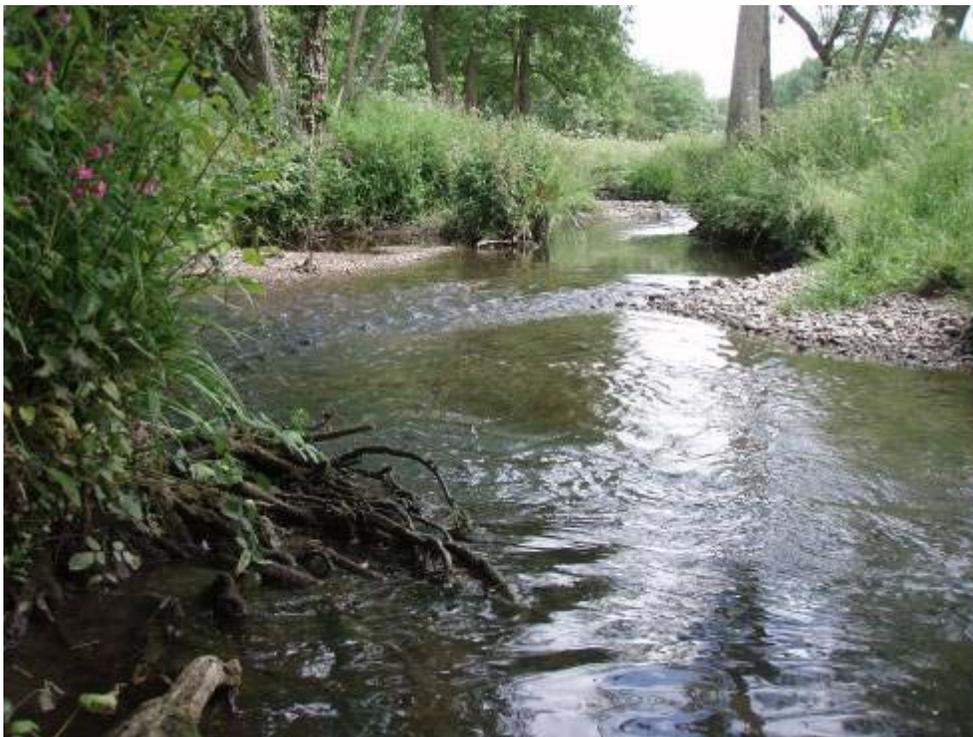
Photo 12 Some great habitat upstream of Mill Cottage – meanders, pools, riffles, gravel bars and tree roots

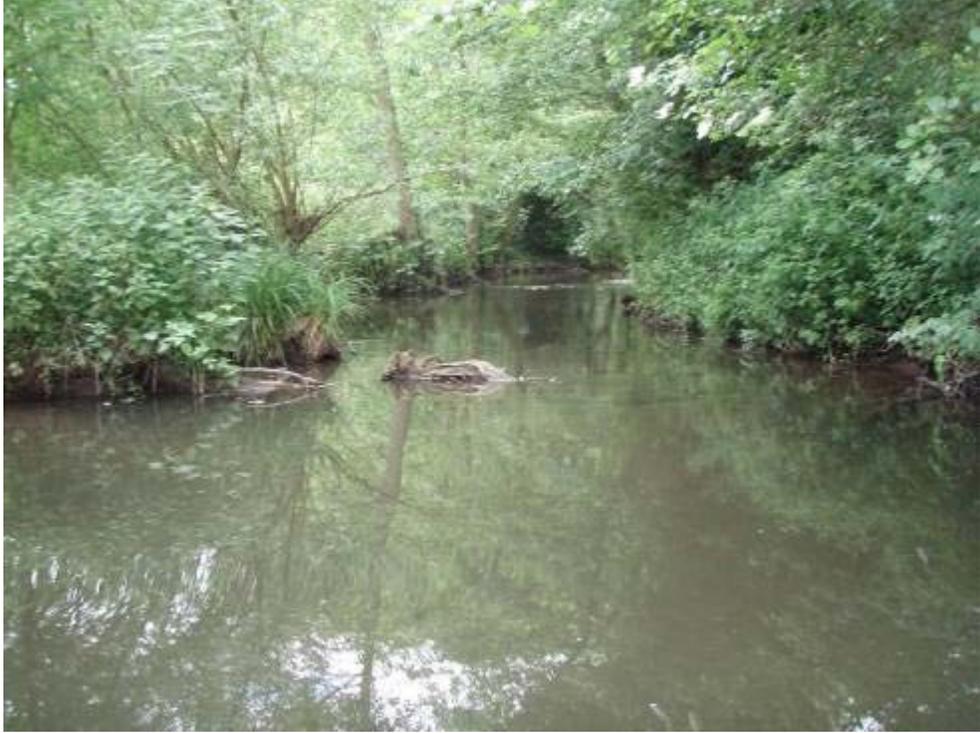
Photo 13 Some sections of the upper reach are straight with a relatively shallow uniform depth – not good trout habitat

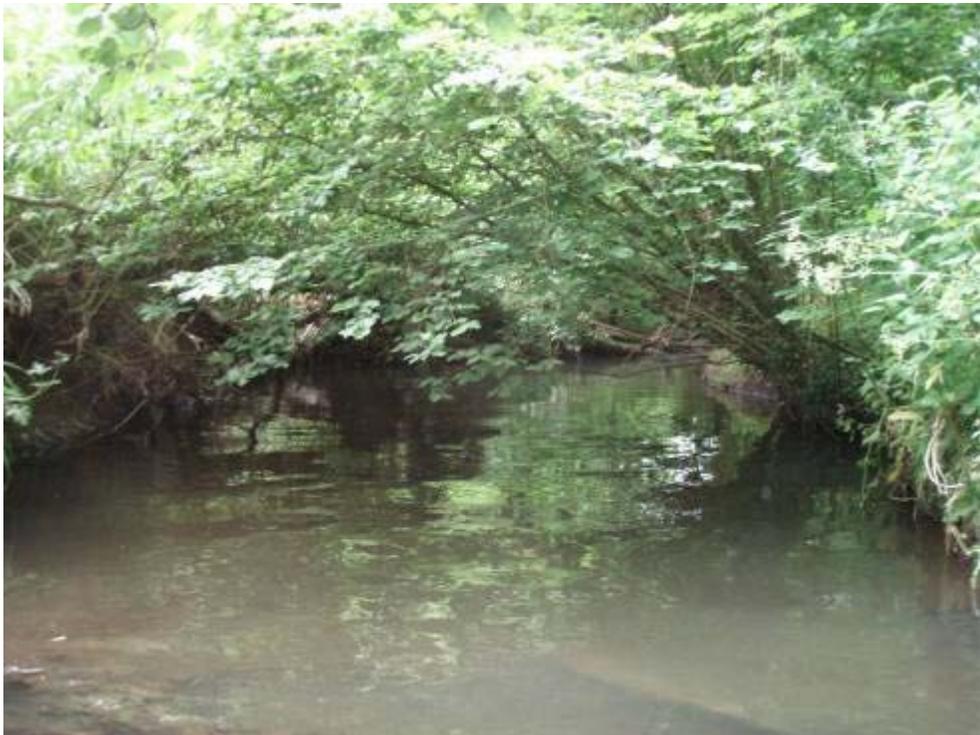
Photo 14 Heavily shaded section of the channel where selective coppicing of overhanging trees would be beneficial

- The more heavily shaded sections of the brook, particularly the reach above the road to the upstream boundary would benefit from a thinning of the tree canopy to allow in more light. The Wild Trout Survival Guide provided during the visit gives some guidance on rotational tree coppicing. The overall aim should be to achieve 'dappled shade' (about 60% shade / 40% light). It is important to remember that shading has a vital role in keeping a watercourse cool and that the upper lethal temperature for trout is in the low twenties Celsius. Careful tree management is therefore a vital tool in mitigating against the effects of climate change.

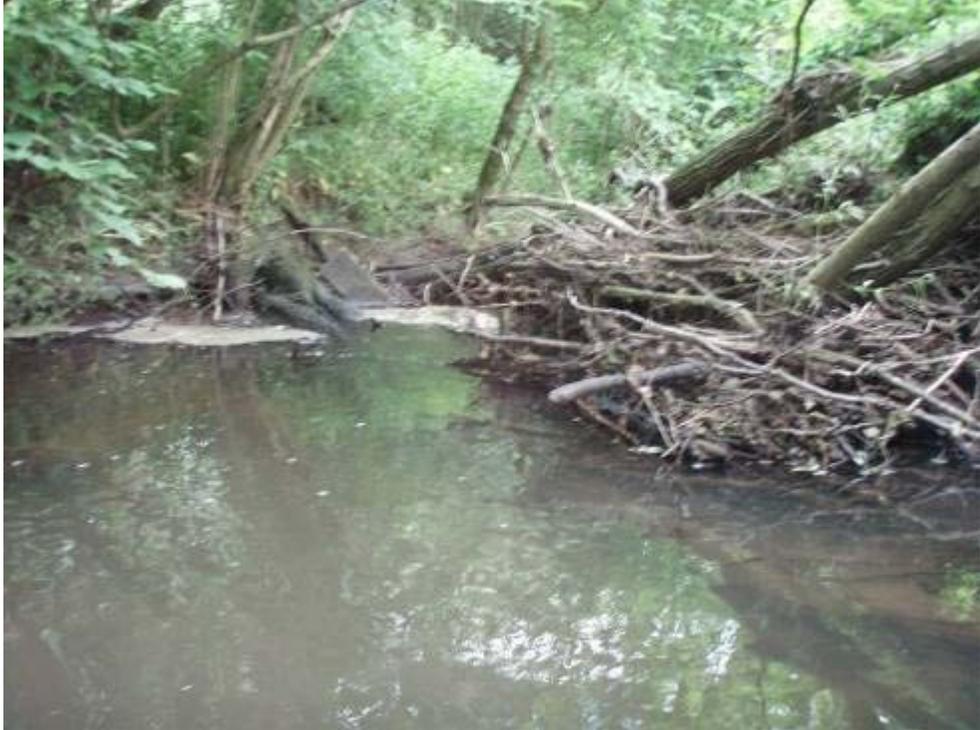
The upstream section of this reach (Dale Meadow) has much better habitat with meanders, pool and riffle structure, wide depth variation and a well-sorted substrate. There are some excellent examples of LWD and its effects on habitat structure (Photos 15 and 17), and these should be retained. Much of the channel here is overgrown and shaded, particularly by previously coppiced hazel trees; it is recommended that these are cut back to improve light penetration and access.

Photo 15 Woody debris dams are beneficial to the brook's ecology and should be retained

- Large woody debris (LWD) within the river channel should be managed with a presumption to retaining it *in situ*. In addition to the ecological benefits, LWD promotes flood water storage in the floodplain during high water events, protecting downstream properties by reducing the height of the flood peak.

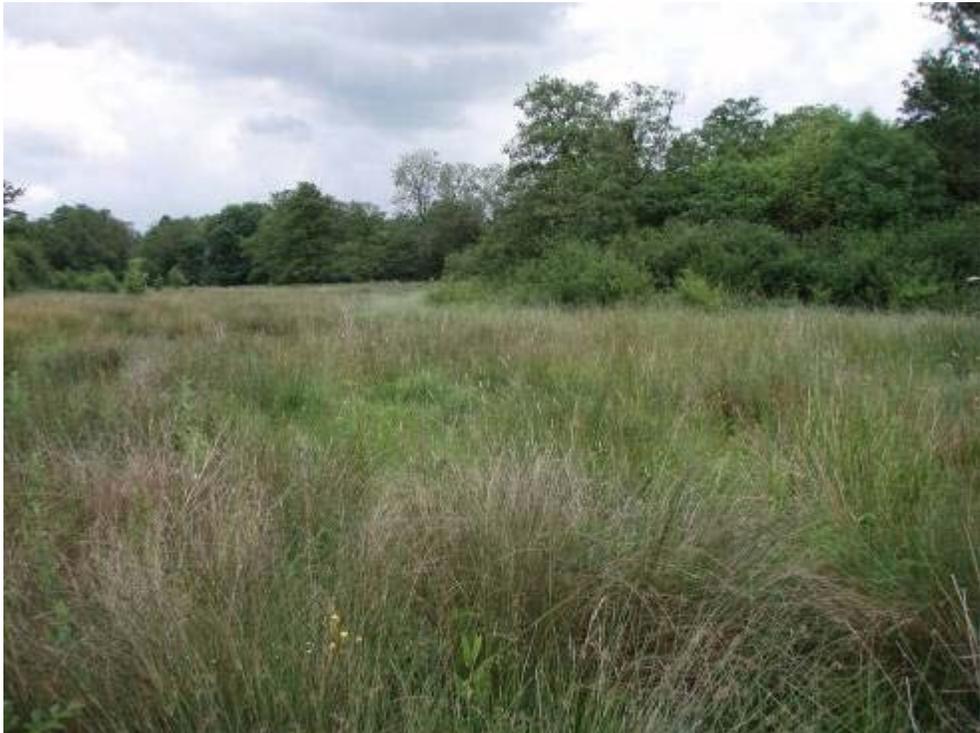
Photo 16 Excellent wet grassland areas are present alongside the upper section of the brook

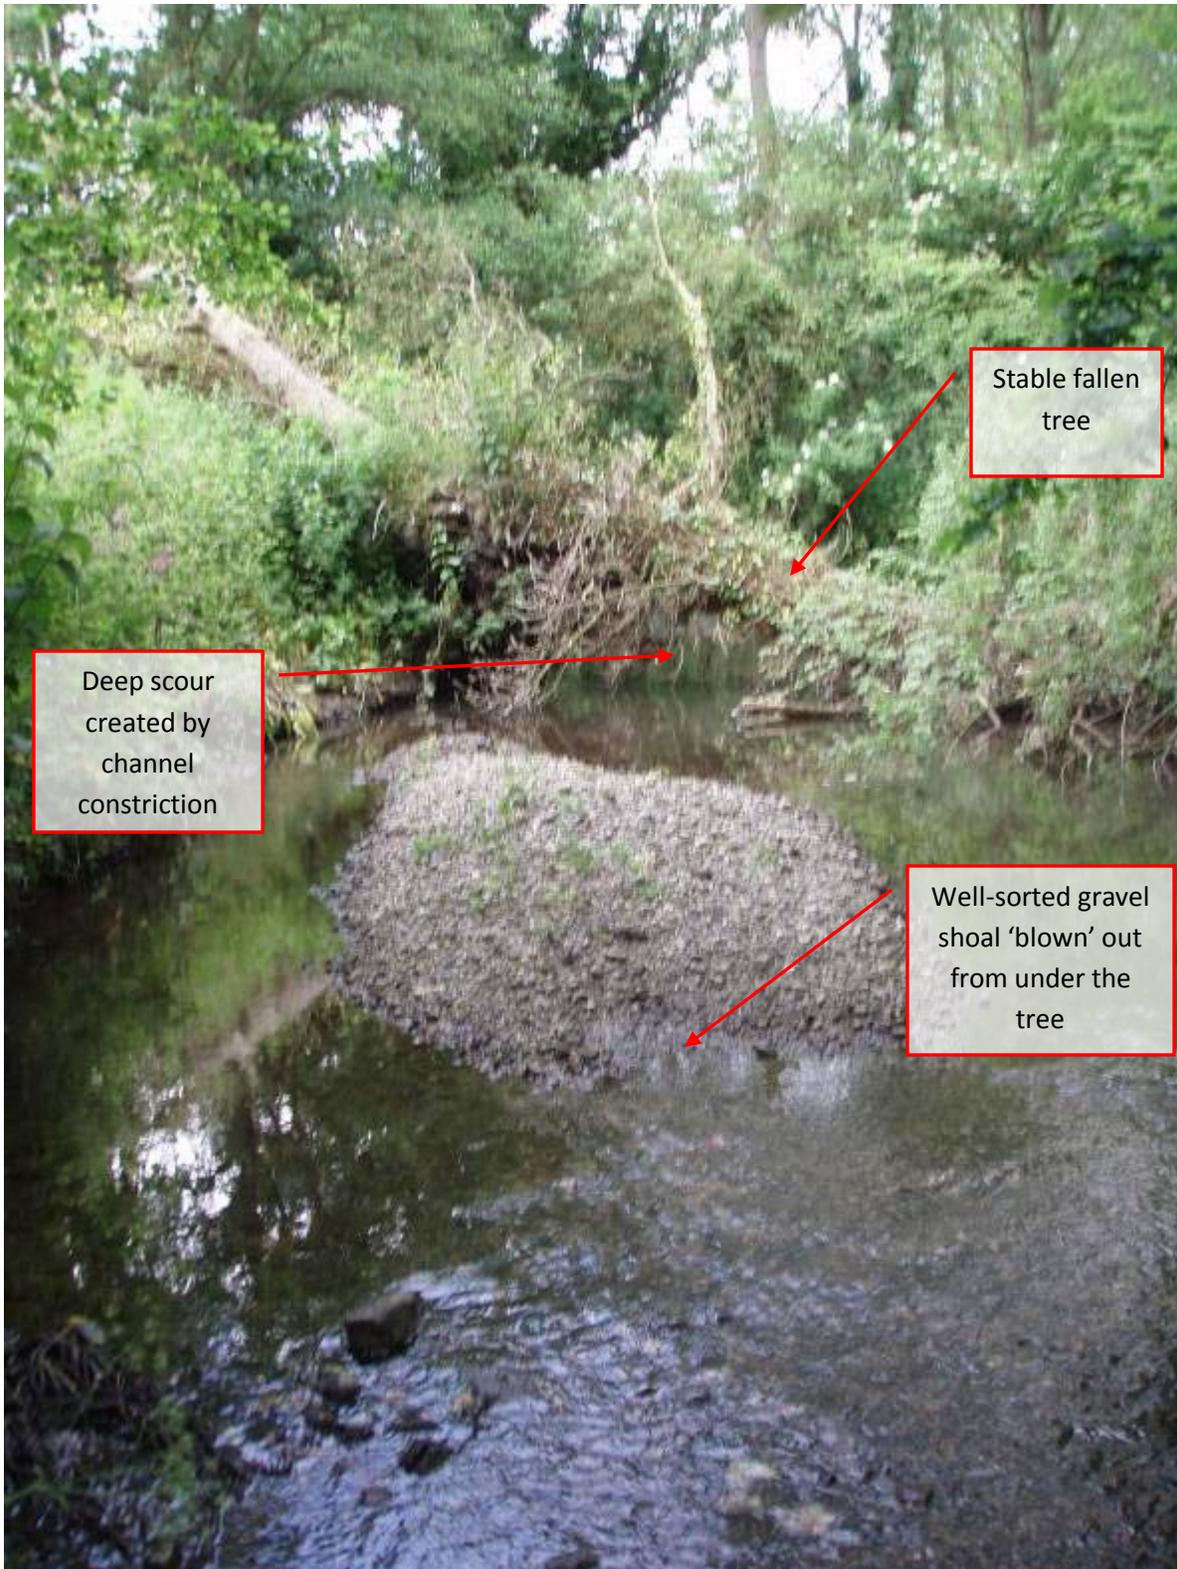
Photo 17 A great example of the effects of retained woody debris on river form and processes.

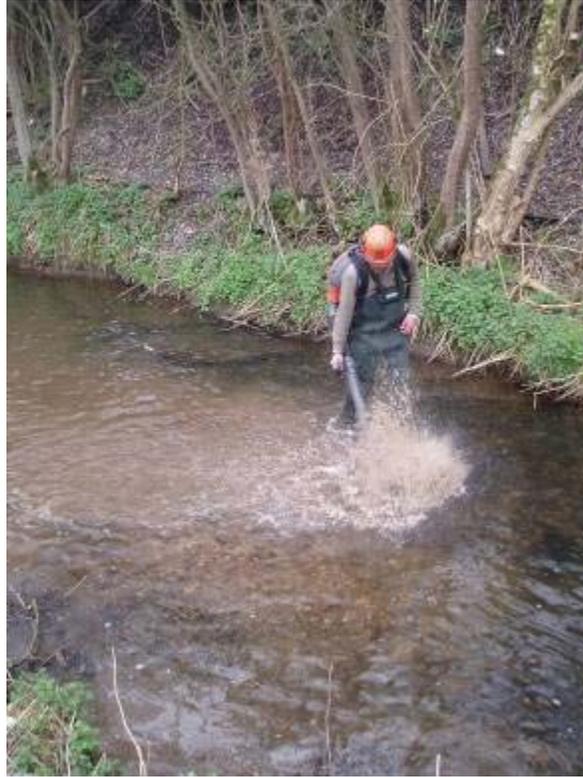
Photo 18 Gravel washing with a leaf blower

- Gravel cleaning should be carried out in late September / early October prior to trout spawning. This can be done with a water pump, hose and 'lance' (scaffold pipe), or with a leaf blower. Some points to note:

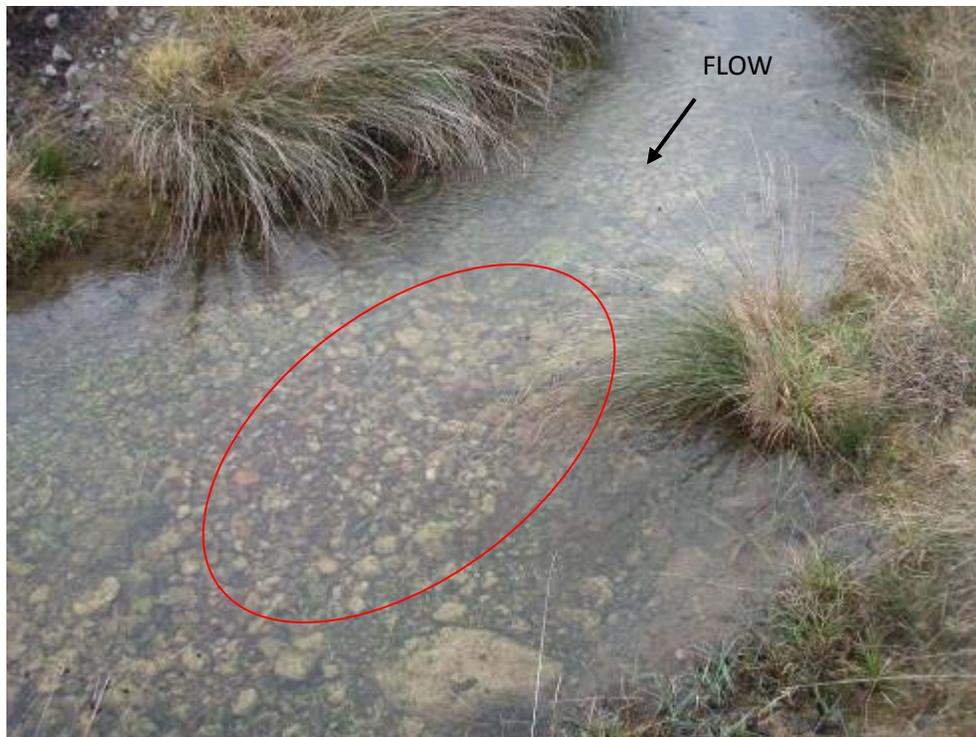
Photo 19 Trout redd with excavated hollow at upstream end and finer, sorted gravel mound at downstream end.

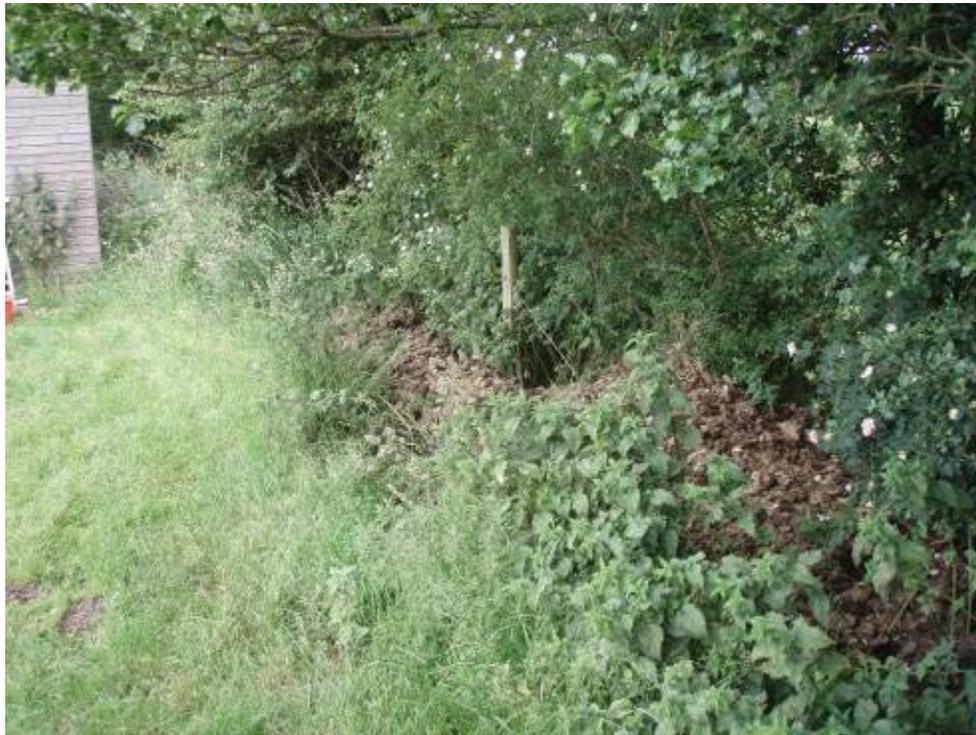
- Continue to manage the land in a sympathetic manner. It is a pleasure to see how The Countryside Stewardship scheme has benefitted the brook and its surroundings and every effort should be made to continue this management. There was one minor issue to note that could affect the water quality of the brook – some horses are stabled on the left bank of the brook on the upstream section, and the manure from mucking out has been deposited at the top of the steep bank of the brook. This is likely to wash in during wet weather, and would be better stored well away from the watercourse.

Photo 20 Horse manure deposited too close to the brook – better off in someone's vegetable patch!
