Advisory Visit for Stockton Angling Limited

River Tees - Winston

Date 23/01/12

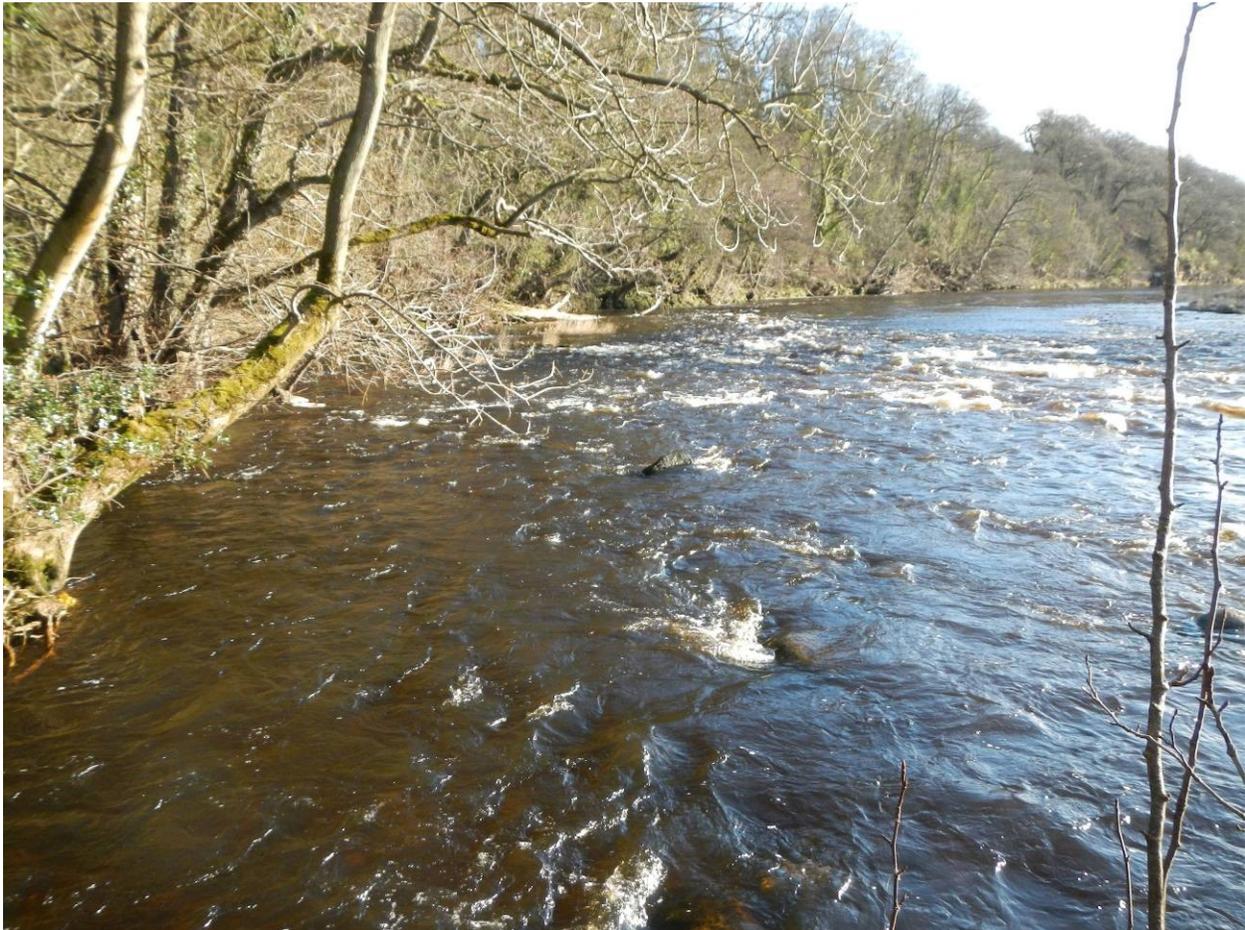
The channel section walked generally comprised long glides with deeper gullies, interspersed with fast riffles and the occasional pool (Picture 1). During the visit the river was suspected to be up by around 30cm, but it was apparent that the river in this area is a dynamic and powerful system even at lower flows. Correspondingly the substrate is generally large cobbles and boulders, with a lesser degree of gravel and fine sediments. This may be influenced to some extent by several reservoirs in the catchment which can act as a sink for gravel. This issue is currently being looked into by the EA and Tees Rivers Trust, and projects to reintroduce gravel are underway.

Picture 1. Fast riffle, typical of this reach, with good tree cover (LHB), flowing into a pool (NZ1597817462).

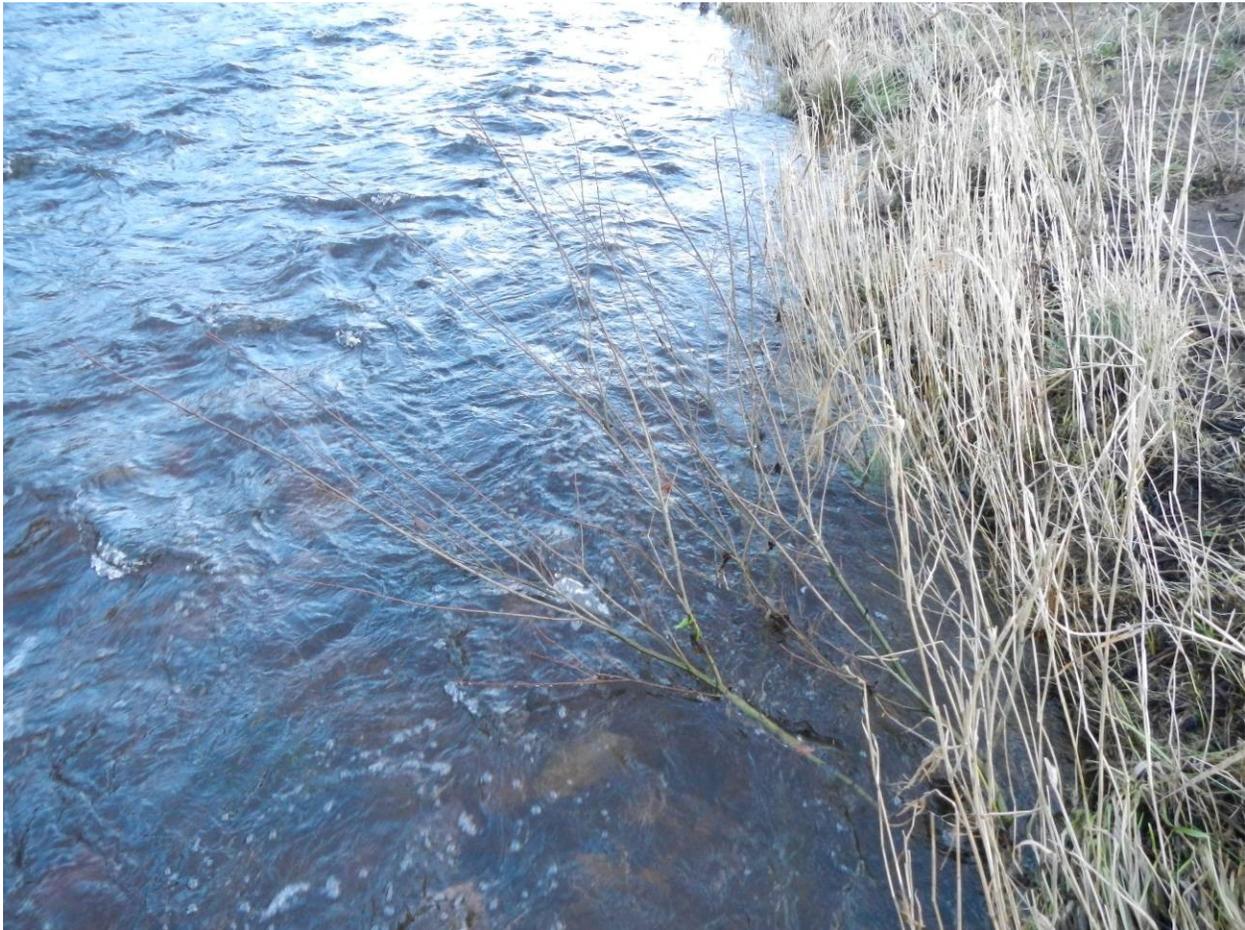
Most of the section walked appeared to support healthy growth of vegetation and self set trees along the banks (Picture 2), which are beneficial on two counts. First of all, the trailing vegetation provides good cover from predation, and shelter for emerging fry. Secondly, healthy vegetation that

Picture 2. Self set willow (*Salix sp.*) which will provide cover and shelter, along with bank protection.

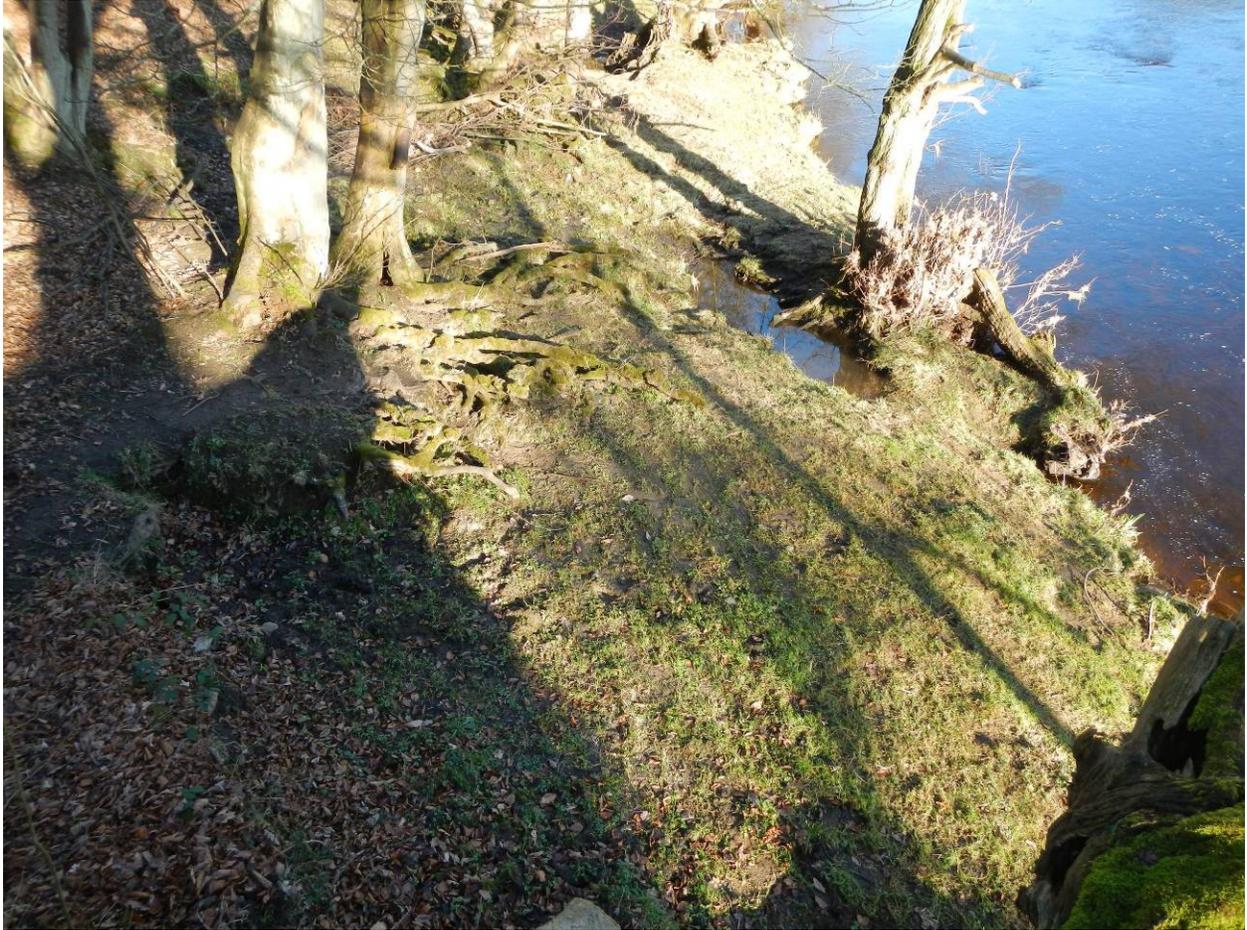
The only area viewed, where marginal cover was considered to be particularly lacking, was around the anglers' hut. In this area livestock are descending the bank from the field above, eating the vegetation and causing disturbance (poaching) to the bank. Due to the shading by deciduous wood in this area vegetation is already limited and grazing is exacerbating this, resulting in additional areas of bare ground and erosion (Picture 3). It is recommended that the landowner/tenant in this area is approached to consider excluding livestock. The loss of grazing is likely to be minimal, so as long as an alternative water source is available, this may be achievable.

Picture 3. Grazed area around the anglers' hut (NZ1429416409). Growth of vegetation here will always be limited by tree shading, so additional grazing pressure should be prevented if possible.

It is advised that the possibility of reinstating fencing to exclude livestock access to the river bank in the area around the fishing hut is investigated, as this would increase bank protection and benefit marginal habitat.

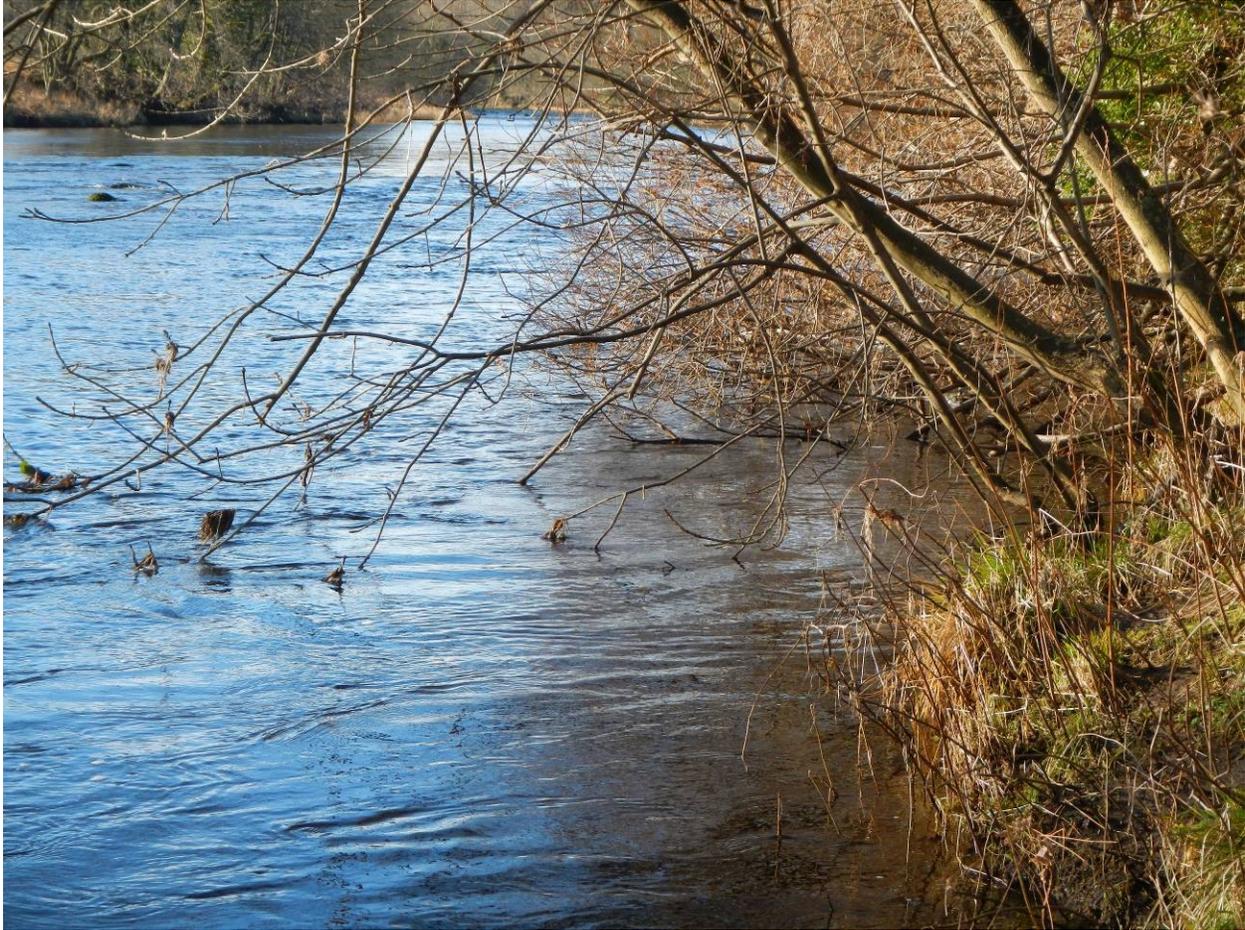
In most areas there was a healthy level of tree cover, which is vital if fish populations are to be optimised. The branches provide shade and protection from predators, as well as a valuable source of terrestrial insects and refuge for emerging aquatic species. The lower they are to the water the better and where trailing in the water they provide the additional benefit of structure and flow disruption, which increases the quality of fish lies (Picture 4).

Picture 4. Low level cover provided by sycamore (*Acer pseudoplatanus*) branches that will really improve the habitat when in leaf. Also note the trailing and partially submerged willow in the background. This provides similar shade and cover, but in addition provides structure in which fish can hide from predators, and shelter from flow.

One area had been subject to pruning and this is something that should be avoided. It is often argued that low and trailing branch cover should be removed or pruned to improve fishing, as there is no point in retaining structure that renders lies unfishable. This is not the case: if the cover is so dense that a lie cannot be fished (which is rarely the case anyway), fish will invariably have to move out from that location at some point to feed. They may spend time in the cover, and will certainly return there when disturbed, but will move out from there at times to feed. It is better to have the fish there and available some of the time than absent from the area due to a lack of cover, as would happen if it is removed.

For this reason it is recommended that rather than removing low branches they should be retained, and where absent, increased via coppicing the occasional tree, or stem, just above water level. The process of coppicing

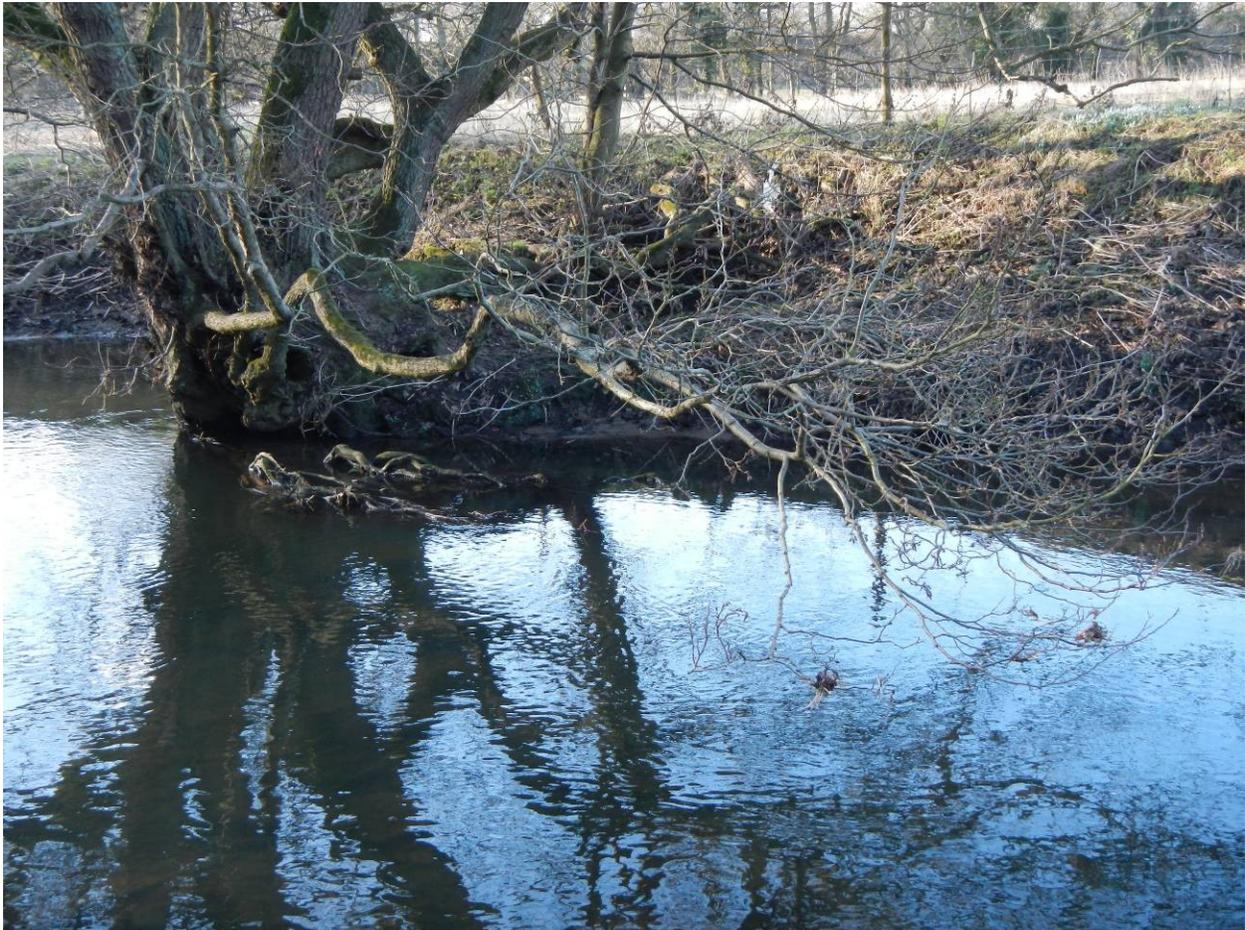
The bottom 100-m section of the Alwent beck was also viewed on the day, which revealed the Beck to have significant potential as a spawning tributary and trout habitat (Picture 5).

Picture 5. The Alwent Beck has good alder (*Alnus glutinosa*) growth along the banks in much of the area viewed, providing good branch and root cover.

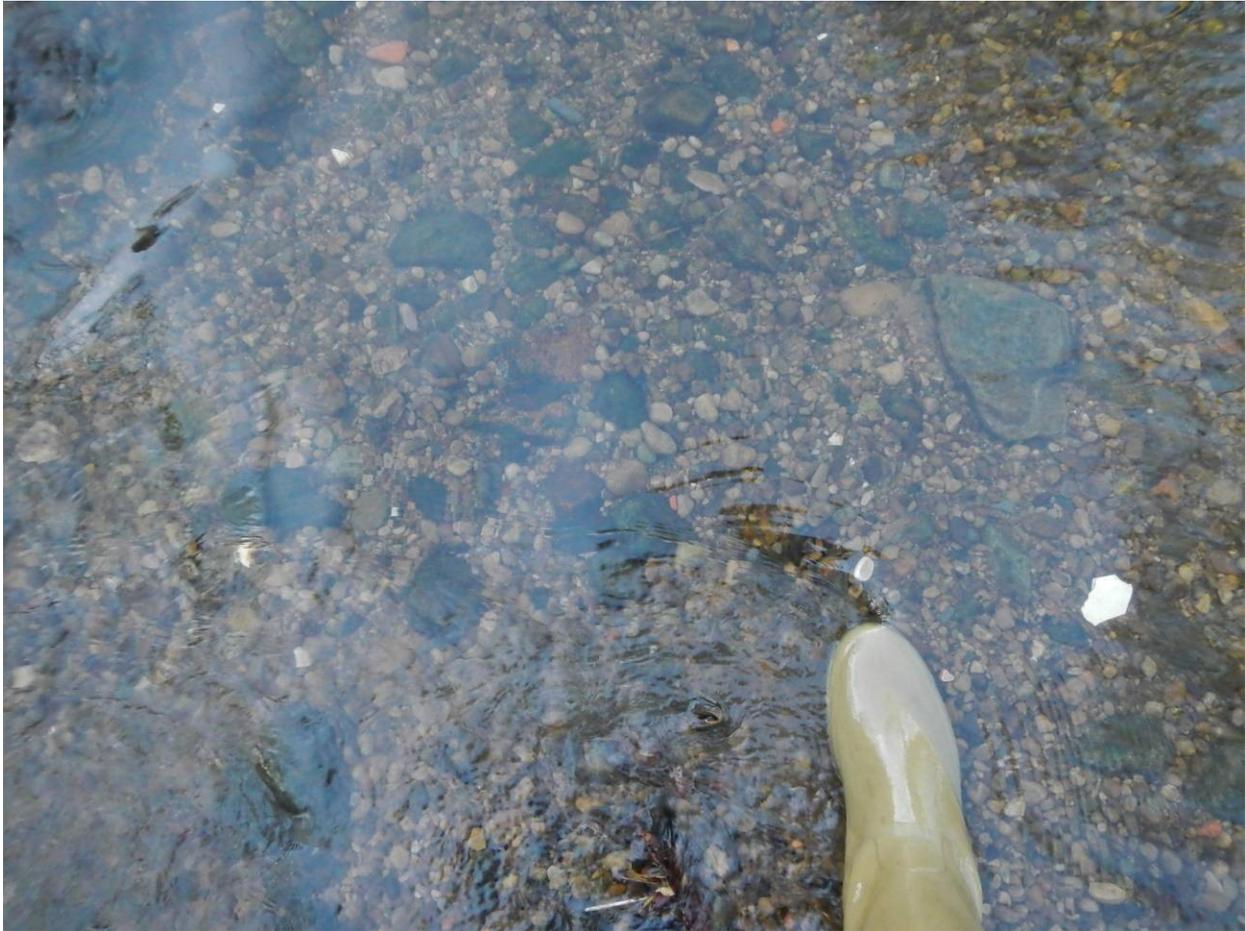
It wasn't however in optimal condition, as suggested by the unfavourable WFD status. A quick assessment of the Beck showed signs of excessive siltation and possible erosion issues upstream. Some of the substrate of the Beck was of a suitable size and volume for spawning (Picture 6). For these reasons it is strongly recommended that the siltation issues are investigated, as the Beck could be a valuable spawning area if improved. The Tees Rivers Trust may be able to assist with this.

Picture 6. Potential trout and grayling spawning substrate on the Alwent Beck. Sedimentation issues need addressing for the potential to be realised.

Once the sources of excess sediment are prevented, habitat on the Beck could be further enhanced with the installation of large woody debris. This would provide cover and increase scouring and sorting of the bed, leaving cleaner, better quality spawning substrate.

Sedimentation issues on the Alwent Beck should be investigated, as this could serve as a valuable spawning and nursery tributary. The Tees Rivers Trust could be well placed to assist with this.

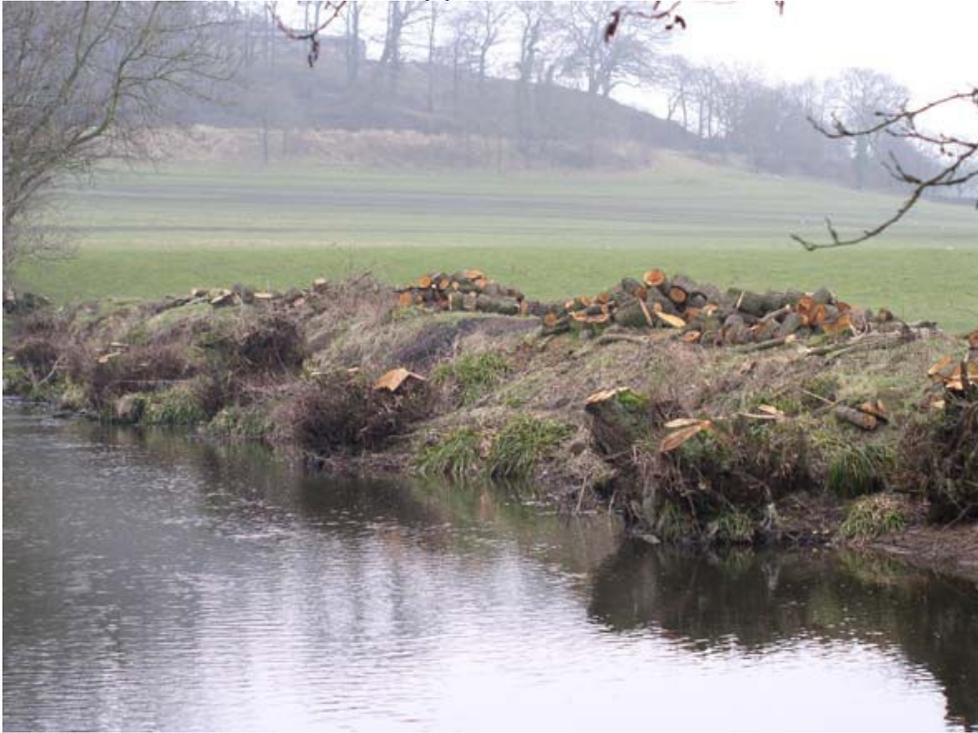
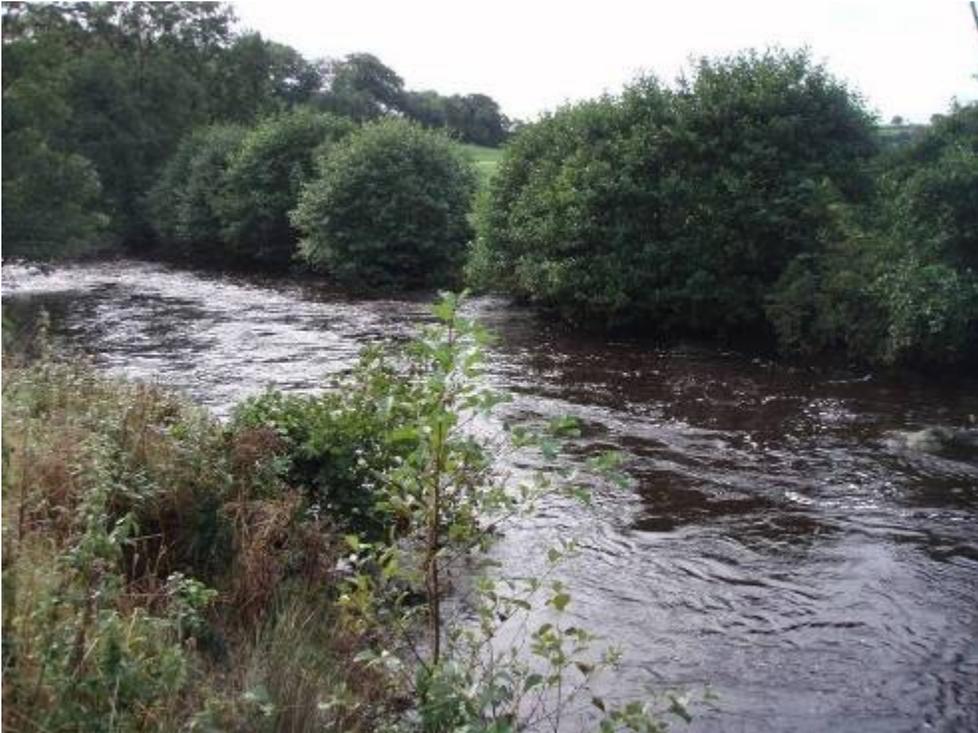
Appendix 2

Coppicing trees produces bushy re-growth which creates excellent low cover over the water. This method should be used sparingly, ideally only on one or two trees in a section. It is important to protect this growth from livestock in areas where grazing occurs. (bottom picture represents 4 years re-growth)

encourages re-growth at a lower level (see example in appendix 2). It also potentially prolongs the life of the tree by taking weight out of the canopy and prevents the tree getting top heavy.
