Advisory Visit
River Teme, Leintwardine
February 2015

1.0 Introduction

This report is the output of a site visit undertaken by Tim Jacklin of the Wild Trout Trust to the River Teme, Leintwardine, Herefordshire, on 18th February, 2015. Comments in this report are based on observations on the day of the site visit and discussions with Barney Rolfe, Lawrence Parker and Cliff Gammon of Leintwardine Angling Club and Liz Etheridge and Peter Giles of the Environment Agency.

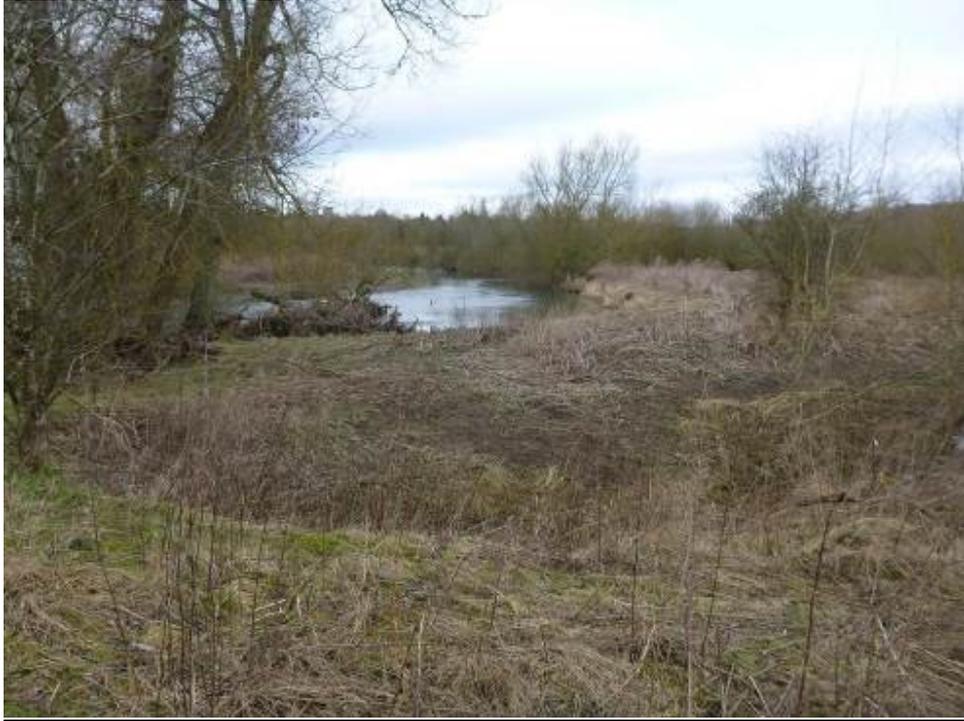
Photo 1 Upstream view from Trippleton towards Leintwardine. Good riparian habitat, although Himalayan balsam is a problem here.

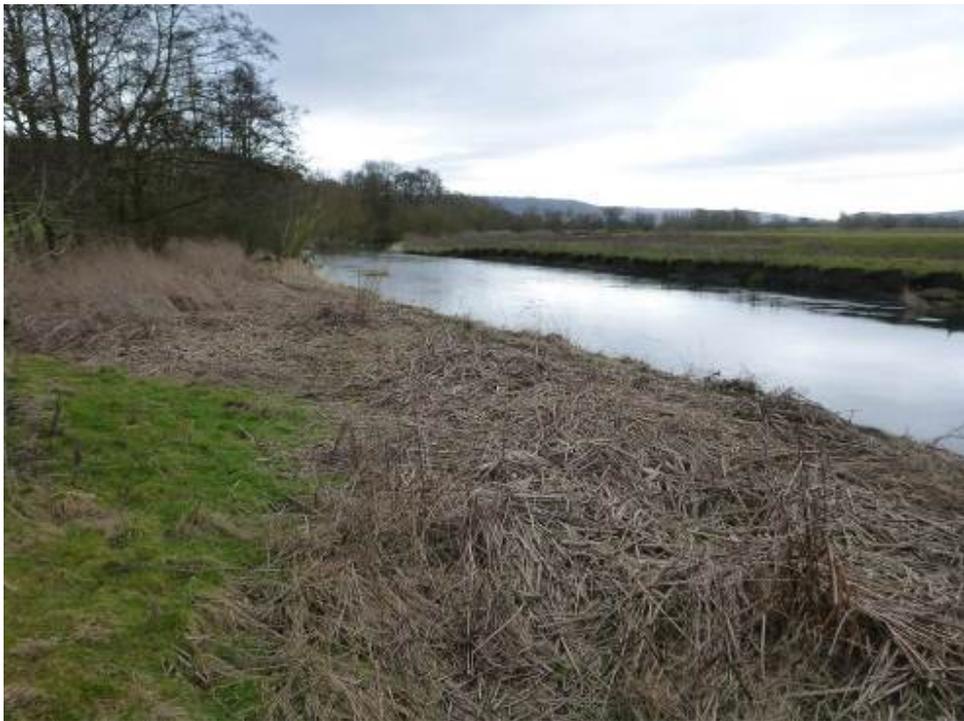
Photo 2 Downstream view from Trippleton, showing the grazed, eroding right (far) bank. The near bank is fenced but has stands of Himalayan balsam.

A complication with excluding livestock from the river bank is the presence of the invasive, non-native plant Himalayan balsam (*Impatiens glandulifera*), which can proliferate in the absence of grazing (Photos 1, 2). Large stands of Himalayan balsam can reduce the diversity of native vegetation and the associated invertebrate life and being an annual, it dies back in winter to leave bare ground vulnerable to erosion; it can also be a nuisance for access to the river.

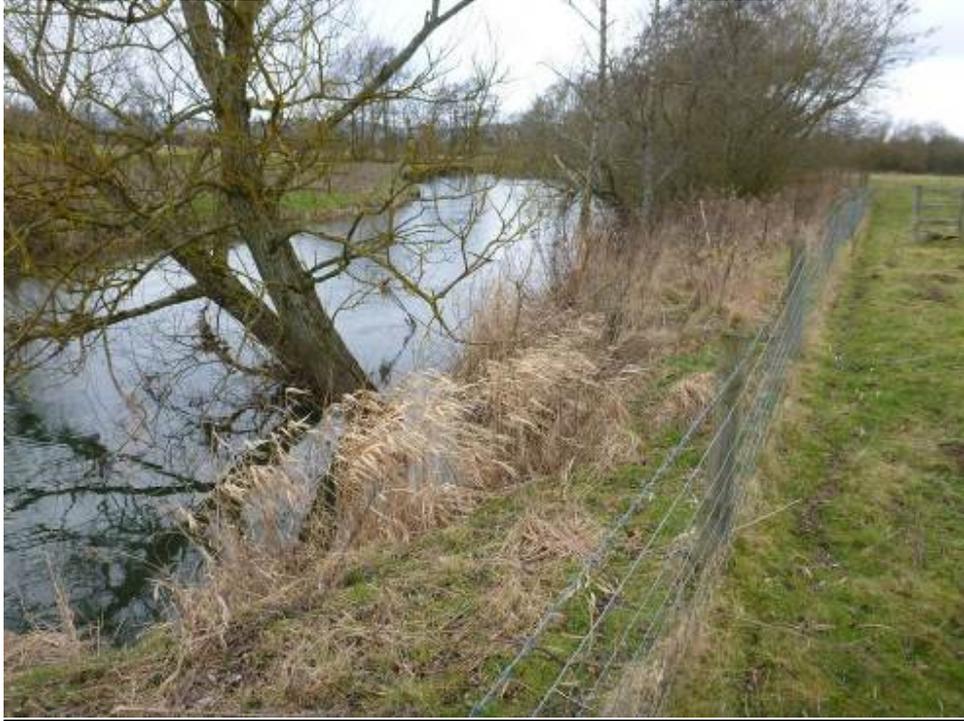
Photo 3 Fenced left bank at Trippleton provides good bank stability and marginal habitat.

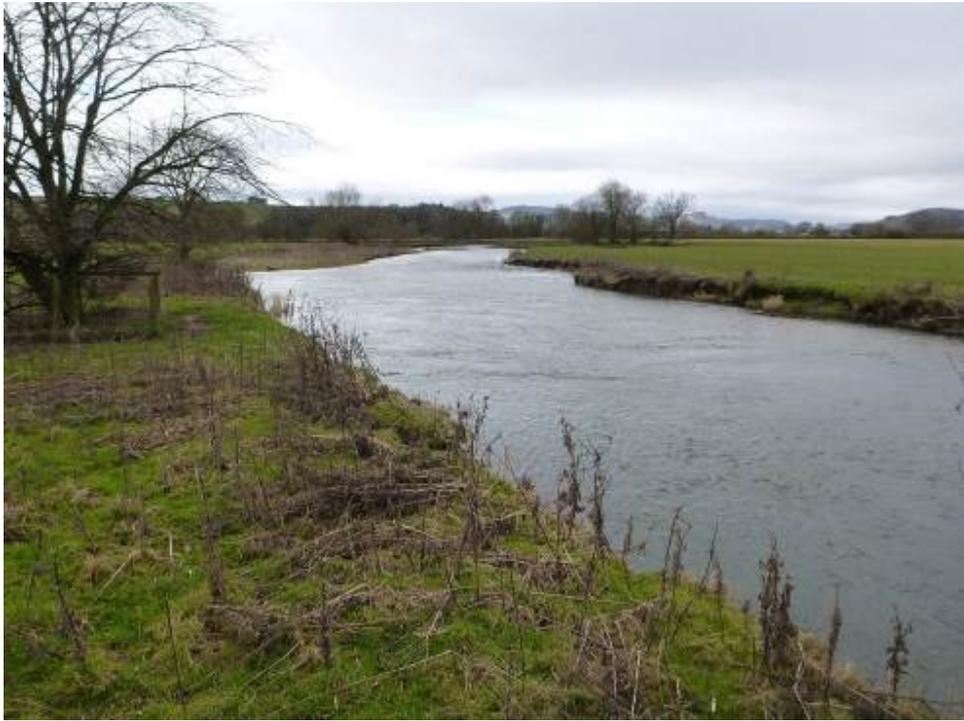
Erosion is a natural river process which seeds sediment into the river, including gravels and cobbles vital for trout and salmon spawning. Indeed, abundant salmon redds have been recorded in the area in Photo 4 where accelerated erosion rates are increasing locally the rate of supply of coarse sediment to the river. However, this must be set against two negative factors:

Photo 4 Unfenced banks at Trippleton with accelerated erosion. This area is known for salmon spawning, but habitat for subsequent juvenile stages is relatively poor.

Excluding grazing from the river banks in open areas (such as those in Photo 4) is recommended, to allow regeneration of coarser vegetation and trees. Liaison with the landowners and tenants is key to achieving this as is understanding the opportunities and constraints provided by agri-

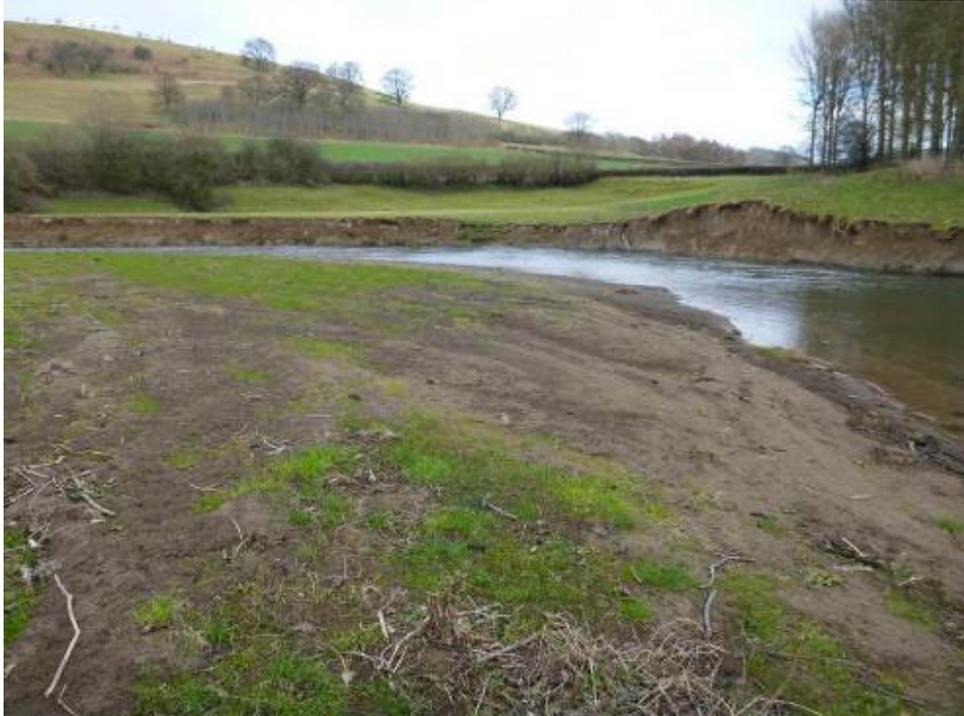
Upstream of Crifftin Ford Bridge, the dynamic nature of the Teme is evident (Photos 5, 6), with actively eroding banks on the outside of meanders and rapidly accumulating sediment on the inside. Reducing the rate at which these processes are occurring would be desirable from a river habitat perspective, but trying to slow or stop the erosion in such active areas using bank reinforcement would be an extremely expensive and likely futile exercise. Only a change in land use to allow more deeply-rooted vegetation (ideally trees) to develop will achieve this aim in the long term.

Photo 5 Upstream of Crifin Ford Bridge (Black Bridge). The dynamic nature of the Teme is evident here, with active erosion and deposition respectively on the outside and inside of a meander.

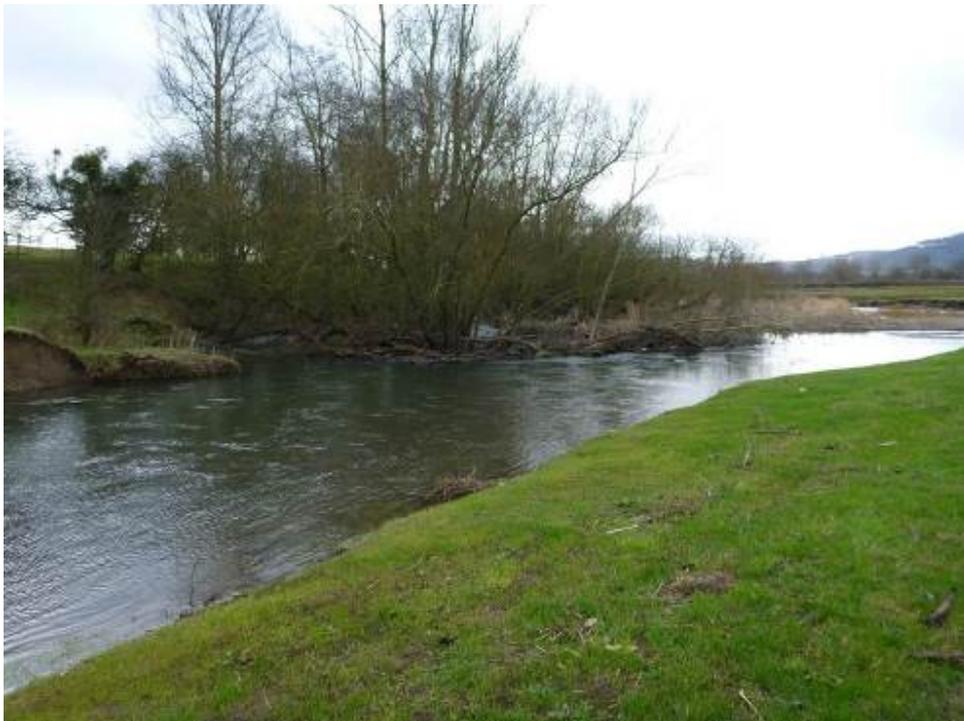
Photo 6 Just downstream of Photo 5, showing a valuable stable woody debris accumulation against a vegetated gravel shoal.

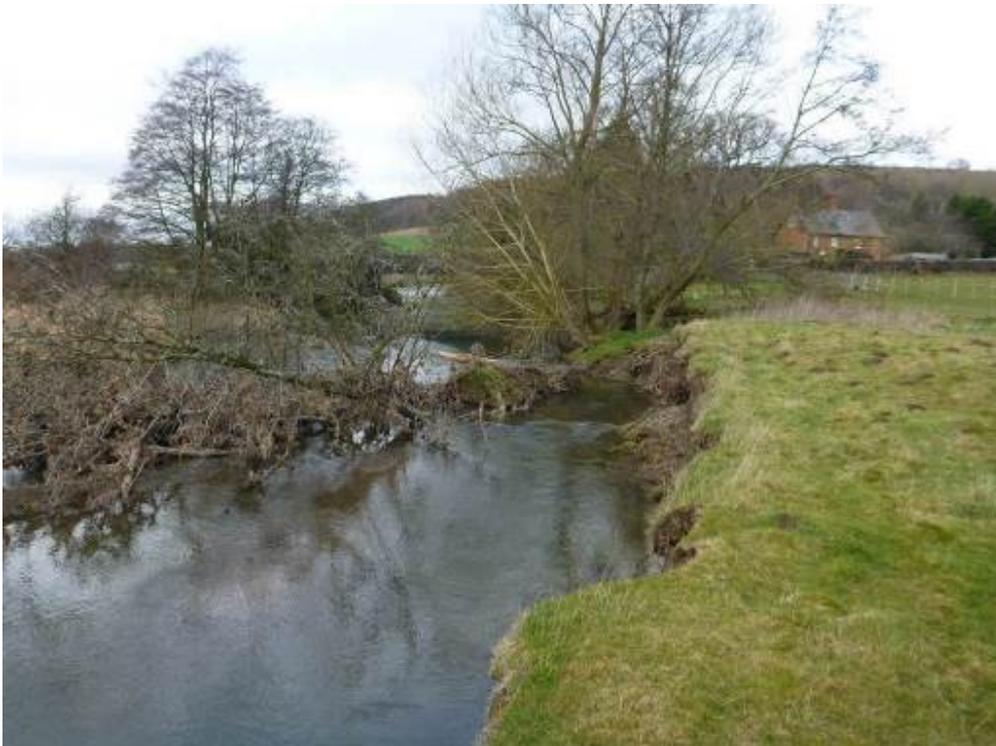
Downstream of the bridge, an alder tree has fallen into the river and become lodged on the river bed (Photo 7). Such “large woody material” (LWM) creates very good instream habitat for trout and salmon. It provides cover for fish to avoid predation; traps leaf litter and other organic detritus which feeds invertebrates, increasing food availability for fish (and fly hatches); and it creates localised variation in current speeds and depths which in turn sorts and grades the river bed sediment into different sizes. This graded sediment provides a range of habitats, the coarser material being suitable for fish spawning and stone-clinging nymphs such as March brown, brook dun and olive upright (Heptageniidae), whilst the finer materials support brook lamprey and Mayfly nymphs (*Ephemera* sp.).

Photo 7 Stable large woody material in the river channel provides excellent instream habitat and should be retained wherever possible.

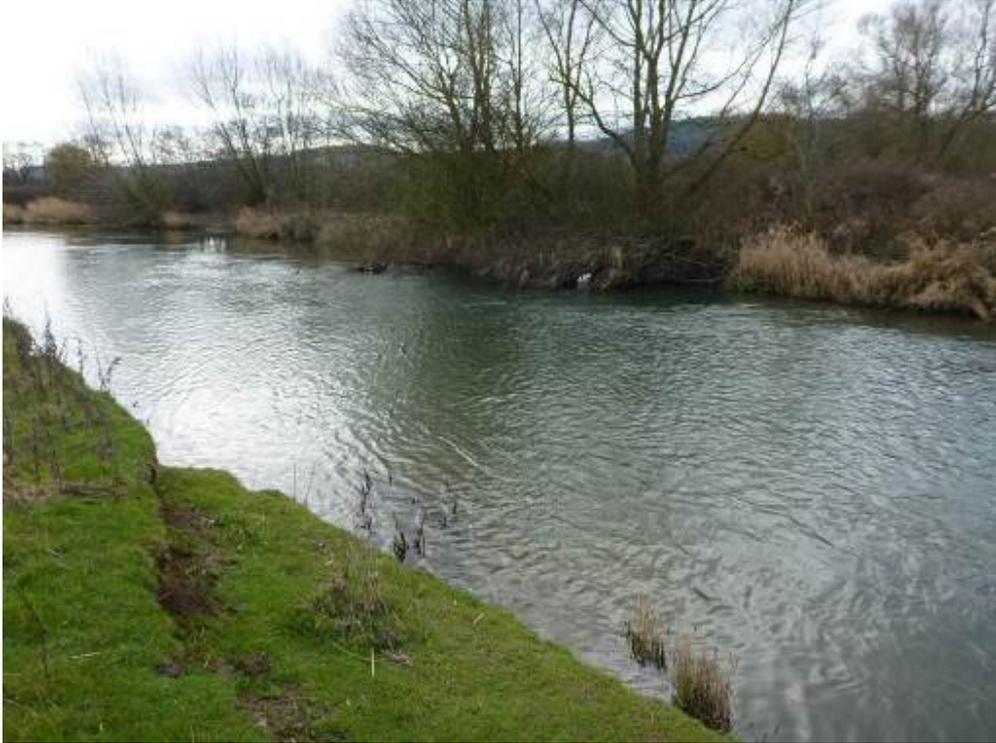
Photo 8 Excellent riparian habitat on the right bank of the river, in contrast to the grazed left bank.

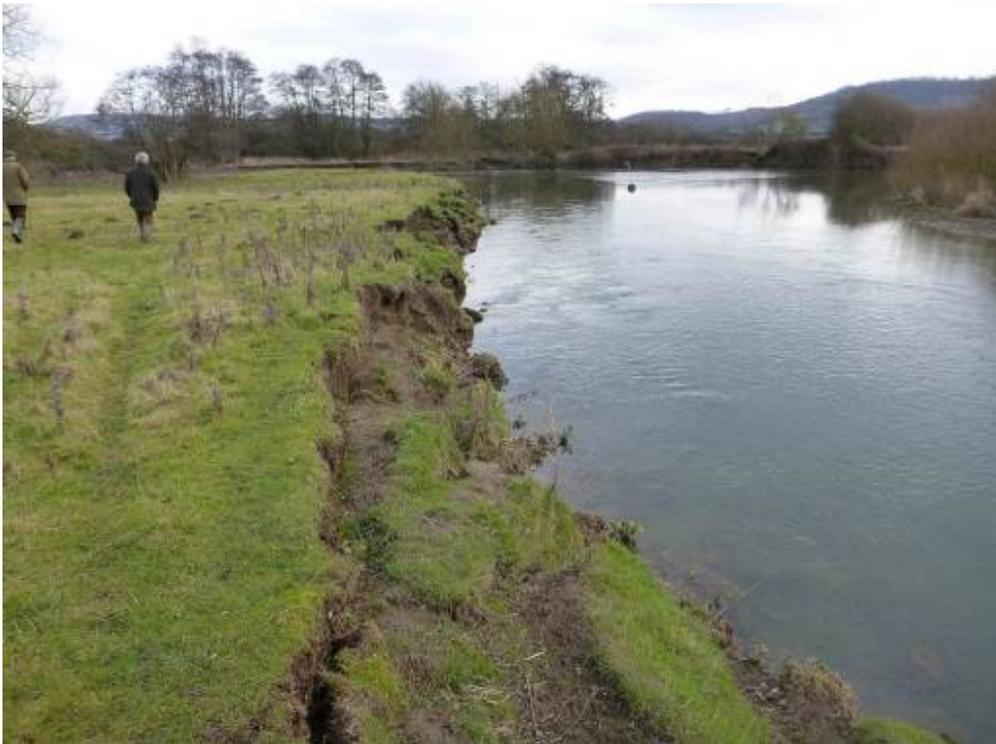
Photo 9 As above: the grazing pressure on the left bank makes it far less stable and prone to erosion like this. If grazing pressure is removed from this bank, increased vegetation cover and root matrices would stabilise the bank and greatly reduce erosion.

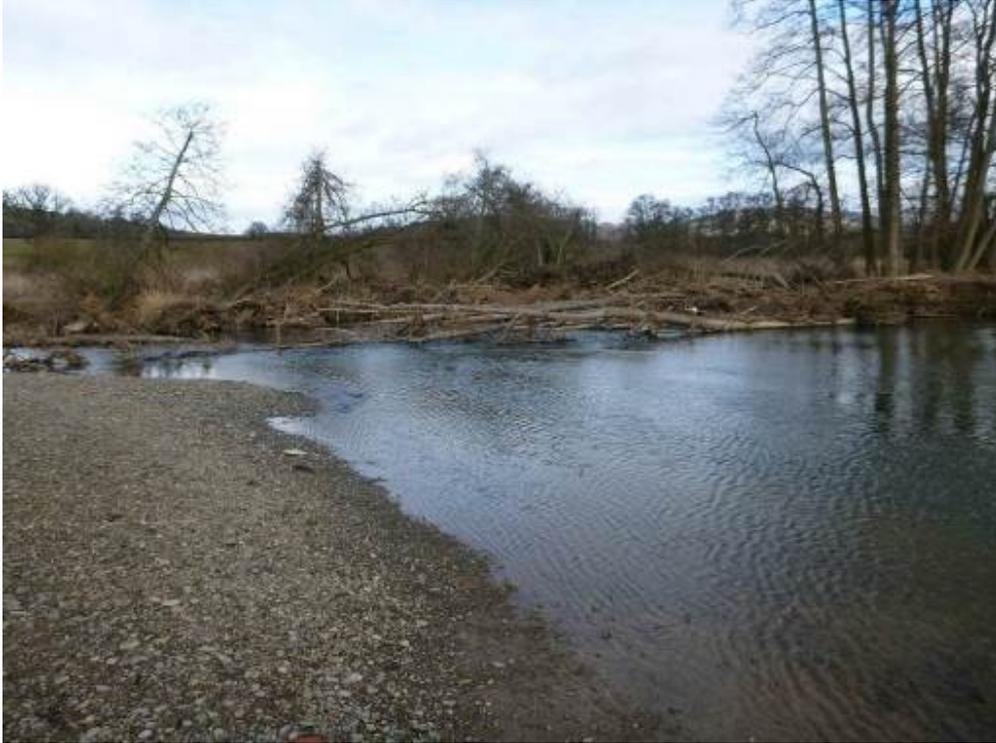
the usual outside. The fallen trees here are backing-up the water at high levels and causing the river to find a new course around them; the lesser stability of the treeless, grazed left bank being the course of least resistance.

Photo 10 Fallen trees at grid reference SO4222271717 (downstream view). Such large accumulations of woody material are rare on British rivers and are very good habitat features. The river is cutting across the inside of a meander bend here to the left of the picture.

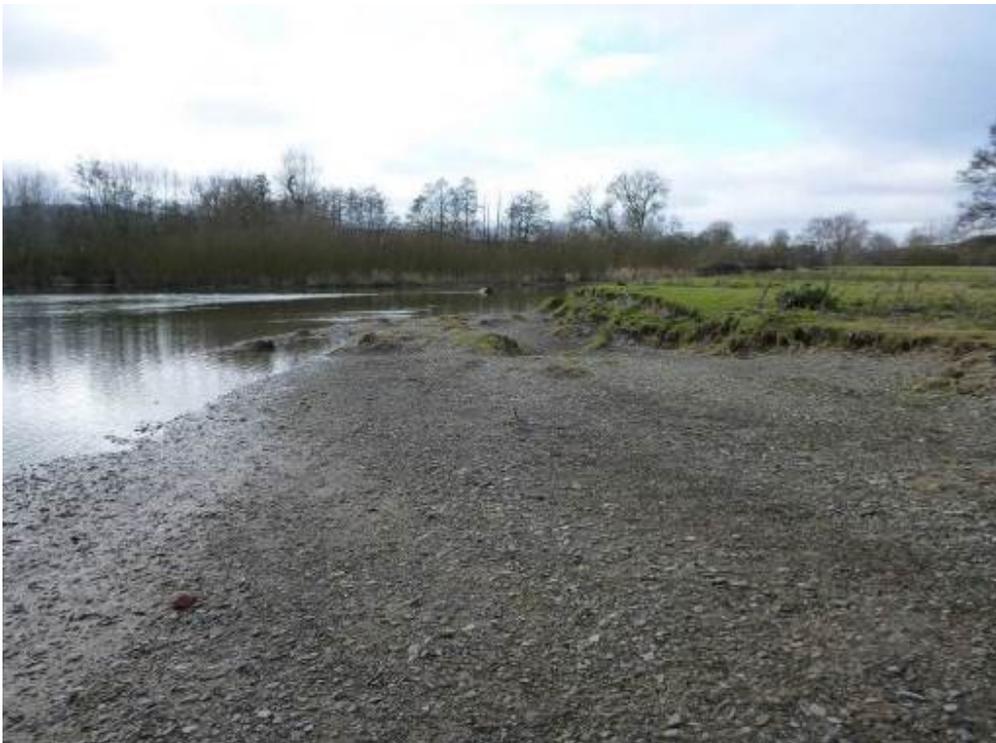
Photo 11 Upstream view from the same position as previous photo.

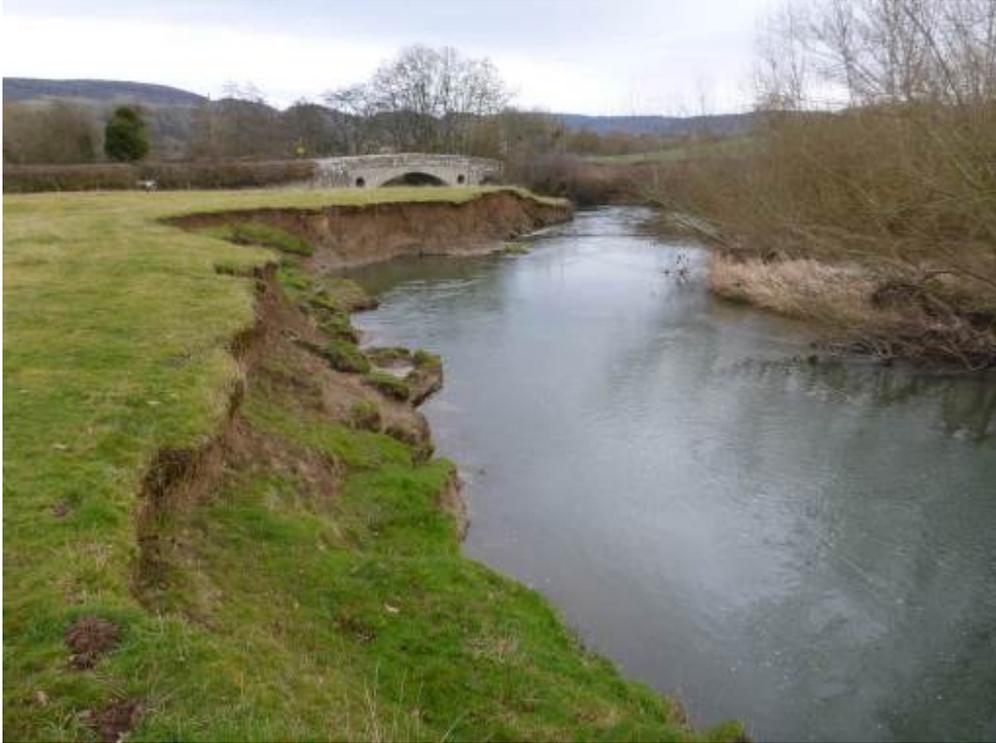
Just upstream of the bridge there is extensive bank erosion on the grazed left bank (Photo 12), which contrasts with the well-vegetated bank opposite. Further erosion in this area threatens the road bridge and consideration should be given to the relative costs of changing the land use on this headland to increase bank stability, compared with a future engineering solution.

Photo 12 Erosion of the left bank upstream of Burrington Bridge

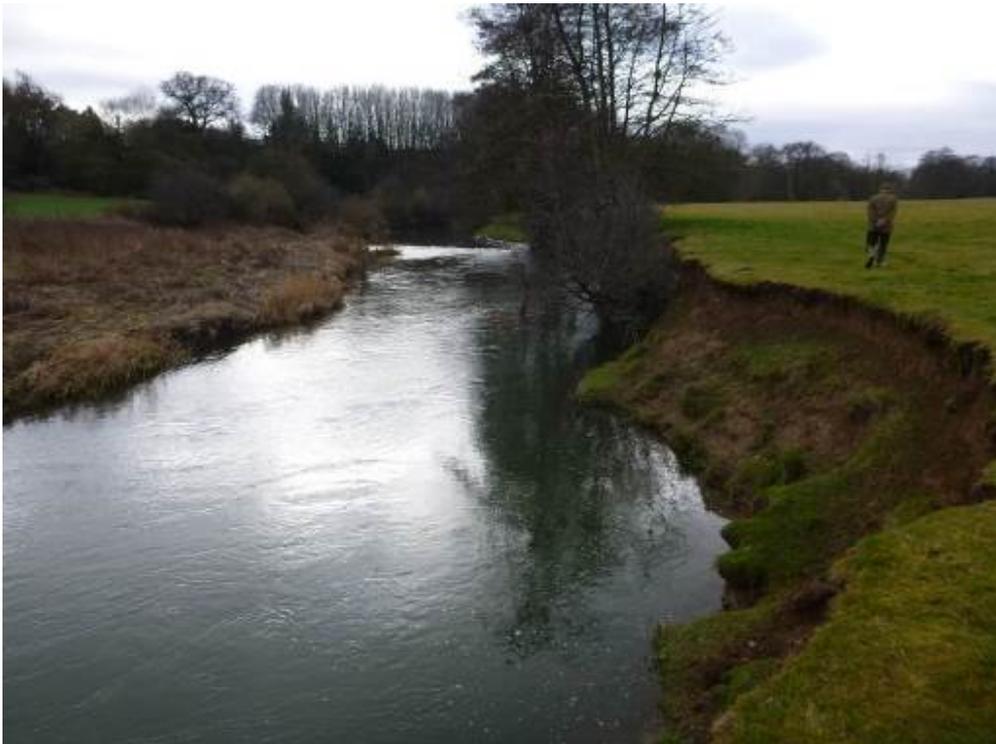
Photo 13 View upstream from same position as previous photo.

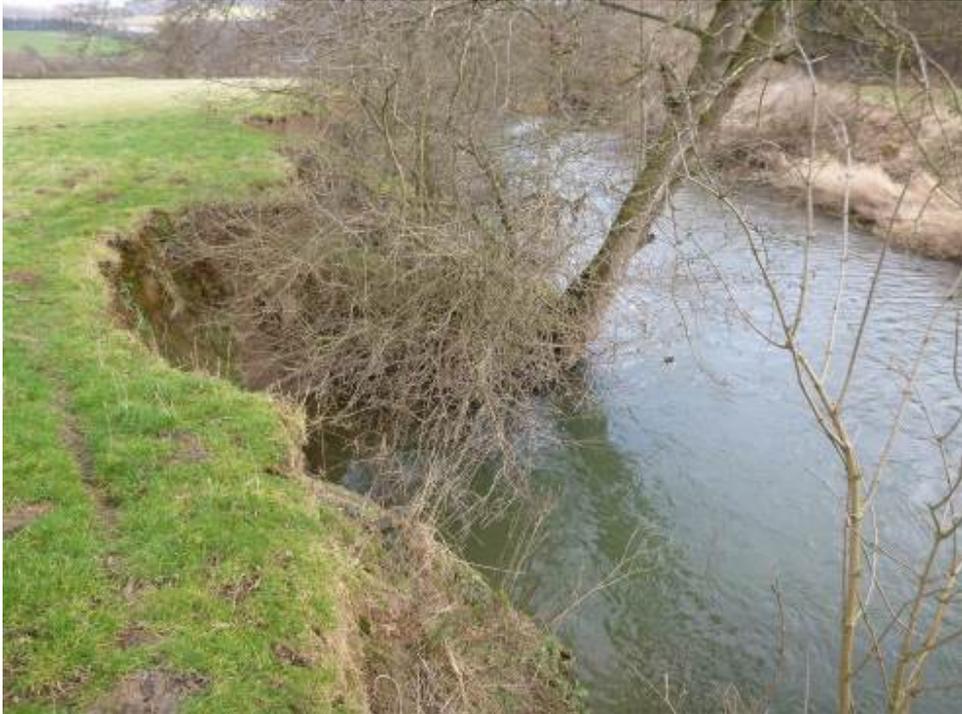
Further upstream, the right bank continues to be well-vegetated with a healthy riparian zone. The left bank has mature trees (mainly alders) but is losing these to accelerated rates of bank erosion. The "scalloping" of the bank shown in Photo 14 is typical of the process that results from grazing around the base of riparian trees and will eventually lead to the same situation as that in Photo 12. The process can be slowed by filling the eroding bays with dense brushwood, for example, hinging in hawthorn trees, but fencing to promote the growth of vegetation and natural tree succession is required to preserve long-term bank stability.

Photo 14 “Scalloping” of the bank which is the result of excessive rates of erosion of the grazed left bank. It results in the loss of trees and eventually the same situation as Photo 12. Areas like the above could be tackled by laying the bushy growth into the water to still the erosive forces near the bank, but fencing off grazing and allowing tree regeneration is also required for a long-term solution.

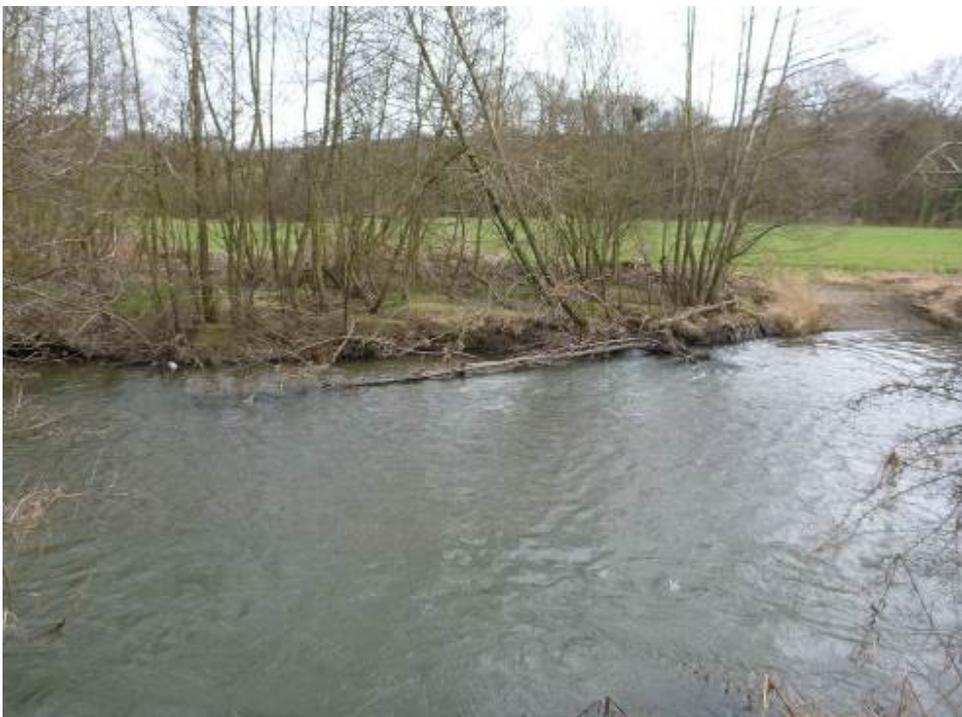
There are a number of areas on the right bank with abundant young trees. Some of these could be hinged and laid into the margins to provide good cover for fish, for example the area in Photo 15 (see Recommendations).

Photo 15 Riparian trees which have fallen into the river margins provide excellent cover for fish. Partially cutting and laying smaller trees such as these is an easy way of improving fish numbers.

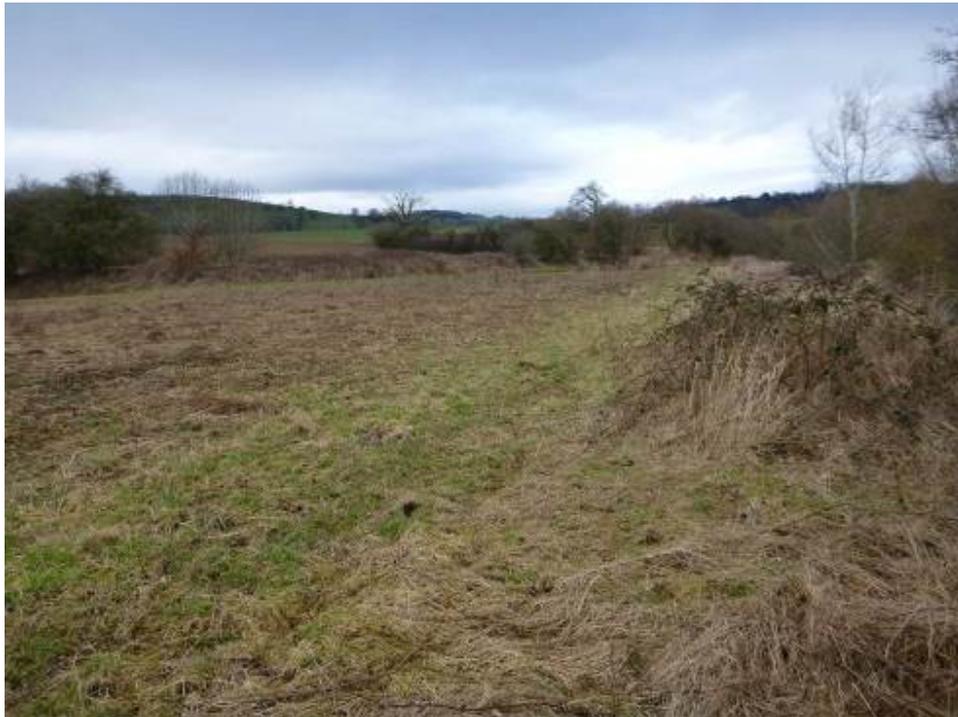
An area alongside the river on the left bank at approximate grid reference SO433718 is in a stewardship agreement which maintains a wide, uncultivated buffer between the river and arable land (Photo 16). The conditions of the agreement only allow cutting of vegetation in late summer, which presents an access problem for members of the fishing club. The club should discuss this with Natural England and the land manager to see if a dispensation could be negotiated to maintain foot access; this would not detract from the purpose of the buffer strip which is doing an excellent job in protecting the river from agricultural run-off and soil erosion.

Photo 16 A buffer strip separating arable land from the river. This is excellent practice for protecting the river, but the restrictions on mowing until late summer impact adversely on angling access. Some flexibility to allow foot access to be maintained is desirable.

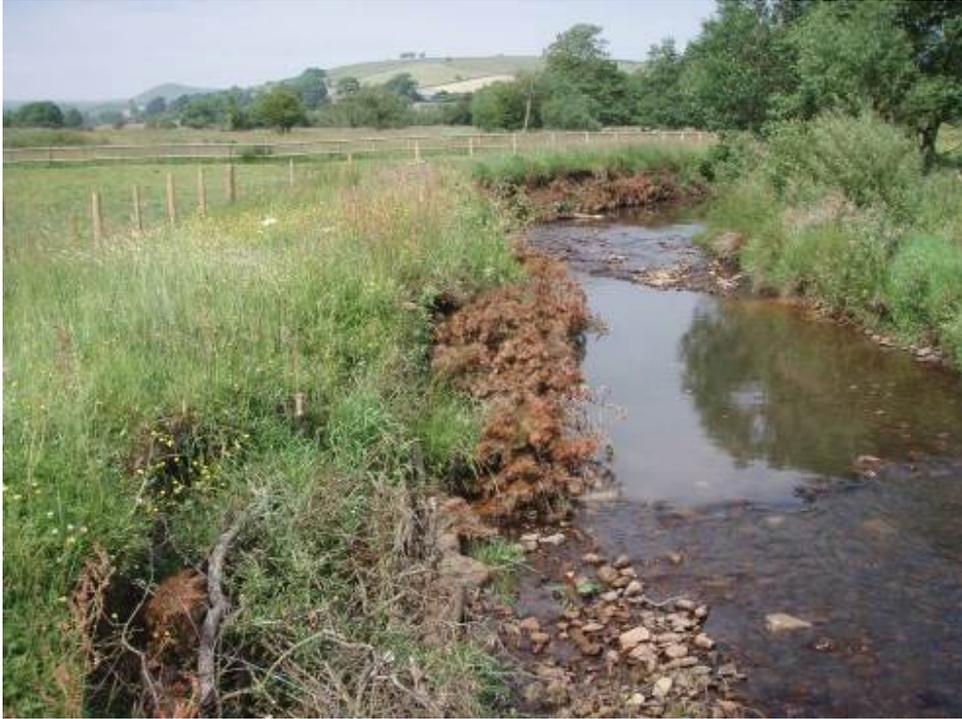
Photo 19 Conifer top revetment against an eroding bank on the River Manifold, Staffs. Note wide fenced adjacent margin which has also been planted with willow slips and is a vital part of the treatment.

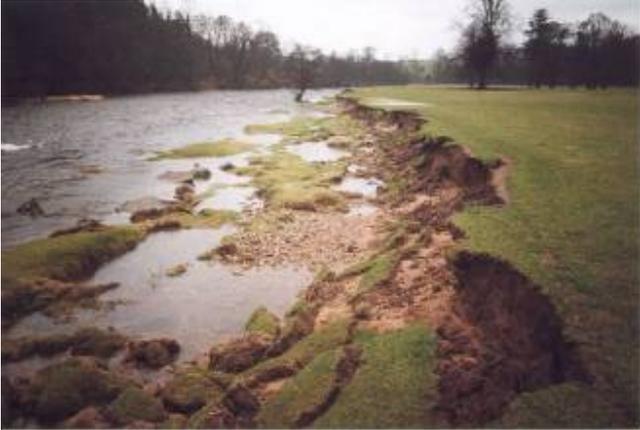
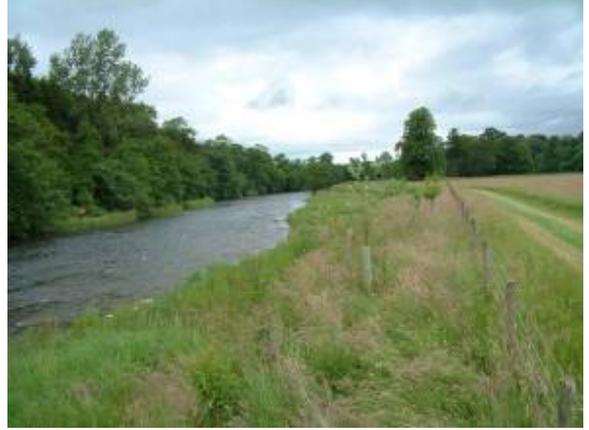
- Examples of fencing projects – before and after

River Eden, Crackenthorpe, November 1998

River Eden, Crackenthorpe, July 2002

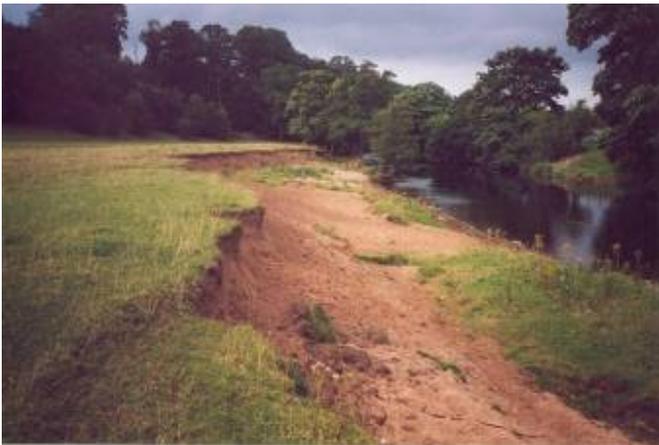
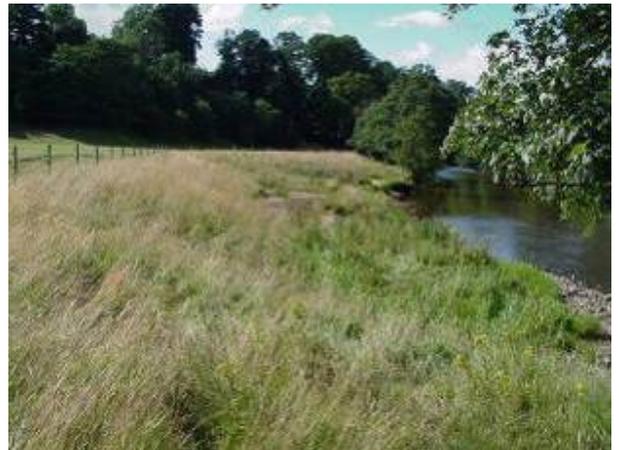
River Eden, Barrowmoor, October 1999

River Eden, Barrowmoor, August 2000

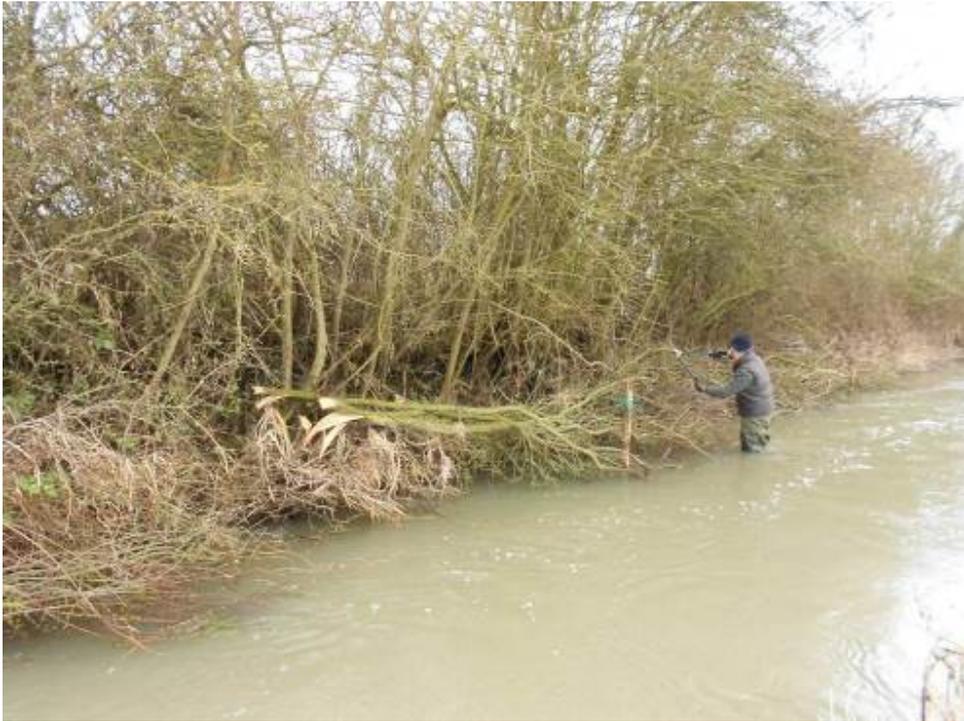
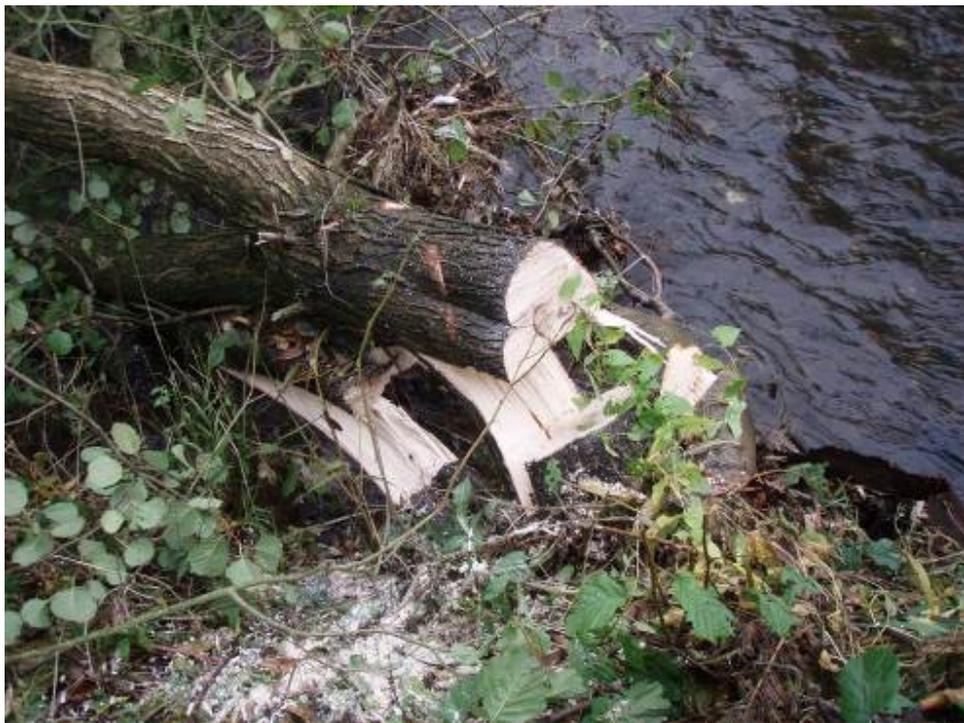
- Introducing low cover by laying smaller trees (up to 20cm diameter)

Partial cutting and laying of trees (like hedge laying) is a quick way of creating low cover which is firmly fixed to the bank.
