River Test, Fulling Mill, near Whitchurch, Hampshire

An Advisory Visit by the Wild Trout Trust June 2015

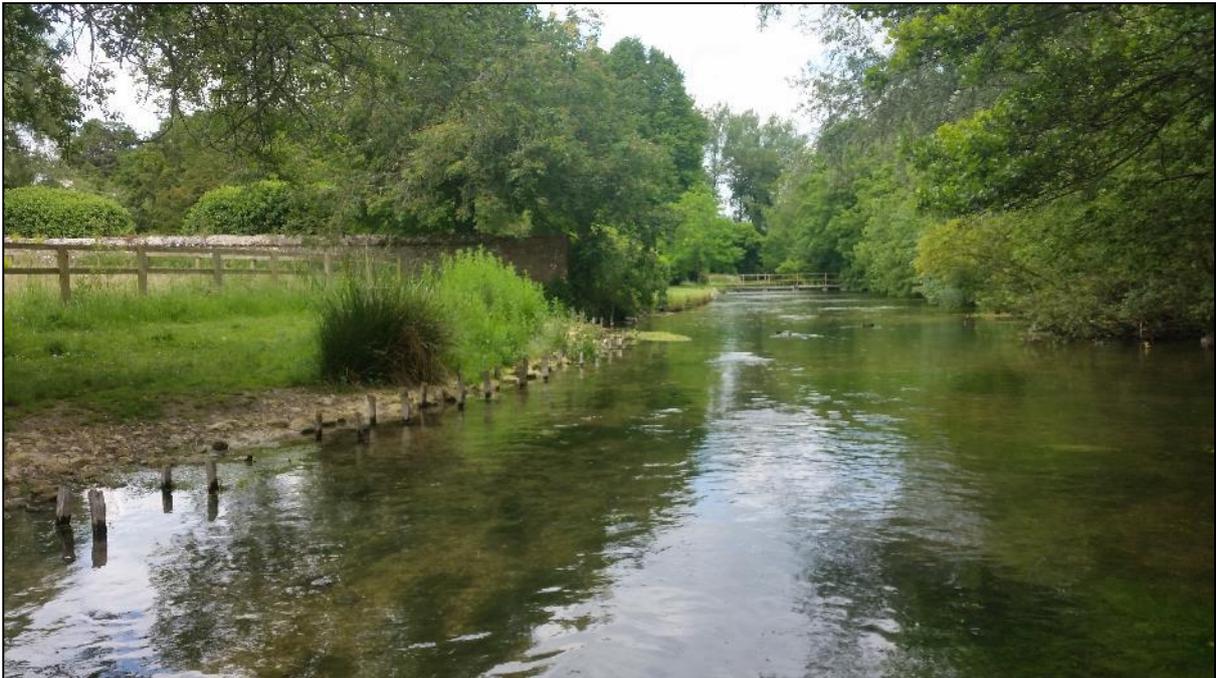
Figure 2: An upstream view of the upstream extent of the fishery

At the top of the reach it is apparent that, at some point in the recent past, a line of marginal brushwood faggot bundles has been installed. This may have been to introduce additional marginal habitat or simply an attempt to abate bank erosion.

The faggots have long since degraded, leaving only the stakes that held them in place (Figure 2). Whilst it is true that relatively high concentrations of people visiting riverbanks to feed ducks, walk their dogs or even just to paddle in the river can elevate the rate of bank erosion, the erosion in this location is not necessarily an immediate cause for concern. However, marginal vegetation can sometimes struggle to flourish against the impacts of trampling by people and dogs and browsing by waterfowl; this is probably why the hazel faggots were not replaced by marginal vegetation as they biodegraded.

4. The upstream extent of the fishery, which is frequented by members of the public (Figure 2) might benefit from the installation of a wide berm of gravel. This would form an accessible 'beach' next to the footpath and bench which would create a focal point where local people can enjoy the river. Attempting to completely exclude the public from the river will only result in less regard for the river and may in any case be an almost impossible task. Signage at this location pointing out that this section of the river is for public enjoyment but politely asking people to refrain from entering the river (or allowing dogs to enter the river) may help keep disturbance of fish, wildlife and anglers to a minimum. Displaying information regarding the value of chalkstreams and importance of the River Test as a Site of Special Scientific Interest (SSSI) may facilitate co-operation from the local community in this regard. Tying this sort of public engagement into a wider project could help win funding from public bodies that might otherwise be unwilling to fund improvements on a private fishery.

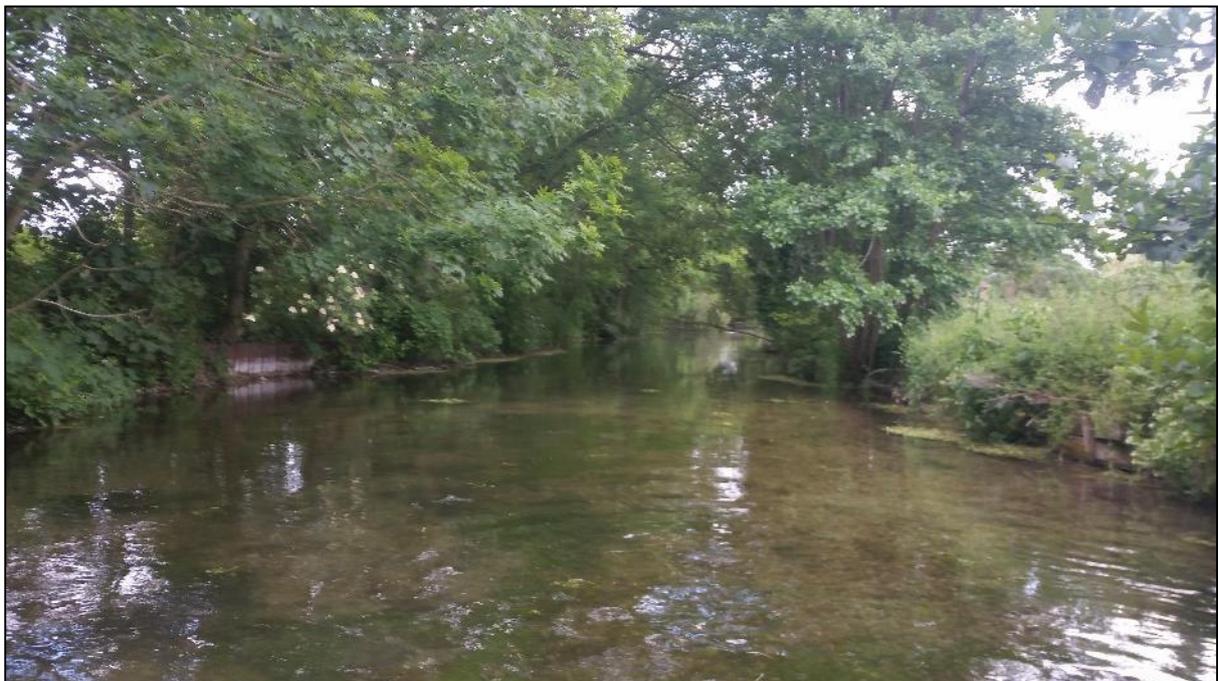
Figure 3: The river is straightened and overly-uniform in width and depth

The reach downstream from here to Fulling Mill is very uniform in width and depth (Figure 3). This is not particularly surprising considering that the river would have functioned as a leat when the mill was in operation. Channel uniformity is a major limiting factor affecting abundance and diversity of the habitat features required to support a healthy wild trout population. In a completely natural river system, the meandering plan form of the river, in combination with natural width variation and flow deflection from submerged structures such as fallen trees, ensure that bed material is regularly scoured from the bed and banks and deposited downstream. This creates a natural sequence of pools, riffles and glides as well as a range of micro-habitats and lies for fish.

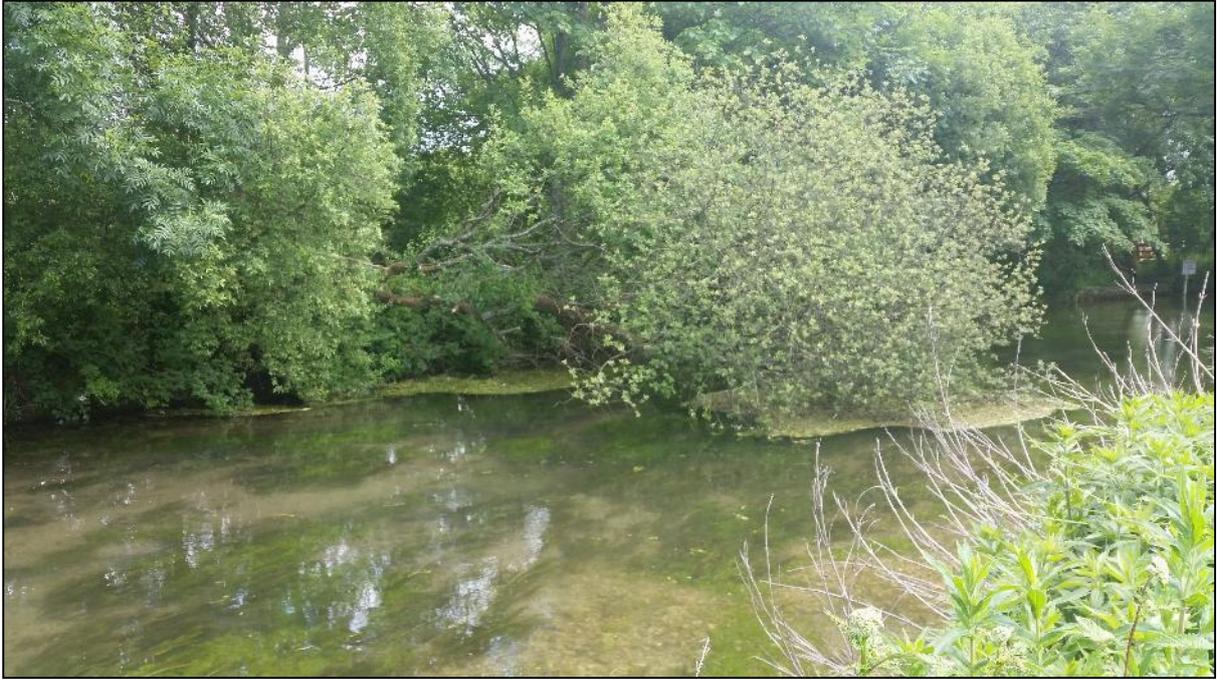
Figure 4: Naturally occurring woody habitat features help to diversify conditions

Fortunately, the uniformity of the channel is mitigated to a certain extent by occasional fallen willow limbs (*Salix* sp.) which provide excellent cover for trout and introduce some flow deflection and scour. The low, shrubby goat willows (*Salix caprea*) in particular along the LB, ensure that the low and trailing, marginal cover that trout favour is abundant (Figures 4 and 5). These also collect valuable rafts of weed that create further shade and cover for large adult trout. Rather than clearing these rafts to 'tidy' the river, as was historically the practice, such rafts

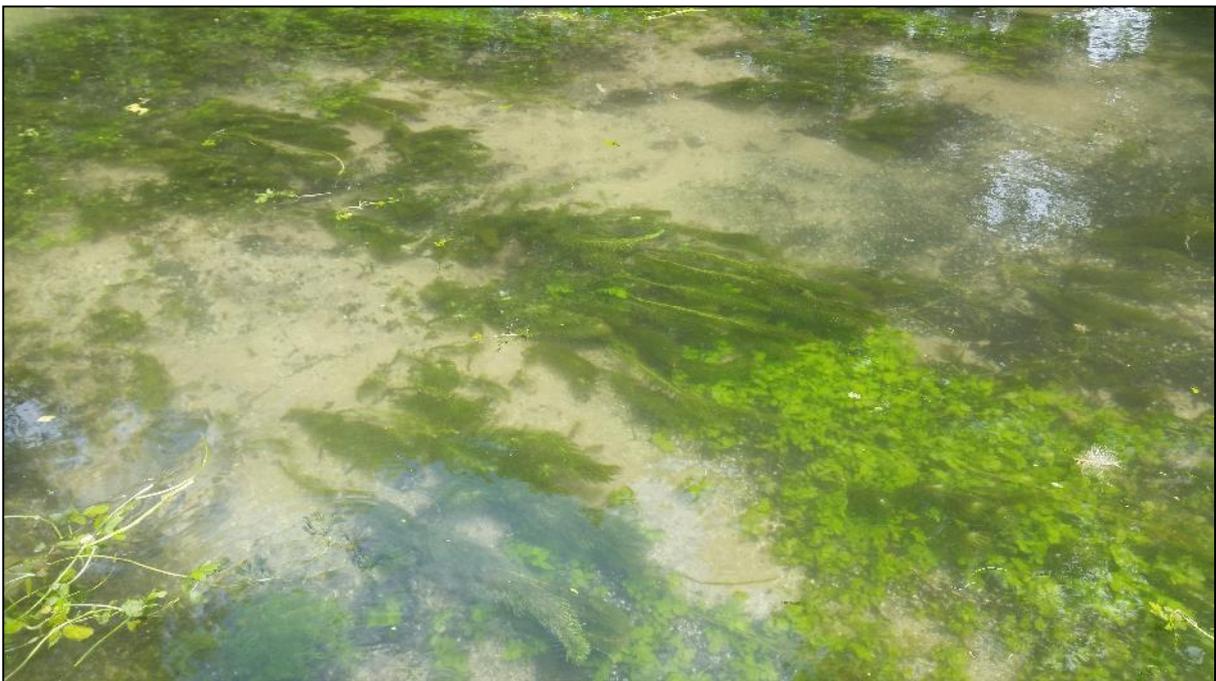
Figure 6: The uniform conditions have caused the bed to become smothered in fine sediment in places.

The uniformity of the habitat is further compounded by the channel being generally over-wide for its average flows. Shallow, wide points within a river are important features in themselves that provide good habitat for juvenile salmonids and other smaller fish; however, too great a length of wide channel can cause flows to become sluggish.

In this case, sluggish flows have allowed fine, sandy sediment to settle uniformly over the bed throughout much of the channel (Figure 6). This scenario can result in the gravel bed becoming smothered, infiltrated and compacted, making it difficult for salmonids to cut their redds (nests) and significantly reducing the survival rates of eggs and alevins (newly hatched salmonids still carrying their yolk sacks) with the gravel. Eggs and alevins require a constant flow of cool, well-oxygenated water to survive; if the interstices between the gravel grains become smothered with fine sediment, eggs and alevins can quickly suffocate. Deposition of fine sediments can also smother flow loving aquatic vegetation like water crowfoot (*Ranunculus* spp.), greatly reducing its health and abundance.

Introducing woody habitat features will help to enhance flow diversity within the reach, and if positioned correctly, will help mobilise fine sediment from the centre channel and allow it to settle in the margins. The introduction of some occasional pinch-points to locally narrow the river will energise flows and could significantly

enhance this effect. This could be achieved by creating some marginal berms, either from brushwood or with imported flint gravel of the appropriate size for the river. Berms can also be used to introduce sinuosity into the straightened channel.

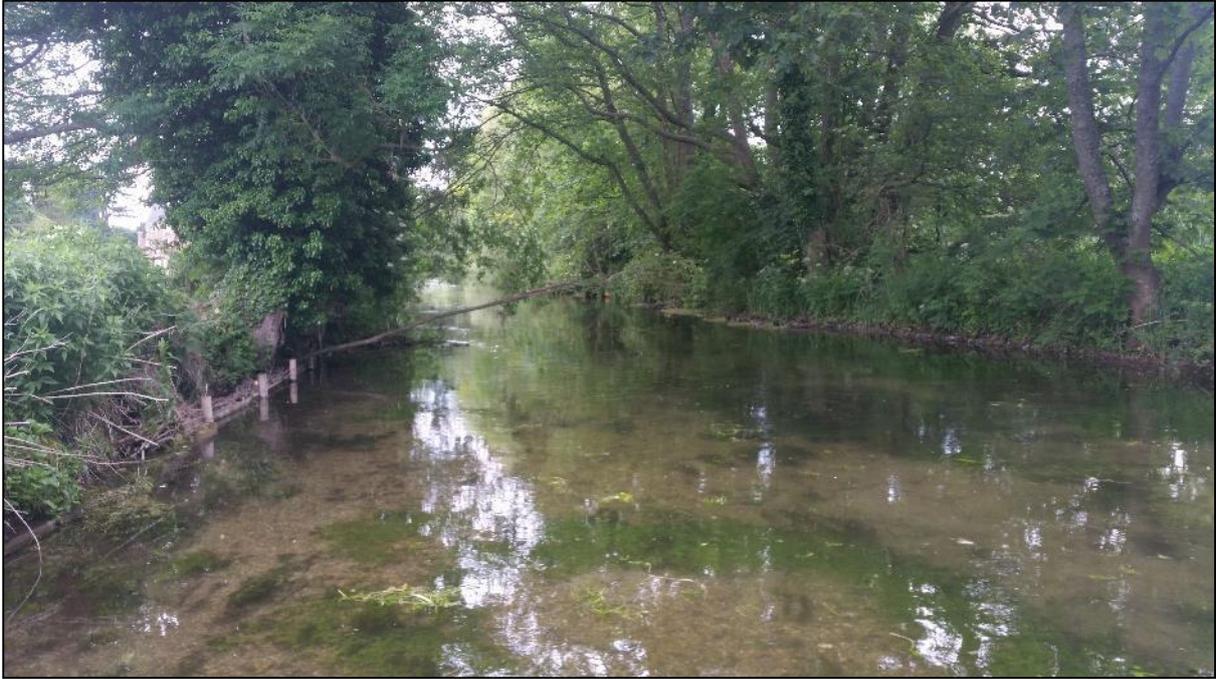
Figure 7: The lower extent of this reach is over-shaded, limiting in-stream productivity

Towards the lower end of the reach upstream of the mill, the banks are densely wooded and the river is over-shaded, inhibiting the growth of both marginal and submerged plants (Figure 7). Achieving the correct balance of light and shade over a river is essential. Too much shade and in-stream productivity can be hindered, too little shade and the river can become choked with encroaching marginal plants or vulnerable to spikes in temperature during periods of prolonged dry, hot weather.

A programme of tree works to create some occasional 'skylights' in the canopy would help to boost in-stream productivity. Allowing light into the river over shallower, narrower (faster-flowing) sections of river will encourage the growth of water crowfoot in particular.

1. A programme of tree works should be initiated to open 'skylights' in the canopies of the most over-shaded parts of the fishery, focussing on letting direct sunlight onto the margins and over shallow, faster-flowing parts of the river.

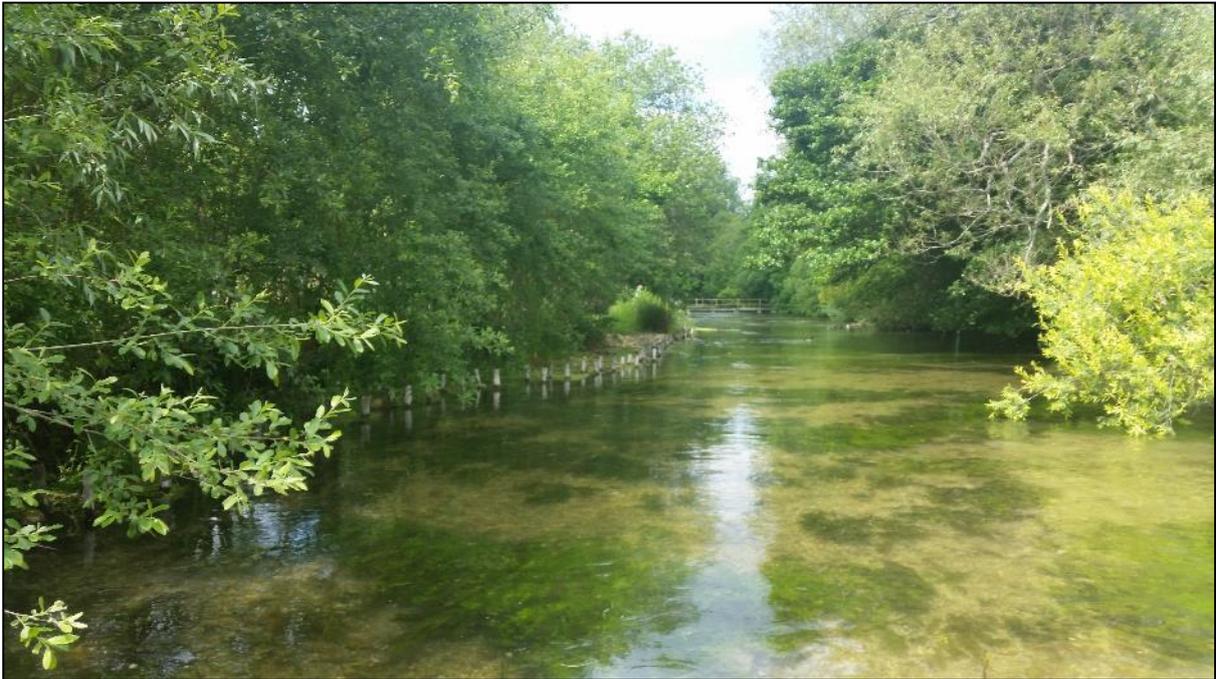
Figure 8: Past brushwood structures have become over-shaded and have failed to become colonised with marginal plants

When introducing new marginal habitat, for example via the creation of brushwood berms, it is important to consider light conditions and ensure that sufficient direct sunlight is available for the berm to become colonised by marginal plants. This is evidenced where stakes mark out the shape of previous coarse woody structures which have failed to become colonised by marginal plants under the heavy shade of bankside willows (Figure 8).

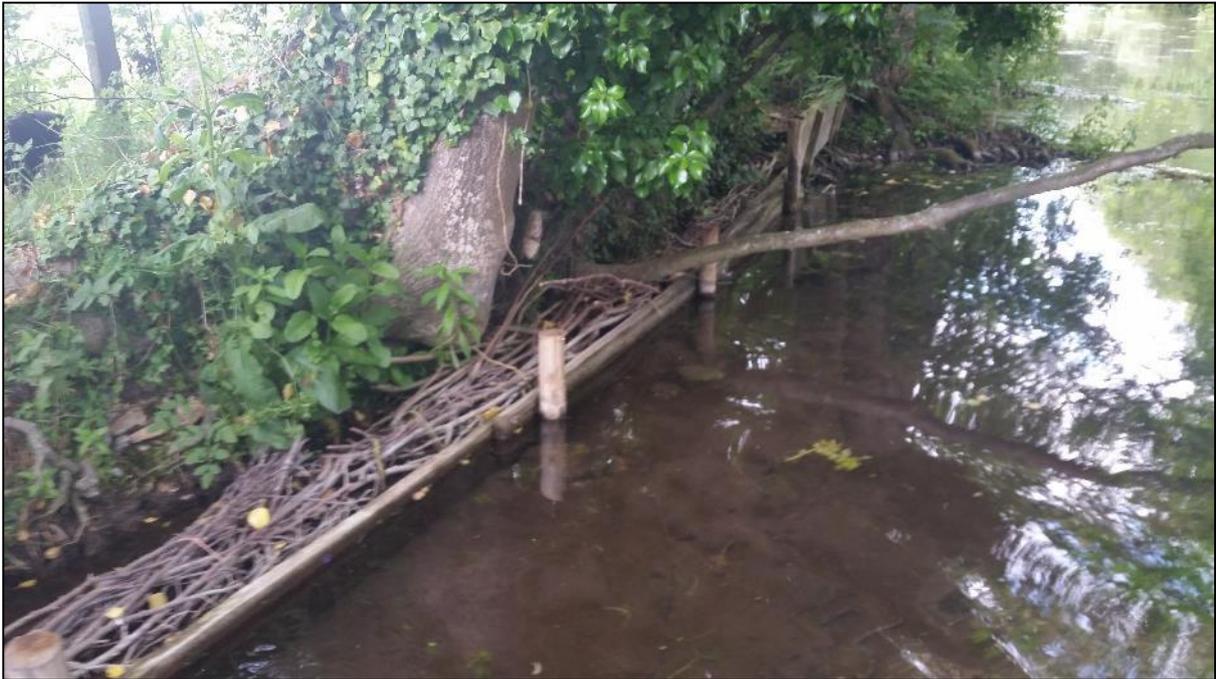
Figure 9: The wooden shuttering is in the process of being replace with brushwood faggots

Much of the RB along this carrier is retained behind shuttering boards, probably installed in an attempt to protect the footpath from erosion. In places, this is in the process of being replaced with brushwood faggot bundles which will provide much better marginal habitat (Figure 9). However, the density of tree cover makes it very unlikely that the faggots will become colonised and eventually replaced by marginal plants. In one location, brushwood faggots have been covered with gravel (Figure 10). This is a good option for protecting the footpath from erosion whilst also retaining a low-level shelf which will remain in place long-term and also create a saturated transitional habitat that will be colonised by marginal plants where light levels allow.

3. Wooden shuttering should be removed from the riverbank wherever possible and, if necessary, replaced with brushwood faggots secured

against the toe of the bank with sweet-chestnut stakes to create a sinuous margin. Covering the faggots with a sloping bank of imported flint gravel (leaving the brushwood exposed under the water) will help protect the footpath and also provide a saturated transitional habitat that will be colonised with marginal plants where light levels are sufficient.

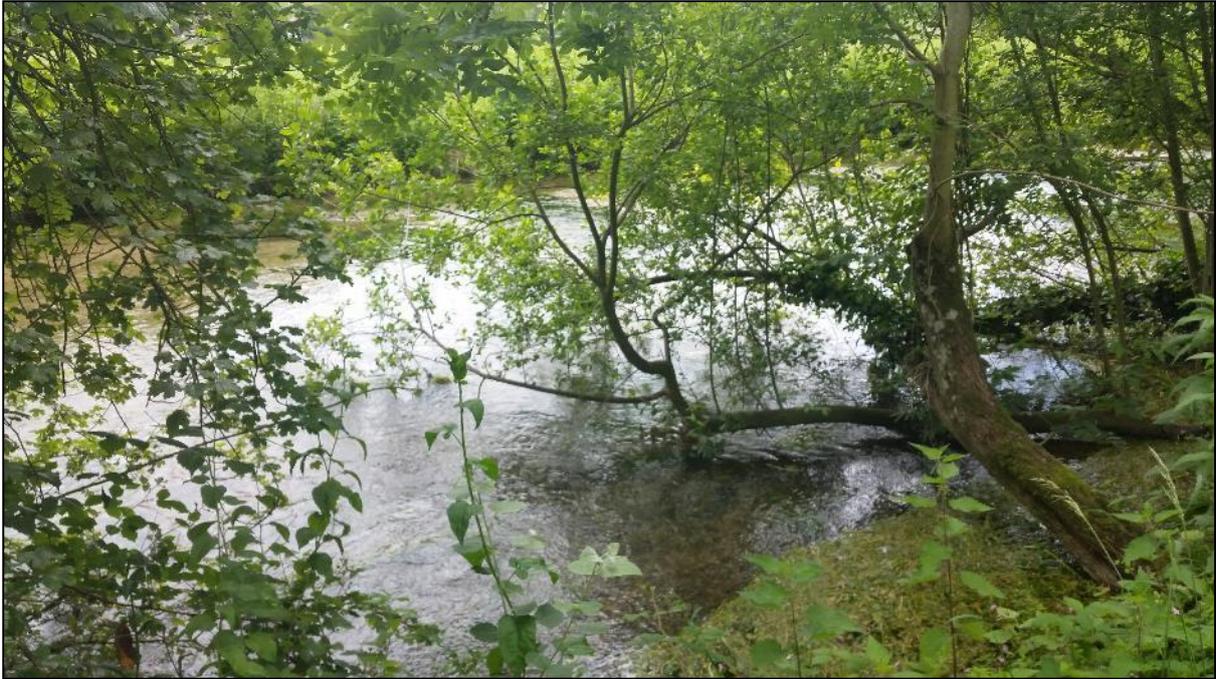
Figure 11: Low-growing limbs provide excellent cover and flow deflection

At the mill, the river is divided between three carriers. The main carrier takes flow around the mill through a straightened but relatively 'wild' channel. The RB in particular (owned by Mr Maitland) provides some good low cover in the form of low, tailing branches (Figure 11) and low growing shrubs. This reach could be enhanced by taking the opportunity to drop already heavily-leaning tree limbs (Figure 12) into the channel to provide some additional flow deflection and marginal habitat. These will then facilitate areas of increased scour and deposition,

site and folding some of the low-lying branches shown in Figure 11 into the margins of the river to provide some refuge habitat for juvenile trout could boost survival rates.

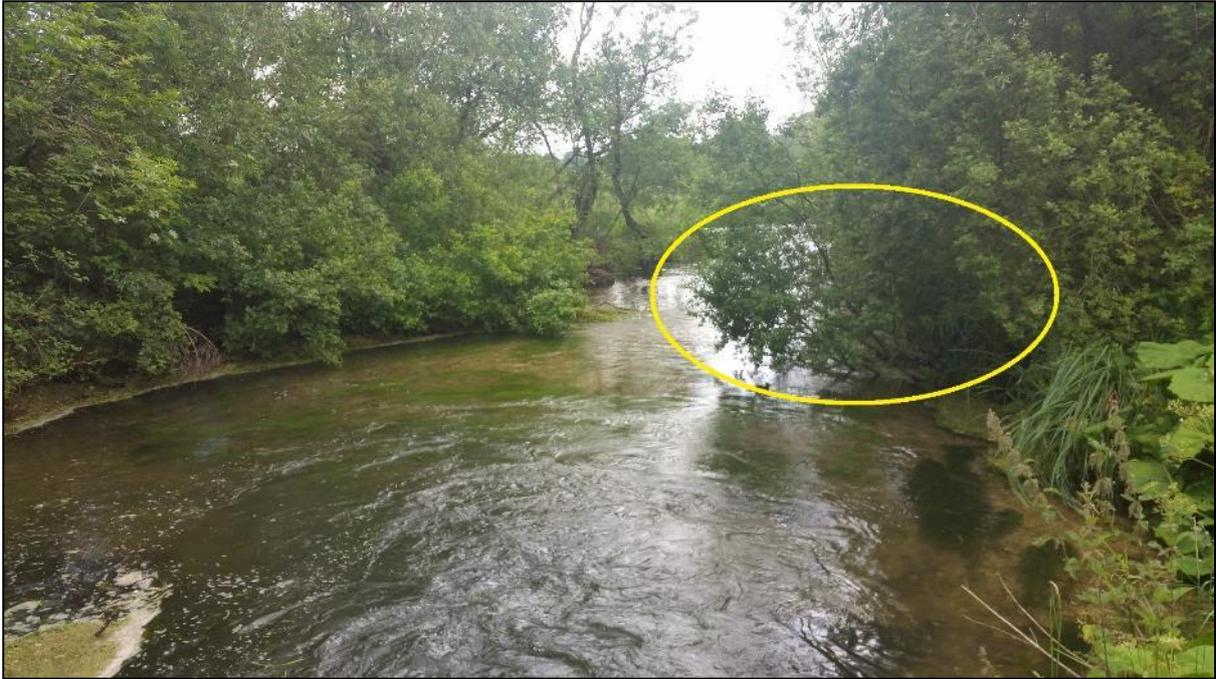
Figure 13: Low branches (highlighted) could be hinged into the water to provide cover for juvenile trout

The footings of an old sluice (no longer present) have scoured a deep pool at the top of this carrier. Gravel scoured from the pool has been deposited a short distance downstream to form a glide and riffle. This is a good potential spawning

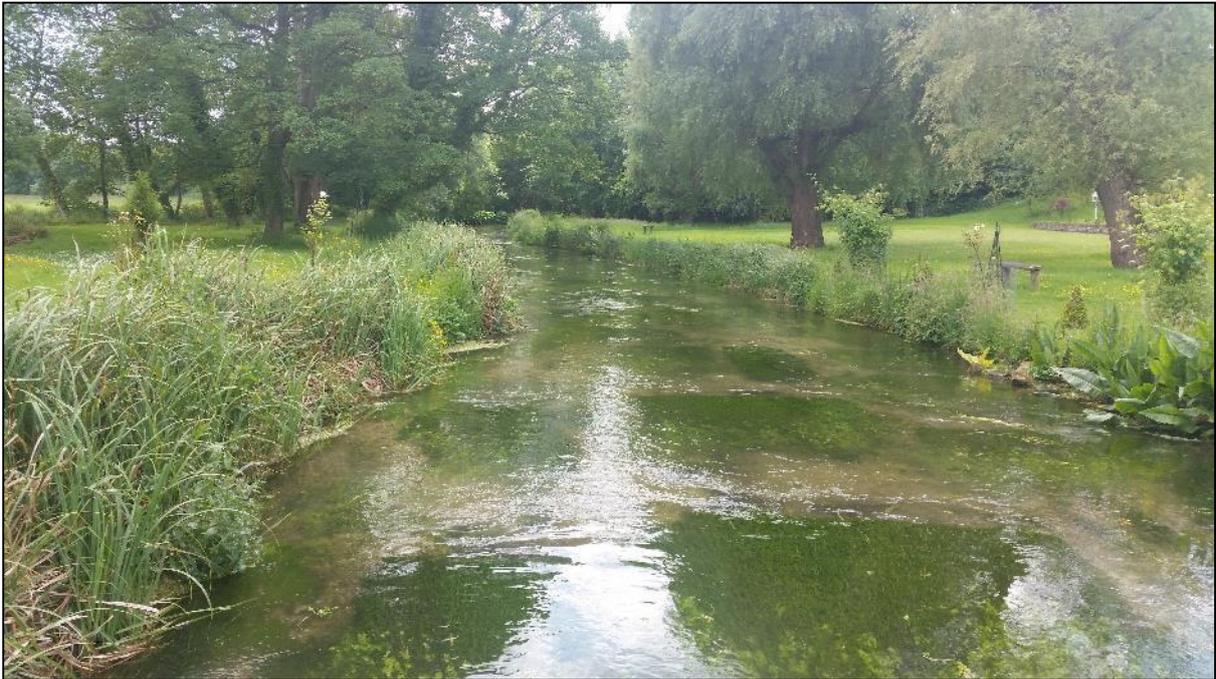
Figure 14: A hands-off approach to bank management has allowed a narrow but diverse margin to develop

The second carrier flows under the mill and out through the gardens of the property. Near the mill, the toe of both banks are retained behind wooden shuttering and marginal habitat is absent. However, after a few metres the management of the riverbank is much more sympathetic and a diverse margin of marginal plants has been allowed to flourish (Figure 14).

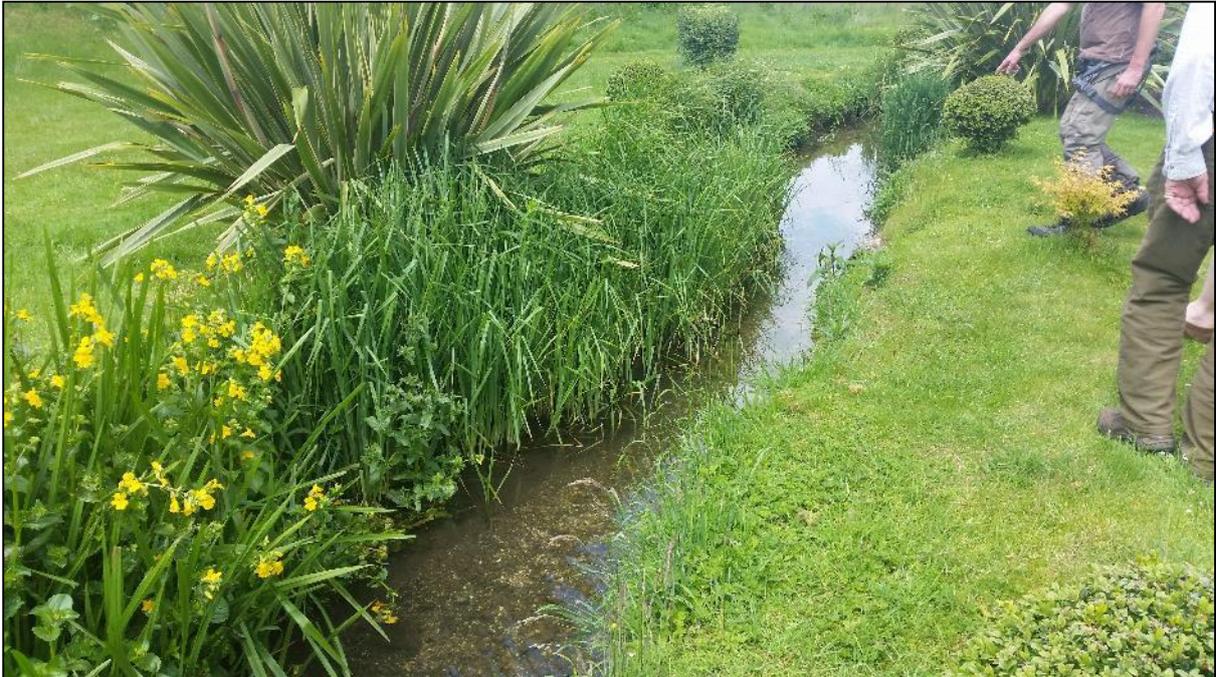
Figure 15: Native marginal cover is vital habitat for fry, but the alien, invasive monkey flower (yellow flowers) should be removed

The alien invasive plant, monkey flower (*Mimulus guttatus*), was observed (yellow flowers shown on Figure 15). This is not a particularly aggressive alien species but should nonetheless be removed.

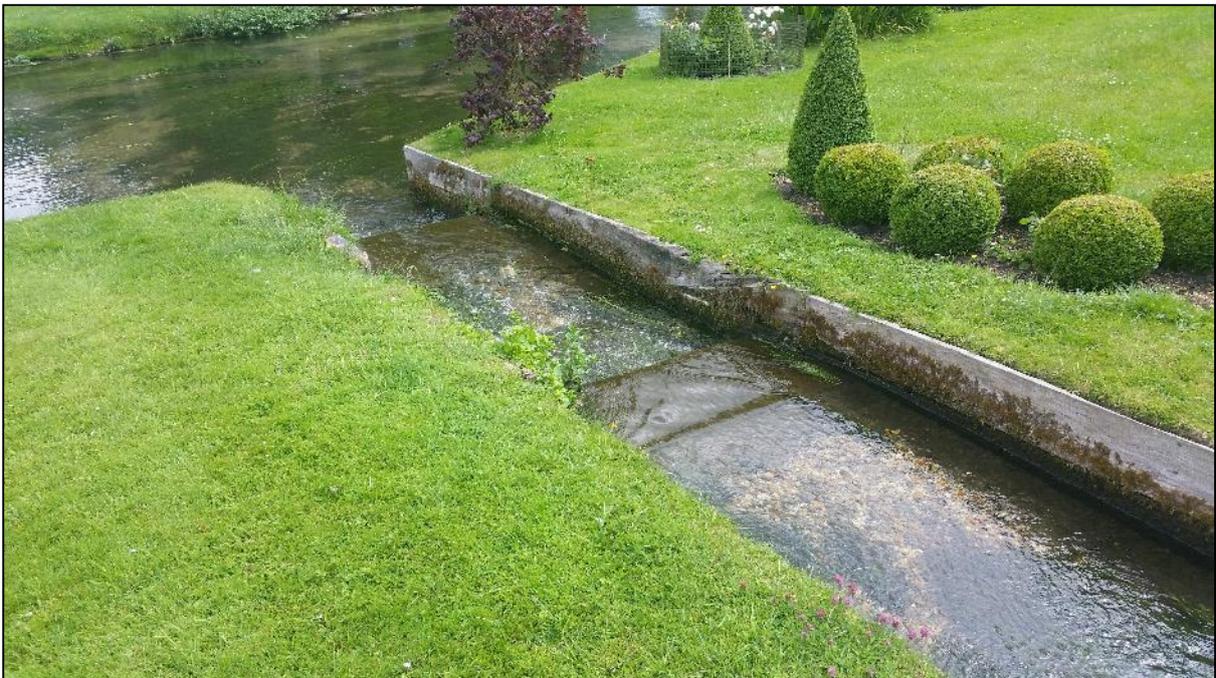
Figure 16: Shuttering and concrete weirs limit habitat quality at the confluence

The third carrier is a short and narrow stream flowing through the garden which would have once been part of the general operation of the mill. This stream has great potential as a spawning and nursery habitat for wild brown trout. Towards the upstream extent of this carrier a good abundance of marginal cover provides excellent refuge habitat for fry (Figure 15) but the banks of lower part of the stream are confined behind shuttering boards and two small weirs impede fish passage (Figure 16).

The weirs are probably passable to most adult trout, especially during winter flows. However, the wide crests of the weirs make the stream less accessible during lower flows and are a significant obstacle for smaller trout to overcome. These

structures should be removed but there is a risk that this action could lead to head-cut bed erosion which would strip out gravel and deepen the channel, reducing its potential as a nursery stream. A re-profiling of the stream post-removal, possibly introducing fresh gravel, may be required. This would make the stream more accessible for smaller fish and also improve its 'attraction flow'. Fish will instinctively follow the flow of greatest momentum (discharge x velocity) when attempting to run upstream. Improving the speed of flow emanating out from the confluence of the small carrier could make it more attractive and improve its potential as a nursery stream for the fishery.

The shuttering should be removed and the banks graded back and planted with marginal plants. This will increase the abundance of cover in the stream and should help boost invertebrate populations.

7. Remove the weirs and monitor head-cut erosion. If required, re-profile the stream plan form and cross section to mitigate against any bed erosion and maximise habitat diversity. Additional gravel may also be required to maintain good spawning habitat.
8. Remove the shuttering boards from the lower part of the stream and grade the banks back. Then plant turfs of marginal plants won from the river nearby into the bank.
