River Test – Tufton

An advisory visit carried out by the Wild Trout Trust – April 2009

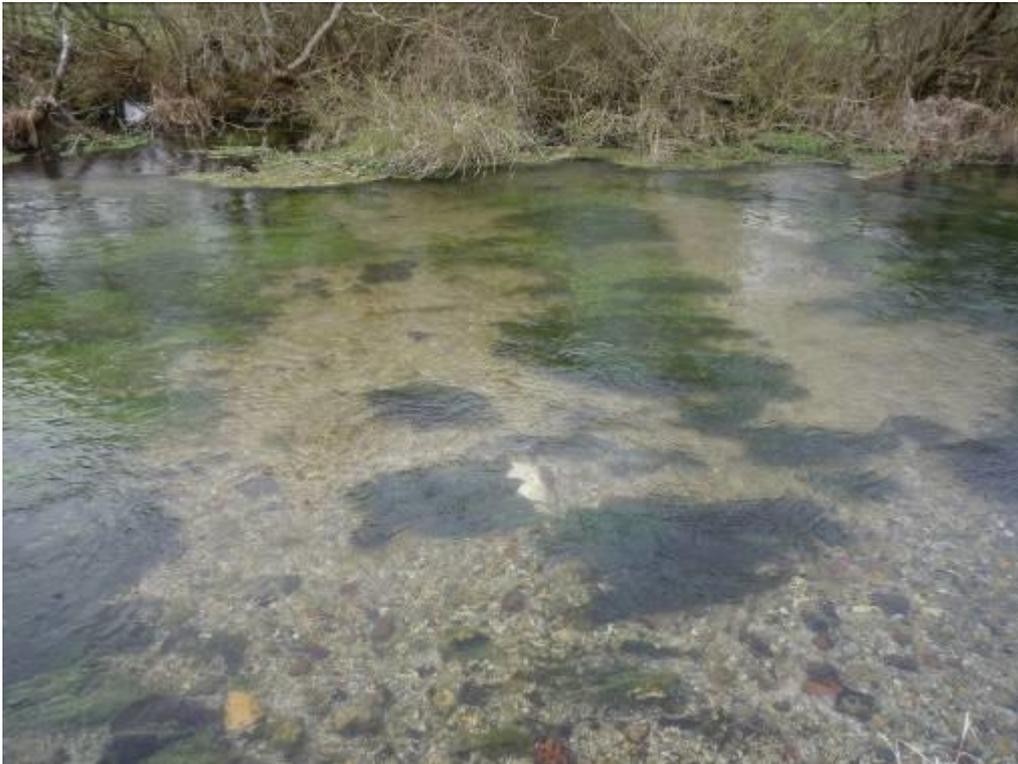
The top section of main river downstream of the A34 road bridge offers lots of potential for enhancement. The channel is far too wide in places for the given discharge and is predominantly made up of a long shallow glide. The gravel substrate within this section of channel appears to be of good quality and is reasonably well sorted due in the main to some careful weed management where a bar cutting technique is employed by the keeper. This has created some gentle diversity in channel depth.

Bar cutting techniques and a superbly covered margin provide excellent habitat for trout.

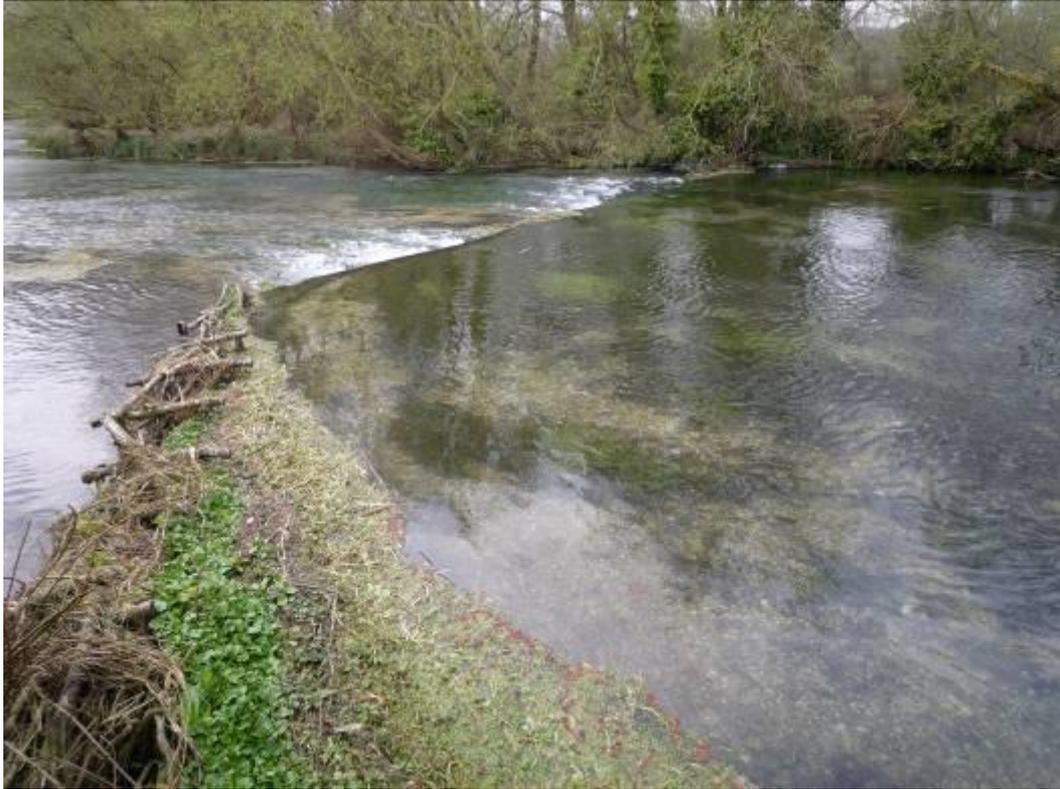
Two thirds of the way down the section there is a low downstream "V" weir which appears to have been constructed in an attempt to provide additional

water depth upstream, possibly to try and promote enhanced lies for trout. The bed upstream has regraded to some extent, negating any perceived benefits of increased water depth.

The low V weir where the bed has regraded upstream. Not an impediment to fish migration but a restriction on habitat development upstream. Note the presence of the red non-native plant *Azolla* in the foreground.

- To consider the partial lowering of the weir on the top main beat and undertake some radical narrowing on selected sections of the existing channel
- On other sections of main river use pegged down LWD to promote local bed scour, improving both holding and spawning potential
- Remove the old metal walkway on the bottom main river beat and keep the centre undershot sluices drawn for as long as possible
- Plant the odd overhanging goat willow on some of the more open sections of fishing bank
- Discourage the planting of daffodil bulbs and encourage a regime of local native plants
- On the carrier reconfigure the low weir or replace with a tree trunk half weir
- Consider the removal or bypass of one or both of the water level control structures on the Bye Carrier
- Consider an early move to using sterile stock fish

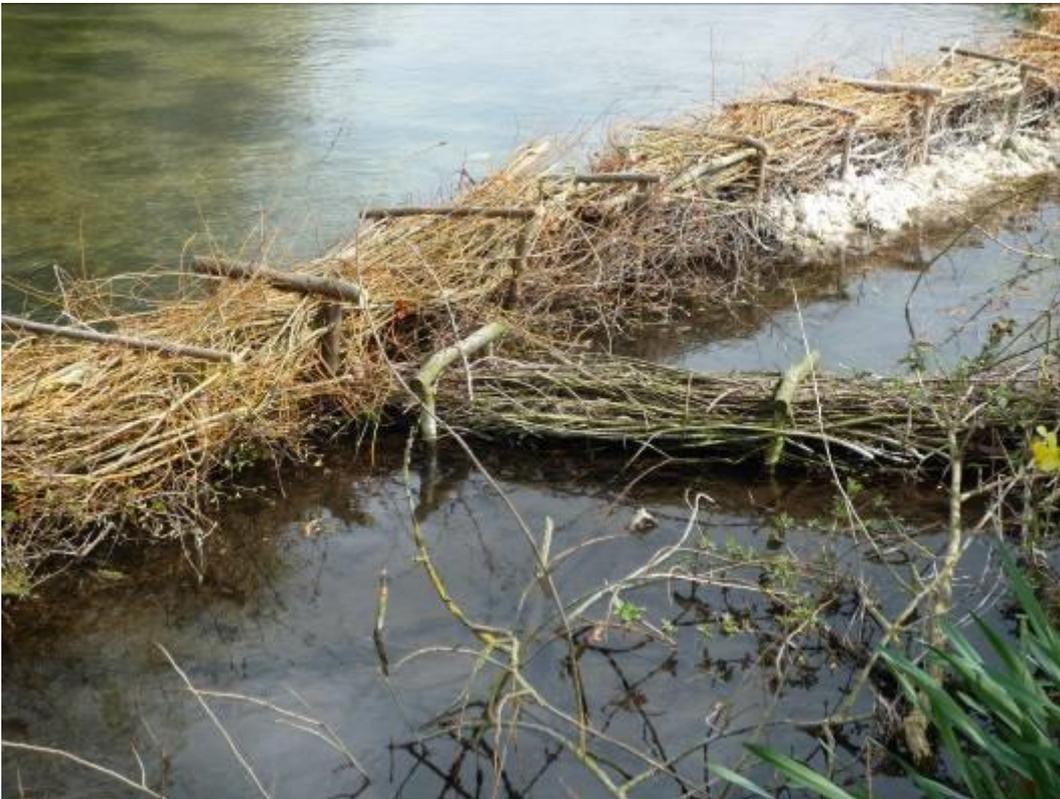
Some recent enhancement works designed to create better quality habitat.

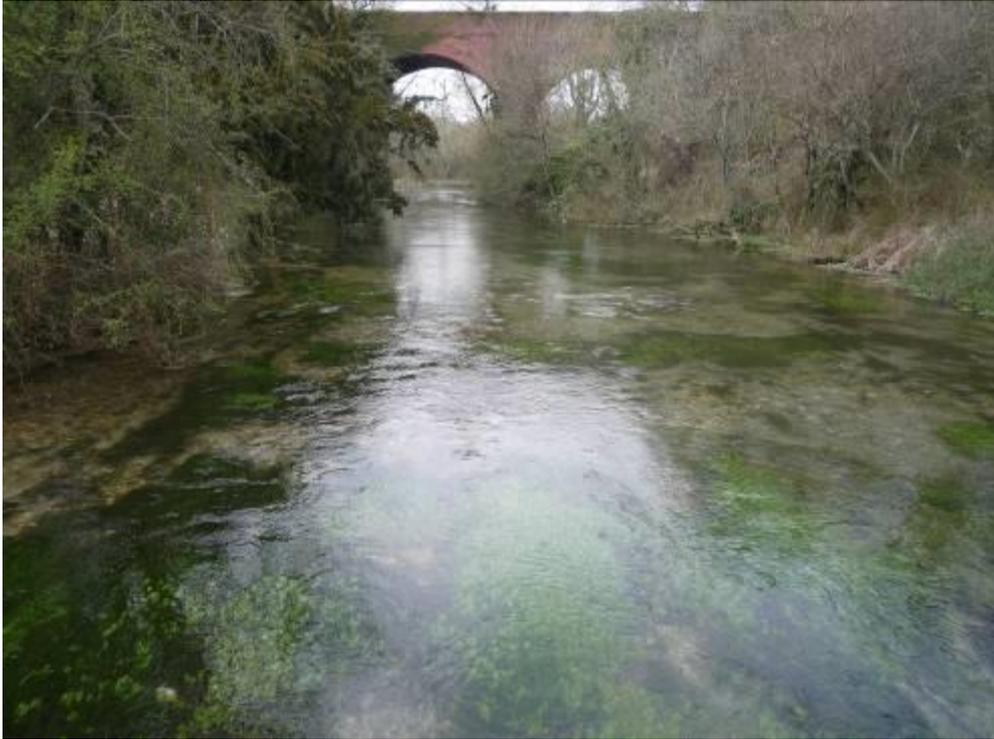
Main river looking towards the railway viaduct – A wide shallow channel which would benefit from a more varied depth profile.

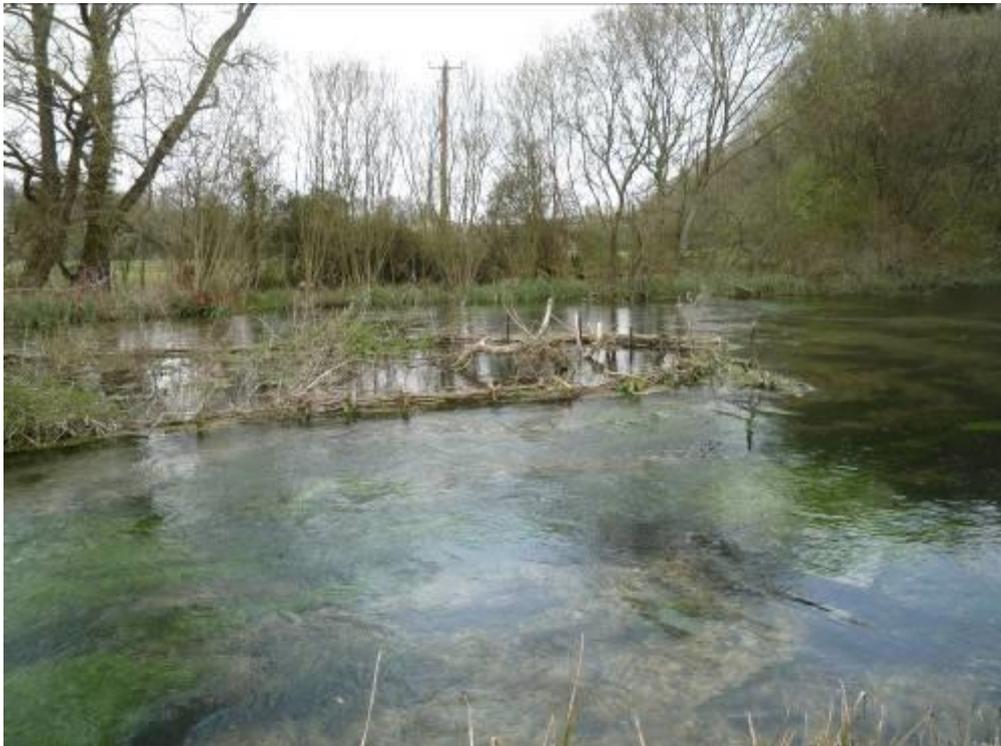
Main river below the viaduct where an island has been constructed. The upstream end of the island needs to be consolidated to protect the whole island from future washout

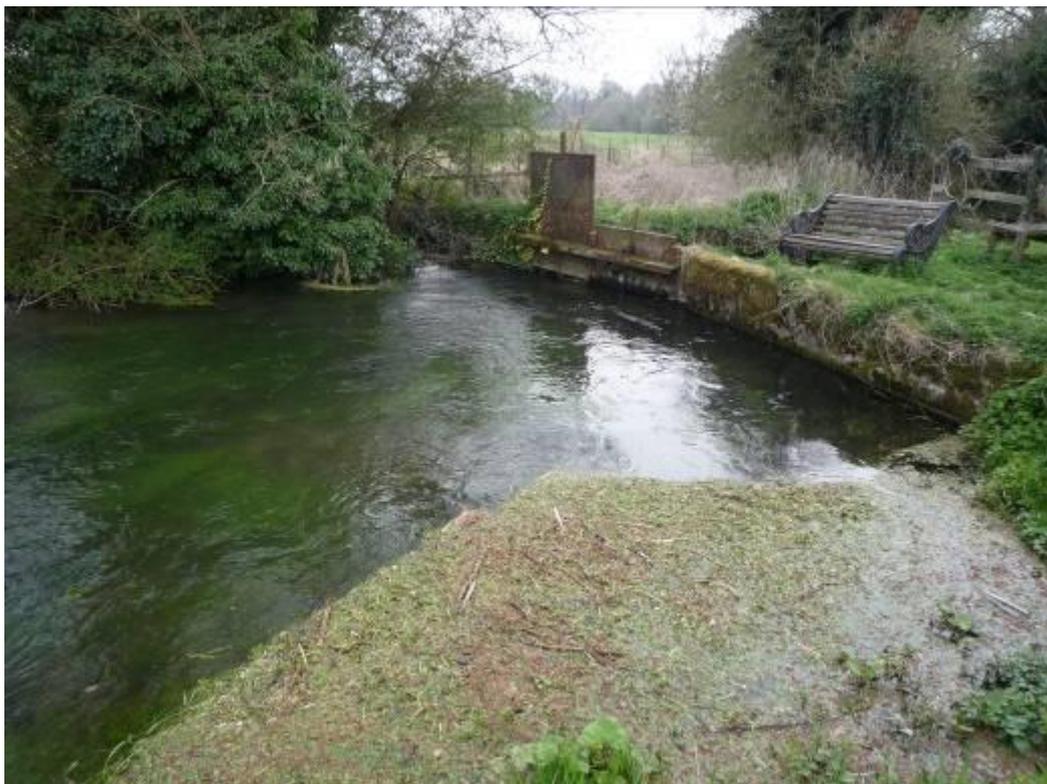
A large water level control structure with two undershot hatches sits approximately halfway along the beat. It is likely that this structure is critical in providing elevated water levels needed to maintain adjacent water meadows. If this facility is not required then it would be sensible to draw both hatches which will locally increase water velocities upstream and create better quality habitats for trout. Frequent manipulation of hatches will not allow the river to respond to changes in annual flow regimes and it is often better to keep them fully drawn for as long as possible.

Middle hatch on the top main river beat with one gate drawn.

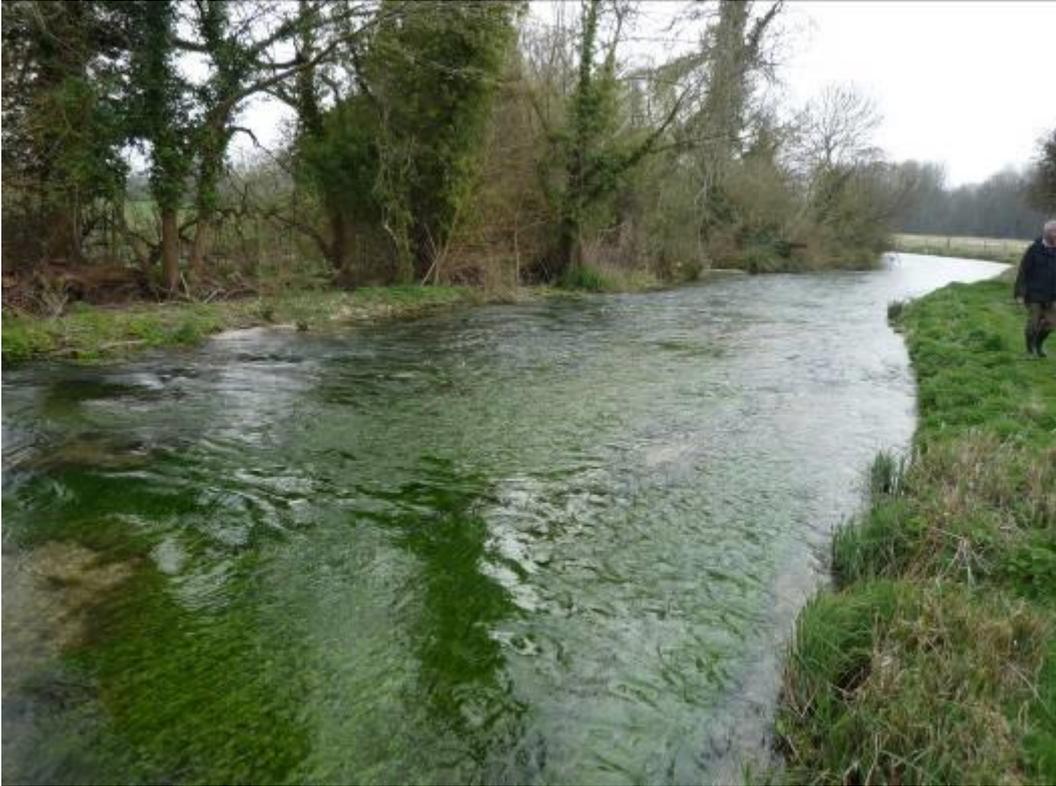
Excellent gradient on the main beat promotes good quality trout habitat

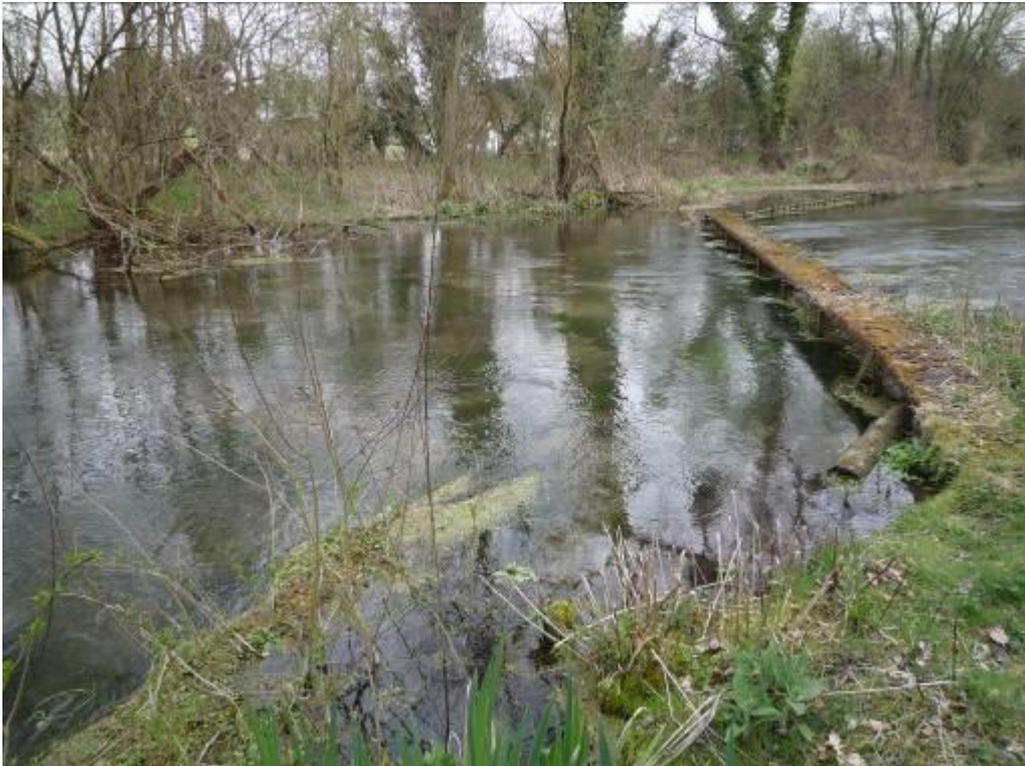
Near the bottom boundary there is an old metal walkway with numerous support stantions that was used to gain access to an old weed rack. The walkway will collect cut weed and debris very easily and unless cleared on a frequent basis will impound the river and reduce water velocities locally upstream.

Old metal walkway and stantions near the bottom boundary can catch cut weed and impound water velocities on the main beat

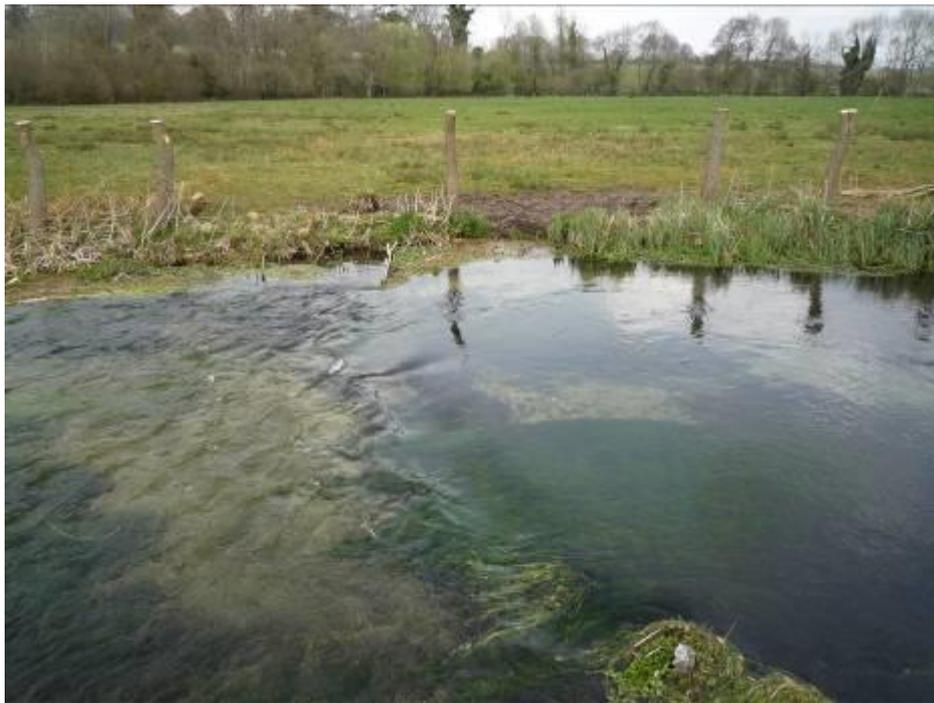
Near the top end of the carrier where it runs perpendicular to the valley some pollarding of marginal willows has taken place to provide a clear flight path for migrating birds. This is a good example of the overall sensitive manner in which the fishery is currently managed.

Pollarded willows where the carrier sweeps across the valley floor

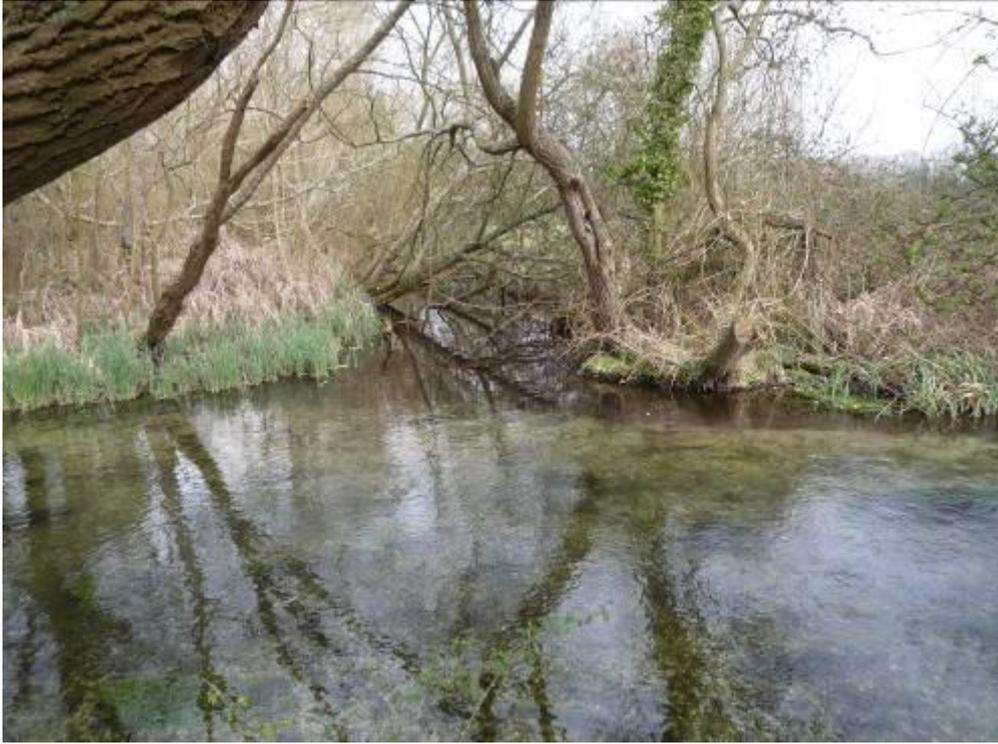
As the carrier swings round towards the margin of the water meadow, a network of valuable marginal habitats on the RB is revealed. These include some connected backwaters which provide critically important habitat for a range of species including eel (*Anguilla anguilla*) and lamprey (*Lampetra sp*). There were also good examples of habitat management with fallen tree bridges providing access for mammals and some large woody debris (LWD) tethered to the margin. LWD plays a vital role in providing habitat for invertebrates. When pegged down it can also act a valuable flow deflector, scouring lies for trout and throwing up fresh gravels for spawning.

A connected backwater on the RB – Superb habitat for a range of different species

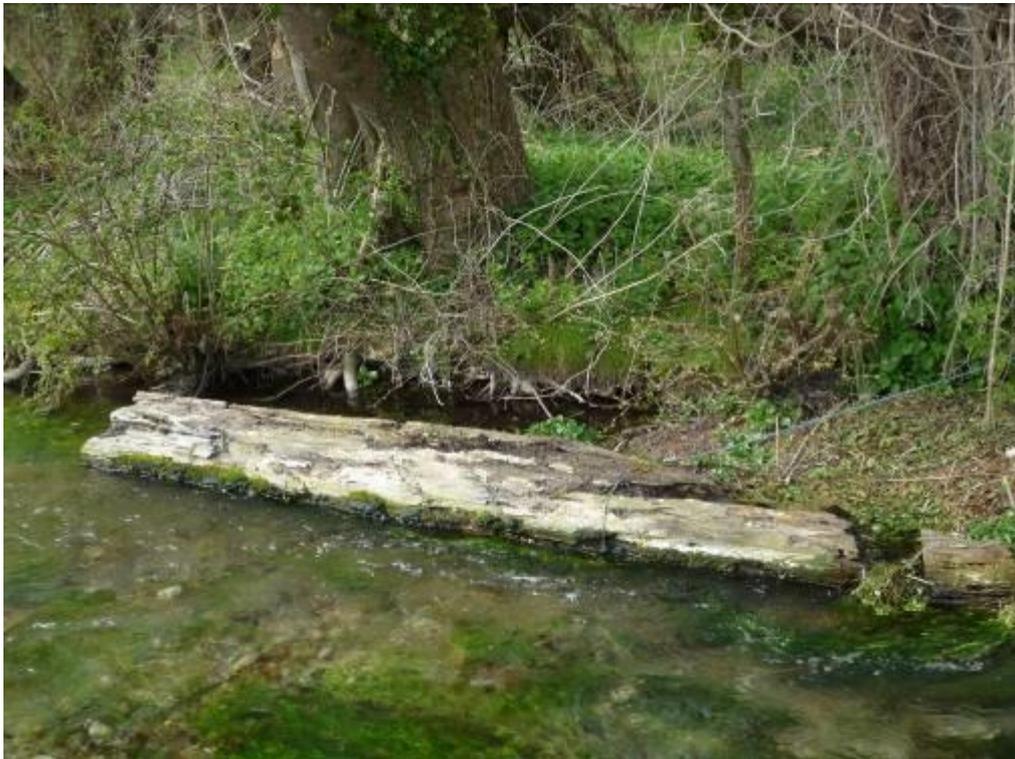
A piece of LWD tethered to the bank. The perfect “fly-board” and cover for juvenile trout

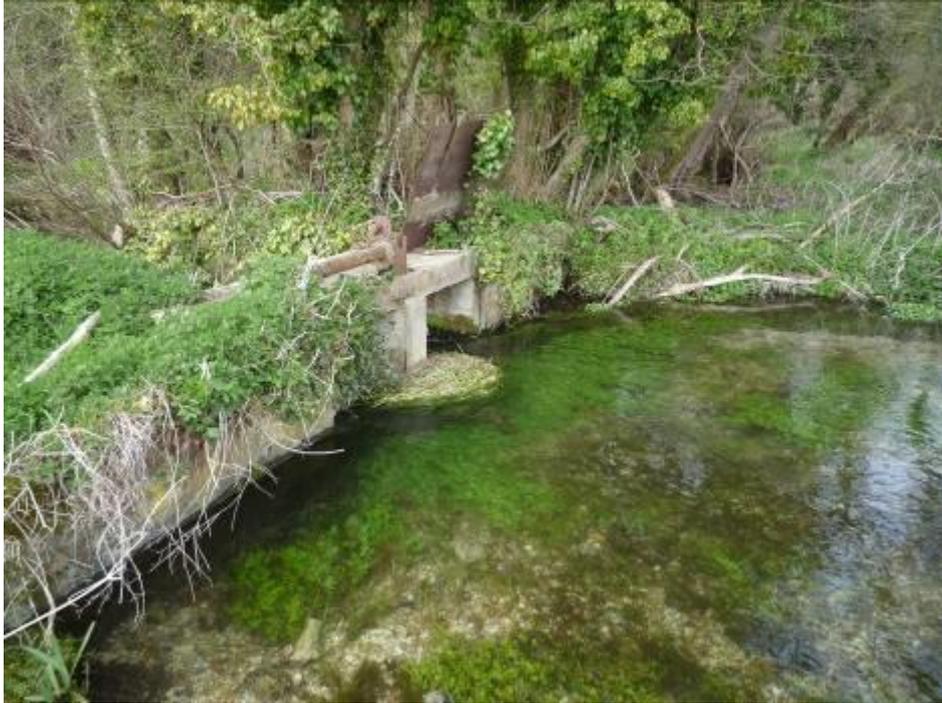
Further downstream there are two old water level control structures. These radically pinch the channel, slow upstream velocities and potentially collect large

Old water level control hatch – Is it really needed?

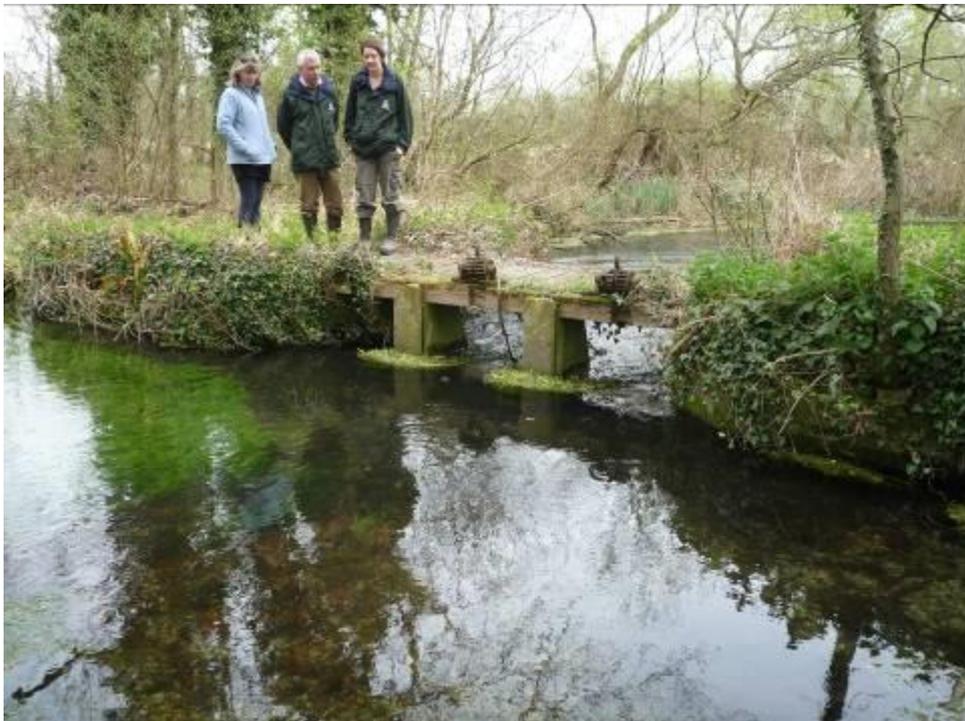
rafts of floating weed and debris. On the downstream structure it might be possible to cut a new channel adjacent to the old weir which will preserve the historical nature of the hatches but will radically improve habitat and require far less maintenance.

Bottom hatch which lends itself to being bypassed with a cut-through channel

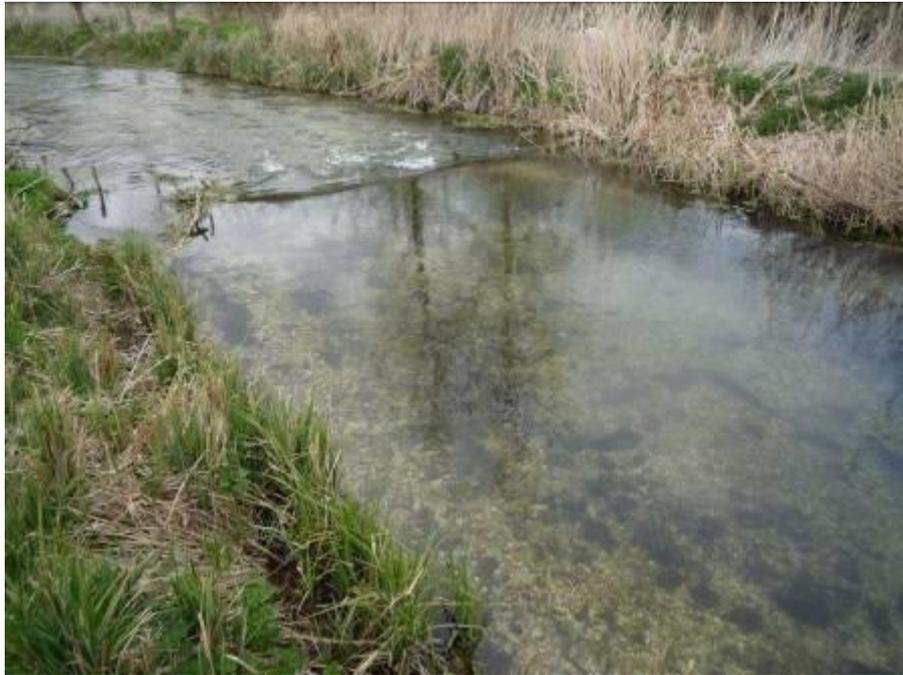
At one or two locations some structures have been installed in an attempt to enhance trout habitat. Full channel width weirs tend to create a few metres of decent habitat at the expense of long sections upstream of the structure. A much better option to promote local scour and enhance holding pools, as well as improving spawning substrate, is to peg in short sections of LWD. This can either be used parallel to the flow or pegged in at slightly upstream angles when used as a half weir

A small weir which looks to have been installed for fishery purposes. A half weir created by pegging in a tree trunk would be a better option

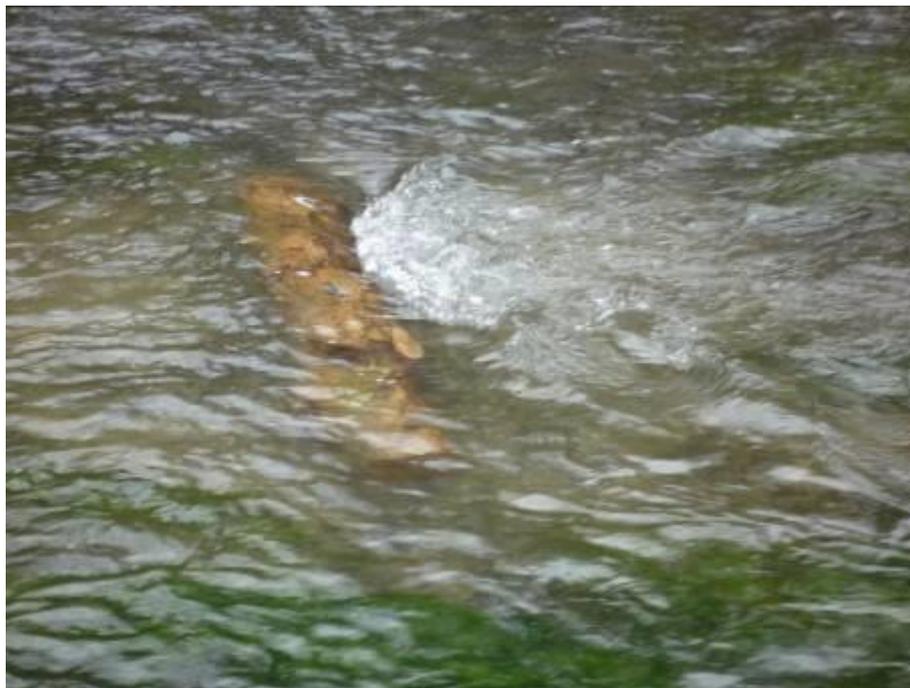
An example of a piece of LWD used to promote local scour on a riffle and promote enhanced spawning habitat

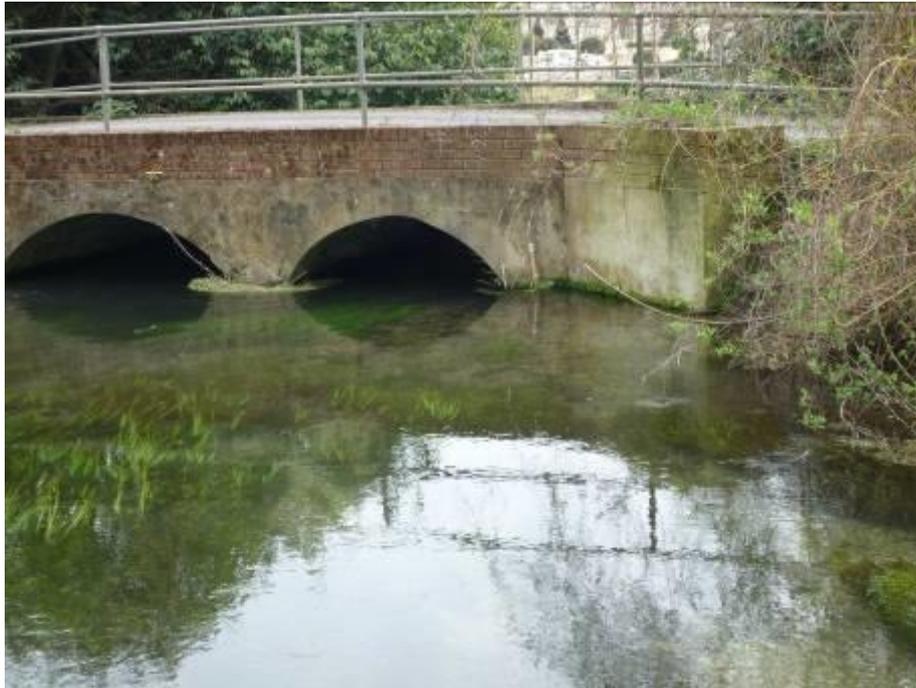
At the very bottom boundary the river flows beneath the road bridge adjacent to the Testbourne estate. The right-hand arch does appear to be smaller than the left and reduced flows through this arch may well have resulted in some accretion of sediments and fine gravels. Lowering the bed level through this right hand arch down to the original invert will help to pull water through the carrier and increase velocities and promote better quality habitat.

Road bridge at the bottom boundary. Lowering the bed level beneath the right hand arch should promote increased velocities in the bottom of the carrier
