## River Test – Tufton

An advisory visit carried out by the Wild Trout Trust – April 2009

This report is the output of a Wild Trout Trust advisory visit undertaken on the River Test at Tufton near Whitchurch in Hampshire. The advisory visit was carried out at the request of the Hampshire Wildlife Trust. The Trust is looking at various options for enhancing local biodiversity and exploring possible habitat enhancement opportunities under Higher Level Stewardship agreements with the landowners.

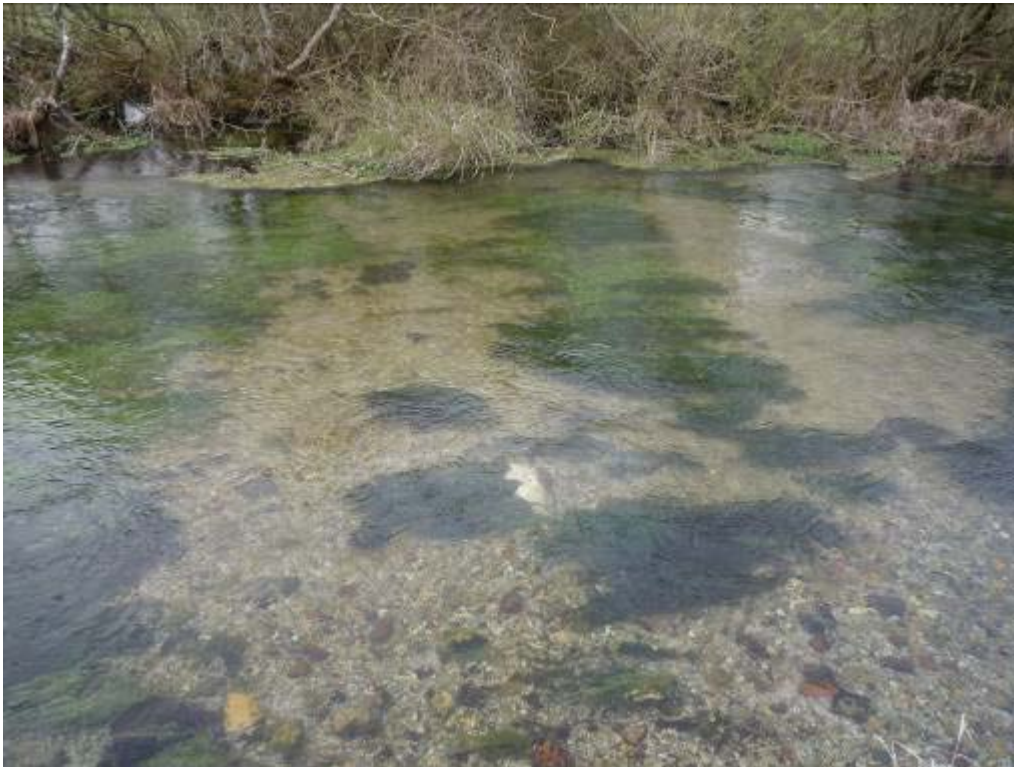
Bar cutting techniques and a superbly covered margin provide excellent habitat for trout.

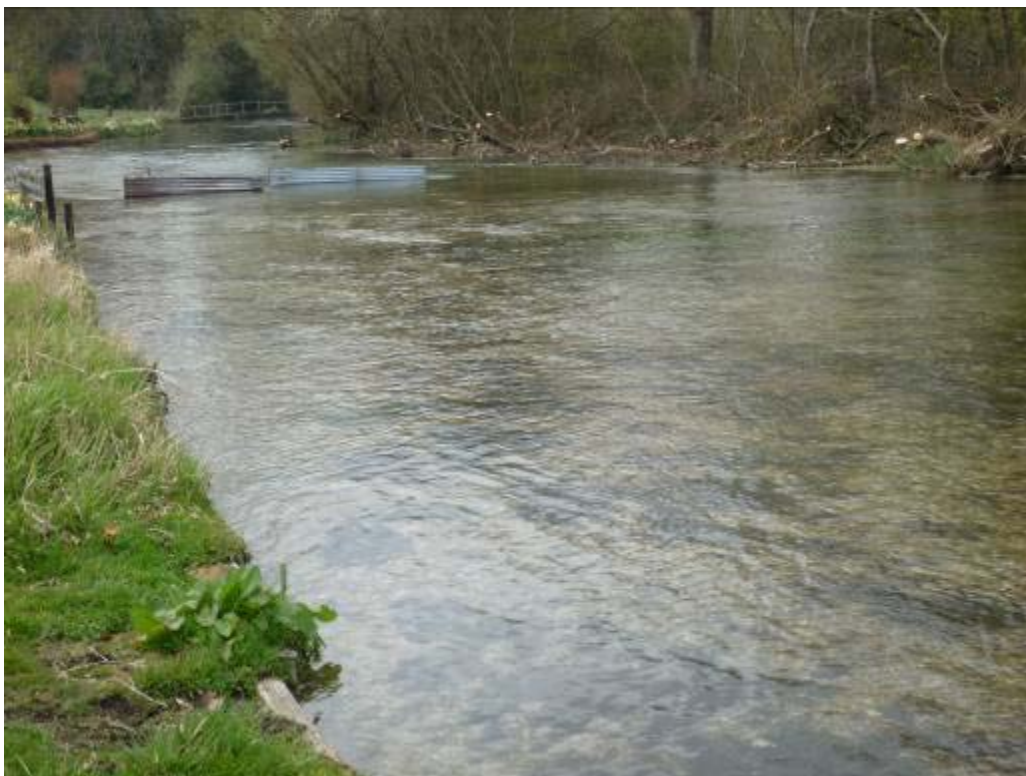
The top section of main river downstream of the A34 road bridge offers lots of potential for enhancement. The channel is far too wide in places for the given discharge and is predominantly made up of a long shallow glide. The gravel substrate within this section of channel appears to be of good quality and is reasonably well sorted due in the main to some careful weed management where a bar cutting technique is employed by the keeper. This has created some gentle diversity in channel depth.

The very wide and shallow channel and temporary mud engine

- To consider the partial lowering of the weir on the top main beat and undertake some radical narrowing on selected sections of the existing channel
- On other sections of main river use pegged down LWD to promote local bed scour, improving both holding and spawning potential
- Remove the old metal walkway on the bottom main river beat and keep the centre undershot sluices drawn for as long as possible
- Plant the odd overhanging goat willow on some of the more open sections of fishing bank
- Discourage the planting of daffodil bulbs and encourage a regime of local native plants
- On the carrier reconfigure the low weir or replace with a tree trunk half weir
- Consider the removal or bypass of one or both of the water level control structures on the Bye Carrier
- Consider an early move to using sterile stock fish

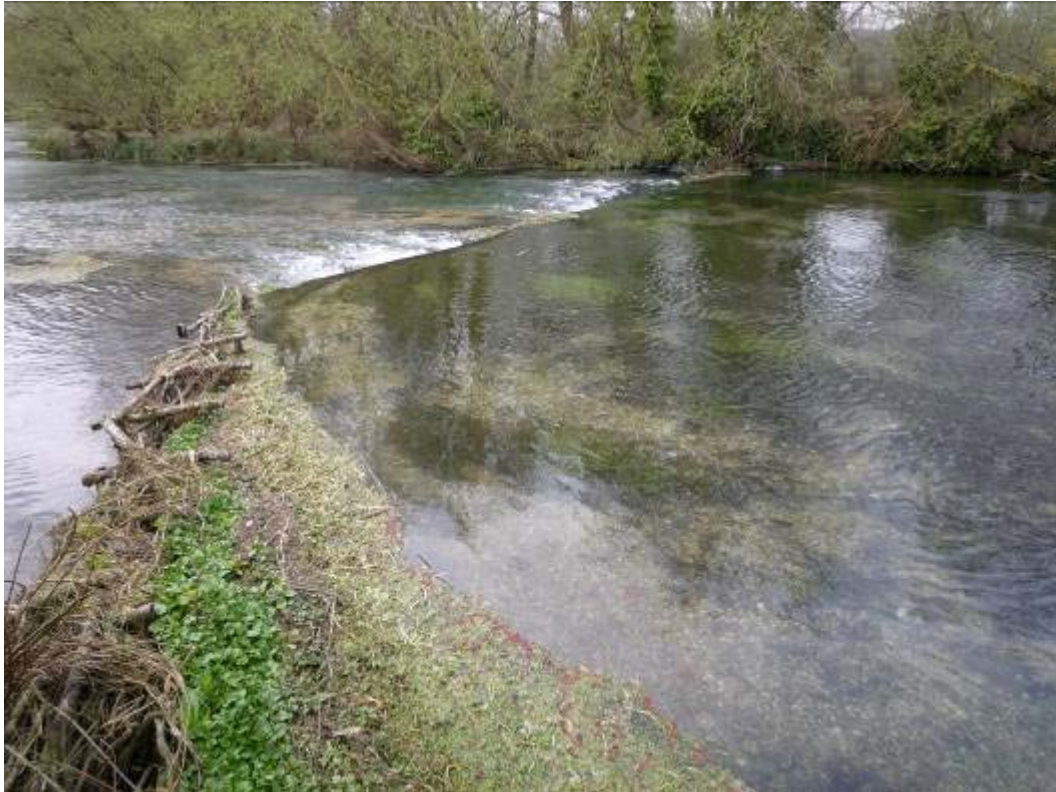
Two thirds of the way down the section there is a low downstream "V" weir which appears to have been constructed in an attempt to provide additional

water depth upstream, possibly to try and promote enhanced lies for trout. The bed upstream has regraded to some extent, negating any perceived benefits of increased water depth.

The low V weir where the bed has regraded upstream. Not an impediment to fish migration but a restriction on habitat development upstream. Note the presence of the red non-native plant *Azolla* in the foreground.

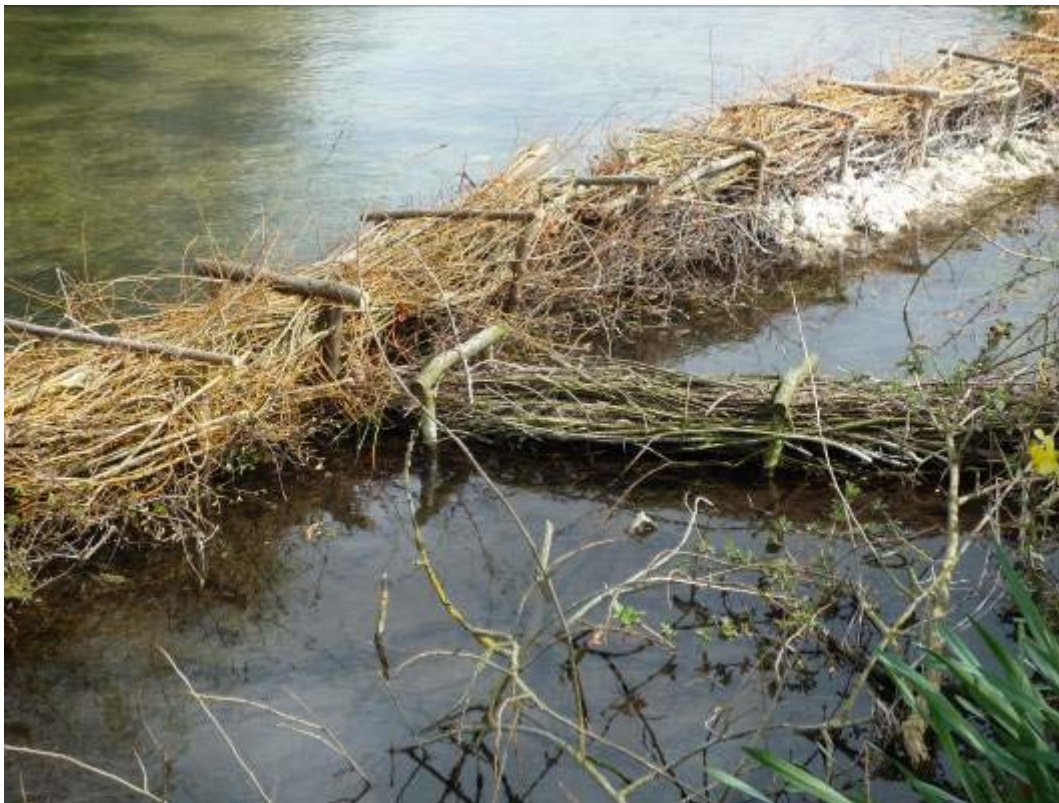
Some recent enhancement works designed to create better quality habitat.

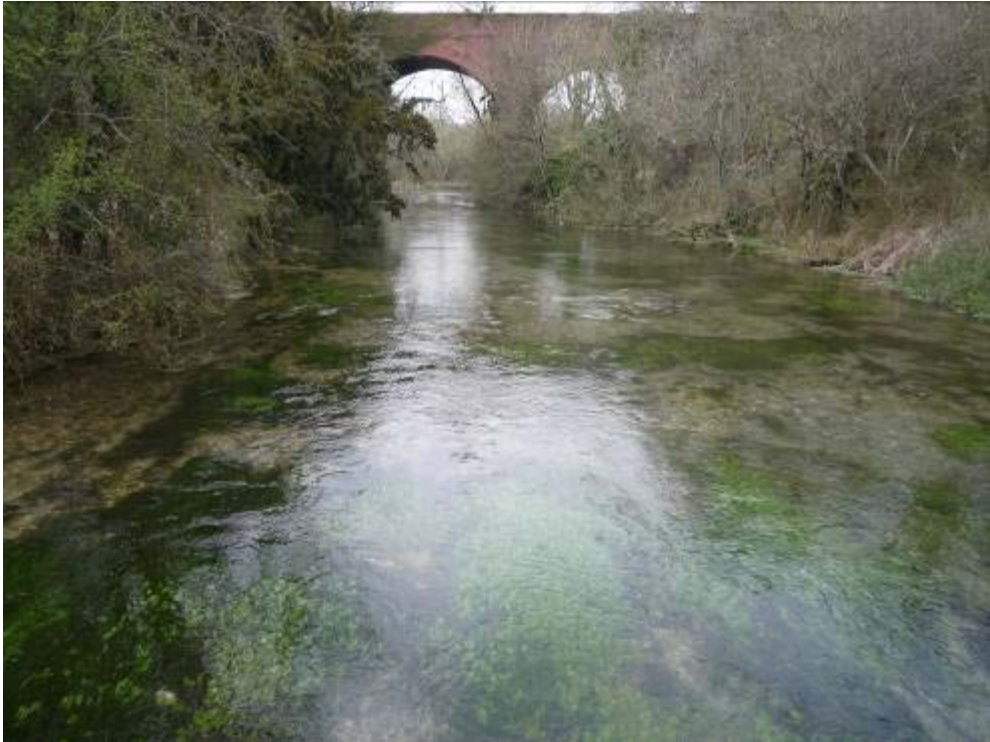
Main river looking towards the railway viaduct – A wide shallow channel which would benefit from a more varied depth profile.

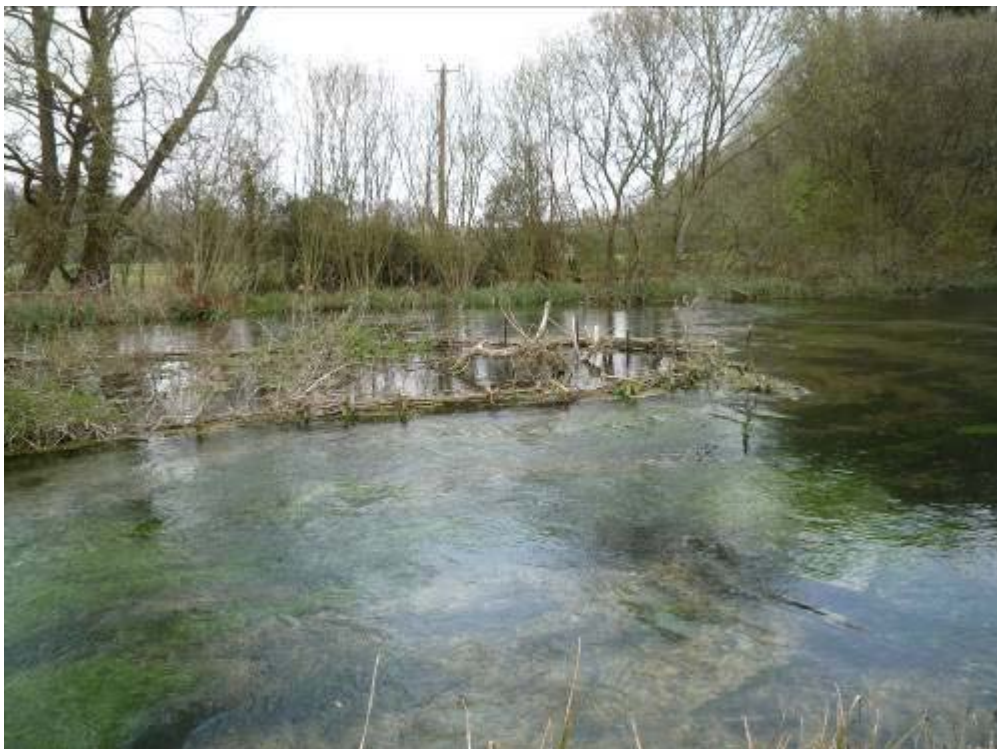
Main river below the viaduct where an island has been constructed. The upstream end of the island needs to be consolidated to protect the whole island from future washout

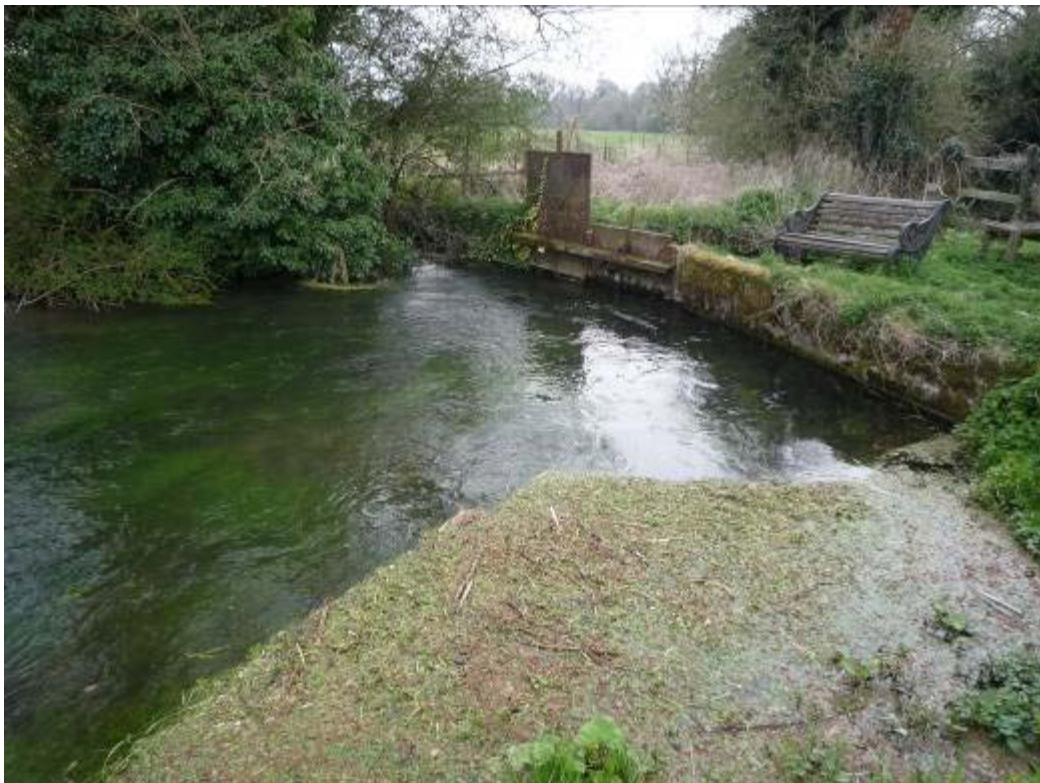
A large water level control structure with two undershot hatches sits approximately halfway along the beat. It is likely that this structure is critical in providing elevated water levels needed to maintain adjacent water meadows. If this facility is not required then it would be sensible to draw both hatches which will locally increase water velocities upstream and create better quality habitats for trout. Frequent manipulation of hatches will not allow the river to respond to changes in annual flow regimes and it is often better to keep them fully drawn for as long as possible.

Middle hatch on the top main river beat with one gate drawn.

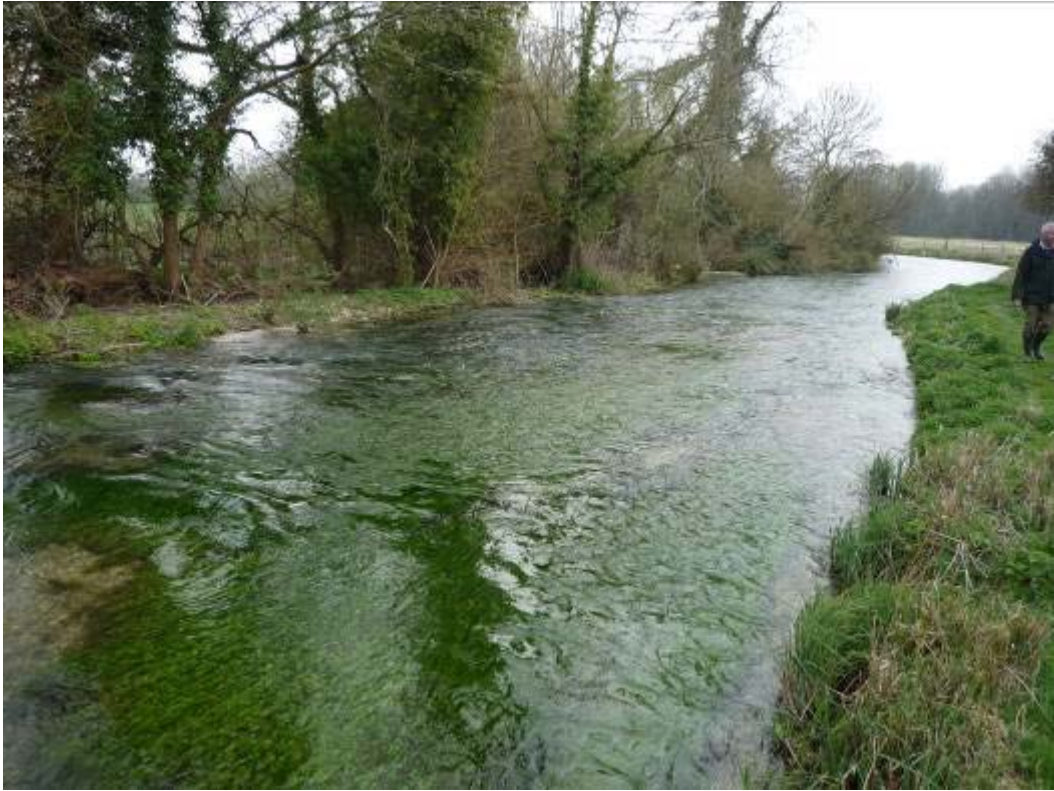
Excellent gradient on the main beat promotes good quality trout habitat

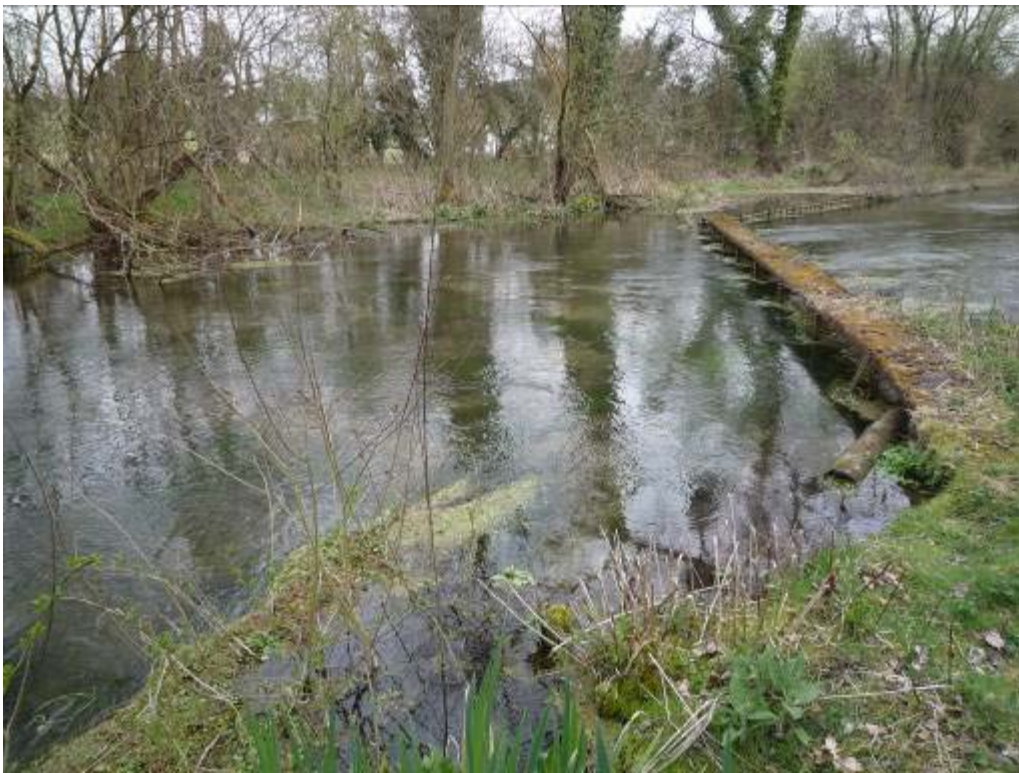
Near the bottom boundary there is an old metal walkway with numerous support stantions that was used to gain access to an old weed rack. The walkway will collect cut weed and debris very easily and unless cleared on a frequent basis will impound the river and reduce water velocities locally upstream.

Old metal walkway and stantions near the bottom boundary can catch cut weed and impound water velocities on the main beat

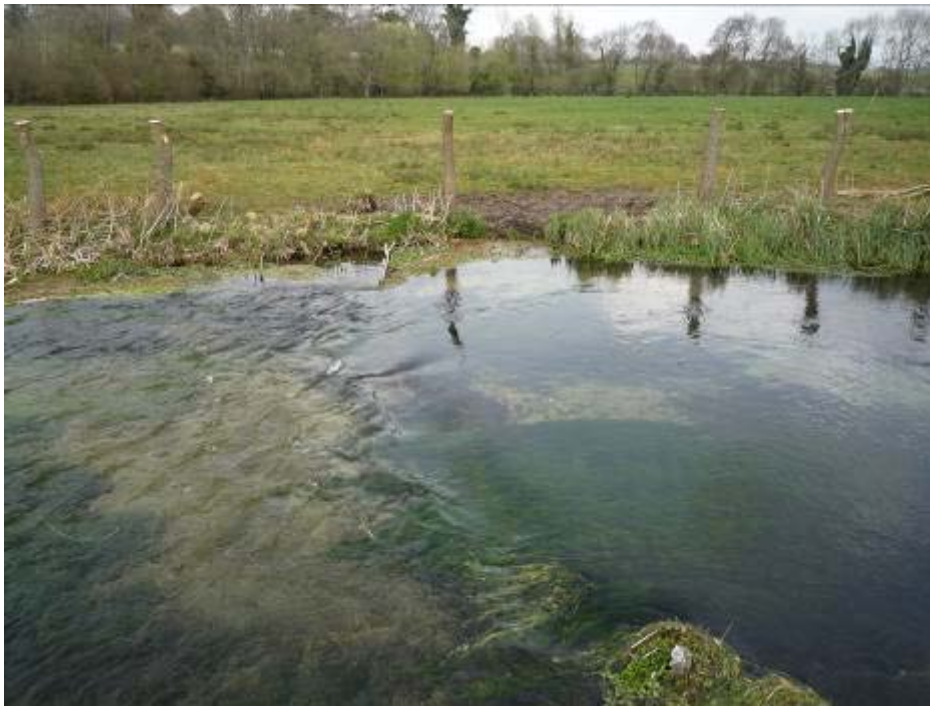
Near the top end of the carrier where it runs perpendicular to the valley some pollarding of marginal willows has taken place to provide a clear flight path for migrating birds. This is a good example of the overall sensitive manner in which the fishery is currently managed.

Pollarded willows where the carrier sweeps across the valley floor

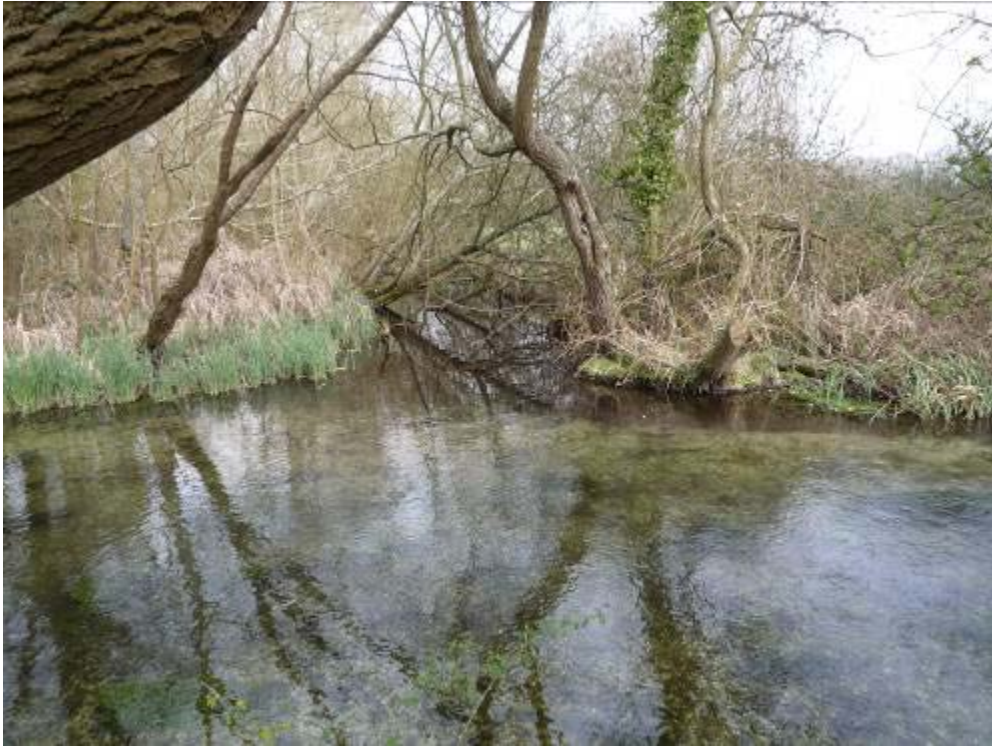
As the carrier swings round towards the margin of the water meadow, a network of valuable marginal habitats on the RB is revealed. These include some connected backwaters which provide critically important habitat for a range of species including eel (*Anguilla anguilla*) and lamprey (*Lampetra sp*). There were also good examples of habitat management with fallen tree bridges providing access for mammals and some large woody debris (LWD) tethered to the margin. LWD plays a vital role in providing habitat for invertebrates. When pegged down it can also act a valuable flow deflector, scouring lies for trout and throwing up fresh gravels for spawning.

A connected backwater on the RB – Superb habitat for a range of different species

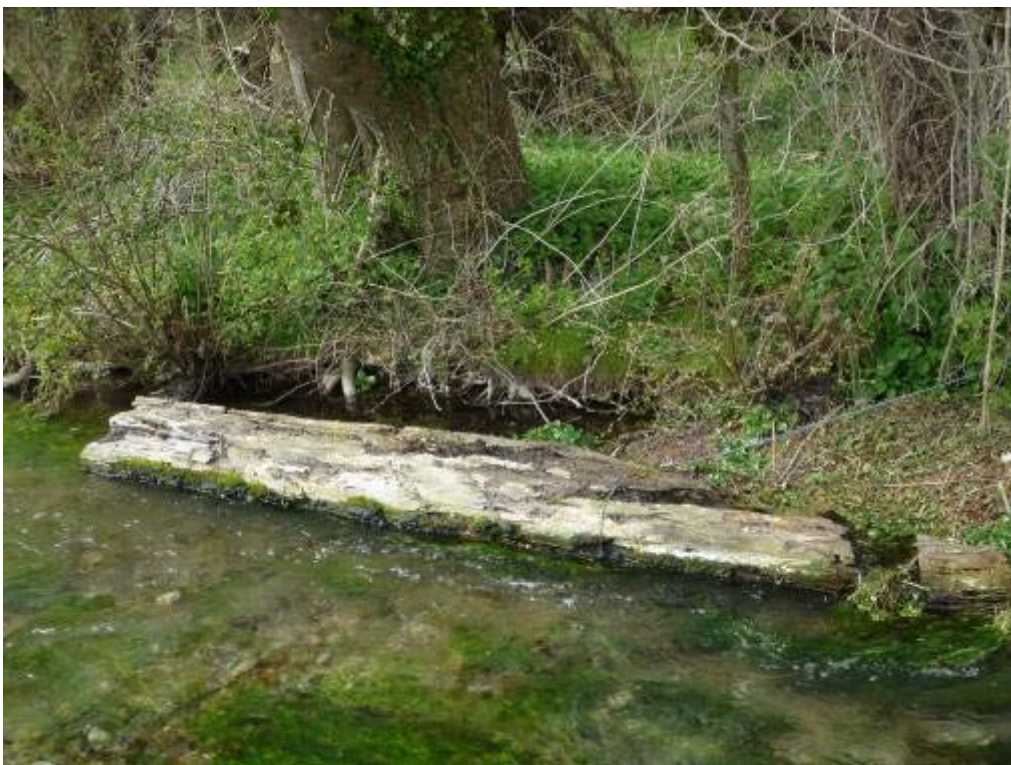
A piece of LWD tethered to the bank. The perfect “fly-board” and cover for juvenile trout

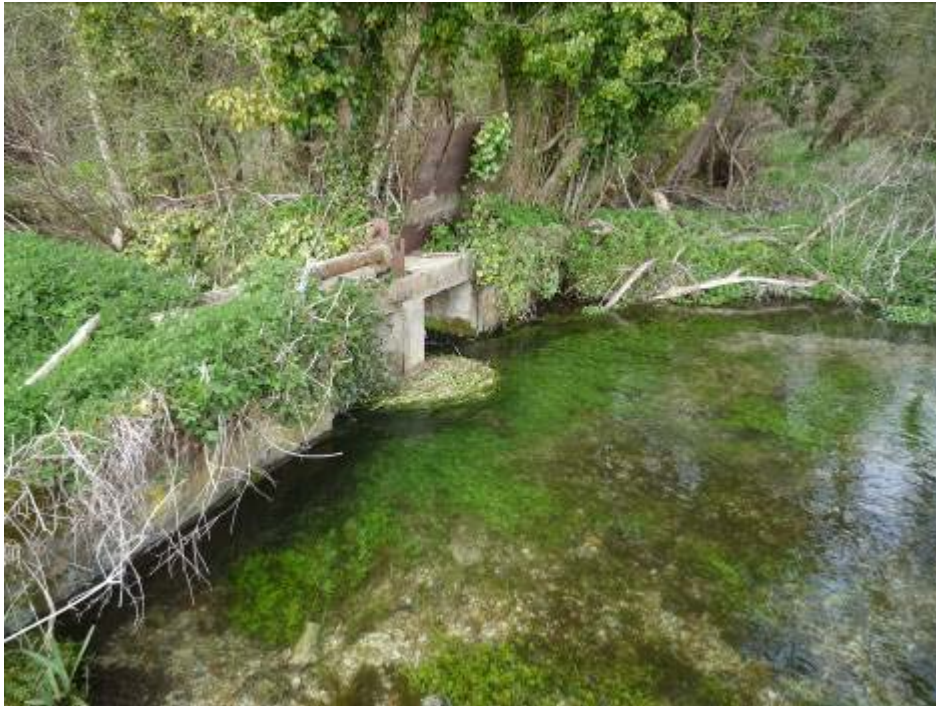
Further downstream there are two old water level control structures. These radically pinch the channel, slow upstream velocities and potentially collect large

Old water level control hatch – Is it really needed?

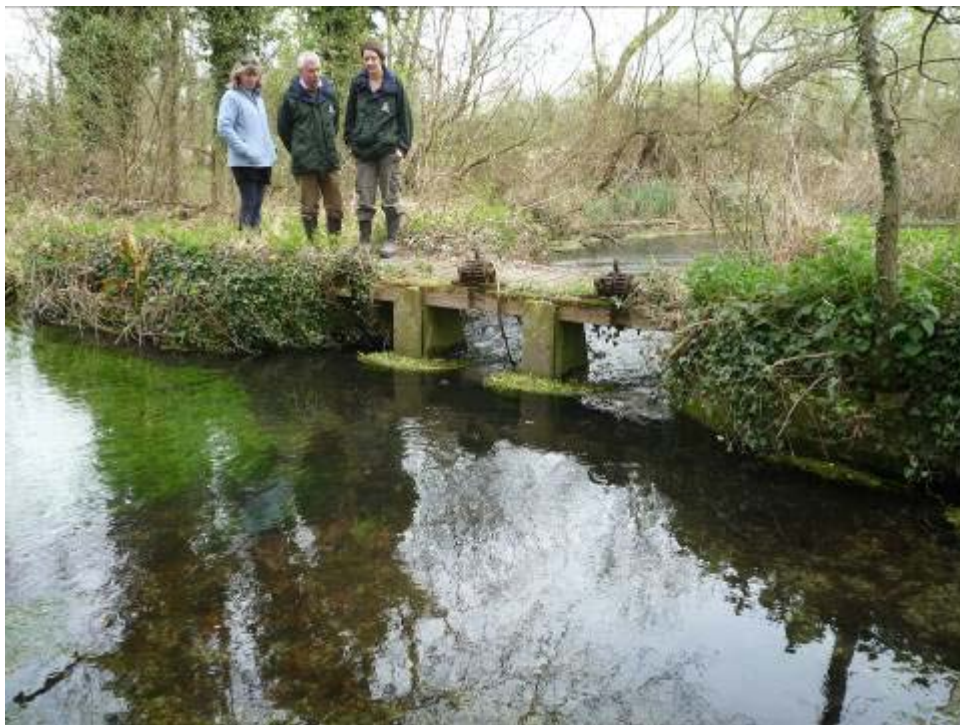
Bottom hatch which lends itself to being bypassed with a cut-through channel

rafts of floating weed and debris. On the downstream structure it might be possible to cut a new channel adjacent to the old weir which will preserve the historical nature of the hatches but will radically improve habitat and require far less maintenance.

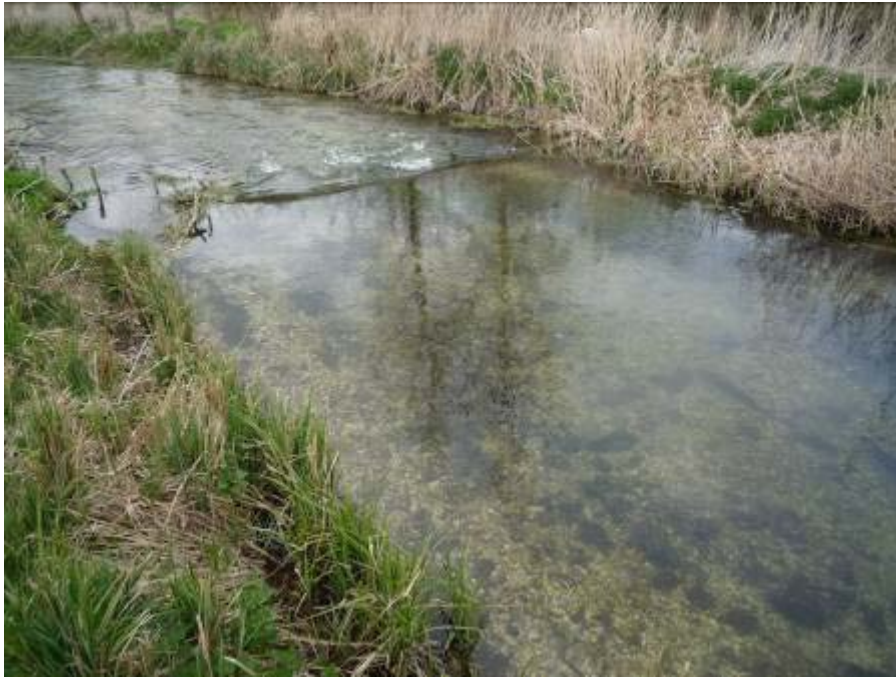
At one or two locations some structures have been installed in an attempt to enhance trout habitat. Full channel width weirs tend to create a few metres of decent habitat at the expense of long sections upstream of the structure. A much better option to promote local scour and enhance holding pools, as well as improving spawning substrate, is to peg in short sections of LWD. This can either be used parallel to the flow or pegged in at slightly upstream angles when used as a half weir

A small weir which looks to have been installed for fishery purposes. A half weir created by pegging in a tree trunk would be a better option

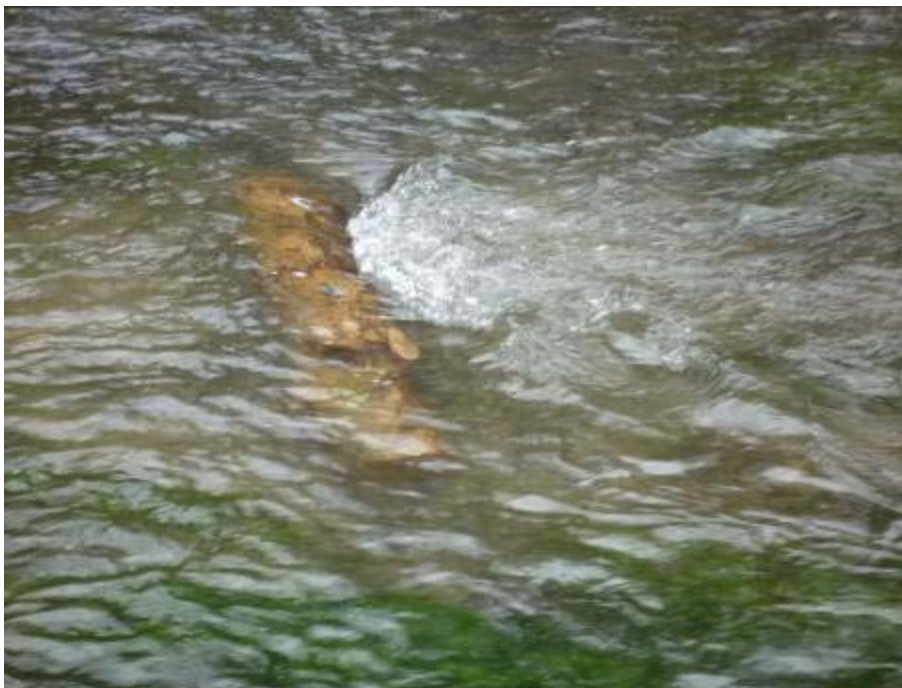
An example of a piece of LWD used to promote local scour on a riffle and promote enhanced spawning habitat

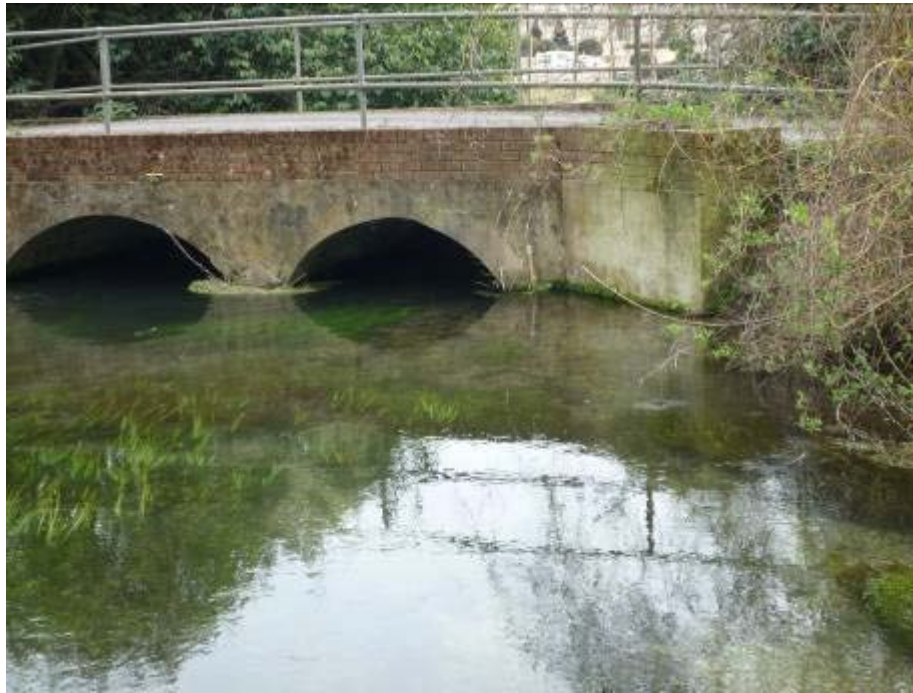
At the very bottom boundary the river flows beneath the road bridge adjacent to the Testbourne estate. The right-hand arch does appear to be smaller than the left and reduced flows through this arch may well have resulted in some accretion of sediments and fine gravels. Lowering the bed level through this right hand arch down to the original invert will help to pull water through the carrier and increase velocities and promote better quality habitat.

Road bridge at the bottom boundary. Lowering the bed level beneath the right hand arch should promote increased velocities in the bottom of the carrier
