## River Test – Chilbolton Common

An advisory visit carried out by the Wild Trout Trust – September 2011

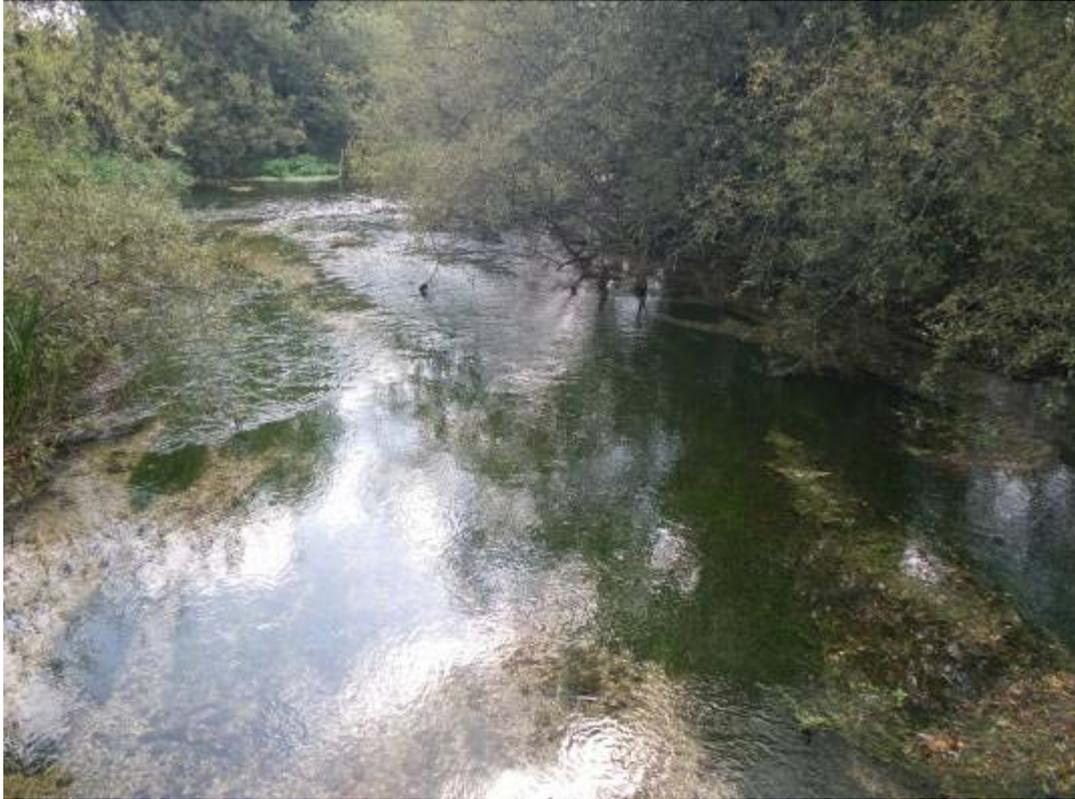
A view from the access point near the bottom of beat1. Good quality trout habitat.

The bulk of the top main river beat (beat 1) was fairly typical of the middle Test, with a very wide channel and a flow pattern dominated by a steady 0.5-m deep glide. The bed material consisted of thin gravels, heavily infiltrated with soft sediments. The marginal fringe of emergent vegetation was adequate on the LB but patchy on the far RB, where the river bank has been partly incorporated into the garden of a riverside house.

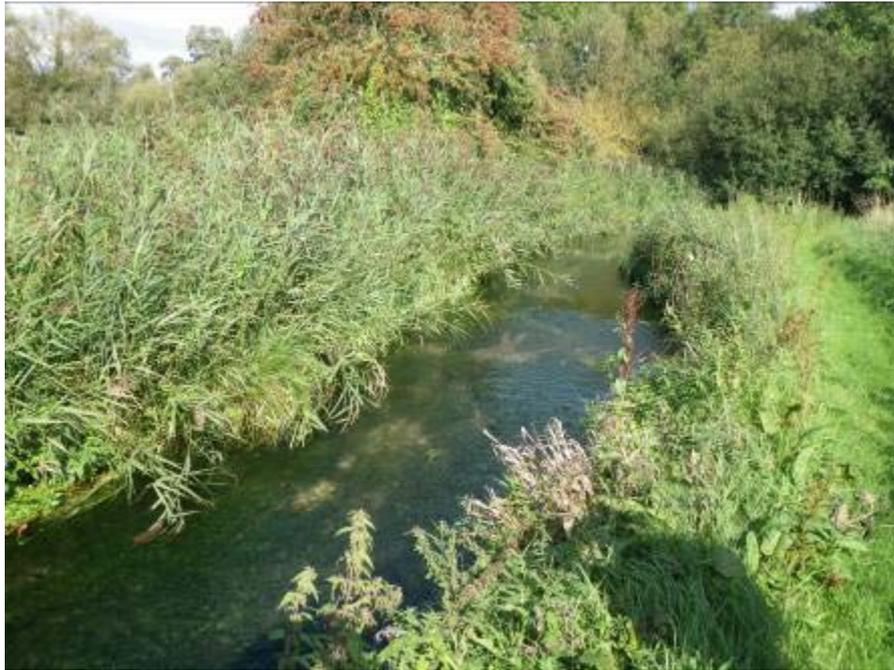
Riparian zone (bank-side) habitat was, by contrast, good, with the left (non fishing) bank providing a good thick fringe of marginal reed cover. This type of habitat is comparatively rare on many Test beats and is essential in providing refuges for the adult phase of many important river flies. When allowed to fold into the channel, the reed also provides a valuable fringe of cover for fish, which is especially important during low flow conditions, when in-channel weed growth is often thin.

Central carrier. Nice shaggy fringe with excellent beds of water crowfoot.

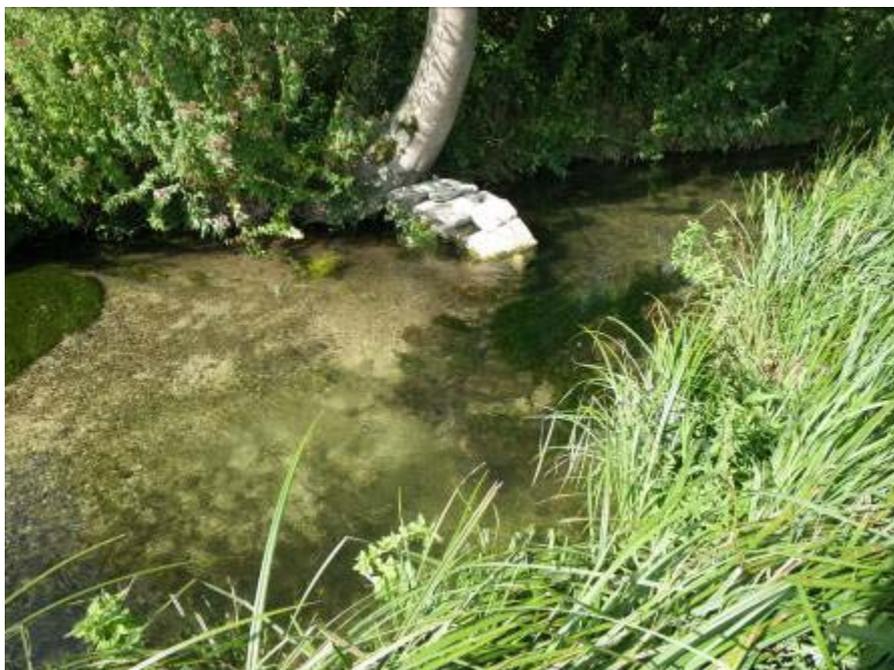
Some attempts to promote local bed scour appear to have been made through the introduction of a short flow deflector constructed from concrete bag work. The site chosen is below the root system of an ash tree and the structure has provide some variety in the bed topography.

Bag-work flow deflector packed under an overhanging ash tree.

Flow deflectors work extremely well on chalk rivers but it is important to use appropriate materials that add some biological value as well as being in keeping

with the chalk river environment. Sections of tree trunk are recommended for this purpose.

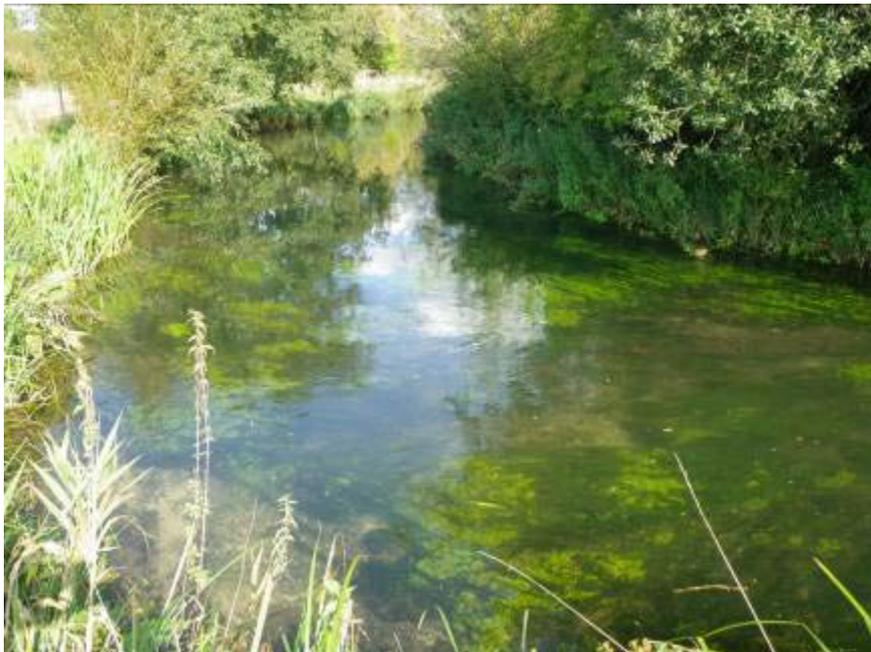
The Pub beat. Great margins but in-channel habitat dominated by a long flat glide.

Only a comparatively short section of the Pub beat was walked. Marginal habitats were relatively luxurious by River Test standards and there were several good examples of low overhanging tree cover providing excellent lies for adult trout. In-channel habitat was predominately smooth laminar glide over a thin gravel and soft sediment bed. Some in-channel cover was provided by beds of water parsnip (*Berula* sp.) and fools cress (*Apium* sp.); however, significant amounts of filamentous algae were also present. The lack of any significant amount of water crowfoot is thought to be due to the comparatively low flow velocities within this particular channel.

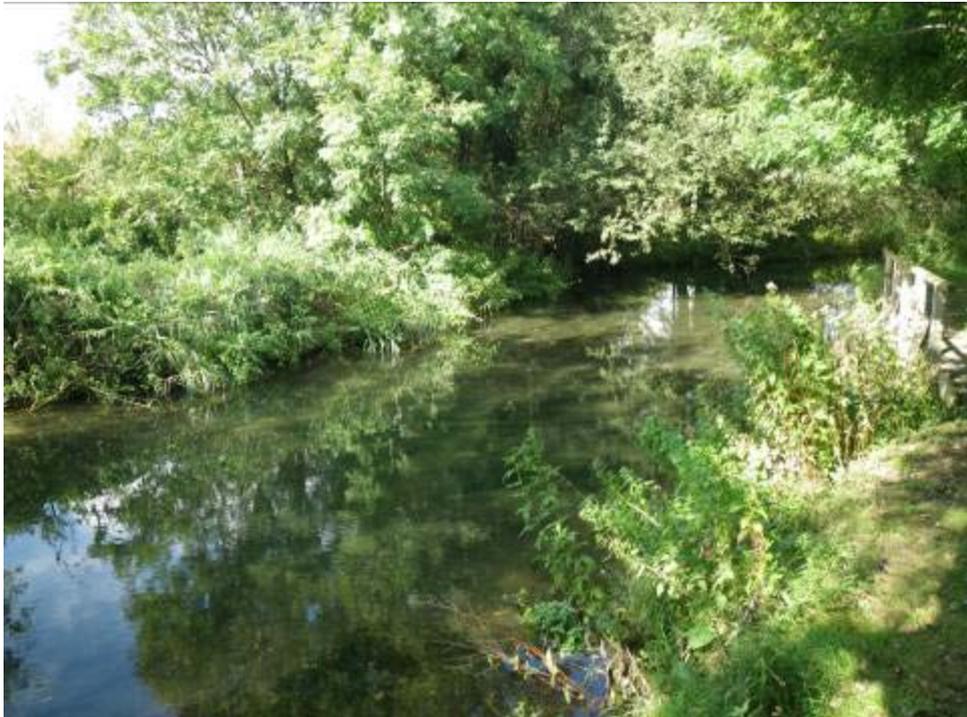
Dappled light and shade near the bottom of the Manor Farm beat provides good trout habitat.

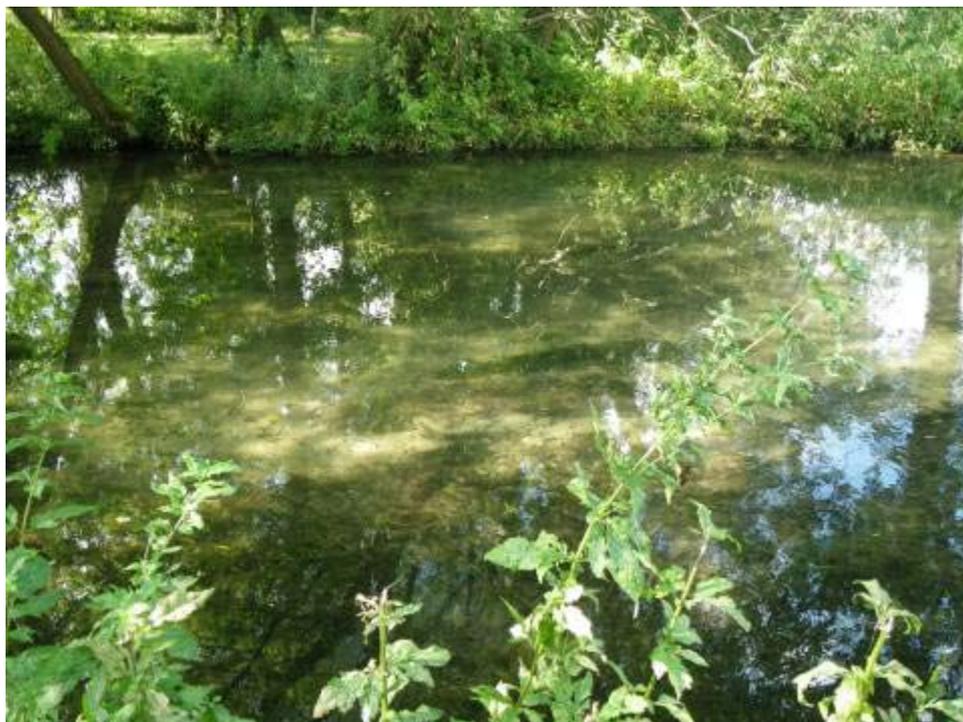
Shaded sections further upstream were comparatively devoid of in-channel cover for trout.

play an important role in providing a thermal refuge during long hot spells, even on groundwater-fed rivers like the Test. Trout respond best to a mix of dappled light and shade, with low overhanging cover particularly valuable and open sections where shafts of light help to stimulate weed growth and natural food production. Some sensitive tree work on this beat would help to stimulate more weed growth and therefore provide in-channel cover for trout and grayling.

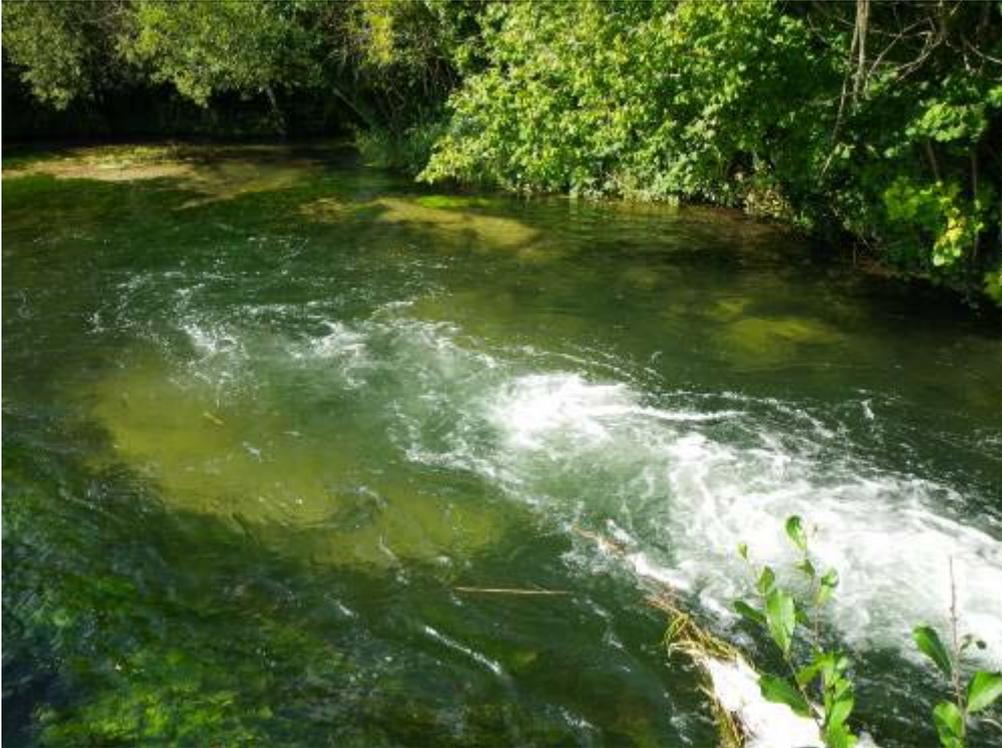
At the top of the beat the river discharges through a hatch. The hatch was probably constructed to control flow splits between the Manor Farm beat and the Wherwell Priory beat which runs parallel.

Home Farm hatch pool.

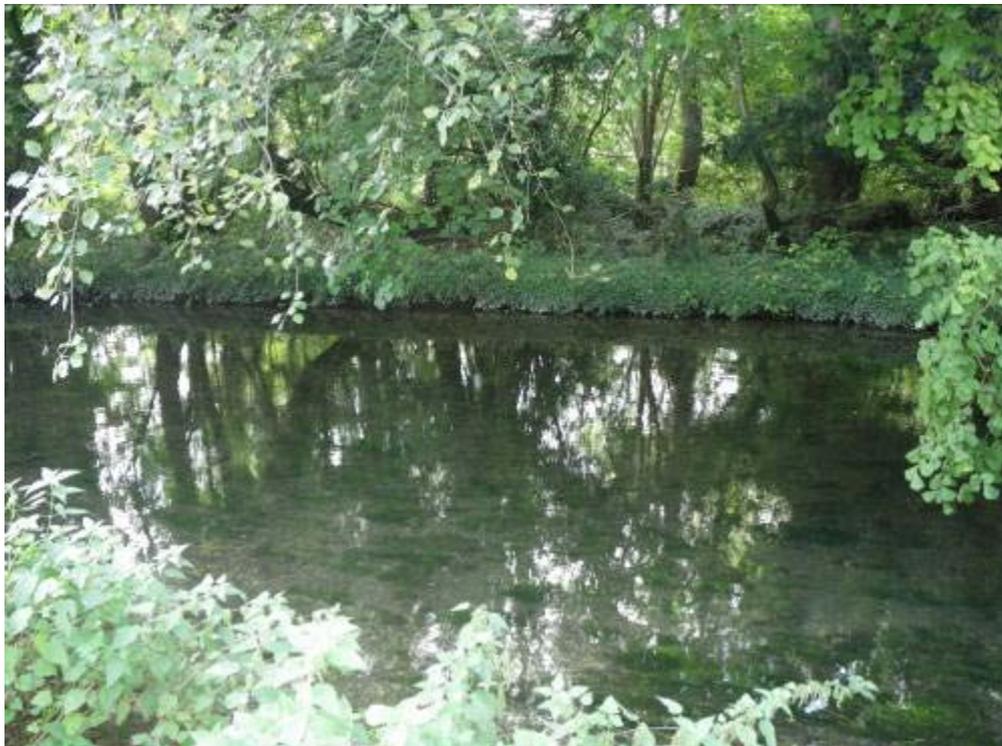
The impounded reach running upstream of the hatch pool.

One of the issues associated with control structures on the River Test and other chalk streams is that they often fragment fish populations and habitat. The short section of river immediately downstream of the hatch pool provides some high quality trout habitat, but the impounding effect of the weir has a disastrous effect on the section of river above the hatches. Any change to the flow regime at this location is problematic as the rights on the parallel channel are under different ownership. The ideal scenario would be to remove the hatches and reclaim the gradient by importing gravels so the bed can be gradually raised over a long section of channel, thus backing the water up sufficiently to provide flow for the Priory beat. Obtaining agreements for undertaking such a radical change is likely to be challenging.

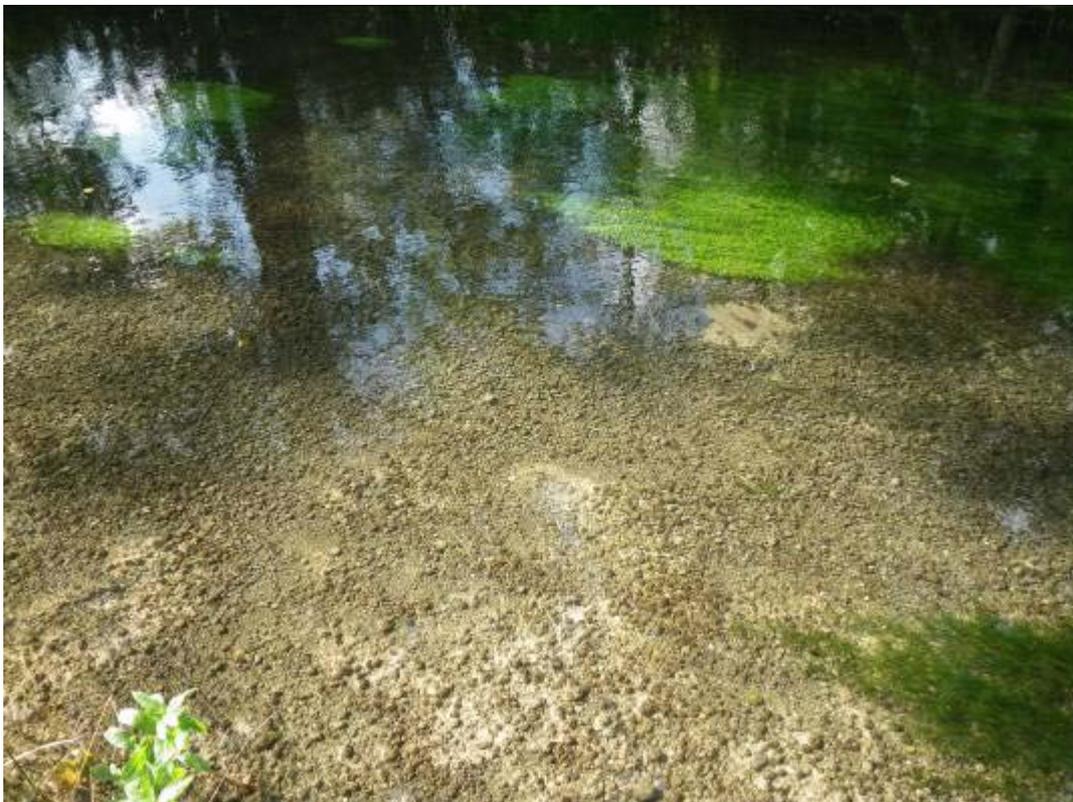
Near the top of the beat the river is comparatively shallow. This should be an ideal spot for spawning trout, however the gravel quality appears to be very poor. A close inspection reveals that much of the bed material is heavily coated with calcium carbonate deposit. This cements the gravels together and severely restricts opportunities for successful spawning.

Shallow glides like this should provide spawning opportunities but gravel quality is very poor.

Where the channel shape is suitable for spawning, the gravel quality is very poor and would benefit from annual cleaning to reduce sediment loads. Large woody debris (LWD) deflectors could also be usefully deployed to help scour fresh gravels and provide improved environments for holding fish as well as spawning. These and other techniques designed to improve chalk stream habitat for trout are described in detail in the WTT Chalkstream Habitat Manual. This is available either on a CD from our office, or as a pdf download via the WTT website [www.wildtrout.org](http://www.wildtrout.org) (via Publications menu).

- If agreement can be reached, implement a programme of spawning gravel improvements. These can range from cleaning existing sites to creating new spawning and nursery sites, either through lowering impoundments to locally pull water through faster, or to import fresh gravels at strategic locations.

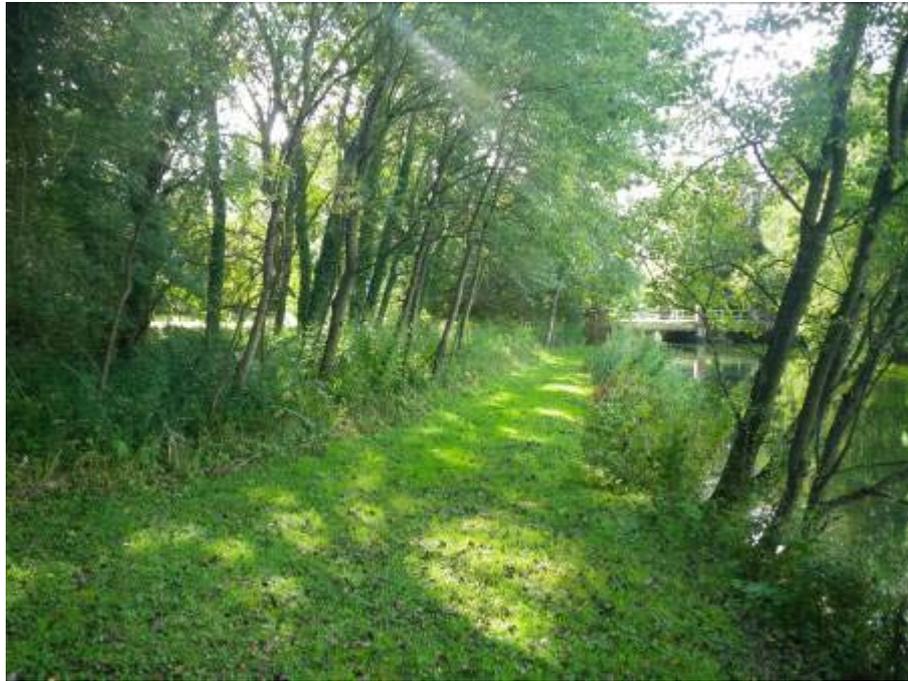
The main river beat (Butchers Mead) is classic middle Test - double bank fishing to a wide flat glide. The fringe was of a reasonable height, perfectly fishable and providing some cover for the anglers, but was a little too thin to be valuable as a refuge for the adult phase of many river flies. On many Test beats the fringe is very closely trimmed to facilitate unimpeded access for casting and in the autumn often completely cut back to bank level. This is now considered by many to be a very damaging practice. Not only does a thick fringe of marginal chalk

Angling bank at the top of the Butchers Mead beat. Coppicing some of the alder may help to stimulate weed growth.

stream plants protect the bank and provide refuge for insects, it is also valuable cover for fish if it is allowed to flop into the margins following the first frosts. Dead annual plants should be raked out of the margins in the spring just prior to the fishing season, when a light trim is also appropriate.

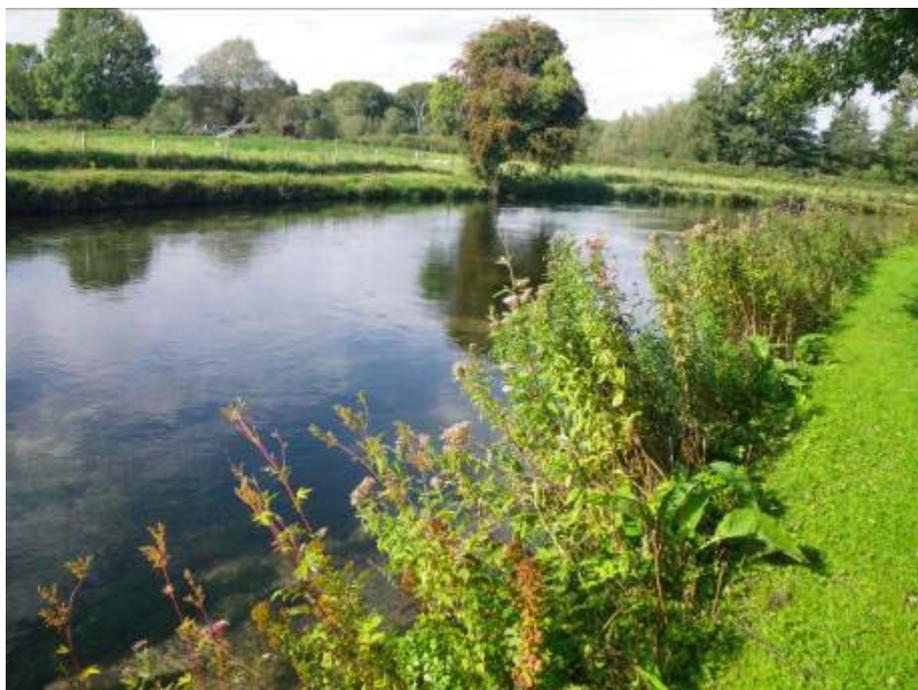
Butchers Mead beat – double bank fishing over a glide habitat.

The Butchers Mead beat is characterised by a slow glide habitat. The reach has no habitat suitable for wild trout production and its ability to hold stocked fish

will be determined by the in-channel weed growth and how it is managed. Successful enhancement of in-channel habitat here is dependent on reaching an agreement with fishery interests on the opposite bank. Options could include tree trunk deflectors, the planting of low overhanging willows, or the creation of in-channel islands to break up flow patterns and provide more interesting and varied flow patterns and depth profiles.

- Explore options with your neighbours for a radical improvement of the Butchers Mead beats. LWD flow deflectors, planting low overhanging willows and possibly installing central channel islands would greatly improve the fishery potential of this beat.

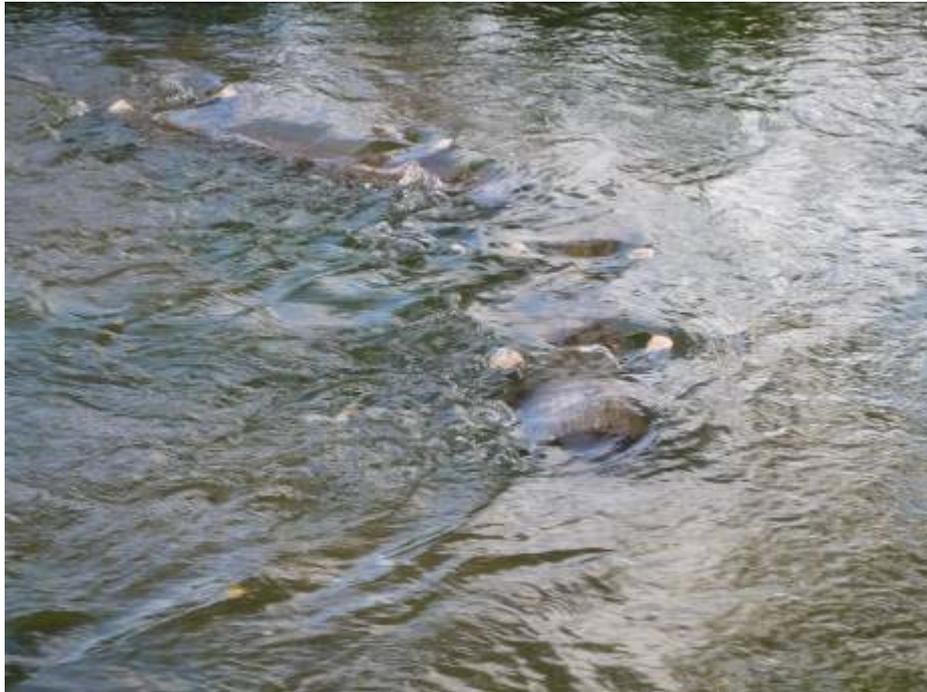
A large tree trunk deflector pegged into the Oakley Stream on the Test used to improve gravel quality for spawning.
