## **Advisory Walkover**

**Thornton Beck, R Nidd ([GB104027063850](https://www.gov.uk/landranger/details/GB104027063850))**

**Prof J Grey ([jgrey@wildtrout.org](mailto:jgrey@wildtrout.org)), July 2020**

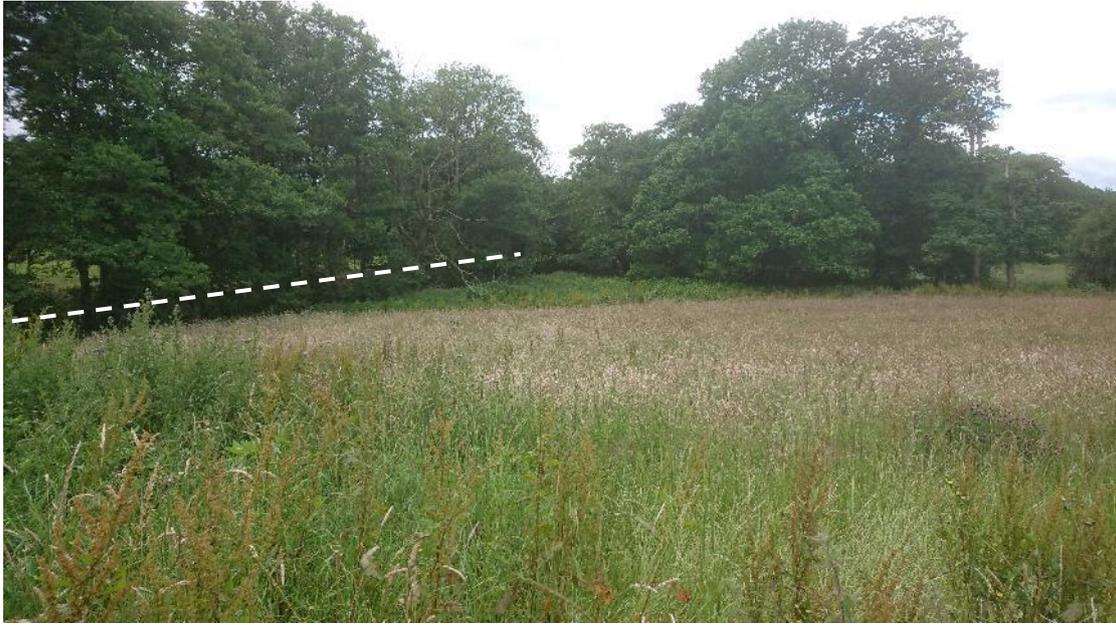
**Fig 1. Looking toward Thornton Beck (dashed white indicative line) from the upstream extent of the walkover at High Mill; SE 25180 62667. There was a clear distinction in the vegetation at the bottom corner of the field (more lush green 'triangle') indicating potential scope for better connection of the beck with its floodplain in that area.**

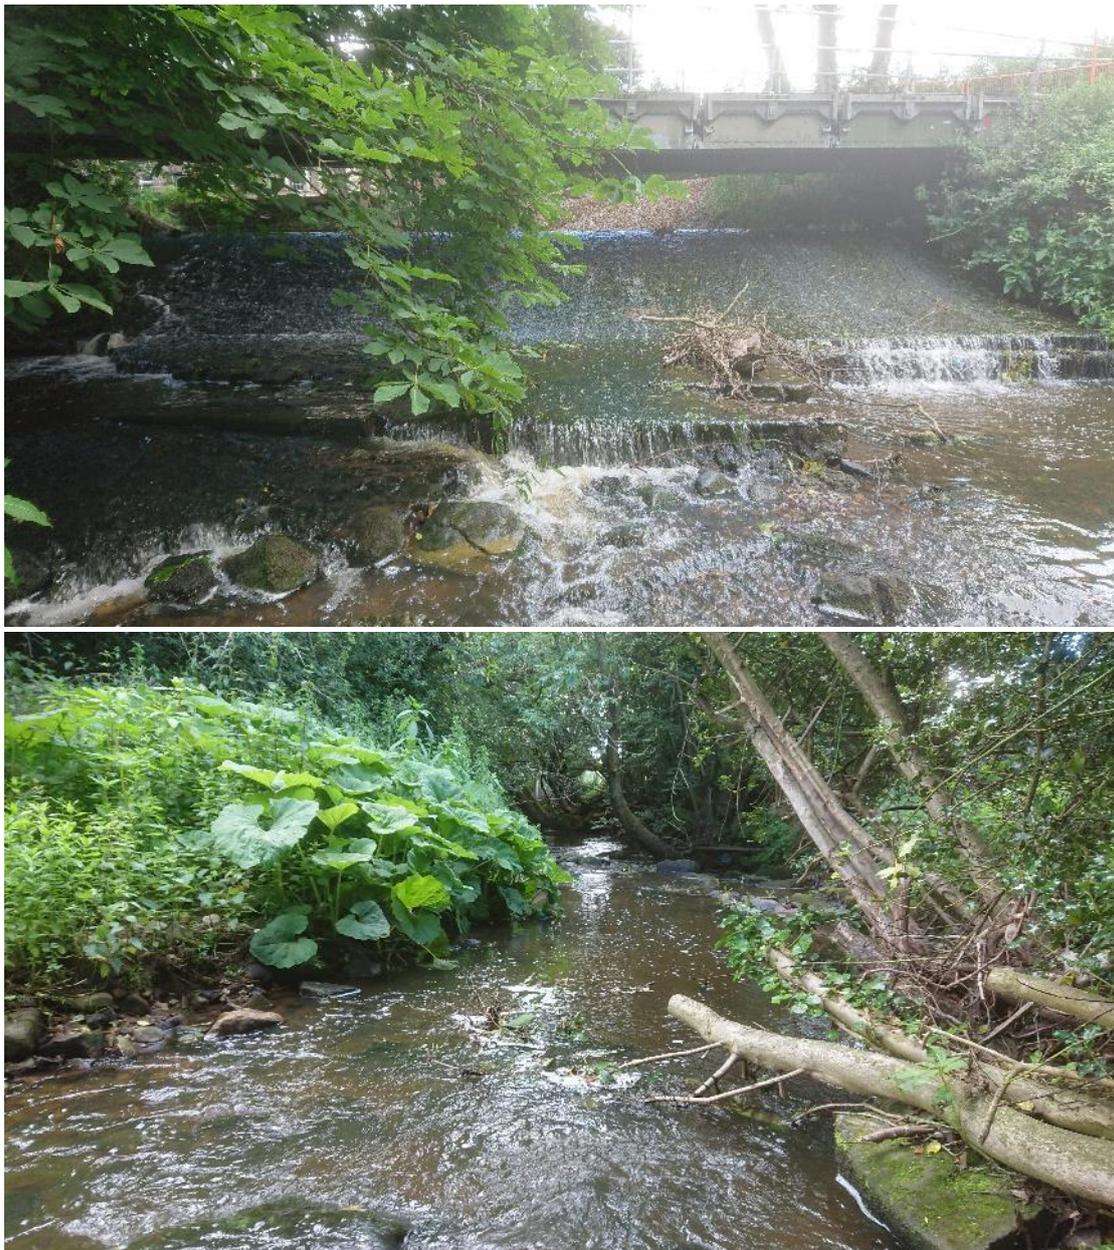
**Fig 3. Upper: the dam associated with the lagoon created head-loss of  $\sim 1.2\text{m}$ . The weir face was relatively smooth and intact but the apron below was badly degraded, presenting a severe impediment to fish passage (in either direction) and to sediment transport downstream. The building of a bailey bridge for plant to access the lagoon had clearly damaged the integrity of both banks upstream of the weir and introduced finer soil and imported angular gravel.**

**Lower: looking downstream from the weir through a section of relatively mature trees growing from the toe of the bank, the beck retained some relatively natural characteristics eg diverse cross-sectional profile, sediment sorting, low cover from the banks. Note however, the removal of part of the horizontal woody material to the foreground, presumably to reduce perceived flood risk although such action rarely reduces flood risk. All it does is maintain high conveyance, getting the water more quickly to the village. Those trailing branches would have trapped debris thereby preventing it reaching the pinch-points downstream in the village where risk of blockage and hence flooding is greater.**

- *The weir* is a redundant feature needlessly maintaining an artificially high water-level and increasing flood risk to the adjacent cottages. Removal should be the aim as it returns all the natural processes of unhindered fish and sediment movement without any maintenance issues, and would lower the water level thereby reducing the risk of flooding. The proximity of the road and buildings constructed after the weir was *in situ*, plus the capping of the lagoon and the undetermined waste contained within, all could potentially be undermined and would thus require assessment on that basis. Alternatives to ease fish passage are available and could be explored but of course do not address issues of impoundment, sediment transport, flood risk and ongoing maintenance. Given the size of other weirs lower down the catchment though, the structure may be deemed of low priority for attention from the Environment Agency.

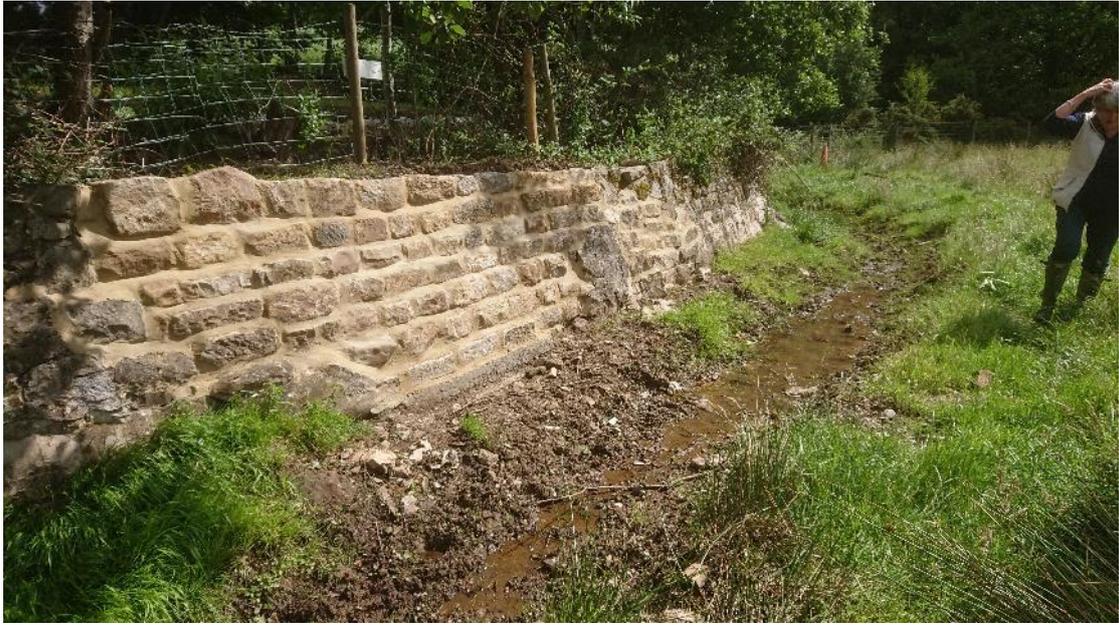
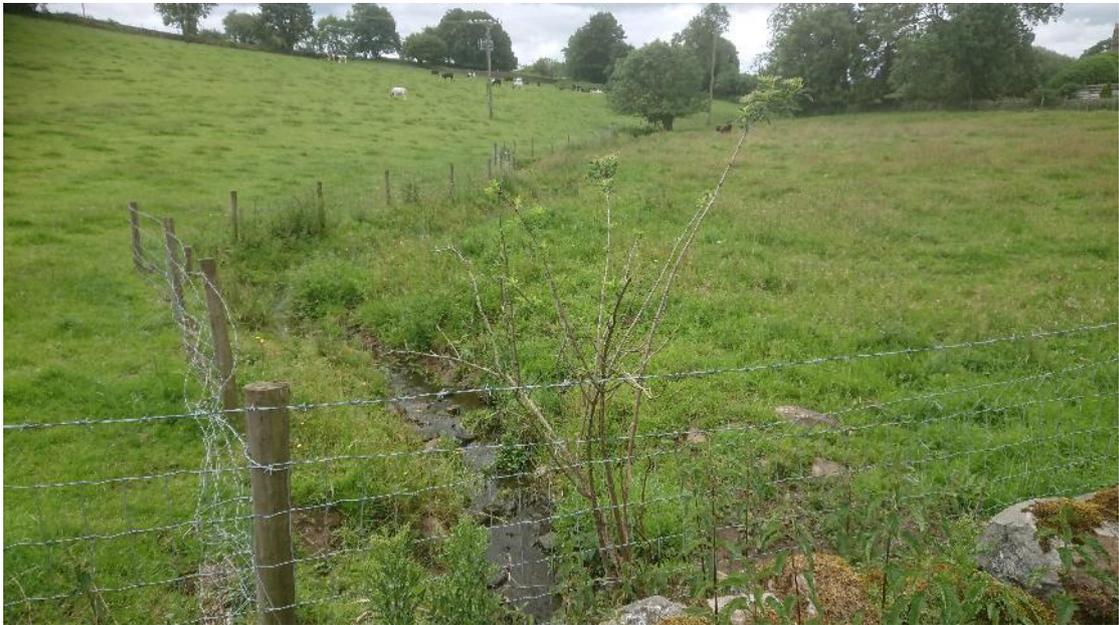
**Fig 4. Examples of the numerous small watercourses contributing flow to Thornton Beck: upper – at the lagoon impoundment wall; and lower – crossing under Law Lane to the east of the village. All of those observed were in part straightened (ie increasing conveyance) and exposed to livestock poaching and grazing, leading to fine sediment ingress to the beck. Ideally these should be fenced off.**

**These shallow watercourses, without any shade, will warm rapidly and even if they retain water will probably be inhospitable for fish fry and invertebrates for much of the summer.**

*Diffuse agricultural pollution:* whereas the majority of Thornton Beck observed during the walkover was protected by livestock exclusion fencing, creating a reasonable buffer zone, the smaller tributaries were more exposed (Fig 4). Poaching / trampling by sheep, cattle or horses, and heavy grazing pressure can all create erosion hotspots (Fig 5) and lead to the ingress of fine silt that smothers gravel and blocks the pores between larger stones and cobbles. The degree to which the bed was impacted suggests that the problem is widespread further up the catchment and a scan of satellite imagery revealed larger fields, fewer hedgerows and apparently narrower buffer strips that could intercept fine sediment run-off to the north and west of the village. Some soil ingress is undoubtedly associated with Himalayan balsam – see below.

Buffer strips offer a multitude of further benefits aside from preventing the loss of soil from the land, such as 'hydraulic roughness' helping to slow the flow of flood waters, shade to keep the water cool, provision of refugia, nesting sites and food for a plethora of wildlife and pollinators, and aesthetics from banks of native wildflowers and grasses. There are benefits to farmers as well: retaining soil on the land or reducing the likelihood of waterborne disease transmission in livestock. Options for fencing should be explored along all watercourses (eg Fig 4), not just Thornton Beck, and there are several potential avenues of supportive funding for fencing.

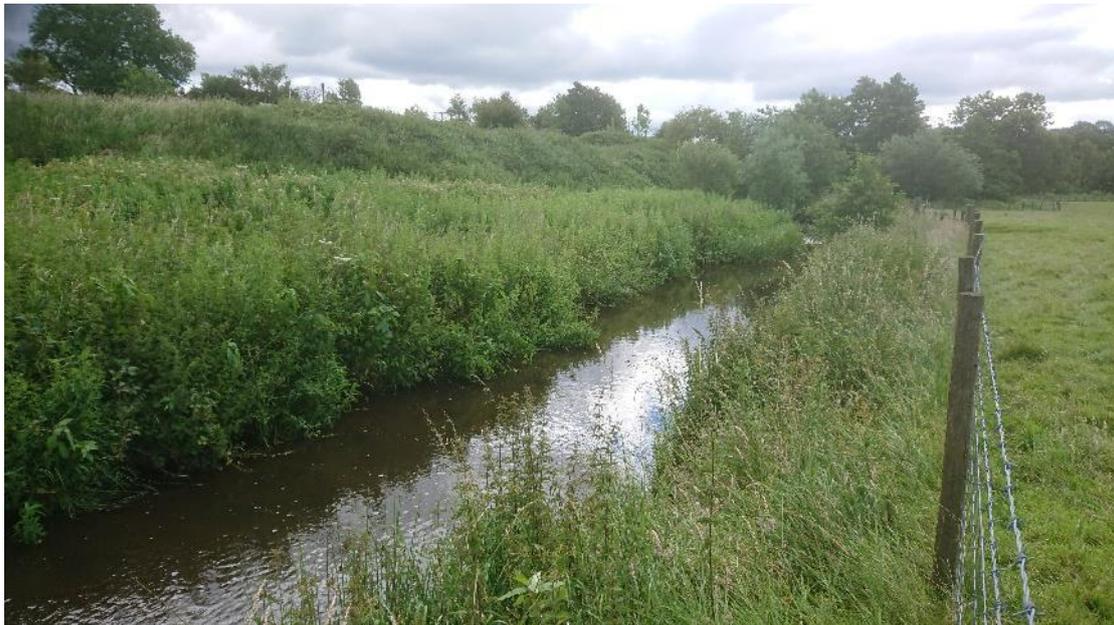
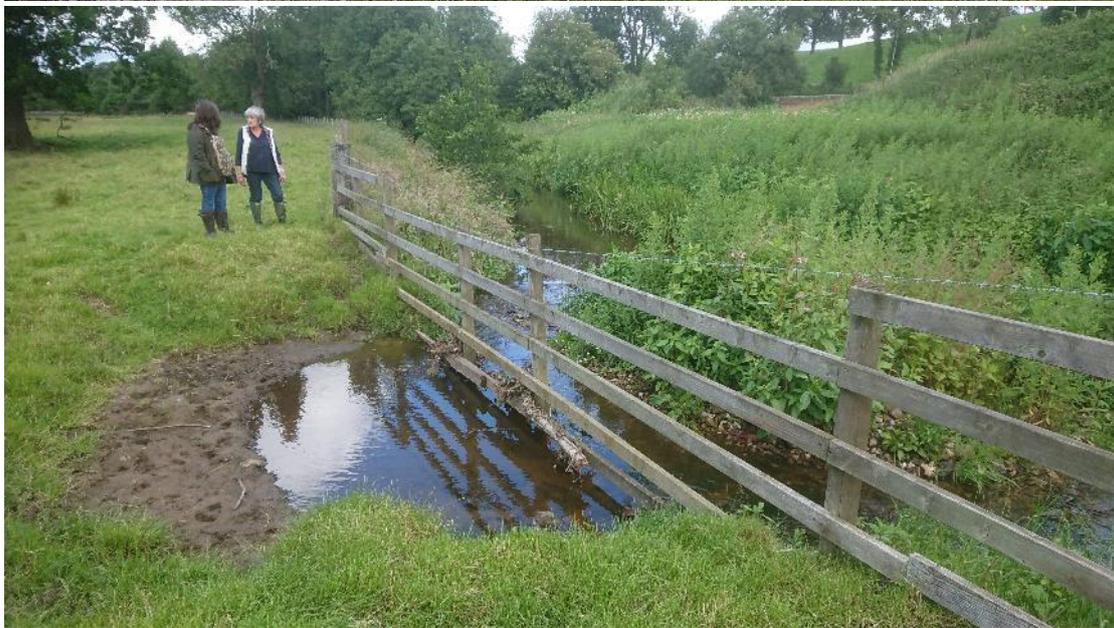
**Fig 5. Upper panel: The straightened reach between the lagoon and the village was reasonably well protected by stock-proof fencing, allowing establishment of a buffer strip of native herbage and encroaching Himalayan balsam. There was surprisingly little natural regeneration of trees which would be beneficial here, especially upon the RB to provide shade.**

**Lower panel: When possible, access points for livestock to the beck should be avoided because they always create a focal point for erosion, fine sediment ingress and nutrient enrichment. Alternative methods or sources of watering (pasture pumps; gravity feed; mains etc) could be explored. If drinking bays like this are unavoidable, then the base and approaches should be formalised with stone of appropriate size to minimise the effect of poaching, and post & rail fencing to the sides would prevent further erosion which would otherwise ever-widen the bay.**

**On this reach, there was relatively little tree cover so some judicious planting with locally sourced native species such as hawthorn, blackthorn or goat willow would be beneficial.**

- *Diffuse agricultural pollution / soil ingress* can be easily countered by preferably excluding livestock from watercourses (because alternative solutions to watering are available) or substantially limiting access and formalising those points (ie drinking bays; Fig 5). Once excluded, natural regeneration of native herbage within the buffer strip should be relatively rapid (although Himalayan balsam will probably require control; below) which will provide greater structural integrity to bank soils via a complex and diverse root matrix and absorb run-off from fields carrying fines and nutrient pollutants.

- *Tree planting & management* - in conjunction with the protection of buffer strips, some tree planting could be undertaken in those areas which are currently highly straightened and exposed (eg Fig 5) using appropriate species (hawthorn, blackthorn, alder, bird cherry, rowan, hazel). Note, to be effective, tree planting requires adequate and lasting protection from livestock browsing.

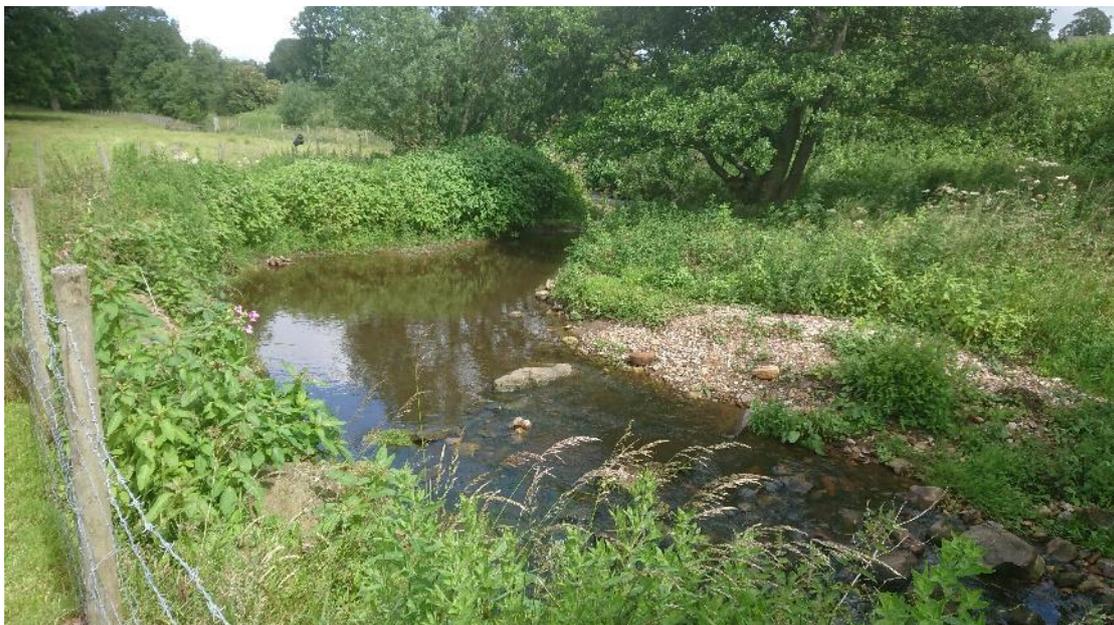
**Fig 8. Evidence of some limited functionality in the Thornton Beck channel – one of the few bends in between the lagoon and the village where flow focussed to the outside of the bend is causing valuable scour, and there was subsequent deposition on the inside of the bend. However, the proportions of the channel were still remarkably consistent: one might expect a narrowing of the channel through the bends.**

**Note the prevalence of Himalayan balsam on this reach.**

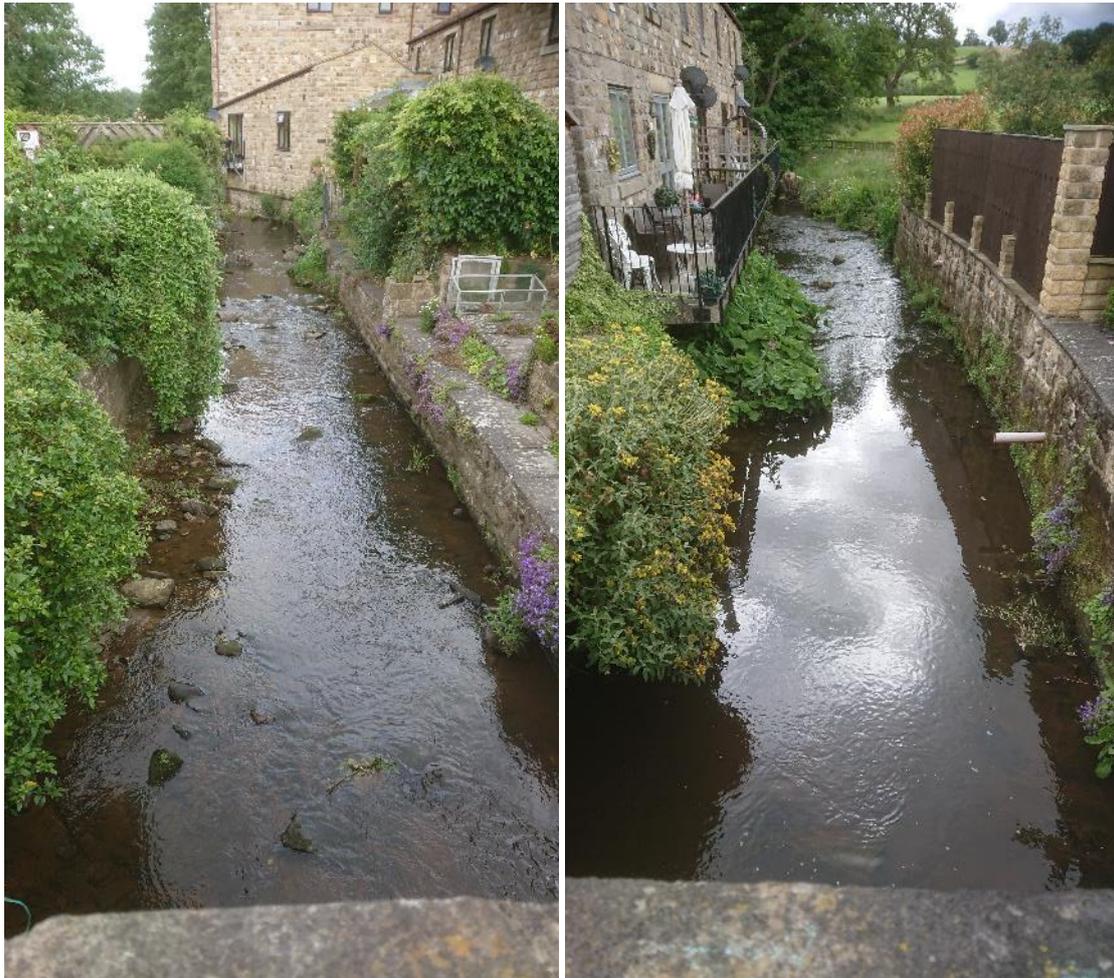
**Fig 9. Looking u/s and d/s (left & right panels, respectively) from the bridge in Low Mill Court highlighting the straightened and constrained nature of the beck through the development.**

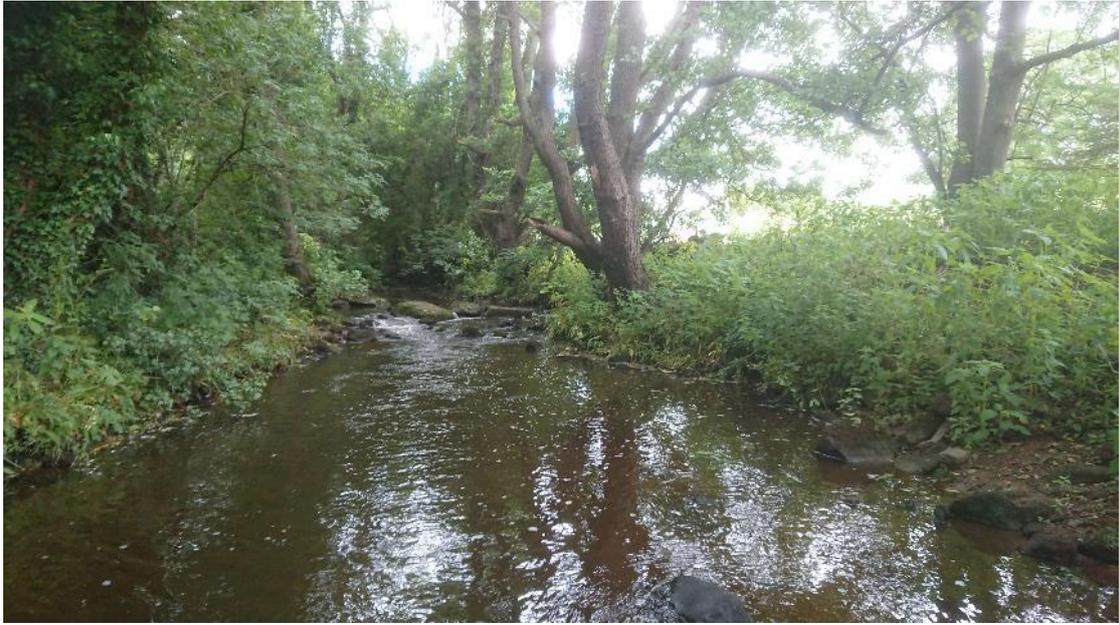
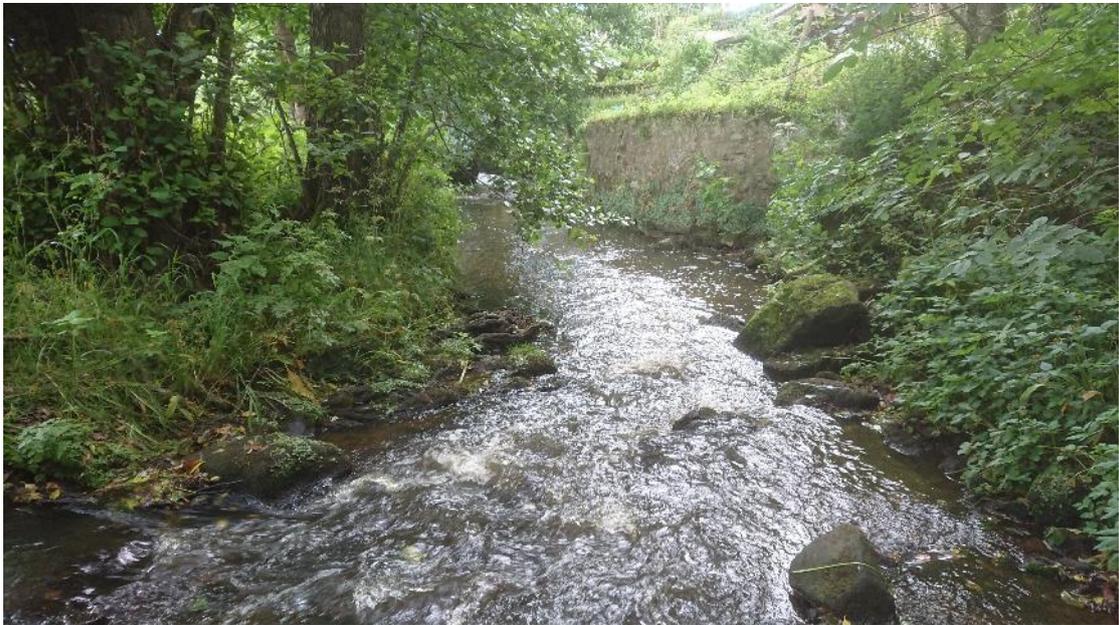
**Fig 11. Looking u/s and d/s from the 'sheep wash', a ford at SE 25976 62326 just off Law Lane and the lower extent of the walkover. The channel and riparian strip were more naturally varied below the confines of the village (aside from the walling to the RB immediately d/s), although Himalayan balsam was rife in the understory. Several otter spraint were noted on the large boulders u/s, mostly comprising the remains of signal crayfish.**
