Project Proposal
Thornton le Dale Village Hub
July 2019

1.0 Introduction & Rationale

2.0 Habitat Assessment

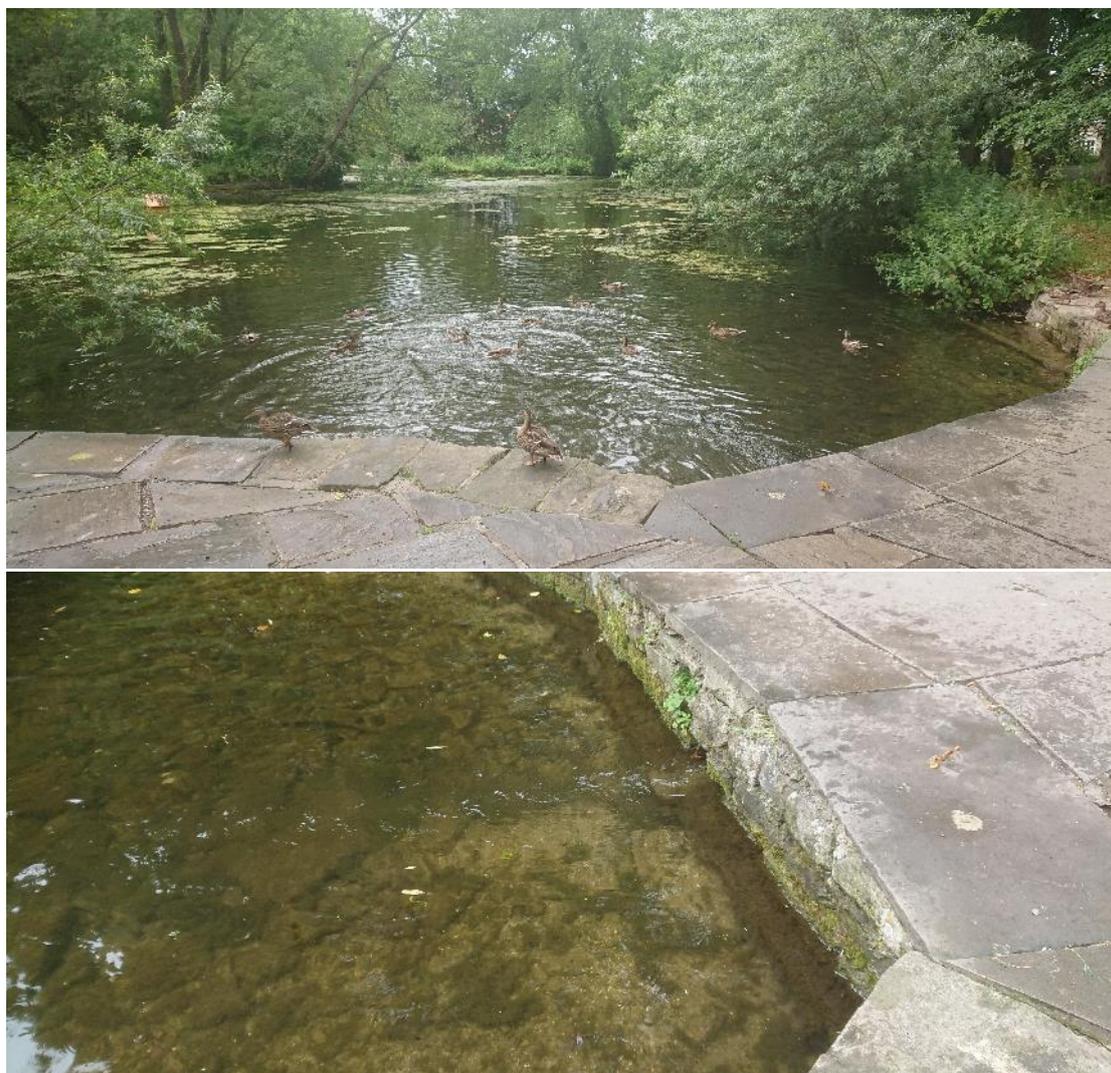
Fig 1. The pond from the formalised banking at the inflow (lower panel). The current of the inflow supplied via a pipe of ~20cm diameter was noticeable only for a distance of ~3m. There was no discernible impact of sediment delivered via the pipe into the pond despite a considerable accumulation of fine silt in the beck at the offtake. Excess biofilm (a matrix of algae, bacteria and other microscopic life) was evident on the stones as a brown filamentous covering. The lighter green silk weed (*Cladophora* spp.), indicative of nutrient enrichment was evident on the surface and smothering submerged plants.

This area is a focal point for people viewing the pond and feeding the ducks. As such, it will remain relatively devoid of vegetation and a point source for nutrients via whatever is fed to the ducks (directly as waste or indirectly as faeces).

The edges were bare stone and concrete and vertical around the formal inflow, the walling effectively severing any ecological tie between the land-water interface. However, the banks were more naturalised within several metres to either side. Low overhanging branches provide shade and cover, as well as access points for insects emerging or entering the water.

Opportunities: This is clearly a 'sacrificial' point on the bank, always subject to heavy footfall and disturbance from people. For education & engagement, there could be signage highlighting where the water supply is coming from and hence signposting people to visit the beck too, and encouragement for people to feed the birds with healthy food in moderation rather than waste bread.

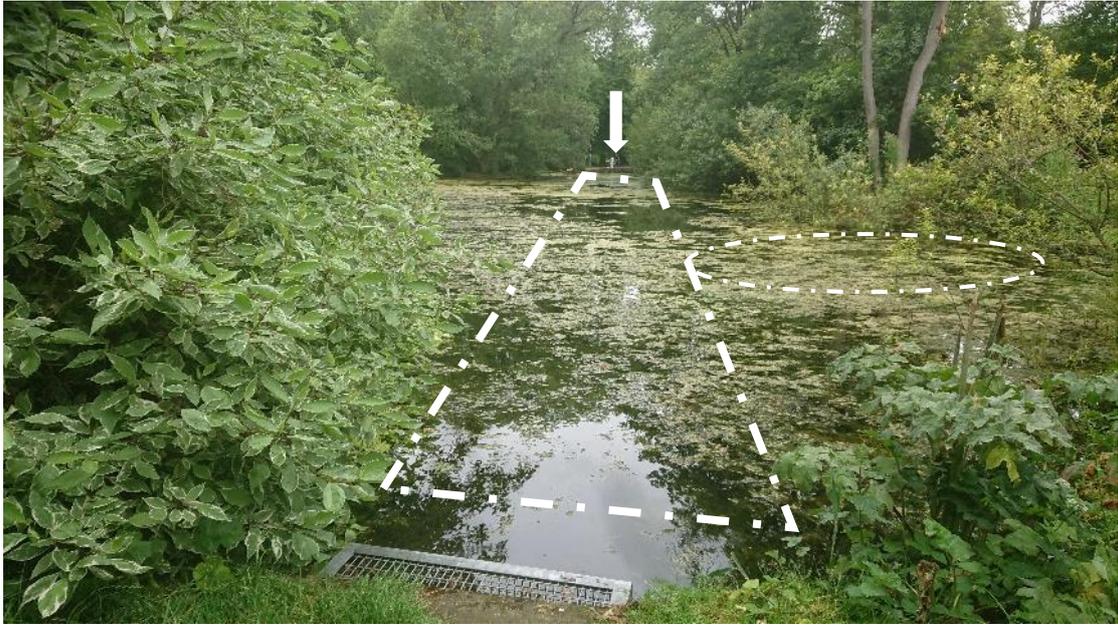
Fig 2. Looking back to the inflow (white arrow) from the screened outflow in the foreground along the longest axis of the pond. The extent of the submerged weed and the problematic silk weed was clear.

Undisturbed, self-set tree cover along the bank can be seen in the top right of the image, and should be maintained thus as a refuge in such a busy site. The low-lying willow branches reaching out over the water provide excellent cover and shade and should not be tidied back. However, a non-native shrub growing next to the outflow (left of image) should be removed.

- **The white dashed polygon depicts a channel maintained through the submerged weed along this axis and also encircling the island. Cutting out the weed creates a greater amount of 'edge' habitat and therefore structural habitat diversity. Removal of the weed biomass will remove nutrient from the system. It may also increase water circulation.**
- **The white dashed ellipse indicates another area for clearing (detail in Fig 3) which would link into the main channel.**
- **A couple of further clearings in the submerged weed could be created near to the bank but against the undisturbed tree cover, i.e. replicating the shallower edge habitat but without the prospect of disturbance at a viewpoint.**

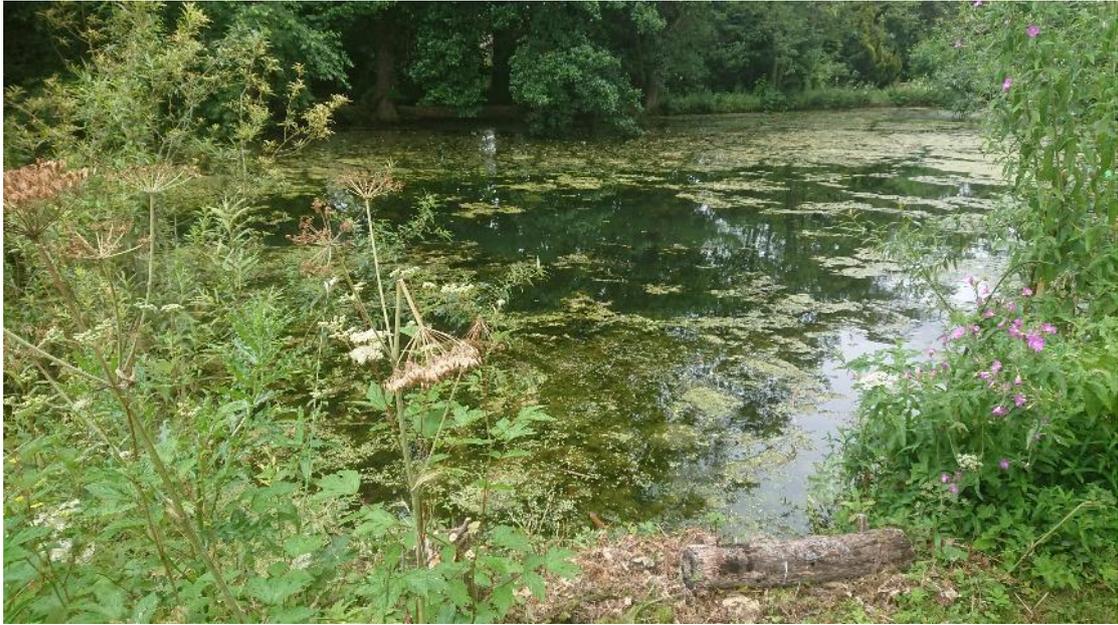
Fig 3. One of the more natural viewpoints allowing for a window on the pond, bordered by native vegetation. Trailing stems from the bankside herbaceous plants keep the margins protected and provide ideal habitat for a variety of invertebrates, despite the underlying formal banking still being vertical.

- **Maintain a 'window' into the water. Keep the pond immediately in front of the viewing platform free from submerged plants, and link into the channel as described in Fig 2.**
- **Construct a berm to one side of the viewing point for true emergent and marginal plants to diversify the plant community and soften the formalised banking, making better access / egress points for invertebrates and vertebrates.**

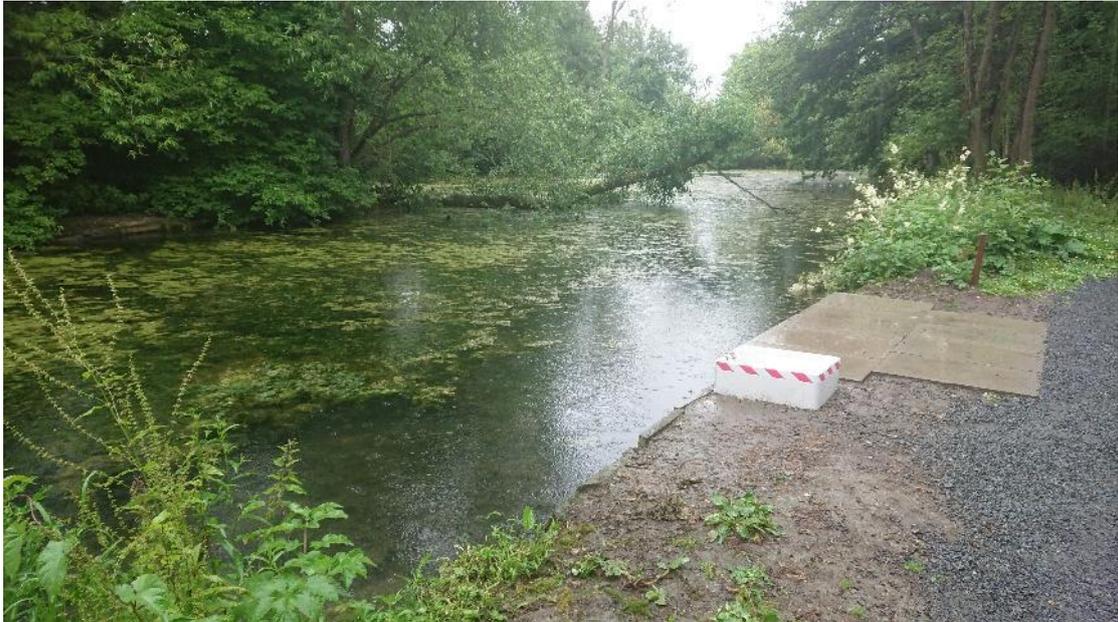
Fig 4. Highly formalised bank around the pond-dipping site. This is a fantastic engagement and education feature but the pond habitat immediately adjacent will degrade over time with disturbance from repeated sweep netting.

The large almost horizontal trunk of a crack willow still growing from the island should be maintained as vital habitat. The boarded banks of the island created an unnatural vertical edge, and there appeared to be little in the way of understory either through shading from the dense tree canopy or from the activities of the numerous waterfowl which use it as a refuge.

- Construction of a berm on either side of the pond-dipping area for the creation of emergent and marginal plant habitat.
- Careful thinning of some overhanging vegetation on the island to diversify the understory and increase opportunities for marginal plants. To be effective, such an activity will require exclusion of waterfowl from the proposed area of the island, and the construction of further berms along the boarded edges. These will also require protection from waterfowl until well established.

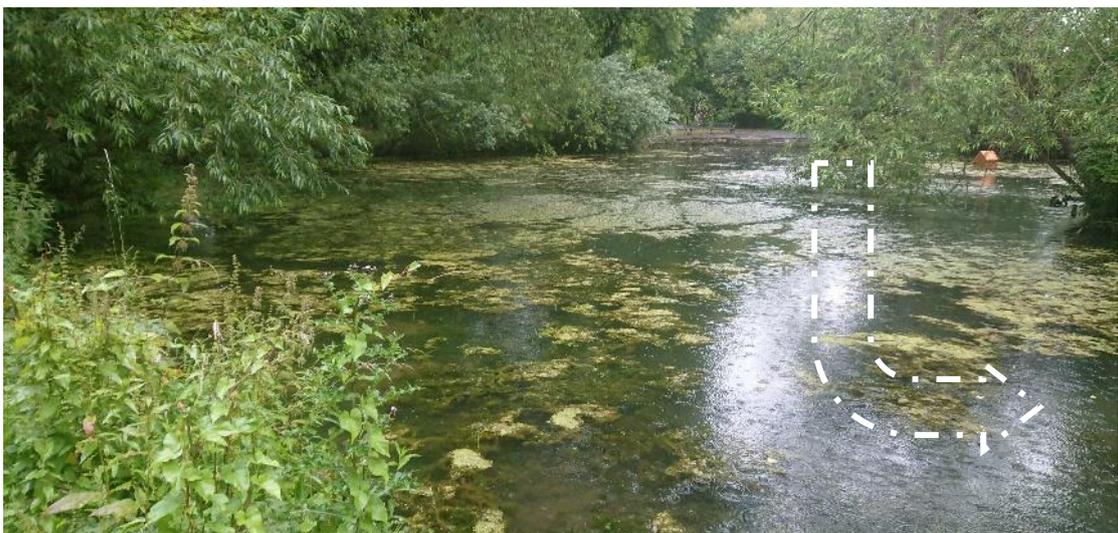
Fig 5. A 'forgotten corner' – the inaccessible bank of the pond between the pond-dipping area and the inflow was lovely and wild and should be retained thus. The only modification proposed would be the opening up of a channel through the weed to circumnavigate the island, extending that proposed in Fig 2.

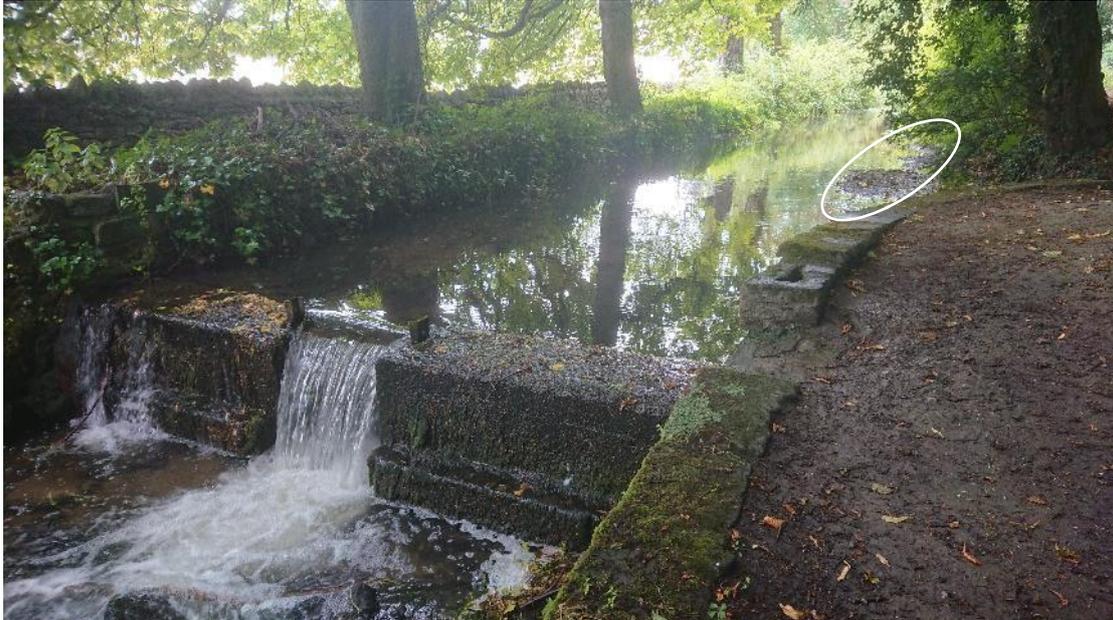
Fig 6. The substantial weir which impounds the flow of a Thornton Beck carrier to provide the offtake for the pond which is piped through the wall immediately u/s on the LB. The carrier is a highly artificial channel historically diverted from Thornton Beck, originally for industry but in latter years adapted for the creation of the pond. As such, it has been engineered to completely unnatural proportions within walled banks; straightened and over-capacity (too wide) meaning that it has lost the capacity to be 'self-cleansing'.

The weir structure obviously causes a severe obstruction to fish passage as well as impounding and hence drowning out habitat u/s. Over time, the u/s reach has filled in and the typical limestone gravel bed has been smothered with fine sediment to the extent that there are exposed banks of mud (white ellipse). The resultant channel is too shallow and uniform, devoid of habitat features.

An extensive mature tree canopy and a high density of evergreen yew trees has resulted in a depauperate understory.

- **Education – this section could be included in the trail around the pond, to highlight how the stream has had to be engineered to accommodate the pond and how the structures impact upon ecology, e.g. fish passage. Plus engagement re restoration.**
- **Restoration of the beck to a functional limestone stream.**
 - **Crown-lifting of the mature trees on the RB (as in the background of the image) to allow light to the understory and to allow a better view from over the wall.**
 - **Introduction of low berms and woody debris to return the channel to natural proportions and create a sinuous path within the confines of walls.**
 - **Planting of marginal / emergent plants and water crowfoot to stabilise berms and focus flows thereby keeping gravel free from silt.**
 - **Fish passage solution at the weir(s) to cater for salmonids and eels.**

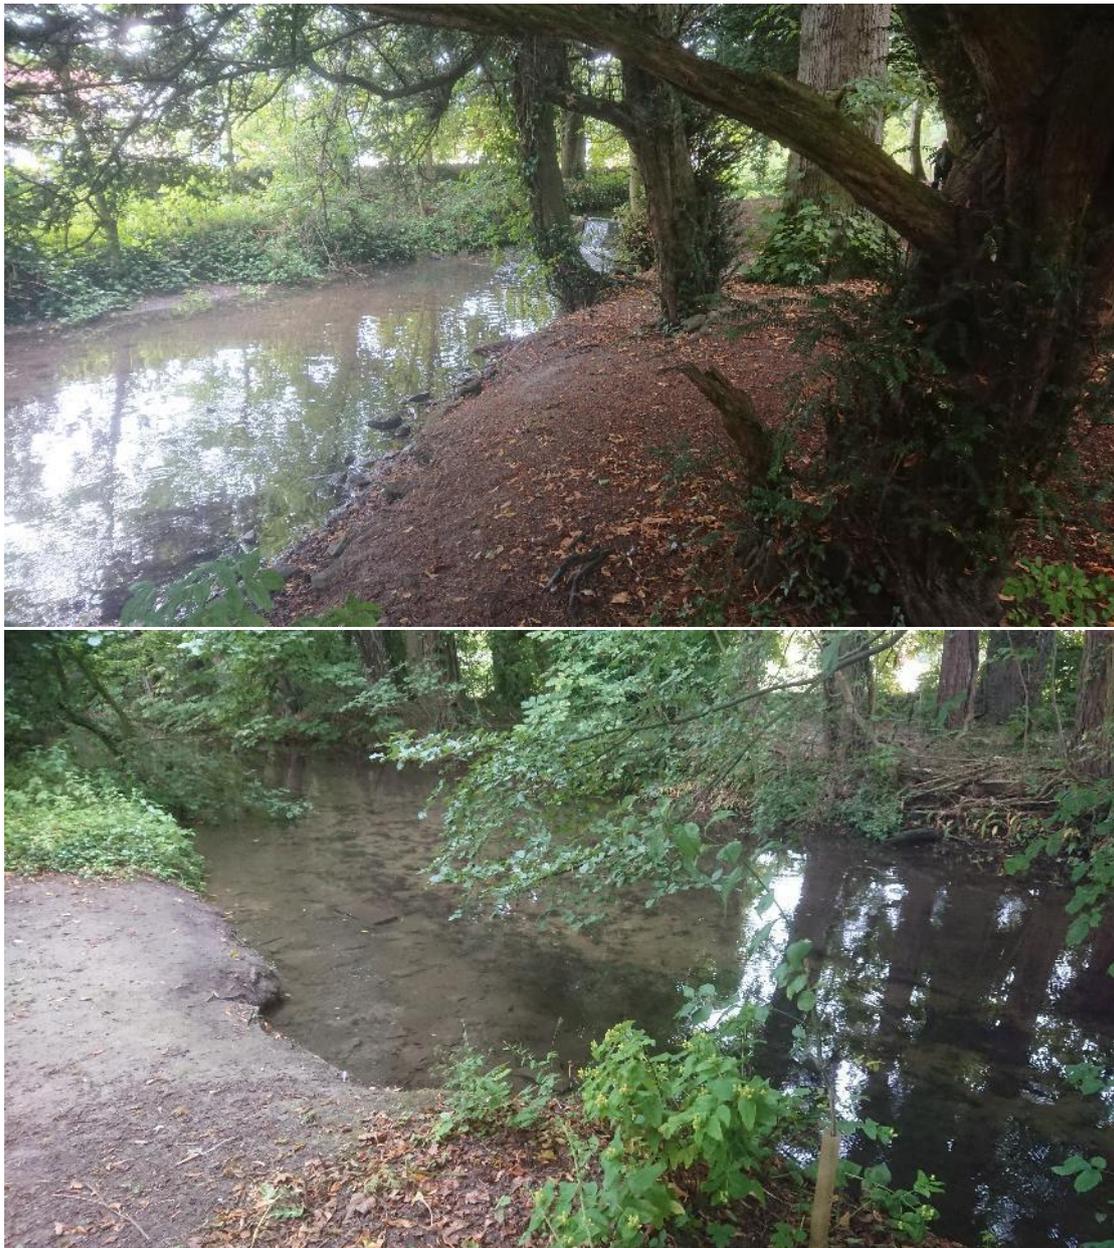
Fig 7. Typical views along much of the beck, highlighting the dense canopy and paucity of understory, degradation/erosion of the bank by footfall at focal points, the overly wide and uniform proportions of the channel, and the subsequent smothering of silt across the bed.

- **Judicious thinning of the canopy to allow more regeneration and understory.**
- **Arisings from the canopy work could be used for berm creation.**
- **Introduction of large woody debris from the plentiful supply on the banks to diversify the channel form.**
- **Restoration of the bank and either formalisation to prevent further degradation or restriction to the currently walled / concreted sections (Figs 6&9).**
- **Education boards re stream ecology and the restoration works.**

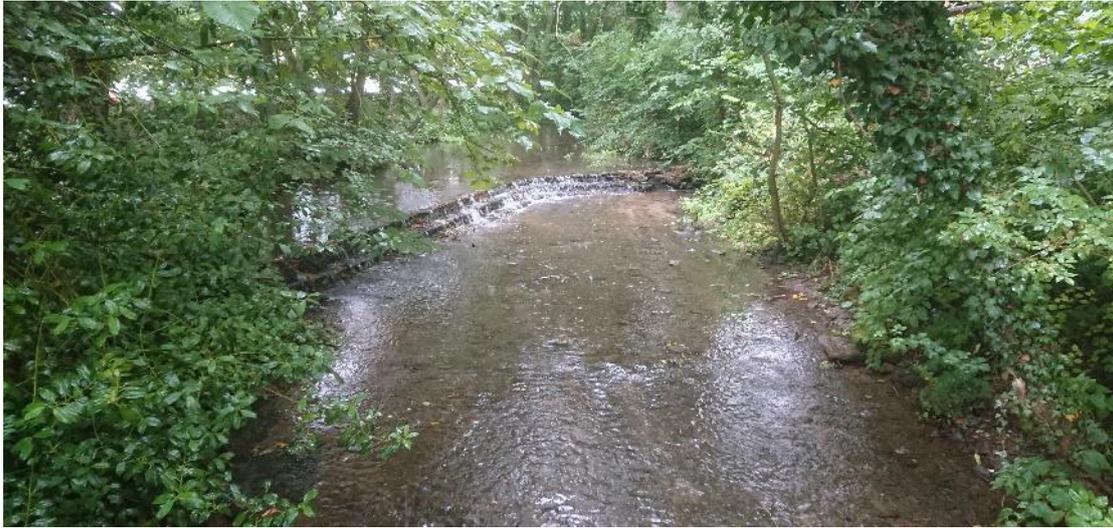
Fig 8. A low-head weir which appeared to split the flow between a small carrier to the forge and on parallel to Maltongate, and the remainder continuing over the weir and around the pond. The considerable width of the structure means that the flow is reduced to a thin skim of water across the channel, and hence there is insufficient depth of water for fish to reside in, let alone approach and attempt to leap the weir.

- Ample opportunity to use bankside vegetation to pinch the channel to a more natural width and hence create a greater depth of faster flowing water (both u/s & d/s of the weir).
- A focal flow arising from the works described above would help to keep silt clear from the gravel.
- Improve fish passage (possibility of a small notch in the weir crest plus eel / lamprey bristles or tiles).

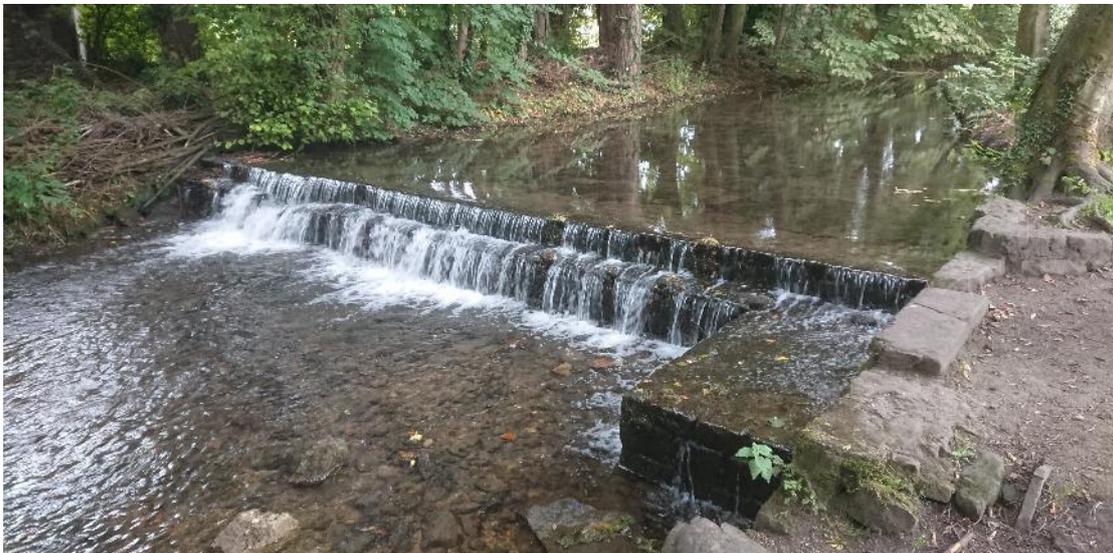
Fig 9. The weir immediately u/s of the pond outflow pipes. It was not immediately clear what historic purpose this weir served. If it was deemed defunct (i.e. no services within the structure, or current abstraction licences associated with it), then it should be removed to reinstate connectivity.

- Part removal of the structure – a nod to its historic presence as part of the education / engagement aspect, but reinstatement of riverine processes through a full bed-depth notch of width to accommodate most flows but pinch sufficiently to create some scour. The walling and infrastructure necessarily remaining around the outflow pipes could be better formalised as steps into the beck here.
- Restoration of a sinuous channel.

The various weirs were noted to be degrading habitat and creating issues of fragmentation, preventing the free movement of sediment and fish. Removal is the gold standard as it reinstates full connectivity and removes any requirement for ongoing maintenance. However, it is appreciated that because of historic and contemporary infrastructure, removing the impounding effects of at least two of the weirs is unlikely to occur. The lowest weir (Fig 9) appears to be redundant and should be removed.

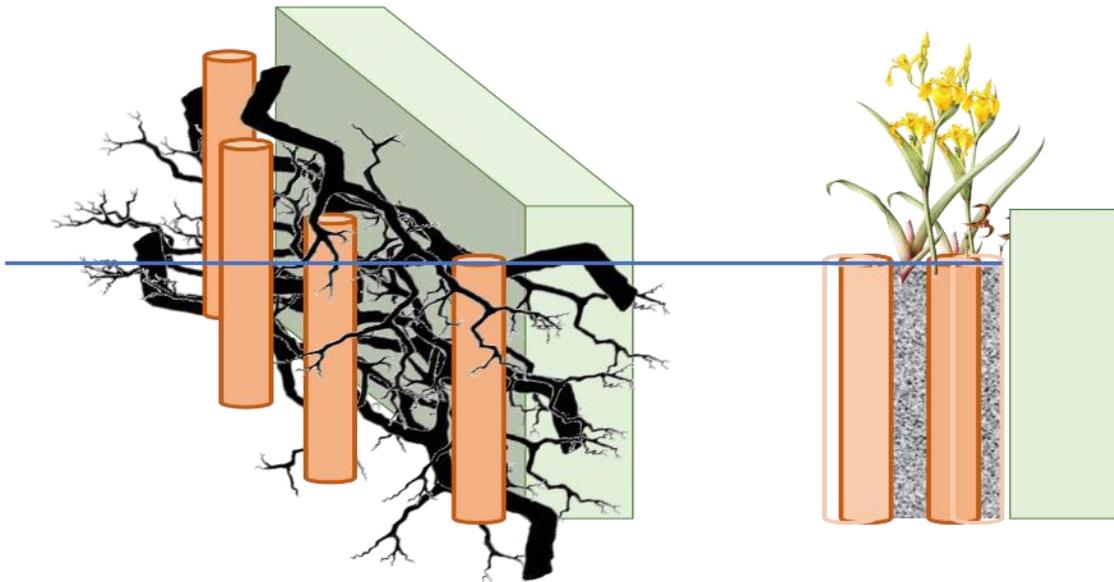
Fig 10. Schematic of brush berm or ledge creation against pond walls: stakes driven flush with water surface, packed tightly with brush and planted with emergent plants like flag iris.

Along the very formal edges of the pond, there is little in the way of emergent vegetation (e.g. flag iris, water mint, bistort etc). These plants will take up nutrients from the water column, as well as providing important habitat structure at the water-land interface. Currently the depth at the edges is too great for most emergent species so to soften the 'step', low-level berms could be created using chestnut stakes and brash arising from tree management, tied or woven into position using biodegradable jute string. Tightly packed brash, perhaps also using some of the submerged weed cleared from

channels, will provide an ideal planting matrix for emergent plant plugs or locally sourced seed. Netting will be required initially to prevent repeated trampling / resting by waterfowl. Sufficient light is also needed for successful establishment and hence there might be some requirement to manage tree cover above any planned berms. Many of our native emergent species are extremely colourful so will enhance the aesthetic appeal of the pond edge as well as increasing plant diversity and improving forage for pollinators.

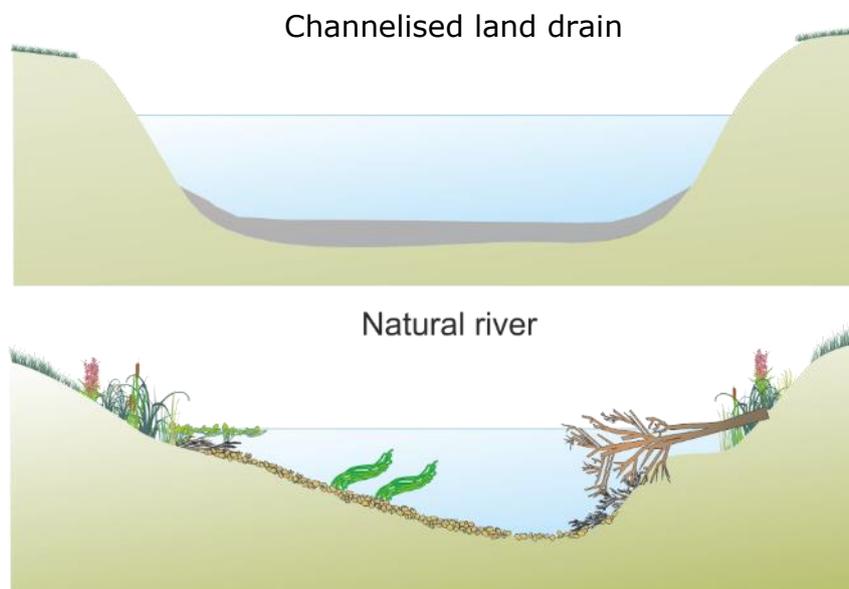
Fig 11. Simplified, uniform dimensions of a trapezoidal channel designed for conveyance of water, as compared to the diversity found in a natural channel.

Currently, the trapezoidal channel is overly straight and uniform. In some areas, deposition of fine sediment has occurred because of insufficient flow energy to carry that silt onward (e.g. Fig 6). Extensive forestry in the fine/sandy surface geology of the catchment has created ongoing problems for Thornton beck and bringing pressure to bear on forestry practices upstream would markedly reduce many of the degrading impacts noted. With ample light, those bars of mud would have been colonised by plants, thereby narrowing the channel to more natural proportions. However, under typical flow conditions, the channel is over-capacity: too wide and hence the water depth generally too shallow; see Figs 7-9 as compared to the schematic in Fig 11.

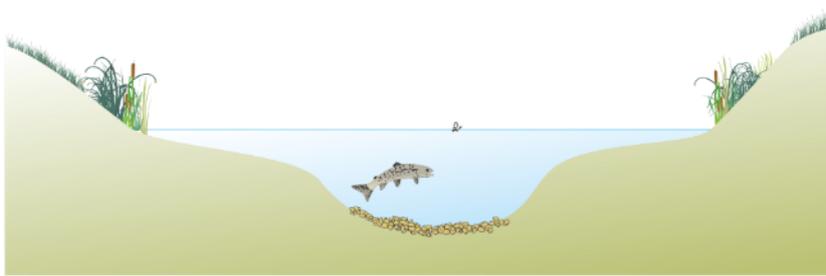
Two-stage channel

Fig 12. Cross section of a watercourse with a two-stage channel wherein water is confined to the deepest point during low flows but can accommodate a much greater volume under spate conditions.

Creation of a two-stage channel, i.e. a meandering low flow channel within the confines of the engineered walls significantly improves opportunities for biodiversity while not increasing flood risk (in cross-section profile - Fig 12, and in creation – Fig 13).

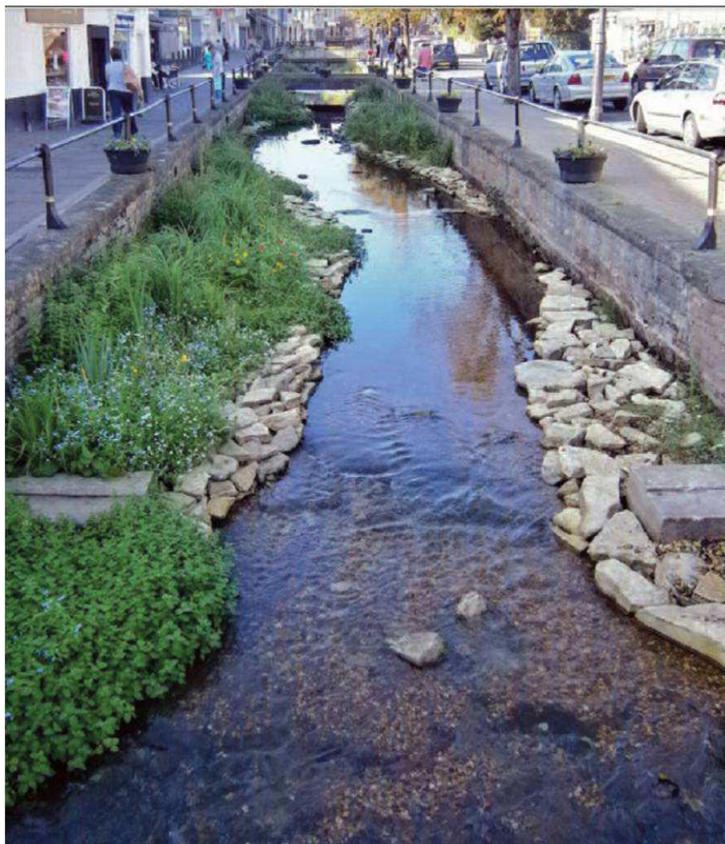
Fig 13. A constructed two-stage channel on the River Somer, creating a sinuous low flow-path. The low berms on either side are quickly overtopped during spate flow and hence do not significantly reduce the carrying capacity of the channel.

As demonstrated for the River Somer (Fig 13), there is space within the carrier of Thornton Beck to consider alternating placement of berms from one bank to the other, thereby creating meanders, and to place them directly opposite each other to 'pinch' the channel and create a deeper run in between. As the beck widens out again downstream of a pinch, it should cause a ramp of deposited gravel which is the ideal habitat for spawning trout.
