## River Trent, Trentham Gardens: Advisory Visit

Paul Gaskell, Wild Trout Trust 23/08/2016

<b>Groundwork West Midlands/Trentham Estate: River Trent</b>
<b>River</b>	River Trent
<b>Waterbody Name</b>	Trent, Fowlea Brook to Tittensor
<b>Waterbody ID</b>	GB104028053271
<b>Management Catchment</b>	Trent Valley Staffordshire
<b>River Basin District</b>	Humber
<b>Current Ecological Quality</b>	Moderate
<b>U/S Grid Ref inspected</b>	SJ8668640812
<b>D/S Grid Ref inspected</b>	SJ8677140473
<b>Length of river inspected</b>	~500m in total

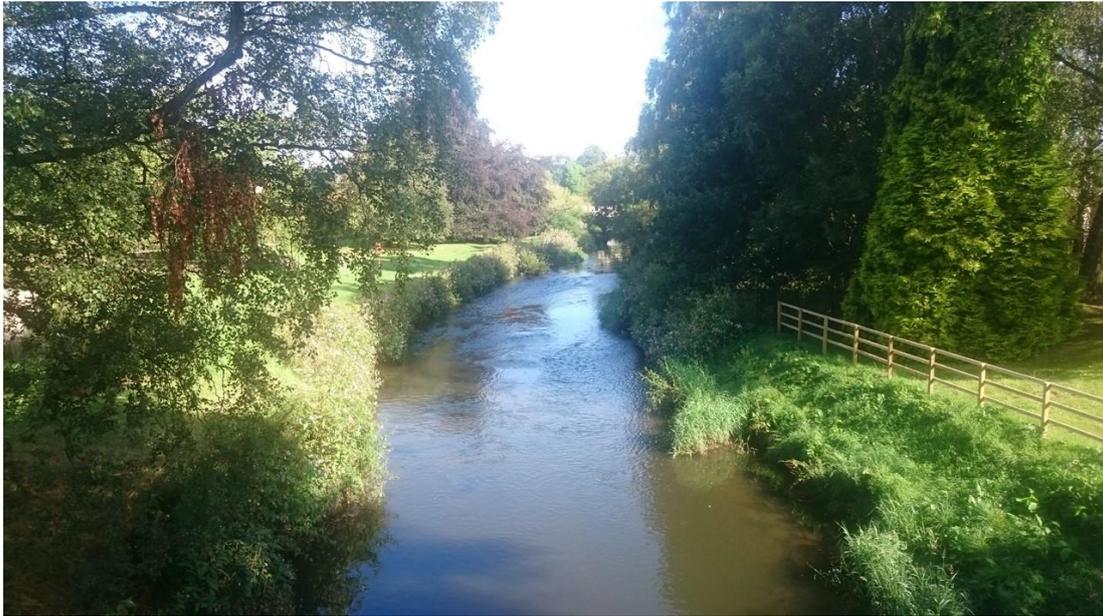
A typical impression of the more formally-gardened sections can be seen from the footbridge at SJ8674140598 (Fig. 1). This is a good indication of the historic channel realignment to make a generally straighter and more uniform channel. Consequently, the riverbed substrate and cross-sectional depth profile are generally less-varied than in channels predominantly formed by natural geomorphological processes.

However, the presence of beds of water crowfoot (*Ranunculus* spp.) not only adds some diversity to the flow but is also indicative of higher water quality

**Figure 1: Photograph facing upstream off the footbridge at SJ8674140598.**

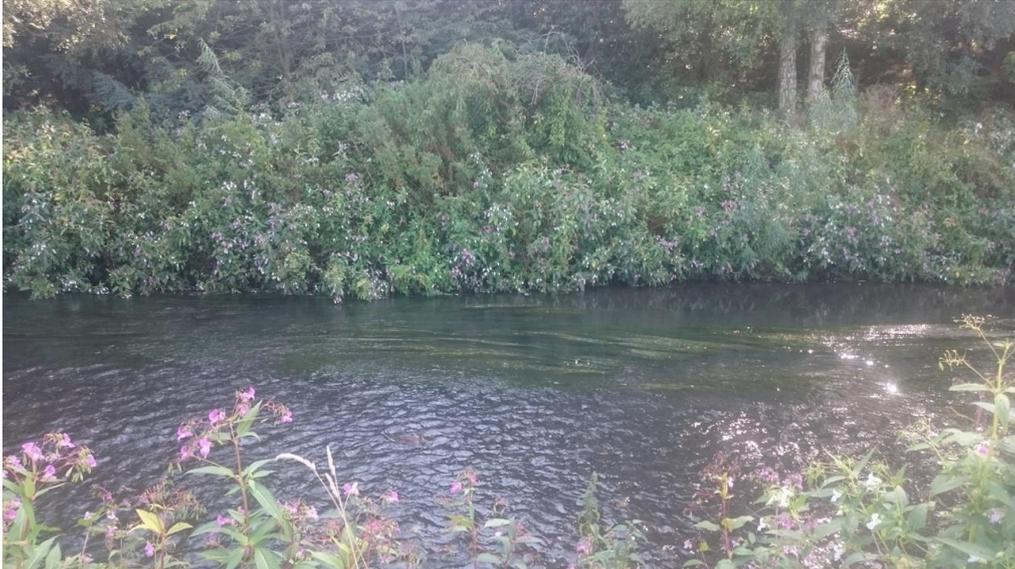
The spacing and the structure of the tree canopy along this section of river does provide a variety in light and shade conditions as is also evident in Fig. 1 as well as in Fig.2. Consequently this is likely to promote natural variation in the distribution and density of water crowfoot patches; with crowfoot flourishing in full sunshine and being inhibited in shady areas. Such variation is a good thing since structural/flow variation tends to provide a greater range of habitat-niche conditions for a wider variety of species.

From the perspective of wild trout, there appear to be two main habitat limitations on robust, self-sustaining populations. First of all, a poor “sorting” of spawning gravels (different particle sizes from fine clays, sands, gravel and cobbles are all aggregated together – somewhat like a “cake mix”). This is compounded by the relatively sandy catchment and associated inputs of finer materials; leading to an increased potential for smothering of trout eggs and difficulty in female trout cutting “redds” (nests) into the gravel bed.

**Figure 2: Closer look at the balsam, tree-shading, water crowfoot and bed substrate.**

Firstly, although mindful of the significant labour involved, it would be extremely beneficial to undertake strimming (below first node on stem) or hand-pulling of the Himalayan balsam infestation (both prior to plants setting seed). In order to not unduly burden the staff of the Trentham Estate directly – it may be possible to co-ordinate with organisations like Groundwork, local Wildlife Trusts or “Friends of” groups (or a combination of all) to have them carry out hand-pulling of balsam. At the discretion of the Estate, it may be possible to reward volunteers with entry to the gardens after successful clearance of a previously-agreed area. Note that “control” rather than “eradication” at the local patch scale is both sufficient and extremely valuable at the broader landscape scale i.e.

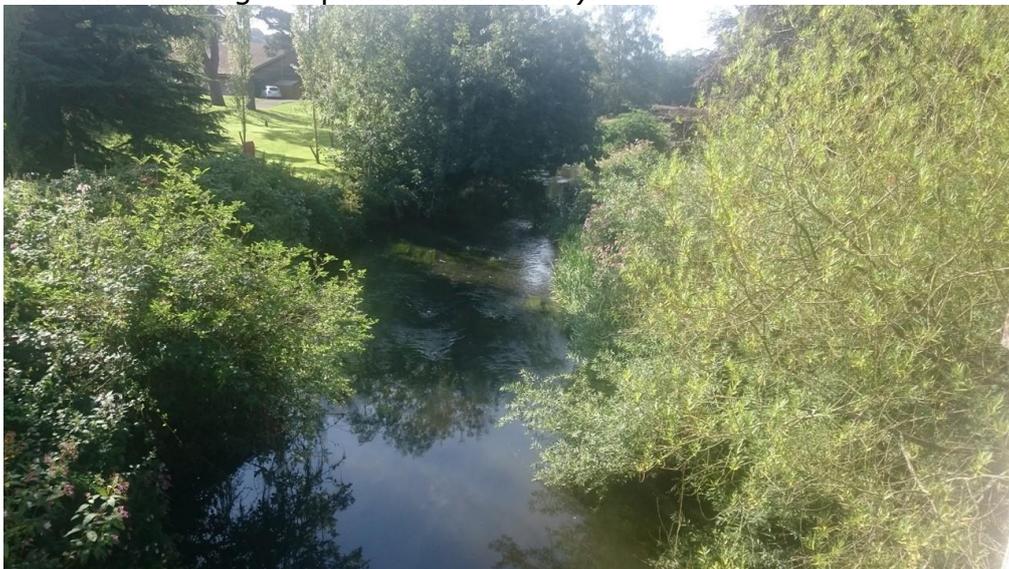
**Figure 3: Some excellent marginal and over-hanging cover is provided by willow and alder at SJ8672340748. While it is not advisable to make an entire reach resemble this section, some additional patches that incorporate the low-growing and easily-managed elements would be extremely valuable at selected points along the river.**

The tremendous value of low, overhanging and submerged cover (e.g. Fig. 3) in terms of cooling, shelter from predation and refuge during spate flows is important to highlight. It is counter-productive to exchange one type of

homogeneity for another (i.e. by lining all "open" banks with a uniform corridor of the vegetation shown in Fig. 3). By the same token, it would add significant ecological value to produce scattered stands of small-scale, low-level woody vegetation at the foot of the banks (for example, trained and hinged or "laid" sapling growth coupled with light coppicing).

By interspersing such patches with more open, herbaceous margins, a good balance of structural diversity would be maintained – along with an aesthetic that is in-keeping with the rest of the grounds. The use of hinging and rotational coppicing, in combination with relatively low-growing/manageable species of trees, can provide this value whilst avoiding excessive additional maintenance.

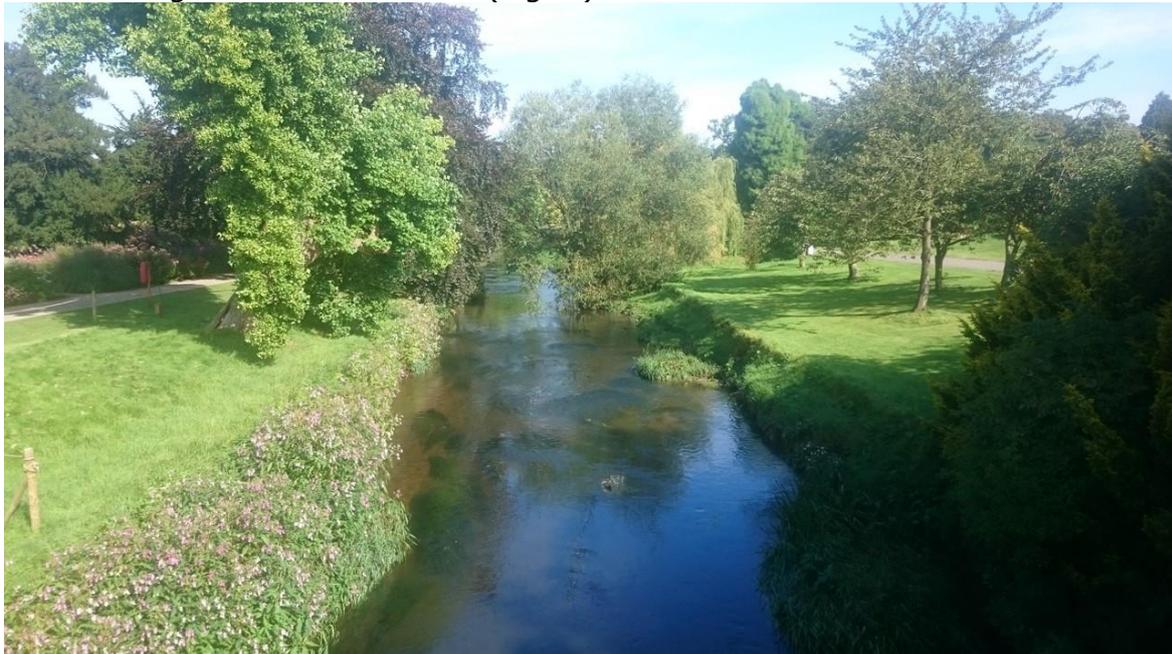
Again, the historic straightening of the channel is evident when looking upstream off the bridge at SJ8672340748 (Fig. 4).

**Figure 4: Straightened channel, balsam infestation and also "block failure" bank erosion.**

The lack of resistance to erosion due to the exclusion of deeper-rooted plants is evident in Figs. 4 and 5. In some cases this will be due to, or exacerbated by balsam infestation - as on the RB (left of frame in Fig. 4). In others it may be due to mowing of vegetation – possibly as on the LB in the reach pictured in Figs. 4 and 5.

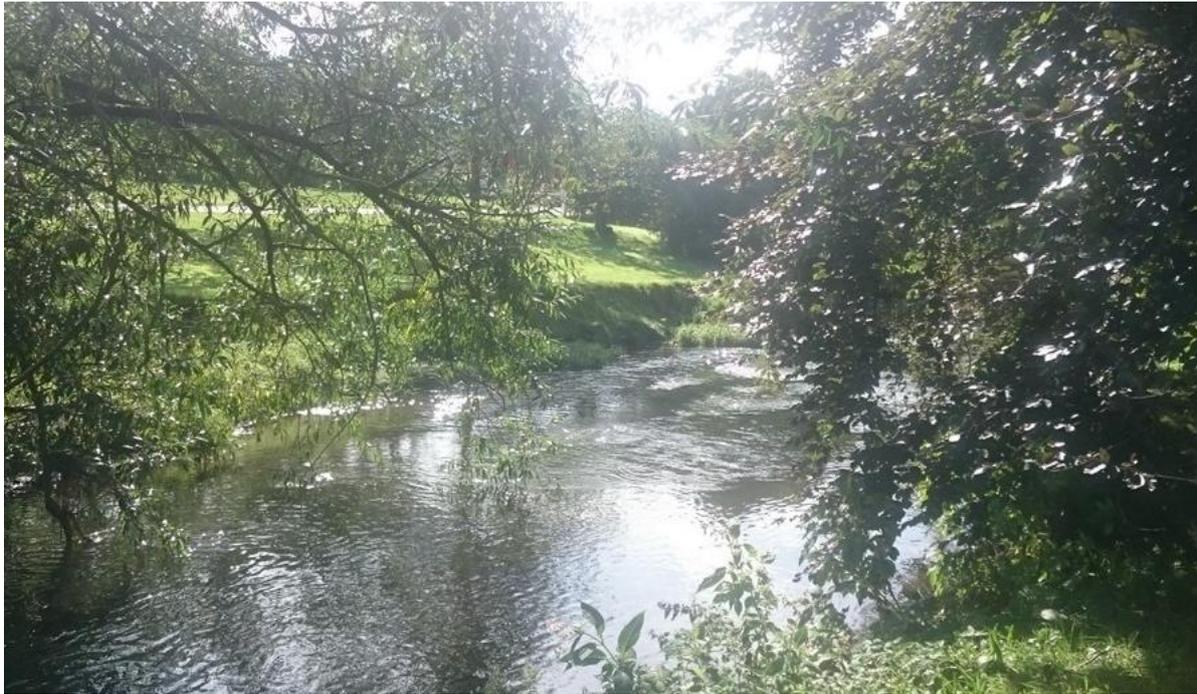
The mechanism by which banks typically erode involves the "toe" (i.e. the joint between river bed and river bank) being scoured out by powerful flows. Beyond a certain point during this process, the weight of the blocks of bank that are being under-cut can no longer be supported by the adjoining land. Those blocks then break off and slump into the river – with much of the soil washing downstream. Often the shallow-root horizon and turf from the upper surface of those blocks is knitted together strongly enough to resist being completely dispersed by the current. These form clumps of vegetated turf that can often be seen in the margins of the river.

**Figure 5: Block-failure visible on the opposite bank. This is due to the shallow root horizon of turf associated with mowing (possibly motivated by previous balsam infestation). However, note also the beneficial, low, overhanging cover from trees. The problem with dense balsam stands is that they prevent succession of trees by out-competing seedlings prior to them becoming tall enough to outstrip the understory.**

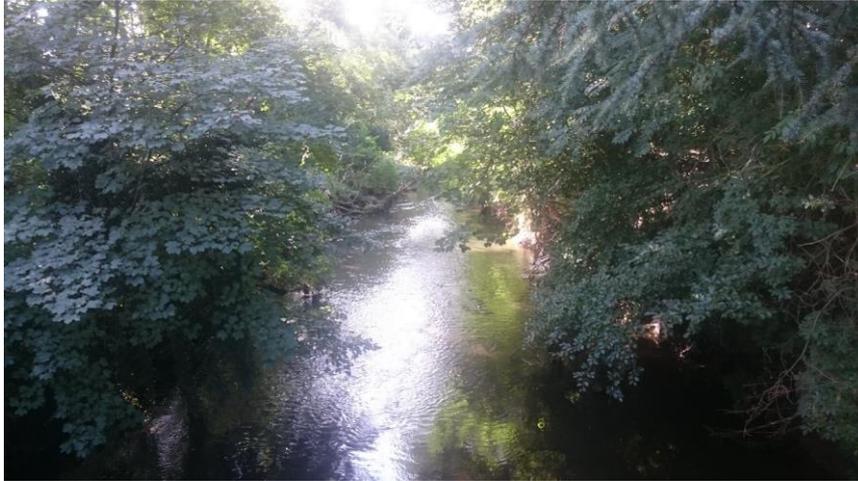
This confluence (at SJ8668640812) was the upstream limit of observations during this visit, however a section of contrasting character was visited at a point downstream at SJ8677140473. Although still within the formal gardens, this section of the river is further from the nearest footpath and sits within a more densely-wooded river corridor. There is currently little management undertaken in this section.

This scenario presents additional opportunities from several standpoints. Firstly, there is a less stringent requirement to aesthetically match the formal planting in the surrounding grounds. Secondly, the light-touch management has allowed some good features to develop - including natural woody material inputs to the channel. However, that same low intervention also results in quite uniform, dense shading and an associated lack of understory vegetation. This is most apparent in the bare muddy banks of the river (Fig. 6). Just a very low-level of rotational coppicing to introduce a slightly more staggered canopy height and

**Figure 6: Some excellent features, which could generate additional ecological value with the introduction of a little more variation in canopy structure and in-channel woody material.**

density structure would be very beneficial here. Some of the woody material arising from that activity could provide some valuable in-stream structure (and geomorphological function) as long as suitably robust anchor-points could be identified.

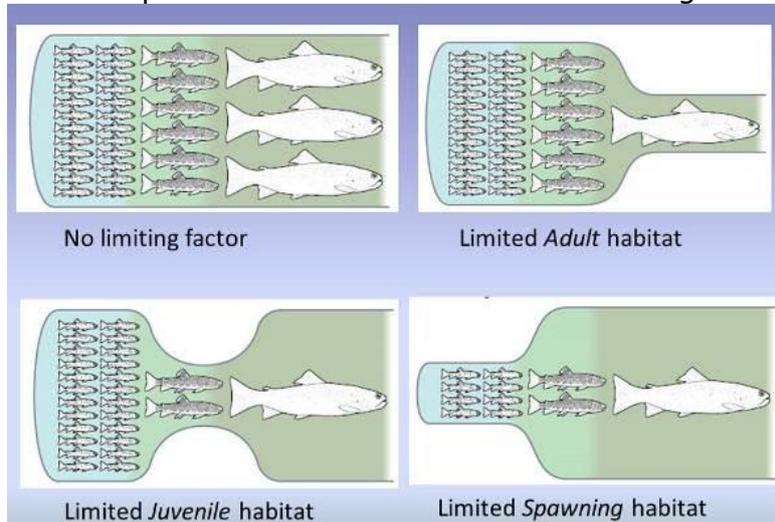
**Figure 7: The impacts on trout populations lacking adequate habitat for key lifecycle stages. Spawning trout require loose mounds of gravel with a good flow of oxygenated water between gravel grains. Juvenile trout need shallow water with plenty of dense submerged/tangled structure for protection against predators and wash-out during spates. Adult trout need deeper pools (usually > 30cm depth) with nearby structural cover such as undercut boulders, sunken trees/tree limbs and/or low overhanging cover (ideally within 30cm of the water's surface. N.B. Excellent quality in one or two out of the three crucial habitats cannot make up for a "weak link" in the remaining critical habitat.**

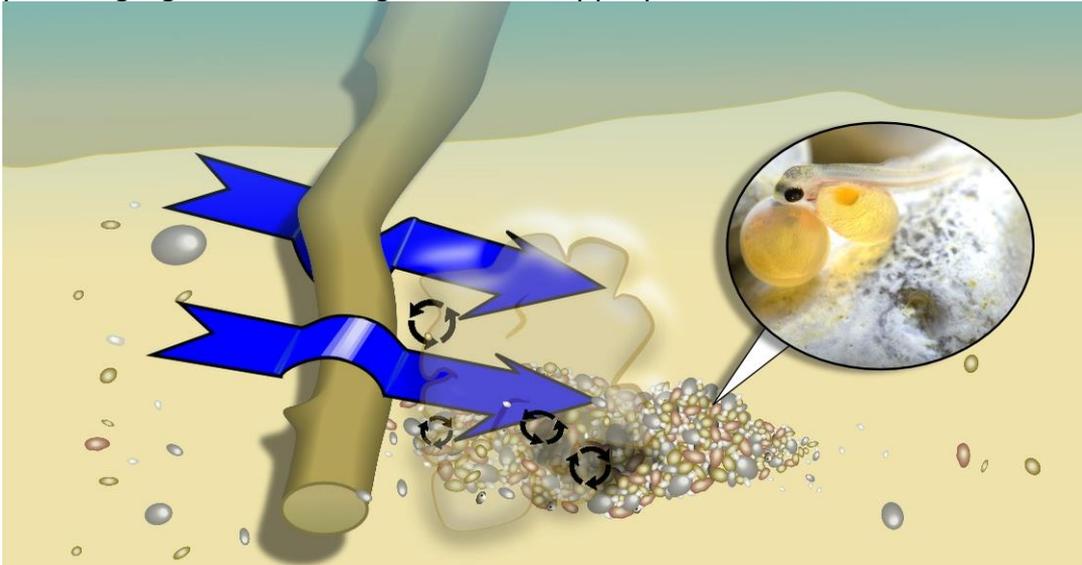
**Figure 8: Features associated with successful trout spawning habitat include the presence of silt-free gravels. Here the action of fallen tree limb is focusing the flows (both under and over the limb as indicated by the blue arrows) on a small area of river-bed that results in silt being blown out from between gravel grains. A small mound of gravel is deposited just below the hollow dug by focused flows. In these silt-free gaps between the grains of gravel it is possible for sufficient oxygen-rich water to flow over the developing eggs and newly-hatched "alevins" to keep them alive as they hide within the gravel mound (inset) until emerging in spring.**

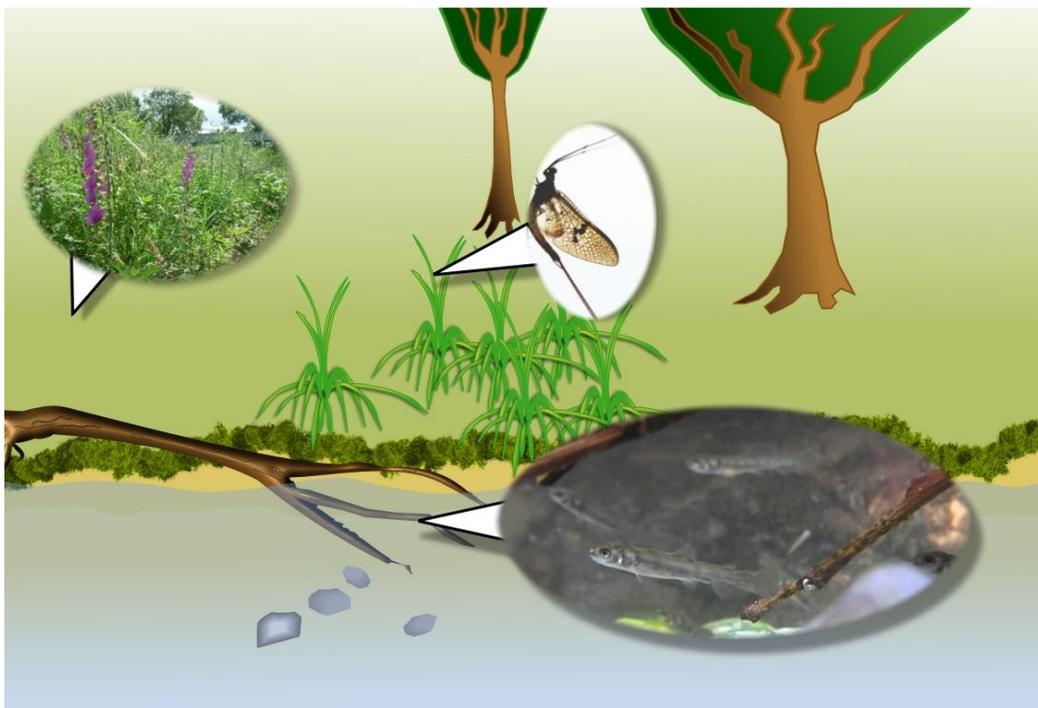
**Figure 9: Larger cobbles and submerged "brashy" cover and/or exposed fronds of tree roots provide vital cover from predation and spate flows to tiny juvenile fish in shallower water (<30cm deep). Trailing overhanging vegetation also provides a similar function and diverse bank-side vegetation has many benefits for invertebrate populations (some of which will provide a ready food supply for the juvenile fish).**

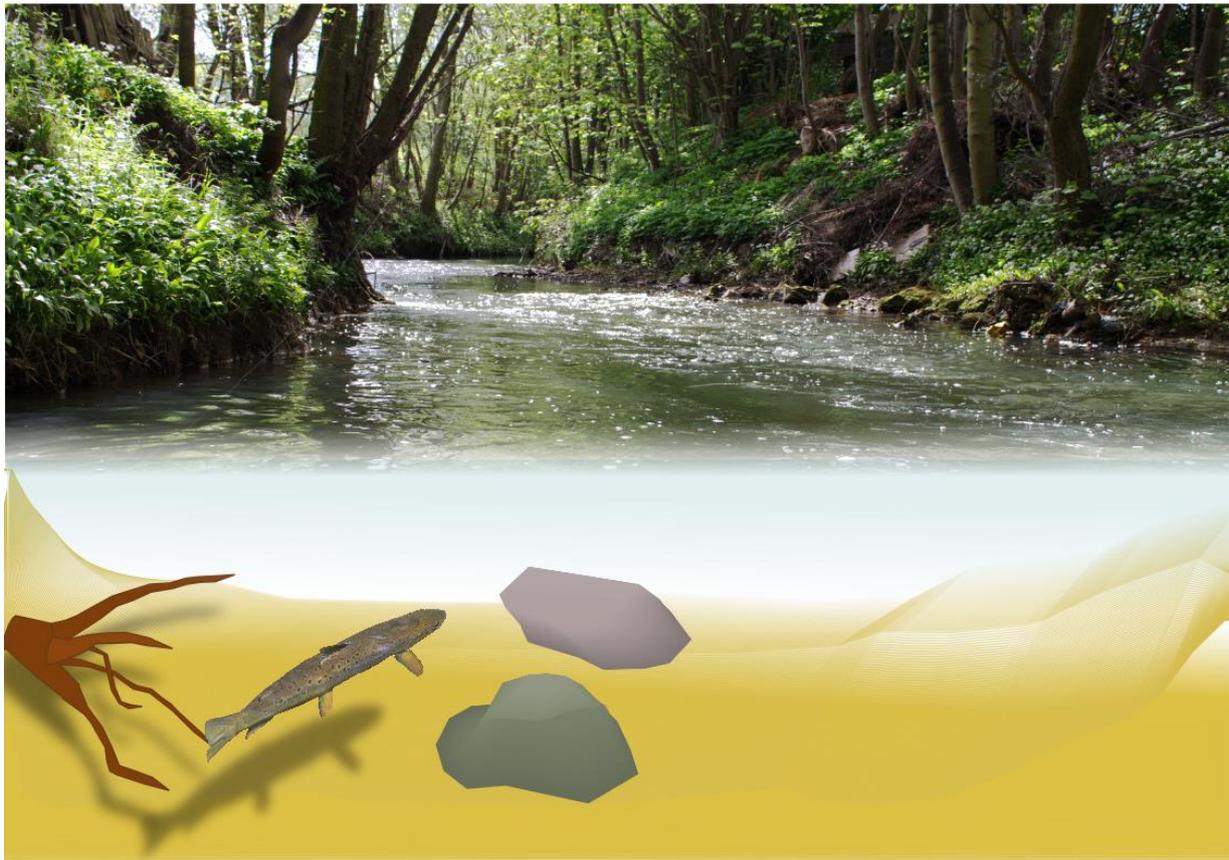
**Figure 10: The availability of deeper water bolt holes (>30cm to several metres), low overhanging cover and larger submerged structures such as boulders, fallen trees, large root-wads etc. close to a good food supply (e.g. below a riffle in this case) are all strong components of adult trout habitat requirements.**

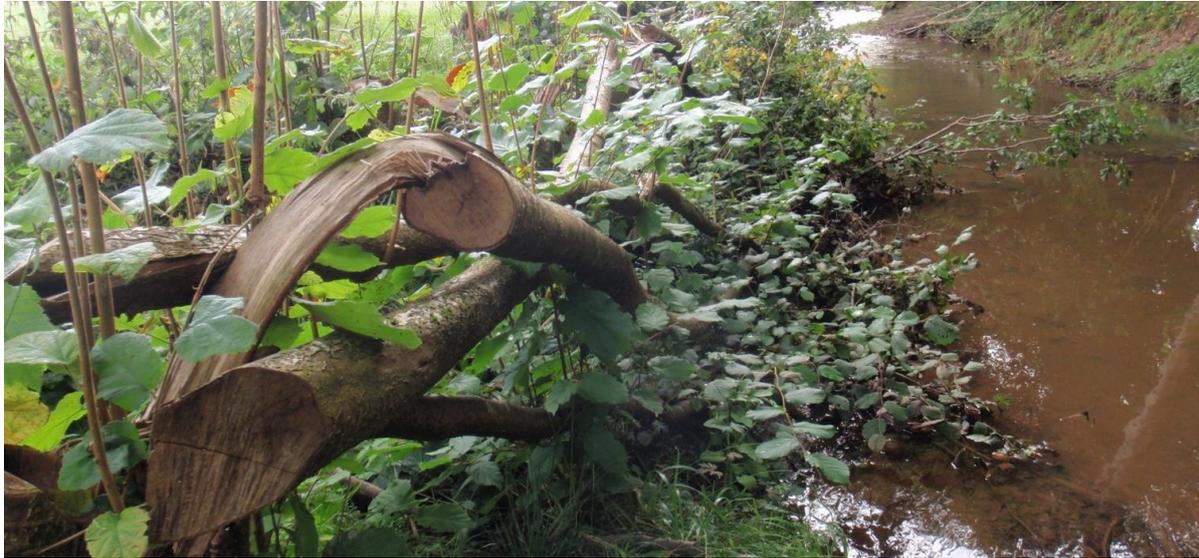
**Figure 11: Hinging or laying of saplings to create marginal cover (in this case using hazel).**

In concert with balsam control, some scattered planting of relatively easily-managed species like Goat Willow (*Salix caprea*) and subsequent “laying” into the margins (as in Fig.11) would provide some additional bank stability and

promote the creation of additional depth. At the same time this would provide submerged cover for juvenile fish.

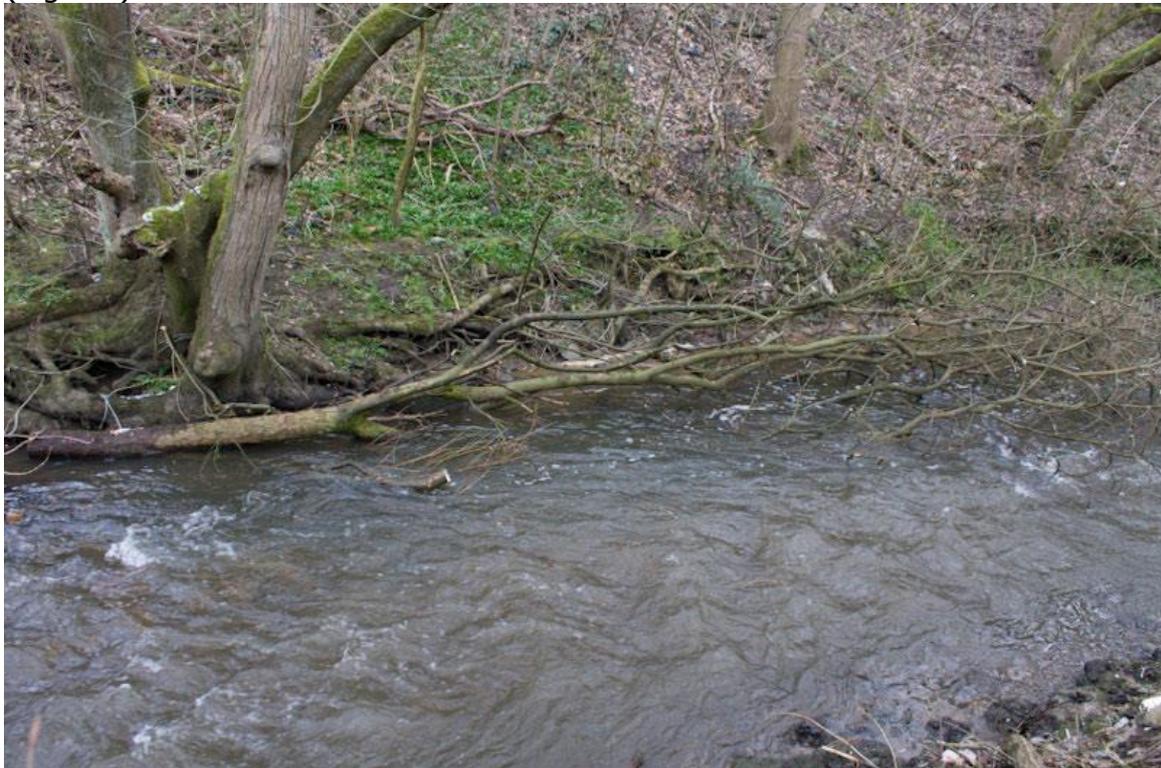
**Figure 12: Newly-installed tree “kicker” (attached to a secure anchor point using braided steel cable).**

The “sorting” of gravel can be achieved by promoting localised bed-scour. A limited amount of such sorting is often associated with marginal tree “kickers” (Fig. 12).

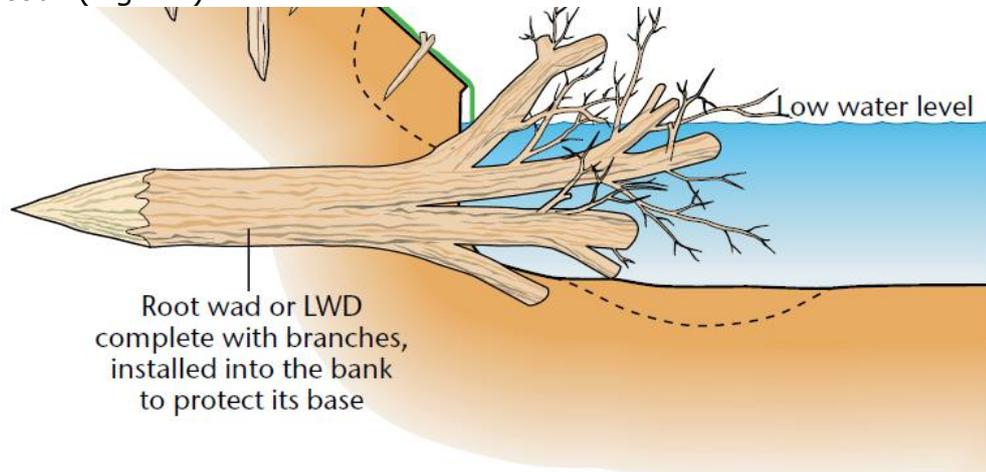
**Figure 13: Root wad (arising from forestry work). The upright trunk is cut to an appropriate length - with a sharpened "point" cut into it. When driven into the bank using an excavator bucket, these are very secure (and often used to protect eroding banks).**

More extensive gravel "sorting" to improve spawning success can be achieved by secure installation of features like root wads (Fig. 13) or by pinning the "free" end of a tree kicker so that the trunk becomes an upstream-angled log which promotes scour (Fig. 14).

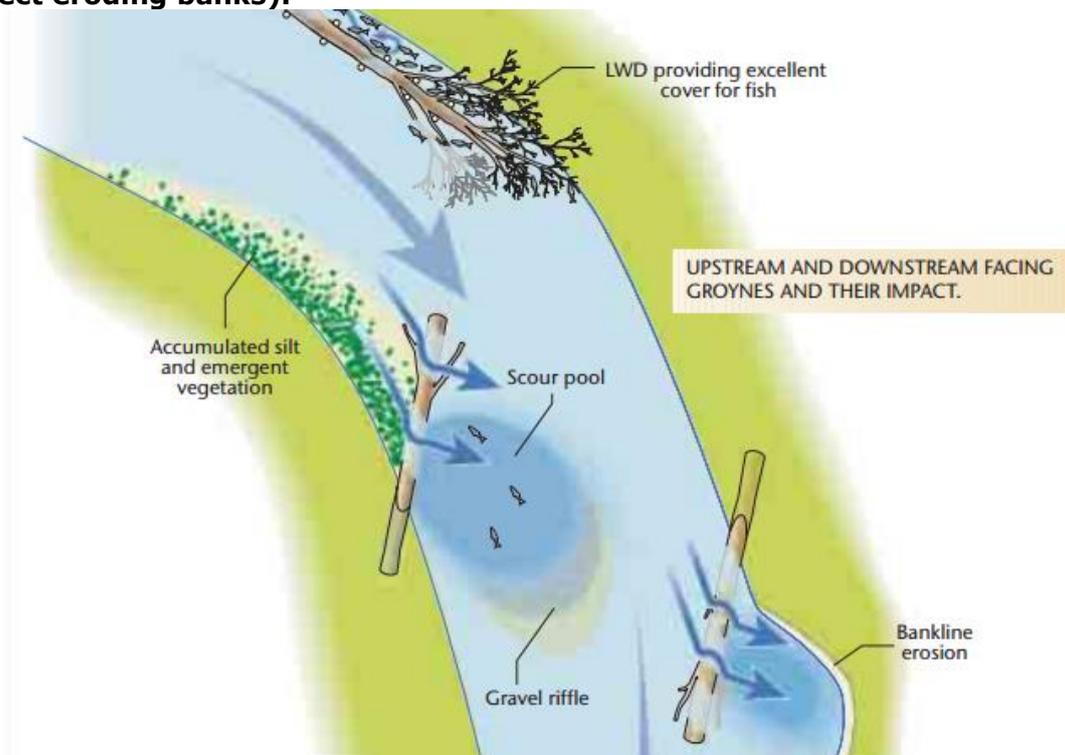
**Figure 14: Note the counter-intuitive effect of upstream versus downstream-angled tree trunks. The upstream-angle promotes scour of the riverbed in the channel. Conversely, downstream angled installations create bank erosion. In the case of Trentham Gardens, the upstream-facing installation is recommended. N.B. the necessary anchoring of the bank-side end of this installed material can either be achieved by burying or by cabling (as for the tree kicker).**
