Advisory Visit

Tributary of Repton Brook, Derbyshire

July 2017

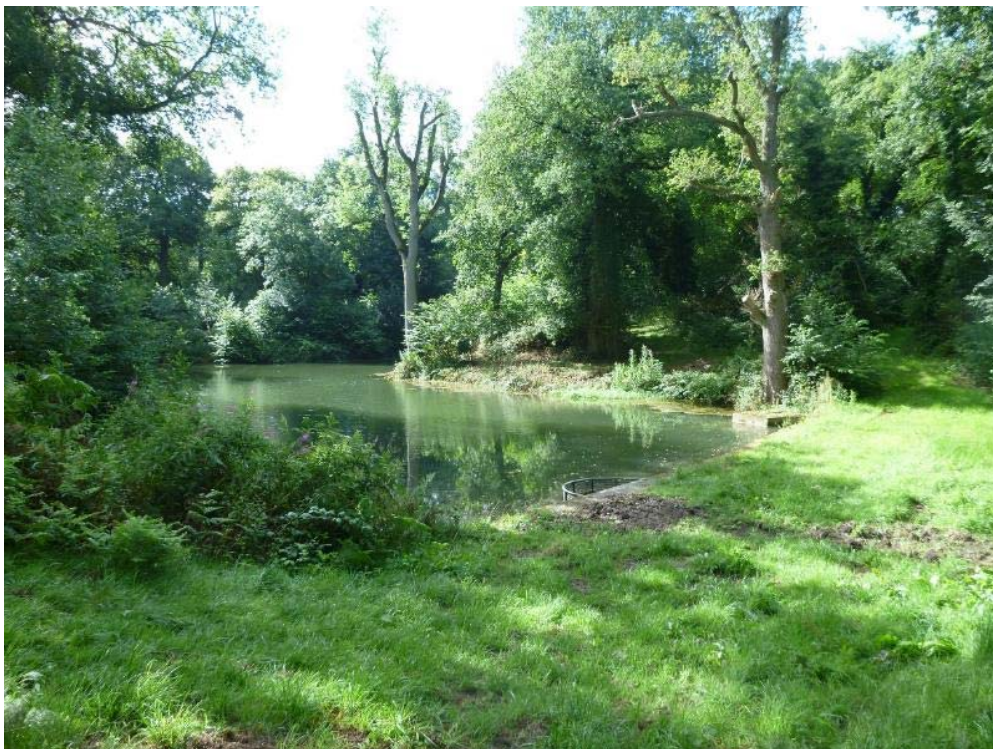
This small unnamed stream is a headwater of the Repton Brook which ultimately joins the River Trent near Willington, Derbyshire. It originates from a spring source approximately 500m upstream of Mr. Moseley's ownership. An online lake thought to be a mediaeval fish pond has been restored here (cover picture). In addition, there is another lake upstream of this site and at least two below, all within approximately 1 km.

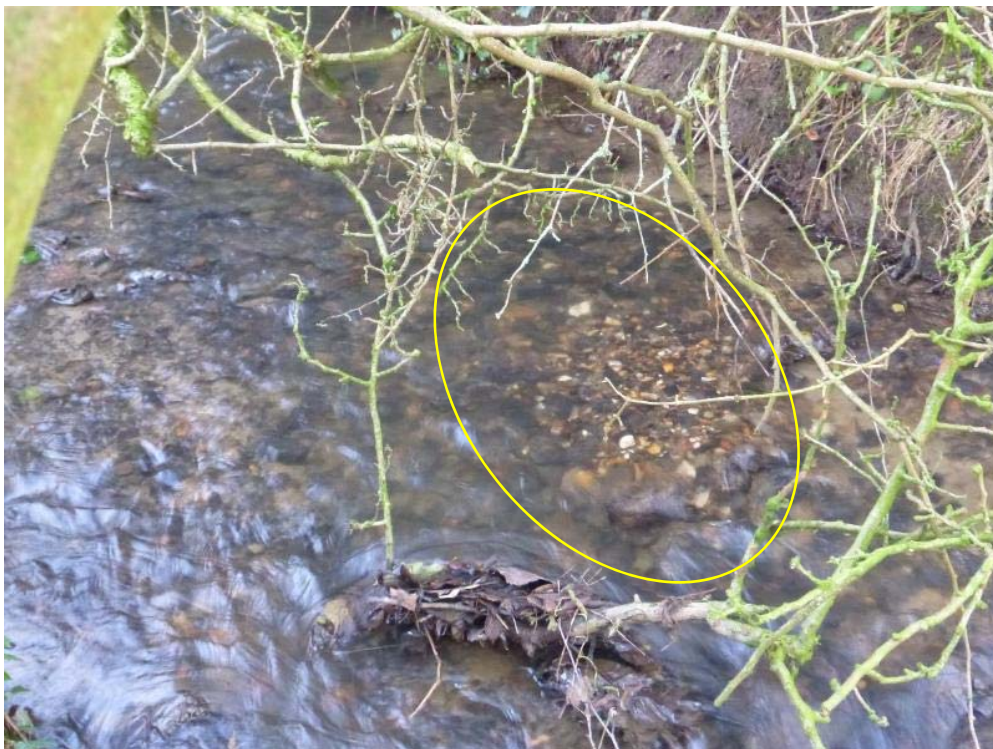
Photo 1 Example of a freshly-made trout redd in a small Lincolnshire stream.

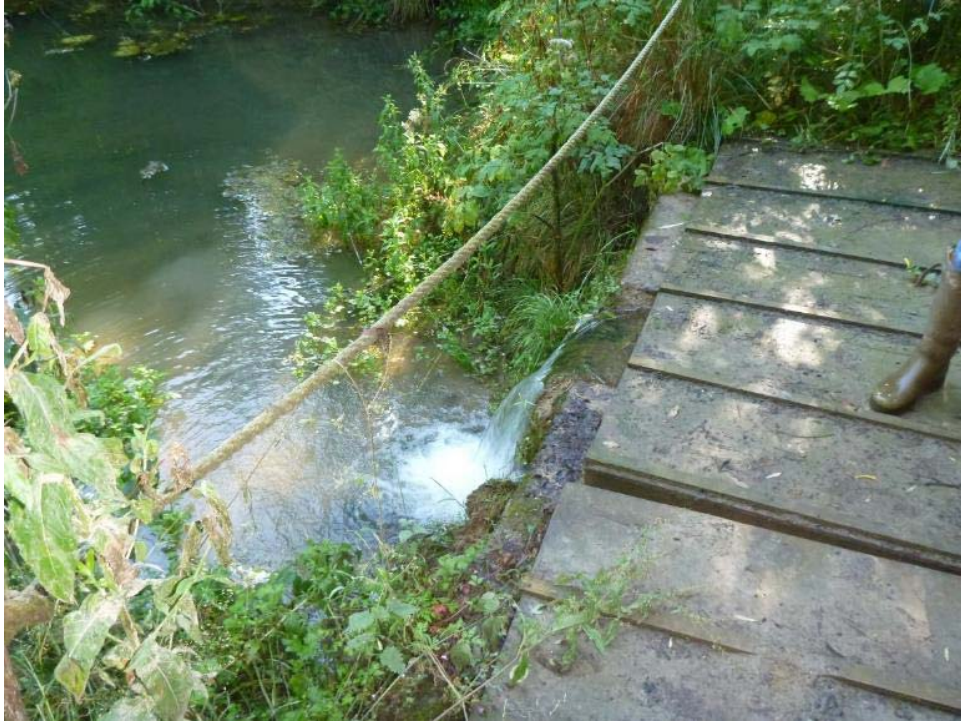
The site has been in Mr. Moseley's ownership for about 15 years and the lake was restored 12 years ago by reconstruction of the dam, overspill and restoration of a C19th ram pump. The lake is approximately 2000 m² (0.5 acre). The inflow drops over an impoundment which also forms a silt trap (Photos 2 and 3). There have been problems with excessive silt inputs from upstream which have now been resolved, but excess fine sediment is still working its way down the system and the silt trap is emptied on an annual basis. The inflow is impassable to fish moving upstream from the lake into the brook.

Photo 2 Inflow to the restored lake. The stream is spring-fed and the flow varies little from that observed on the day of the visit.

Consideration could also be given to improving the lake inlet for fish passage, although there is little room there given its proximity to the boundary of ownership.

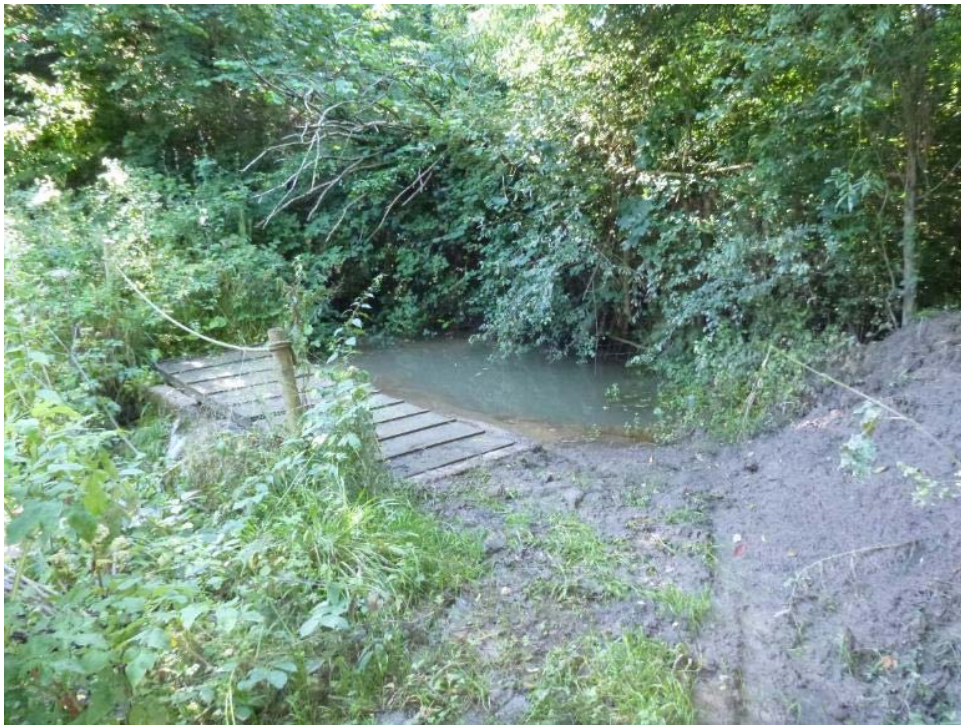
Photo 3 A silt trap is located on the tributary stream and emptied annually. There have been problems with excessive silt inputs upstream which have now been resolved, but it is still working its way down the system.

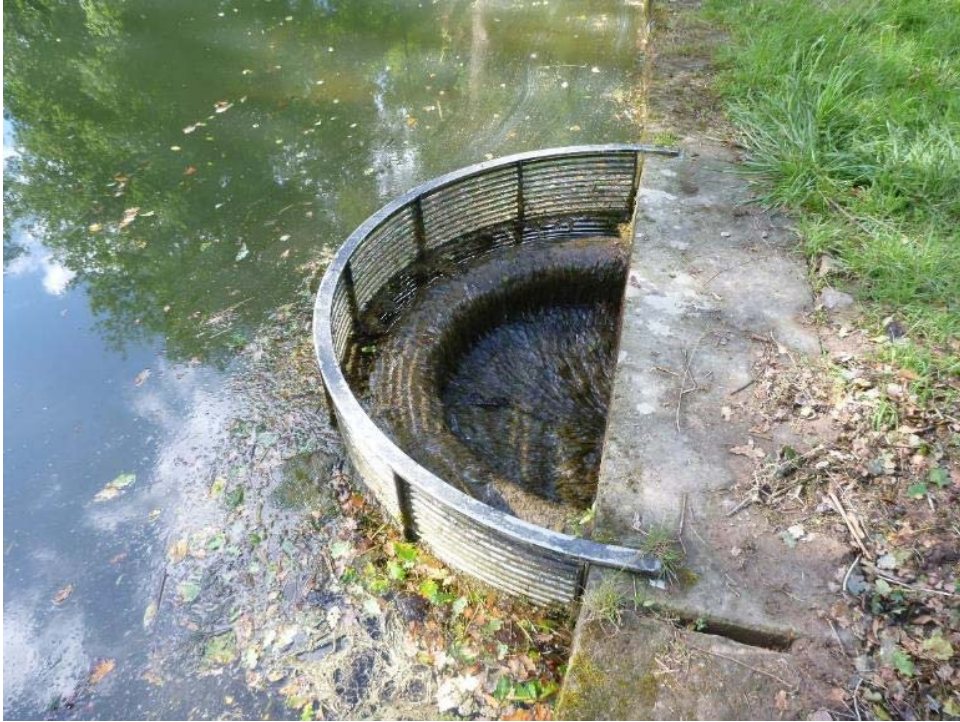
The lake outflows through a fixed level overspill in the dam (Photo 4), through a buried culvert pipe approximately 2ft diameter onto a stone

spillway and on into the brook downstream. The culvert is impassable to fish moving upstream because:

- the downstream end is perched a few inches above the shallow spillway, so fish cannot swim or leap into it;
- the flow through the culvert is too shallow and rapid for fish to swim through successfully;
- The upstream end (Photo 4) is not passable to fish in its present form.

Photo 4 The outflow from the restored pond. There is also a restored ram pump at the southern end of the dam.

- Consider improving the lake outflow to facilitate upstream fish movement. This would require a survey of the area and measurement of the flow to see if there is a practical solution. The present problems outlined on page 4 would need to be addressed by raising water levels to drown the toe of the culvert, slowing the flow within the culvert using baffles and modifying the overspill structure (Photo 4) by notching. The principle is to provide a solid plume of water over an “adherent nappe” (i.e. with little turbulence or entrained air), through which fish can swim. Further information is available here:

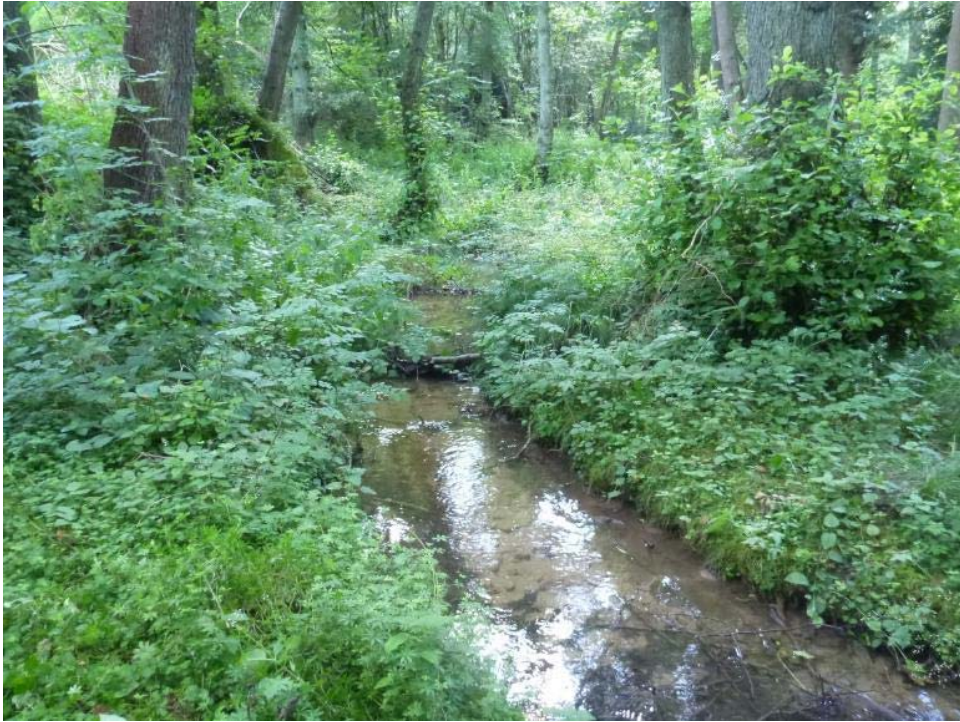
Breeding opportunities for wild trout appear to be very limited in the brook, although upstream of the lake was not inspected, as it is in different ownership. There is little gravel of suitable spawning size (5 – 40 mm diameter), and that present is in very thin layers over a clay bed. The channel has little depth variation, being predominantly shallow glide habitat and lacking in pools and riffles (Photo 5). The volume of fine sediment in the brook could also be a problem by clogging gravels. Despite this, trout have a surprising propensity to reproduce in unpromising conditions and only a small number of redds can sustain a population, particularly in a system with stable flows such as this. Wild brown trout have been reported in this reach of the brook; some relatively straightforward habitat improvements could greatly improve their prospects (see Recommendations).

Photo 5 The brook downstream of the lake.

- Improve the habitat conditions in the brook downstream of the lake by retaining naturally occurring fallen wood and by introducing features such as those shown in Photos 9 – 16.

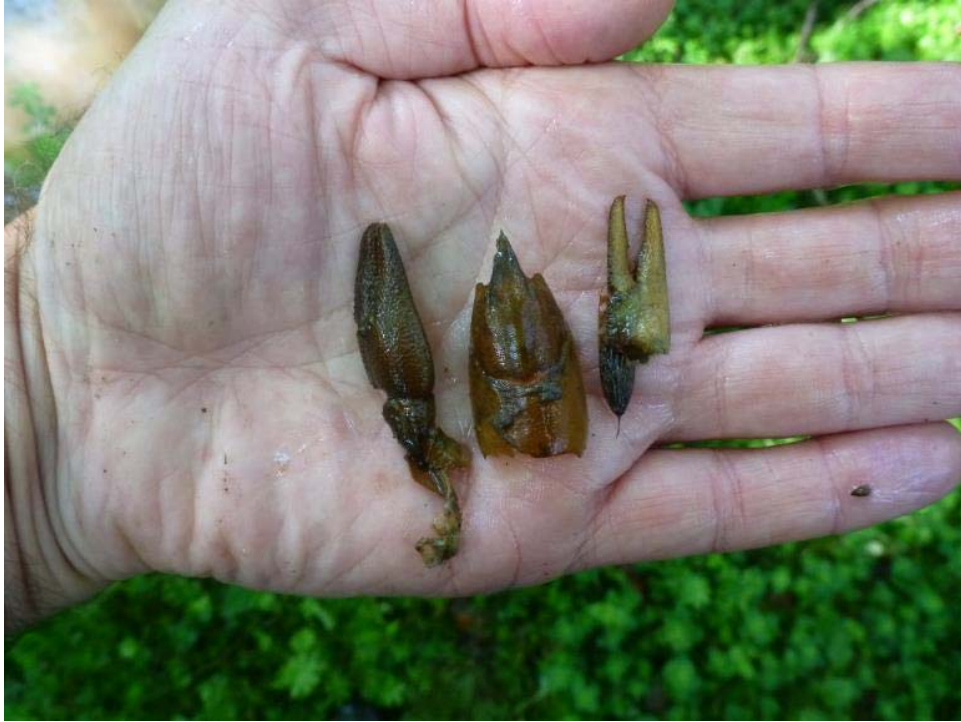
Native white-clawed crayfish (*Austropotamobius pallipes*) are present in the brook and were observed during the visit, along with remains from moulting / predation which were used to confirm identification (Photo 6). This is the UK's only native species of crayfish and has suffered a severe decline in recent decades, being classified as endangered on the International Union for the Conservation of Nature (IUCN) Red List. The primary reason for the decline is the spread of introduced, non-native crayfish, particularly signal crayfish (*Pacifastacus leniusculus*) and the associated crayfish plague (*Aphanomyces astaci*); this is a fungal disease carried by the non-natives which are resistant, but deadly to the native crayfish.

Photo 6 Native white-clawed crayfish (*Austropotamobius pallipes*) are present in the brook. Several live individuals were observed in addition to these remains used to confirm identification.

Crayfish plague can be transferred on any wet surface, so it is important that great care is taken not to import the disease from areas where non-native crayfish exist. Wet footwear and clothing, fishing tackle, nets and tools are all potential vectors. Simple precautionary measures should be taken such as cleaning and drying equipment in sunlight, disinfection (with e.g. FAM30, Virkon, etc.) or having a specific set of equipment for this site. Any fish introduction to the site represents a risk of introducing crayfish plague unless there is certainty that the source is free from contact with non-native crayfish (see below). Prior written consent for fish introduction from the Environment Agency is a legal requirement.

- Ensure practical measures are in place to protect the site from the transmission of crayfish plague, as described above. Further guidance is available here www.nonnativespecies.org/checkcleandry .

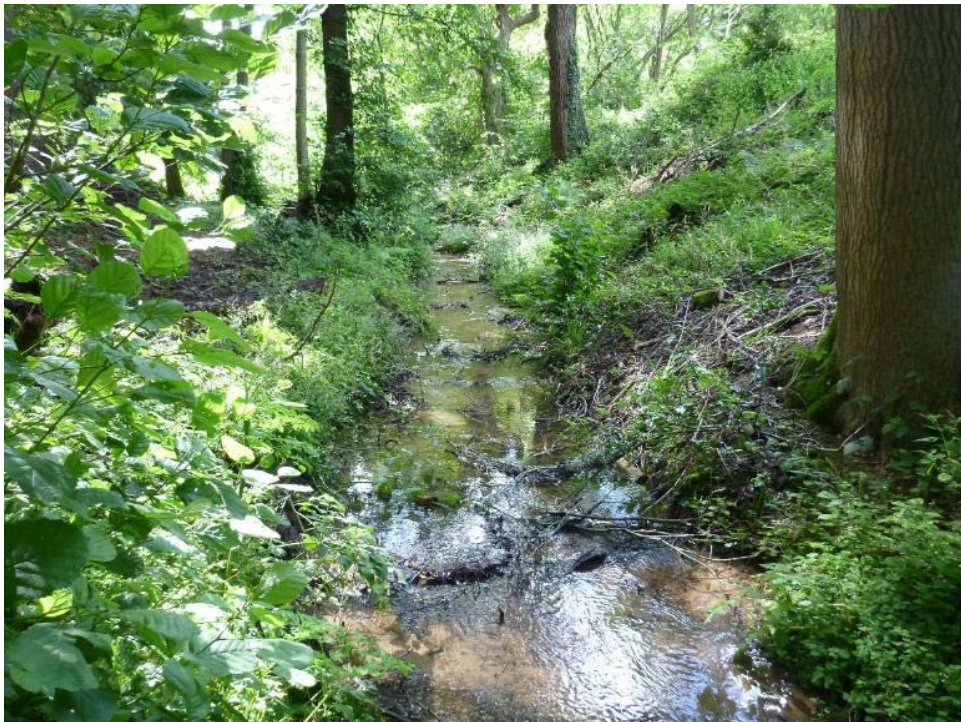
Some sections of the brook have recently been cleared as part of wider works to restore the woodland and coppice (Photo 7). Large woody material in the river channel forms important habitat, so best practice is to leave it in place. The trunks and branches of fallen trees cause localised scour, which

increase the variety of depths in the channel and grades the river bed substrate into different sizes; this provides a variety of habitats for invertebrates and fish, including improved trout spawning conditions and niches for native crayfish. The in-channel structure also traps leaf litter and twigs which are important inputs at the base of the food chain in small streams like this.

Photo 7 Some sections of the brook have recently been cleared of fallen trees and woody debris. Such material forms important habitats and should be carefully managed with the emphasis being on its retention.

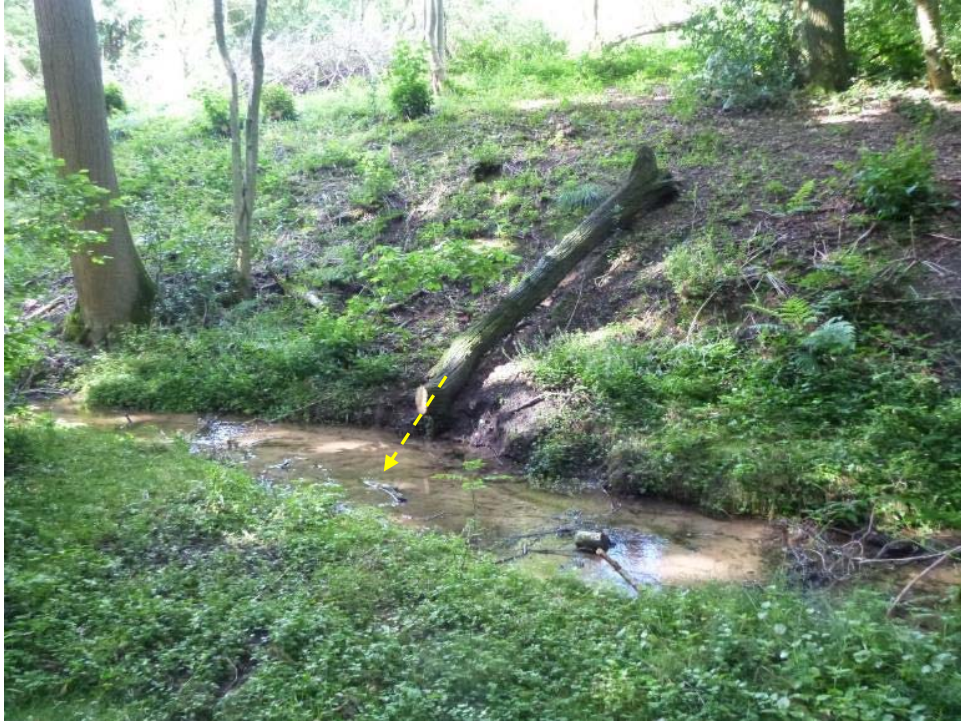
There are plenty of materials available from the recent woodland works to use for in-channel habitat improvements, such as large trunks (Photo 8) and brushwood. Techniques are described in the Recommendations section.

Photo 8 If trunks fall into the channel, leaving them extending into and across the channel, rather than trimming, is good practice. There is considerable scope for using materials on site to improve the in-stream habitat, for example sliding the end of the above trunk into the channel to form a flow deflector.

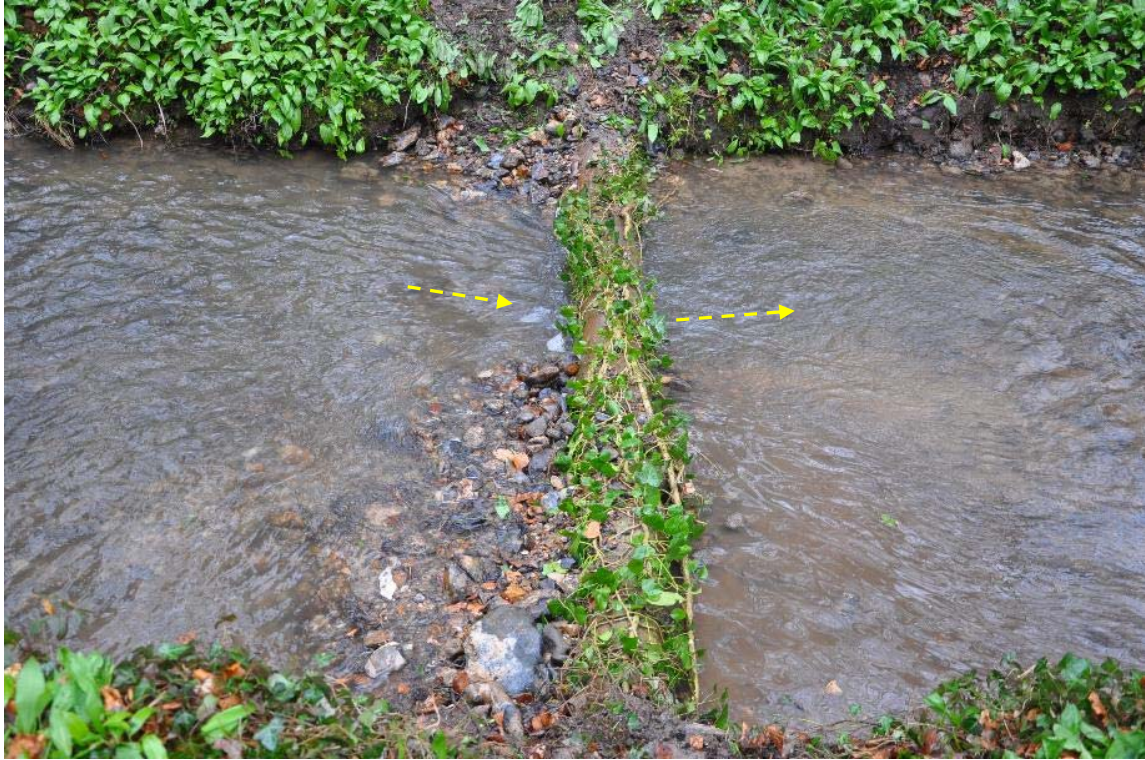
Photo 9 A cross-channel log, keyed into the bank and set at or just above bed level, with a narrow channel excavated (yellow arrow) beneath to promote bed scour. Excavated material is placed at the sides against the bank.

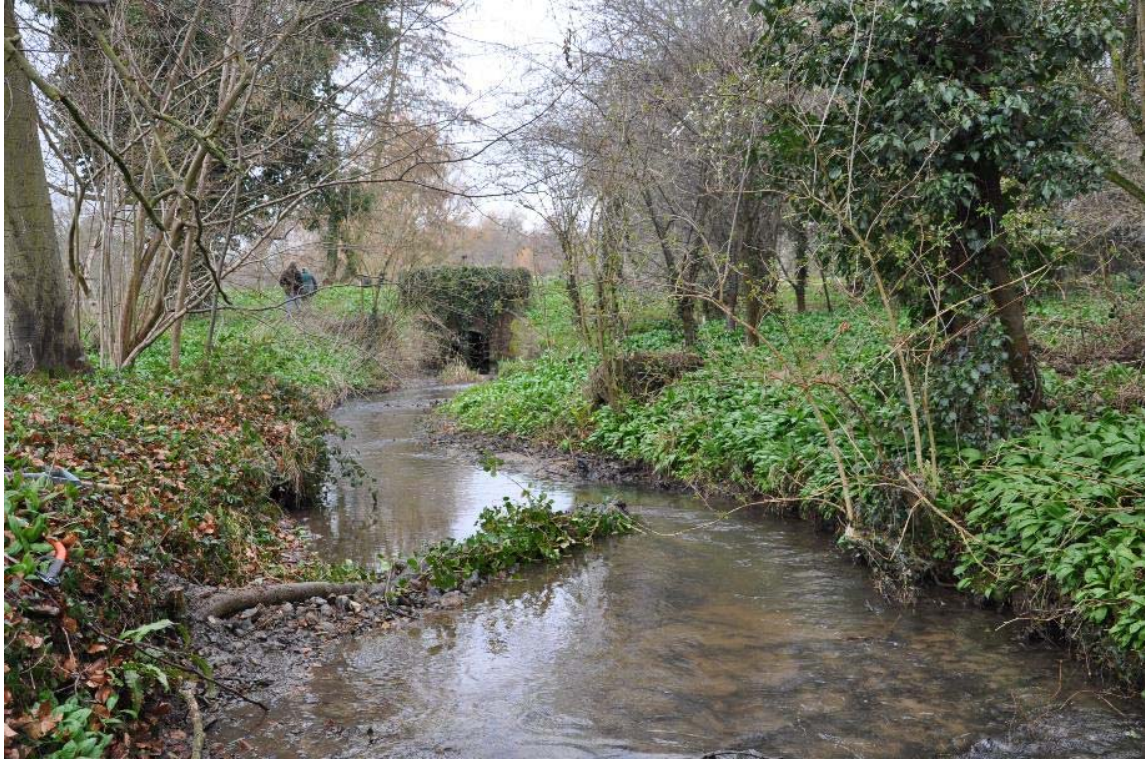
Photo 11 Logs positioned in the channel to pinch the flow, in this case without bank re-profiling. Some bed excavation near the apex of the log.

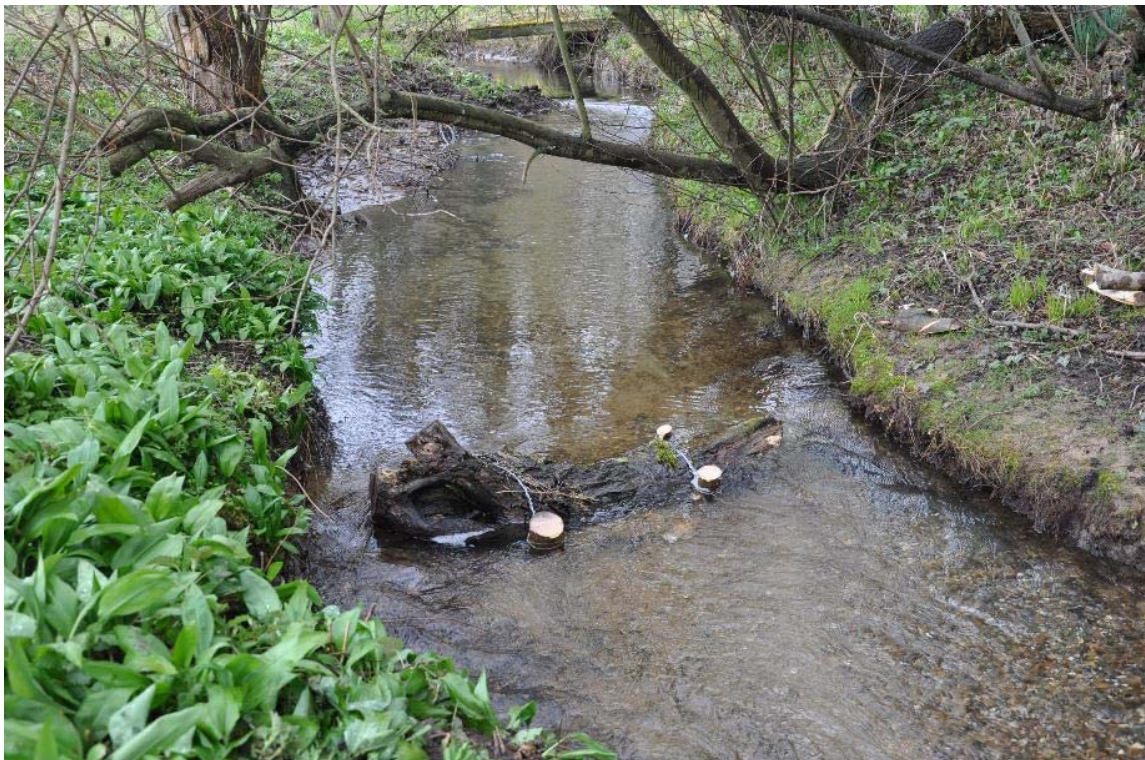
Photo 12 Woody structure pinned to the river bed promoting bed scour and sorting of clean gravel suitable for fish spawning. In the very small stream at Daniel Hayes, large enough trunks would be secure without the need for pinning.

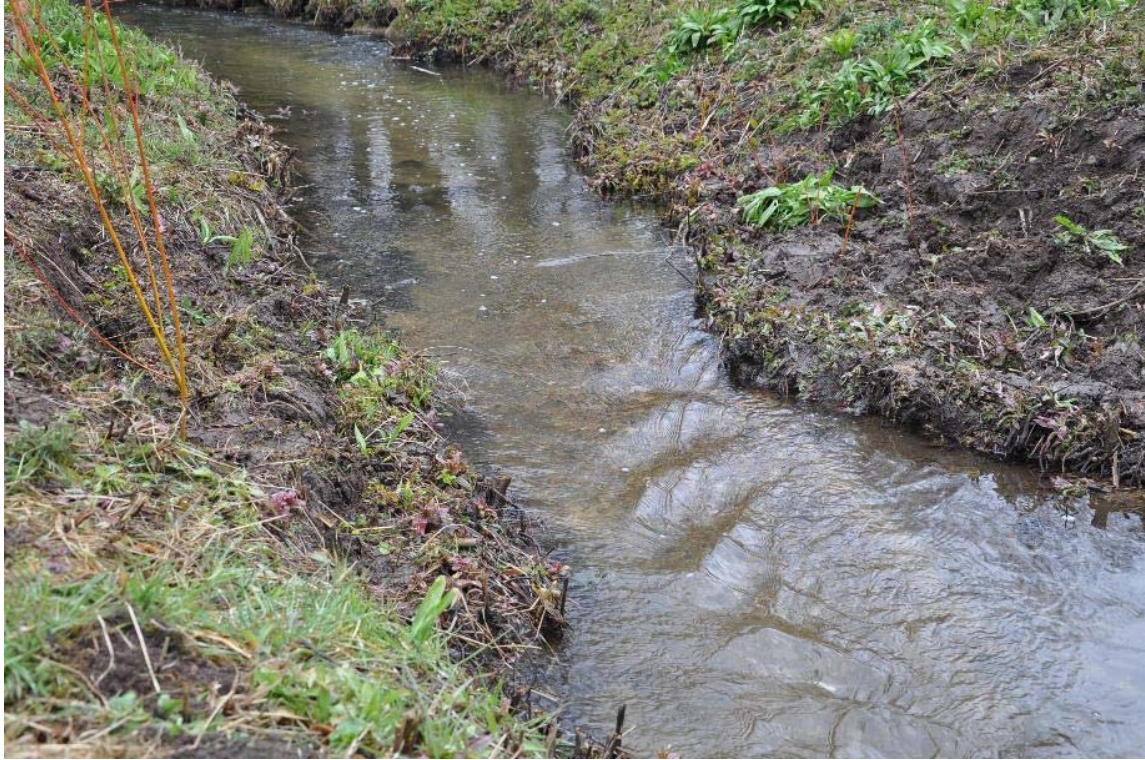
Photo 13 Simple bank re-profiling to pinch the channel. The front edge of the new bank could be defined with brushwood bundles before re-profiling.

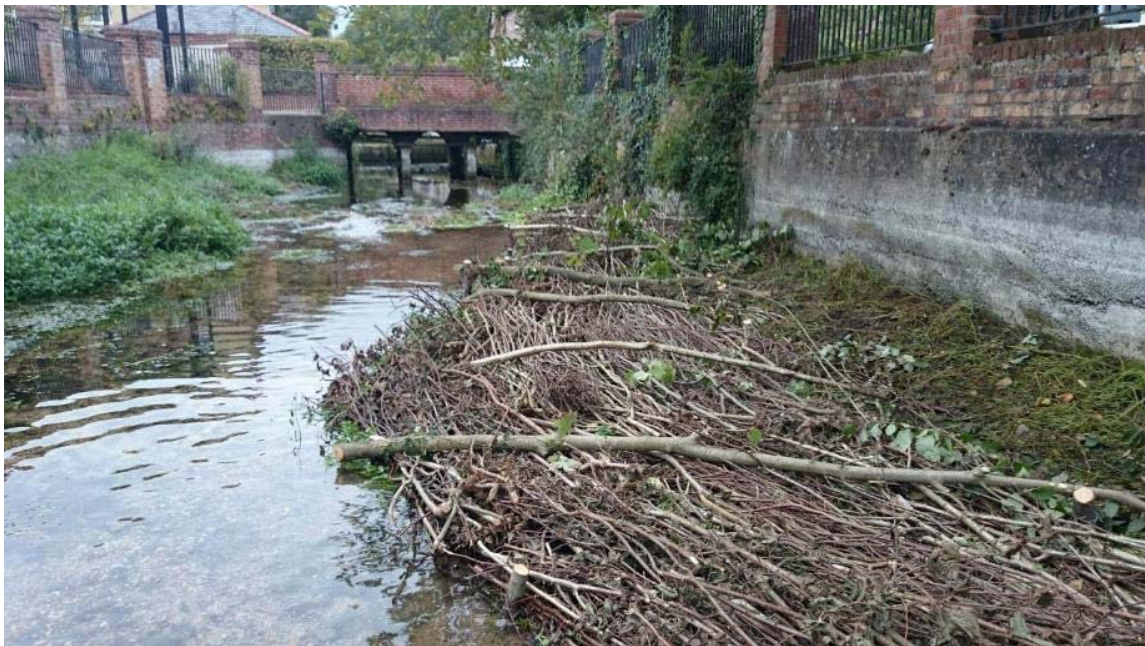
Photo 14 Marginal ledges made from stakes, battens and packed with brushwood could be used to achieve a similar channel narrowing effect, in addition to providing good crayfish habitat.

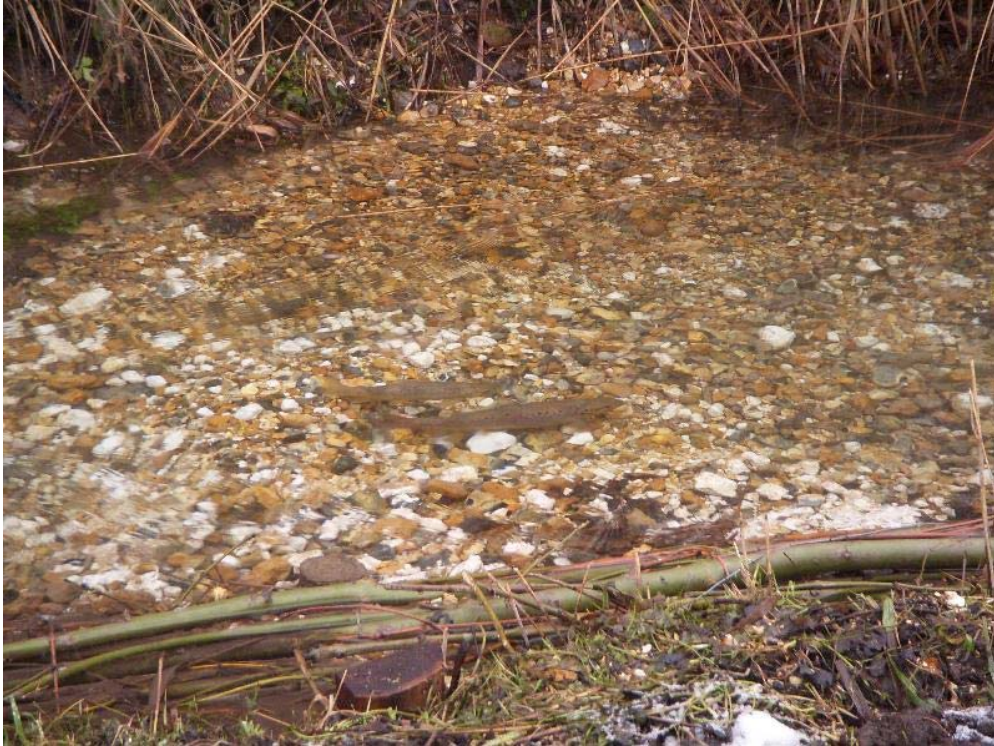
Photo 15 Introduced gravel in combination with channel pinching could be used to create some trout spawning areas.

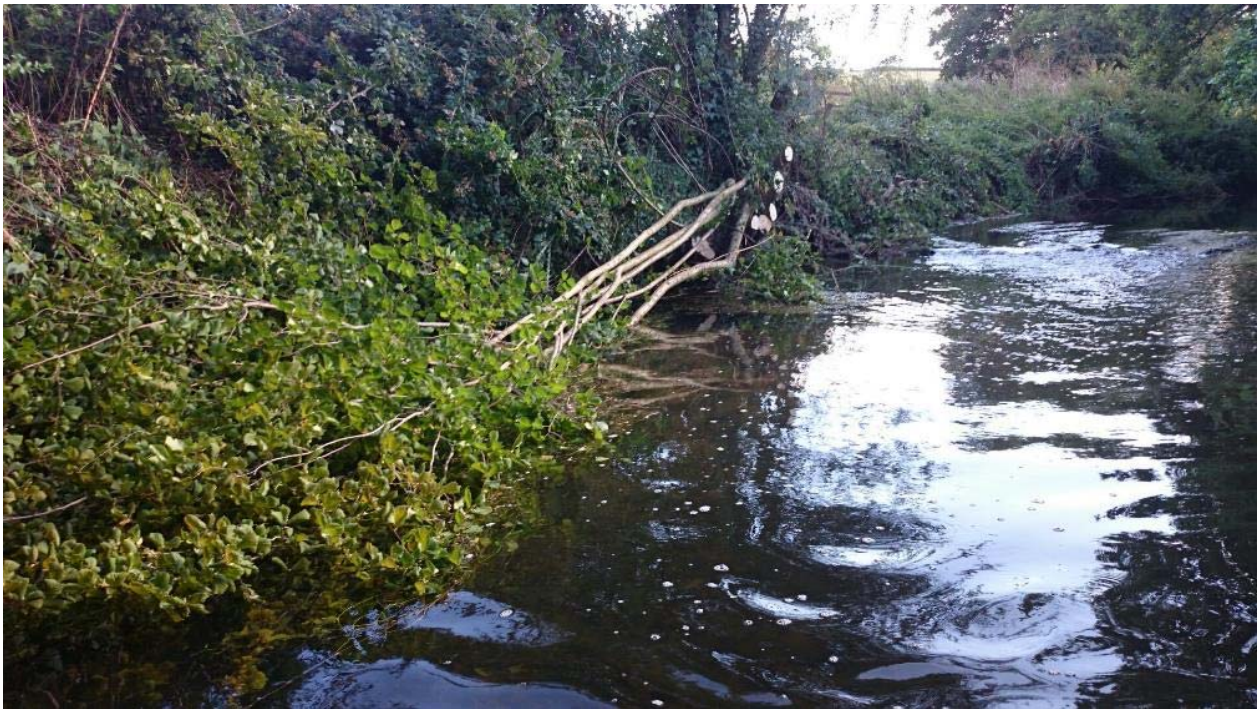
Photo 16 Simply hinging suitable bankside trees over into the channel creates good habitat structure (like hedge laying).
