Advisory Visit

Ullswater Tributaries near Watermillock

River Eden Catchment

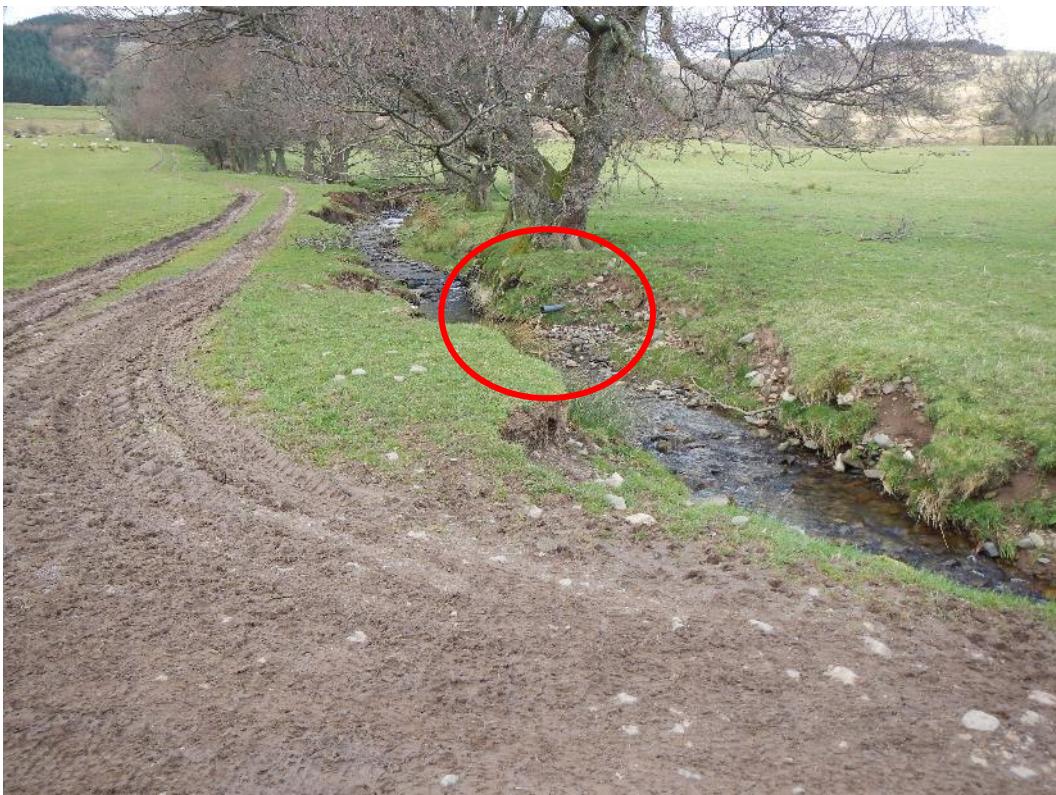
Starting at Parkhouse Gill & Kirkstyle Gill (the most westerly tributary of Parkhouse Gill) within the sheep pasture, the channels appear to be unnaturally straight (Figs 1 & 2). Although running from relatively steep fells, the area in question is slightly lower gradient than upstream and downstream (visual inspection and Ordnance survey maps), so would be expected to meander more (steeper watercourses naturally meander less because of their increased flow energy). In addition, the watercourses do not seem to follow the low points of the valley, instead following a straighter line across the slope. This suggests the watercourses have been artificially straightened and / or realigned. Surprisingly, this kind of channel modification work often pre-dates even the oldest readily available maps.

Signs of additional drainage (Fig 1) and low points of wet ground (indicated by rushes) within the adjacent fields hint at possible past locations of the watercourse(s) (Fig. 3). A straight ditch also appears from the ground in the field downslope between the gills, potentially draining from the land where watercourses originally flowed, with those past channels still acting like sub-surface drains. The ditch (Fig. 4) and additional field drains (Fig.1) now drain the adjacent lower-lying land.

Figure 1. The straight channel of Kirkstyle Gill (NY42482121): erosion is creating some sinuosity, but the channel remains far straighter than would be expected. Livestock access has led to a lack of tree regeneration (only old, mature trees) and impoverished botanical diversity, which is contributing to poor quality bankside habitat, increased erosion (through a lack of protection and root structure) and detrimental fine sediment input to the watercourse. Note the pipe/field drain (red circle) and incised channel.

To counteract the impact of past channel straightening and other land management issues, restoration of the watercourse to create more naturally sinuous channels is recommended. This report provides an initial scoping of the options, with several sites on both the Parkhouse Gill and unnamed watercourse having potential for significant habitat improvement. It is therefore recommended that further, more detailed site inspections and background research using freely-available LiDAR maps (**Light Detection And Ranging** - a technique which provides detailed topography of the ground, helping to identify former channels) are undertaken to ascertain the potential for channel improvements at the following:

Livestock exclusion from the watercourses is recommended as an urgent management action to reduce erosion pressures and allow the regeneration of a naturally diverse flora. However, rather than simply creating narrow buffer strips along the watercourses via livestock exclusion, the project could be expanded to incorporate river restoration and woodland regeneration to provide even greater benefits for livestock and wildlife.

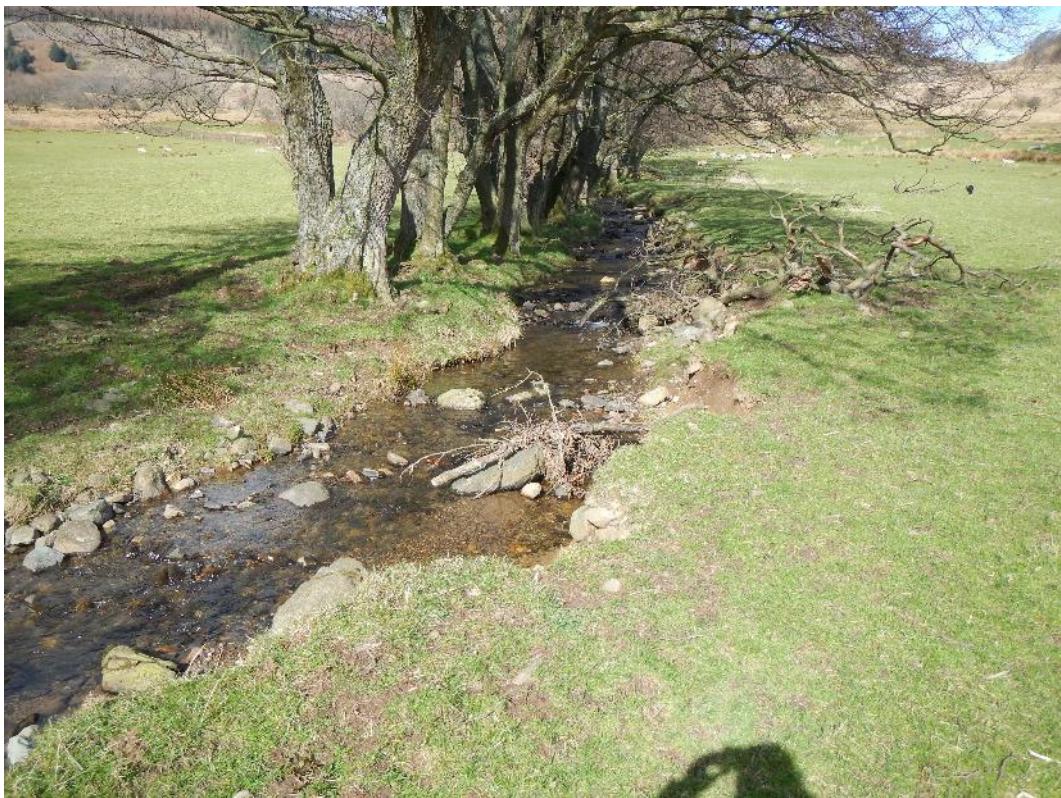
Figure 2. The channel of the other upper spur of Parkhouse Gill (NY42572127). Note the extended straight section (highlighted by the line of mature trees) and lack of pools/depth variation.

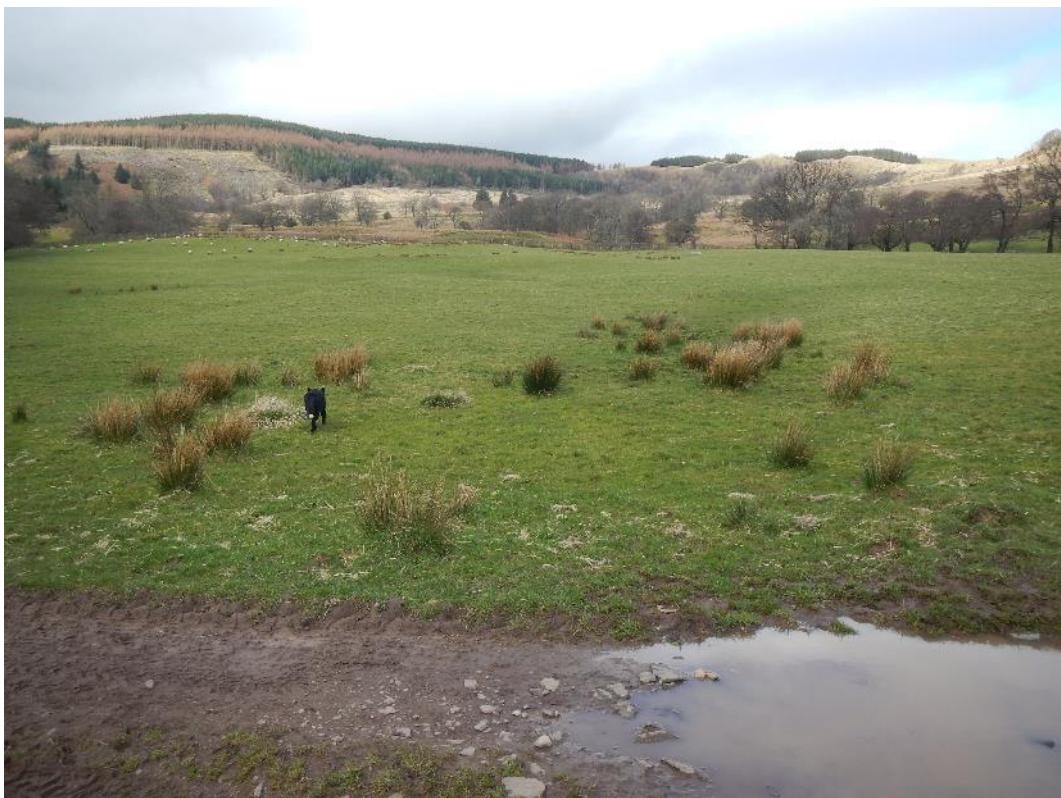
Figure 3. The straightened channels of Kirkstyle Gill and the other upper spur of Parkhouse Gill lie to the far left and right of shot, respectively, with lower-lying areas within the field between (NY42522122). Further, more detailed inspection (including LiDAR) would be beneficial to better interpret the hydrology and geomorphology of the area.

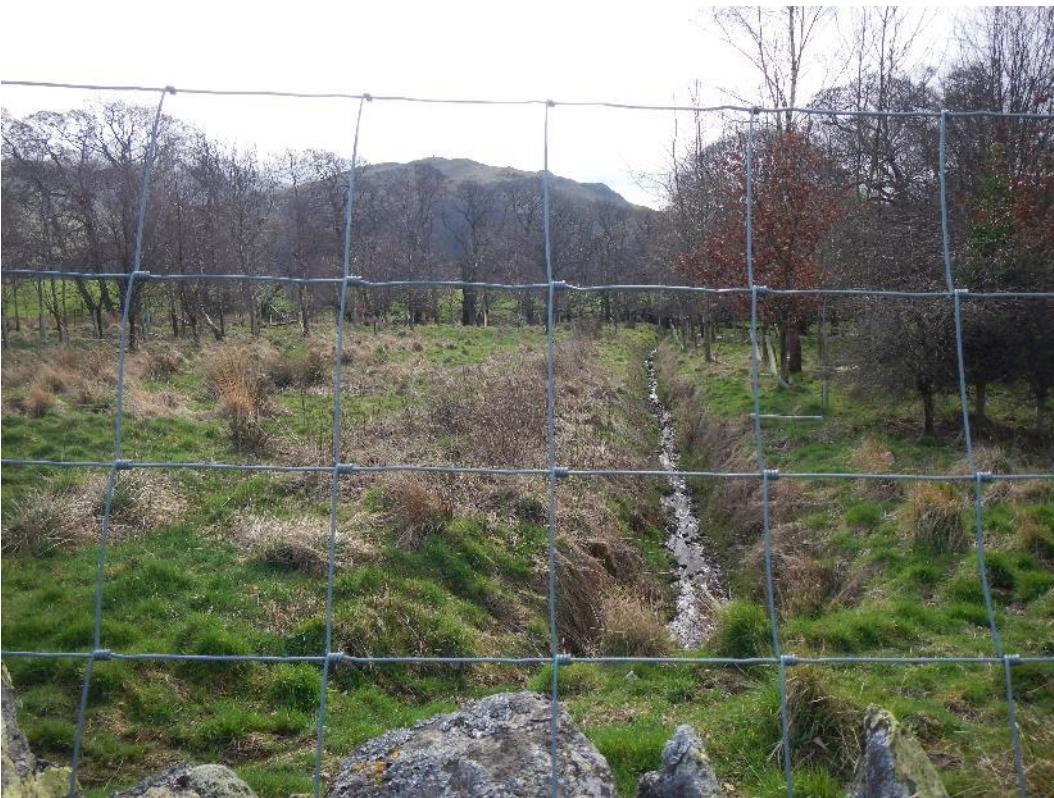
Figure 4. Immediately downslope of the field in which the low-lying land/possible historical channels were observed, a watercourse appears from nowhere within a small enclosed plantation (NY42522121). This water possibly represents residual flow from past channels that still collect water from the adjoining land upslope.

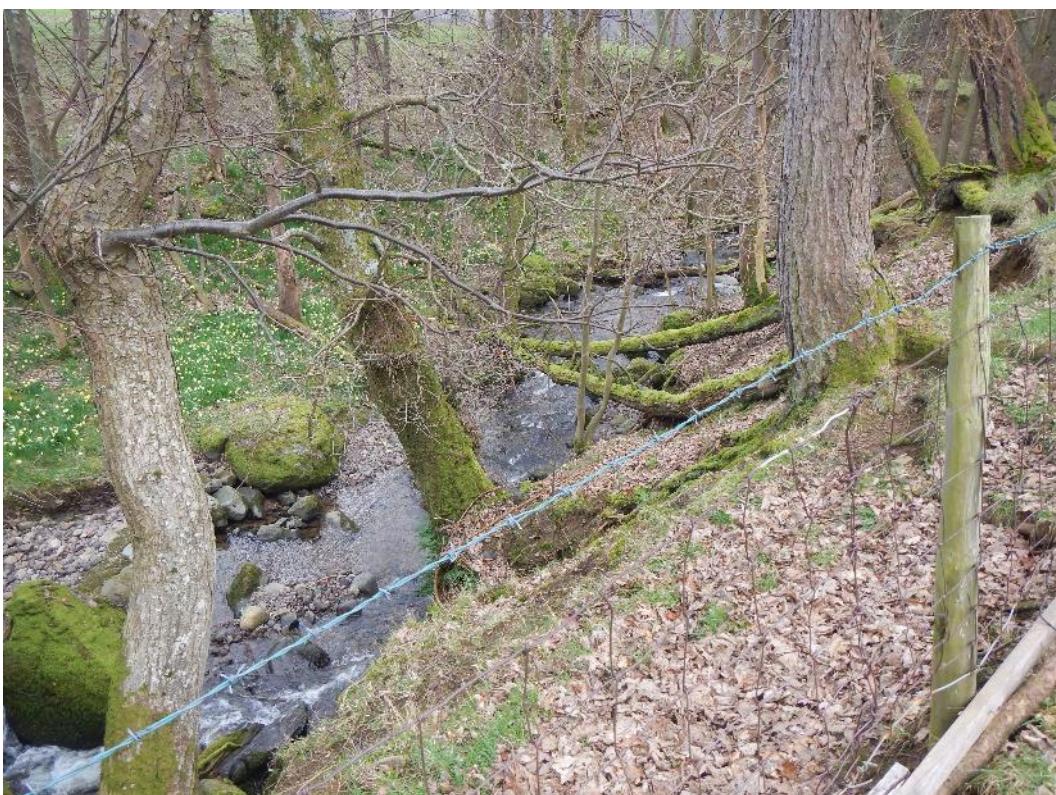
Downstream of the straight watercourse sections, Parkhouse Gill enters a less intensively managed section and the habitat quality improves greatly. Although being considerably steeper, the watercourse is more energetic and diverse. The first section is protected within the extent of the small plantation before flowing through mature woodland (Fig. 5), where habitat quality improves further, although failure of the enclosure fence now allows livestock access, which will degrade the habitat if not reinstated (Fig. 6).

Figure 5. Much higher quality watercourse habitat is evident within the mature woodland section (NY42512106). Habitat diversity is greatly increased where livestock access has been restricted historically. Natural additions of woody material, along with leaf litter, provides vital nutrients to the beck that nourish invertebrate populations and the fish which prey upon them. Note that even the straighter sections exhibit greater channel and flow diversity than the straightened sections upstream.

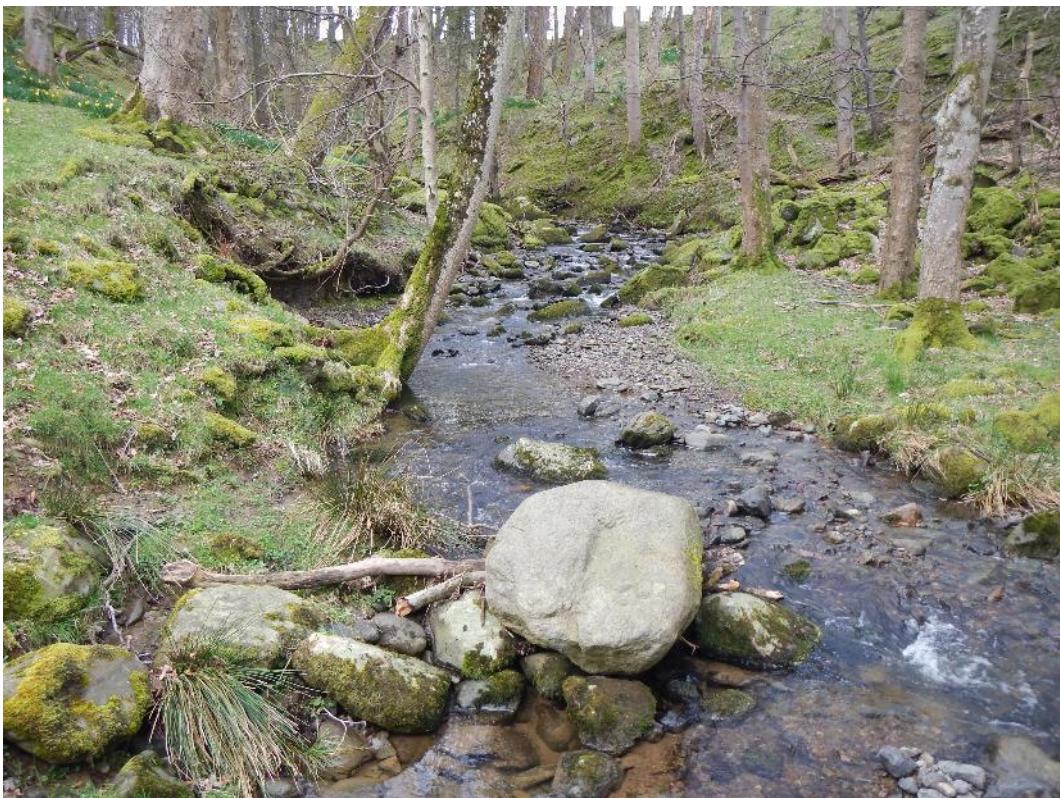
Figure 6. High quality, naturally rugged upland beck habitat that almost certainly supports trout and possibly even the occasional juvenile salmon (NY42552088). As a bare minimum, livestock fencing should be reinstated but improvement of the tree species structure within the woodland would also be beneficial.

The age structure and species composition of trees within the woodland is sub-optimal, being relatively uniform and dominated by sycamores. Additional management of the woodland to improve the understory would be beneficial (particularly in the heavily sycamore dominated lower section towards the A592 road). It is understood that the Woodland Trust are already involved at the site and can also advise on tree management. Any work should consider the vital synergies with the aquatic environment, taking location-specific advice from specialists (ecology and fisheries). Retaining, and encouraging (through ring-barking of less desirable trees) standing deadwood would be beneficial, as would deploying some of the procured woody material into the channel to increase roughness, providing habitat and flood management benefits. If carefully managed, areas of increased light penetration within the woodland could facilitate a greater diversity of native species (natural regeneration and planting). However, much of the shading along the watercourse should be retained to preserve vital water temperature regulation and preventing over-warming.

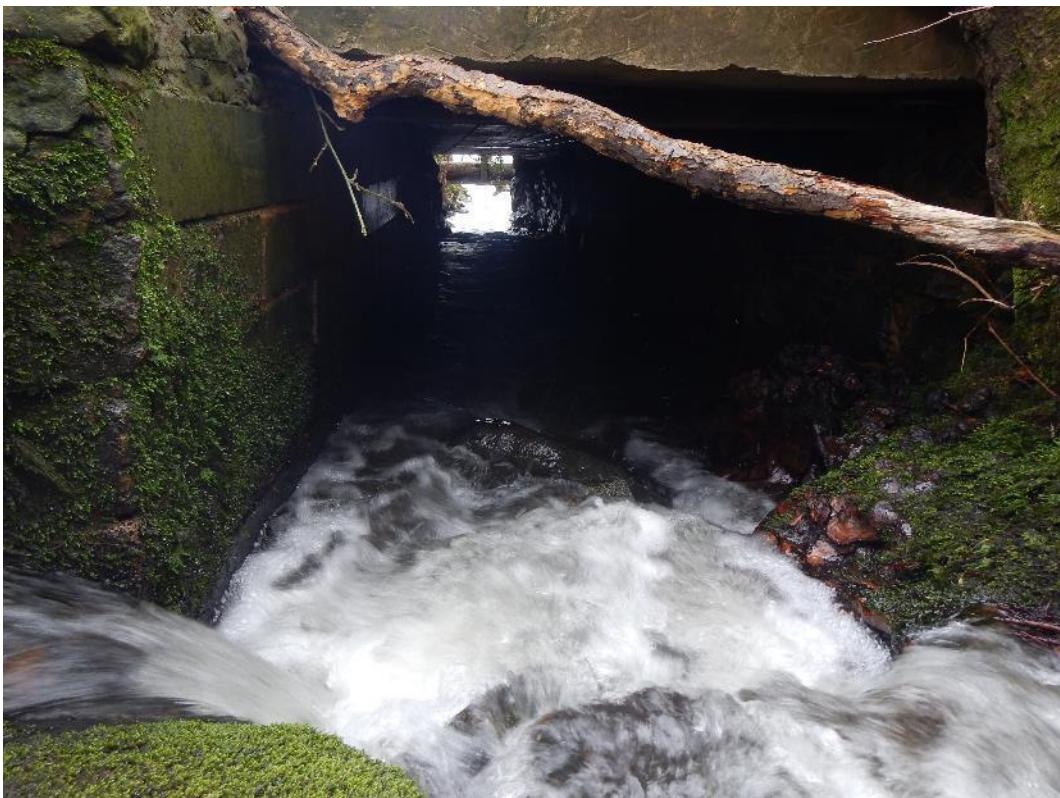
The A592 road culvert (NY42572071) towards the confluence of the beck and Ullswater is very steep, potentially limiting fish passage opportunities, but does retain a relatively natural bed. The aperture is small and likely prone to occasional blockage and fluming of high flows, reducing its passability, but under certain flow conditions fish can ascend beck.

Figure 7. The A592 road culvert on Parkhouse Gill: passable, but some obstruction to fish, primarily due to the steepening of the bed immediately upstream due to retention of coarse sediment at the structure. Ideally, the structure would be larger to allow free passage of fish and sediment, but it is passable to most fish in certain flows.

Most of the culverts inspected are adequate, and although they would ideally be larger to reduce the potential for blockage, the cost of upgrading is likely to be prohibitive, particularly for the A579 road structures. However, the culvert on the unnamed watercourse at NY 42976 21172 would be worth improving to reinstate free fish access. This would be particularly pertinent if channel improvements are undertaken to the watercourse upstream and downstream and it could potentially be included as part of an improvement project.

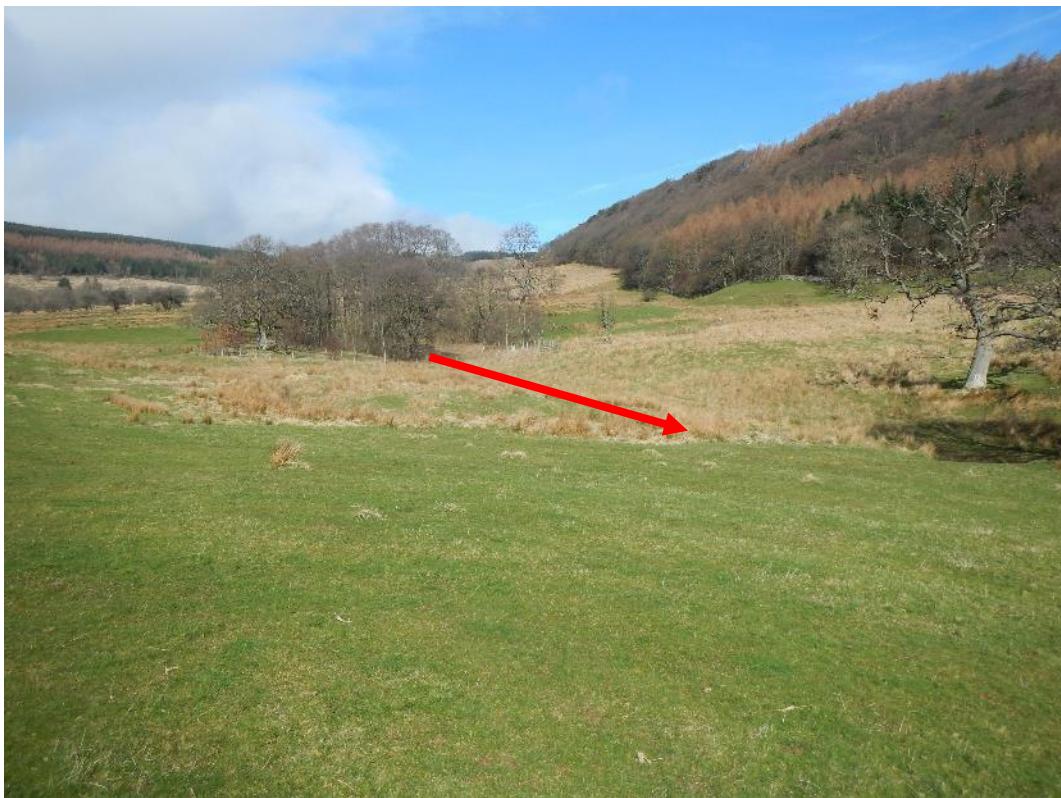
Figure 8. The red line represents a straight channel that has been artificially cut across the natural meander. This is visible from aerial photography.

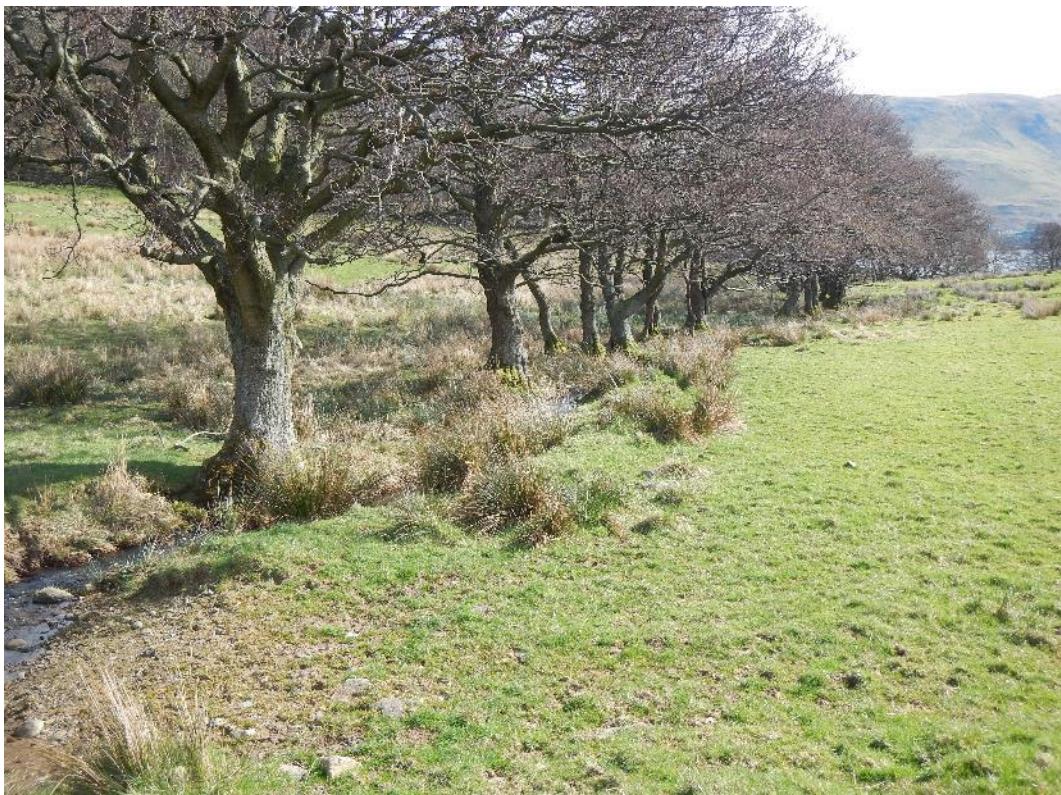
A similar scenario was observed along the next watercourse east (NY 42814 21279), where some semblance of a sinuous channel remains, although clear signs of past attempts at straightening and ditch creation are evident (Fig. 9). The straight channel downstream, flowing alongside low, wet ground adjacent to the LB highlights the past channel alterations (Fig. 10). As with the neighbouring watercourse, the stream is showing signs of recovery and is developing increased sinuosity but lacks the expected natural channel diversity. As a bare minimum, excluding livestock from the watercourses would allow tree regeneration (as facilitated by woodland enclosures further upstream), but the ideal scenario would be a more aspirational corridor restoration scheme.

Figure 9. Looking downstream at another section of almost certainly straightened channel. The low boggy area to the left of shot is the suspected location of past meanders, while the watercourse now flows straight, predominantly to the right side of the tree line. Again, note the lack of herbaceous vegetation (only grass and rushes) and tree regeneration as a direct result of a long history of sheep grazing.

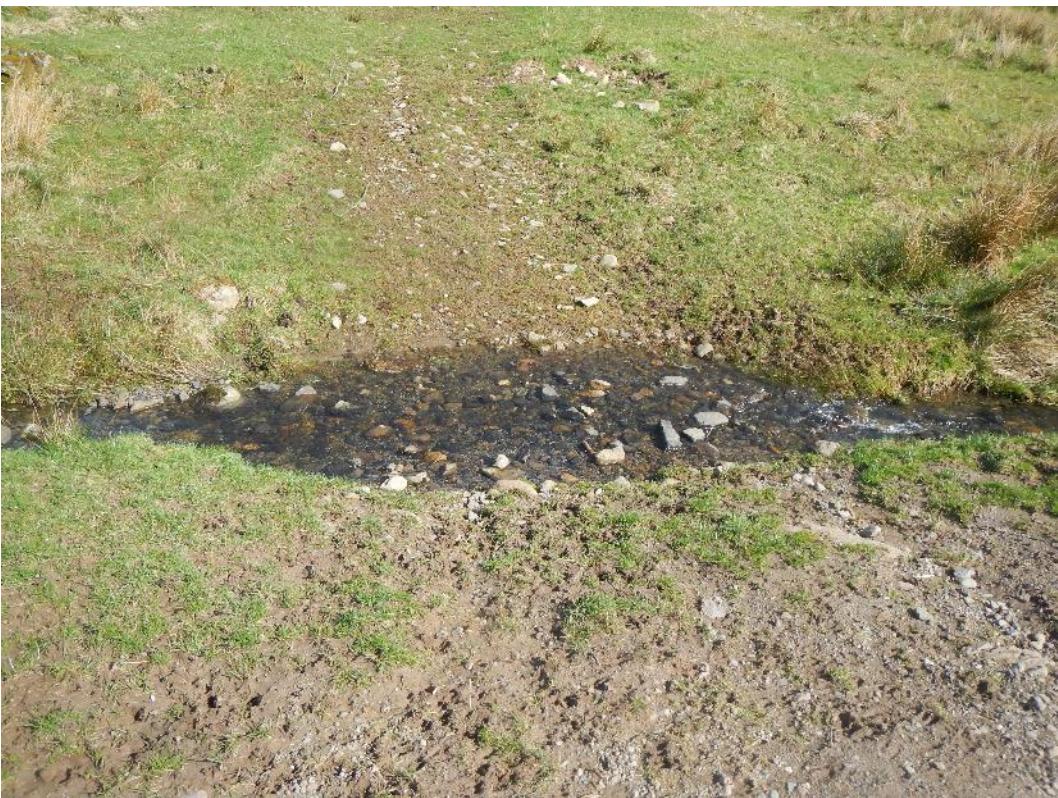
Figure 10. Crossing point and poaching that undoubtedly supplies excess fine sediment to the watercourse in wet conditions (NY42962123). Note the high-quality gravelly substrate of the watercourse that could contribute to good habitat within a restored, sinuous channel.

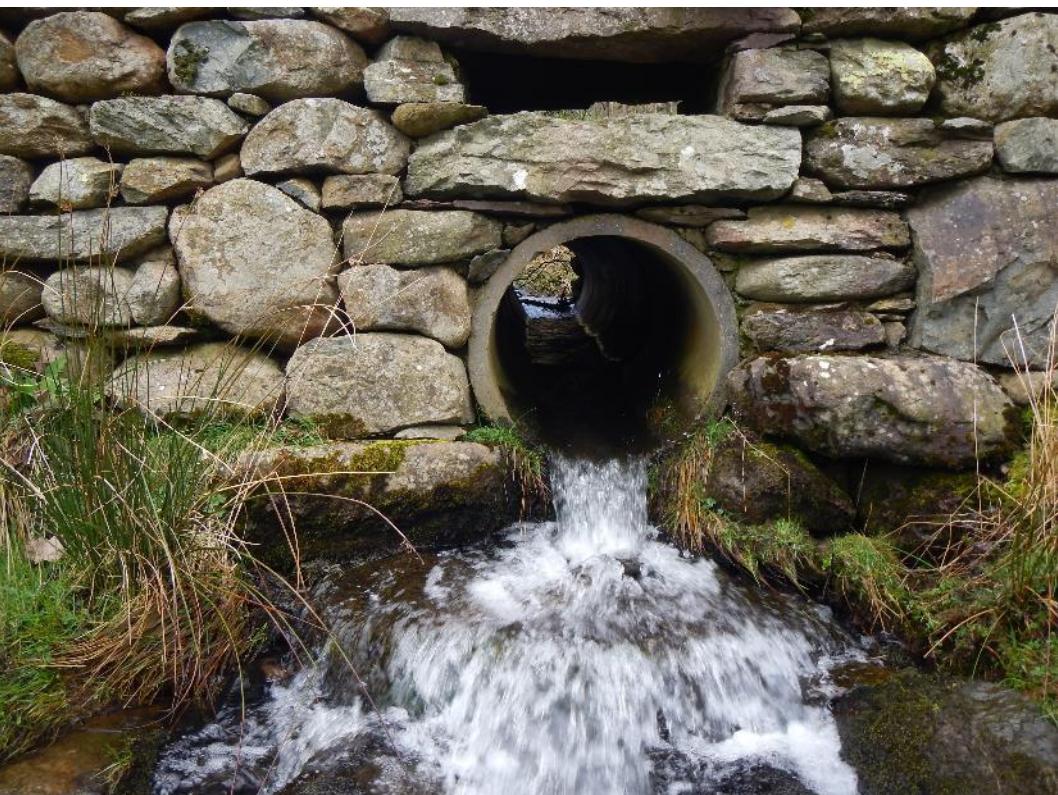
A culvert at the downstream end of the field (NY 42976 21172) greatly impedes fish access up the watercourse and should ideally be replaced with a clear span bridge or sunken culvert (Fig. 11). The channel downstream was not inspected in detail but is clearly straightened and of poor habitat quality (Fig. 12). Increasing the sinuosity of the watercourse would be beneficial. At the very downstream end of the watercourse, the culvert carrying the A592 road is not an issue, being comparatively large with adequate water depth and natural bed to allow uninhibited fish passage (Fig. 13).

Figure 11. Perched culvert that will greatly inhibit fish access to the channel upstream, reducing its potential as a salmonid spawning and juvenile nursery area. Replacing this structure with an appropriately-sized clear span bridge, or large bore sunken culvert would improve fish passage and sediment conveyance and reduce the potential for blockage and maintenance issues.

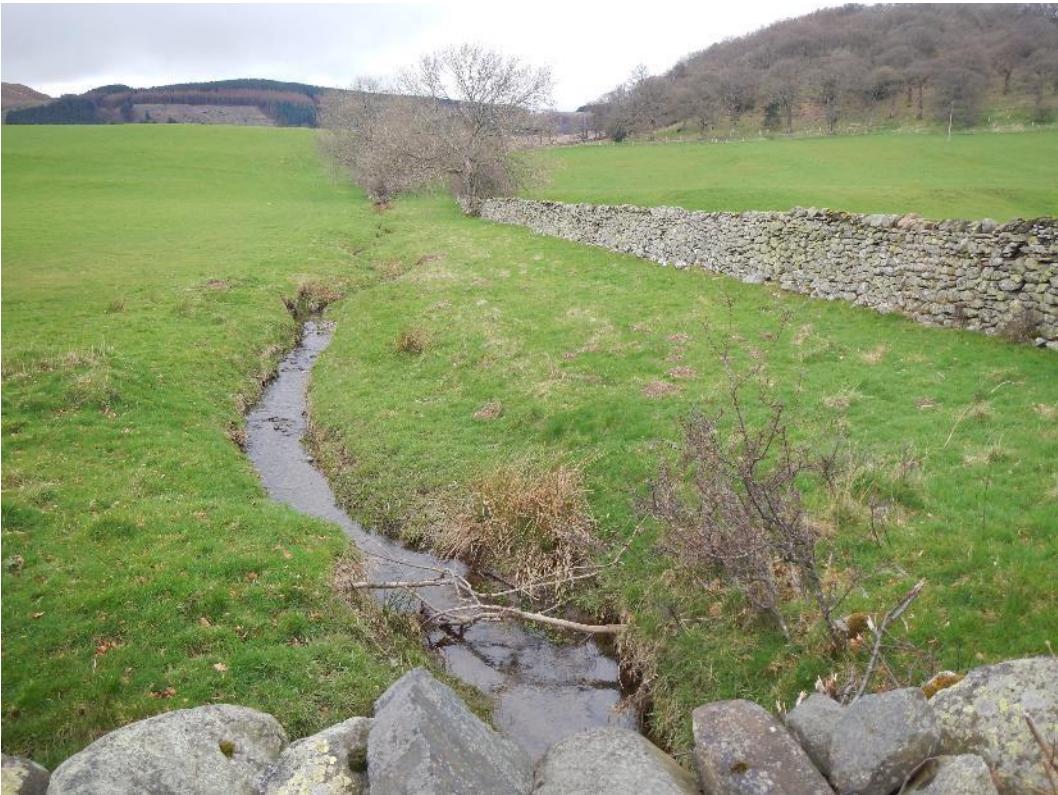
Figure 12. The straightened watercourse in its lower reaches, just upstream of Ullswater. Over time, some small meandering has begun to re-establish, but the watercourse remains far straighter and, therefore, shorter than it should be, running parallel with the wall.

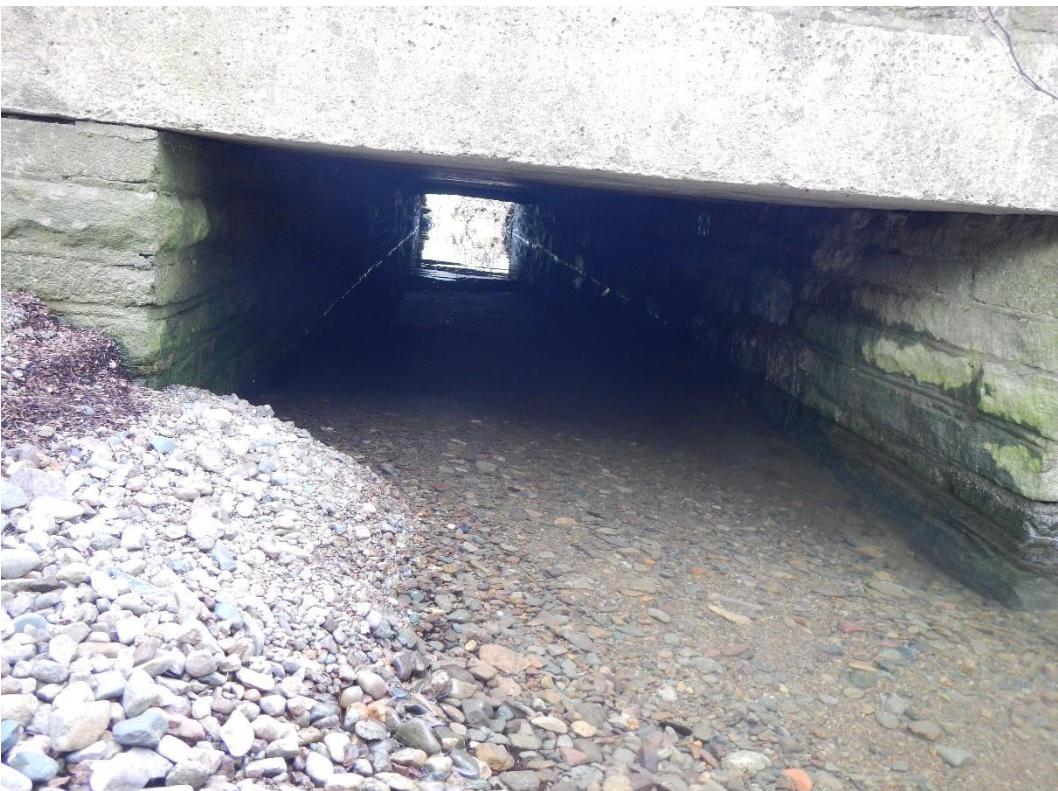
Figure 13. Free fish passage is afforded by the natural bedded A592 culvert on the unnamed tributary, with ample water depth and low flow velocity.

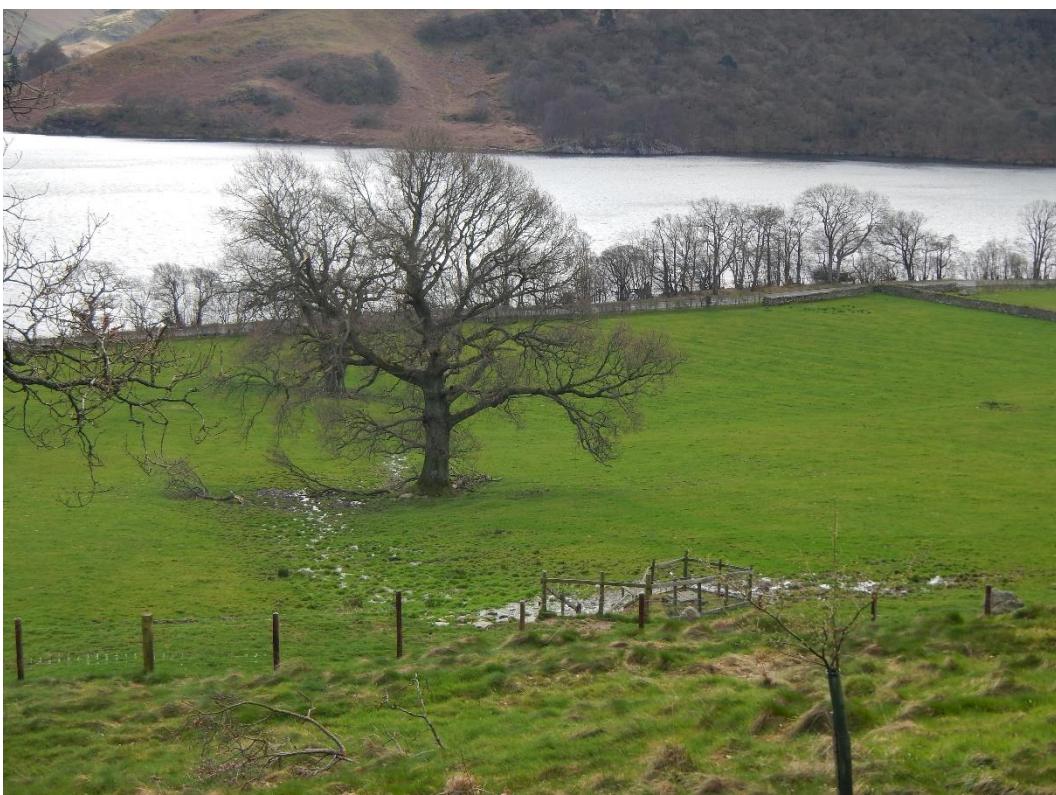
Figure 14. A wet area of ground (thought to be a spring) where the creation of wet woodland habitat could have multiple benefits (NY 43159 21188).

In addition to the general planting of more woodland habitat, a particularly boggy area of land (suspected to be a spring) could be developed into wet woodland (Fig. 14). Again, providing shelter benefits within the field but also a valuable, scarce habitat type on land that is currently sub optimal for livestock grazing.
