Project Proposal
River Derwent (Upper catchment)
Cumbria
July 2016

Undertaken by Gareth Pedley

1.0 Introduction

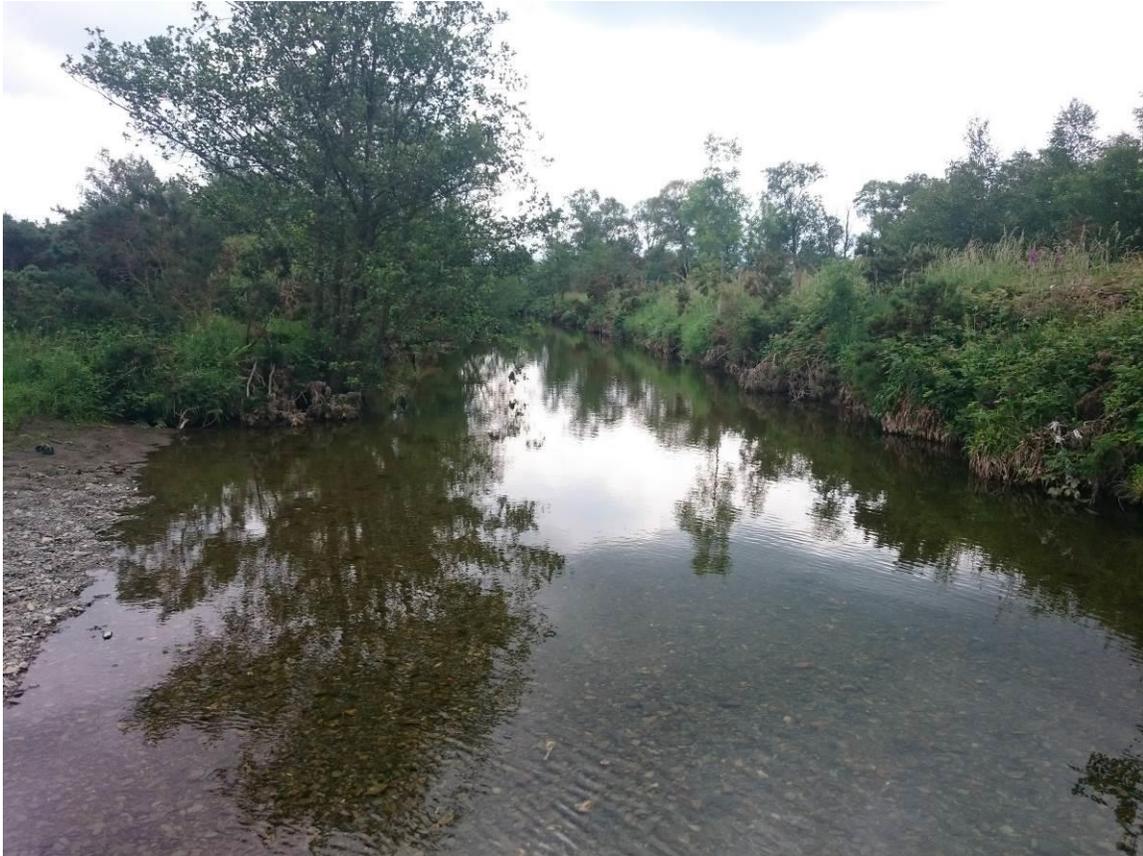
Figure 1. Even after the major floods of 2016, long sections of the more heavily dredged sections remain over capacity and lacking in discrete morphological features and habitat. These will require further large movements of sediment from upstream to reinstate a more natural channel morphology, a process that could take many more years but could be assisted with in-channel work.

Newlands Beck is a prime example of a watercourse that has begun to recover post-dredging, greatly assisted by the winter floods of 2016 which mobilised large volumes of sediment and facilitated the formation of beneficial features within the channel. However, towards the upstream end of the reach visited, long straight heavily dredged sections of channel remain (Fig 1) where, owing to the extent of past channel modification, they will take longer to recover.

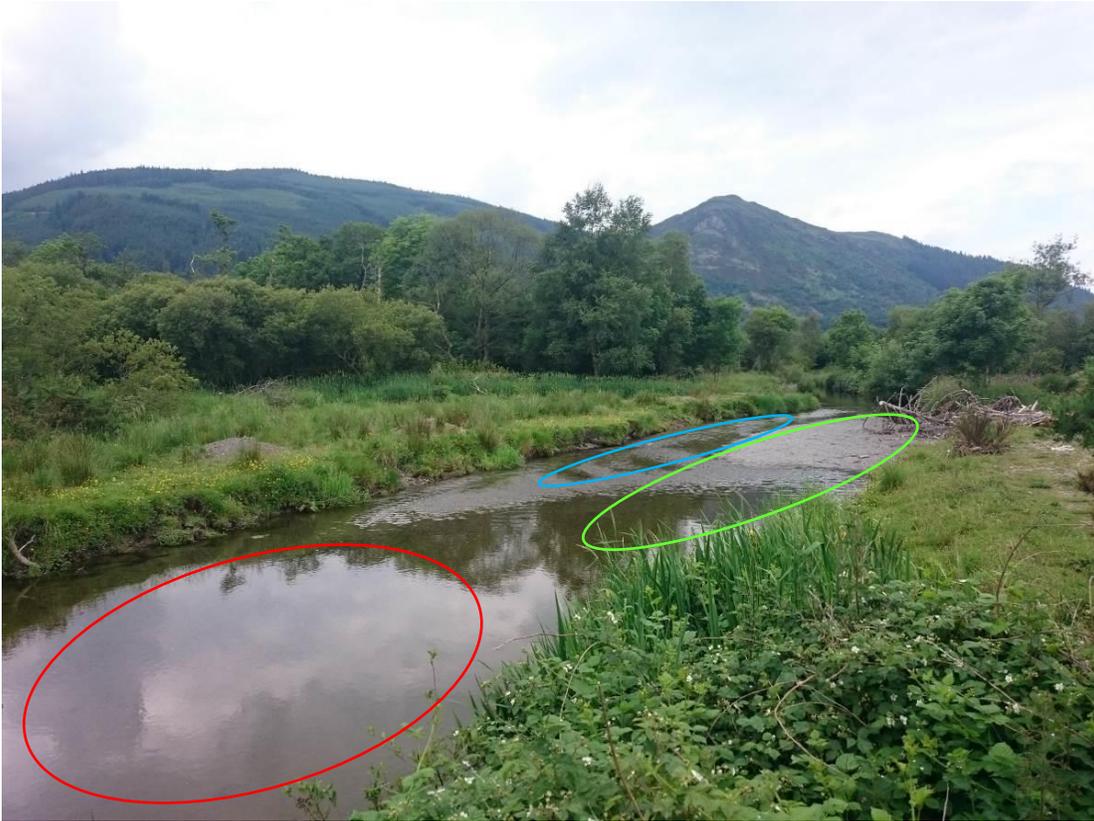
Figure 2. The d/s end of an over-capacity channel section (red ellipse) where deposition (green ellipse) has helped to narrow the channel, accelerating flow velocities that will maintain the water depth (blue ellipse) and clean and sort gravels.

In other areas, even where the Beck still follows an un-natural straightened course, the formation of valuable depositional features within the channel has begun to reinstate a more natural channel morphology. This has re-energising flows within the channel making it more capable of conveying any further sediments supplied from upstream. In-channel structure such as bankside willows greatly assist the deposition of sediments, creating diffusion of flow energy in the margins of the watercourse where bed material supplied from u/s will form bars. These in-turn narrow areas of the channel, focussing flows to provide scour that will maintain sediment transport, maintaining water depth and conveyance of flows. The scoured substrate is then deposited further d/s as sorted materials that provide high quality invertebrate and salmonid spawning habitat (Figs 2 & 3).

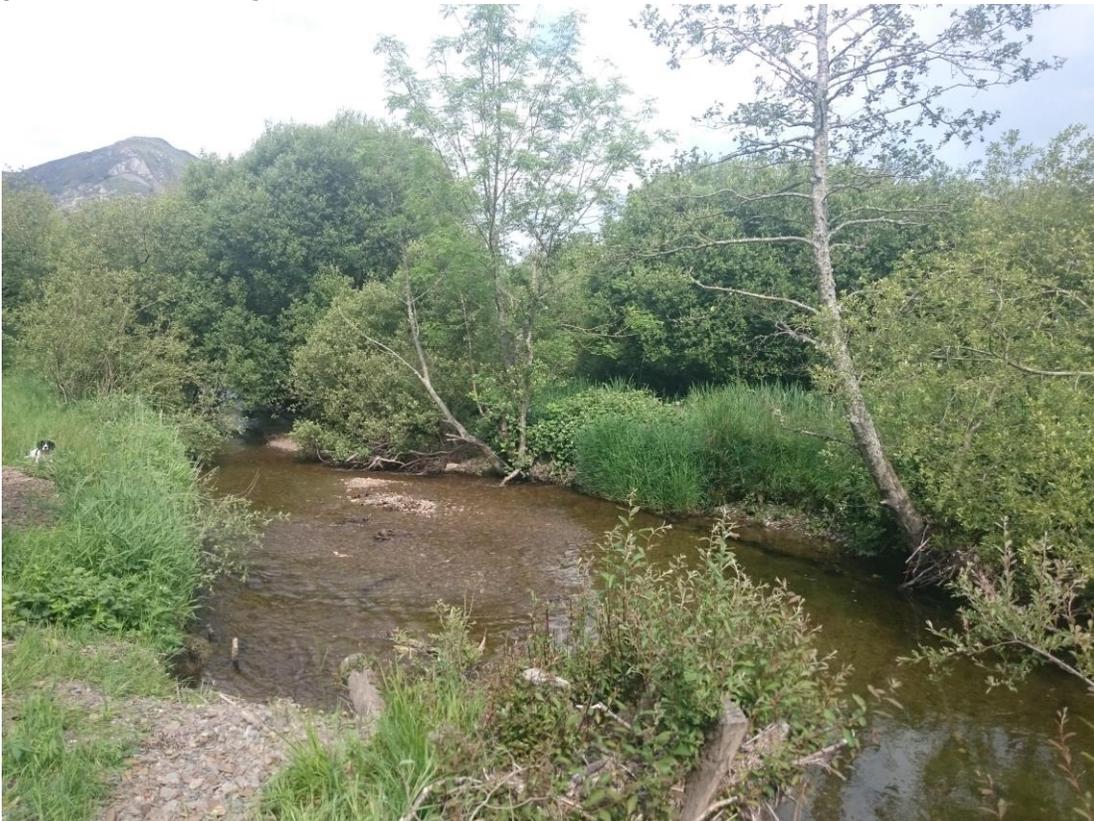
Figure 3. More valuable depositional features that provide invertebrate and salmonid spawning habitat. It is also vital to retain the overhanging and trailing cover that provides habitat features and assist in retaining areas of gravel while facilitating scour in other areas.

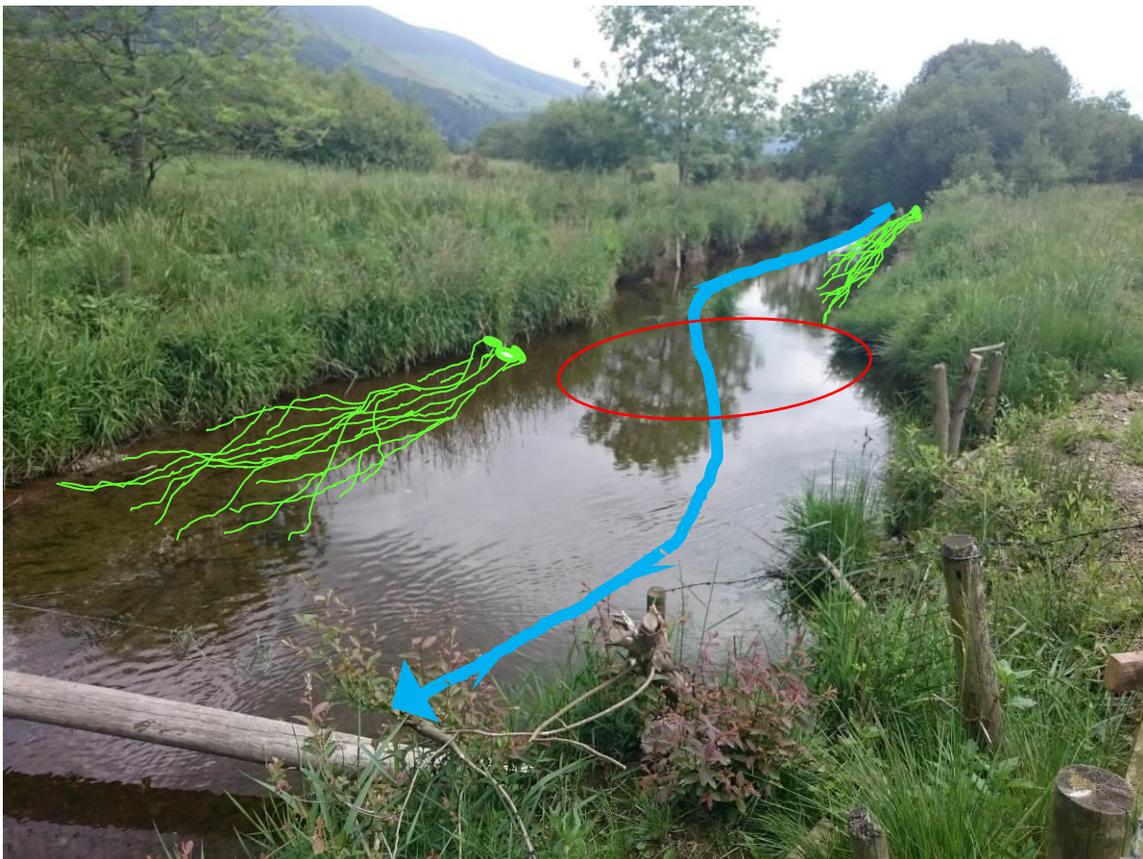
Figure 4. A section of channel that is already beginning to recover some sinuosity within its straightened course. The strategic placement of in-channel structure (willow) could help to accentuate the channel sinuosity, with the narrowing and focussing of the flow created also helping to maintain areas of deeper channel and sediment conveyance, ensuring to allow enough space for shallower gravelly areas (red ellipse).

Figure 4, shows an area further d/s of where fewer bankside trees and trailing branches are available to encourage the formation of in-channel features. Here, pinning live willow into the channel could kick-start the process. This technique would be used to slow flows within alternate river margins to facilitate gravel deposition there. The deposition will then focus flows from one bank to the other which would maintain depth in those areas. It is important to ensure that sufficient distance is allowed between any installed structures so that mid-channel features are also allowed to form.

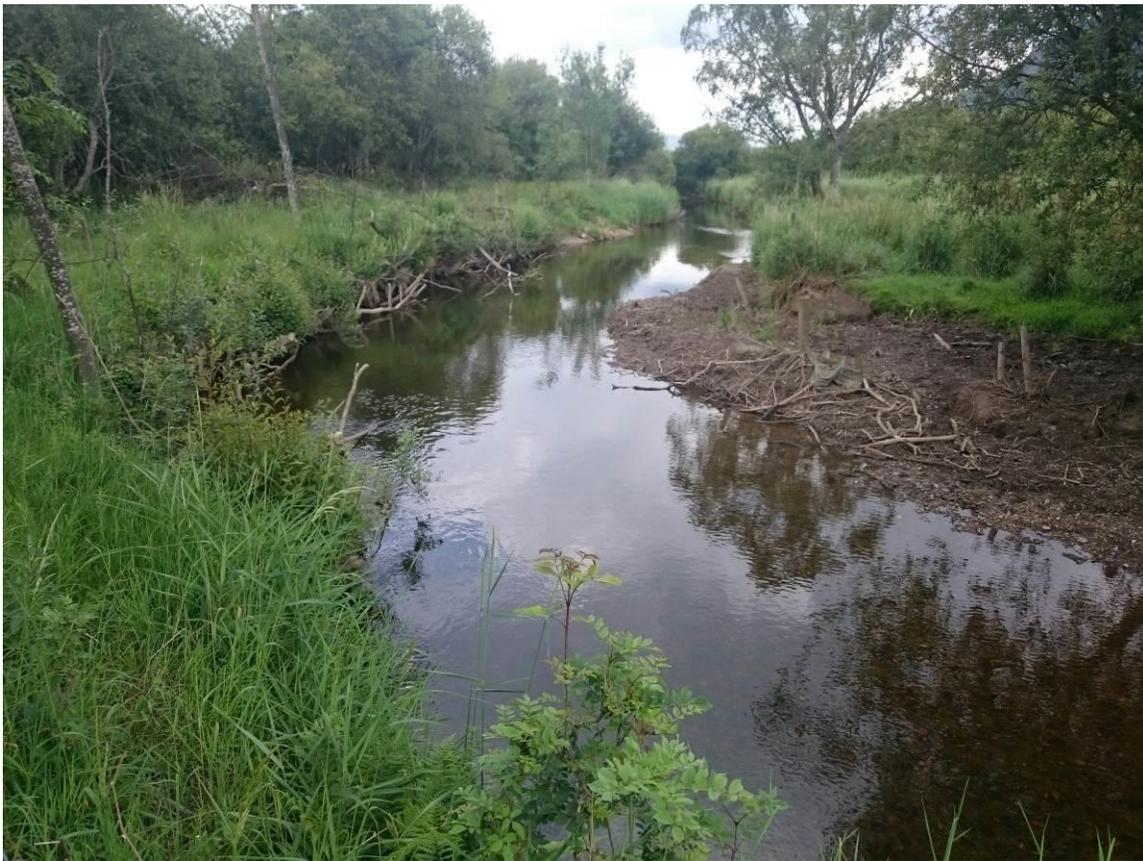
Figure 5. One of the few sharp bends provides valuable deep-water habitat that could be enhanced with the installation of brush and willow planting that would also consolidate the bank.

Immediately d/s, one of the few sharp bends in the section presents an ideal opportunity to enhance deeper pool habitat and naturally protect and reinforce the bank on the outside bend (Fig 5). The remains of old bank revetment can be employed as additional anchor points around which willow can be secured, reducing the requirement for additional posts. In conjunction, planting of willow whips into the bank around the brush will further consolidate the banks (Fig 6). As with u/s, the straight, over-capacity section of channel flowing out of the bend can be enhanced with the installation of alternate willow branches/shrubs (Fig 7) and in other areas, where bankside willows are present, the same effect can be employed by laying occasional trees into the channel.

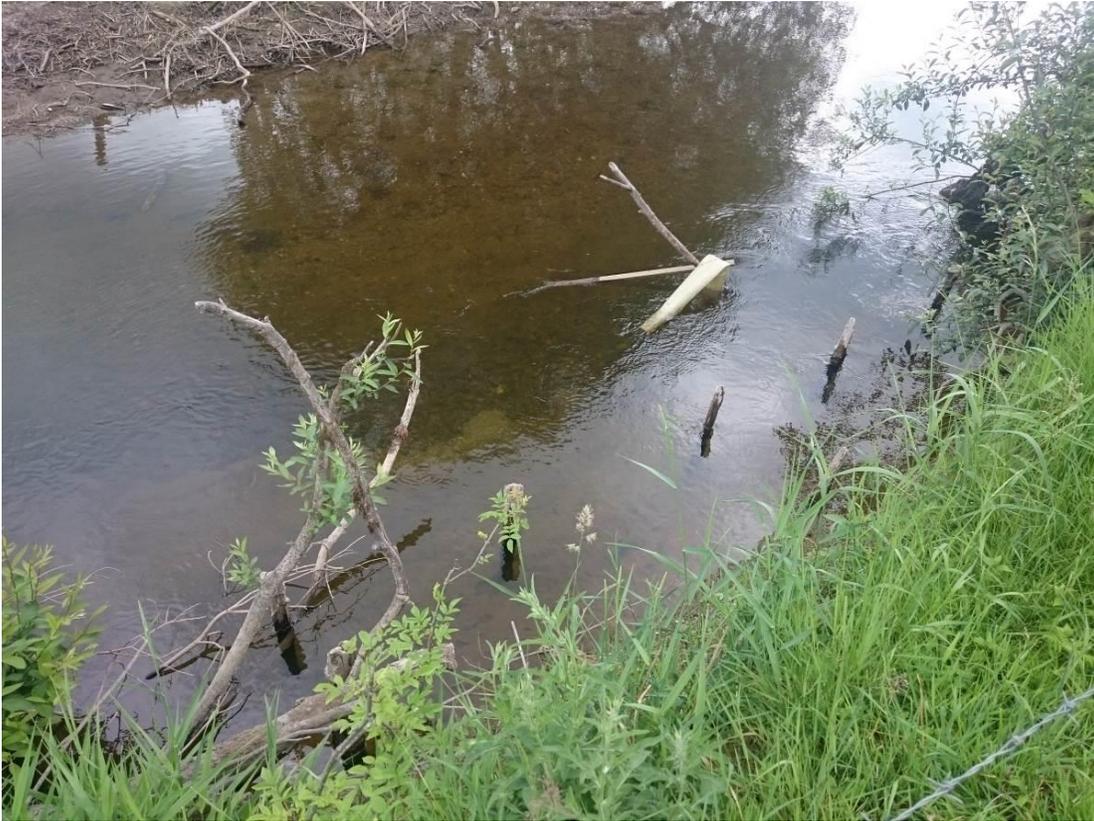
Figure 6. The remains of old bank protection can be employed alongside new anchor points (posts and wire) to secure the structure.

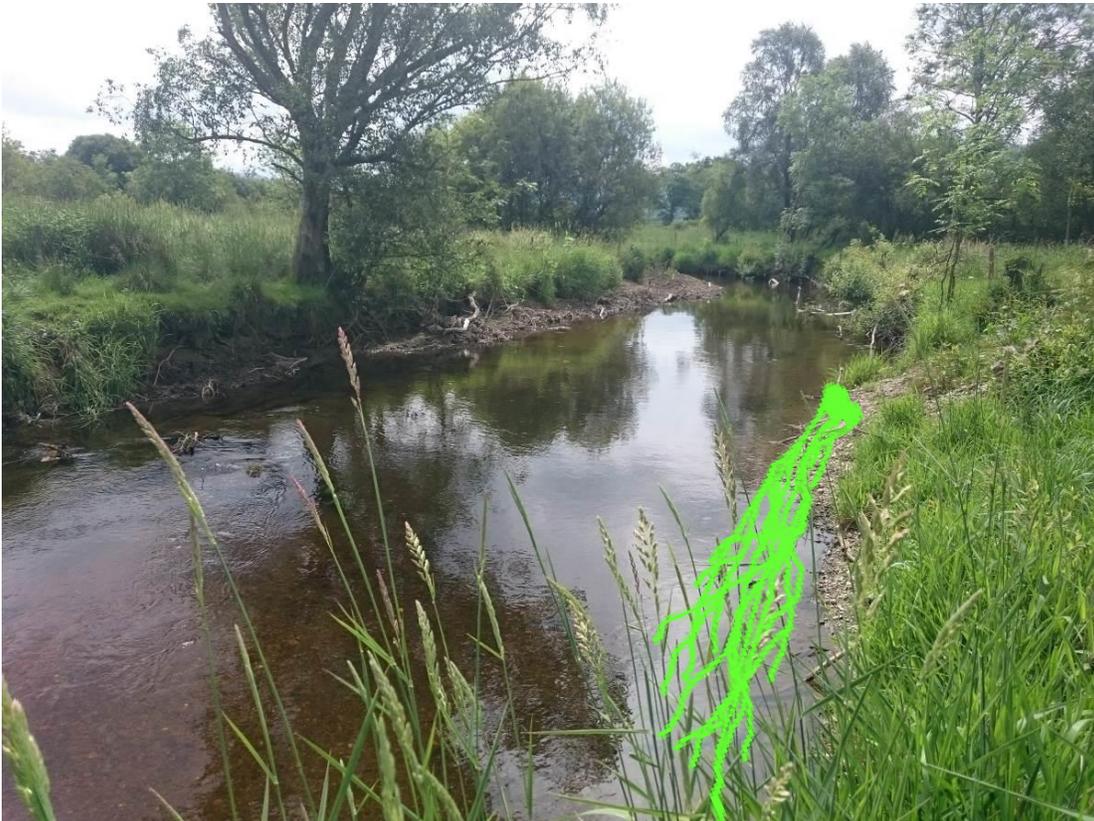
Figure 6. Brush pinned in alternate margins can again be employed to diversify flows, accentuate the sinuosity of the channel and encourage the formation of in-channel features.

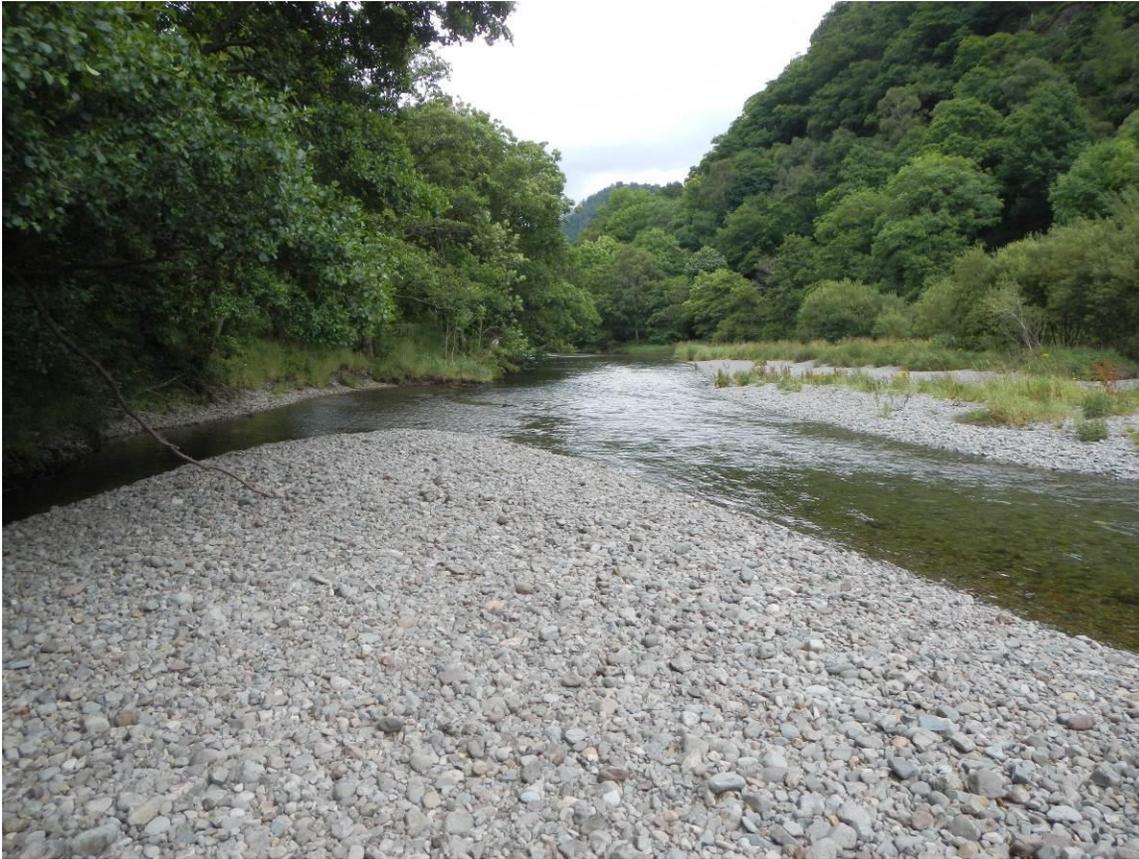
Figure 7. Improving habitat as a result of beneficial gravel and cobble deposition following high flows.

The Derwent u/s of Derwentwater has been degraded in a similar manner to Newlands Beck, through straightening and dredging; correspondingly, the same techniques are proposed to assist in the recovery of the channel and improvement of habitat quality. Figure 7, a short distance d/s of Grange Bridge, demonstrates the morphological and habitat improvements that have occurred where sediment supplied from u/s is allowed to deposit and form bars with the channel. This has created a narrow, low-flow channel that then maintains water depth and sediment conveyance in mid-low flows and a wider high-flow channel with greater capacity to convey flood water. Such areas should simply be allowed to recover over time. Natural stabilisation of the bars will facilitate scouring of the bed and maintenance of sediment conveyance.

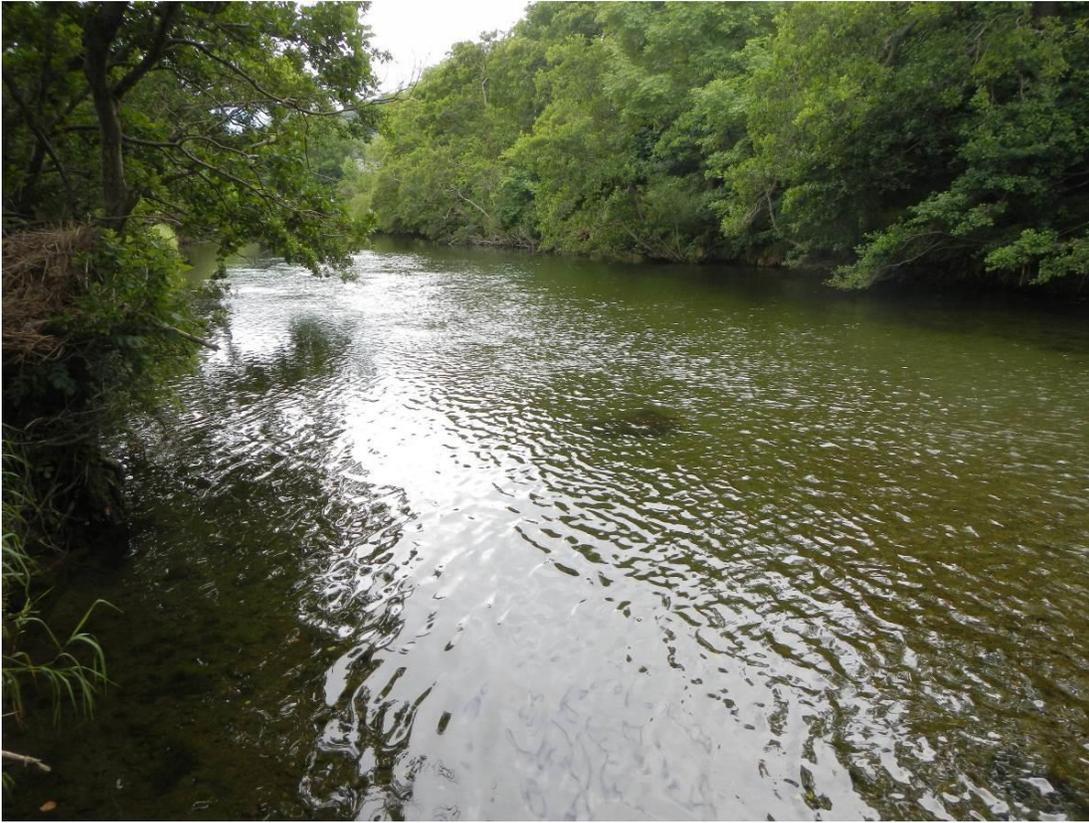
Figure 8. Typical over-capacity section lacking in morphological diversity on the upper Derwent.

As with sites on Newlands Beck, there are still many areas of over-capacity channel have yet to recover owing to the scale of the channel dredging and realignment that was historically undertaken. In these areas willow laying and/or brush installation would also be highly beneficial. If undertaken at strategic sites throughout this reach (NY 25365 17477 - NY 26269 19119) the work could greatly assist the natural recovery of the channel and improve habitats, including fish cover, thereby providing additional fish holding capacity and greater protection from predators.

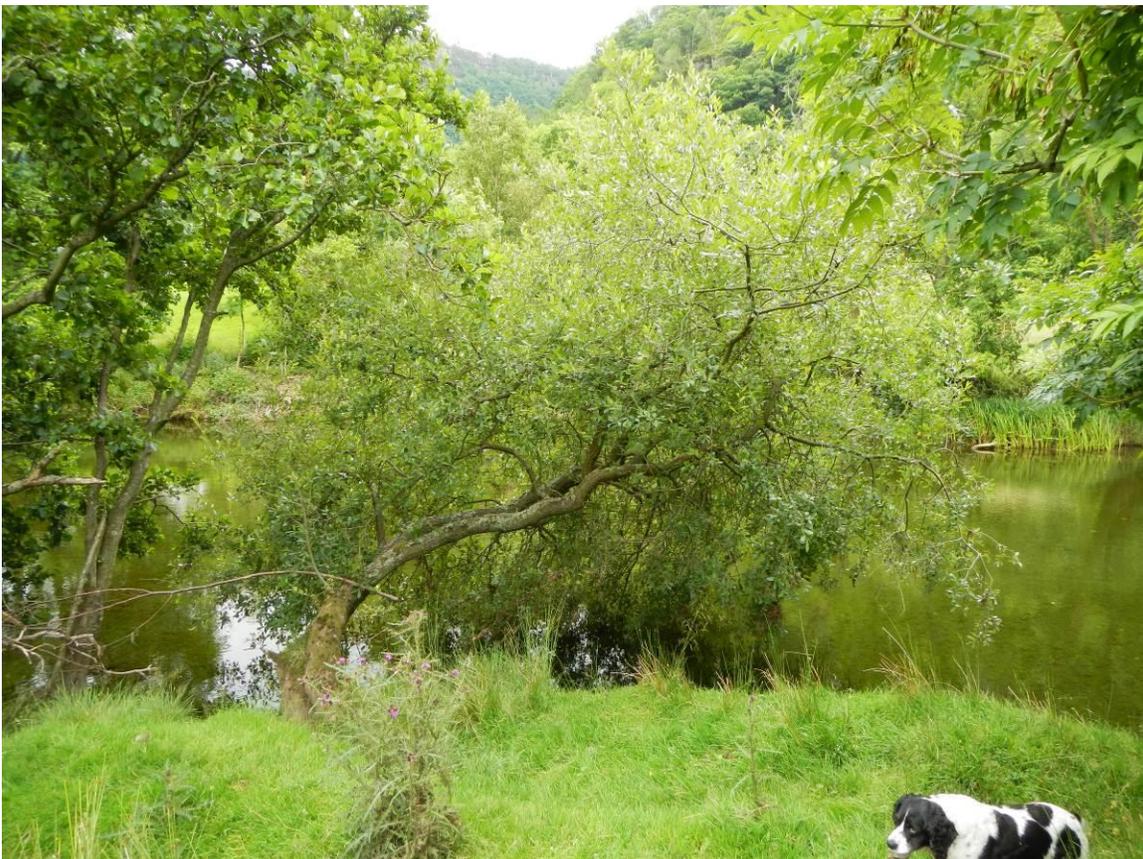
Figure 9. An example of a mature willow that could easily be laid into the channel to provide habitat structure in the short-term and encourage deposition of valuable morphological features in the long-term.

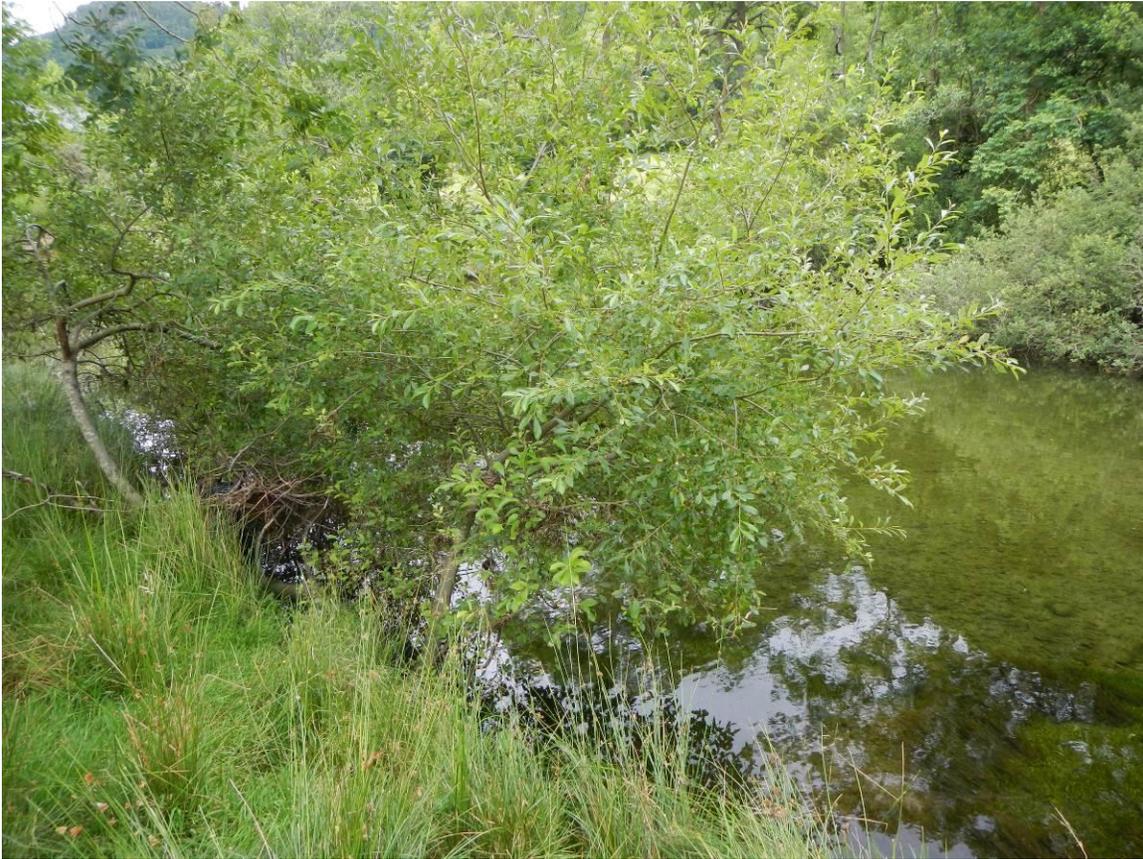
Figure 10. Smaller willows that could be laid for demonstration/participation during a workshop.

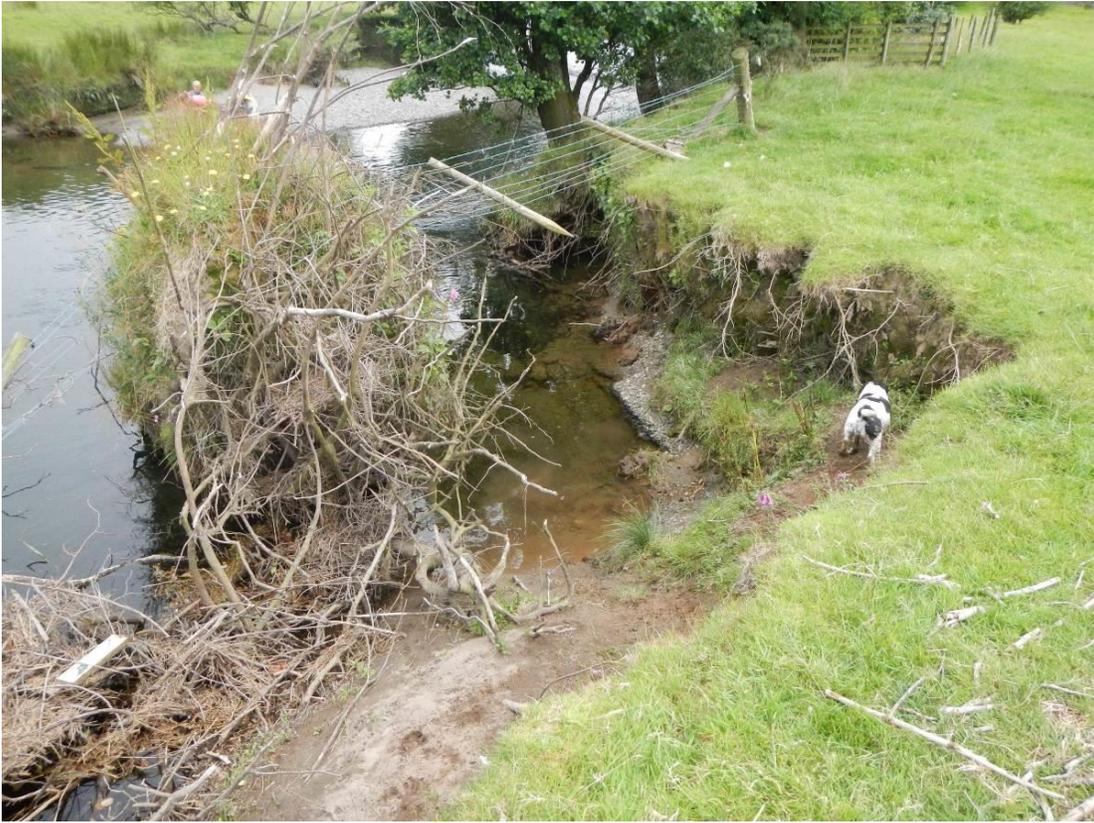
Figure 11. Before work.

At NY 25763 18133, a large tree has become undermined and fallen into the river and now provides valuable in-channel woody material (Fig 11). The destabilisation of the bank has, however, lead to bank erosion and it is proposed that brash mattress type green revetment is employed to stabilise the bank (Fig 12). Aside from the habitat benefits provided by the brash and reinstatement of trees along that area of bank, the greater bank protection should reduce the landowner's requirement to remove the in-channel tree. With the bank stabilised it would be worthwhile reinstating buffer fencing along that section of river bank (and any others not currently protected from stock grazing). This will be important in maintaining bank stability through the root mass of the buffer strip vegetation, encourage tree regeneration and help prevent further tree loss. It is far easier to control bank erosion if the trees are retained in the first place, rather than having to reinstate trees and stabilise a bank afterwards.

The technique to address the bank erosion would be simply to drive posts into the bank (live willow where available) to be used as anchor points for brash (including live willow) that will dissipate flow energy and encourage sediment deposition. The brash would be secured with wire and batons (longer branches secured over the top of the brash). Fencing would then be required to allow a greater diversity of vegetation to develop along the bank.

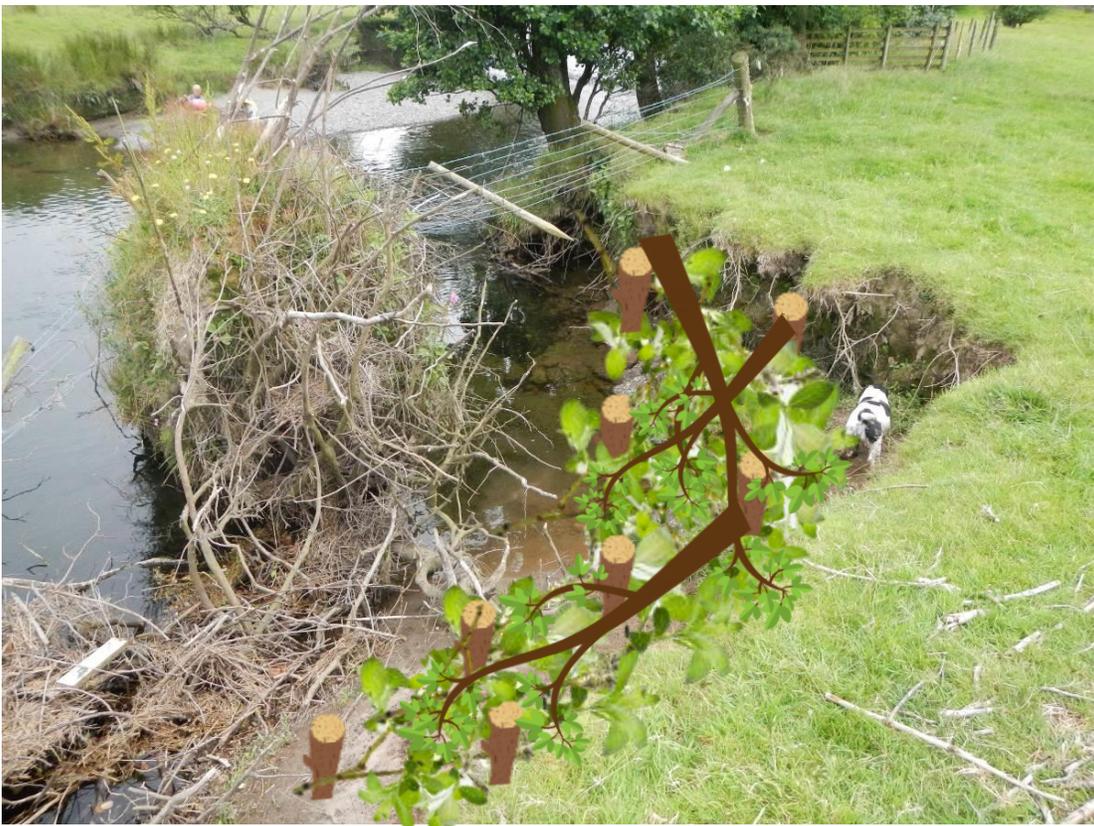
Figure 12. Proposed work, with brush secured into the erosion void to protect the bank.

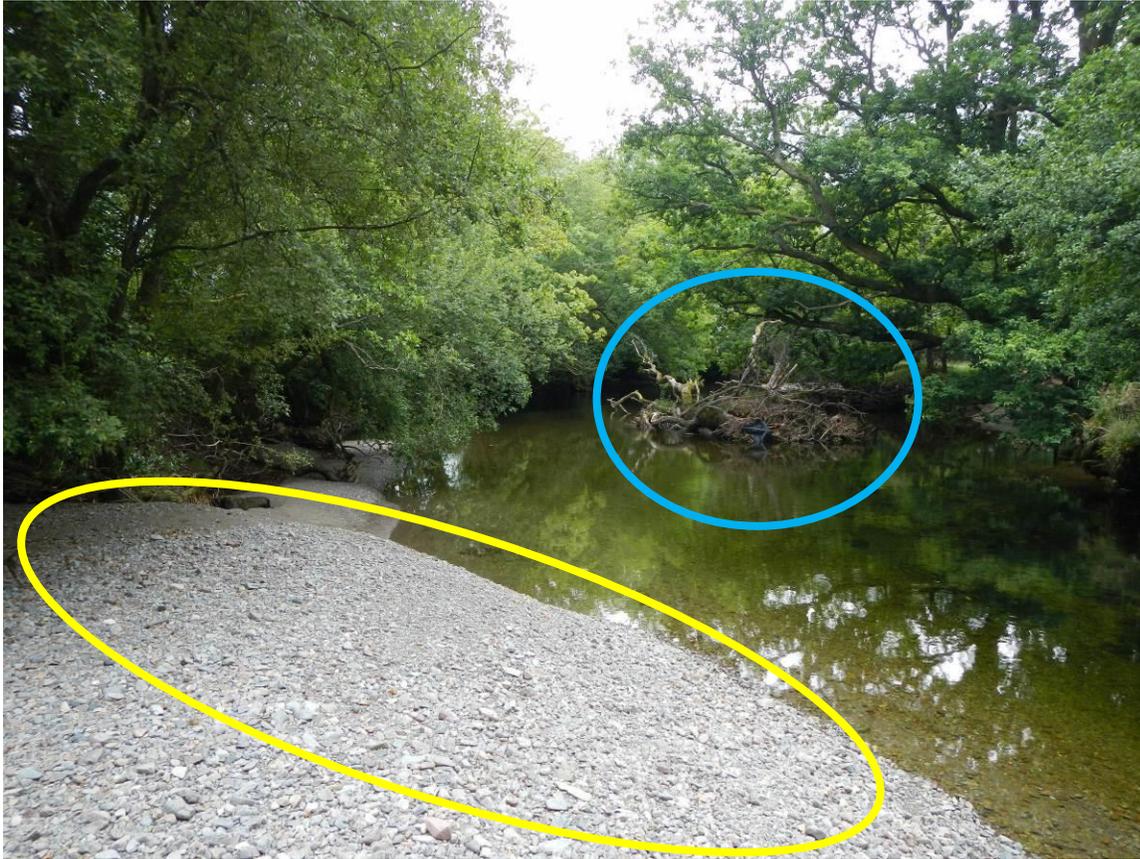
In some areas the tree lined nature of the banks and inputs of woody material to the channel have already led to habitat improvements, providing in-channel cover and the formation of depositional features with the margins (Fig 13).

Figure 13. A healthy level of light and shade, beneficial depositional features (yellow ellipse) and high quality in-channel structure (blue ellipse) all add to the quality of habitat.

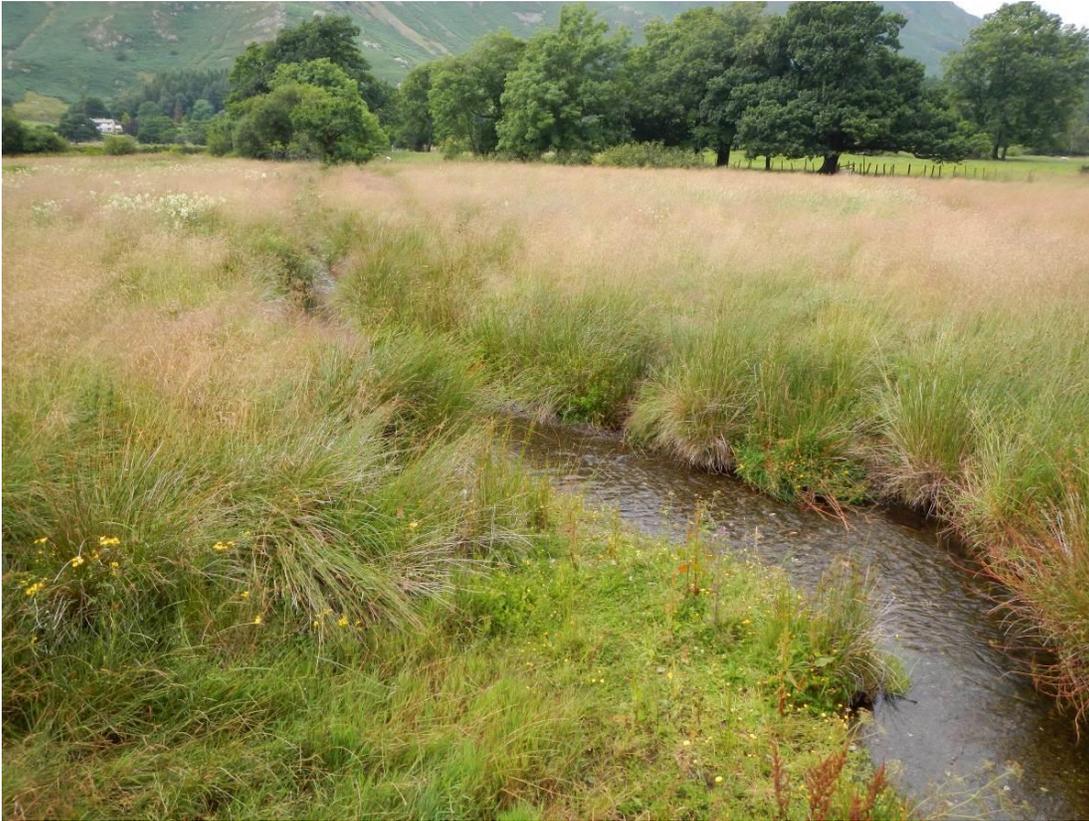
Figure 14. A small straightened tributary with potential for enhancement as a spawning and juvenile area.

At NY 25679 18286, a small dredged and straightened tributary enters the Derwent and presents an ideal opportunity for improving salmonid spawning and juvenile habitat, particularly for smaller resident trout. The straightened channel would ideally be realigned back to a more natural sinuous channel to fully restore the habitat there but, in the short-term, habitat can be improved by tree planting along the banks to improve cover and provide in-channel structure (Fig 14). The tributary already contains high quality spawning substrate but lacks depth and vital scouring flows to sort the substrate in many places (Fig 15).

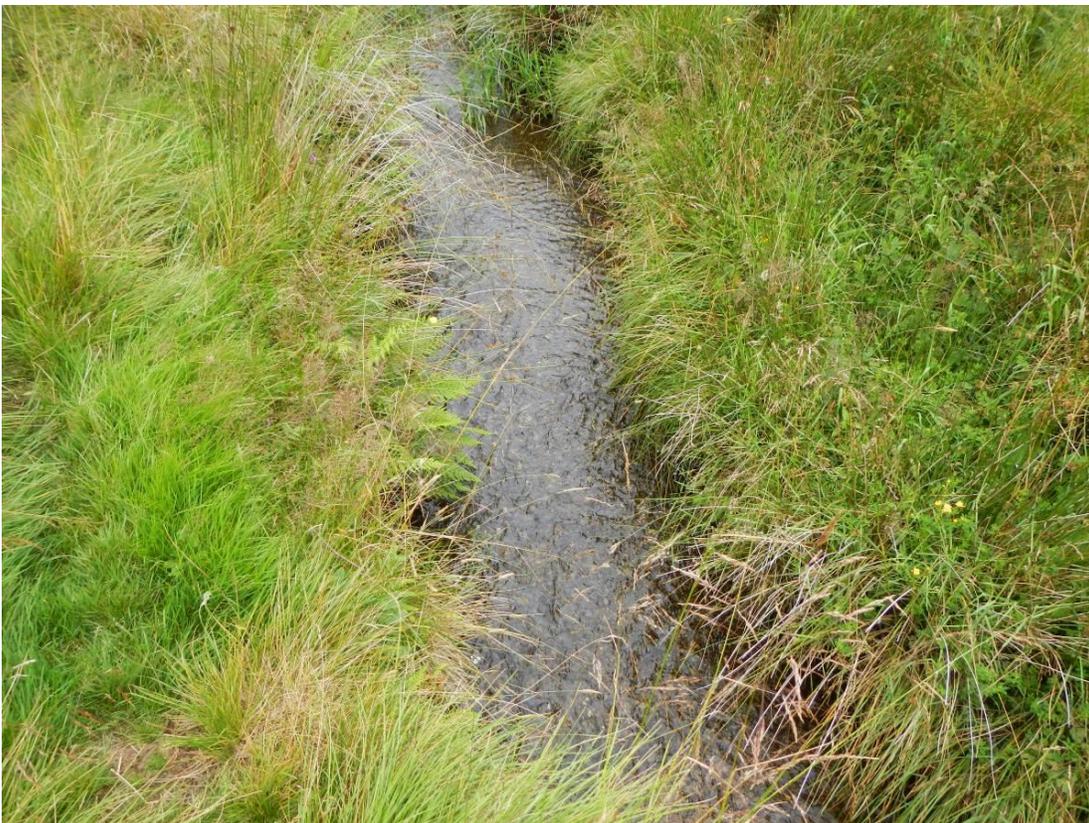
Figure 15. The tributary already provides the potential of high quality substrate if in-channel structure can be introduced to assist with sorting of the material and creation of deeper parr-holding areas.

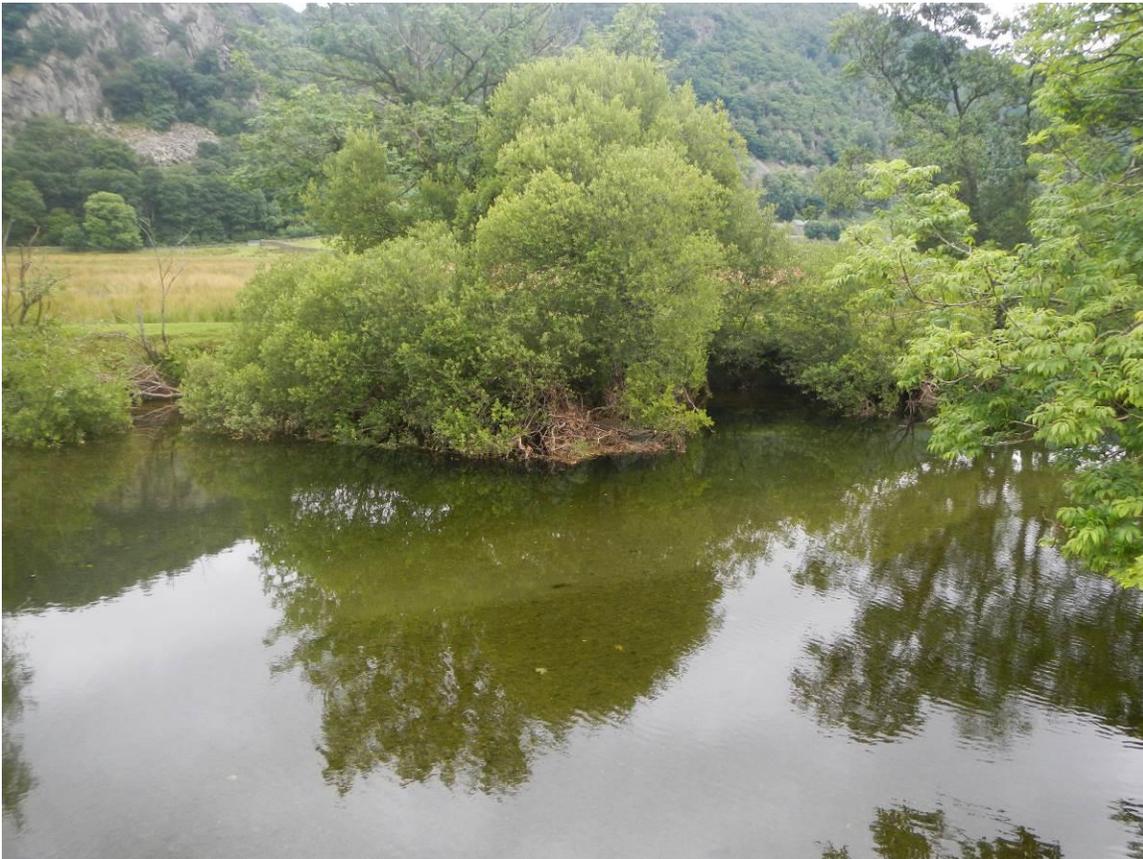
Figure 16. High quality trailing cover provided by willow, although the lack of flow velocity and diversity resulting from past dredging and impoundment from the lake limit its benefit.

Towards Derwentwater, dredging of the channel and the impounding effect of the lake reduce the habitat quality for rheophilic species but areas of low and trailing cover coupled with in-channel structure from trees that have toppled into the channel provide some par and adult salmonid habitat (Figs 16 & 17). The undercutting and loss of trees could well have been exacerbated by past dredging that will have interrupted sediment supply throughout the river, leading long-lasting impacts. To protect the areas of bank from which the trees have been lost (Fig 17), willow stake/whip planting would be beneficial to help consolidate the soil and provide replacement bankside cover.

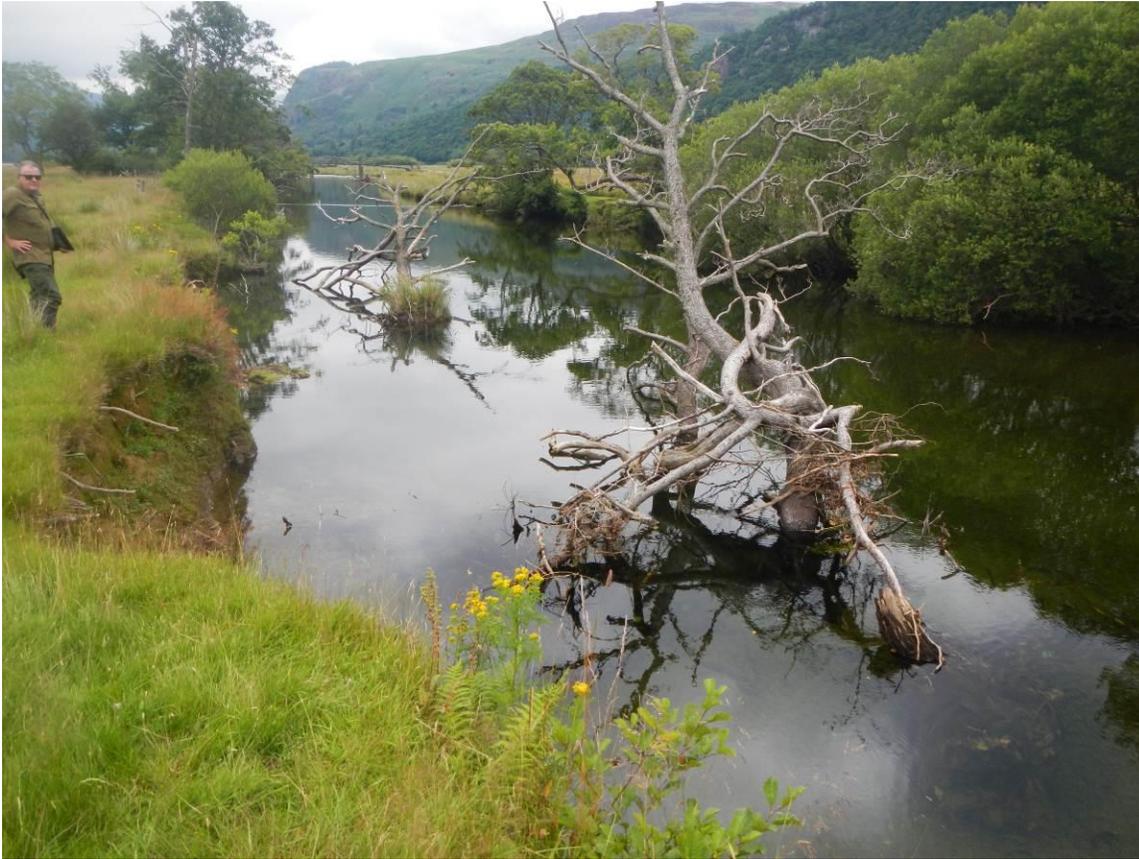
Figure 17. Trees that have become undermined and toppled into the river provide valuable habitat and should be retained in place. Willow planting along the adjacent bank would help to reinstate marginal cover and stabilise the bank.

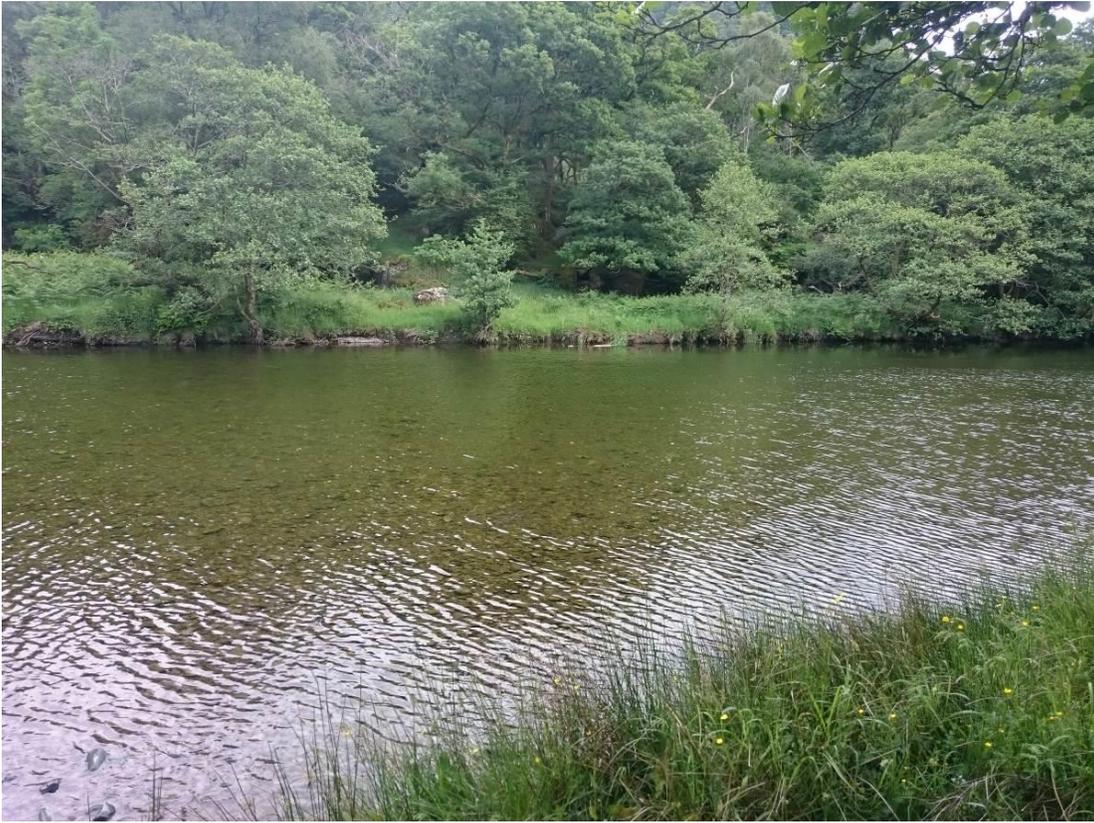
Figure 18. An example of the kind of over-capacity channel and poor quality habitat that could be greatly enhanced through additional in-channel structure.

The situation in the section inspected u/s of Grange Bridge is very similar to that d/s, with over-capacity channel sections resulting from past dredging and realignment work (Fig 18). As such, the prescription for those sections is the same, employing laid willows and pinned woody material within the river margins to encourage flow diversity and facilitate gravel deposition in the margins that will help create a more sinuous, self-cleansing channel (Fig 19). In some areas where pliable, layable species are not present, it may also be beneficial to employ tree kicker techniques which would be used in the same way as laid willows, to create structure within the river margin and improve the channel morphology (Fig 20).

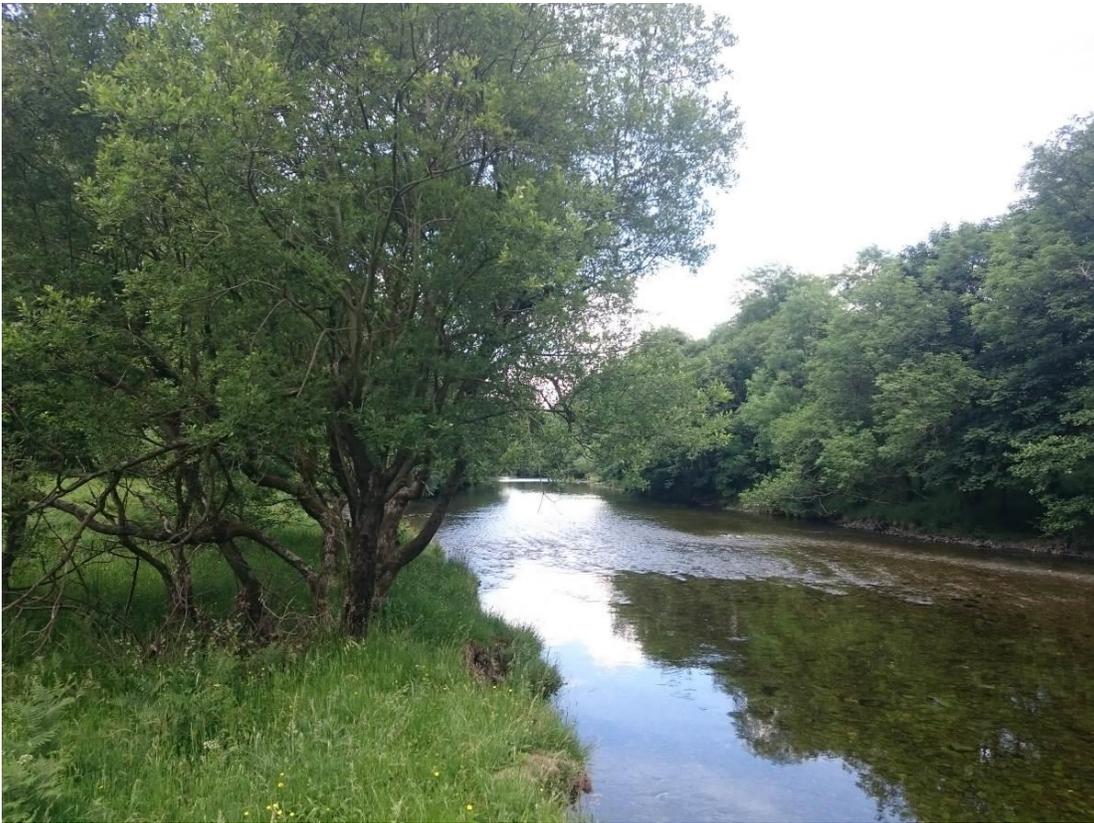
Figure 19. Over-capacity channel that could be very easily enhanced by laying the bankside willow into the river margin.
