Project Proposal
River Derwent (Upper catchment)
Cumbria
July 2016

Undertaken by Gareth Pedley

1.0 Introduction

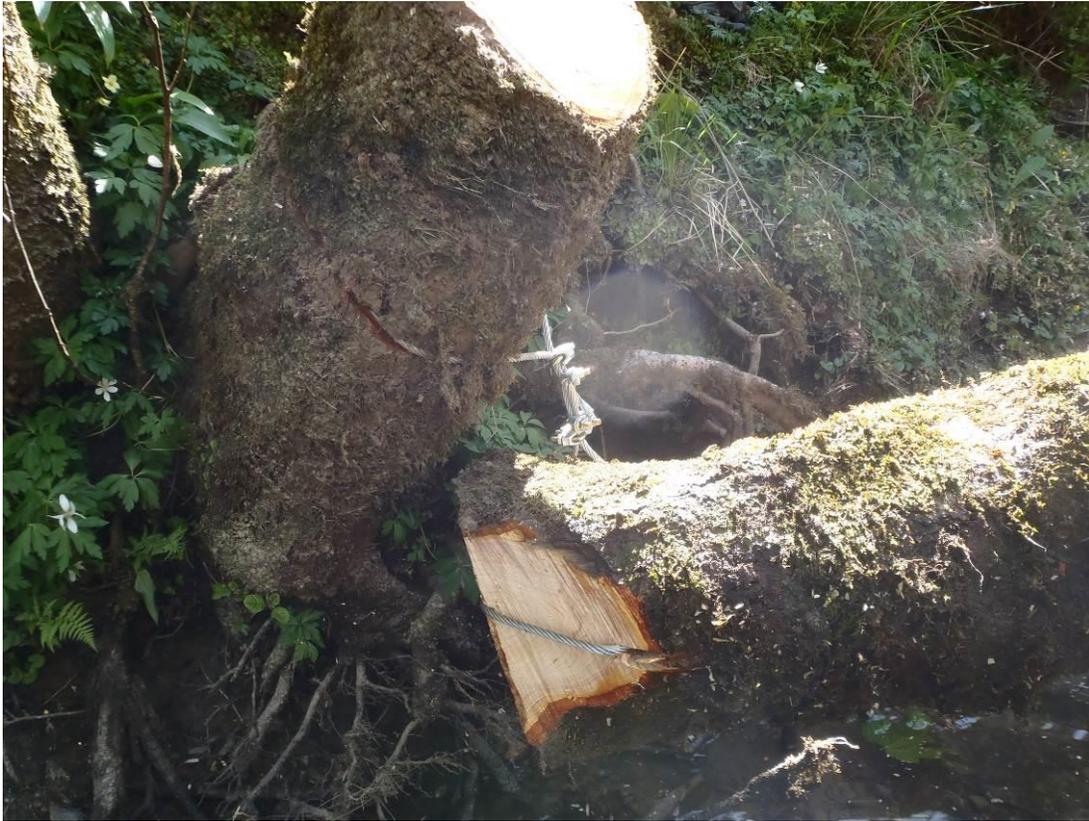
Figure 20. An example of a tree kicker fixing. This technique could be used to secure less pliable species that cannot be laid, with the tree cut at a, low coppice and then cable to its own trunk.

The situation in the section inspected u/s of Grange Bridge is very similar to that d/s, with over-capacity channel sections resulting from past dredging and realignment work (Fig 18). As such, the prescription for those sections is the same, employing laid willows and pinned woody material within the river margins to encourage flow diversity and facilitate gravel deposition in the margins that will help create a more sinuous, self-cleansing channel (Fig 19). In some areas where pliable, layable species are not present, it may also be beneficial to employ tree kicker techniques which would be used in the same way as laid willows, to create structure within the river margin and improve the channel morphology (Fig 20).

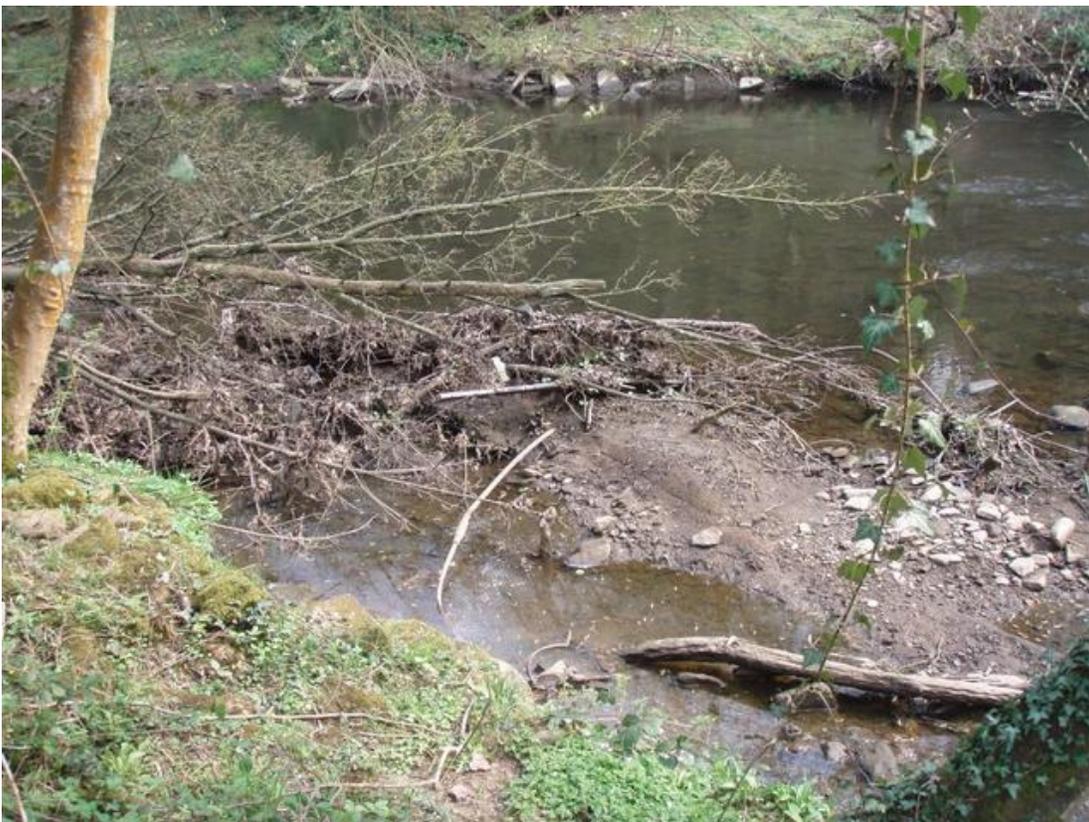
Figure 21. Beneficial deposition around a tree kicker.
