Higher Horselake Farm – Teign tributary

An Advisory Visit by the Wild Trout Trust – August 2014

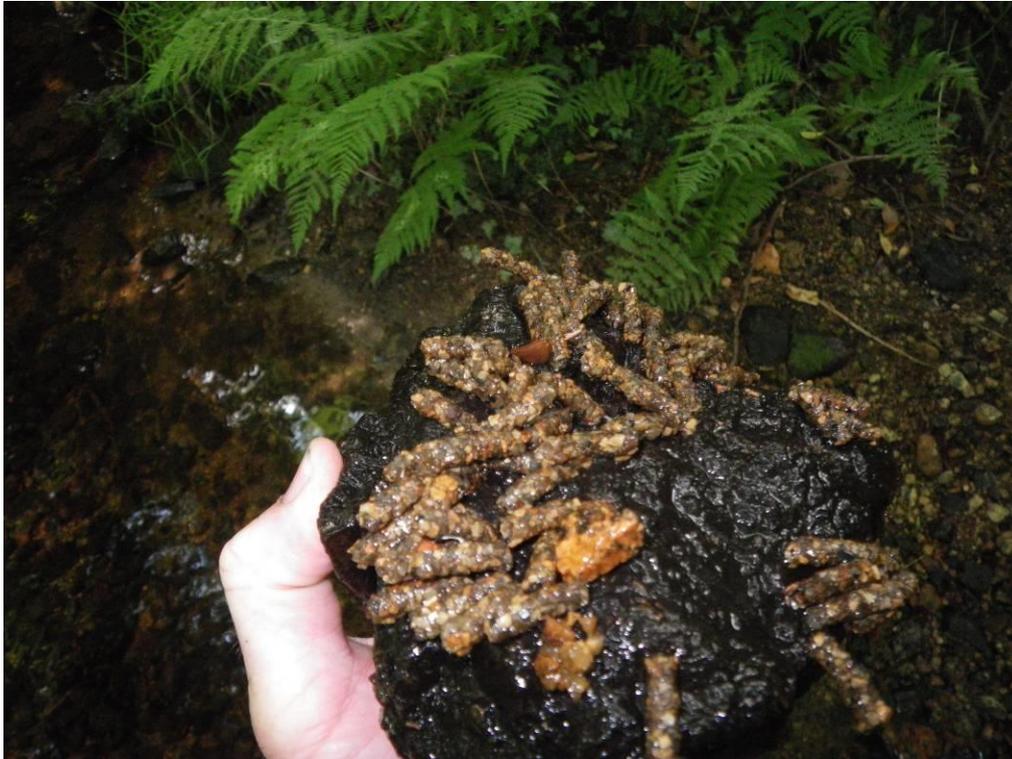
Habitat quality within the stream channels was considered to be good for trout, particularly on the natural channel where the stream has formed classic pool, riffle and glide regimes. The streams were well shaded with occasional shafts of light hitting the channel. The bed was mainly fine silts and gravels with occasional outcrops of coarse gravel in the 10-50mm range – ideal for trout spawning. A cursory look under some large stones revealed prolific numbers of olive (mayfly) nymphs, shrimps and caddis larvae (photo 1), all indicating very good water quality conditions.

Photo1: Large numbers of caddis larvae clinging to the underside of a stone in the feeder stream. A good indicator of high quality water.

The stream itself is in relatively good condition. Making sure that at least some direct sunlight reaches the channel is helpful and having a relaxed approach to woody debris (LWD) within the channel will also be important.

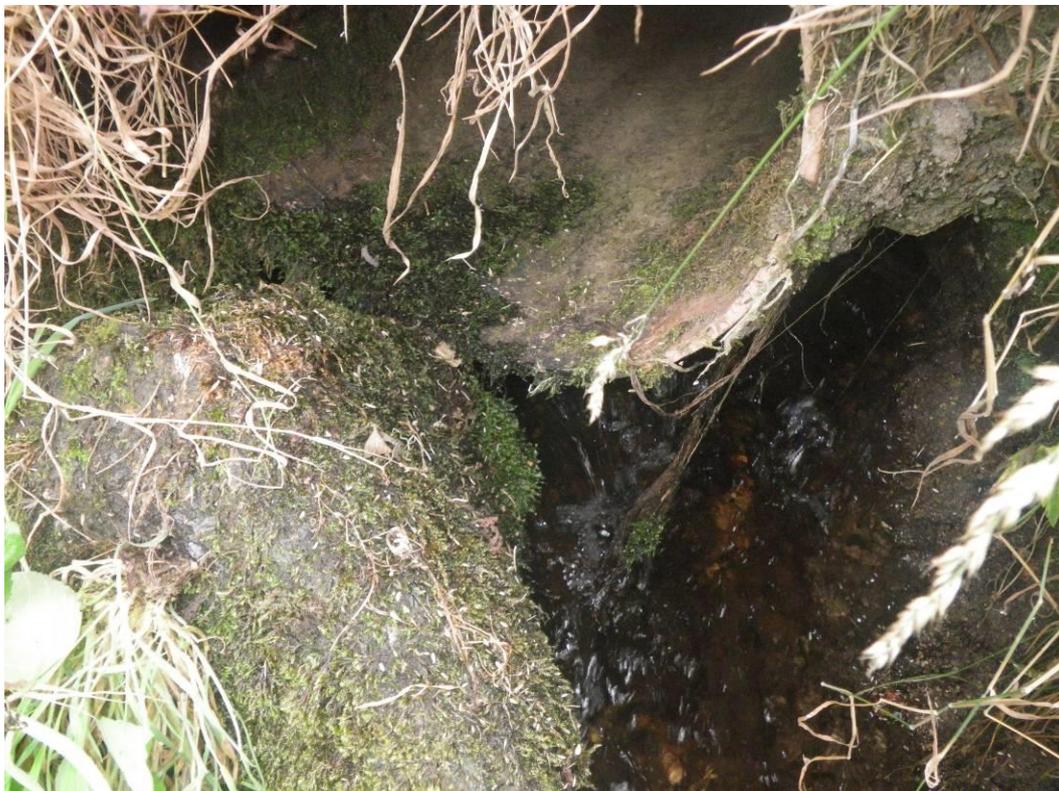
The dams and culverts connecting the lakes were all in very poor condition (photo 2) and in some cases water was completely bypassing the intended culverts, which were partially blocked in favour of an eroded subterranean route. This could lead to complete dam failure.

Photo 2. Water flowing under the connecting culvert – not through it.

- Plan a suitable route for a new bypass channel. A new channel could be constructed within the boundaries of the existing lake.
- Construct a monk sluice on the dam and an inlet structure that ensures the majority of the flow bypasses the lake.
- Manage the gradient in the bypass channel with a series of low (less than 200mm head loss) rock weirs to facilitate improved fish migration. Low weirs should be well spaced and no closer together along the stream than 6 times the channel width.
- Submit plans to the EA and your LA as an enquiry rather than application for permissions. This will save time and money and safeguard against the likelihood that well developed plans submitted for formal consent will be rejected.

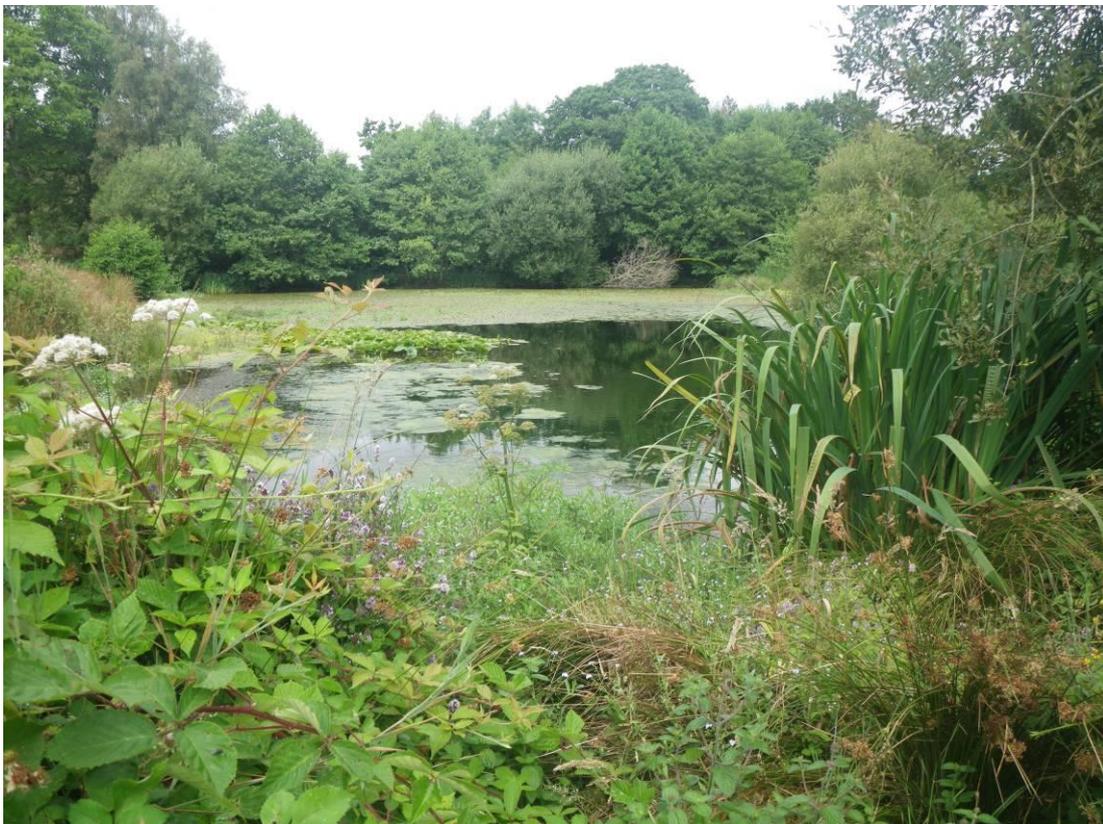
All three lakes support significant quantities of aquatic plants both submerged and emergent. The rich and luxuriant nature of the plant growth indicates that the valley floor is nutrient rich. The source of nutrient may well be coming in via the feed stream but steep sided valleys that lead down from both sides might also provide nutrients from point source locations such as private sewage systems, farm yards or possibly via diffuse sources where water filters through fertilized fields towards the top of the valley. This should be investigated in a little more detail as although the standing water was not packed with algal species (often an indication of excessive nutrient loading) the sheer quantity of macrophyte growth might present some future difficulties, particularly if significant investment was made in returning one of the lakes to what is hoped could be a viable fishery.

Photo 3. Bottom lake looking towards the dam, supporting luxuriant weed growth.

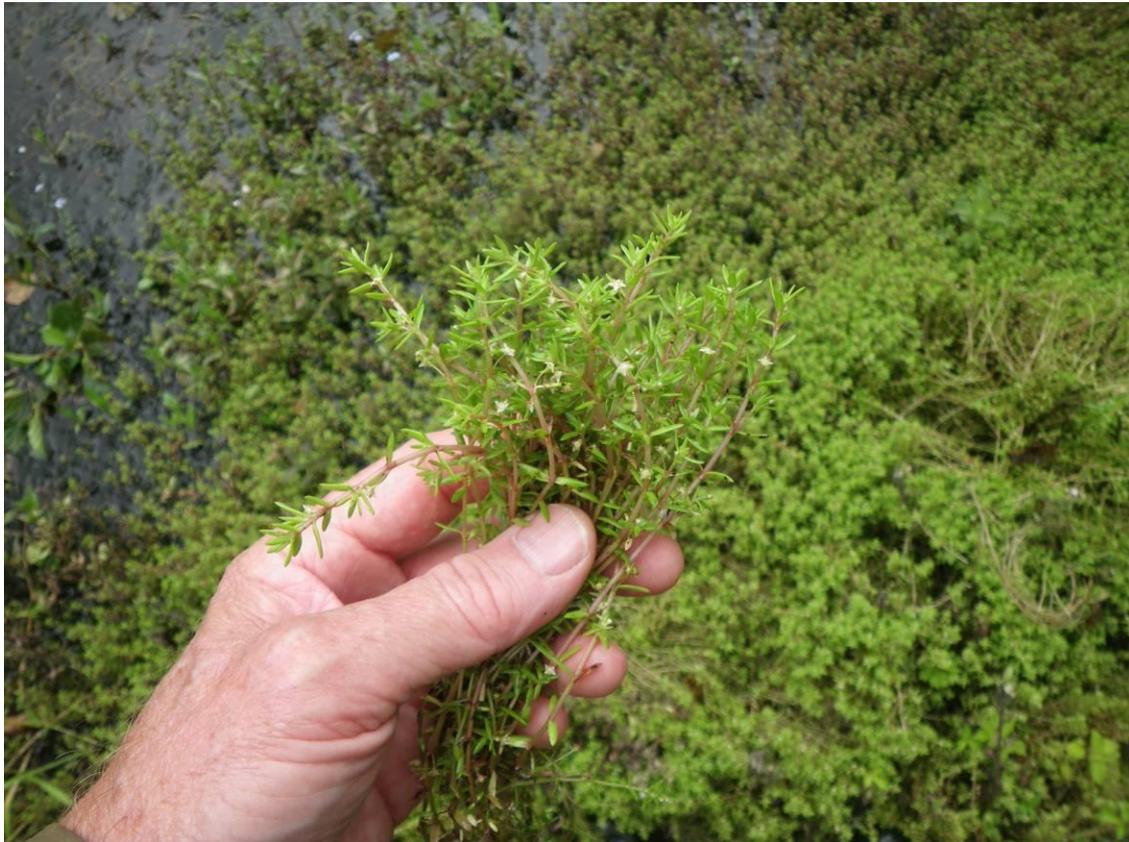
One area of concern surrounds a plant observed mainly on the top pond but is highly likely to be present in all three (Photo 4). The plant is known as New Zealand Pygmy Weed or Australian Swamp Stone Crop (*Crassula helmsii*). As the names suggest, this is a non-native species and one that has been flagged up by DEFRA as a designated Non Native Invasive Species.

This plant is highly invasive and can grow in damp ground right through to fully submerged situations. Its control is extremely difficult as new plants can propagate from small scraps of the 'parent' plant. Professional advice on its eradication should be sought. A start point is the EA's new guide on aquatic plant management (see <http://www.wildtrout.org/news/managing-plants-rivers->

Photo 4. Stonecrop coating the margins of the top lake and one which should be eradicated if at all possible.

- Seek professional advice on control of the Australian Swamp Stoencrop.
- Manage the stream with a light touch. Coppice the odd tree to promote shafts of light over shallow runs and leave woody debris in the channel where possible.
- Carry out some research into the age of the lakes.
- If they are very old then proceed with plans to reinstate the bottom lake.
- Carry out a levels survey of the bottom lake and surrounding land.
- Investigate the nature of the underlying geology. If the lake is only three foot deep overlying granite then a trout fishery isn't a viable option.
