River Medway – Upper Medway Fly Fishers

An Advisory Visit by the Wild Trout Trust April 2015

1. Introduction

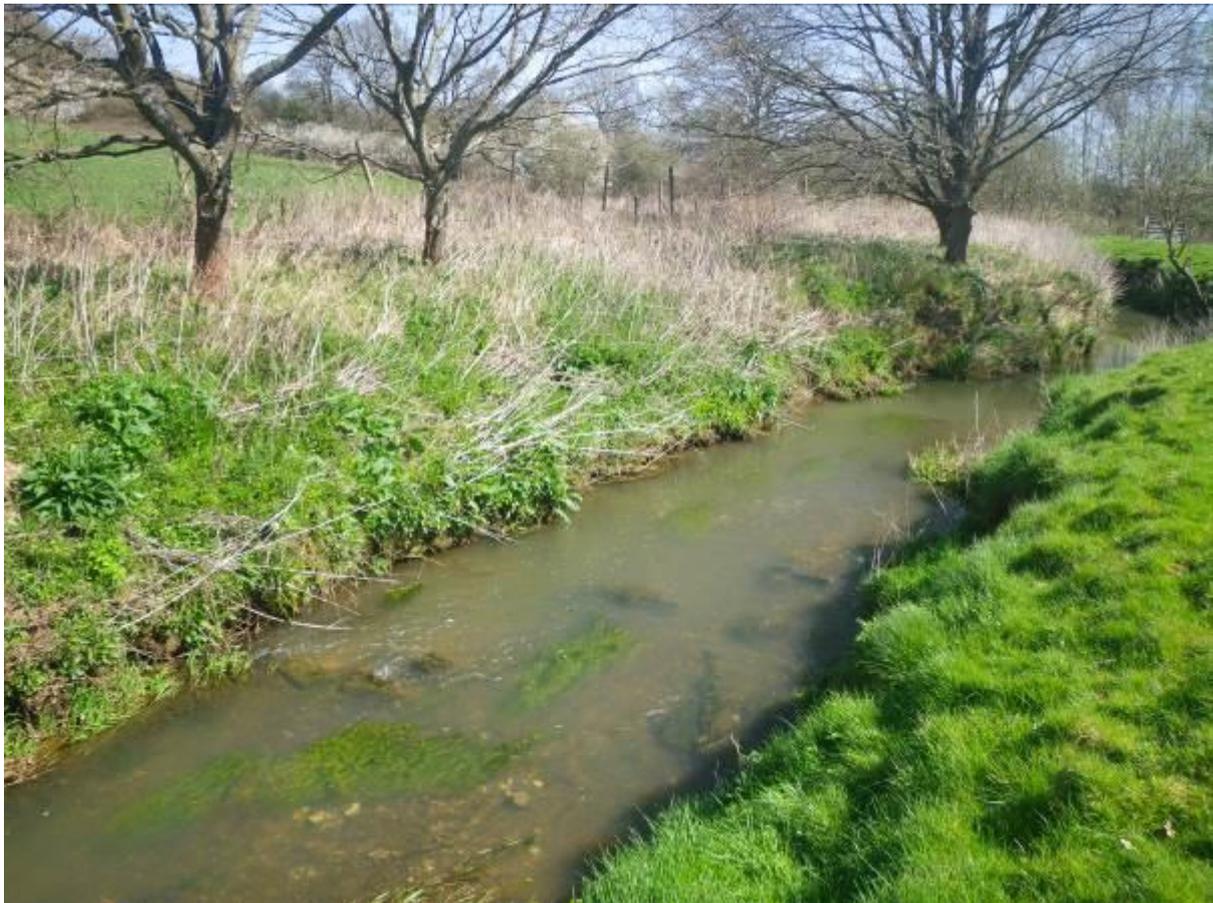
1). In the lower half of the beat, some excellent spawning opportunities have been created through the import of gravels to form shallow riffle and glide sections (cover photo).

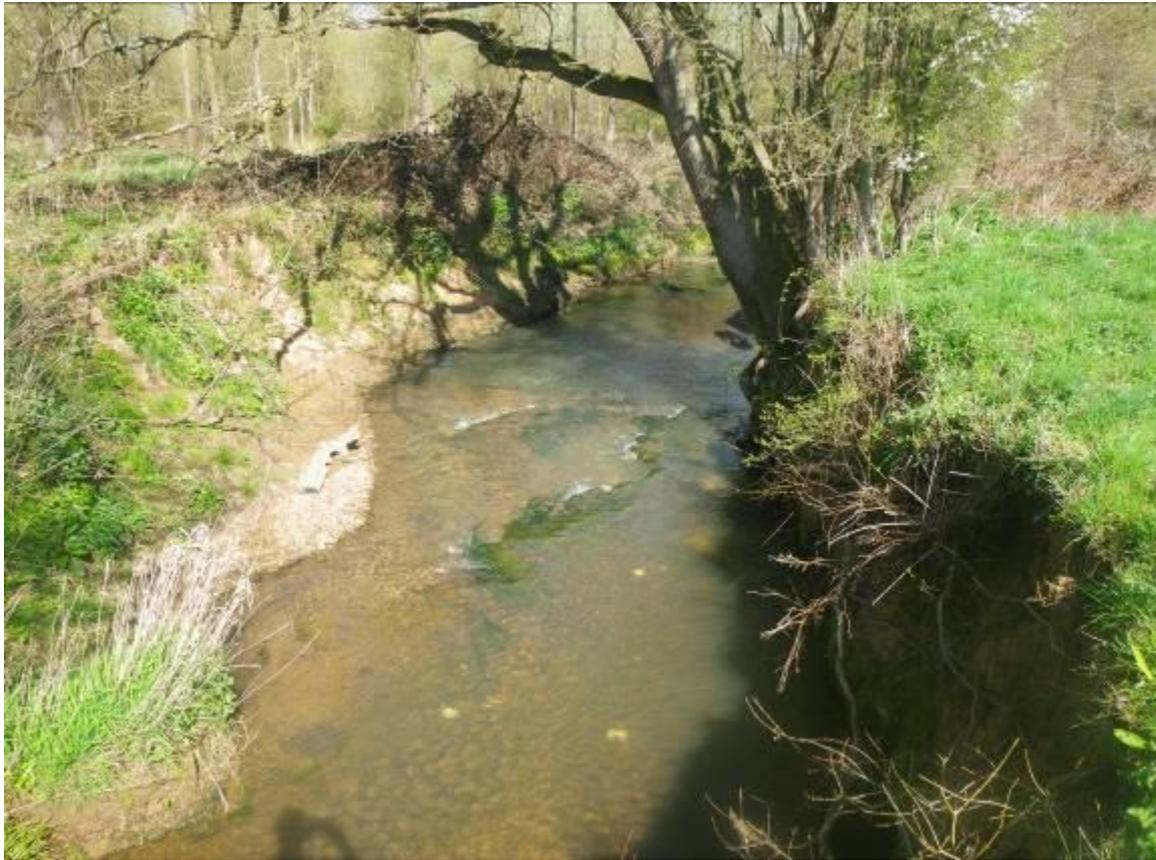
The river bed is relatively rich in gravel deposits, with regular outcrops of eroded sand and iron stone which provide ample opportunities for trout spawning (photo

Photo 1. Typical section of varied habitat supporting a well-covered pool and a shallow gravelly run with spawning potential.

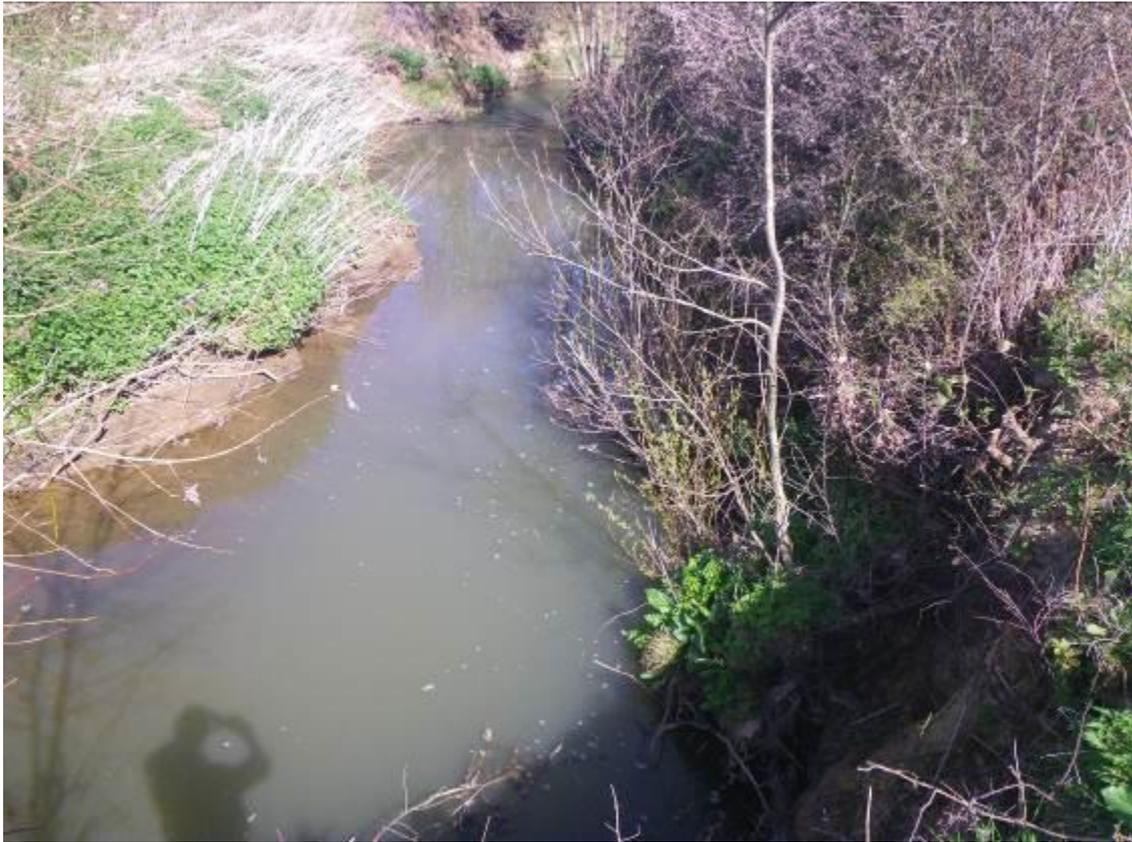
The banks are liberally dotted with mature alder and ash trees, with occasional thorns and willow trees, providing valuable cooling shade. This aspect of the habitat is crucially important, particularly in a small lowland trout stream located in the South East, where low flows following below-average rainfall could promote elevated water temperatures during the high summer period. There were one or two good examples of willow becoming established on the toe of a slumped bank proving good quality habitat (photo 2).

Photo 2. A good example of a low willow established on the toe of the bank which stabilises the bank and provides valuable low cover for trout.

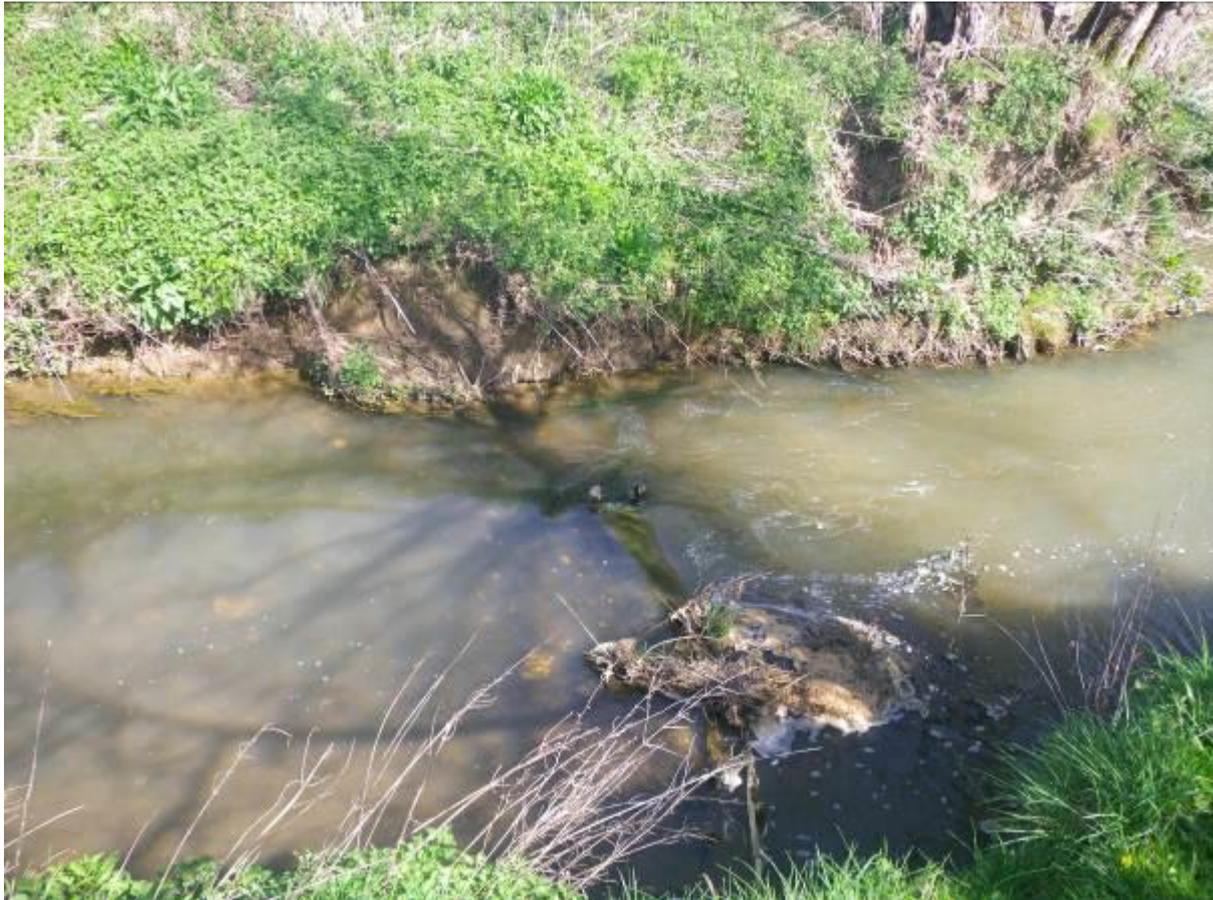
The UMFF have worked tirelessly to get the stream into a fishable condition by removing fallen trees and scrub. Care must be taken to ensure there is not a desire to make the channel too "tidy". The club have used some of the tree trunks to peg into the channel to successfully create improved holding lies for adult trout (photo 3). This work has undoubtedly helped to maintain the varied bed structure which is vital for all trout life stages, however, there was a distinct lack of scrubby, coarse woody debris, particularly in the margins of shallow runs. This lack of cover in strategic areas could be impacting on fry and parr survival. The club have successfully translocated water crowfoot in an attempt to provide more in-channel cover and in places this has worked well but weed growth was limited to open areas and cannot be established in many of the deeply set and more shaded sections of channel.

Photo 3. Woody debris groyne promoting useful bed scour.

It is in some of these sections where more coarse woody debris could be usefully secured into the toe of the bank. The nearer this additional cover can be located to potential spawning sites, the more likely it is that improved survival from fry to parr can be achieved. Additional cover over deeper pool habitat will also benefit adult trout.

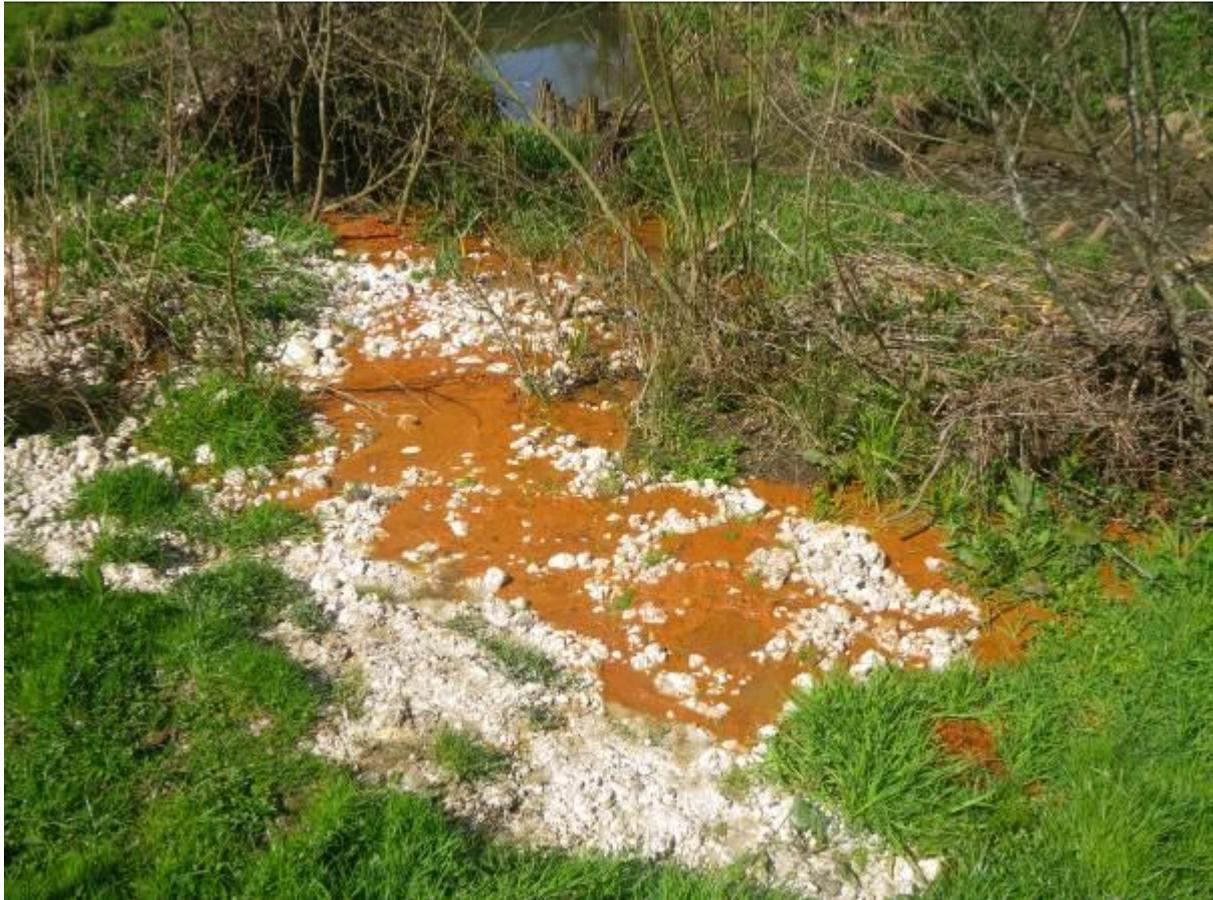
Several iron (ochre) rich springs discharge into this section of the Medway which is typical for many streams that flow through the Weald. The club have attempted to buffer the acidic nature of several of the discharges by revetting the bank and backfilling the local areas with boulder chalk (photo 4).

Photo 4. An iron rich spring source buffered with imported chalk.

Attempting to manipulate the natural chemistry of local spring sources is unlikely to have a measurable impact on river pH but may impact the ecology of the immediate area. Opportunities to improve the diversity and density of invertebrates can be achieved via habitat improvements. Again, packing shallow riffle margins with brushwood, which provides both a primary food source for grazing invertebrates, as well as an environment for filter feeders to anchor themselves in the flow, will promote a healthy food web from which trout could benefit.

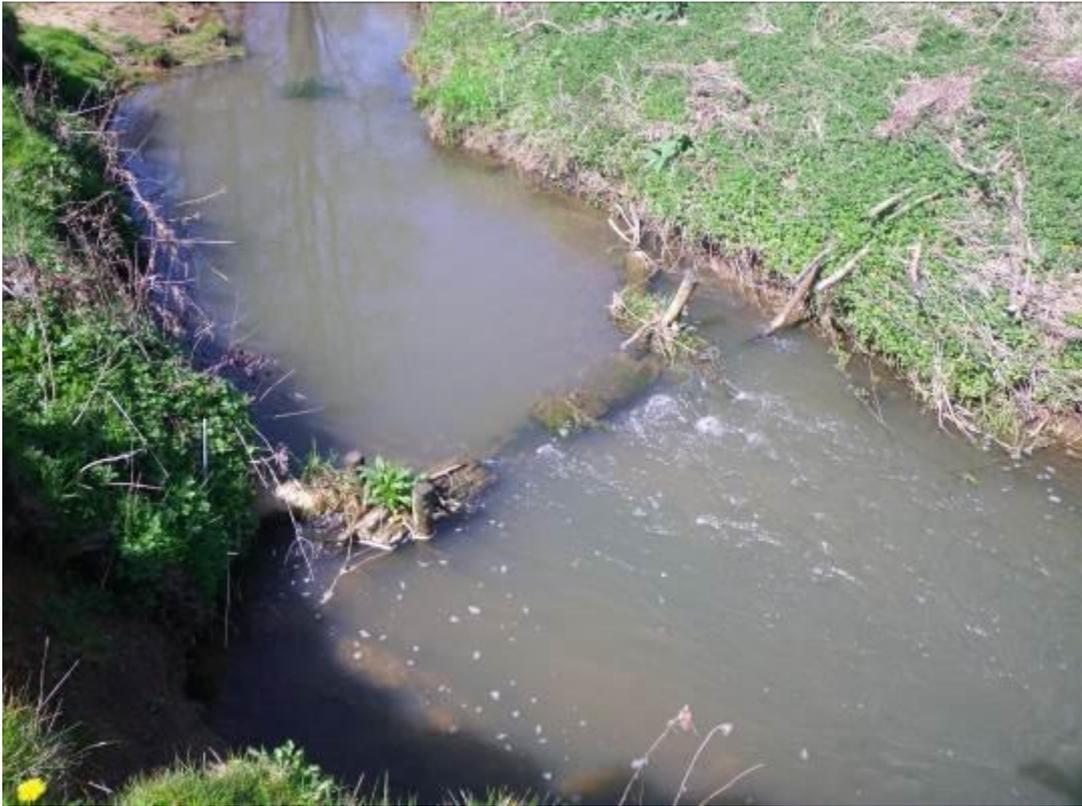
A few log weirs have been installed (photo 5) with a notch cut out to provide free fish movement. These structures have promoted some good habitat immediately downstream of the structure but are still having a slight impounding effect on the water immediately upstream, potentially promoting silt deposition. An effective alternative is to install two separate upstream facing logs in a "V" formation (example in photo 6). This configuration has the benefit of concentrating erosive flow velocities towards the centre of the channel and provides a free gap down to bed level, reducing the risks of sediments collecting immediately above the structure.

Photo 5. Full width log with notch on the Medway

- **Promote more in-channel cover, especially in shallow margins adjacent to spawning sites.**
- **Consider planting some low, scrubby tree species into the toe of slumped banks.**
- **Consider modifying some of the existing full width log weirs into upstream V deflectors.**
- **The WTT would be happy to demonstrate some of the techniques recommended in this report via a Practical Visit (PV) where a Conservation Officer would work alongside members of the UMFF during a work party day.**

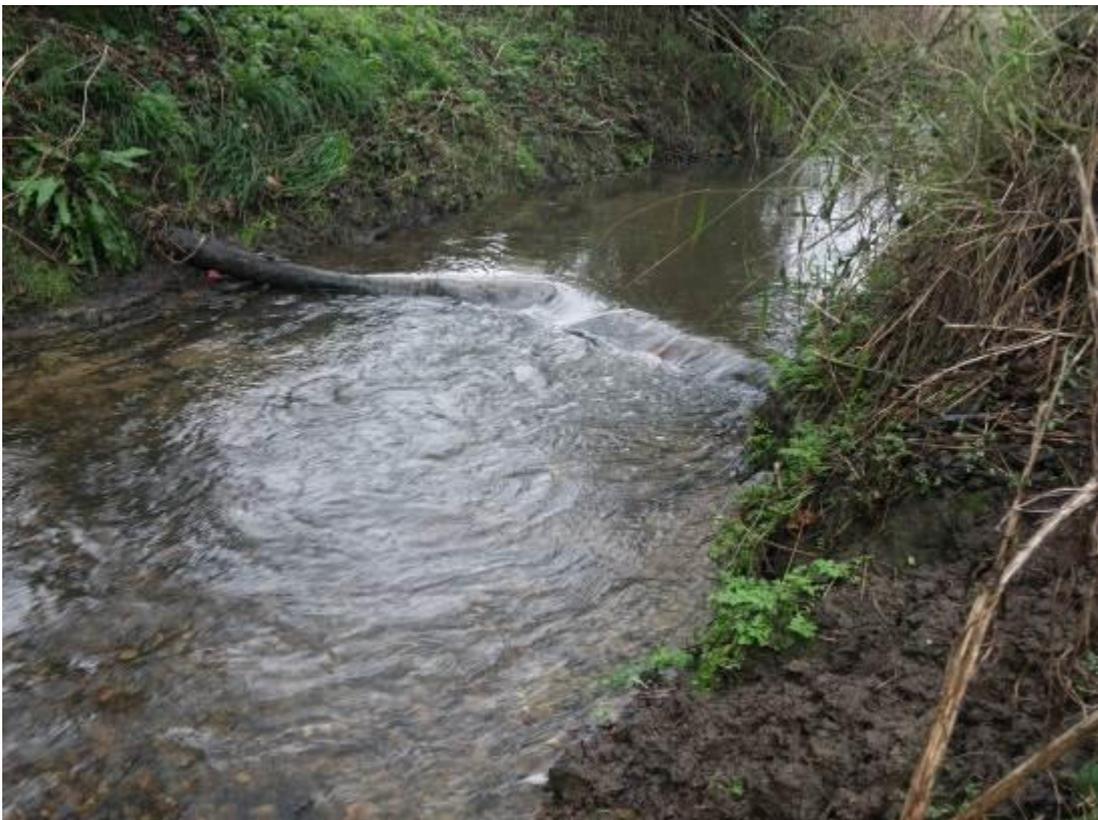
Photo 6. An upstream facing V structure with narrow gap made from two separate logs which concentrate the flow and reducing risks associated with upstream deposition.

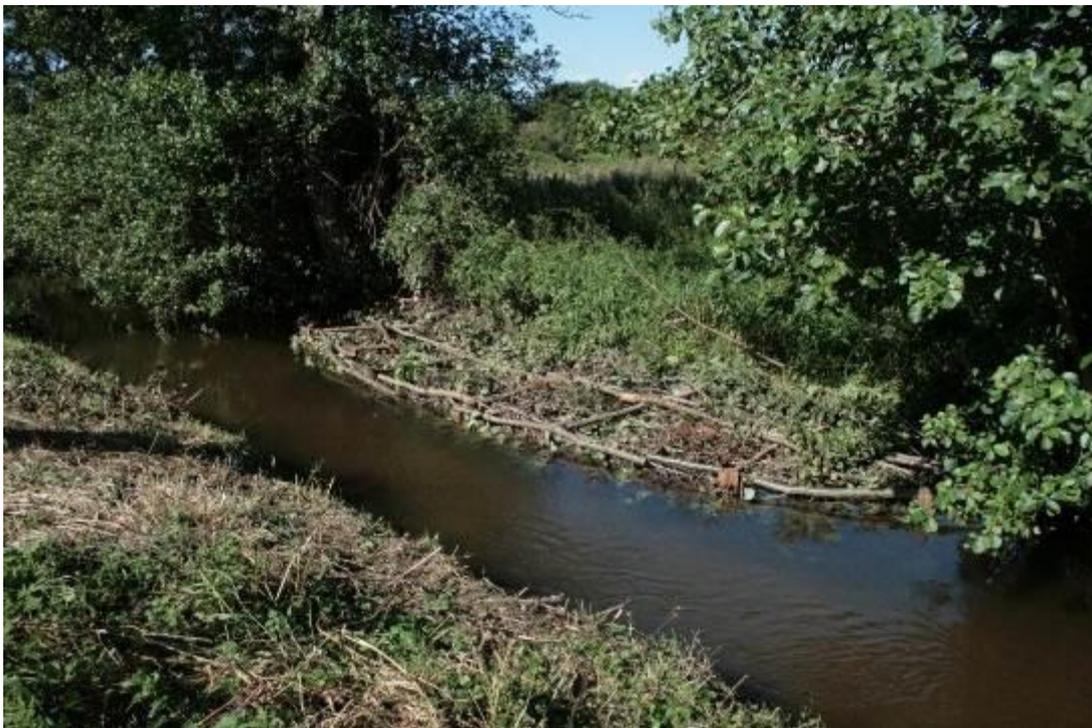
Photo 7. An example of a brushwood shelf on the River Glaven, Norfolk.

Creating the ideal balance between fishable water and improved habitat for trout is always tricky. A good strategy is to promote low, overhanging shade on the outside of bends, or over holding pools and to provide more brushwood cover in the margins of shallow glides and riffles. This will not interfere with access for fishing but could help to significantly boost wild trout survival to adulthood. Examples of brushwood shelves can be seen in photos 7 and 8.

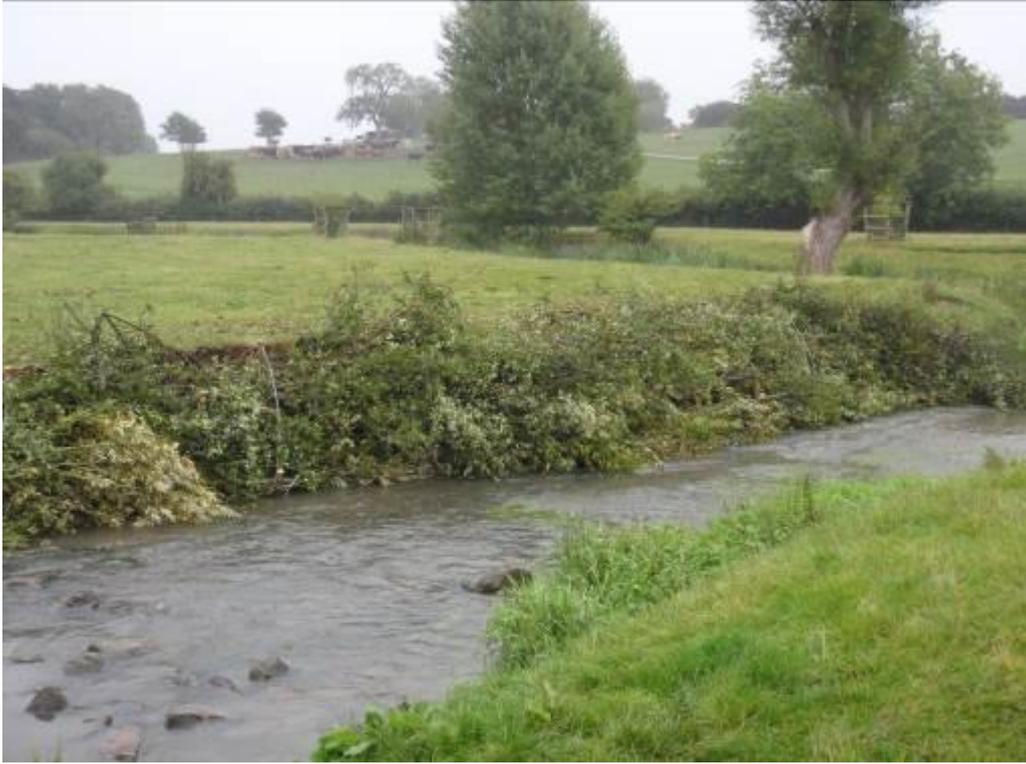
Photo 8. Brushwood packed against the face of an eroding bank on the Great Ouse.

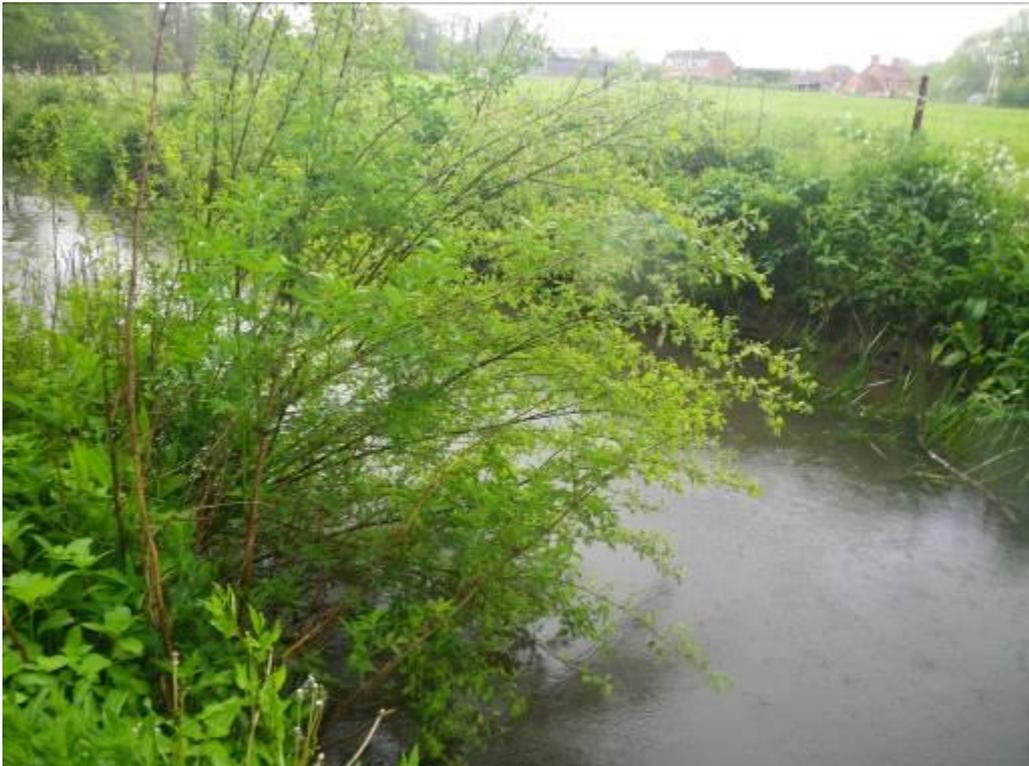
Photo 9. A goat willow planted into the toe of the bank can provide a great cover for trout.

Planting goat willow *Salix caprea*, or possibly thorn trees into the toe of slumped bank margins will help to provide cover and stabilise river banks. Simply trimming up the trees to facilitate a cast is all that's required.

Some good examples of low, overhanging cover can be found in photos 9 and 10.

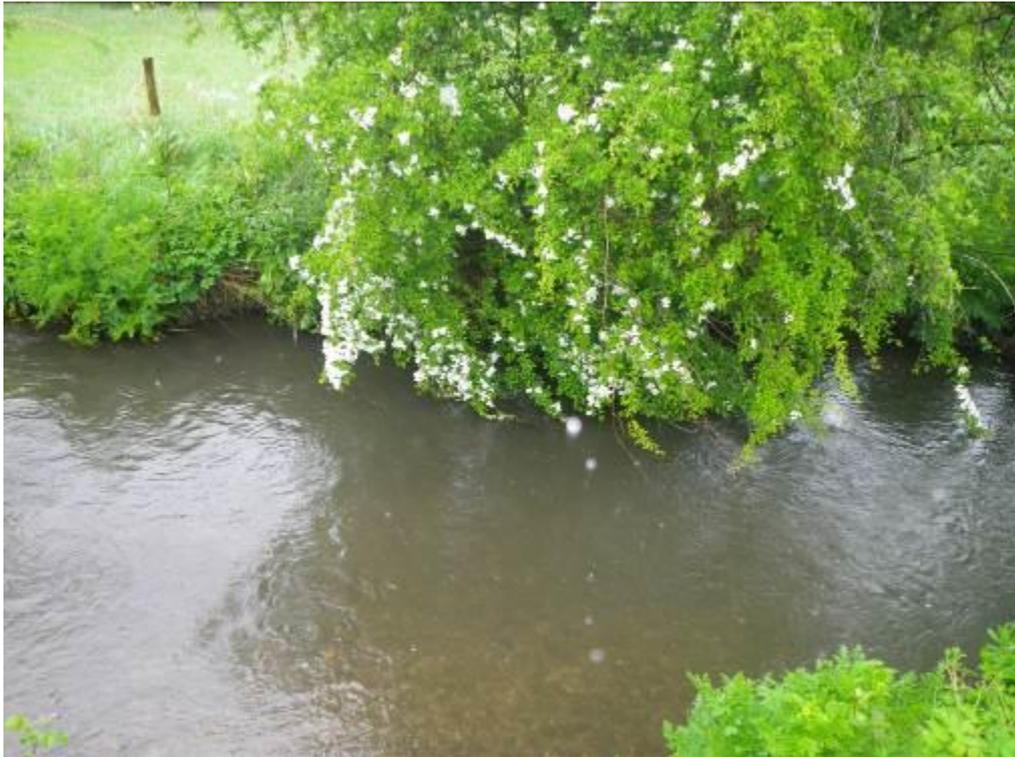
Photo 10. Thorn bushes make valuable riverside trees and provide shelter and a source of food via terrestrial invertebrates.
