## **Upper Dearne Woodlands – Upper Cumberworth**

**An advisory visit carried out by the Wild Trout Trust – March 9th 2015**

This report is the output of a Wild Trout Trust Advisory Visit (AV) undertaken along **approximately 1.2 km of the River Dearne in the Upper Cumberworth and Denby Dale area between an upstream limit at National Grid Reference SE 20242 08008 and a downstream limit at SE21355 08249.**

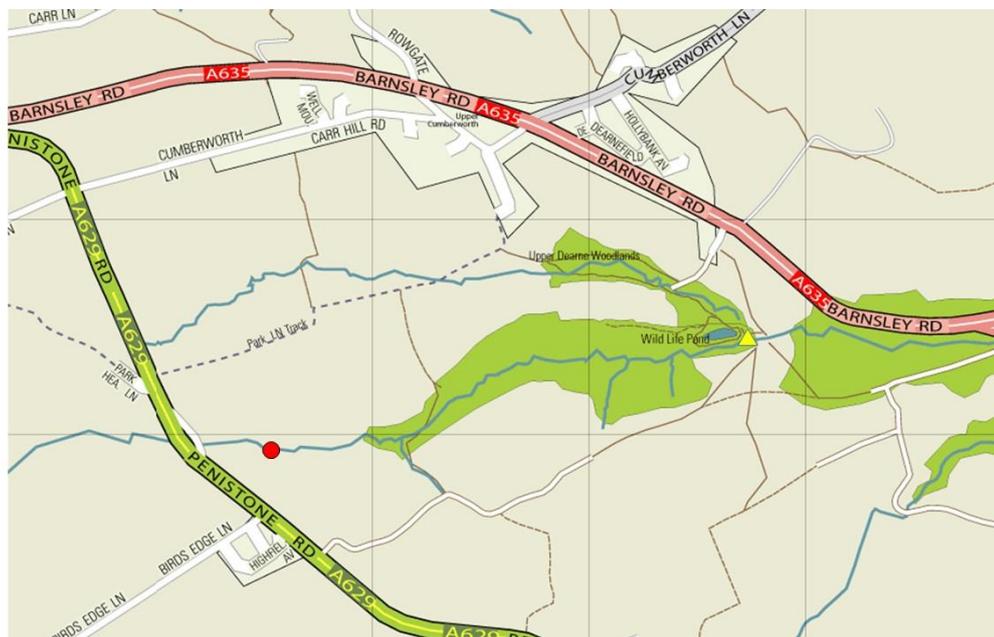
Figure 1: Map of visited reach including upstream (red dot) and downstream (yellow triangle) limits of inspected reaches

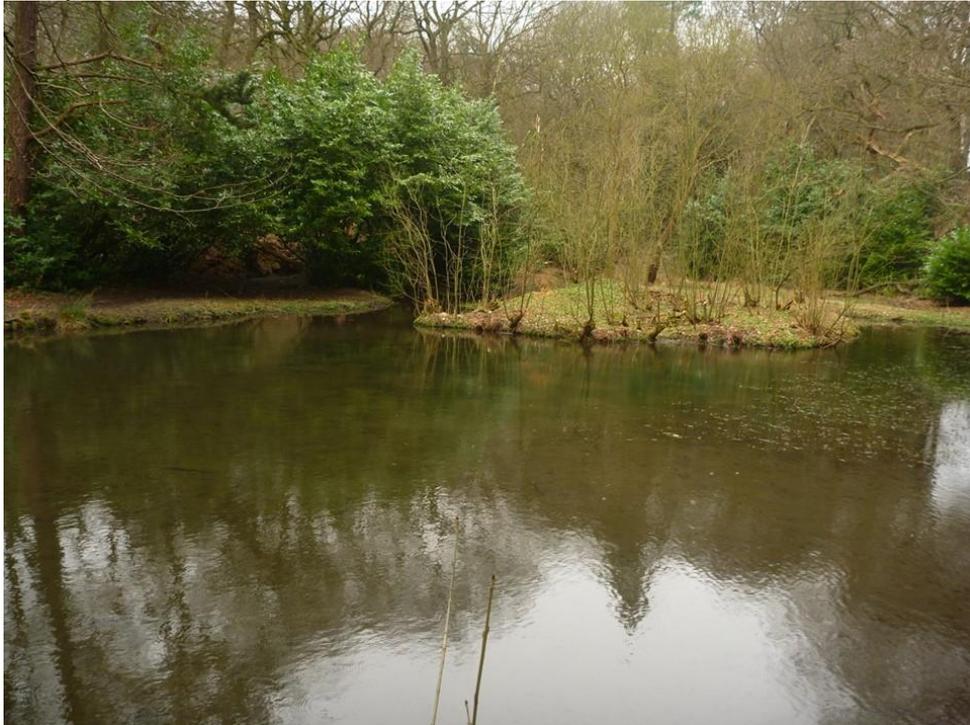
The most prominent example of sediment interception is, of course, the on-stream lake (Fig. 5) produced by damming of Park Dyke at the lake outlets to both Park Dyke and the River Dearne.

**Figure 5: Ornamental lake created predominantly by damming the Park Dyke**

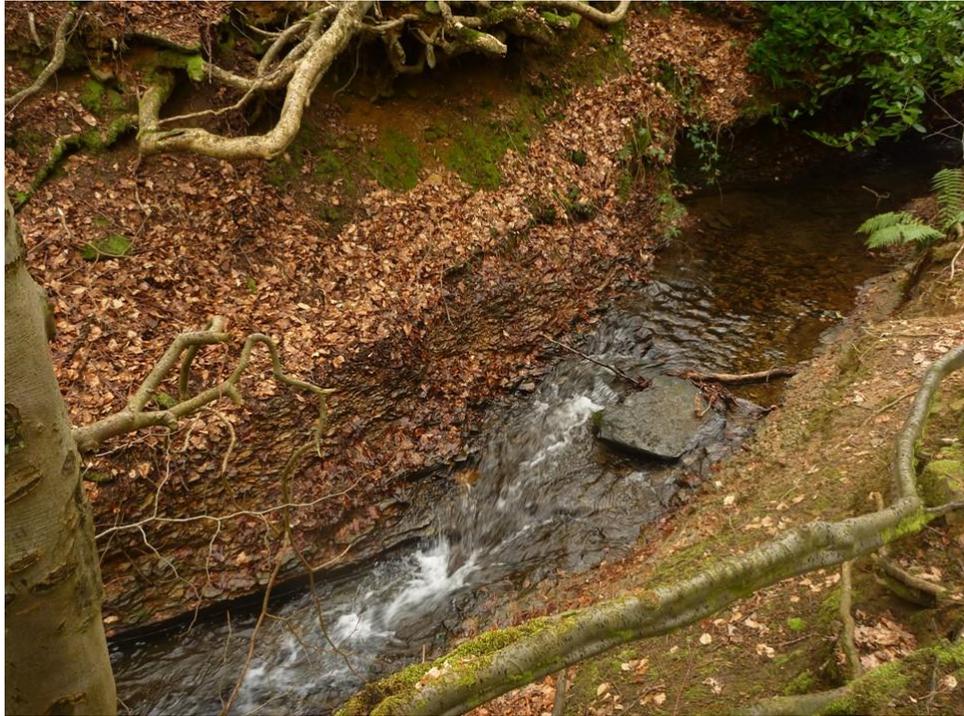
**Figure 7: Potential increase in erosion/channel incision downstream of the weir pictured in Fig. 6. This would result from the retention of riverbed material above the weir. Retained material would, otherwise, replace and offset eroded material in the downstream channel – reducing the rate at which the stream cuts through the streambed.**

Given the exemption to works carried out without licences prior to 2006 this means that there should not be a problem with allowing the volunteer-constructed weirs to degrade naturally. Notching these structures and performing maintenance under the aim of clearing blockages would also aid this process. Additional legal advice may be useful in order to explore more proactive removal of these impounding structures.

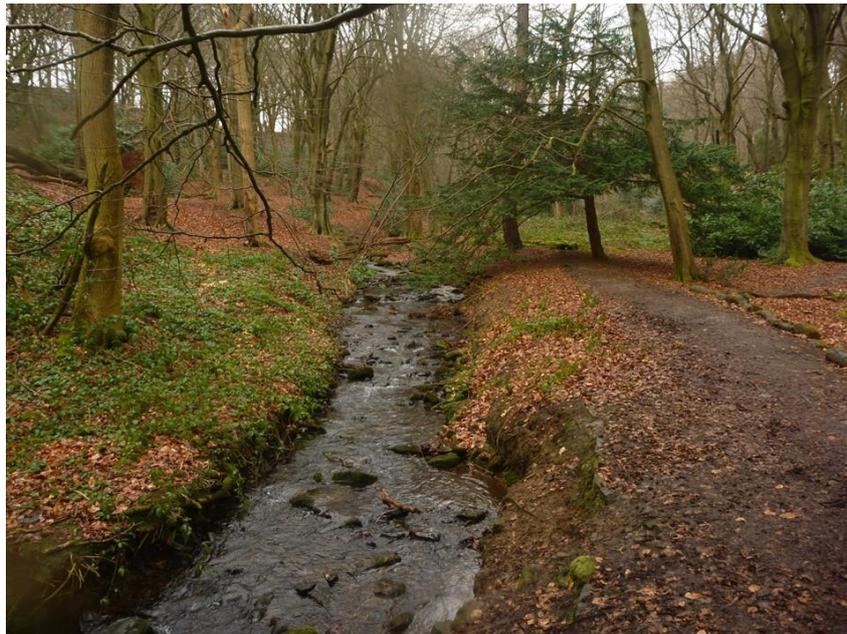
Away from the influence of artificial impounding structures (weirs), some nice stream features were noted. These included free-flowing sections with a good variation in cross-sectional depth (Fig.9) as well as examples of vital inputs of large woody debris (LWD; Figs. 10 and 11).

**Figure 9: Channel with more natural dimensions and cross-sectional depth variation**

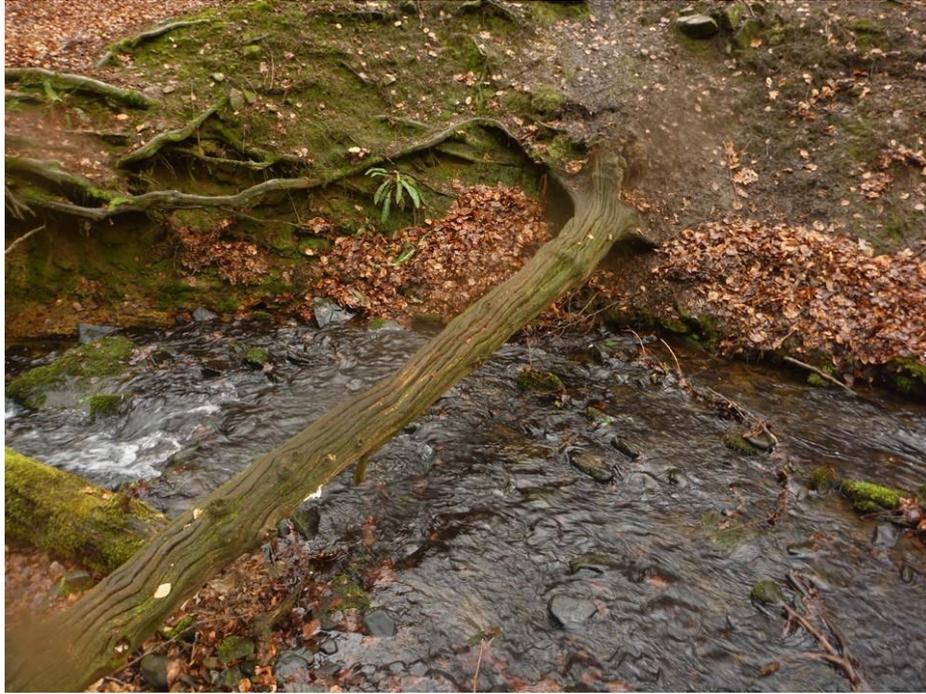
The input and retention (i.e. lack of removal as part of stream management practices) of LWD are absolutely vital factors in the generation of healthy streams. As well as the increased cover from predation that such debris produces, there are a host of physical processes that LWD drives in streams:

**Figure 10: Part of a natural LWD input at SE 21098 08177. Under high flows this may provide some substrate-sorting via undershot scour. However, more benefits will be realised as the trunk degrades and sags into the stream directly.**

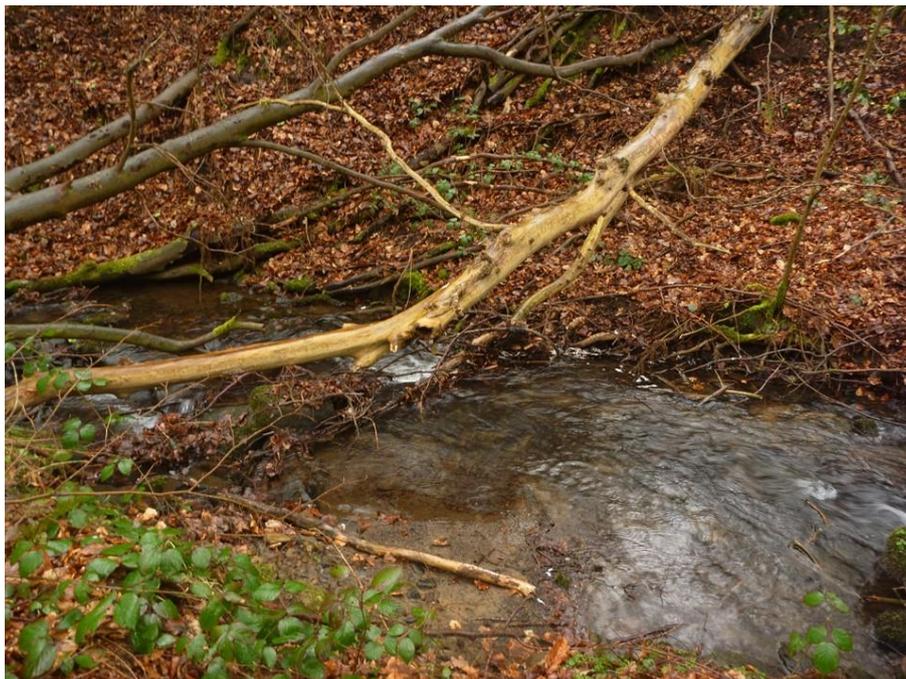
**Figure 11: The leaf litter retention and increased structural benefits of partially-submerged LWD are readily evident in this photo at SE21051 08184**

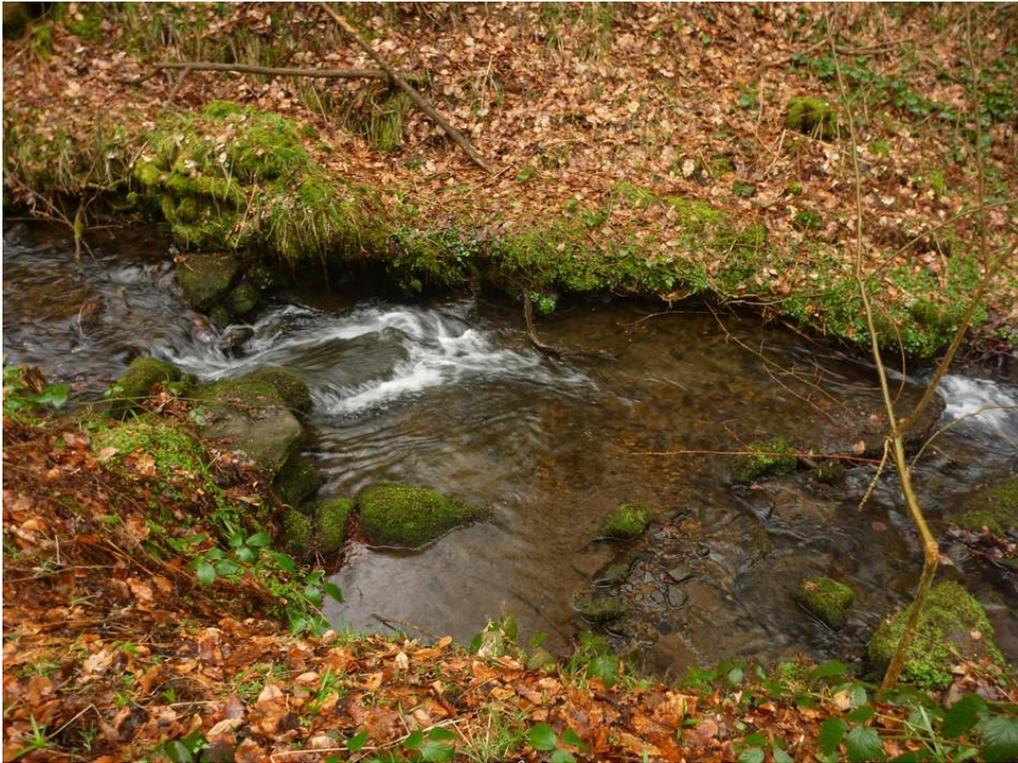
The natural plunge-pool sequences that form in some sections of the river could provide habitat for larger juvenile fish as well as the occasional deposit of potential spawning substrate (Fig. 12).

**Figure 12: Part of a plunge pool sequence in which many pools had a small gravel deposit at their outflowing ends**

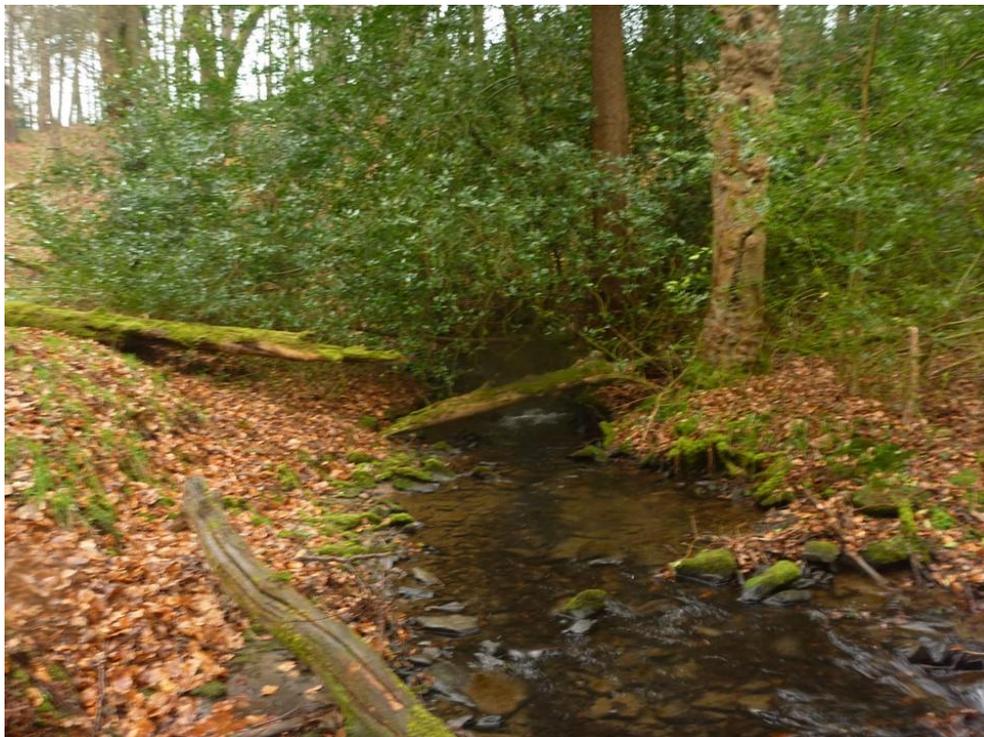
Due to the shallow nature of the stream (and generally dark/solar-absorbant riverbed), in the absence of trees it would be extremely vulnerable to high summer temperatures. The presence of one or two short sections of near complete shade are, consequently, a good thing from this perspective (e.g. Fig. 13).

**Figure 13: Short section of dense shade at SE 20787 08141 providing a refuge for cold water specialist species during hot weather**

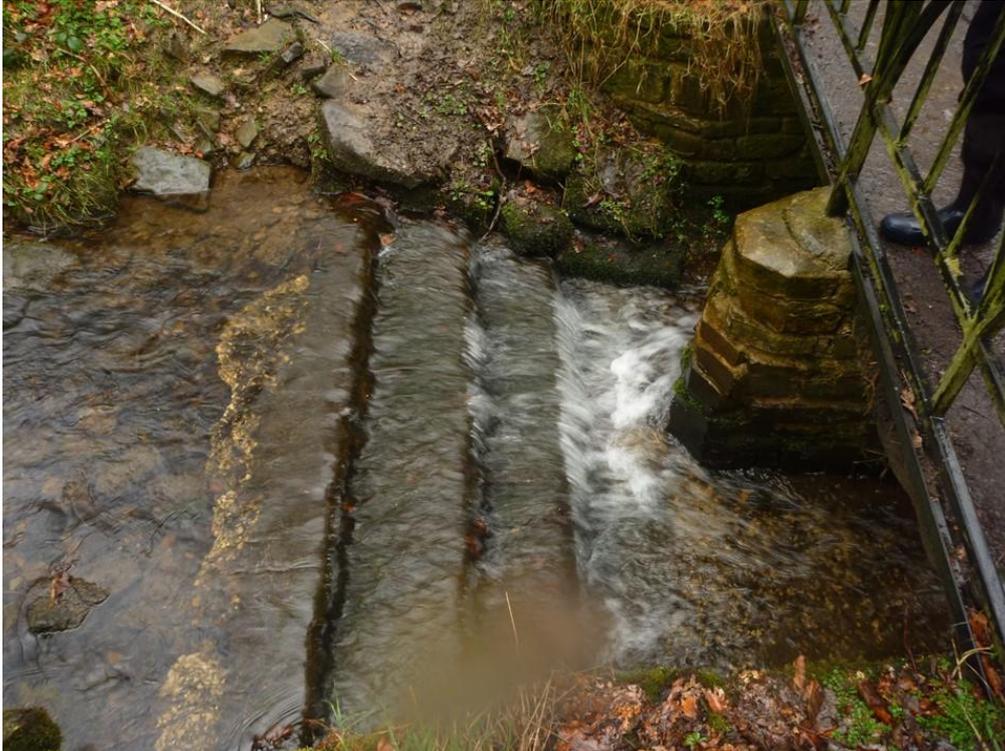
A barrier to migration was noted at the footbridge crossing at SE 20607 08024 (Fig. 14) in the form of a low, stepped weir upstream of the bridge footings.

**Figure 14:** Although (individually) relatively small in height - each of these vertical steps is separated by extremely shallow water on the horizontal surfaces. This provides no opportunity for fish to progress up this obstacle

For the step weir just above the footbridge at SE 20607 08024, there will certainly be additional considerations for relevant permissions to place suitable notches (Fig. 21) and construct simple "pre-barrage" structures (Fig. 22) to ease fish passage over this barrier. Some introductory guidance on seeking permissions (also relevant to buffer strip fencing) is given in the following short video:

As an interim or possible alternative (and very simple) measure – wooden boards could be attached to the downstream faces of each step in the weir (Fig. 23). Leaving gaps as shown in the diagram will create a stepped series of pools with reasonable access for fish into each. Simply drilling into the face of each step and inserting appropriate gauge rawl plugs would allow each board to be fixed in place.

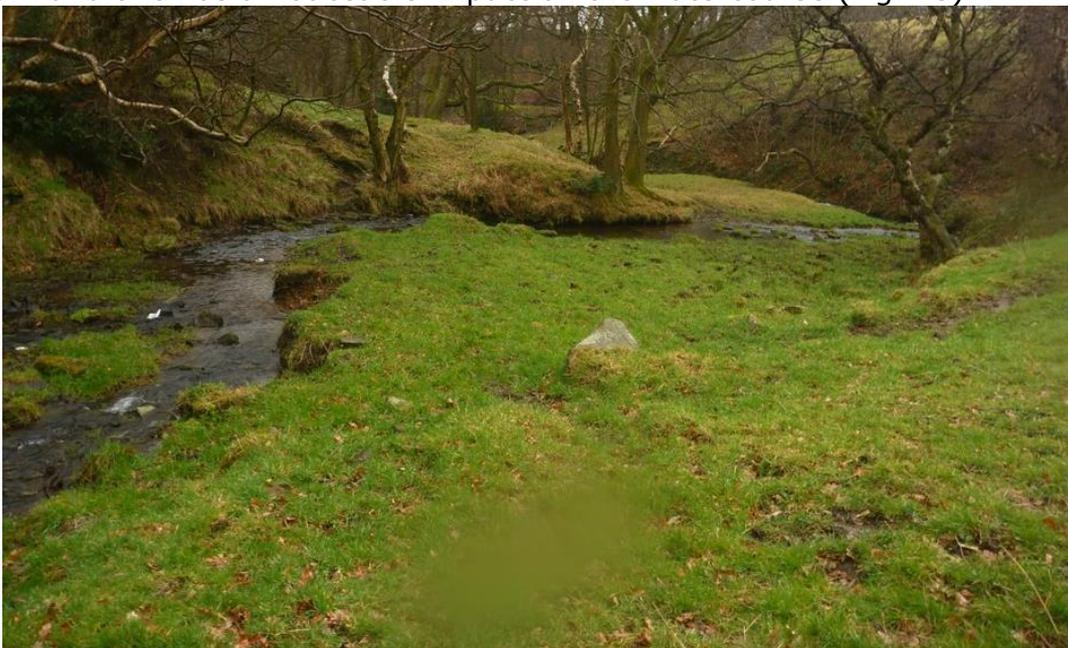
From the lower limit visited up to SE 20483 07997, the stream benefits from the varied riparian woodland that is cared for by the Upper Dearne Woodlands Group. However, at SE20483 07997, there is grazing access right down to the stream and this has a noticeable impact on the watercourse (Fig. 15).

**Figure 15:** Grazing access causing accelerated bank erosion.

The compaction of the ground and lack of penetrating, deep root systems that result from grazing result in increased over-land flood water (and potential pollutant) inputs. Long sections of riparian grazing prevents deep root systems

Additionally, to mitigate the water quality and flash-flood impacts of grazing/pasture compaction, it is recommended that a grazing exclusion buffer strip is established on both banks of the river upstream of the woodland section (pending appropriate approval from relevant land owners and regulatory authorities). If possible, this riparian buffer zone would be at least 5-m wide on both sides of the stream (top-hung “water gates”, Figs. 19 and 20, can be used to maintain a crossing point as necessary to preserve access). Buffer strips of less than 5m could still provide some worthwhile benefits, as long as the fence was set back sufficiently to avoid damage/loss during spate flows.

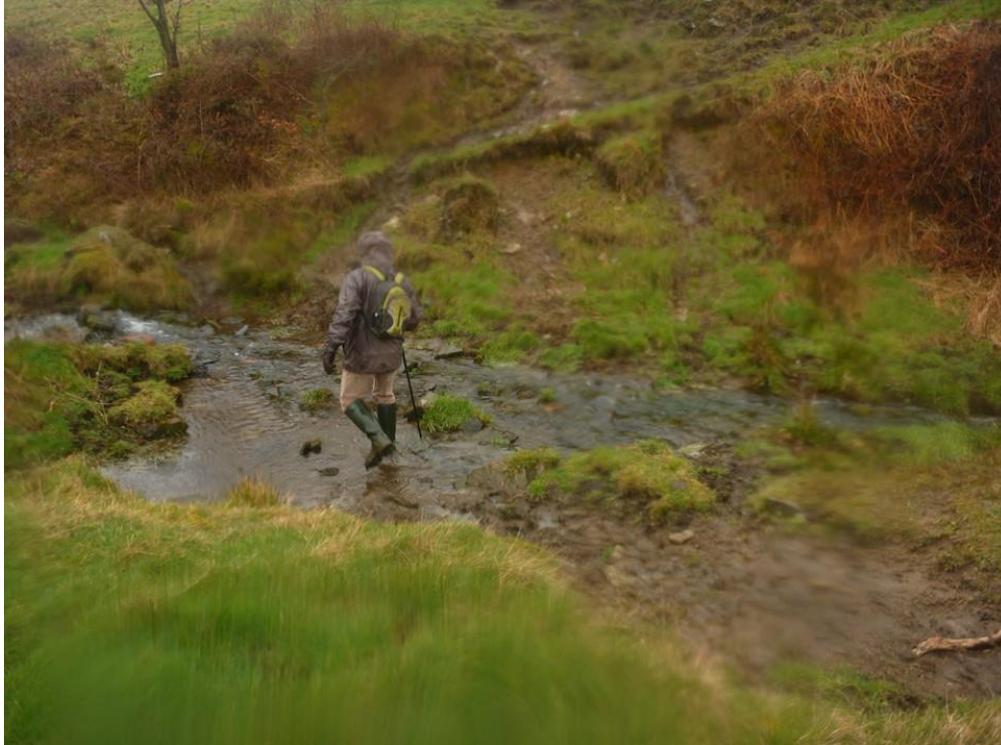
from developing and binding the bank together. This tends to make the river uniformly wide and shallow – constraining the diversity of flora and fauna that can live in those conditions. The combination of increased surface-water runoff ([https://youtu.be/00tcTY\\_UEk4](https://youtu.be/00tcTY_UEk4)), “poaching” of banks by livestock footfall combined with siting of access tracks (Fig. 16) and the associated sediment input pathways all have negative impacts on the stream.

**Figure 16: Grazing combined with the breakdown of the bank (poaching) by livestock in combination with the hard surface of the access track making a runoff pathway into the river causes water quality issues to this section of the Upper Dearne at SE 20335 07978.**

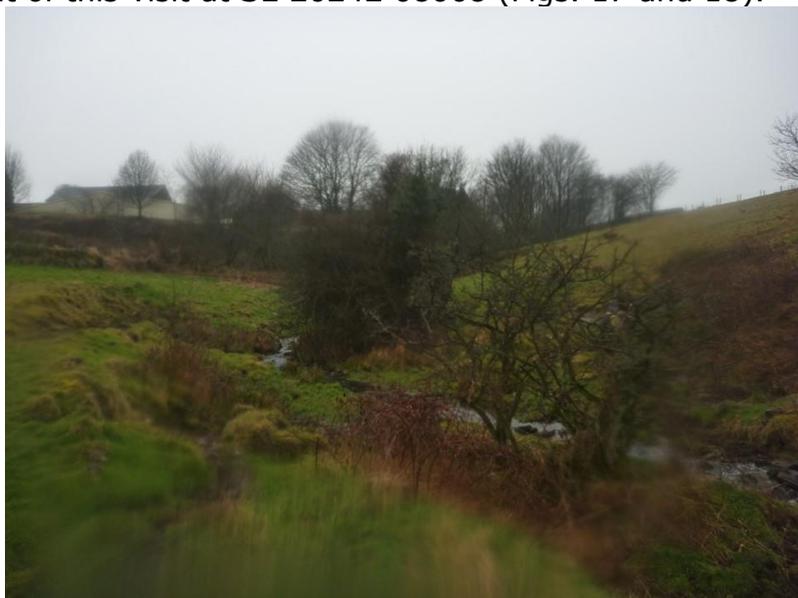
Those negative effects on water quality (via sediment and nutrient runoff in surface water) are apparently acting on the whole reach all the way to the upstream limit of this visit at SE 20242 08008 (Figs. 17 and 18).

**Figure 17: Photograph facing upstream on RHB from the same point that the photograph in Fig. 16 was taken**

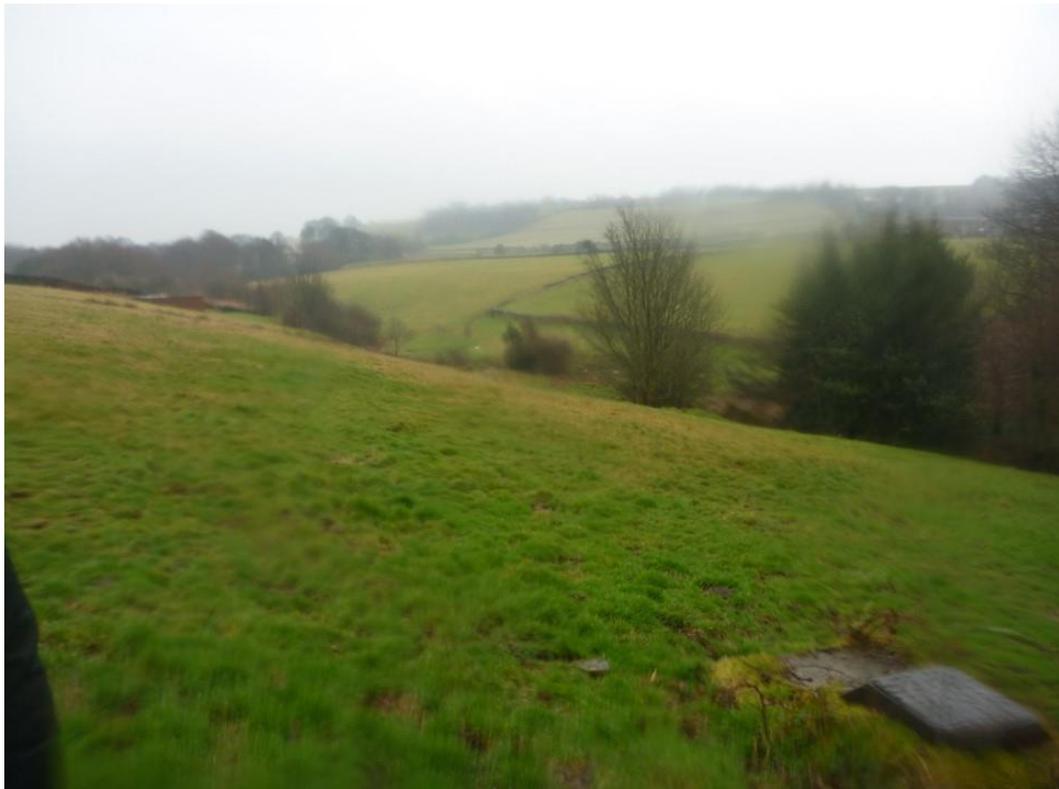
Figure 18: Steep, grazed slopes with little to intercept overland runoff of water, nutrients and sediment into the stream at the bottom of the valley

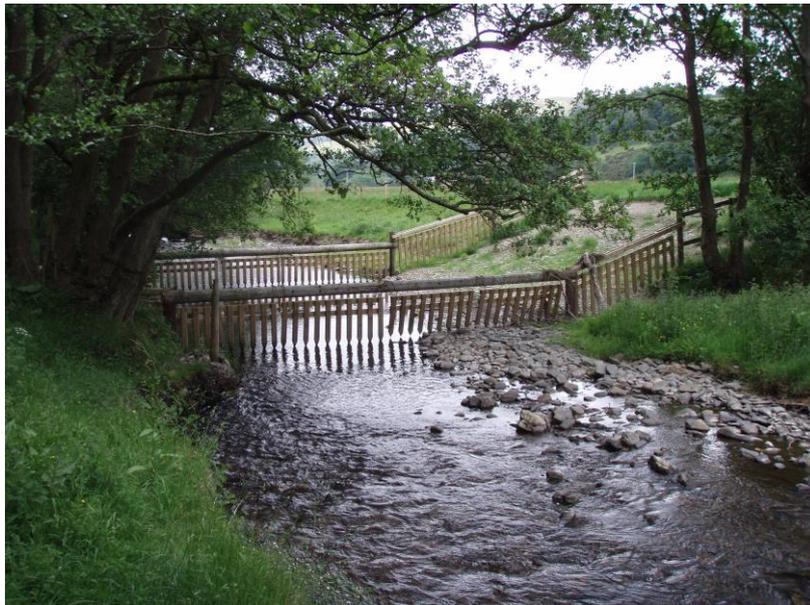
Figure 19: Cattle drink and crossing point using traditional fencing panels

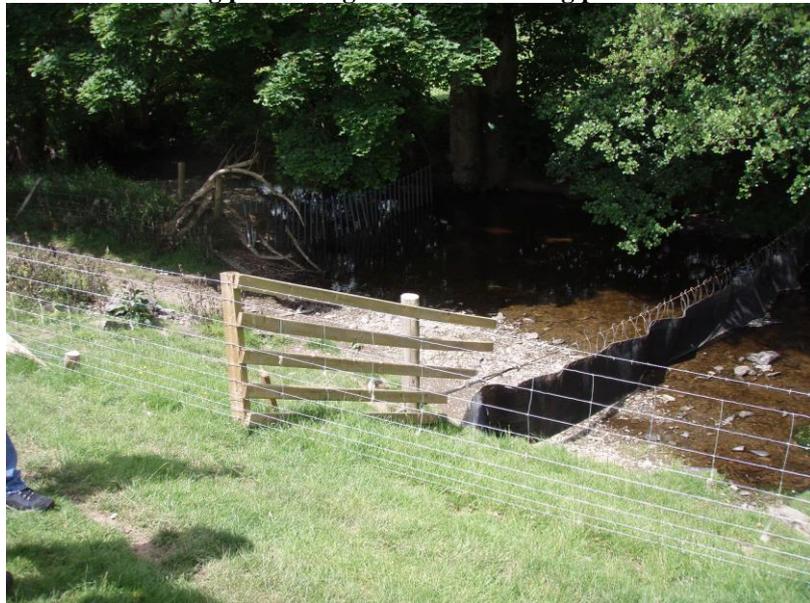
Figure 20: Top-hung gate using heavy rubber curtain material as an adaptation to local conditions, available materials and local livestock requirements

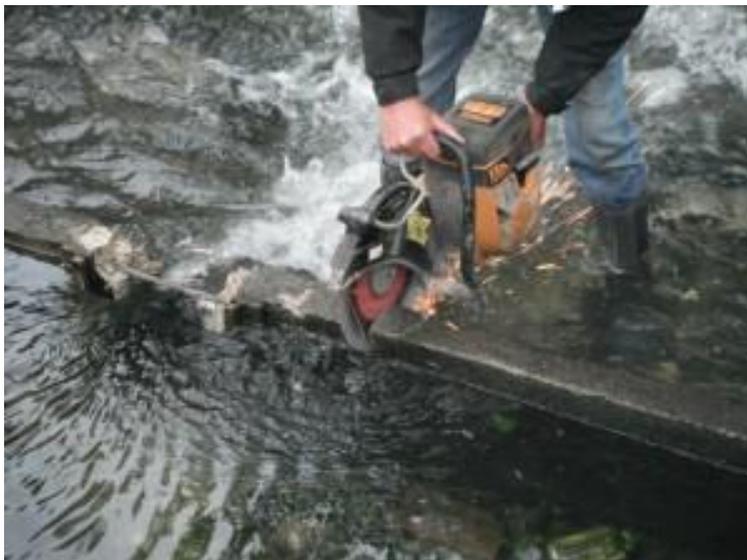
**Figure 21: Notching a low concrete weir step**

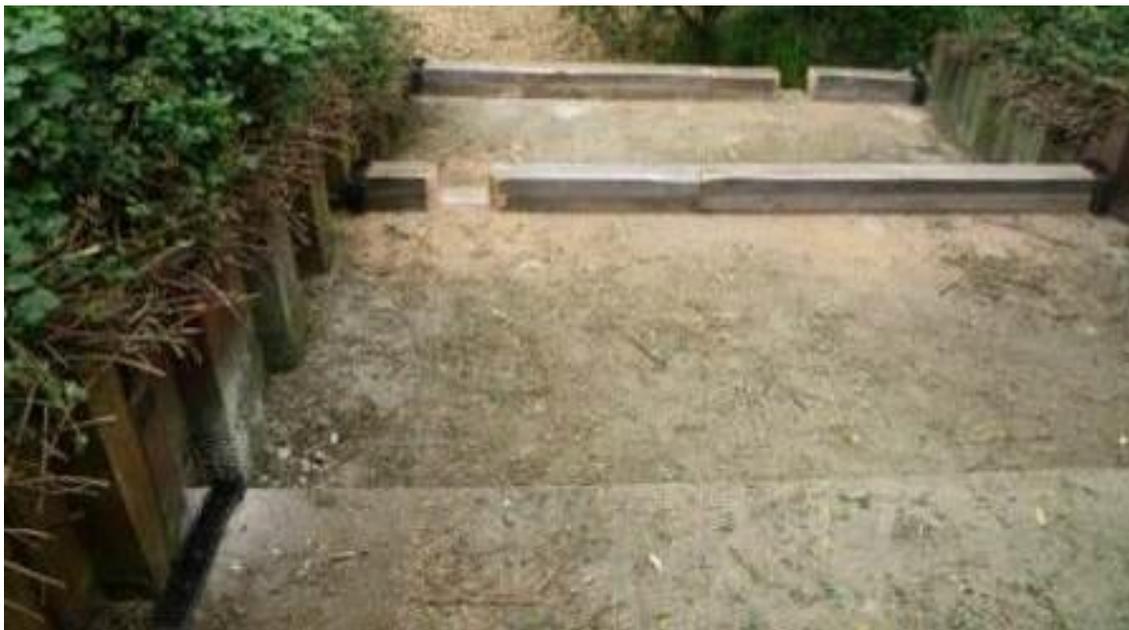
**Figure 22: Simple pre-barrage (shown dry) that holds enough water back to produce resting pools and breaks down a barrier into several smaller jumps**

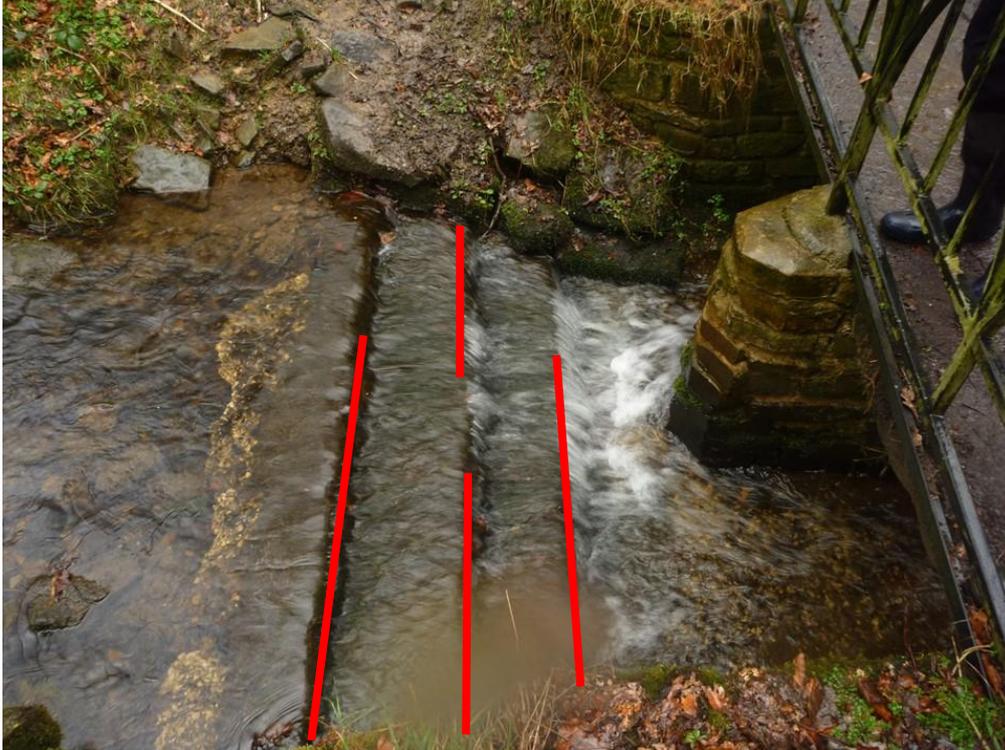
**Figure 23: Schematic with red lines indicating positions of wooden boards that could be used to raise the level of water between each step. This may also need to be augmented by an increased water level beneath the bridge (perhaps via bolting sleepers to the stream bed just downstream of the bridge)**
