**Advisory Visit for Tanfield Angling Club  
River Ure - West Tanfield**

**Date 09/01/2012**

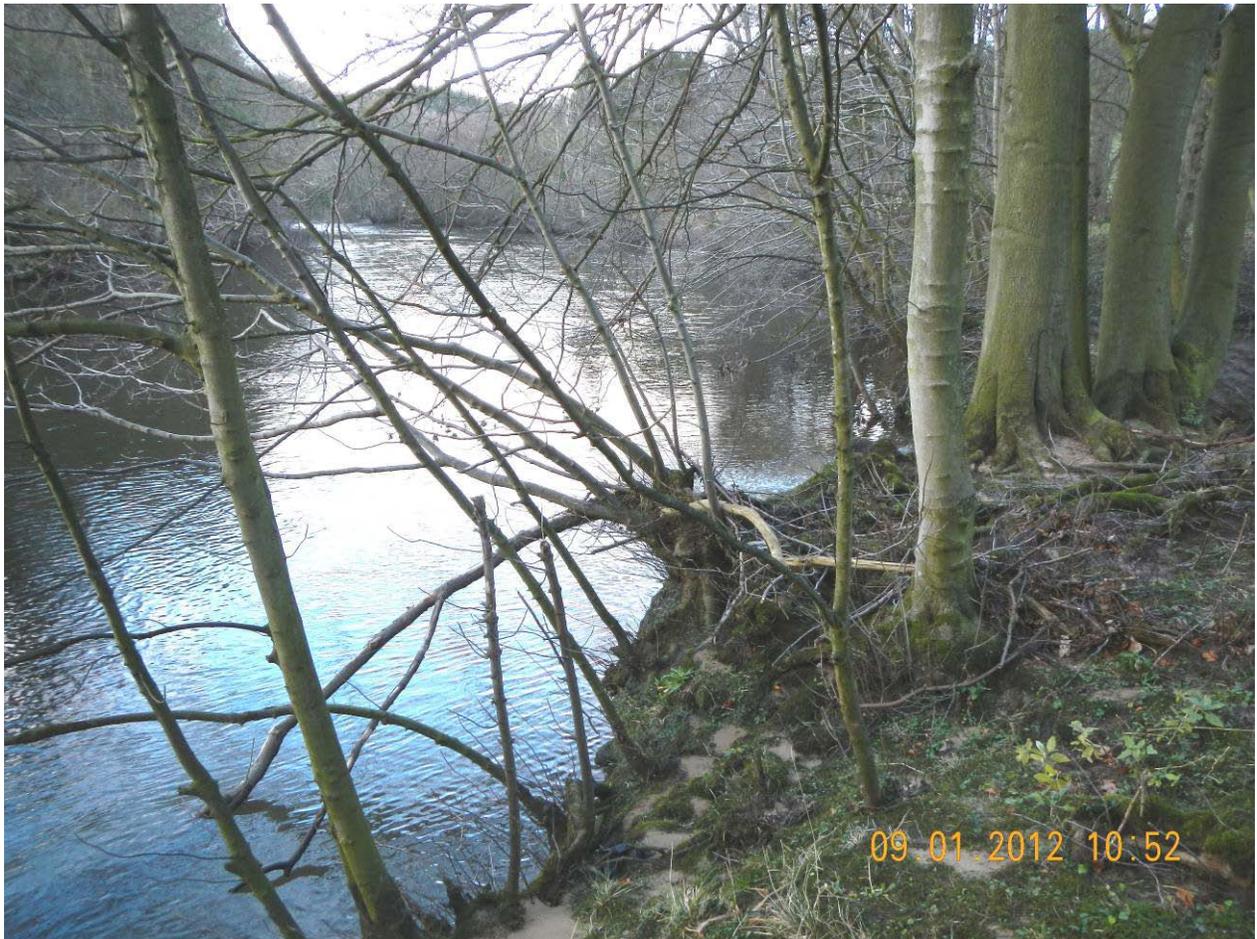
The river was walked from the top boundary progressing downstream. The first point of note was the healthy array of aerial cover along the river margins, which the adjacent woodland provided (Picture 1).

Picture 1. Good marginal tree growth that will provide shade and bank stability (SE2385477703).

The habitat has been maintained through a minimal management approach on the bankside trees. This is an optimal scenario and is commended, as it allows beneficial cover, shade, and security for trout, increasing the number of fish an area can support. The trees also provide a valuable source of terrestrial insects to the river for the trout and grayling to feed on. Branches trailing into the water complement this, adding small flow diversions and improving fish lies through creation of food lanes where natural prey items accumulate.

Limited coppicing and pollarding may be beneficial in places to increase light penetration to the river bank, and to prolong tree life through re-growth and

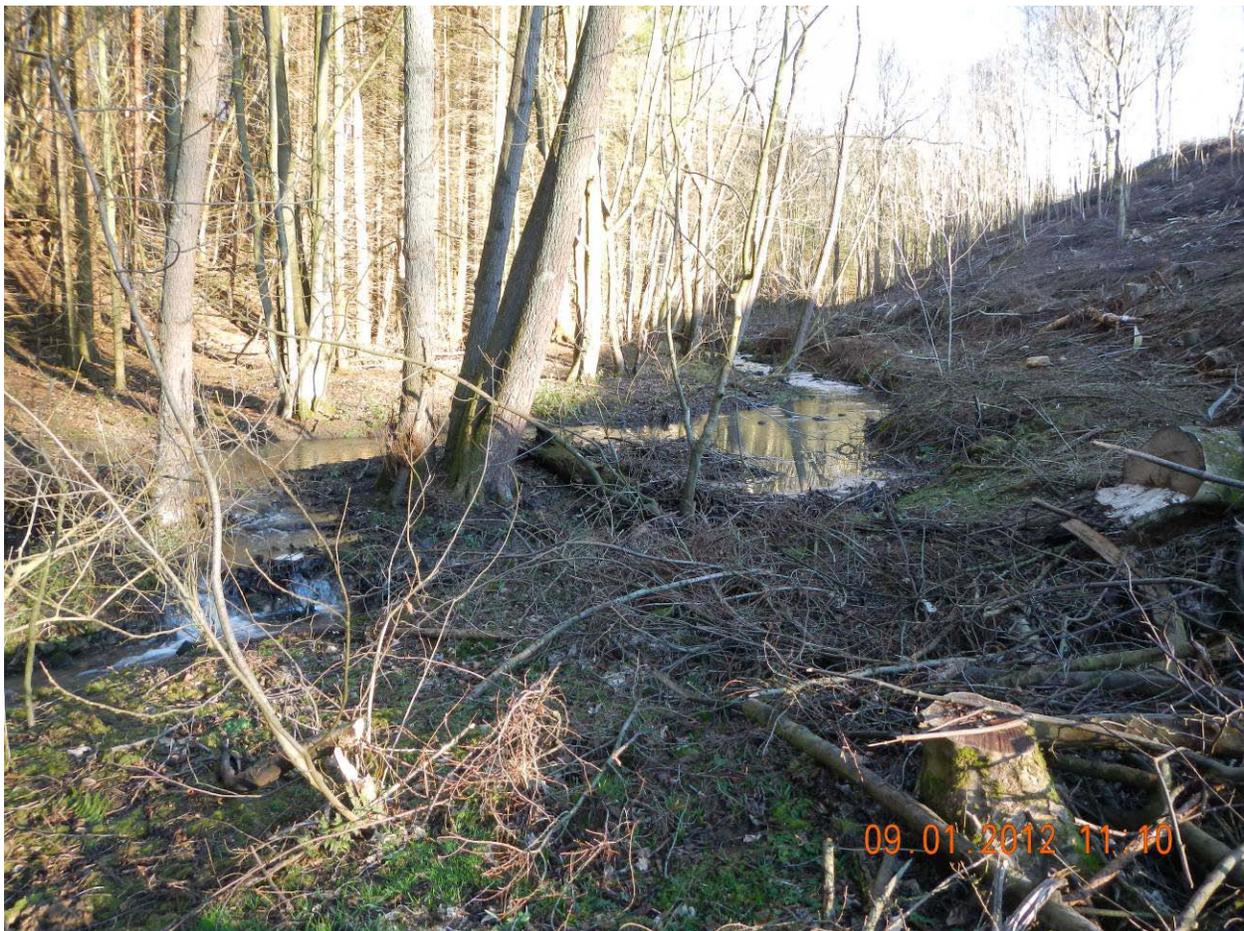
This situation was not the case on Black Robin Beck (SE2386177708), which is a much smaller tributary (0.5-3.5m wide), where heavy shading has restricted productivity. A large area of woodland at the lower end of the Beck (LHB) had recently been sympathetically felled, retaining some of the bank side trees and shrubs, but allowing greater light penetration into the steep sided valley (Picture 2). This should benefit the Beck, as although unlikely to produce aquatic plants due to its character, the banks should now produce better vegetation to bind them together and reduce erosion.

Picture 2. Tree thinning on Black Robin Beck to the right of the picture (SE239047778).

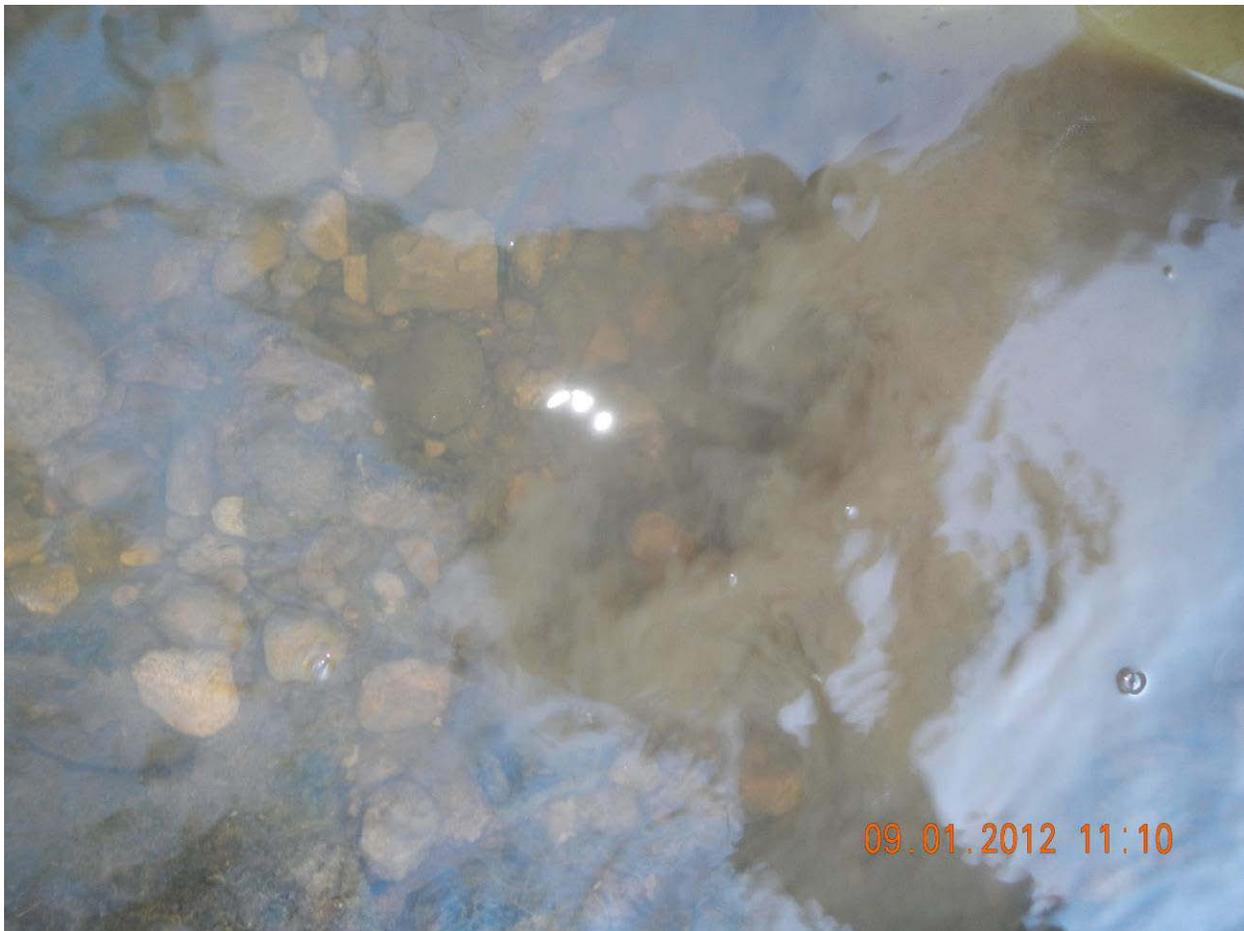
Excessive sediment loading was present on the bed (Picture 3), which limits the potential of the Beck for spawning, but this may be rectifiable. A walkover of the Black Robin Beck should be undertaken to identify any fine sediment sources, as a first step in their control. It may be that the sediment input is resulting from surface run-off associated with a lack of herbaceous vegetation on the Beck's banks as might occur with excessive shading, or perhaps more likely, live stock access to the banks and associated over-grazing.

**Picture 3. Sediment deposition on graves and silt plume mobilised from the bed by wellington boot (SE2388977787).**

the bed. Over-widening of a channel can also exacerbate sediment deposition issues through reduced flow velocity. When investigating the causes of the sedimentation issues it would be worth also trying to identify whether there are factors likely to be increasing the amount of surface run-off entering the Beck, both as a source of sediment and high flow. This could shed some light as to where excess nutrients could be entering the system.

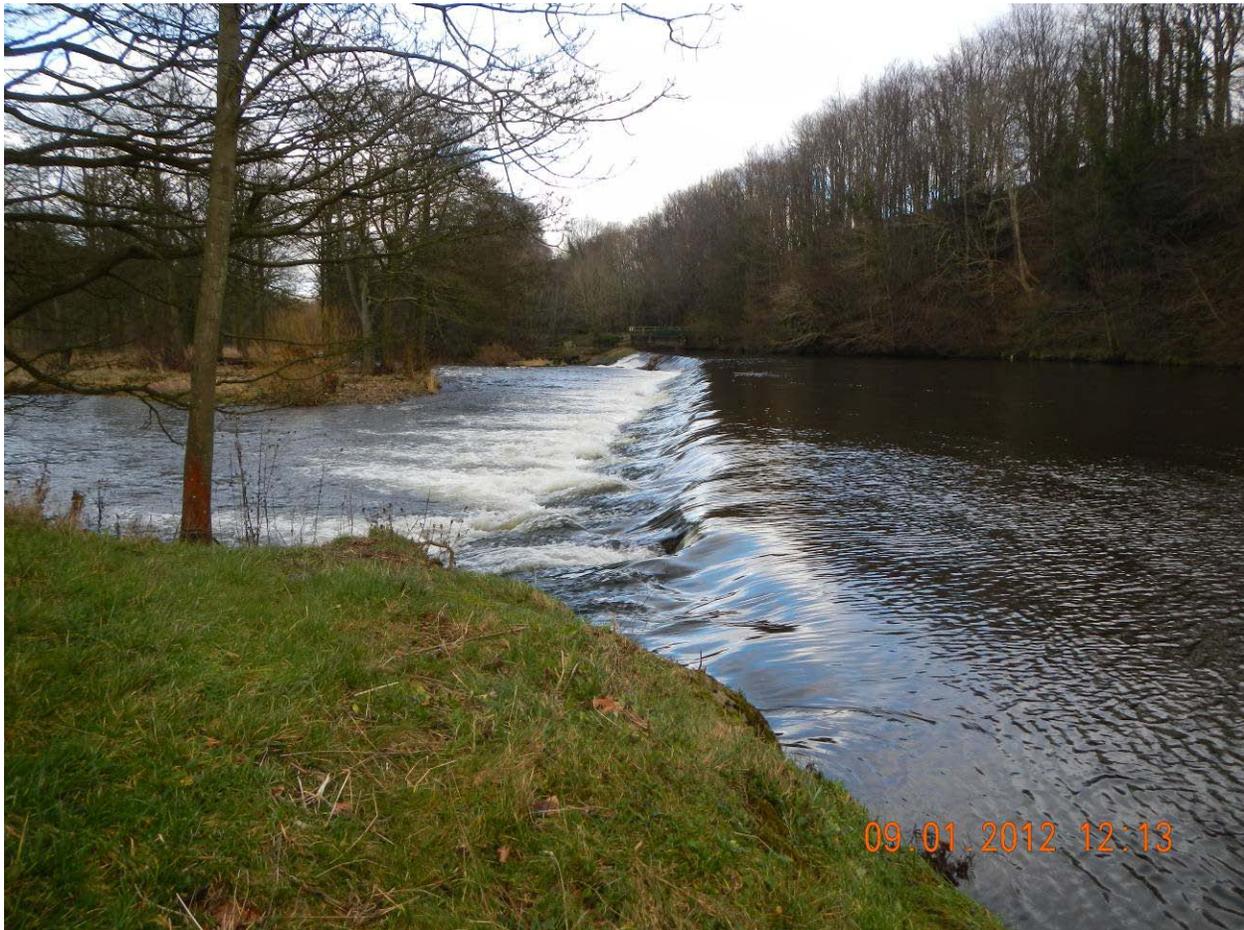
Picture 4. Mickley Weir (SE2503376850).

The weir will retain mobile substrate above, but will provide little benefit as the slower flow of the deeper impounded water will also increase deposition of finer sediments. This reduces the habitat suitability for many of the species native to the area and also renders it unsuitable for spawning. The retention of bed material will also starve the reach immediately downstream. In an ideal scenario the weir would be removed but as the weir supports a hydropower installation its removal is not possible.

The weir also poses a significant obstacle to fish passage and is likely to be difficult for trout, and impassable to grayling at most flows. Larger migratory salmonids will pass it at higher flows, with some difficulty, but it will pose a significant behavioural barrier that is only passable in certain flows. A barrier of this size will undoubtedly be on the EA's prioritised list for fish passage

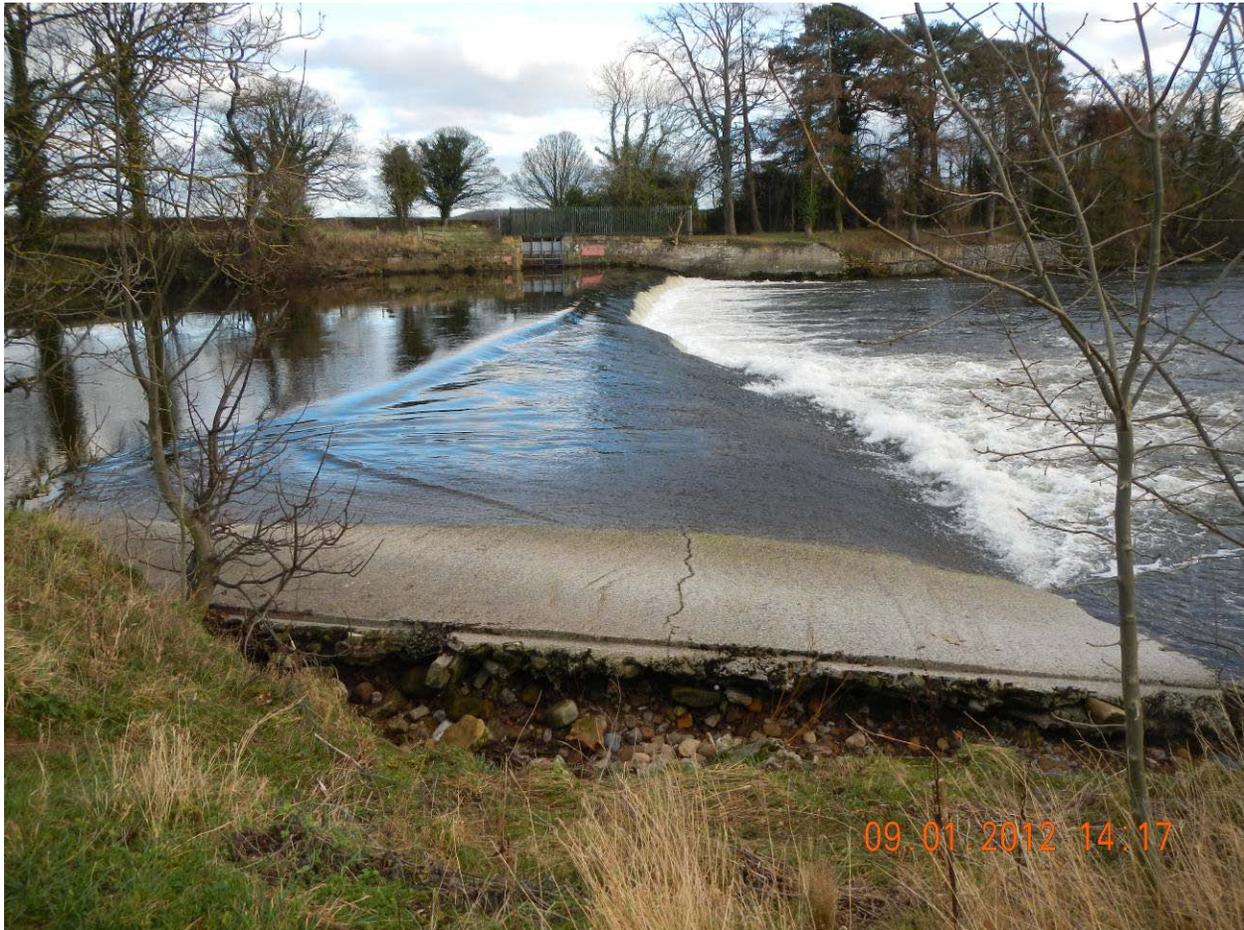
One of the other obstructions is Tanfield Weir, downstream of Tanfield Bridge (Picture 5). This poses an even greater barrier to fish migration, but again supplies hydropower and also provides bank stability to houses upstream, so unfortunately cannot be removed. The weir is high on the EA's regional prioritisation list for fish passage improvement and so should hopefully be altered within the next few years as funding becomes available.

Picture 5. Tanfield Weir (SE2751678741).

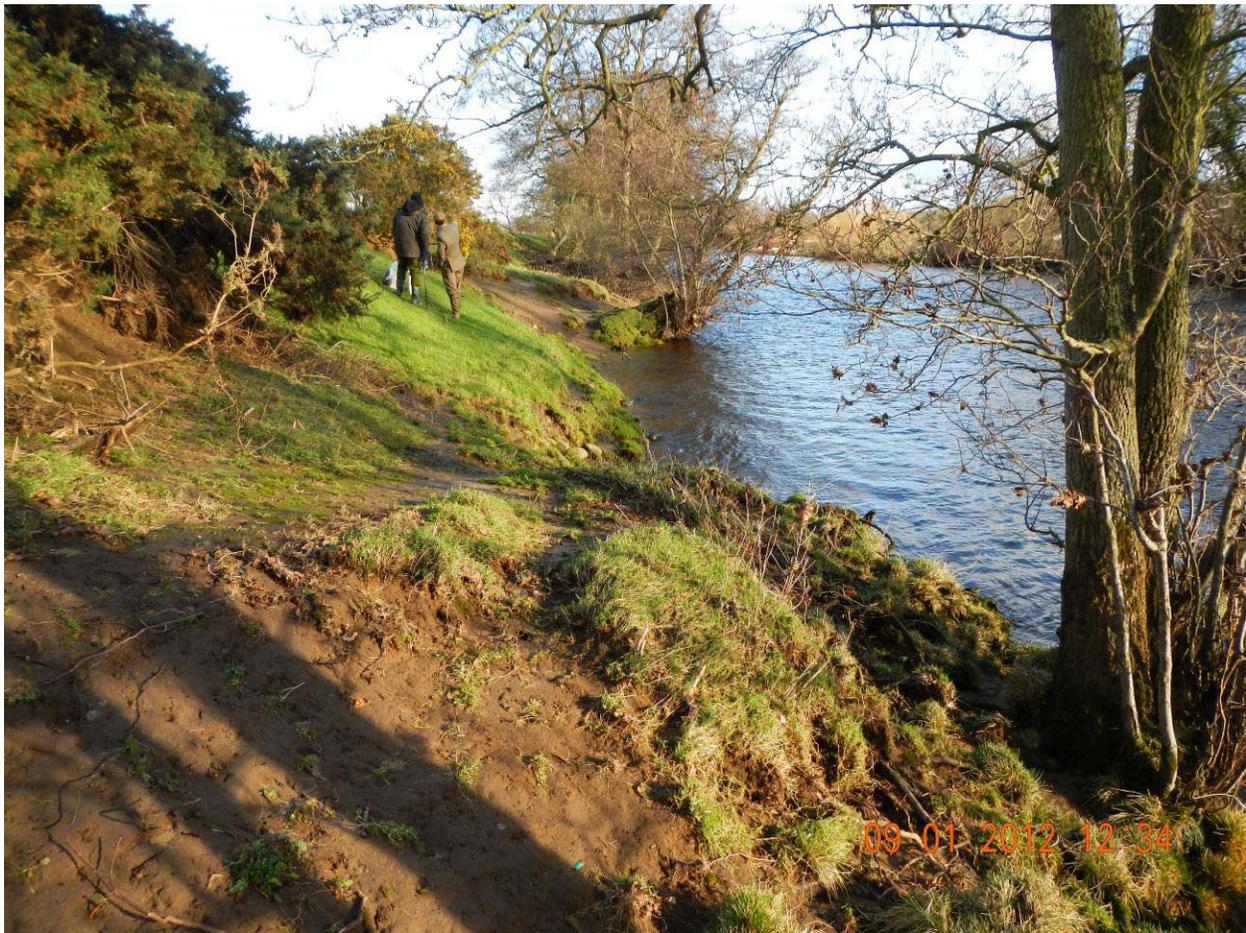
River bank stability was good overall as a healthy array of marginal vegetation, or trees (in the wooded areas) was present in most areas. These bind the soil together with their root network and reduce the velocity of flow hitting the bank, reducing erosion. The notable exceptions to this were the areas in which livestock had access to the river bank (Pictures 6 and 7). In these areas it was immediately apparent that grazing and trampling had led to increased bank erosion in high flows. This in turn will lead to over-

**Picture 6. Erosion caused by over grazing of the riverbank, leading to loss of land and increased sediment input to the river (SE2577377247).**

widening of the channel and increased sediment input to the river. The problem should be addressed by greatly reduced grazing pressure on fields adjacent to watercourses, or buffer fencing to exclude livestock from the river margin. There are many potential designs for buffer fencing but a possible layout can be seen in appendix 2. Tree kickers or brash could also be employed to direct flows away from the bank.

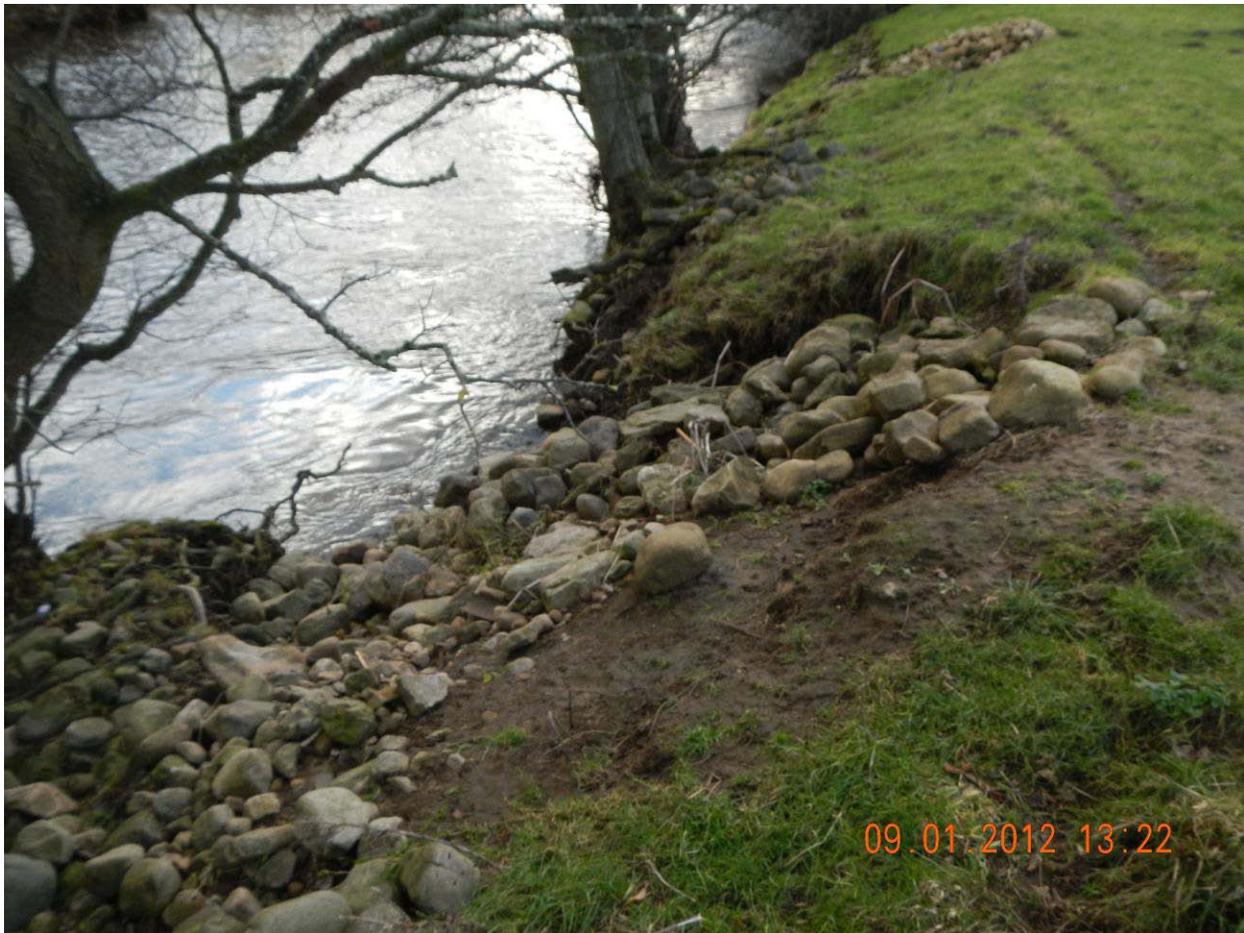
**Picture 7. Erosion problems. Here stone has been placed on the damaged bank but the problem could be prevented by livestock exclusion (SE2669377603).**

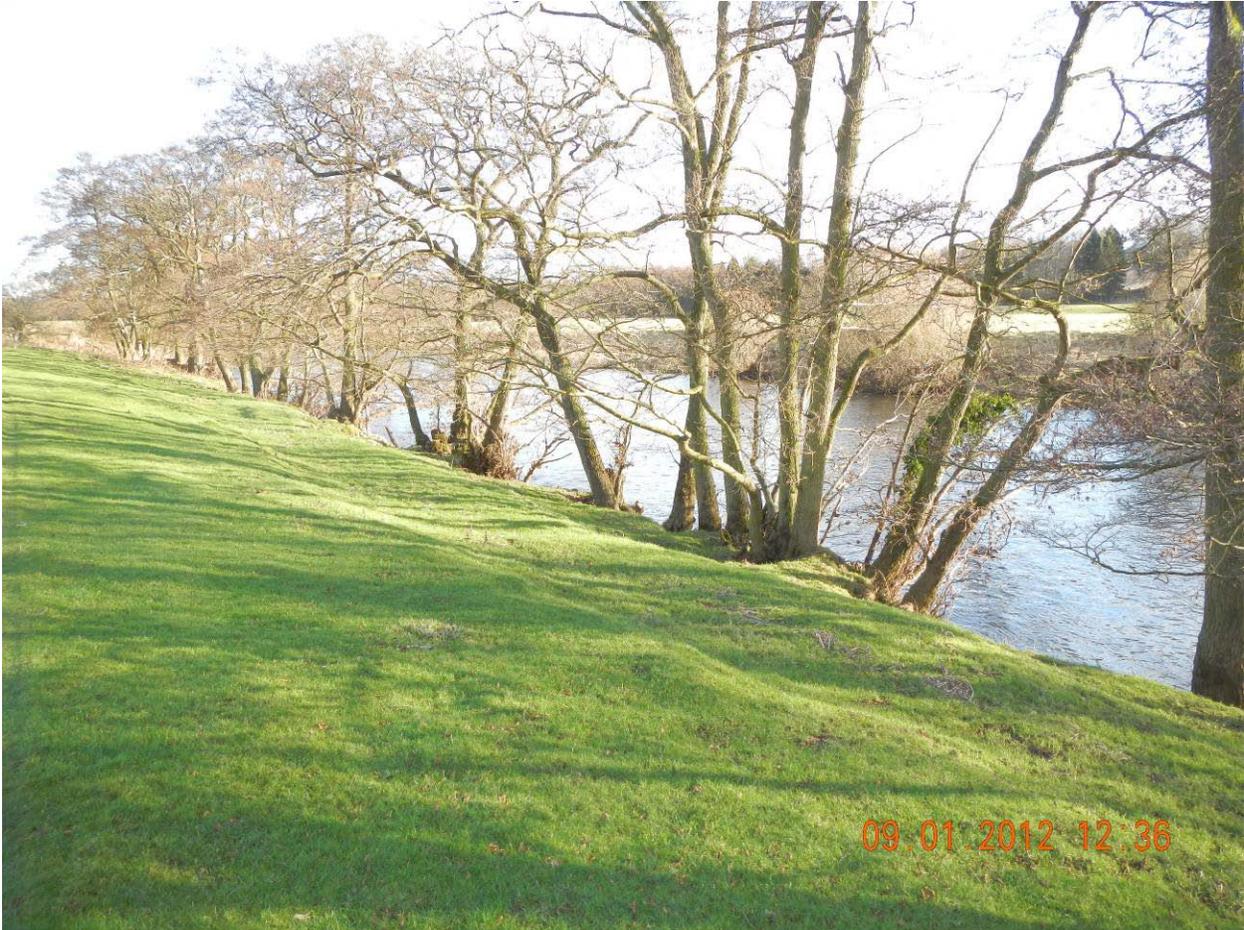
There was a general lack of large woody debris (LWD), observed on the river, but this is probably due to the dynamic river type transporting the material downstream rather than a lack of supply or mismanagement. With this in mind it may be beneficial to increase the retention of such structure by felling a few selected trees into the river and securing them in place with steel cable attached between the trunk and stump. This would be particularly beneficial in areas where there is a monoculture of mature alder trees along the bank as seen in picture 8. Here the multiple trunks and close set trees mean that the work will result in minimal impact on the overall tree canopy.

**Picture 8. Suitable area for selective tree felling into the channel to increase LWD. Buffer fencing would also be beneficial (SE258777298).**

Creation/increasing Large Woody Debris	<ul style="list-style-type: none"> <li>• Regular locations along the river</li> <li>• Old Wives - SE258777298</li> </ul>	<ul style="list-style-type: none"> <li>• Riverkeeper's time</li> </ul>	David Grffiths
Hinging willow	<ul style="list-style-type: none"> <li>• Regular locations, particularly from Mickley Weir, downstream</li> <li>• Willow below power lines at</li> </ul>	<ul style="list-style-type: none"> <li>• Riverkeeper's time</li> </ul>	David Grffiths

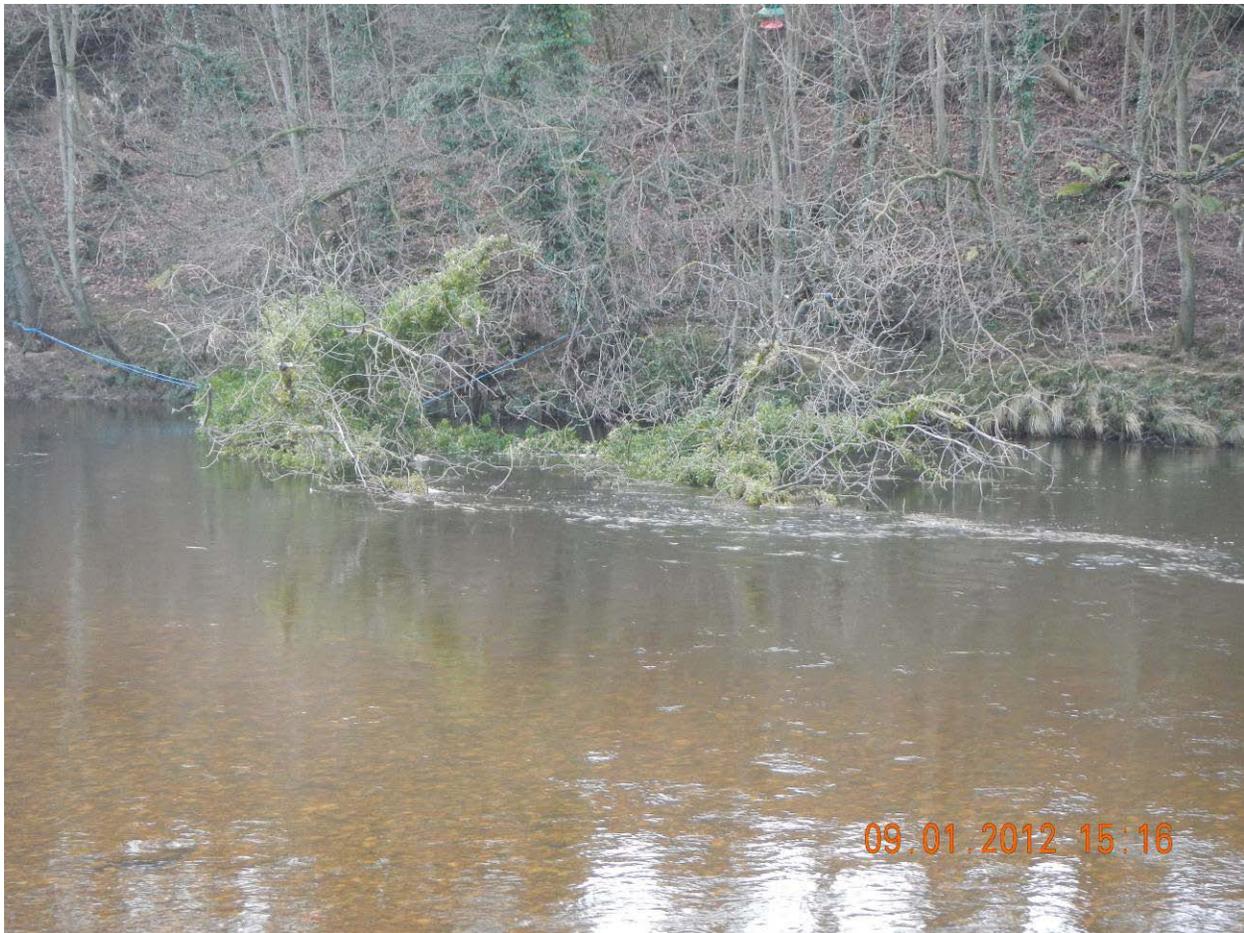
**Picture 9. Tree felled into the river to increase LWD which provides fish cover and flow deflection (SE2631478232).**

In addition to the cover such structures provide, redirection of flow resulting from this kind of work is likely to create new lies and increase scour, producing new pools and more varied habitats. Areas around the structure and associated reduced flow velocities may also provide shelter and protection for smaller juvenile trout that may otherwise struggle to remain within the reach in high flow events. These areas may also provide areas for deposition of smaller gravel suitable for trout and grayling spawning.

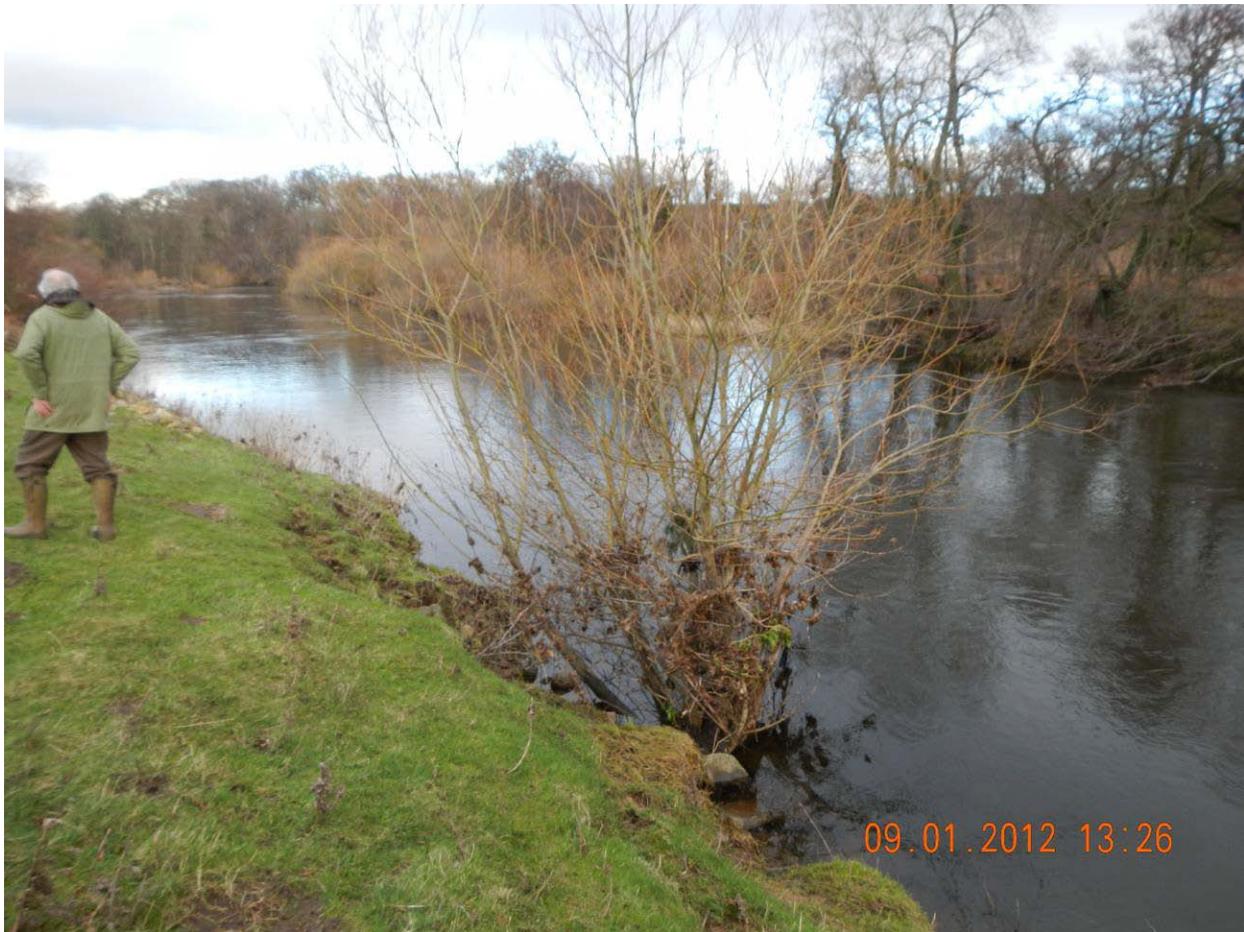
**Picture 9. Willow that would benefit from hinging near Lowside Deep (SE267527720).**

Another method that would complement woody debris is hinging/laying. The stem of smaller more supple trees and shrubs can be partially cut through, allowing them to be laid into the channel in a downstream direction. This should be done at 45° or less to the flow so that high flows are deflected off the branches and excessive amounts of debris does not collect around them. This method is particularly effective with willow, sallow and hawthorn but can also be used on smaller alders and hazel. The method works like laying

This technique would be particularly beneficial for the small willow beneath the electricity cables near Lowside Deep (Picture 9, SE267527720). This would greatly delay the requirement for maintenance to prevent the tree from interfering with the cables.

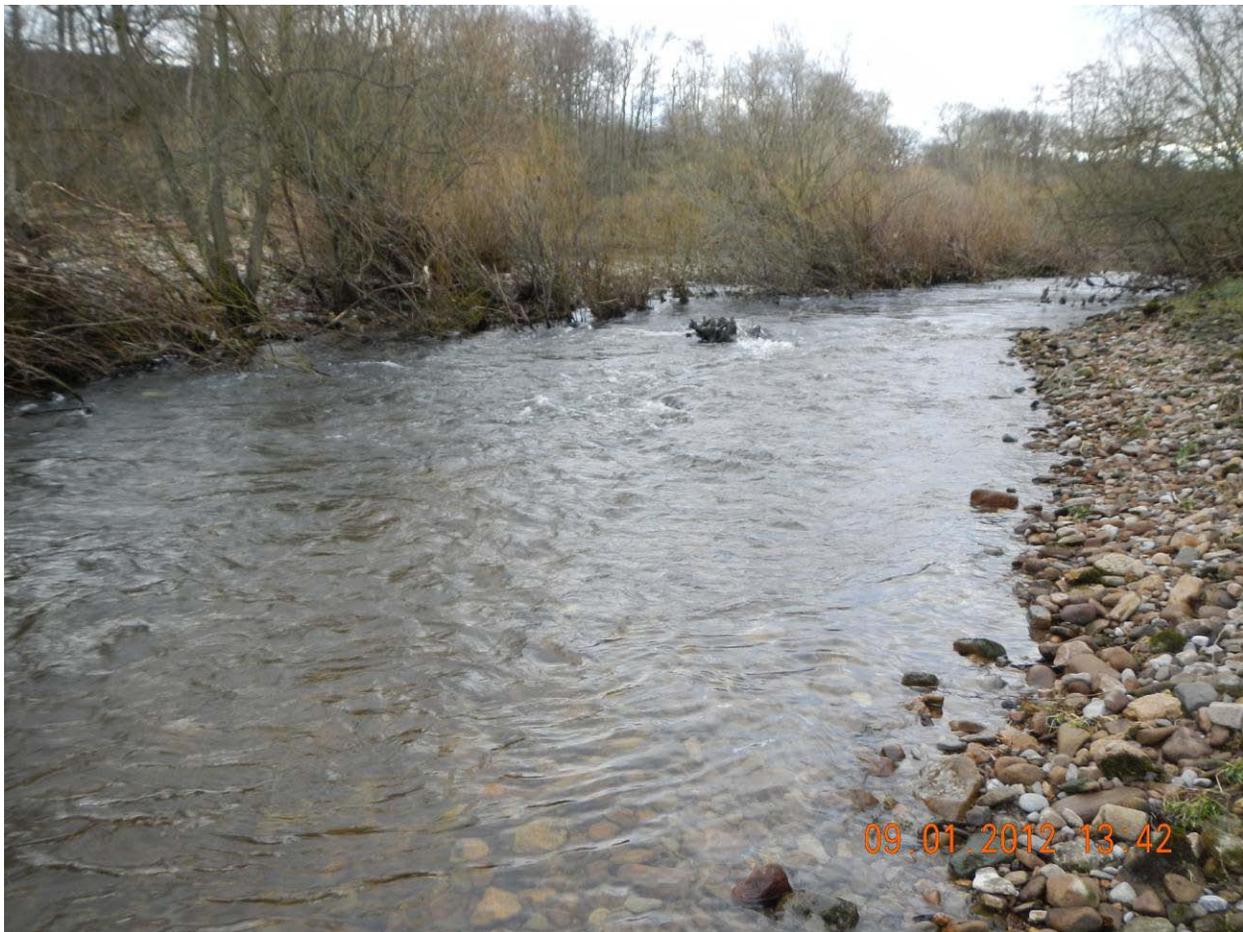
**Picture 10. Area of fast flow in side-channel near Saw Dub, where increased cover and shelter could enhance spawning and juvenile habitat (SE2684877949).**

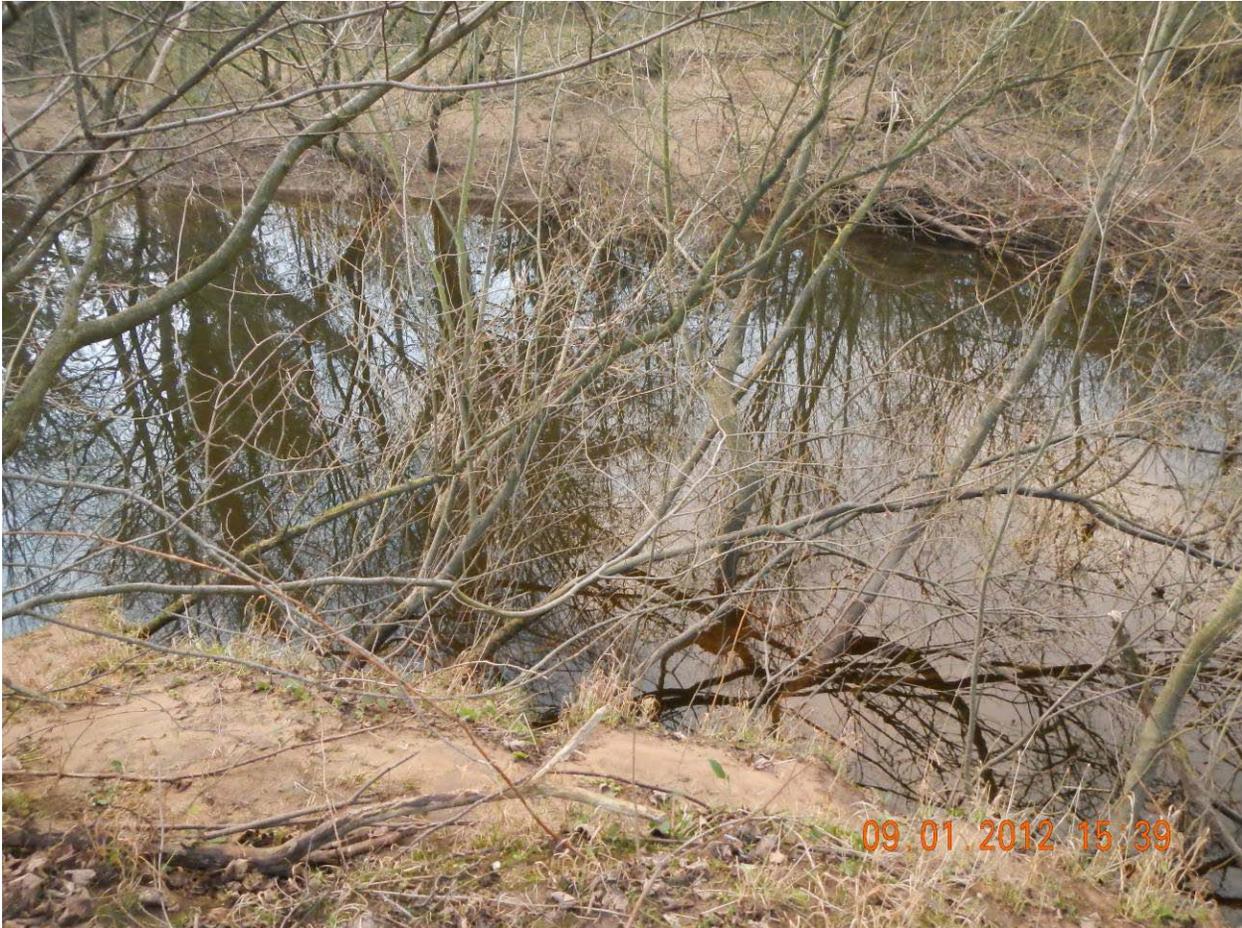
**Picture 11. Backwater to the side of the island near Slee Gill (SE2657178581). Here the flow is slow for parr, but laying some of the bankside trees into the channel would increase cover and protection for them as they drop down from upstream as fry.**

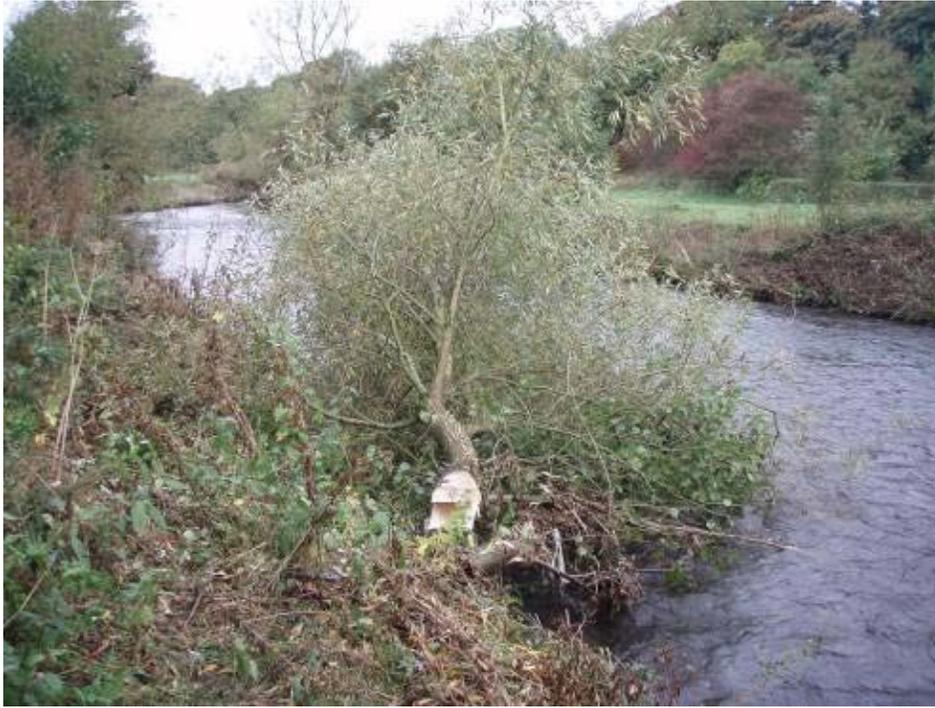
**Picture A. Hinged Willow.**

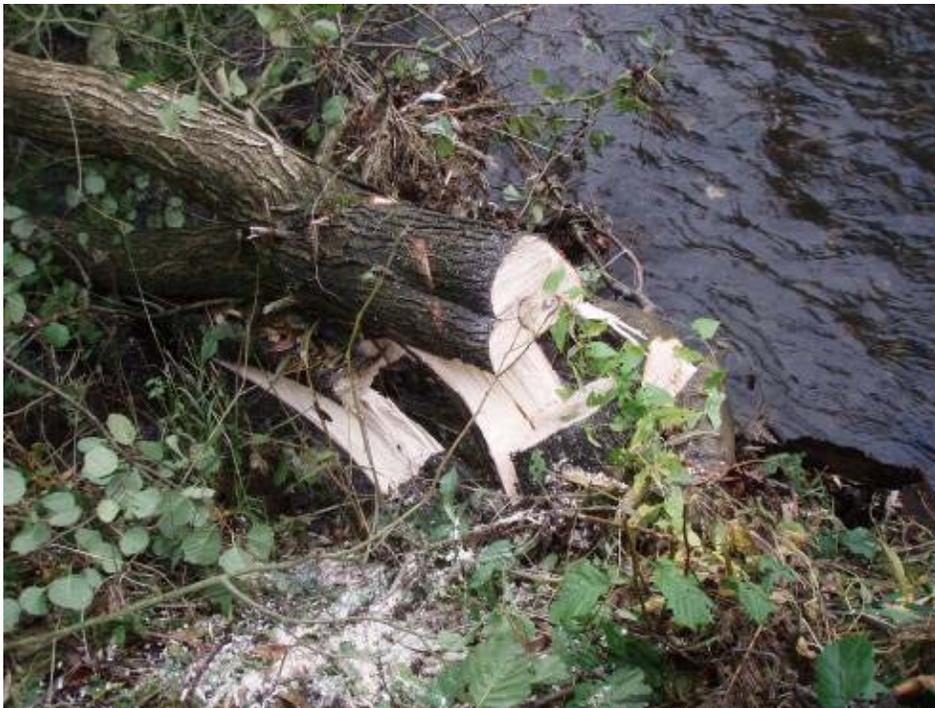
**Picture B. Partial cutting and laying of willow (like hedge laying) is a quick way of creating low cover which is firmly fixed to the stump and bank.**

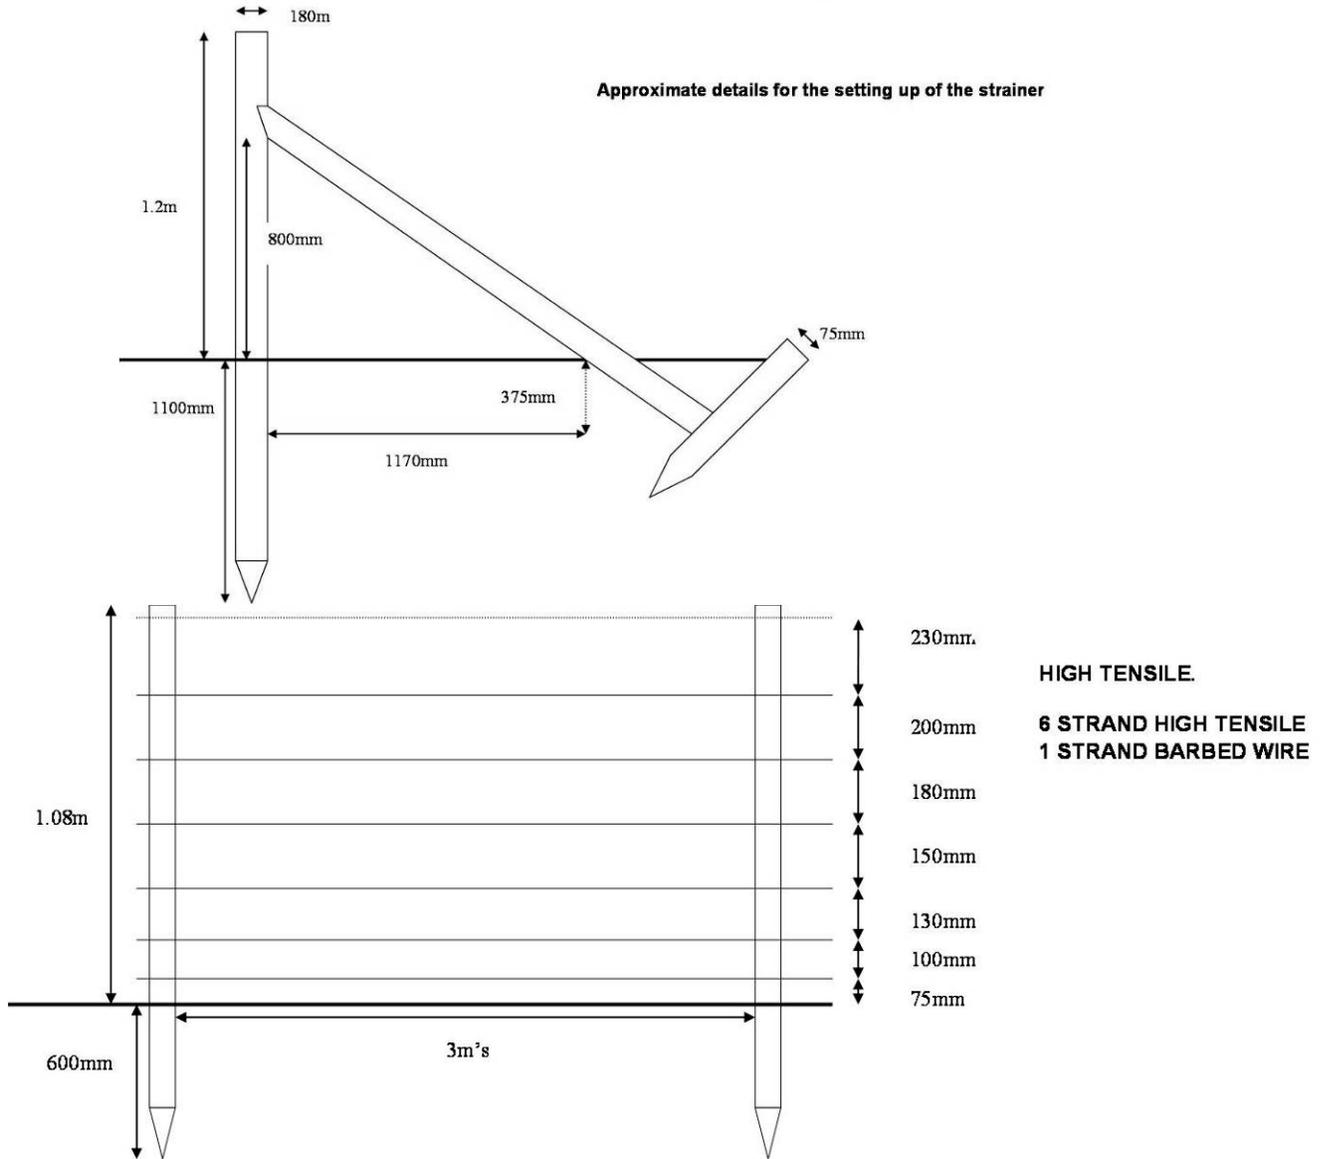
## Appendix 2 Specification for buffer fencing

- Shall not be less than 1.06m high from ground to top wire.
- Wire shall be galvanised (BS4102), 3.15 mm diameter.
- Straining Posts shall be 180mm minimum top diameter x 2.4m's to be driven into the ground.
- Strainers to be set at centres not exceeding 50m's.
- Turning posts shall be 155mm top diameter x 2.1m's. May be pointed and driven to 900mm into the ground.
- Struts shall be 120mm dia x 2.1m long and notched into the straining post at an angle no greater than 45 degrees. Allow two struts for strainer/turner where angle is less than 135 or one bisecting the angle where the internal angle is greater than 135.
- Intermediate post shall be 75 - 100mm dia x 1700mm to be driven to 450mm. To be set at no more than 3 m intervals.
- Galvanised steel radisseurs to be used to tighten strands.

On upland spate rivers it may also be beneficial to install additional straining posts to provide sacrificial sections that can be allowed to wash out in floods, saving the rest of the fence.

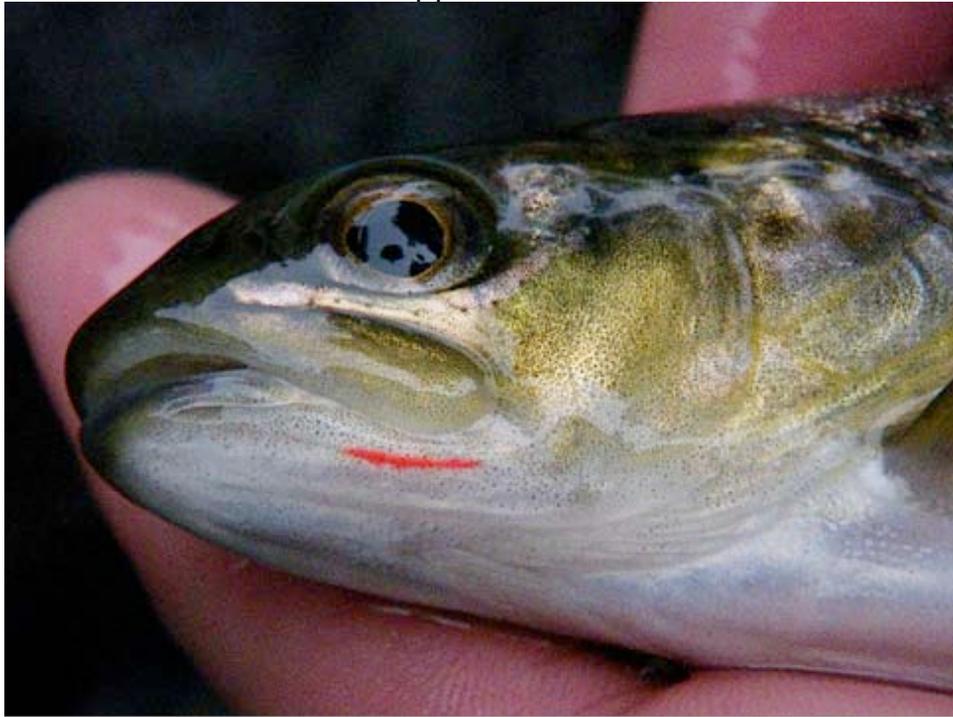
**Picture C. A fish with an orange Visual Implant Elastomer (VIE) mark on lower jaw. This type of mark is injected just beneath the skin.**

There are several methods available for marking fish, including panjet dye (Picture E, appendix 4) and Visual Implant Elastomer (VIE), which are coloured elastomer markers inserted into the fish's skin (Picture C & D appendix 2). Further advice should be available from your local Environment Agency fisheries officers.

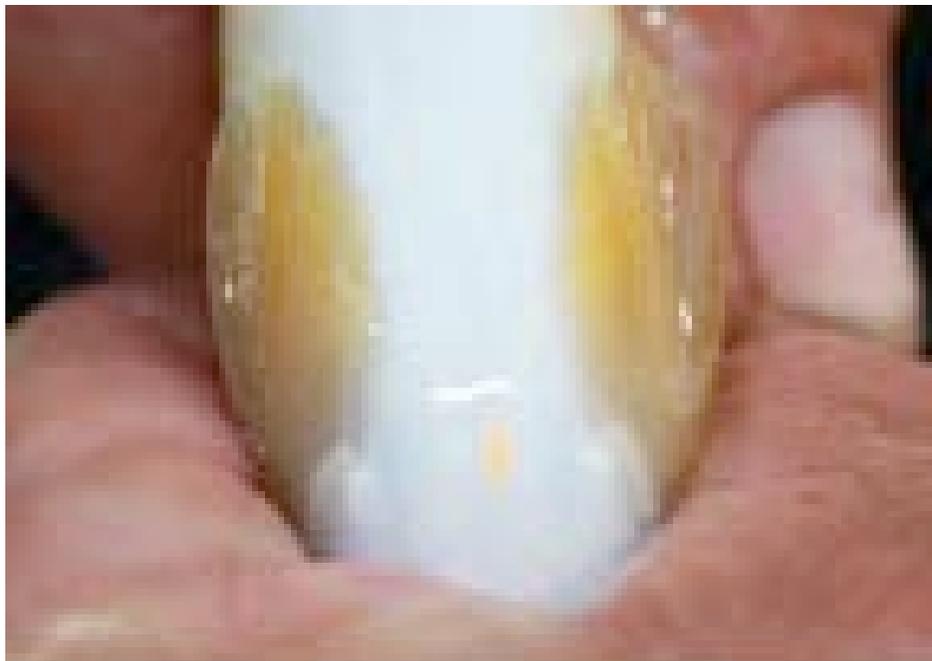
**Picture D. A fish with a pale orange VIE implant on its belly.**

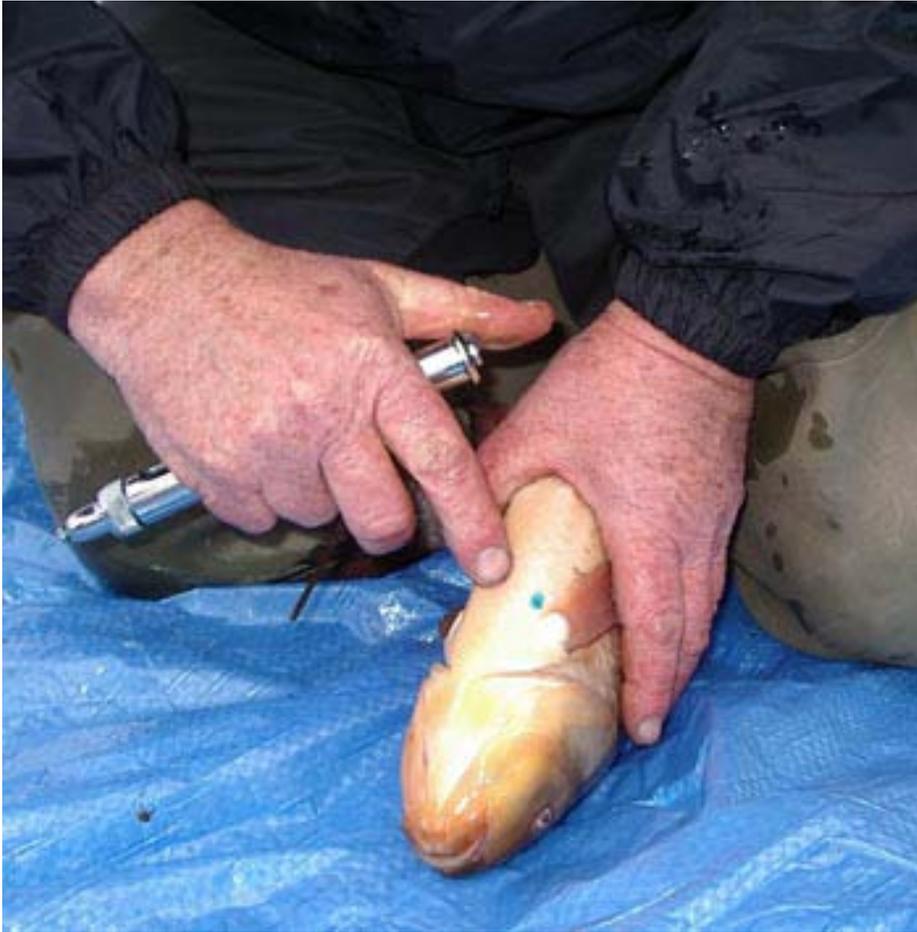
**Picture E. Blue panjet mark at the base of the pectoral fin.**
