**Wild Trout Trust
Advisory Visit Report**

**River Ure – Jervaulx Abbey,
North Yorkshire**

Undertaken on Behalf of Jervaulx Fly Fishers

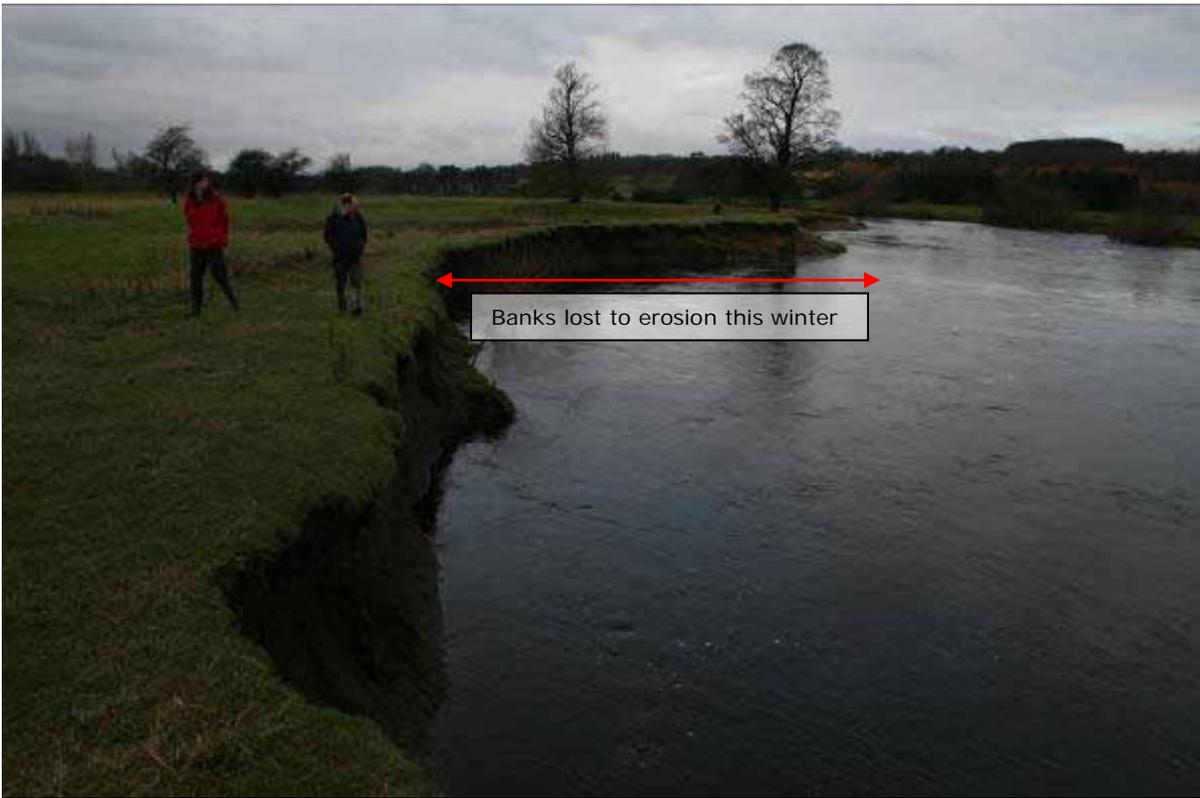
This whole of the reach visited is suffering from extensive erosion problems on both the LHB and RHB. River banks are constantly on the move, it is a natural part of the river processes of erosion and deposition. In places the banks of the River Ure are composed of soft sands and gravels, a highly erodible material. The roots of bank vegetation bind the soil together, making it more resistant to the powerful erosion forces of the river. Unmanaged livestock grazing pressure from high stocking densities can result in a loss of river bank vegetation which accelerates river bank erosion. This causes two problems for not only is valuable land lost, but the water can also become choked with sediment, which has a devastating effect on the biodiversity of the river and the ability of trout to spawn.

In places the rate of erosion is very fast with several metres of bank having been already lost this winter. In places where trees are present this has slowed the rate of erosion considerably. To compound the problem there are no fences to exclude stock from the highly unstable banks.

Severe erosion on the River Ure at Jervaulx Abbey

In the worst areas of erosion the toe of the bank and the bank itself all require protection. It is suggested that 'tree-kickers' are deployed in this section.

In conjunction with kickers the problems of slope stability need also to be addressed. This can be undertaken by re-profiling the sheer cliff faces back to a slope of around 30°. Coupled with this it is strongly recommended that the re-profiled slope be stabilised with the sowing of grass seed 'conservation mix' and/or planting of whips (alder / willow). The bank work should be undertaken as early as possible to allow roots to establish and stabilise banks before the winter spate season. An alternative and potentially less expensive approach (machinery / spoil disposal) to re-profiling may be the stabilisation of the banks using an evergreen revetment such as pines, firs or recycled Christmas trees. The more limbs and fine branches a tree has the more it will continue to slow the streams current after the needles are gone, allowing sediments to accumulate within the anchored trees. Anchoring trees to the streambank in a manner that will resist the force of the water is imperative. In order to protect the area of active erosion an evergreen revetment needs to extend beyond the area of exposed soils on the riverbank. Start downstream of the exposed soil anchoring each tree in place with the butt end of the trunk pointing upstream. Work upstream laying each tree so that it overlaps the previously laid tree until the revetment extends beyond the exposed soils. The first row of trees needs to be placed so that tree crown (the widest part of the tree) rests on the toe of the bank slope.

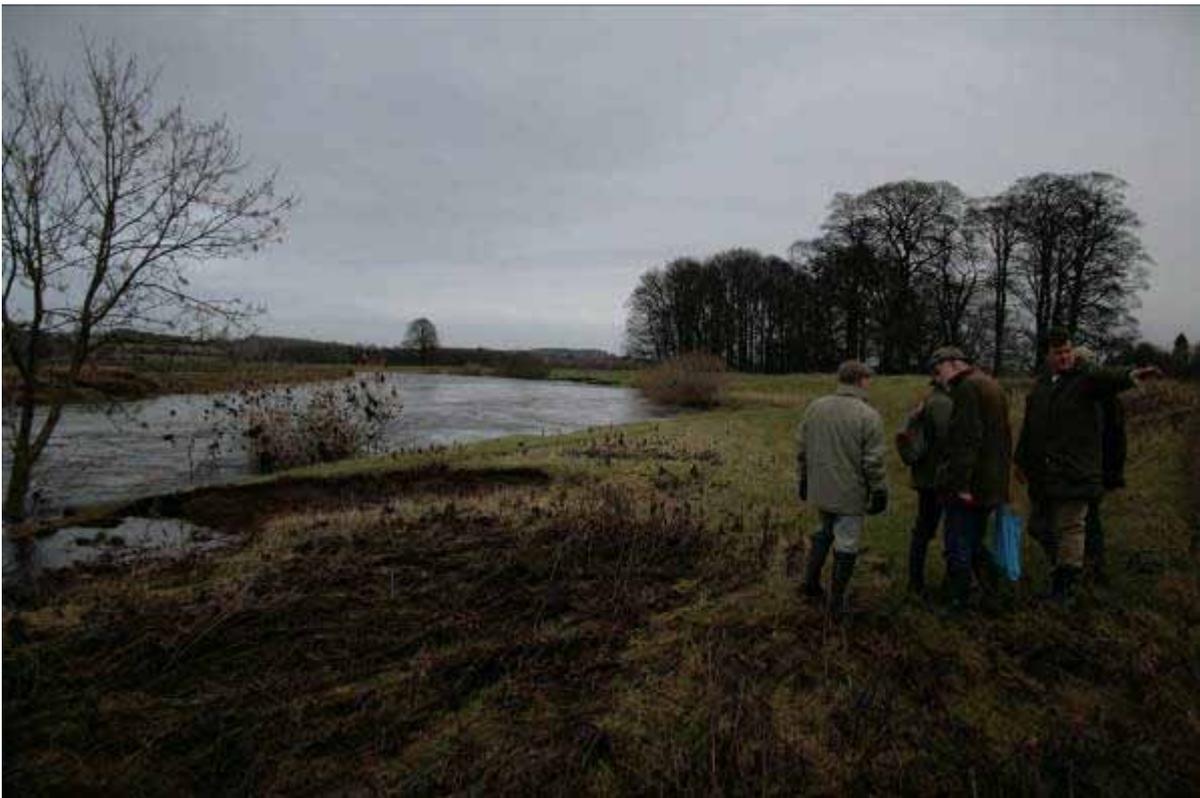
Note the trees in the foreground and background which appear to be slowing the rate of erosion.

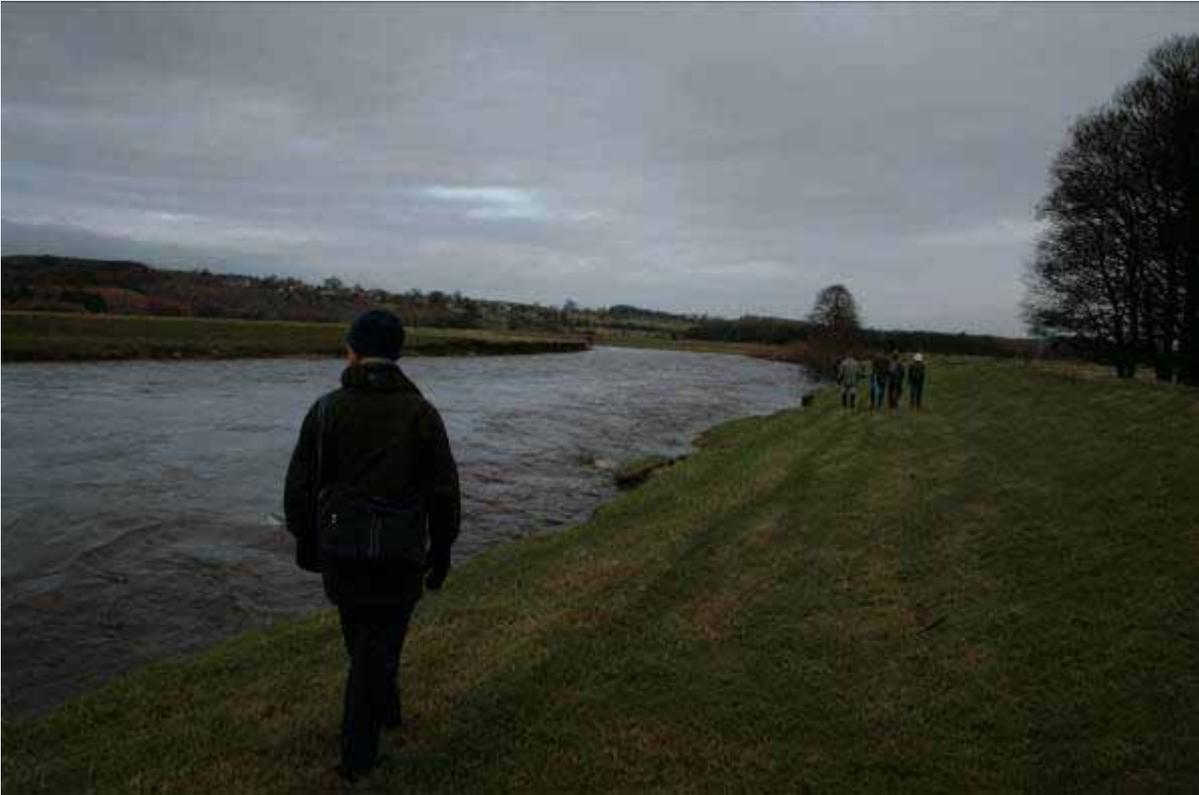
Note: the almost total lack of riparian tree and shrub growth

It is recommended that a new fence line be installed to create a buffer zone / conservation area along the whole of the RHB. Grazing pressure appears to be speeding-up rates of erosion due to compaction of soil and vegetation loss. Creation of a buffer strip of **at least 10m** will allow development of a vegetated 'conservation area'. Consideration should be given to planting with a wild flower conservation mix and willow / alder whips to facilitate greater bank protection.

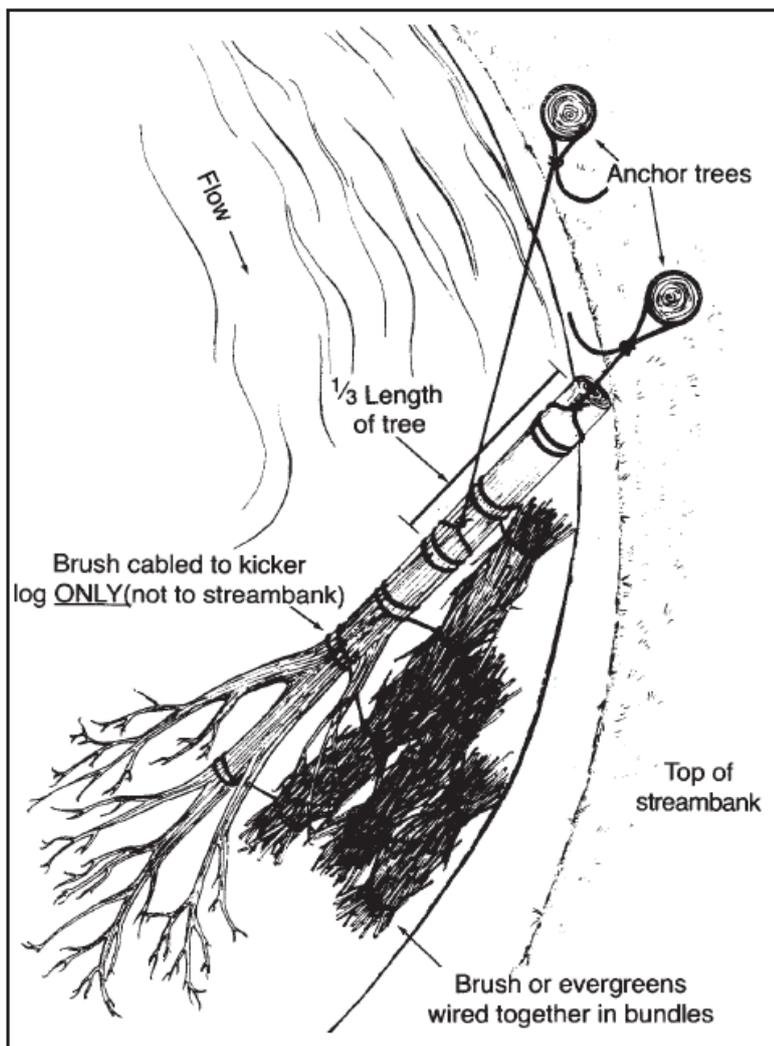
Figure 1. Tree Kicker Construction

Tree "kickers" are hardwood logs which are used to deflect stream flow away from an unstable bank area. One or more logs are anchored to the streambank and placed at an angle to "kick" stream flow away from the bank and towards the middle of the stream. Brush is tied between the log and the bank to prevent scour erosion. Tree kickers are most often used to correct bank undercutting especially where the crest of the cut is 1.5m or more above normal water levels. A kicker deflects the concentration of stream energy away from the bank. In addition, kickers help to re-build the bank by providing an area for sediments to deposit and provide underwater structure for fish and aquatic insects.

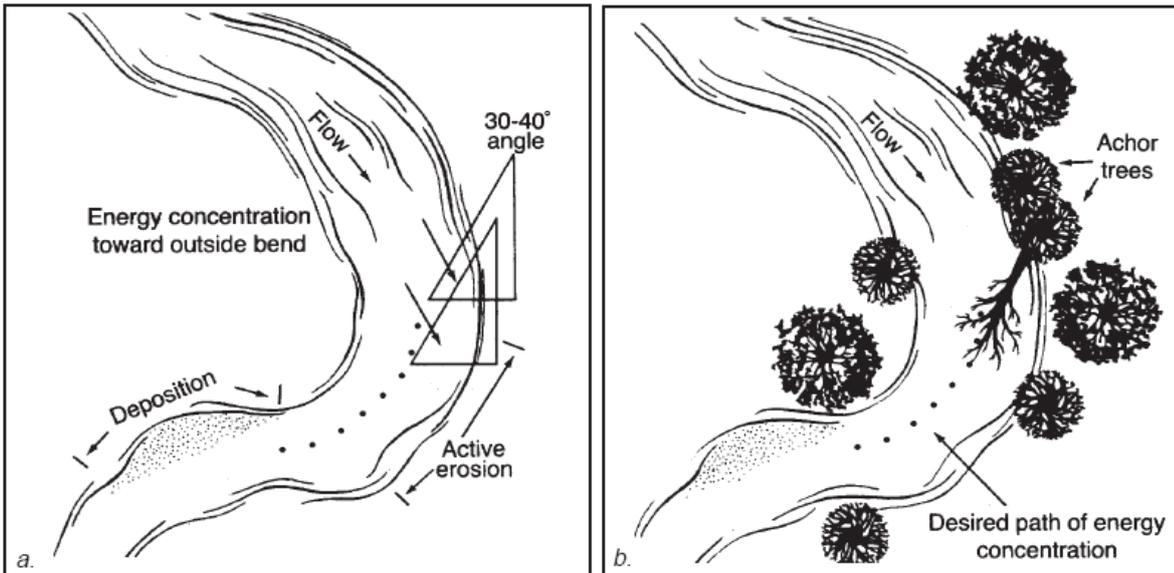
Figure 2. Placement of Kickers

Kickers need to be securely anchored to the streambank. Anchoring it to two live anchor-trees on the bank is best. If no anchor trees are available consideration should be given to installing a deadman anchor. The same angle is used for placing the kicker log. A T-shaped trench will need to be excavated and the kicker will need to be cabled to a large telephone pole or log placed in the crossbar of the 'T'

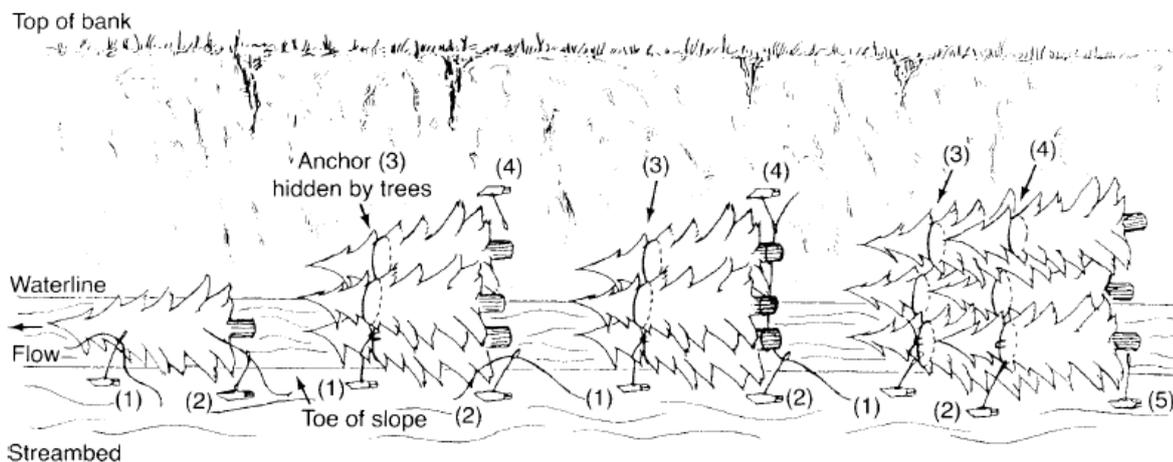
Figure 6. Constructing a Multiple-Row Revetment - Figure shows the general placement of cable. Cable should be wrapped around trunks only and not the outside branches. Compress the trees, pull the cable together as tight as possible and clamp tightly.
