Water Framework Directive Ecological status failure for trout: investigation into potential causes and suggested remediation on waterbodies GB112069060780 (upper Etherow) and GB112069061050 (lower Etherow)

Problem definition

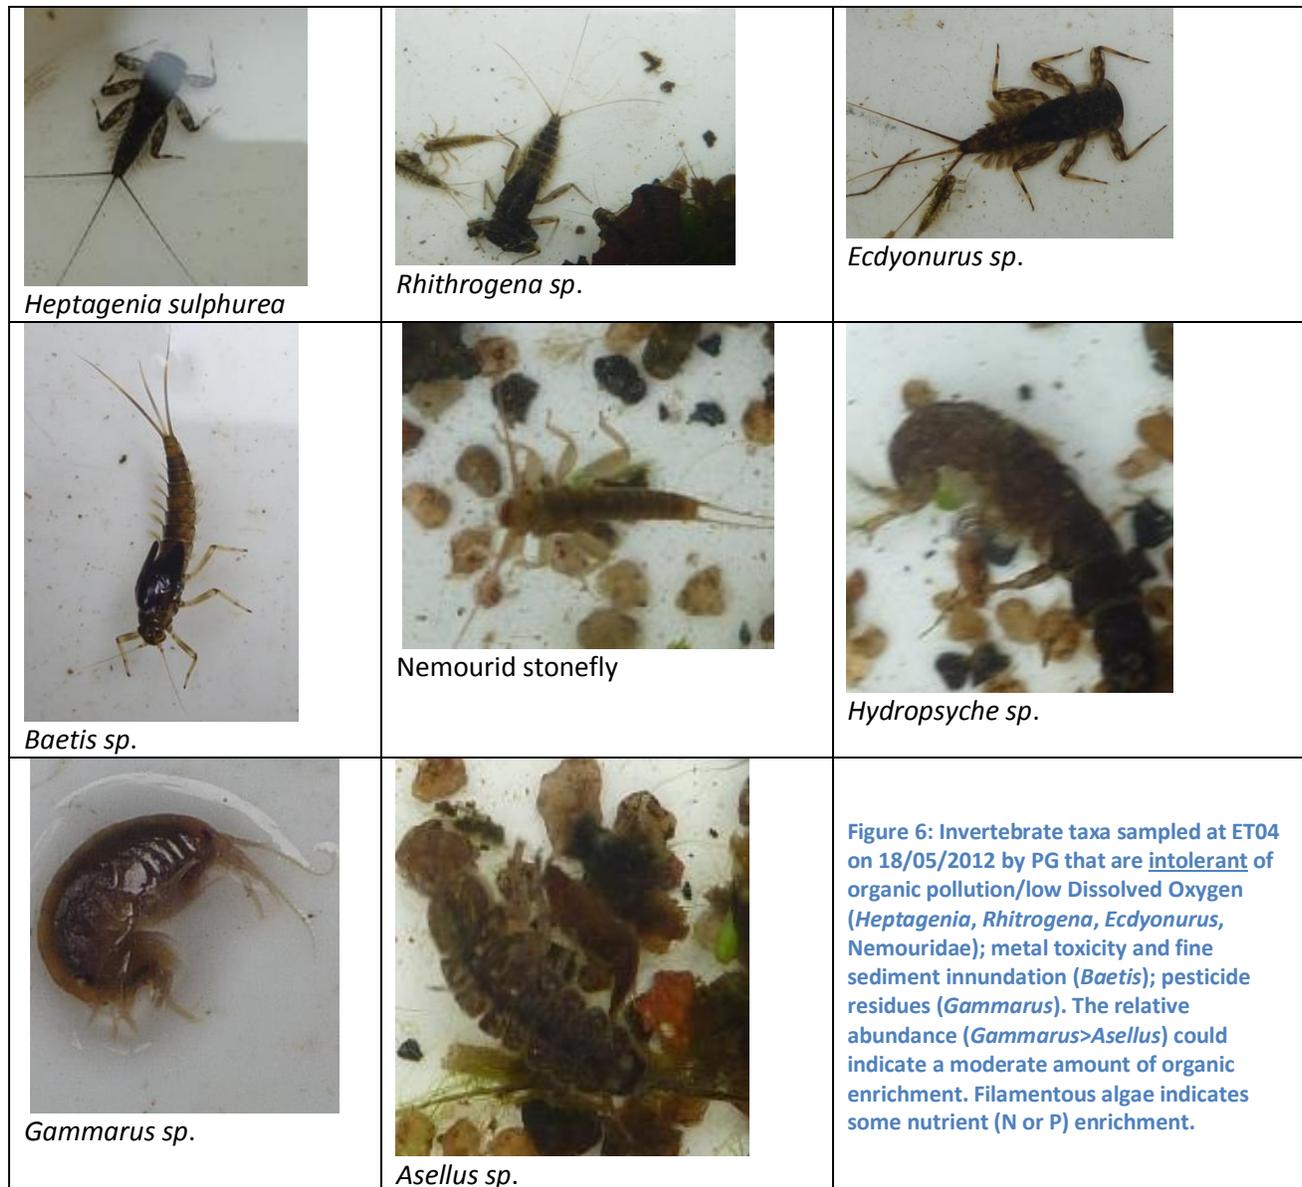
On-site investigations at ET04 enabled the potential for gross water quality impacts to be ruled out as a cause for consistent fish declines at this site. The presence of abundant and diverse benthic macroinvertebrate fauna indicates a generally high baseline water quality and also a generally productive invertebrate foodweb (Fig. 6). Furthermore, the presence of a range of taxa especially sensitive to low oxygen levels (the three genera of Heptageniidae plus Nemourid stonefly larvae) shows that trout oxygen requirements are well catered for. The presence of several large (>12 mm long) *Gammarus sp.* individuals and large (>15 mm long) Trichopteran larvae also indicate that water quality has been acceptable to these organisms over the past several years. This indicates that serious episodic pollution has not impacted the system recently and that the baseline condition of “good water quality” is a reasonable to expect. Finally, the sensitivities to fine sediment inundation, metal pollution and

pesticide residues accorded to the specific taxa identified in Figure 6 also indicate that direct impacts upon trout are unlikely to occur via any of these stressors. The lack of fine sediment impact on, in particular, *Baetis spp.* populations amongst gravel deposits in this reach indicates a good potential for post-spawning survival of trout eggs.

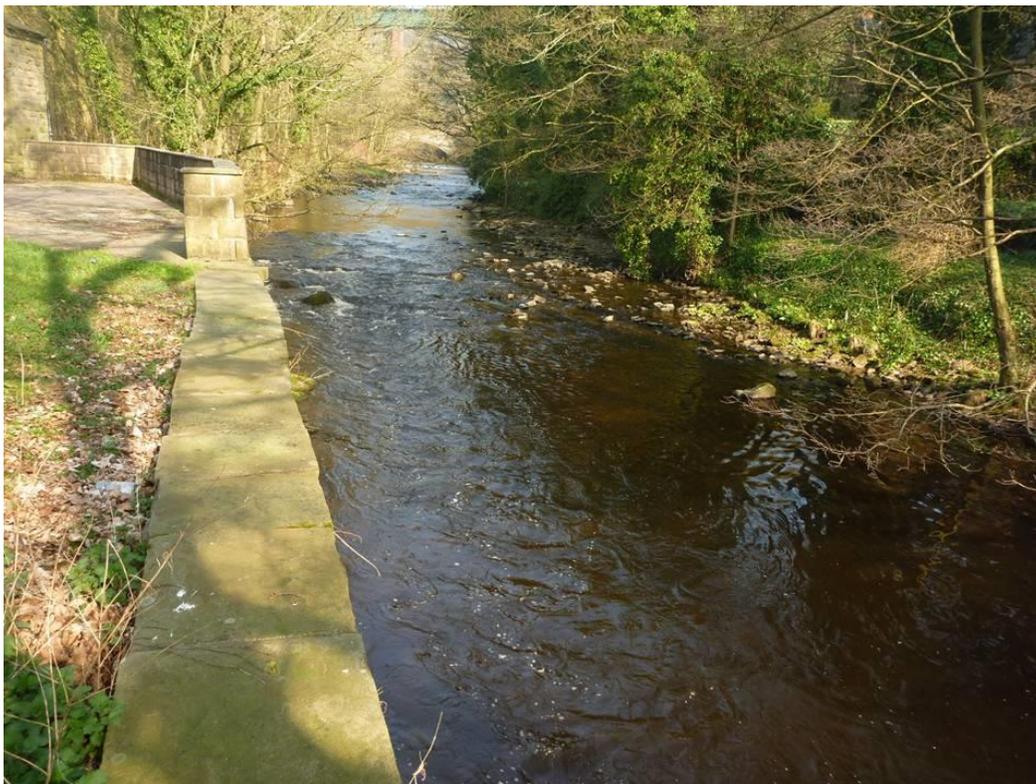
The remainder of the impact identification process concentrates on observed habitat conditions. Surprisingly, if the presence of multiple weirs is ignored, the better quality habitat was witnessed in the historically-walled/industrially-modified sections of the river. The steep bedslope, when flows are not impounded behind weirs, has allowed the regeneration of valuable geomorphological variety - including point bars, lateral scour pools and a good variety of substrate particle sizes including gravels, cobble and boulders e.g. at National Grid Reference (NGR) SJ99679, 93690 (Fig.7). These factors are augmented by the presence of well-developed riparian woodland (although some Himalayan balsam was noted amongst the understory vegetation). The River Restoration Centre report also identifies a number of reaches displaying similarly varied and valuable habitat within modified/post-industrial reaches.

Figure 7: Point bar formation (right to upper centre of frame) with scour pool formed by “bank” resistance generated by wall footings (nearside) with varied mature woodland (picture taken prior to leaf-out) providing some lovely riffle and pool habitat for a variety of flow-loving species.

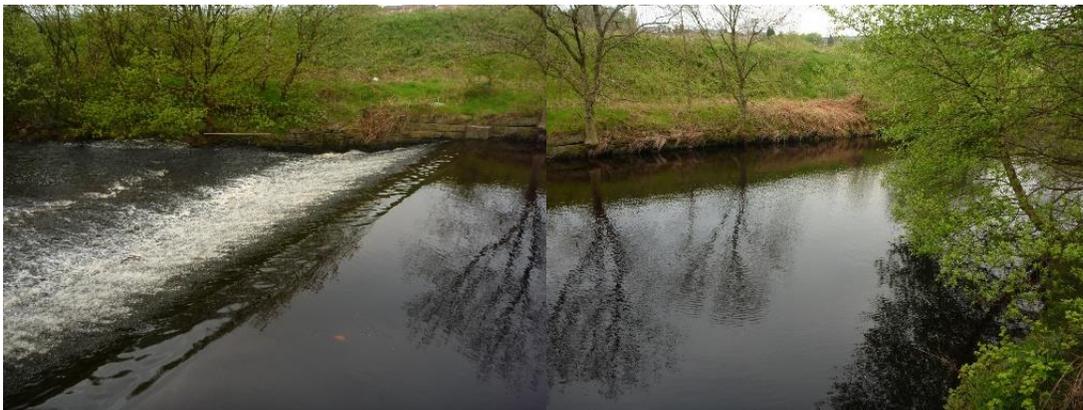
The negative impact on habitat upstream as well as, potentially, downstream of weirs also lends weight to the notion that weir removal is the most desirable option in terms of wild trout and many other riverine species’ conservation goals. The impoundment of water reduces both the average velocity and the variability of flow. Increased deposition of fine sediment occurs across the majority of the channel width and the variety of microhabitats is substantially reduced. The lack of opportunity for erosion and deposition to recreate valuable geomorphological variety is a natural corollary of a blanket increase in fine sediment deposition for example upstream of the weir at SK 01955 96855 (Fig 8).

Figure 8: Low crump weir at SK 01955 96855 that is impounding and degrading a section of habitat below the reservoir source of the river Etherow

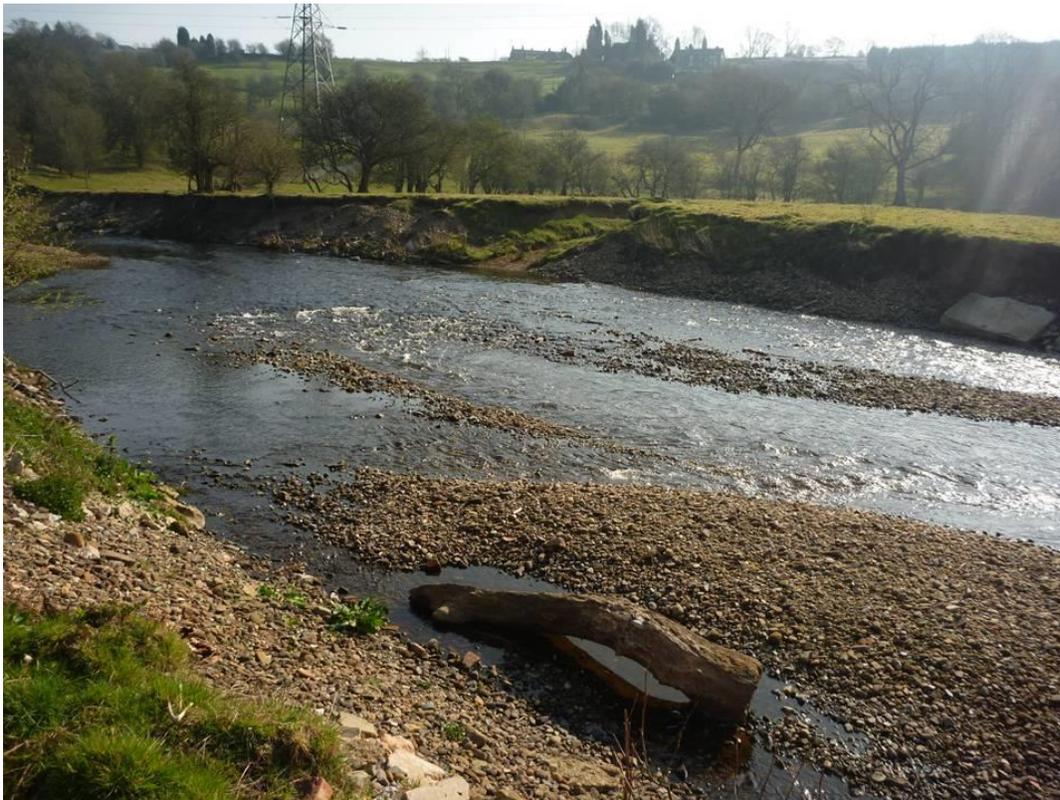
Figure 9: Grazing, lack of tree succession gravel extraction at NGR SJ 99733 93398

The lack of varied riparian vegetation, and in particular the lack of regeneration and succession of bankside trees is significantly reducing the habitat value of this reach for a multitude of aquatic and terrestrial species. It is also contributing to the rate of erosion and flashiness of the river at this point that the landowners are apparently attempting to ameliorate by gravel extraction and construction of flood bunds. It would be far more effective to utilize in-stream brash revetments and exclusion of grazing and mowing to allow the formation of a soft, shaggy marginal flora. Supplemental tree planting

would further consolidate bank resistance. Over and above the tackling of landowner-perceived erosion problems, these options would also confer significant biodiversity benefits – including improving the prospects for juvenile and adult trout.

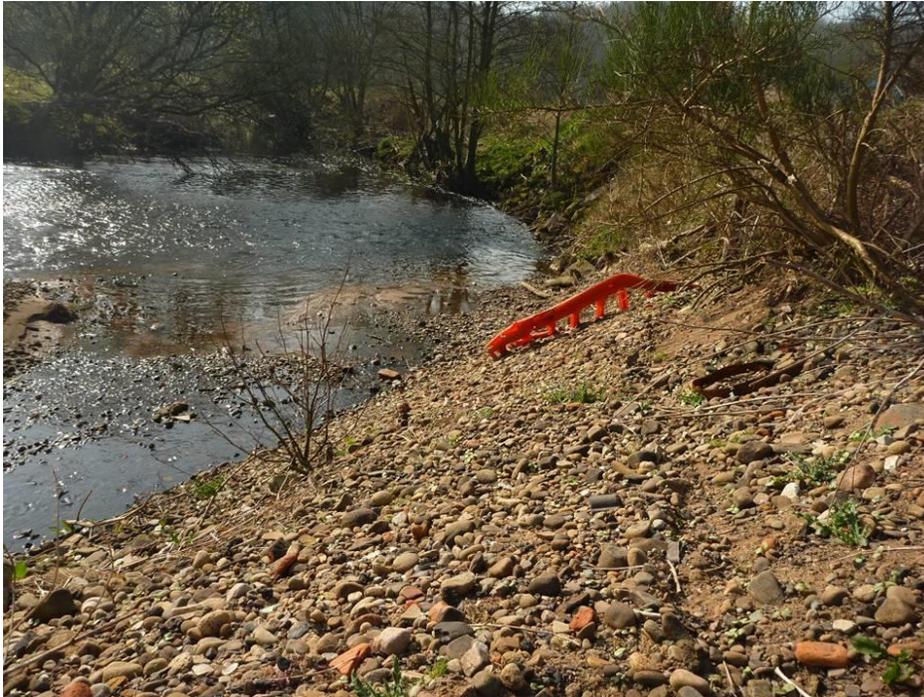
Figure 10: Gravel extraction and ad-hoc bank regrading – presumably for attempted flood prevention at NGR SJ 99733 93398

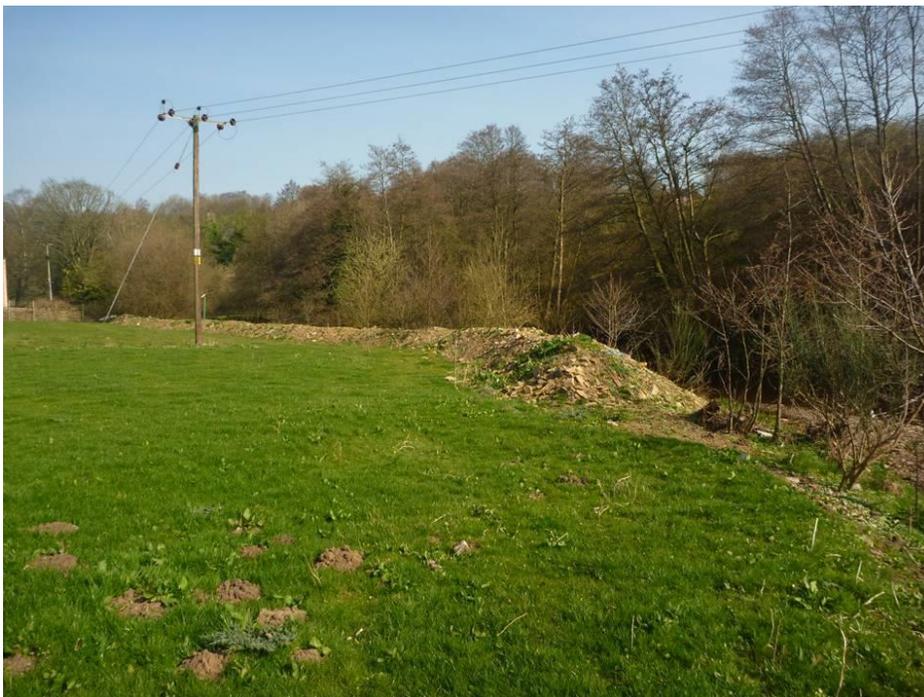
Figure 11: Ad-hoc flood bund constructed from material extracted from the river bed at NGR SJ 99733 93398

An opportunity to integrate improvements to the rural site and those proposed subsequently for the upper, heavily modified, reach also exists. With respect to the rural reach – the removal of the flood bund could be offset (in flood risk terms) by the creation of a wetland/scrape area with improved connection to the main river channel on the opposite bank (Fig. 16). The gravel material arising from flood bund removal, connecting channel and wetland scrape creation could be transported for use in the improvements to the heavily modified channel upstream.

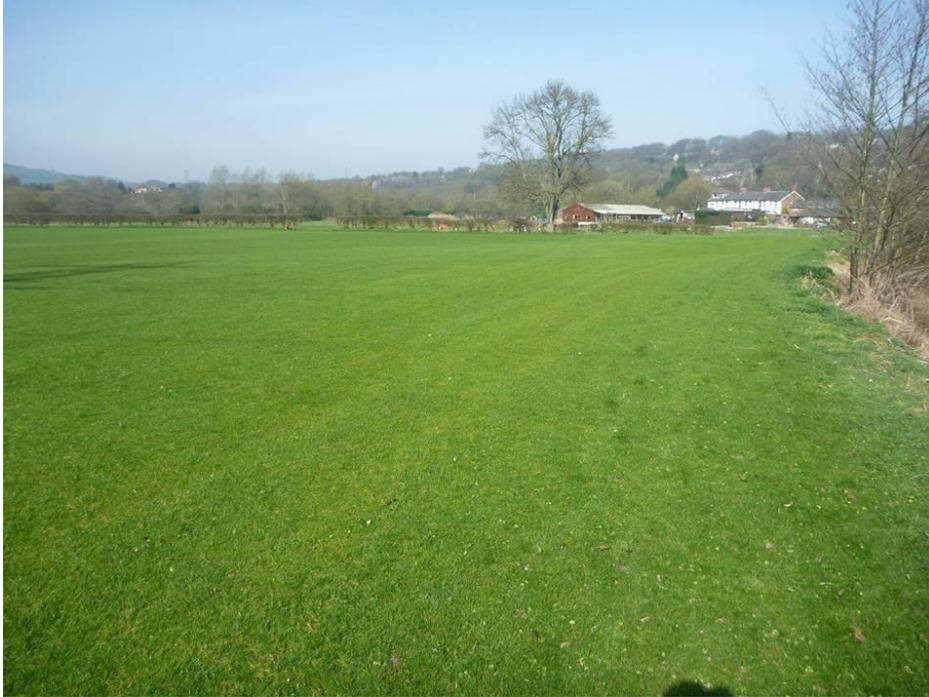
Figure 12: Turf cultivation and lack of riparian tree regeneration/succession at NGR SJ 99765 93312

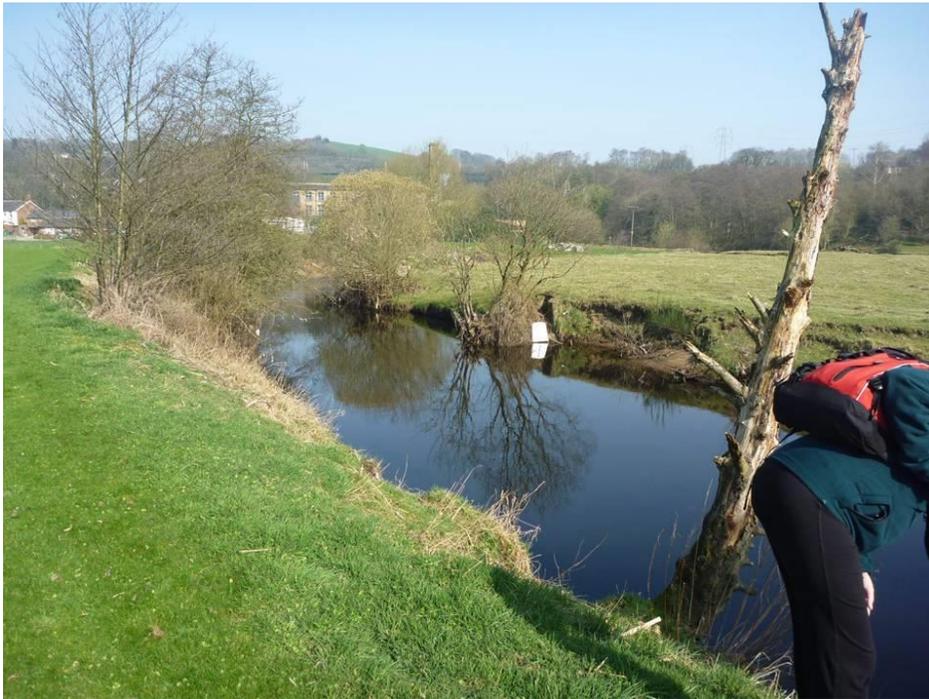
Figure 13: Lack of tree succession, showing incised channel and lack of buffer strip to attenuate runoff from surrounding cultivated and grazed land at NGR SJ 99765 93312. Compare the uniform flow and depth to the “post industrial” modified setting - but much higher habitat value - of Figure 7

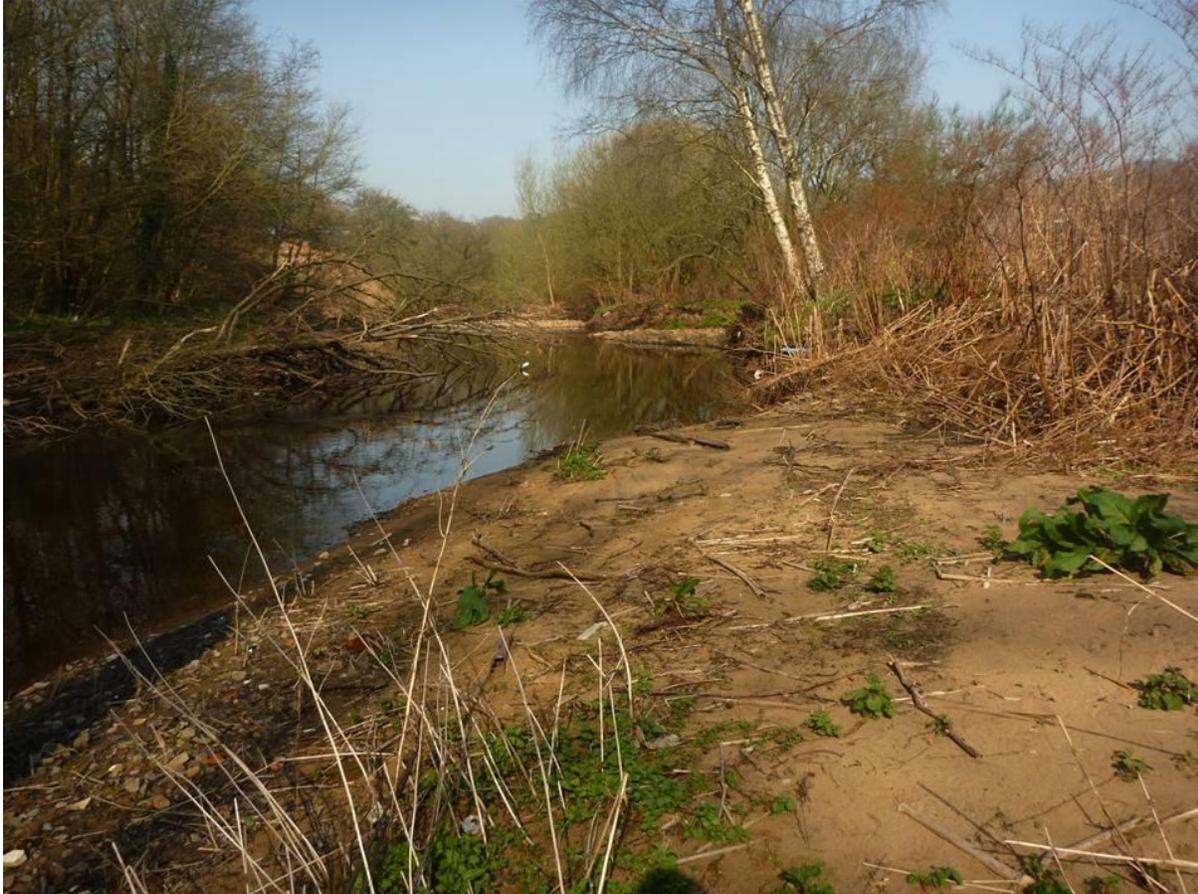
Although the presence of a well-wooded bank improves matters just downstream of the turf cultivating operation, the opposite bank has been badly degraded by the presence of Japanese knotweed and Himalayan balsam (Fig. 14). This has resulted in a generally overwide/overshallow channel, but is also elevating the inputs of fine sand and silt above a rate that is helpful for good trout spawning success.

Figure 14: NGR SJ99580 93243. Good in-channel cover and increased bank erosion resistance on the left hand bank (left of frame) - but significant impacts of Japanese knotweed and Himalayan balsam infestation on the right bank (centre and right of frame). The bare sand left following annual die-back of these competitively dominant plants will wash into the river in great quantities during winter spates. This will also act to maintain a shallow and uniform channel – even though the opposite bank has improved resistance to erosion compared to the overgrazed and cultivated section upstream.

Stem injection of Japanese knotweed and either strimming (below first node) or hand pulling of Himalayan balsam (composted on site) just prior to seed setting would give immediate benefits to the infested areas at NGR SJ99580 93243. Even in areas where upstream recolonisation sources remain, the WTT has seen (via Trout in the Town volunteer work) significant floral recovery in localized areas that Himalayan balsam is regularly “weeded” out. Similarly, because of the relatively slow initial establishment of Japanese knotweed, significant benefits to removal via stem injection exist. This option avoids any requirement for disposal of biohazardous waste on site as well as avoiding:

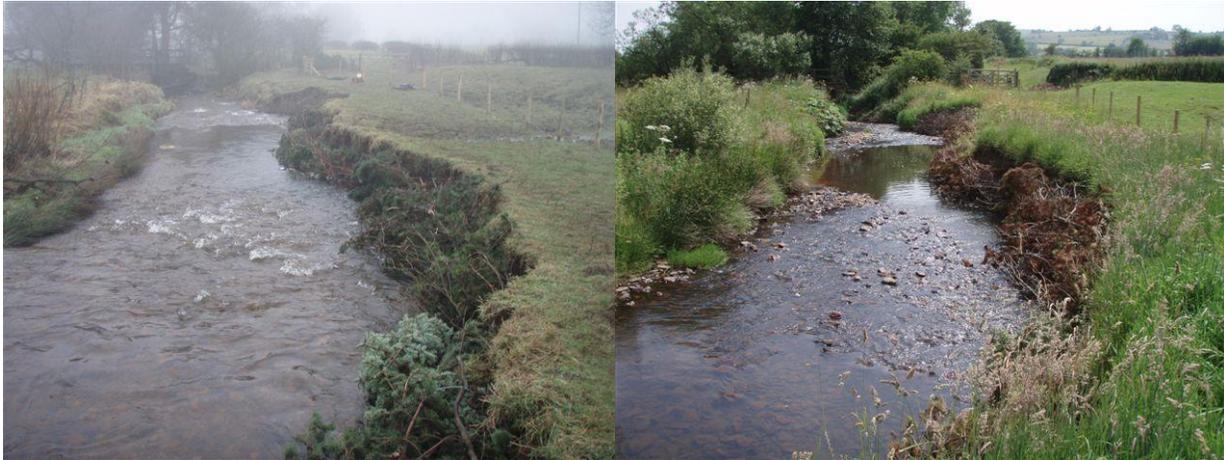
Figure 15: Brush revetment and buffer strip fencing on installation (left) and four months post-installation (right)

Within the cultivated and grazed sections, the simple installation of buffer strip fencing, augmented by tree planting will be a huge step towards improving ecological status. The fencing should be sited at least two meters into the field side of the obvious bank-top and should also include gated access for either heavy plant or periodic light, managed grazing. In addition, to speed the natural narrowing and increased bank erosion resistance (as well as to provide excellent juvenile and adult trout cover); brush revetments should be installed at the bank-toe within this section (Fig.15).

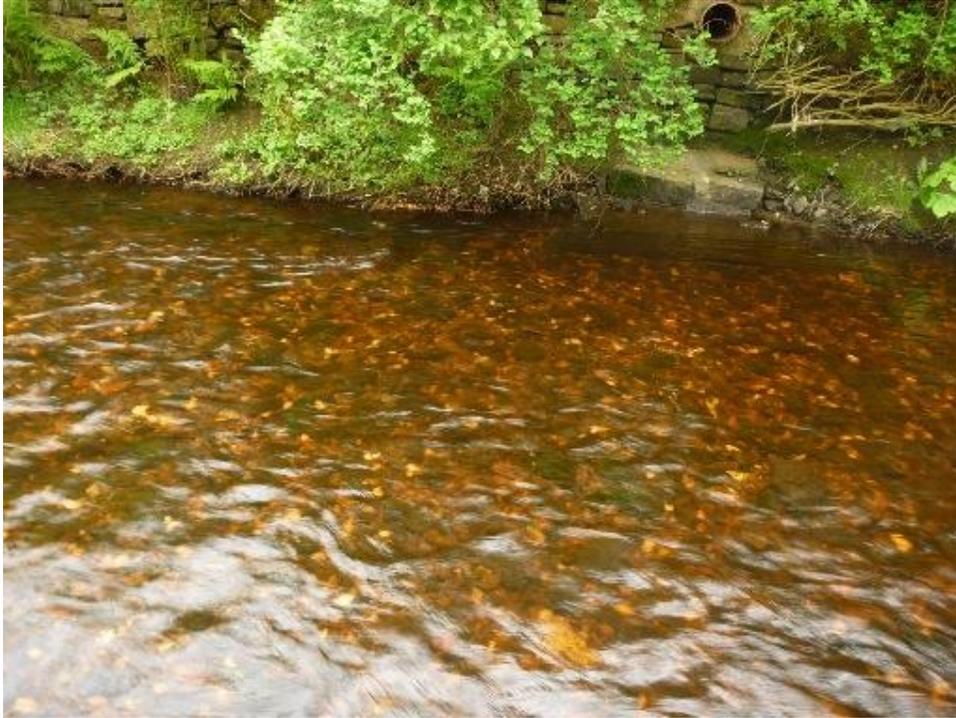
Figure 17: Typical channel and substrate in the area of ET04 - a great opportunity to increase juvenile fish survival by increasing wetted marginal brush cover

In the channel at ET04 and directly upstream in the modified reaches, use of marginal brush will be an invaluable addition to habitat complexity (Figs. 17 and 18). This will function both to reduce predator exploitation of fish, but also as a cool water refuge for both trout and invertebrates with a lower maximal temperature tolerance. In the area of ET04 itself, there would be value in the inclusion of pinned log flow deflectors to promote localized bed scour and sorting of clean spawning gravels.

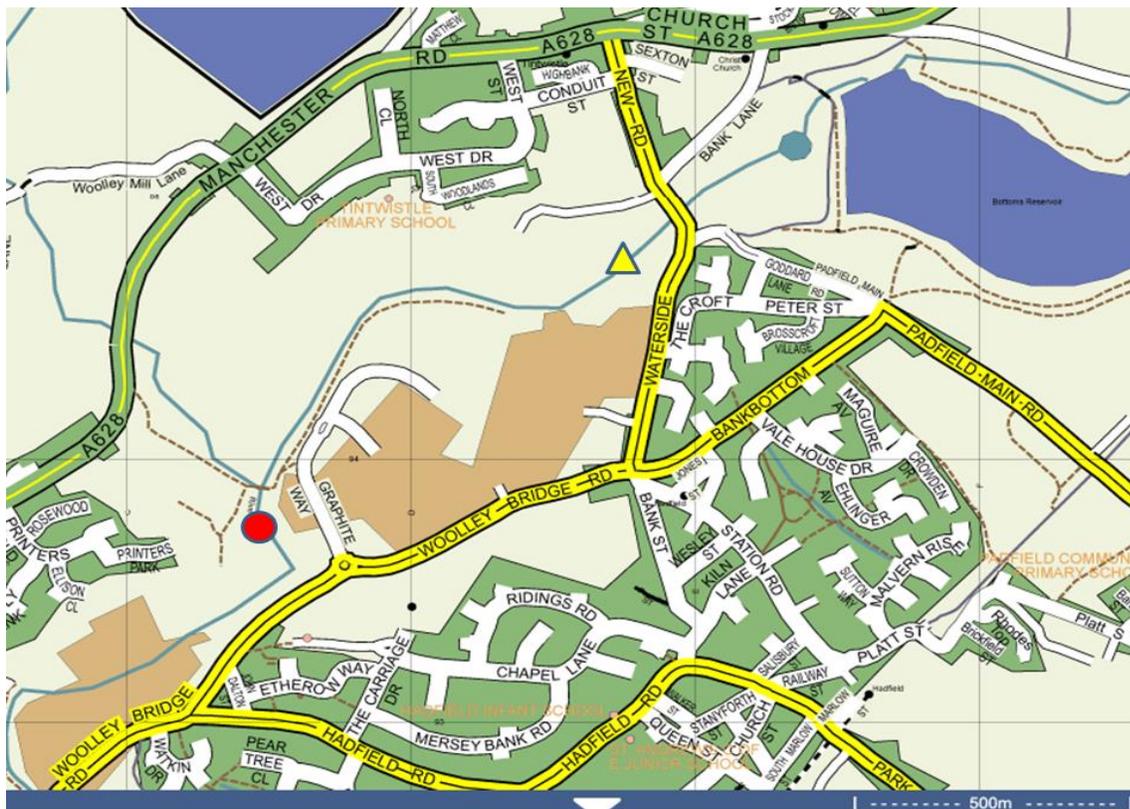
Figure 19: Locations of two key barriers (weirs) that, when tackled, could offer huge potential benefits to trout recruitment; Etherow works weir (red circle) and Bridge and Waterside Cotton Mills weir (yellow triangle)

By taking different approaches to tackling connectivity at SK01359632 (Etherow works weir) and SK01959685 (Bridge and Waterside cotton mills weir); both Fig. 19, an optimal combination of fish access, habitat quality and prevention of crayfish re-colonisation is sought.

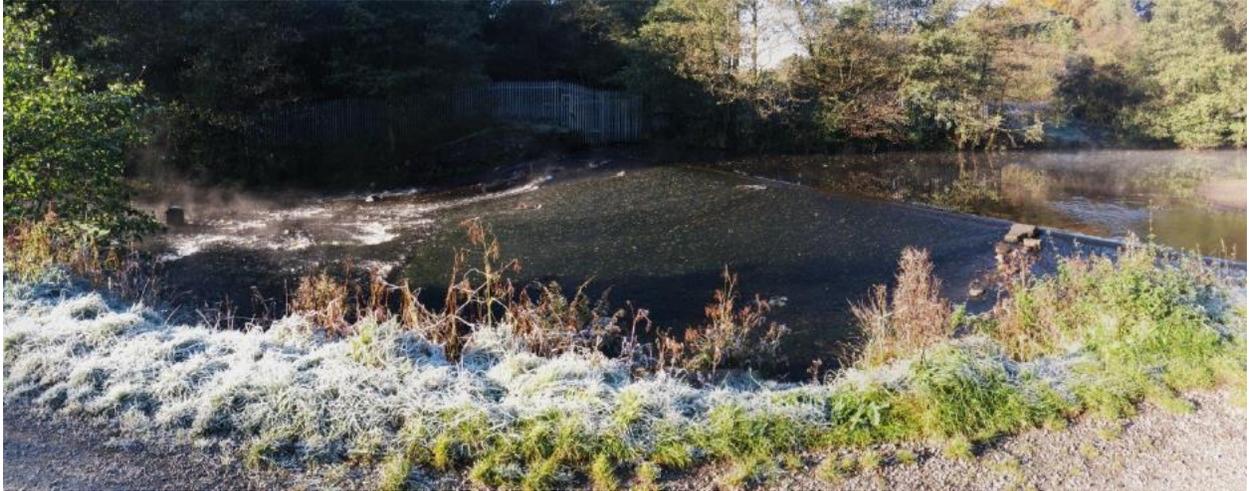
Figure 20: Etherow Works weir panorama taken from River Restoration Centre report

A simple and cheap option for weir passage is suggested for Etherow works weir (Fig. 20) – and involves the use of a diagonal “balk” on the downstream face of the crump weir (Fig. 21). This option provides access for trout, but still retains a potential “gatekeeping” function for invasive crayfish – as long as an especially heavy density of traps were to be sited around and within the easement. It must be

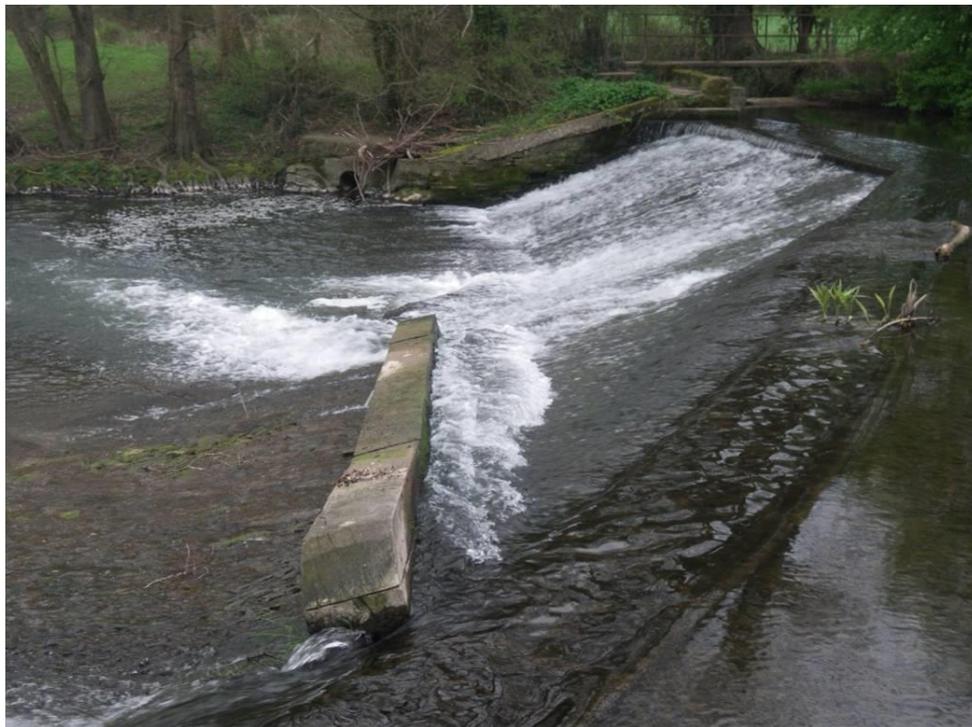
Figure 21: Diagonal baulk bolted to crump weir (in this case constructed from wooden sleepers). Alternatives include concrete over rebar frame construction.

A small notch at the weir lip (i.e. the exit of the easement) would be beneficial to fish passage and also offer a small increase to the flow velocity and associated diversity upstream of the weir. However, a much more extensive increase to flow velocity and diversity would be proposed at the Bridge and
