Advisory Visit

River Wear, on behalf of Bishop Auckland District Angling Club

16th June, 2008

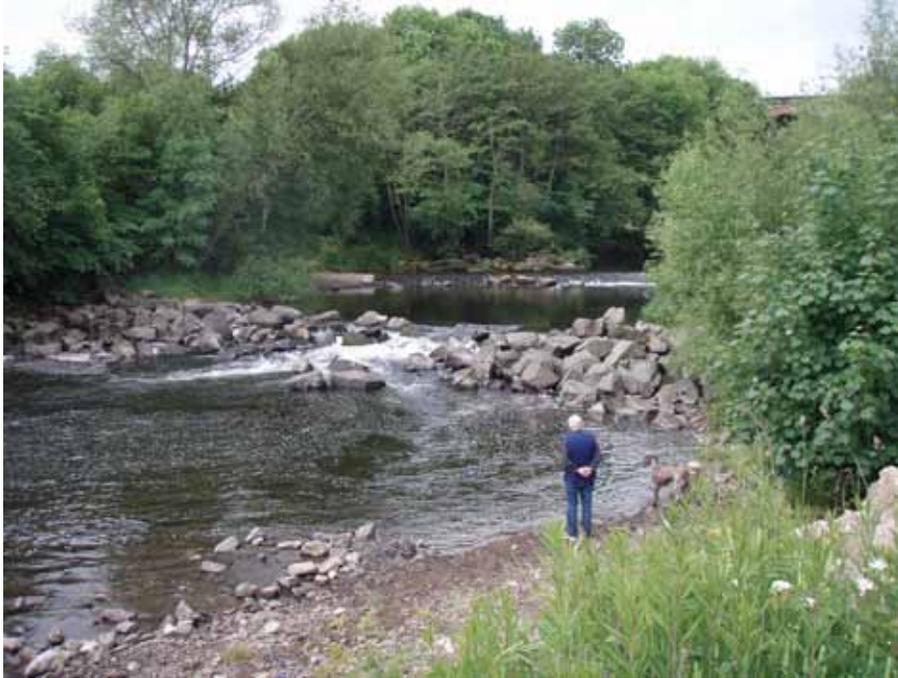
Photo 1 Weir and ford (background) and block stone pre-barrage downstream of Witton Park viaduct

Just downstream of the viaduct there is a long diagonal weir across the river creating a ford, and just downstream of this a weir made from large blocks of stone (possibly a pre-barrage to increase water levels below the ford weir, easing passage for migratory fish). Immediately below the block stone weir on the LHB there is an area of bank erosion where stone bank revetment has failed; the erosion is probably due to back-eddies from the weir at high flows. Below these structures the river has a gentle gradient and there is a long glide with bankside vegetation overhanging the river on both banks providing excellent cover for adult trout and sea trout. The vegetation is

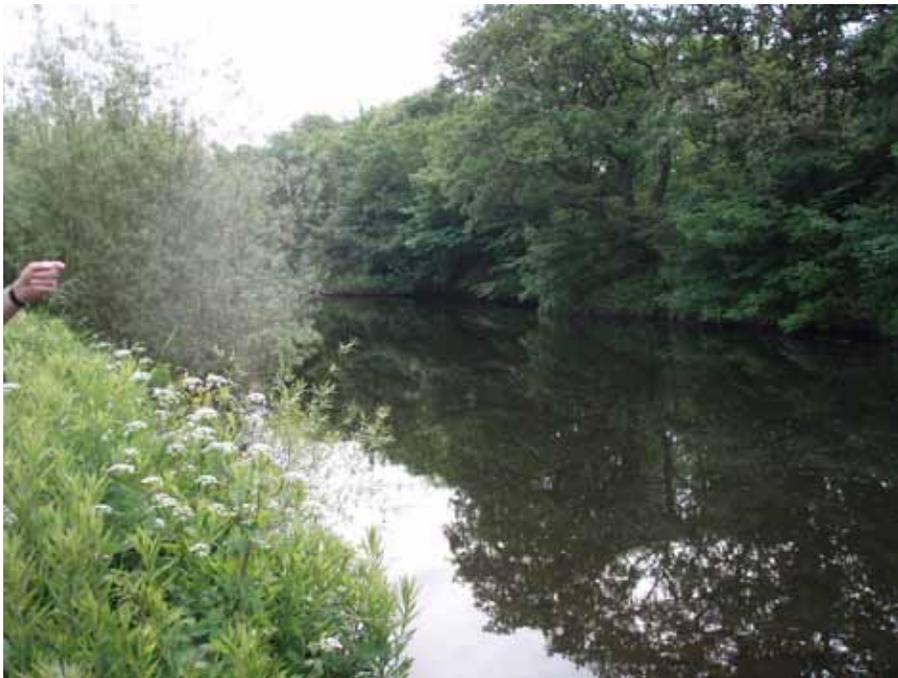
Photo 2 River downstream of the weirs in Photo 1 showing good bankside cover

mainly young willow trees and herbaceous plants on the LHB and mature deciduous trees on the RHB.

The bankside vegetation limits access to the water for angling, and the club have cut a number of access points along the river.

- It is recommended that low cover in the form of overhanging tree branches and bushes is retained wherever possible; this is valuable habitat for adult trout, sea trout salmon and other species. Tree cover can also provide valuable temperature refuges, something that may become more important as summer temperatures increase due the predicted effects of climate change. Members should be discouraged from removing overhanging trees and bushes for the sake of easier fishing. The club has already created some access points to the river, and anglers should be encouraged to use these and wade between them.

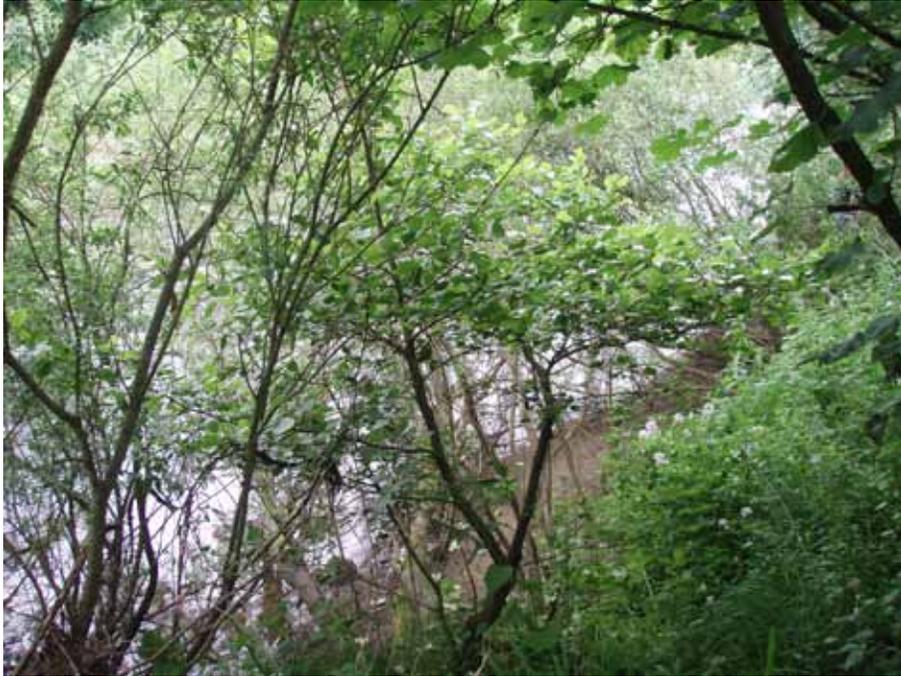
Photo 3 Riparian trees providing good marginal cover

At Wadsworth (Map 2, area 12 in the club book) the river has steep banks with difficult access to the water's edge. The banks are covered with a mixture of young trees (up to 20ft high) including willow, sallow, sycamore and ash, and there is a good understorey of herbaceous vegetation. The riparian trees overhang the river margin and provide excellent cover for fish. The river is shallow and streamy with a substrate of boulder, cobble and gravel providing good habitat for juvenile salmonids. The banks here are owned by the club, and were formerly waste land following the cessation of heavy industry (iron works, gravel excavation and British Rail tip).

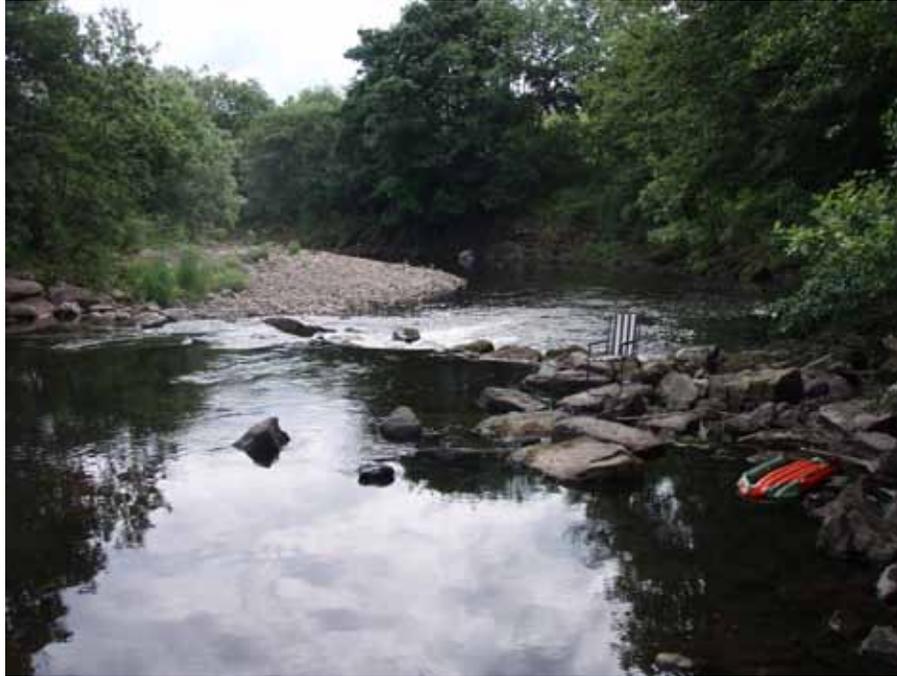
Photo 5 Block stone weir at the downstream end of Long Pool

Further upstream is another block stone weir which impounds a long section of water known as Long Pool (Map 2, area 10). Here there was evidence of recent unauthorised fishing in the form of discarded nylon line, sweetcorn tins and folding chairs. The club reported regular incidents of unauthorised fishing and has 20 bailiffs to enforce club rules.

The origin of the block stone weirs is not certain and it was suggested they could have been installed by previous club committees, the river authority or the Army. According to Alan Ornsby this structure was installed 10 years ago to lift upstream water levels below the next weir upstream. Inspection of satellite photographs (Google maps) suggests there are three or four such structures in this part of the river.

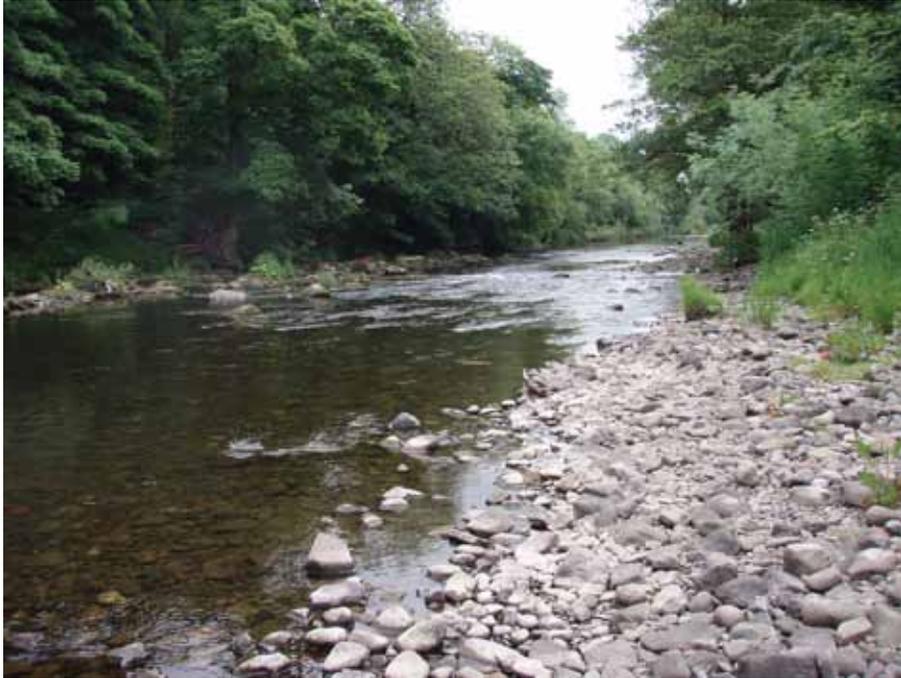
Photo 6 View downstream at The Willows, downstream of Get Hooked centre

There is a good variety of habitat here with shallow glides, riffles and boulders (area 13-14, Map 2). The LHB is wooded with mature ash, alder, sycamore and willow and there is limited access to the water on this bank. The club own both the fishing rights and the land on the RHB, and lease the rights on the LHB from Northumbria Water.

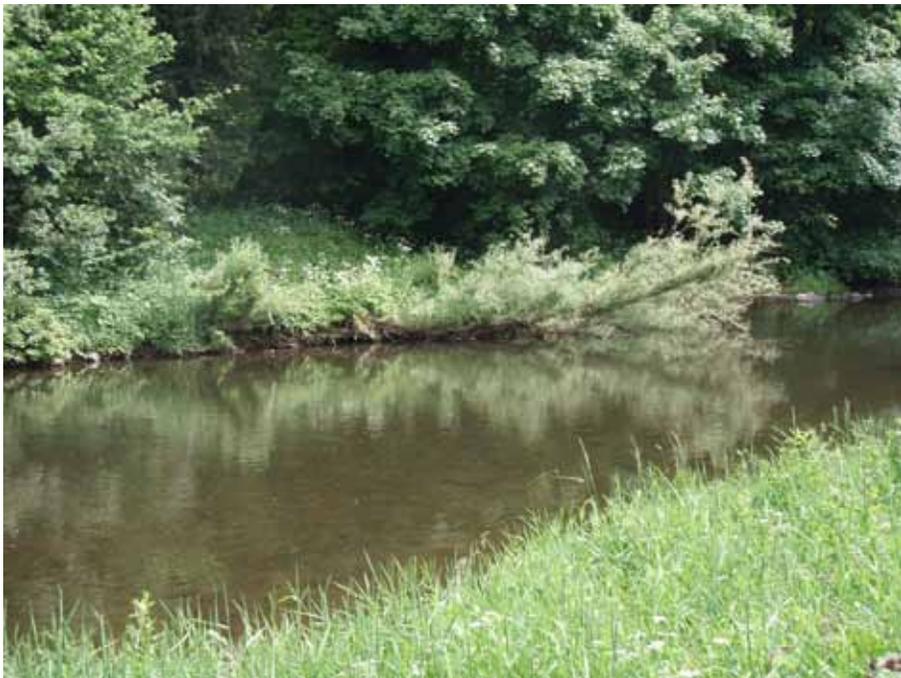
Photo 7 Good example of Large Woody Debris - a fallen willow rooted to the bank

Apart from a fallen willow which had remained rooted to the far bank, there was little in the way of Large Woody Debris (LWD) in the river channel. A kingfisher was observed using a branch of the fallen willow as a feeding perch. The club tend to remove fallen trees from the river where they are causing the flow to erode the bank and, using contractors, recently removed a large debris dam from another section of river. The EA had declined to remove the debris dam as it was not perceived as a flood risk.

- The club should adopt a policy of leaving Large Woody Debris in the river unless it is causing significant problems. As a guide the following simple check list has been developed by the West Country Rivers Trust:

In the short-term the club should introduce LWD. Willows can be 'trained' to hang over the channel by nicking the trunks and pushing them over.

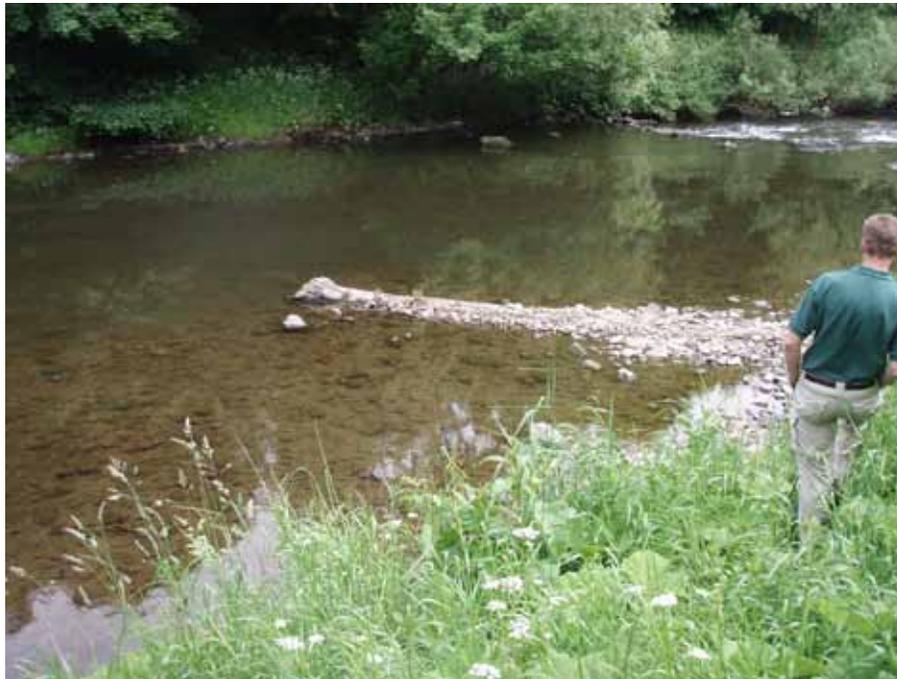
Photo 8 Upstream pointing log deflector

A flow deflector had been installed in the river consisting of a log pointing upstream at about 45° to the bank and anchored with post and wire. The log had accumulated gravel around it and was consolidated into the river bed. The deflector is well-positioned in terms of its angle, and is deflecting flows into the centre of the river channel (rather than towards the bank) scouring deeper areas and sorting gravel. However the deflector is too short to be having a significant effect and should extend at least a third of the way across the river channel.

The introduction of upstream facing submerged log deflectors (single or paired) is recommended to create localised scour pools in the margins and mid-channel. LWD will need to be securely 'keyed' into the bank and possibly the river bed using posts or rebar and wire (in a similar way to the existing deflector – Photo 8) to avoid problems of washout. Another option would be to 'hinge' trees, leaving them still connected to stumps; again for added security these can be secured to the bed of the river using posts and wire.

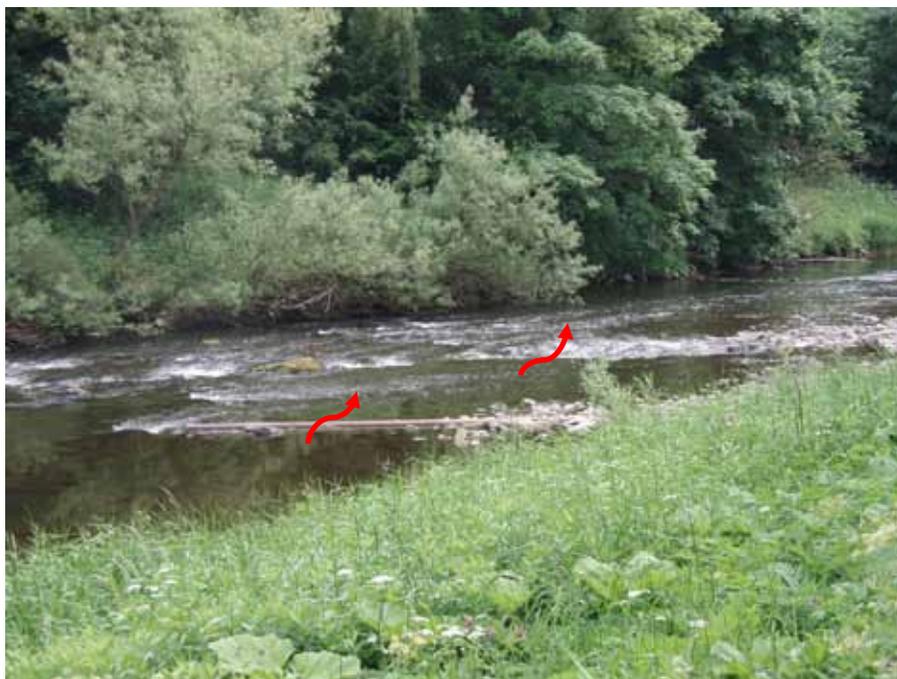
Photo 9 Showing the flow deflected to the centre (arrows) of the river by upstream pointing structures

Downstream of the deflector was another similarly positioned structure and gravel bar demonstrating the deflection of water perpendicular to these structures (Photo 9).

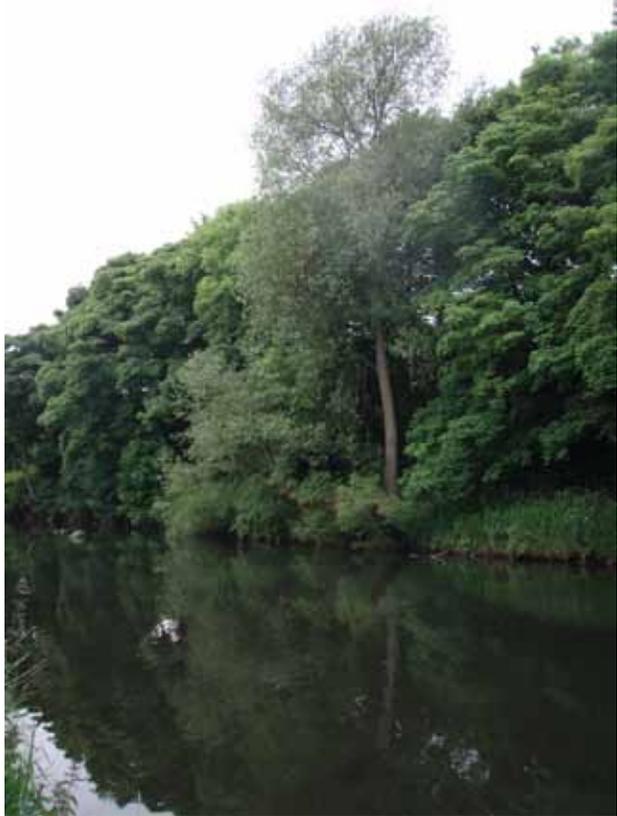
Willow trees suitable for hinging on the RHB at Newfield

The RHB here is controlled by Ferry Hill AC and is well wooded with mature trees. There are the remains of some old bridge footings in the river at this point. In contrast to the reaches seen previously on this visit there is a lack of low, overhanging cover at the edges of the river channel. It was

- On the Newfield section of the river there are a number of opportunities for introducing LWD to improve flow and depth variation. There are some large willow trees on the RHB that would lend themselves well to hinging into the river. LWD could be securely anchored in this area by fixing it to the remains of the bridge footings (Photo 11).
