Wellow Brook, Wellow, Somerset

An Advisory Visit Report by the Wild Trout Trust in May 2013

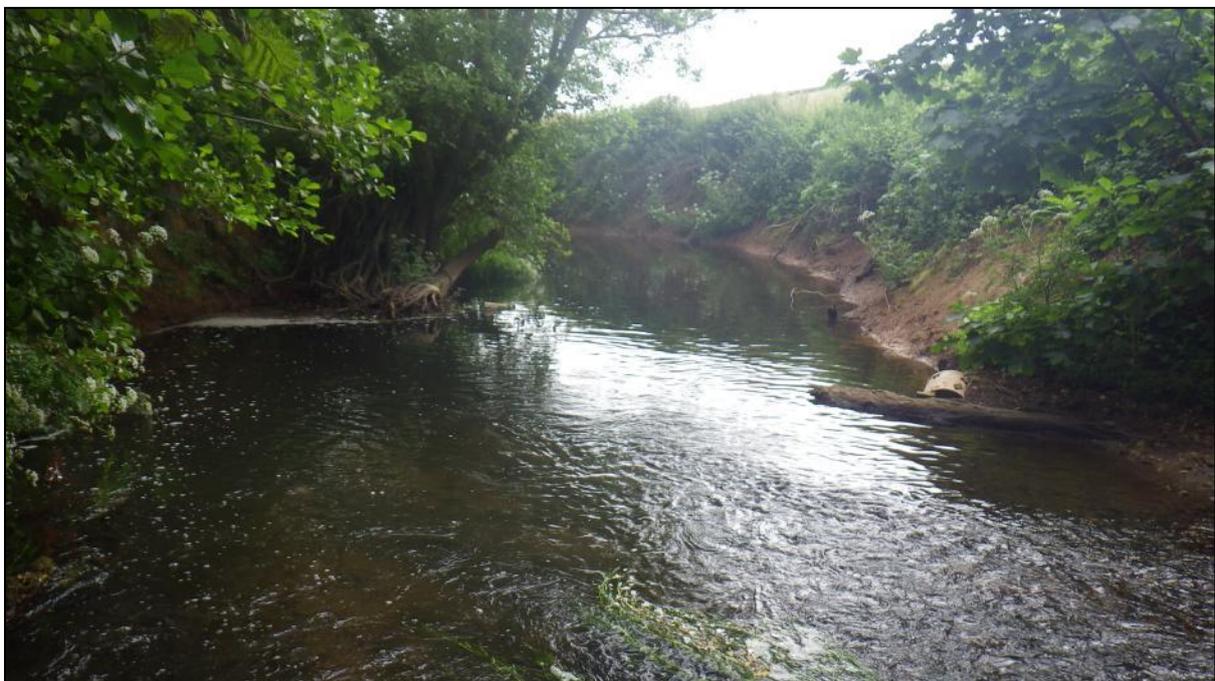
Figure 2: A natural sequence of riffles and pools combined with an abundance of woody debris provides a good variation in depth and flow velocity

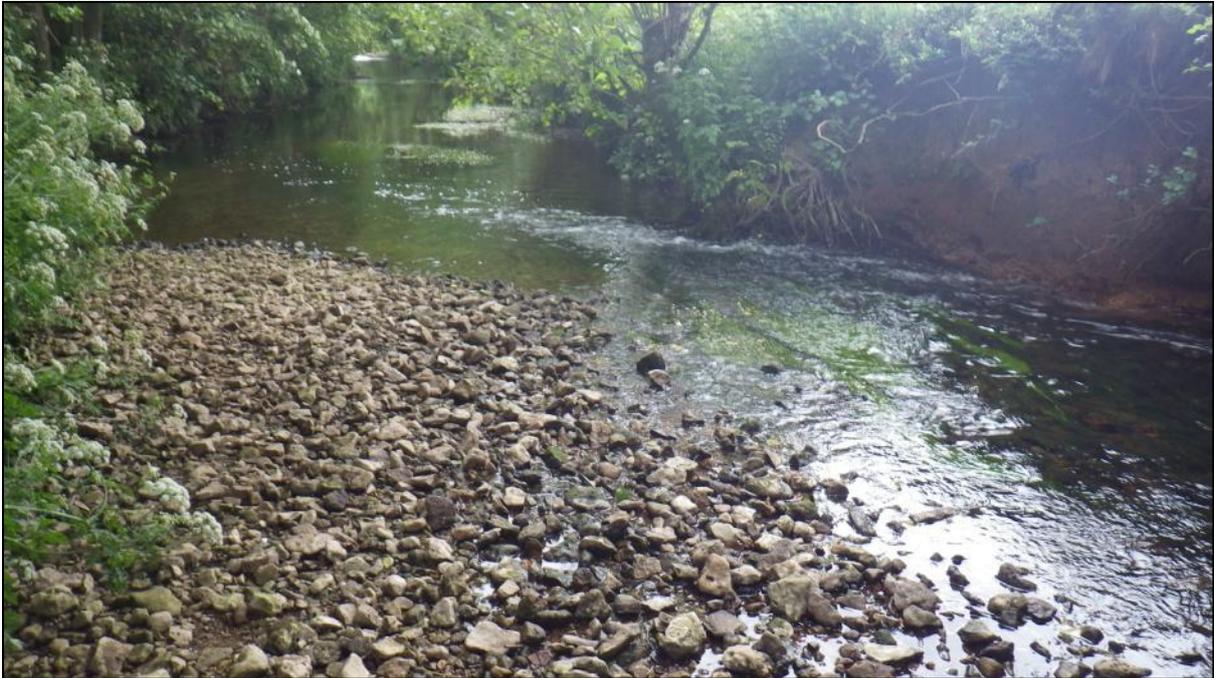
Throughout the WFFC waters a number of gravel shoals were observed. Being in depositional areas many were compacted with fine sediment. However, the edges of these shoals may provide spawning opportunities during high flows and opportunities may exist to enhance these areas via the introduction of some simple log deflectors.

Figure 6: Gravel shoals and bars may provide some additional spawning opportunities, especially if enhanced with some simple flow deflectors

- Boost the availability and quality of spawning habitat by installing some simple log deflectors to help 'sort' gravels. Installing deflectors to increase scour over known spawning sites could help improve egg/alevin survival and some additional deflectors at the edges of existing shoals and berms may help to broaden the opportunities for spawning.

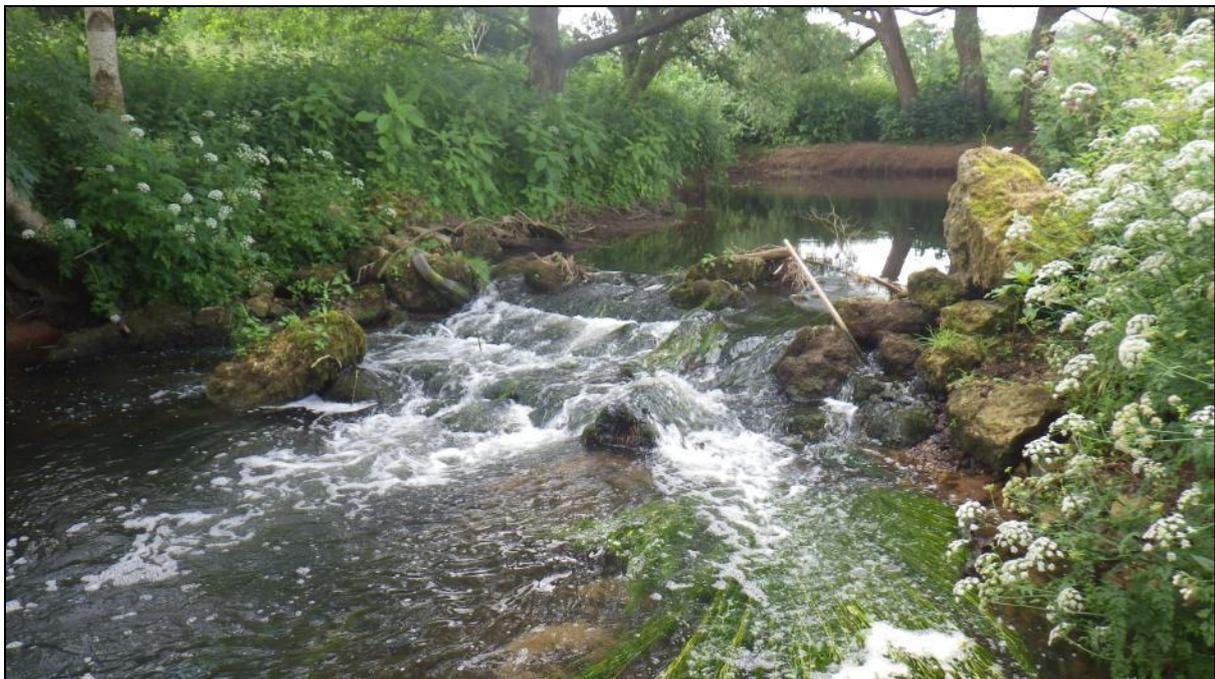
At ST 73691 57551 and ST 73650 57514, boulder weirs have been constructed across the river. These structures were reportedly installed to help oxygenate the river and to create holding water upstream. These are two widely held misconceptions about weirs, with the negative impacts of impounding flow (decreasing velocities and oxygenation) and interrupting sediment transport (causing deposition and channel shallowing) far outweighing any benefits; besides, neither function is presently required as the river is well oxygenated with an abundance of natural pools and good holding habitat. These structures may be passable to larger fish, especially during spate flows, but may present a significant obstacle to small adults. Considering the high proportion of small fish in the surviving population, the weirs could hinder the recovery of the trout population.

In addition to inhibiting fish movements, weirs impound the river upstream. This creates an area of deep, slow flowing water. As the flow slackens, fine sediment drops out of suspension and deposits evenly across the bed. This smothers the gravel bed and creates a uniform habitat, reducing the number and diversity of habitat niches. A uniform habitat will result in a reduction in biodiversity and ultimately a reduction in the robustness of the food web that supports the resident trout population.

Figure 8: The boulder-constructed weirs provide no useful function and could hinder the recovery of the trout population

One similar weir, downstream at Poorfield Wood near Midford, was recently partially dismantled (with EA consent). This was undertaken by hand with volunteers and took only a few hours to do. By removing boulders from the centre of the weir but retaining the sides, the structure was transformed from a weir to a 'pinch point' whereby flow is accelerated through the structure and helps to retain scour through the old weir pool below. This technique allows significant improvements to fish passage to be implemented whilst retaining good fishing at what are often favoured angling spots. Wherever possible, weirs should be removed down to bed level, thereby facilitating natural scouring and sediment transportation.

- The boulder weirs at ST 73691 57551 and ST 73650 57514 should be deconstructed in order to maximise fish passage and allow natural geomorphology to resume. Removing the central section of the weir down to the natural bed level and reinforcing the edges will create a 'pinch point' to accelerate flow through the structure and retain scour through the existing weir pool.

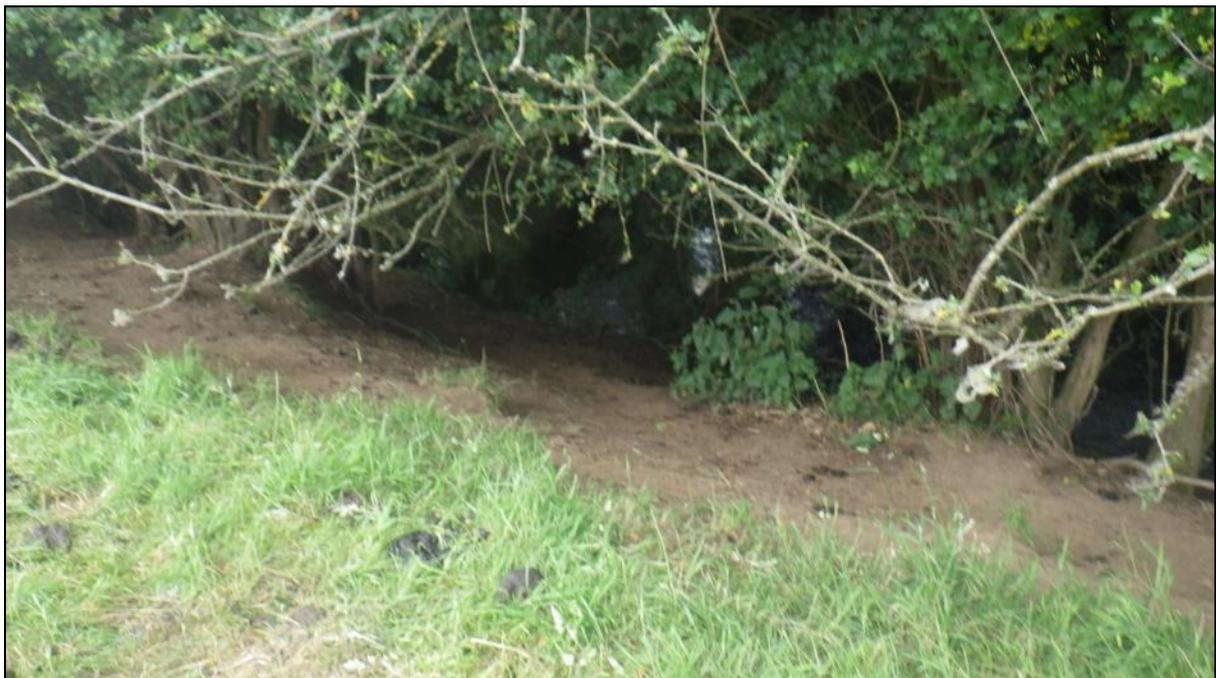
Through the middle reaches of the club's waters, where the river flows close to Littleton Lane, the land above the right bank rises steeply and is grazed by sheep. On the steep bank, grazing and sheep footfall, combined with the shade cast by bankside trees has left those banks bare of vegetation and exposed to erosion. This is likely to be a site of significant input of soil into the river, and the

quantity of fine sediment entering the river may be an important limiting factor on the success of spawning and egg survival. Consequently, reducing the volume of sediment entering the river may help recovery of the trout population, particularly as the natural sediment input on a spatey system like the Wellow, with its light alluvial soils is already likely to be high.

Figure 9: Livestock, heavy shading and steep banks combine to create a potentially significant input of soil into the river

A dialogue should be opened up with the land owner and/or tenant farmer to discuss the possibility of installing buffer fencing along the top of the bank to exclude livestock from the river. In addition, a programme of rotational tree works to allow more light onto the bank and encourage the growth of bankside vegetation to bind the soil together would be beneficial.

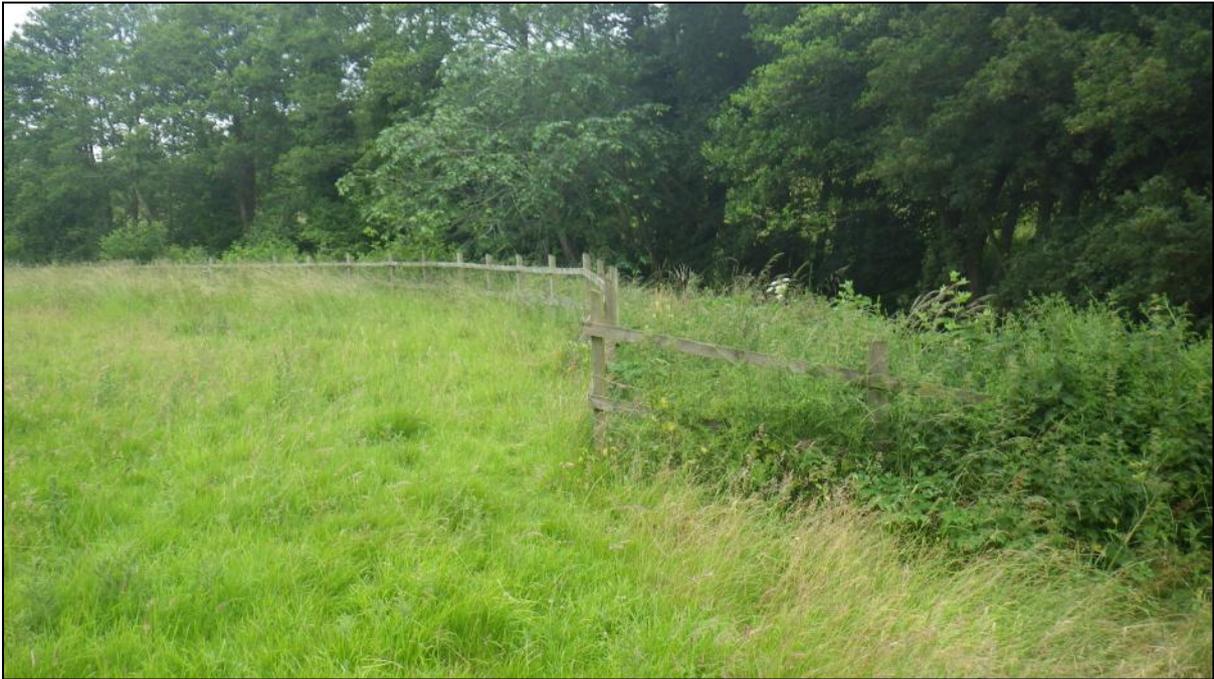
A little further upstream, a section of the river is completely fenced-off from the adjacent grazing land. The result has been the development of a densely vegetated margin. This margin is helping hold the bank together and will also acts as a filter, helping to reduce sediment input from surface run-off and provide habitat for terrestrial invertebrates. Terrestrial bugs and beetles often fall from marginal plants and low-lying branches and supplement trout diet

Figure 10: Fenced river margins allow a dense margin to develop which helps reinforce the bank and reduce sediment input

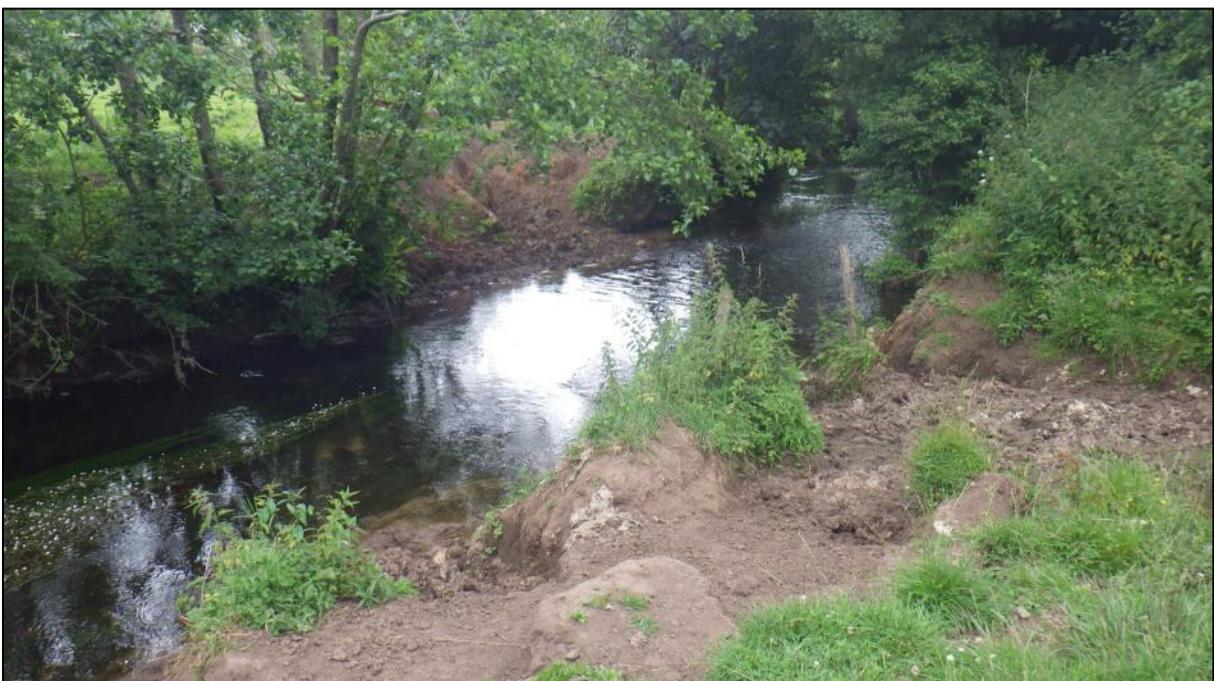
Upstream of the fenced-off reach, near the Dairy Hill Bridge, cattle accessing the river have severely poached the bank. The contrast between these two sections clearly illustrates the value of a well-fenced bank.

Figure 11: Severely cattle-poached banks are vulnerable to erosion and input sediment into the river

Bank poaching can be a significant point-source of excess sediment and left unchecked can often cause the river to become over-wide and slow flowing. However, poached banks are not necessarily always bad for the river. A little poaching can introduce some shallow gradient habitat that can often be absent from steeply incised rivers. These shallow margins can be an important habitat for fry and for certain invertebrate and plant species. The creation of occasional formal, fenced cattle drinks, perhaps excavated slightly back from the river, may be beneficial. Examples of formal cattle drinks and alternative livestock-watering options are explored in the *Recommendations* section.

- Where grazing and bank poaching is a problem, engage with local land owners/farmers to explore options for fencing off the banks. The construction of formal cattle drinks which allow much more controlled access to the river could help to limit bank erosion and sedimentation.
