WILD TROUT TRUST

River Went

(Upstream of Ackworth School Phase 1 Works)

12/10/2020

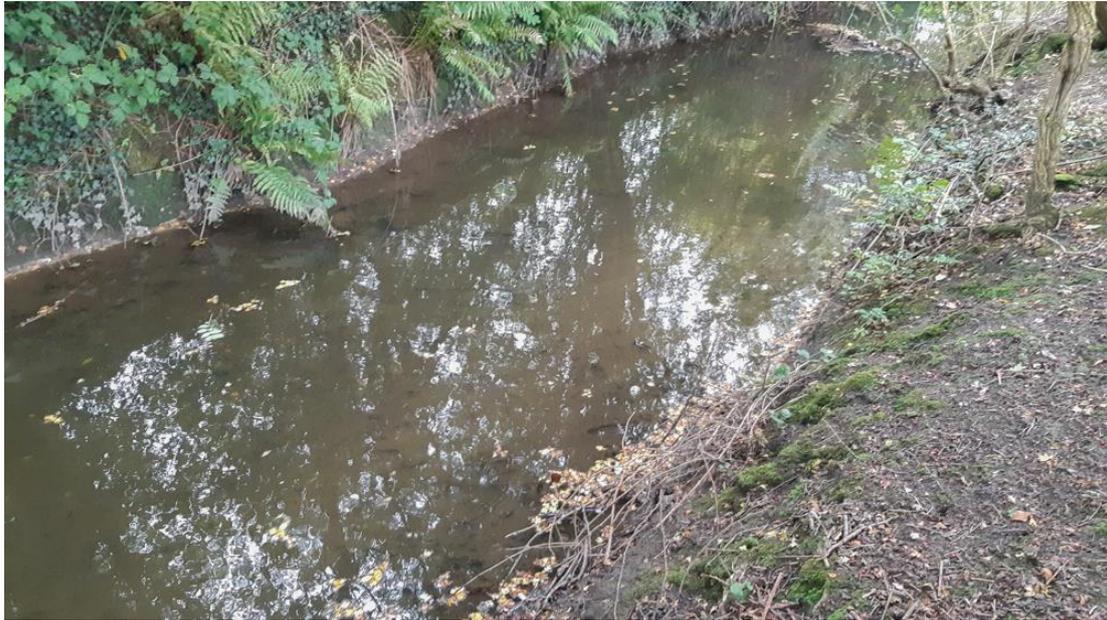
Figure 2: Typical example of muddy/clay dominated stream bed – with no spawning habitat available

The legacy of mining activities means that potential spawning gravel substrate is in extremely short supply within the Went – and this section is no exception to that pattern (Figs. 2 and 3)

Viewed in the most positive terms, there is a clear opportunity to improve the potential for full lifecycles of gravel-spawning species via appropriate introduction of gravels. Furthermore, there will be fewer restrictions upon the timing of such works – due to an absence of breeding fish to disturb during what would, typically, be breeding season for UK native trout.

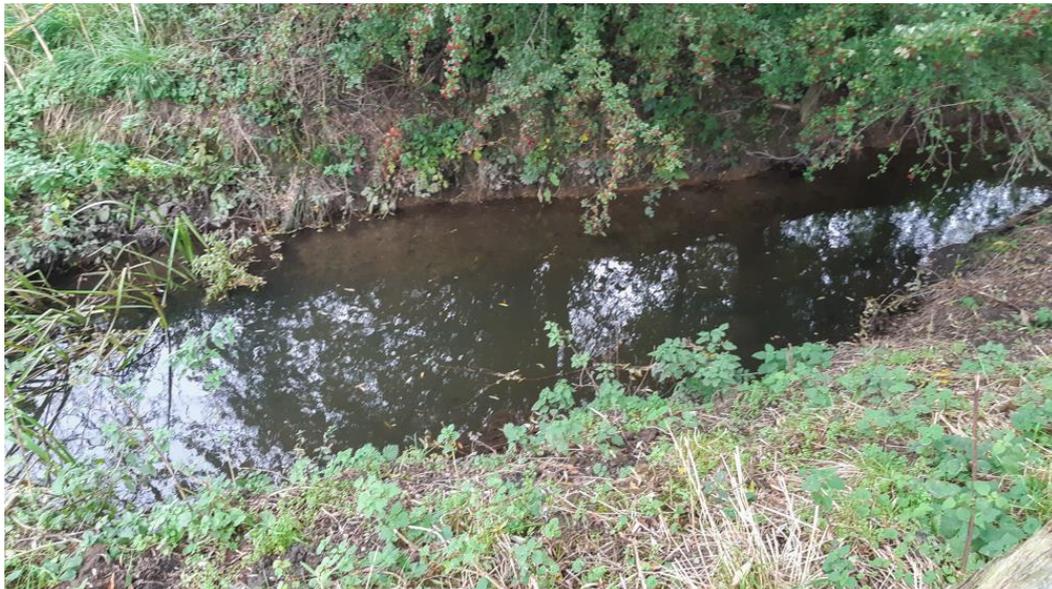
Figure 3: Another example of the lack of spawning gravels available for salmonid fish

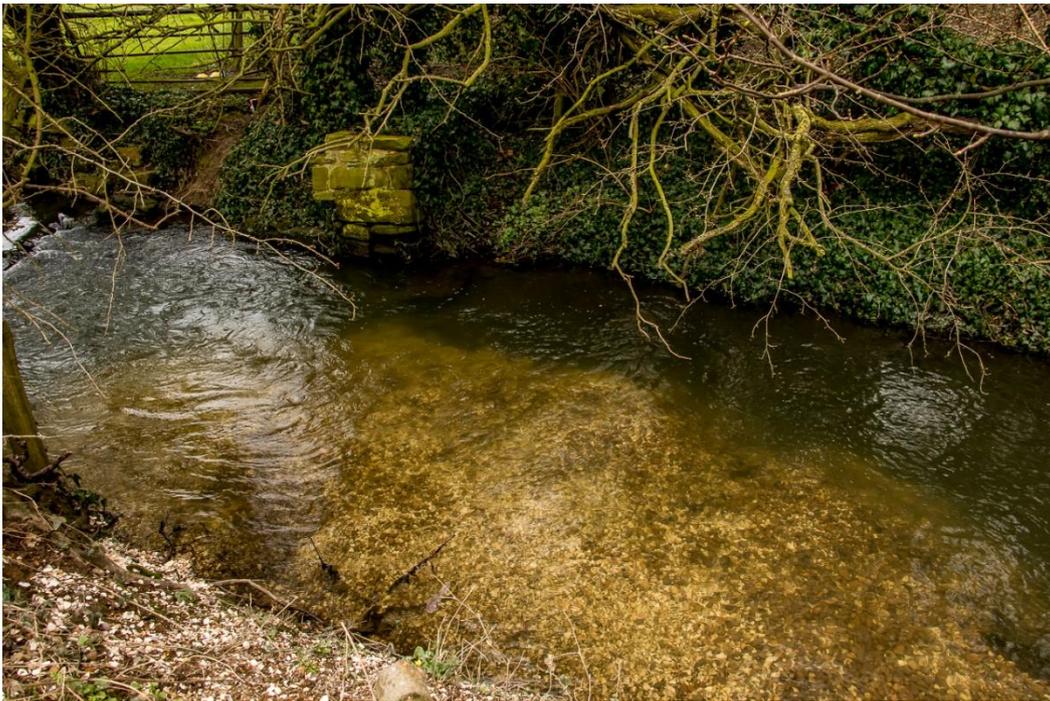
Figure 4: Previous spawning gravel introduction at Ackworth School

As well as gravel introductions (in line with previous, successful works just below the downstream limit of the reach considered in this report; Fig. 4); introduction and secure anchoring of natural woody material will be beneficial (e.g. Figs. 5 and 6 from the phase 1 works at Ackworth School)

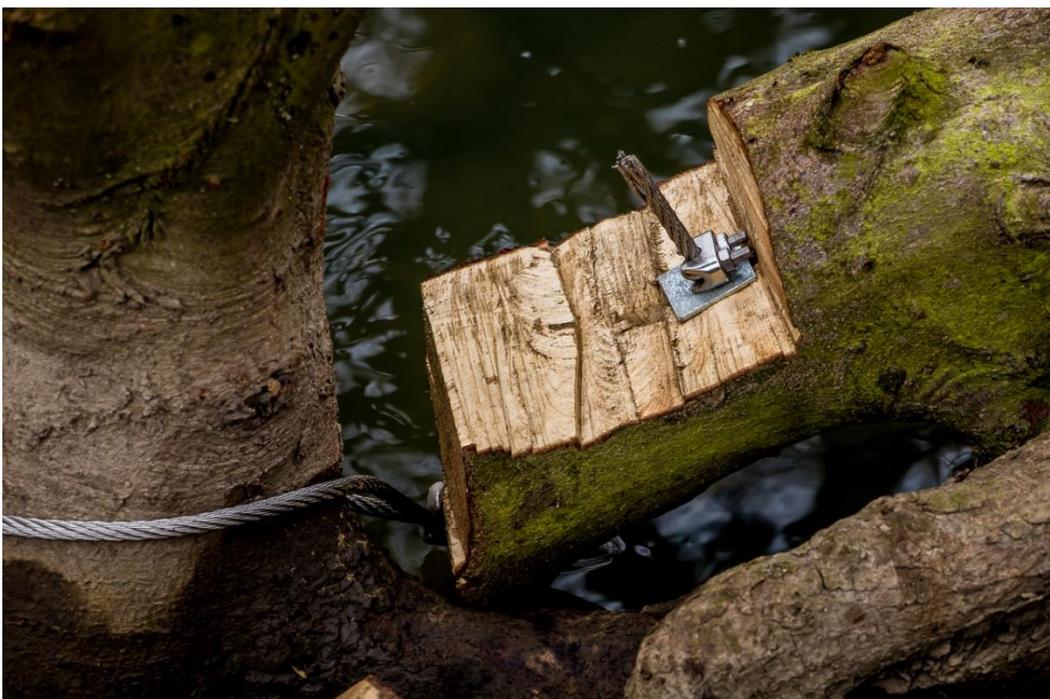
Figure 5: Steel cable anchoring a tree crown in the Went next to Ackworth School

In terms of secure anchoring, cost-effectiveness and natural appearance and function, cabled tree crowns are a very good option. This will also enable some very light-touch restructuring of the riparian tree canopy. That will create greater diversity in the light/shade regime. At the same time, existing substantial natural cover (e.g. Fig. 6) should be retained.

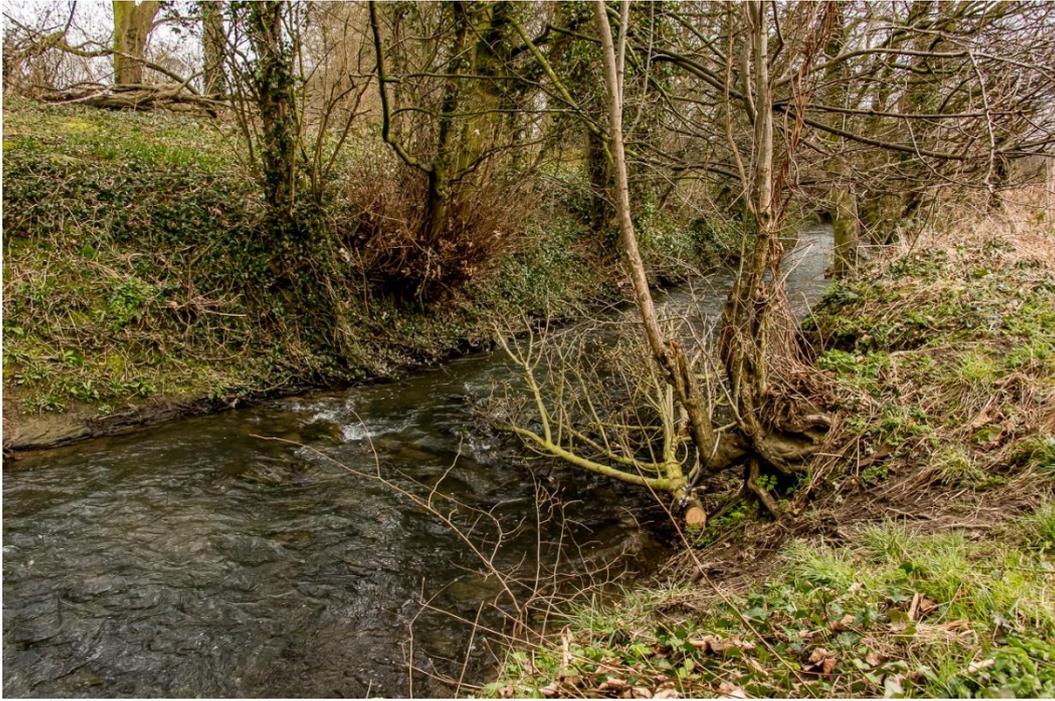
Figure 6: Anchored tree crown – sometimes called a “tree kicker” installation

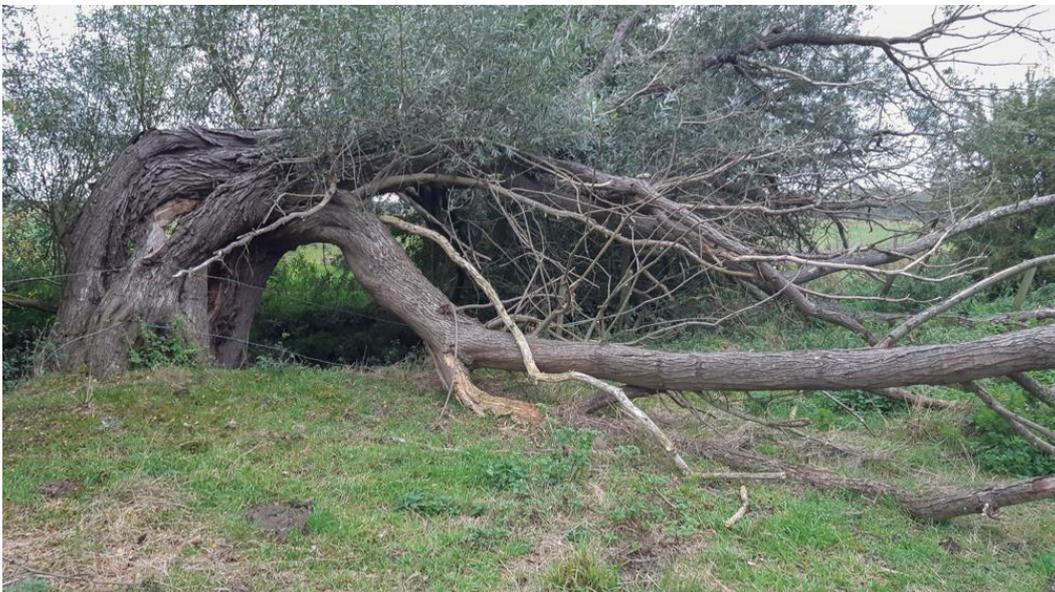
Figure 7: Retaining the portions of this fallen tree that do not compromise the stock-exclusion fence is a positive contribution to habitat quality

At the same time, tree limbs that damage (or prevent the reinstatement) of fencing should be removed. The re-instatement of stock-exclusion fencing would be a positive benefit to the riparian vegetation and in-stream habitat throughout the visited reach.

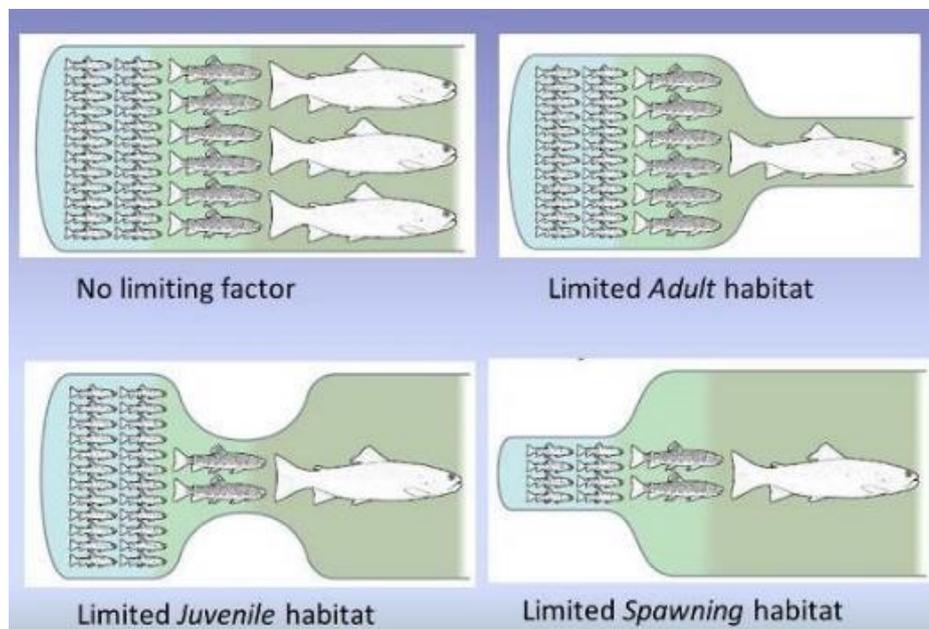
Figure 8: The impacts on trout populations lacking adequate habitat for key lifecycle stages. Spawning trout require loose mounds of gravel with a good flow of oxygenated water between gravel grains. Juvenile trout need shallow water with plenty of dense submerged/tangled structure for protection against predators and wash-out during spates. Adult trout need deeper pools (usually > 30cm depth) with nearby structural cover such as undercut boulders, sunken trees/tree limbs and/or low overhanging cover (ideally trailing on, or at least within 30cm of, the water's surface). Excellent quality in one or two out of the three crucial habitats cannot make up for a "weak link" in the remaining critical habitat.

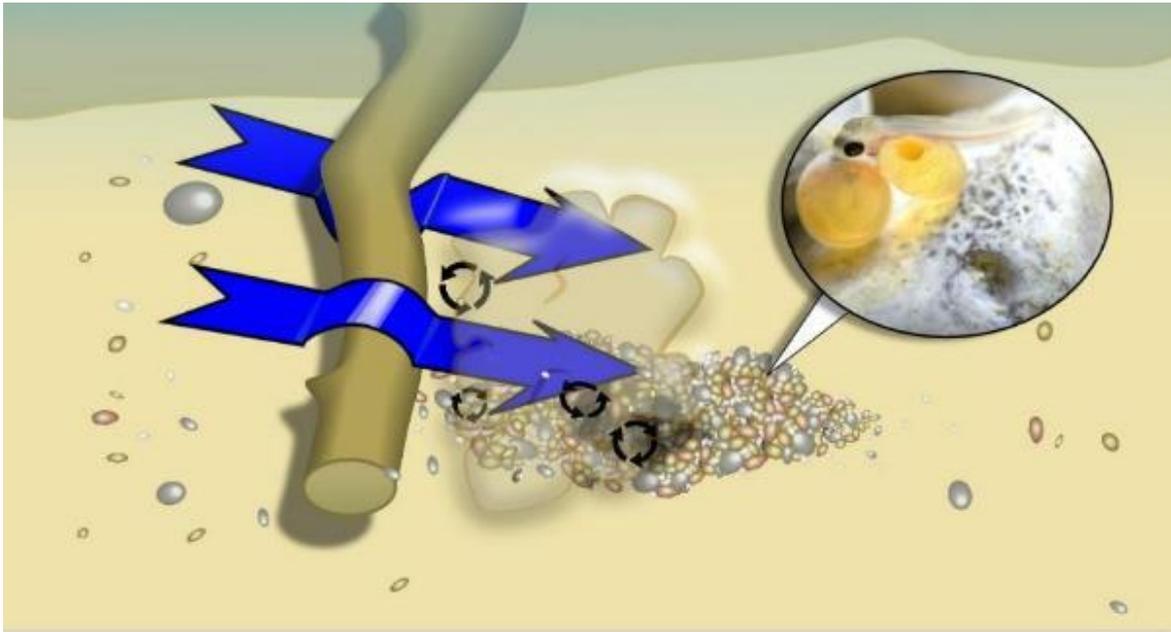
Figure 9: Features associated with successful trout spawning habitat include the presence of silt-free gravels. Here the action of fallen tree limb is focusing the flows (both under and over the limb as indicated by the blue arrows) on a small area of river-bed that results in silt being mobilised from between gravel grains. A small mound of gravel is deposited just downstream of the hollow dug by focused flows. In these silt-free gaps between the grains of gravel it is possible for sufficient oxygen-rich water to flow over the developing eggs and newly-hatched "alevins" to keep them alive within the gravel mound (inset) until emerging in spring.

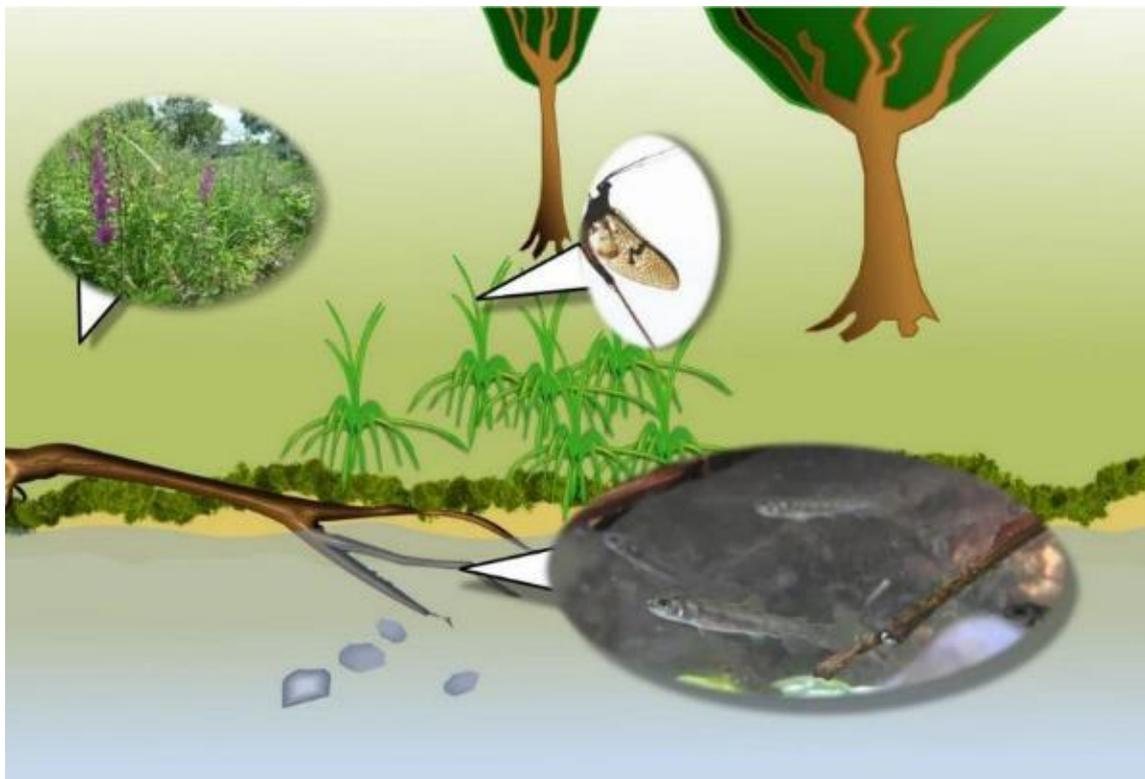
Figure 10: Larger cobbles and submerged "brashy" cover and/or exposed fronds of tree roots provide vital cover from predation and spate flows to tiny juvenile fish in shallower water (<30cm deep). Trailing, overhanging vegetation also provides a similar function and diverse bank-side vegetation has many benefits for invertebrate populations (some of which will provide a ready food supply for the juvenile fish).

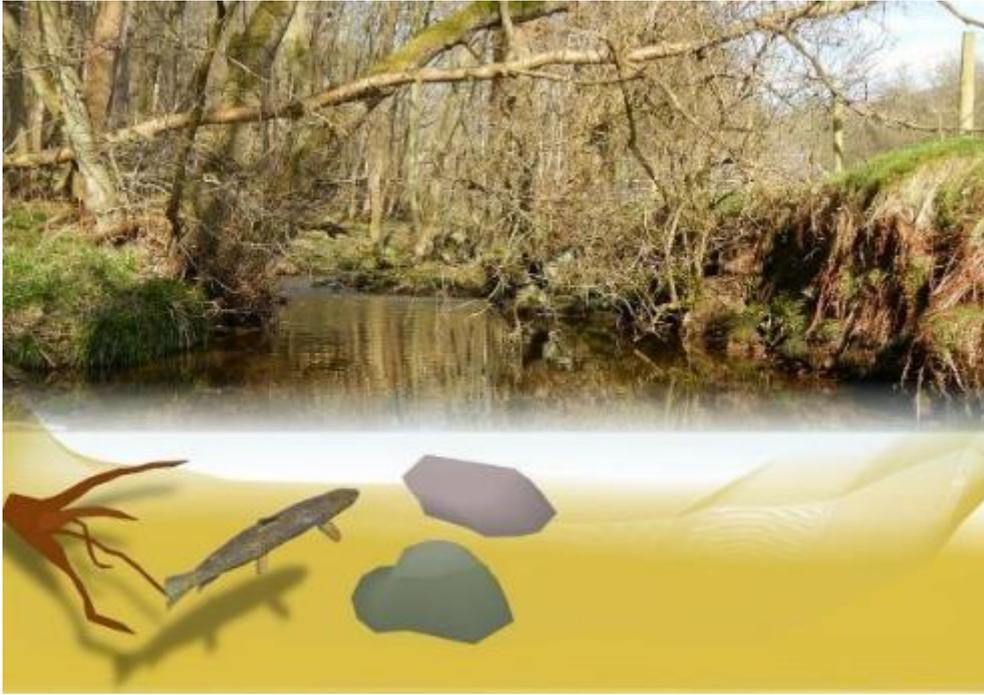
Figure 11: The availability of deeper water bolt holes (>30cm to several metres), low overhanging cover and/or larger submerged structures such as boulders, fallen trees, large root-wads etc. close to a good food supply (e.g. below a riffle and with prey likely to fall from overhanging tree canopy in this case) are all strong components of adult trout habitat requirements.
