**ADVISORY VISIT TO THE RIVER WEY,
SURREY,
UNDERTAKEN BY VAUGHAN LEWIS,
WINDRUSH AEC LTD, ON BEHALF OF
FARNHAM ANGLING SOCIETY
MAY 2007**

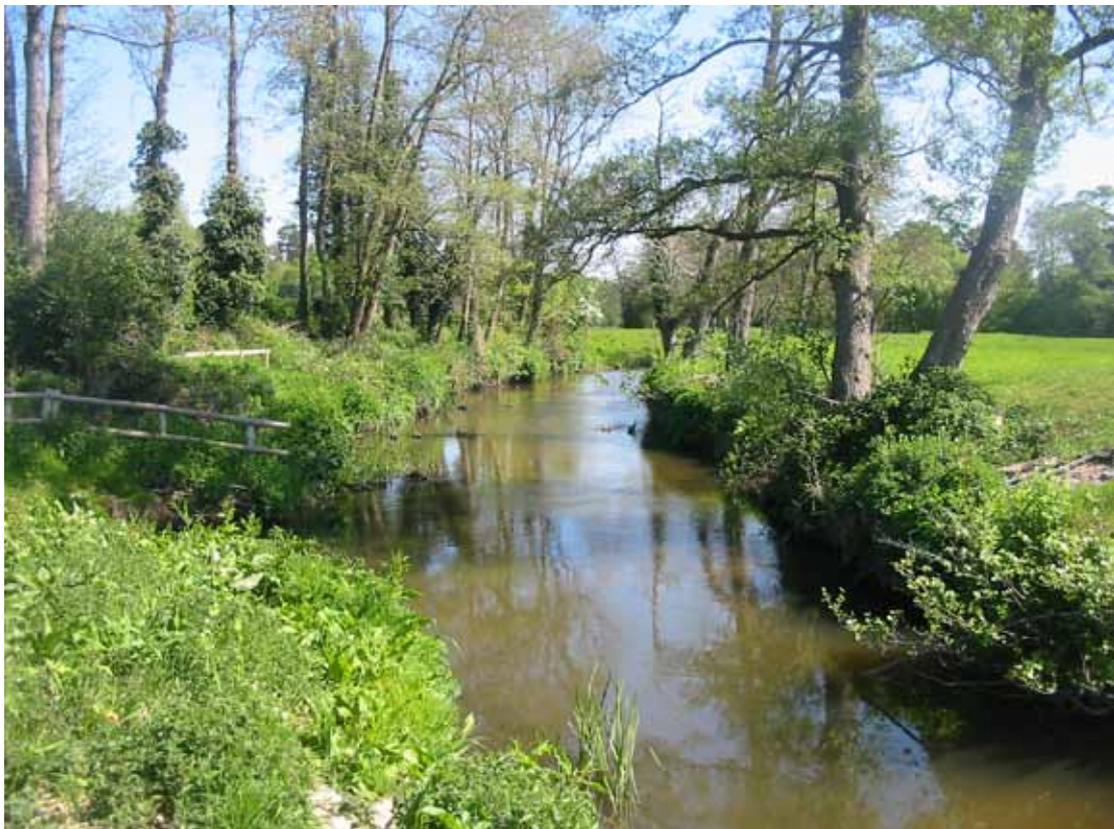
The river ran through greensand dominated geology. The river had a strongly meandering course. There was a well-developed pool-riffle regime, with significant lengths of shallow and deep glide also present. The substrate was dominated by fine, mobile sand. In places, this was very deep, with any gravel present in the riffle areas heavily coated with sand. It was very likely that there was significant entrainment of fine sand within the gravel matrix, reducing its value for spawning brown trout.

Typical section of the River Wey at Frensham

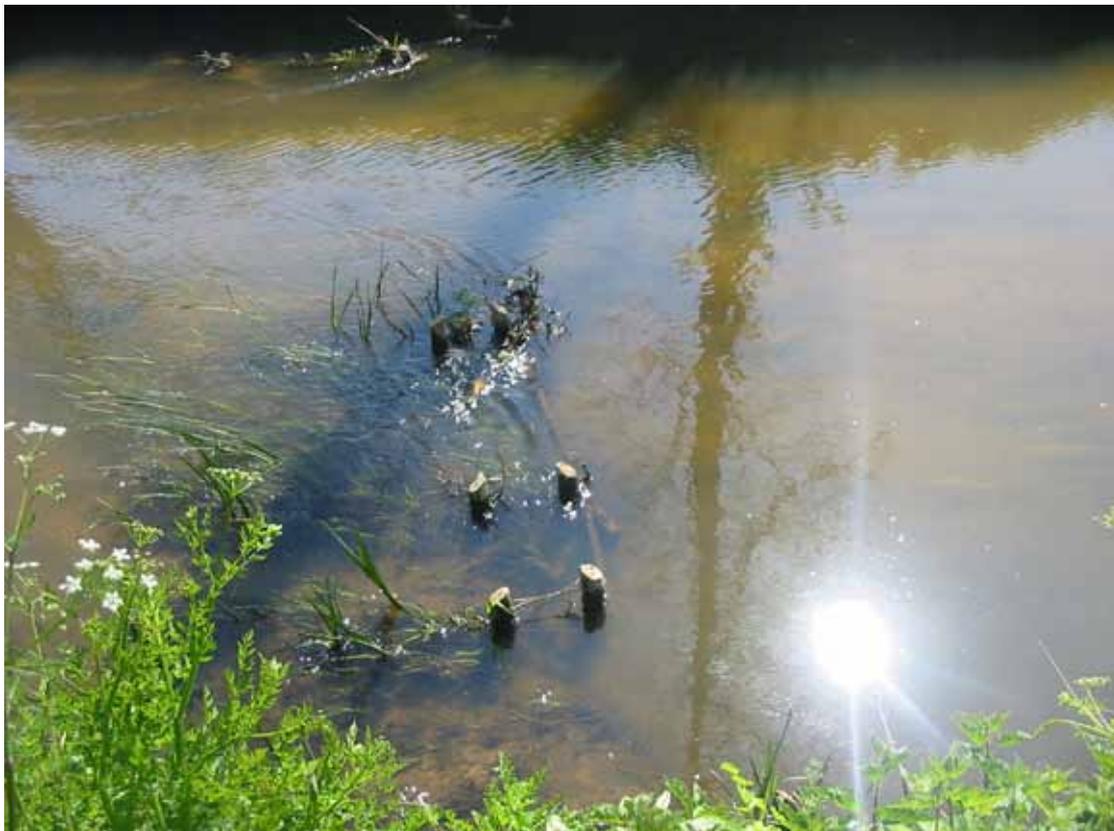
Some basic deflectors had been installed by the Environment Agency a few years ago. These had been constructed pointing downstream with the result that there had been some bank erosion, leaving the groynes remote from the bank.

Wooden groyne

- If it proves possible to reduce grazing pressure on the riverbanks, either by fencing or other mechanisms, then it would be possible to improve instream habitat by the introduction of Large Woody Debris deflectors, in the form of tree trunks/large limbs arising from coppicing of the alder trees. **NO WORK OF THIS NATURE SHOULD BE CONTEMPLATED UNLESS THE OVER-GRAZING ISSUE IS RESOLVED AS THE UNVEGETATED BANKS WOULD BE VERY PRONE TO EXCESSIVE EROSION.** Trunks should be placed on the inside of bends facing upstream with their end securely keyed into the bank to prevent erosion at this vulnerable location. Wooden stakes and wire should be used to hold the LWD in the channel. Alternatively, smaller, upstream paired 'v' groynes could be used to promote scouring of mid-channel pools.

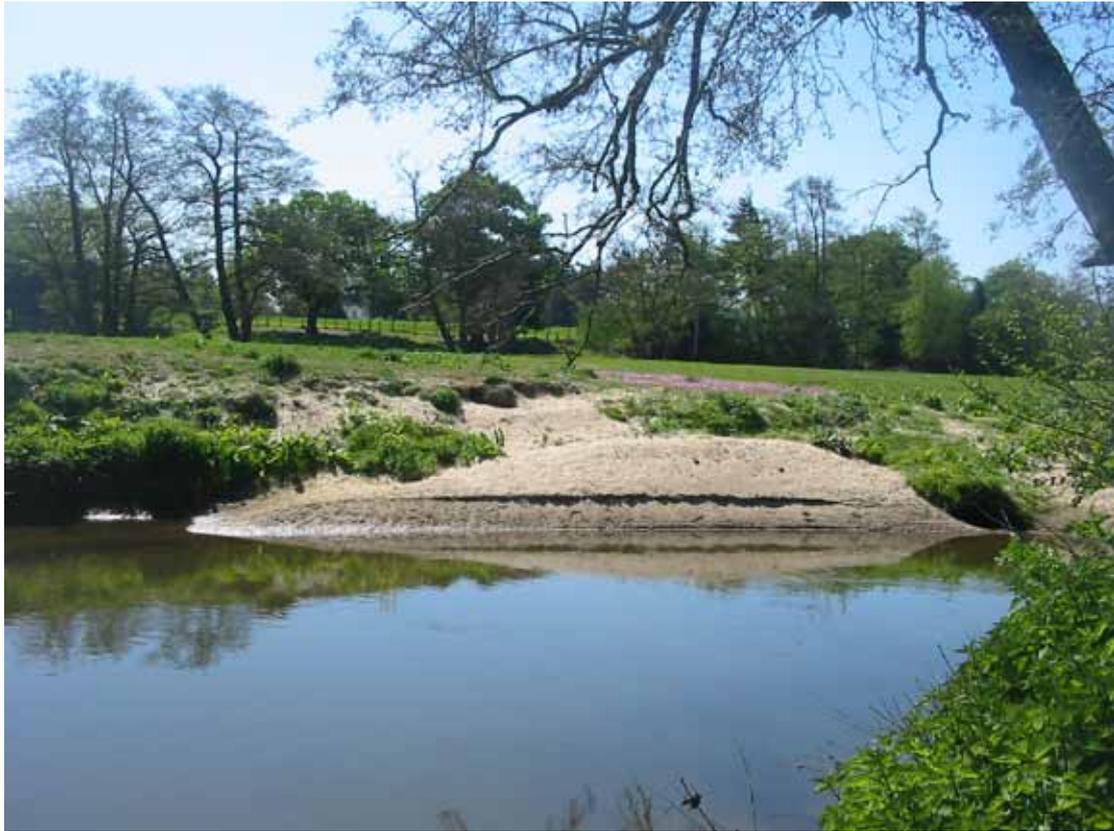
Surrounding land use was dominated by improved pasture for stock grazing. Extensive and severe bank erosion was visible as a result of overgrazing, with sections of exposed sand visible. There was clear evidence of large inputs of sand into the channel, with much of its bed heavily coated with sand.

Exposed banks of sand caused by excessive grazing pressure

- At a local level, there was clear evidence of overgrazing of the riverbanks. Damage resulting from this was all too obvious; sections of bank were devoid of vegetation with extensive areas of exposed sand apparent. Casual observation of the riverbed revealed huge tracts dominated by fine sand with little submerged vegetation or gravel remaining visible. It is imperative that protection is given to both banks from agricultural stock, along the length of the fishery. **WITHOUT THIS HAPPENING THERE IS LITTLE PROSPECT OF LONG TERM IMPROVEMENT TO THE INSTREAM AND RIPARIAN HABITAT OF THE RIVER OR TO THE FISH STOCKS THAT IT HOLDS.** The sediment will also be affecting a range of macroinvertebrate and macrophyte species, and will prejudice attempts by the EA and others to meet biodiversity targets for the river.

- Protection from grazing stock can be achieved in a number of ways. Standard 3 barbed wire strand and post fencing can be erected to prevent stock accessing the banks. Cost of this option would be in the region of £4/linear metre. Alternatively, temporary electric fencing could be erected during the periods when grazing animals will occupy the field. Whatever system is adopted, it is important that an adequate width of grass is fenced off. Ideally, this would be at least 5m from the top of the riverbank. This width would allow for the partial control of sediment in any run-off from the land, and would also allow for a degree of erosion to take place whilst the damaged vegetation is re-establishing. If insufficient buffer width is left between the riverbank and fence, there is a real risk that erosion will reach the fence before protective vegetation has re-established. Compensation payments could be made to the farmer for any loss of grazing occasioned by the new fence. It will also be necessary to include suitably designed stock watering areas within each field. There are a number of illustrations pre and post erection of riparian fencing shown in the Wild Trout Survival provided with this visit.

Alternative mechanisms for the protection of the banks centre on changes to the present management. These include managing the fields for hay or silage, with aftermath grazing by sheep using electric fencing to prevent access to the water. A final alternative would be for the club to rent or buy the grazing, allowing it to control the grazing pressure and hence erosion of the banks. This system would only work if the fields in question were surplus to requirements for the present farming regime. Present grazing rents would be expected to be in the region of £100/ha, with agricultural land values of around £10,000/ha.

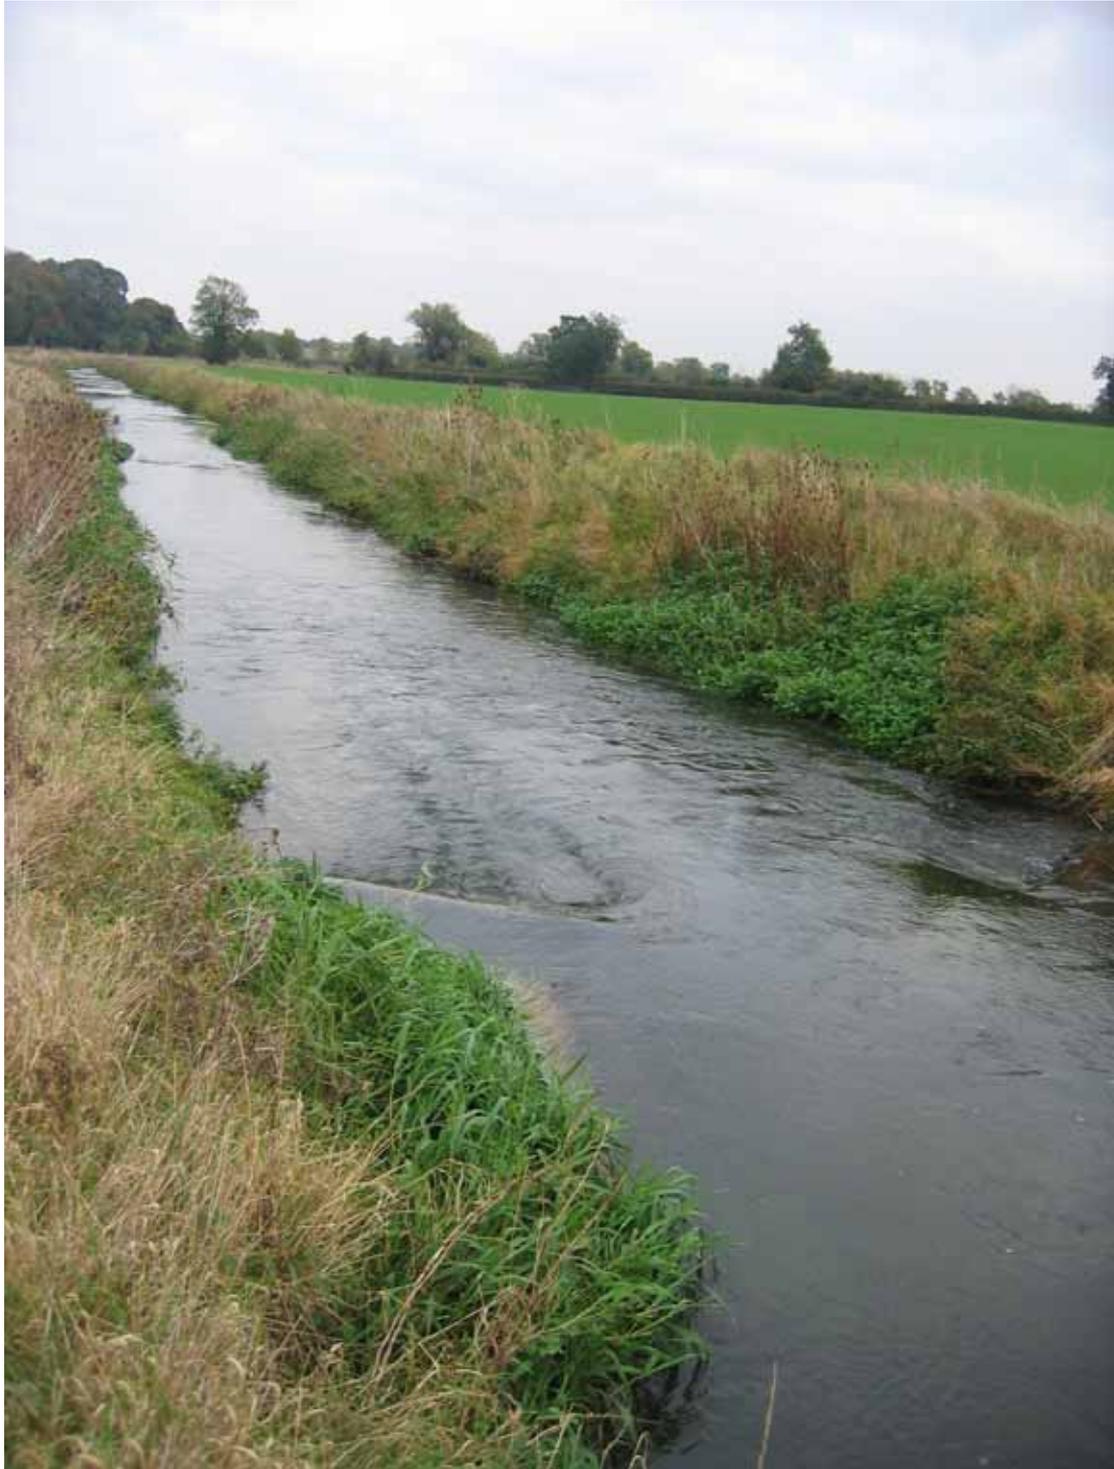
Upstream facing ‘v’ groyne in a small river
