## River Wey – Headley Wood Farm

An advisory visit carried out by the Wild Trout Trust – December 2008

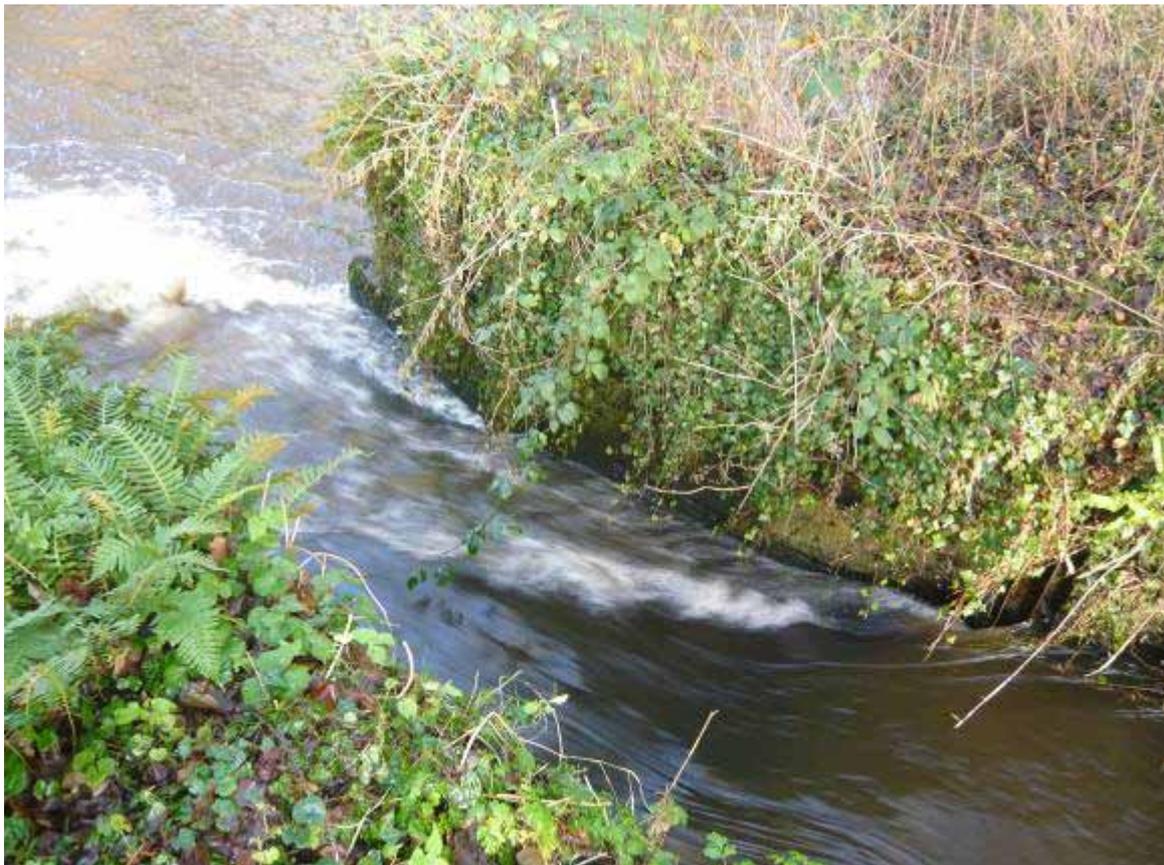
The section inspected was from the bottom boundary of the fishery up to the access road which roughly represents the bottom half of the fishery. This section is bisected by a low weir just upstream of the adjacent lake. This is an old structure and the river bed upstream has largely re-graded to form good quality holding water. Unusually, the section upstream of the structure is generally regarded as one of the most productive sections of the fishery.

Old weir halfway along the beat

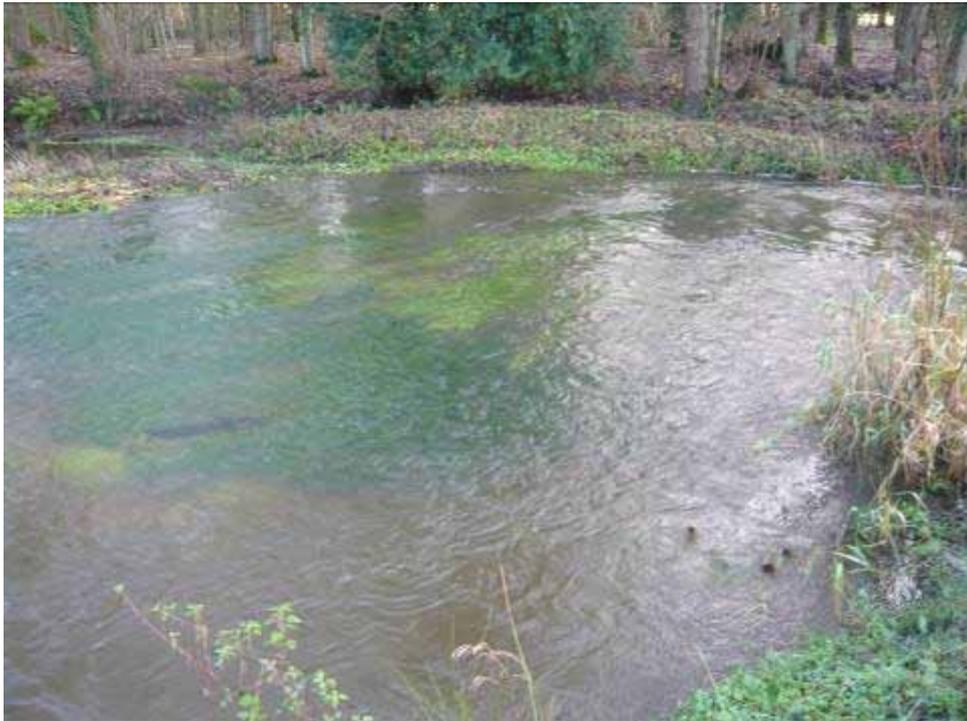
A wide shallow riffle near the bottom of the fishery. Good juvenile trout habitat

Some spawning will be taking place on those comparatively short sections of gravel riffle and glide that are present. Time spent cleaning these known sites in October may well give a significant boost to your local trout production.

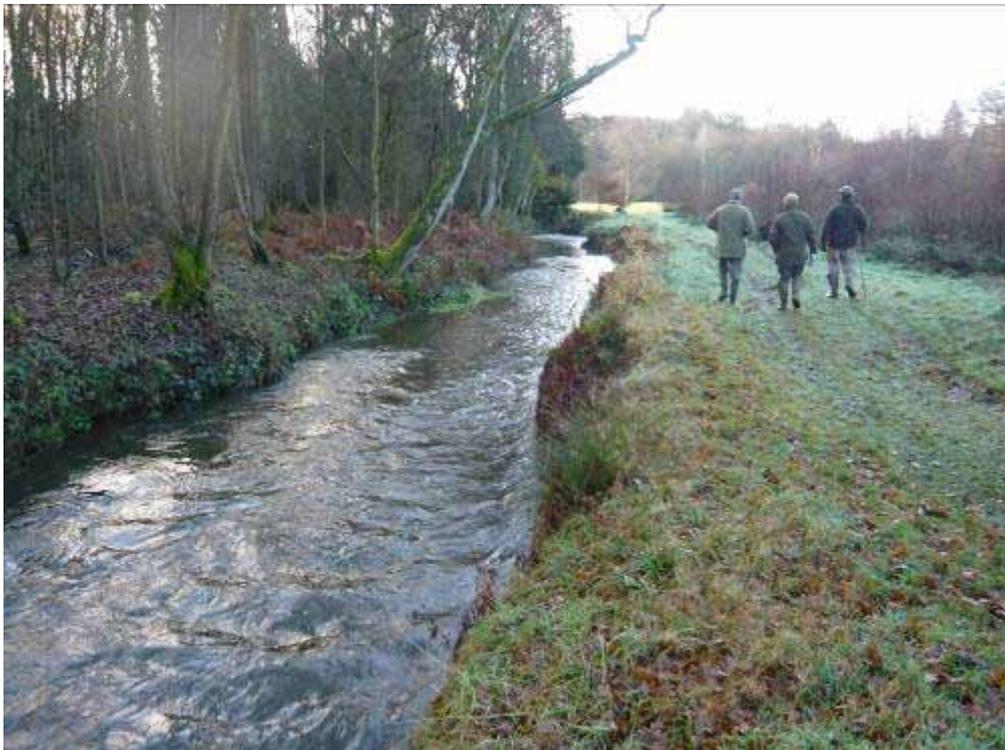
A good steep gradient but very little in-channel cover

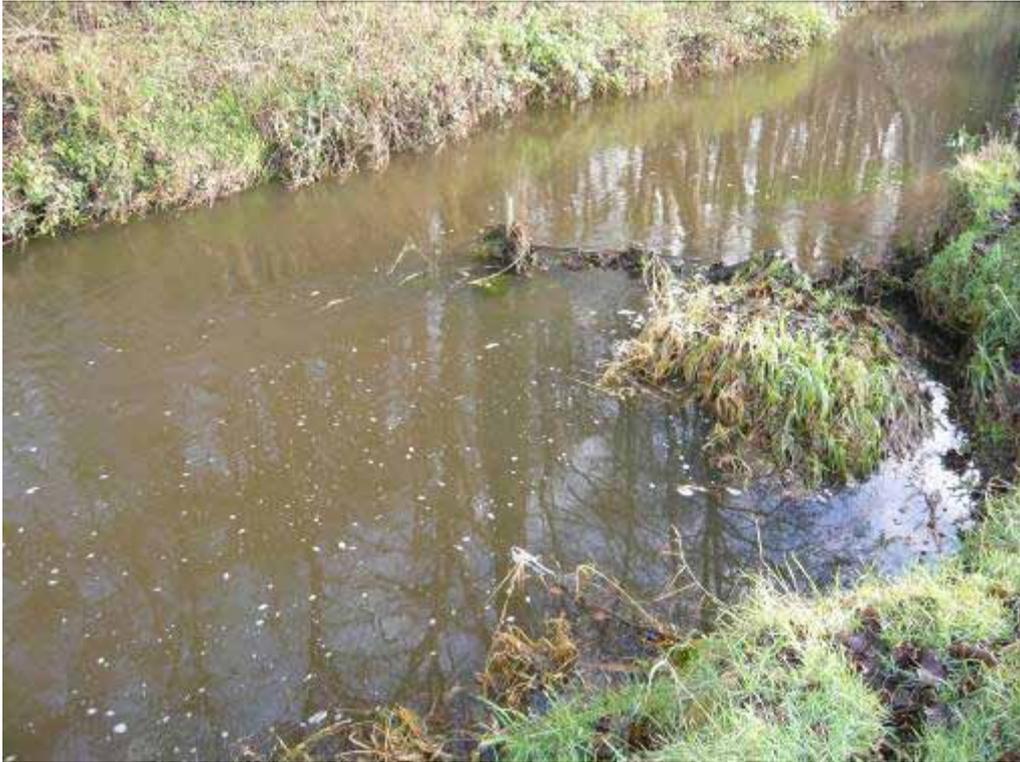
A post and chicken wire flow deflector. Deflectors pointing downstream can make the channel even wider

The series of chicken wire groynes currently installed are unsightly and poorly located. Structures pointing downstream will promote scour likely to undermine the banks and make the channel even wider. These groynes should be removed and replaced with one or two tree trunks pinned to the bank and bed. Details on this and other lowland river habitat restoration techniques can be found in the WTT Chalkstream habitat manual.

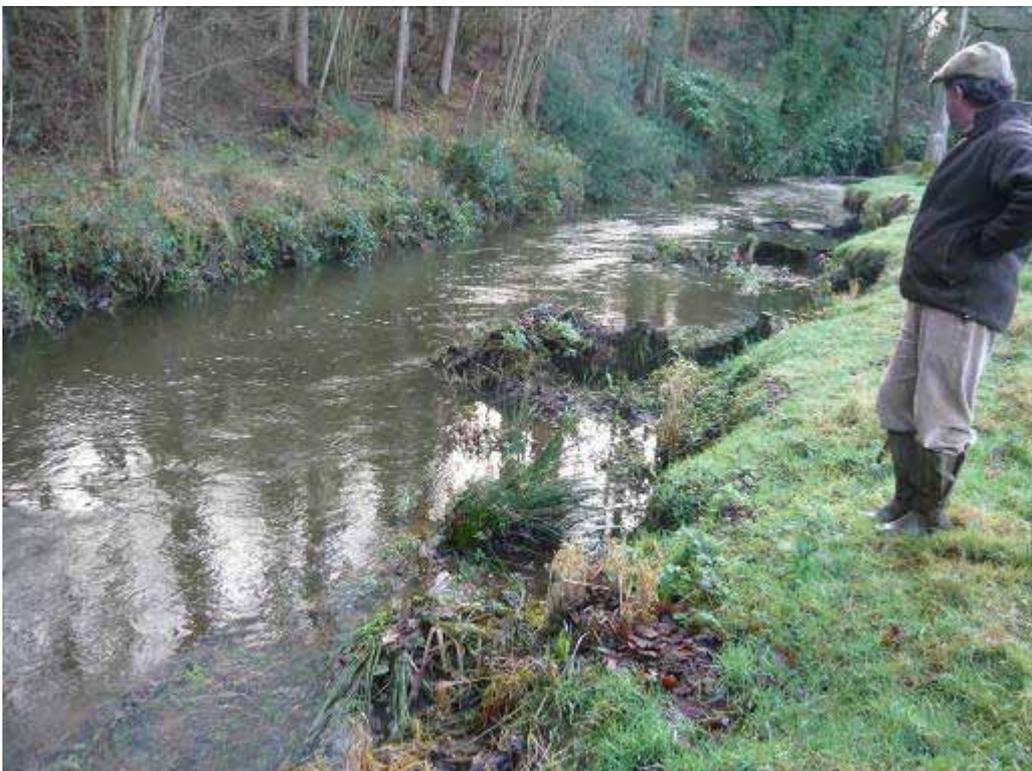
A series of chicken wire groynes. Some habitat has been created but better results can be achieved with tree trunk deflectors.

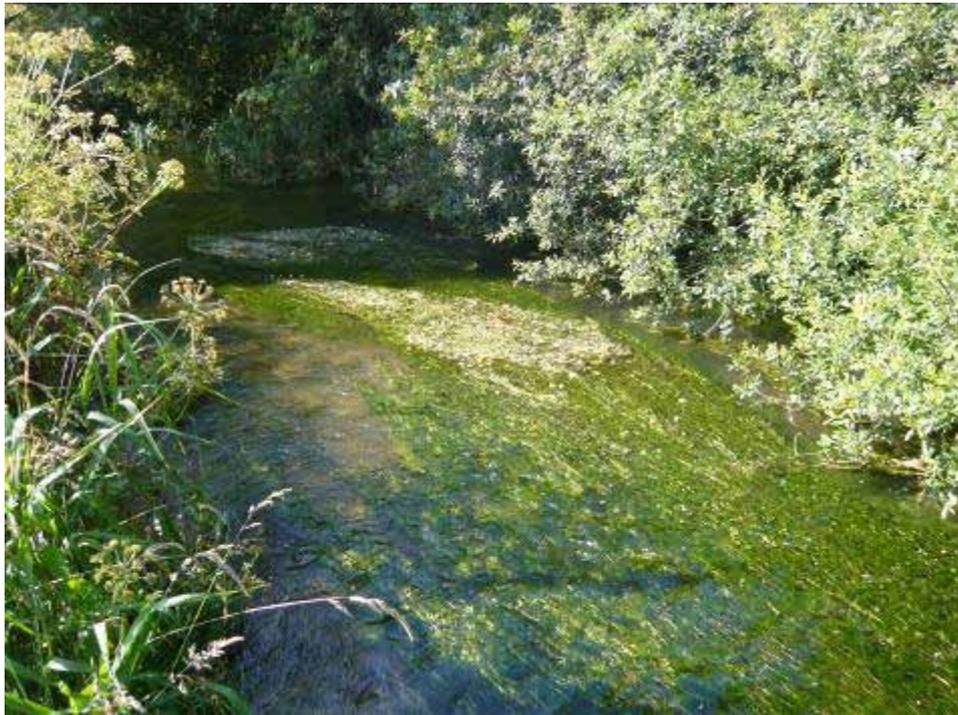
A goat willow fringed margin on the Meon. This will provide cover even in the winter.

Winter marginal cover is very scarce. A programme coppicing back tall plantation trees and planting small shrubby willows will provide the ideal combination of dappled light and shade favoured by wild trout.

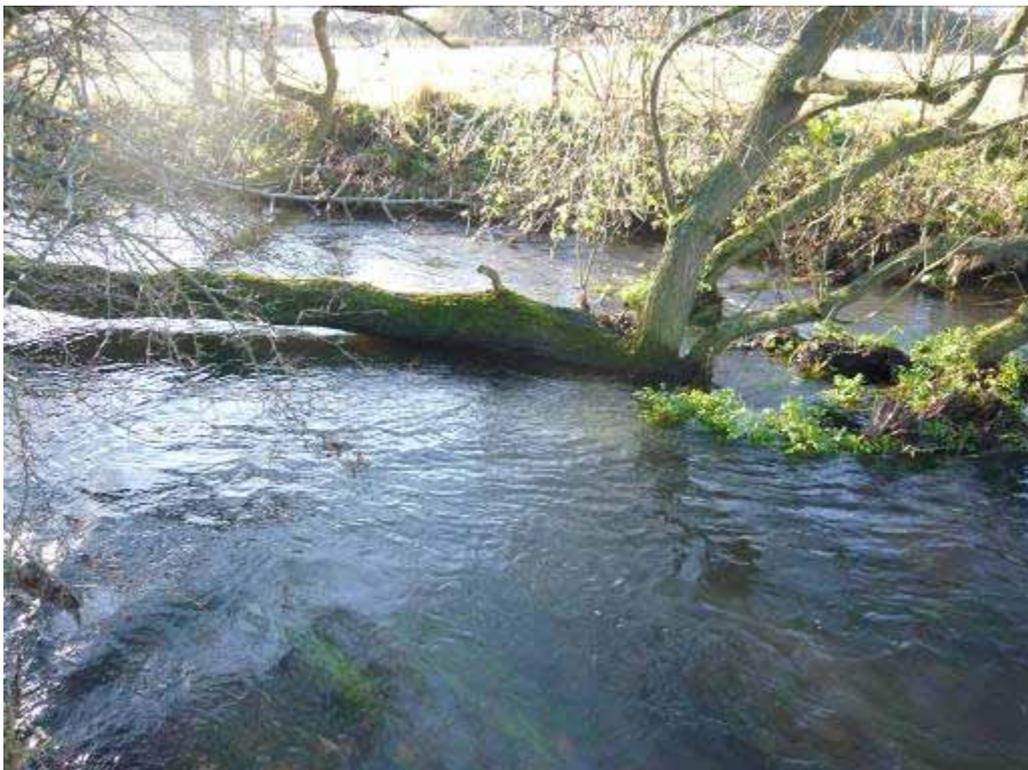
A good example LWD in the River Itchen. Water hitting the underside of this live willow will be forced down creating a fantastic lie for adult trout and blowing up gravels into a spawning riffle downstream.

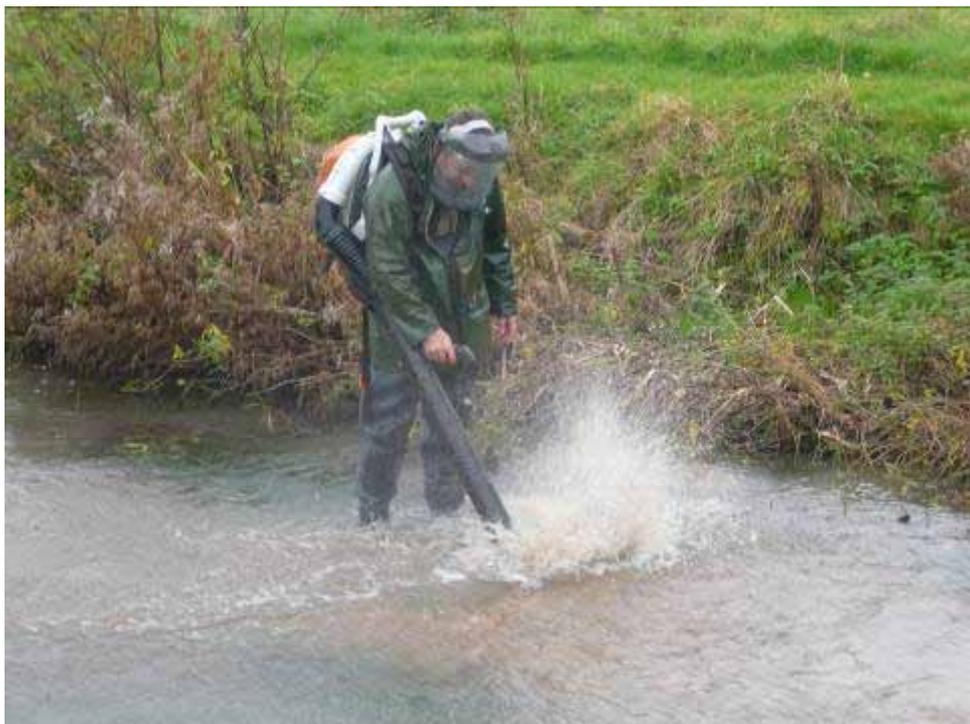
Gravel cleaning using a backpack leaf blower.
