River Wey – Headley Wood Farm

An advisory visit carried out by the Wild Trout Trust – December 2008

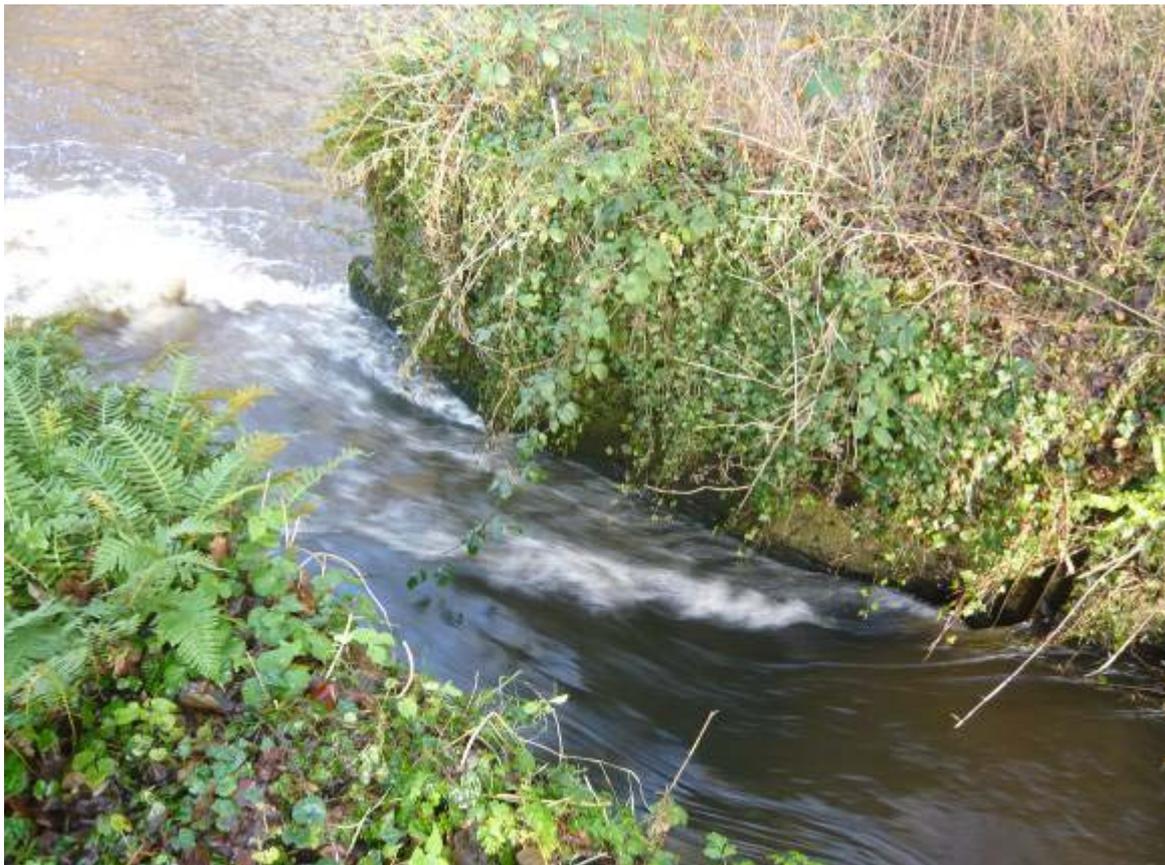
The section inspected was from the bottom boundary of the fishery up to the access road which roughly represents the bottom half of the fishery. This section is bisected by a low weir just upstream of the adjacent lake. This is an old structure and the river bed upstream has largely re-graded to form good quality holding water. Unusually, the section upstream of the structure is generally regarded as one of the most productive sections of the fishery.

Old weir halfway along the beat

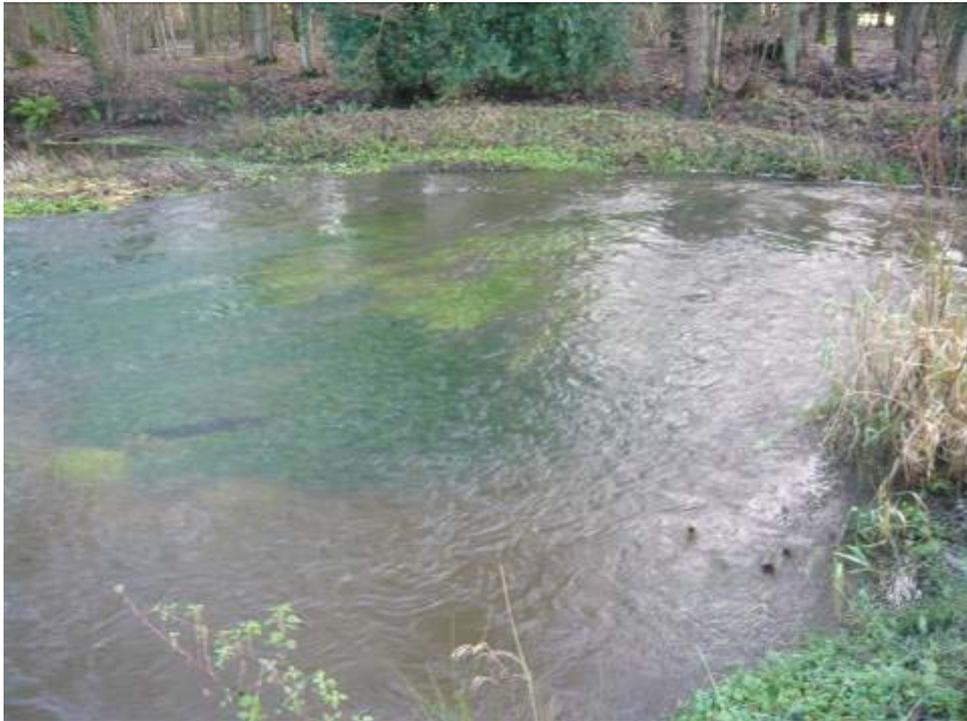
A wide shallow riffle near the bottom of the fishery. Good juvenile trout habitat

Some spawning will be taking place on those comparatively short sections of gravel riffle and glide that are present. Time spent cleaning these known sites in October may well give a significant boost to your local trout production.

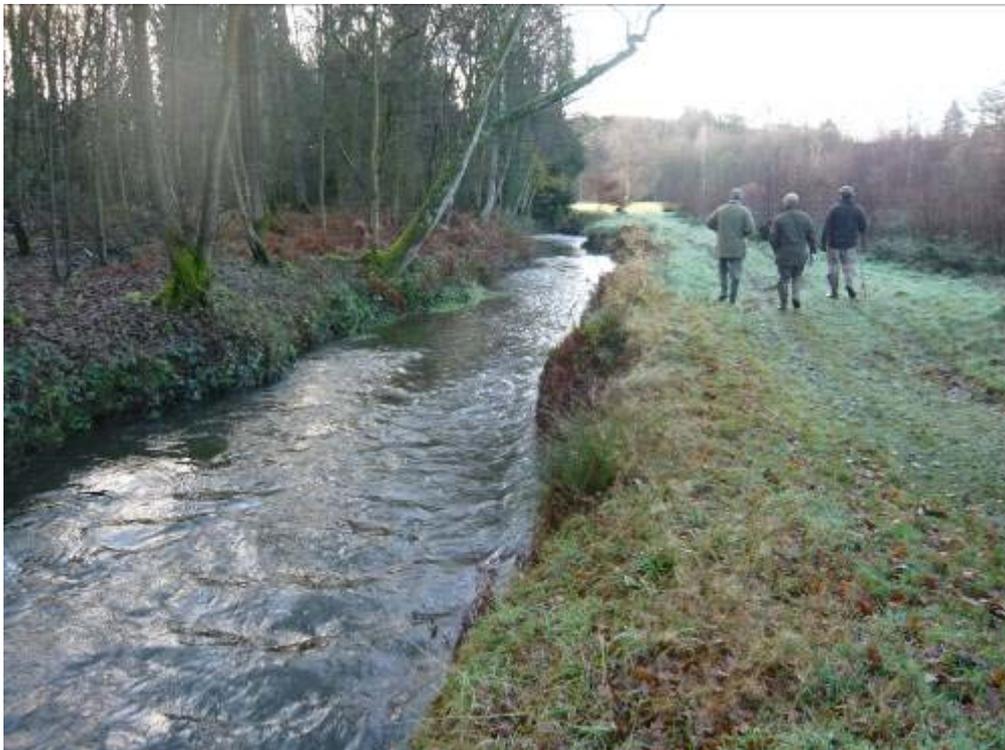
A good steep gradient but very little in-channel cover

The Wey at Headley Wood Farm is ideally located to benefit from displaced juvenile trout looking for good holding water. Breaking up the areas of smooth laminar flow with imported LWD will create more attractive holding areas and provide a primary source of food and habitat for invertebrates.

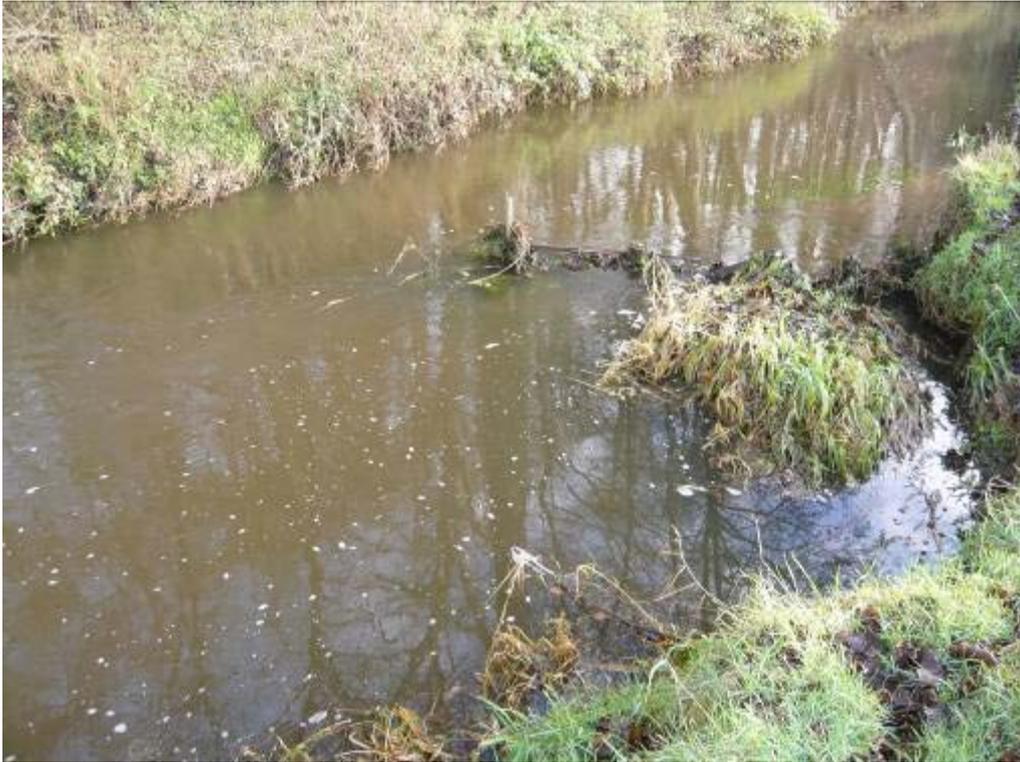
A post and chicken wire flow deflector. Deflectors pointing downstream can make the channel even wider

The series of chicken wire groynes currently installed are unsightly and poorly located. Structures pointing downstream will promote scour likely to undermine the banks and make the channel even wider. These groynes should be removed and replaced with one or two tree trunks pinned to the bank and bed. Details on this and other lowland river habitat restoration techniques can be found in the WTT Chalkstream habitat manual.

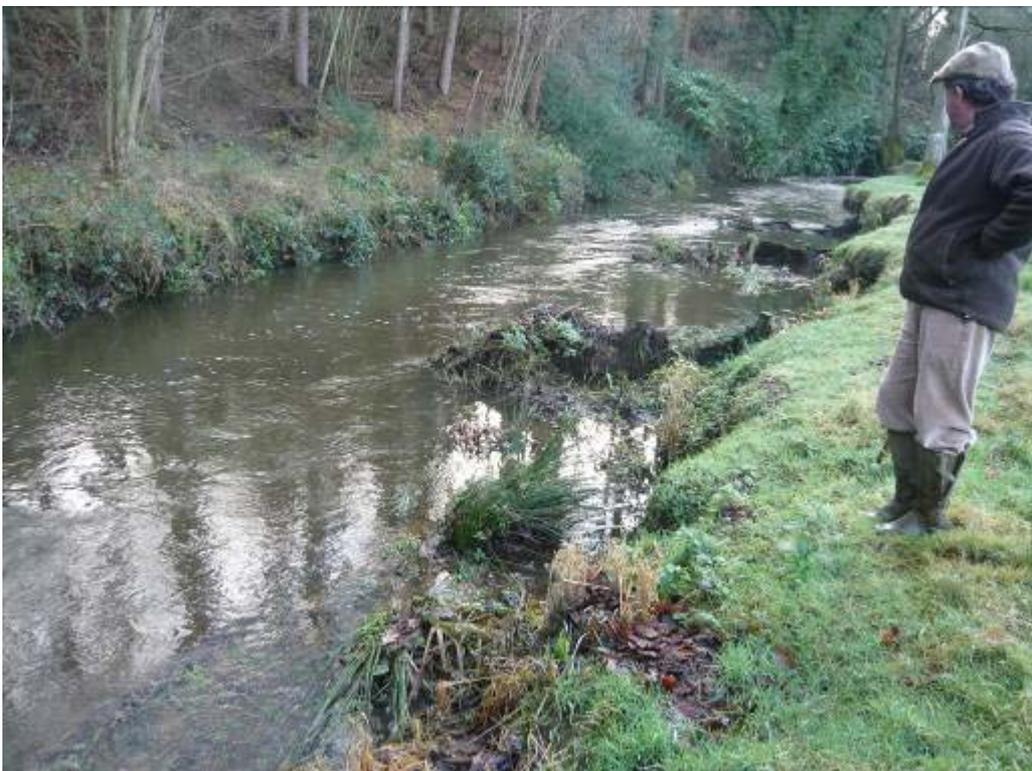
A series of chicken wire groynes. Some habitat has been created but better results can be achieved with tree trunk deflectors.

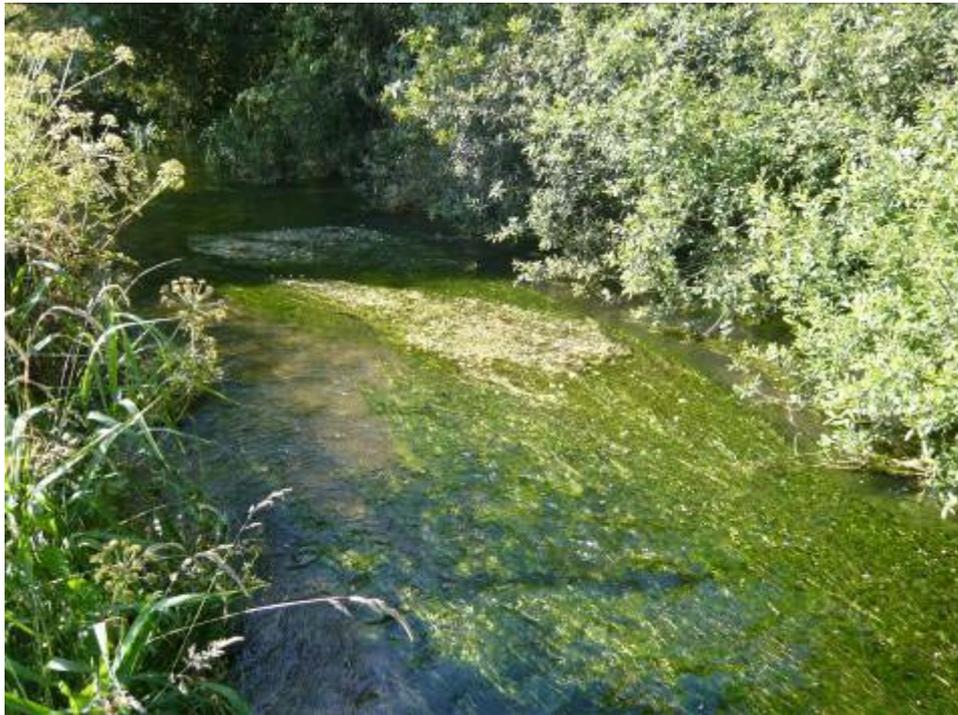
A goat willow fringed margin on the Meon. This will provide cover even in the winter.

Winter marginal cover is very scarce. A programme coppicing back tall plantation trees and planting small shrubby willows will provide the ideal combination of dappled light and shade favoured by wild trout.

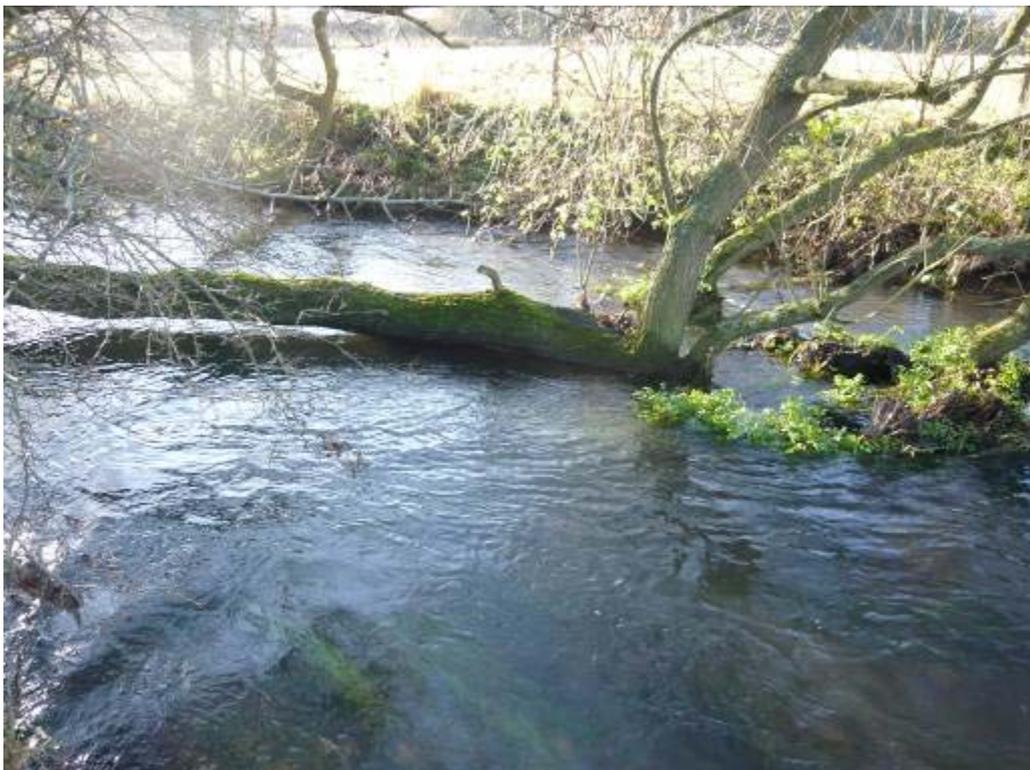
A good example LWD in the River Itchen. Water hitting the underside of this live willow will be forced down creating a fantastic lie for adult trout and blowing up gravels into a spawning riffle downstream.

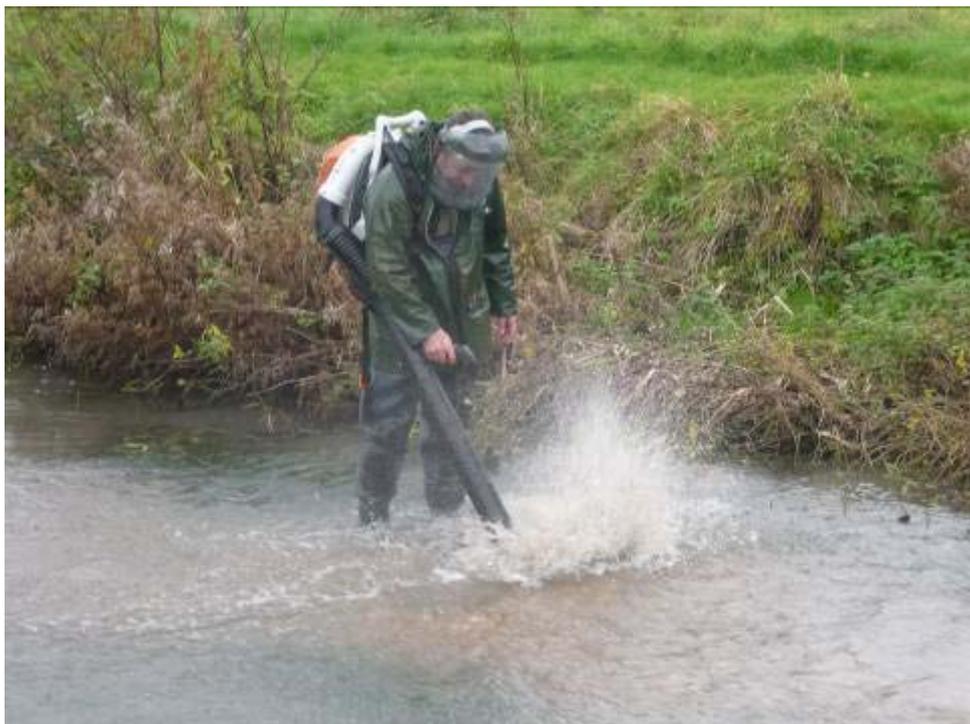
Gravel cleaning using a backpack leaf blower.
