**Wild Trout Trust
Advisory Visit Report**

**River Wharfe – Bolton Abbey Estate,
(Barden Bridge) North Yorkshire**

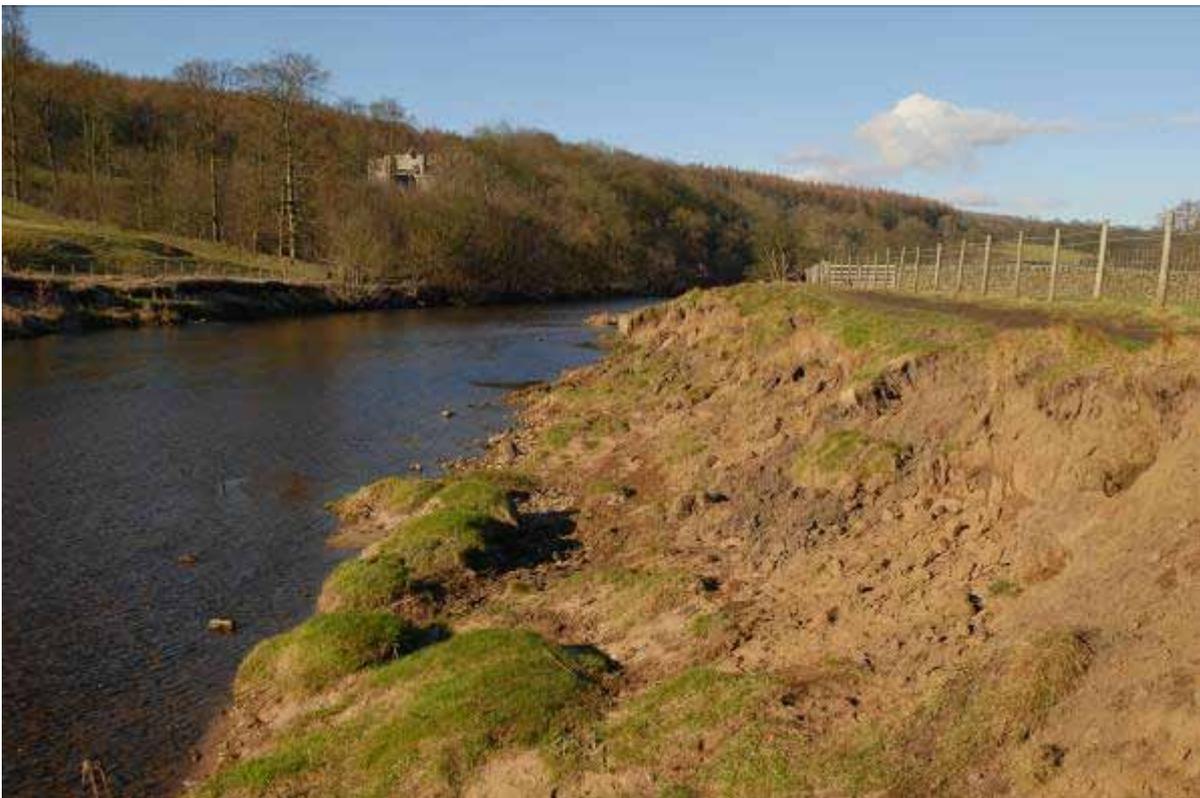
The section of the river downstream of Barden Bridge to the Aqueduct is suffering from extensive erosion problems on the LHB. River banks are constantly on the move, it is a natural part of the river processes of erosion and deposition. In places the banks of the River Wharfe are composed of soft sands and gravels, a highly erodable material.

Erosion on River Wharfe looking u/s to Barden Bridge

Immediately downstream of Barden Bridge it is recommended that a new fence line be installed to create a buffer zone / conservation area down to the Aqueduct. The popular recreational usage of this site is potentially speeding-up rates of erosion due to compaction of soil and vegetation loss. Creation of a buffer strip of at least 10m will allow development of a vegetated 'conservation area'. Consideration should be given to planting with a wild flower conservation mix and willow / alder whips to facilitate greater bank protection. In areas where grazing occurs fences should be repaired and installed.

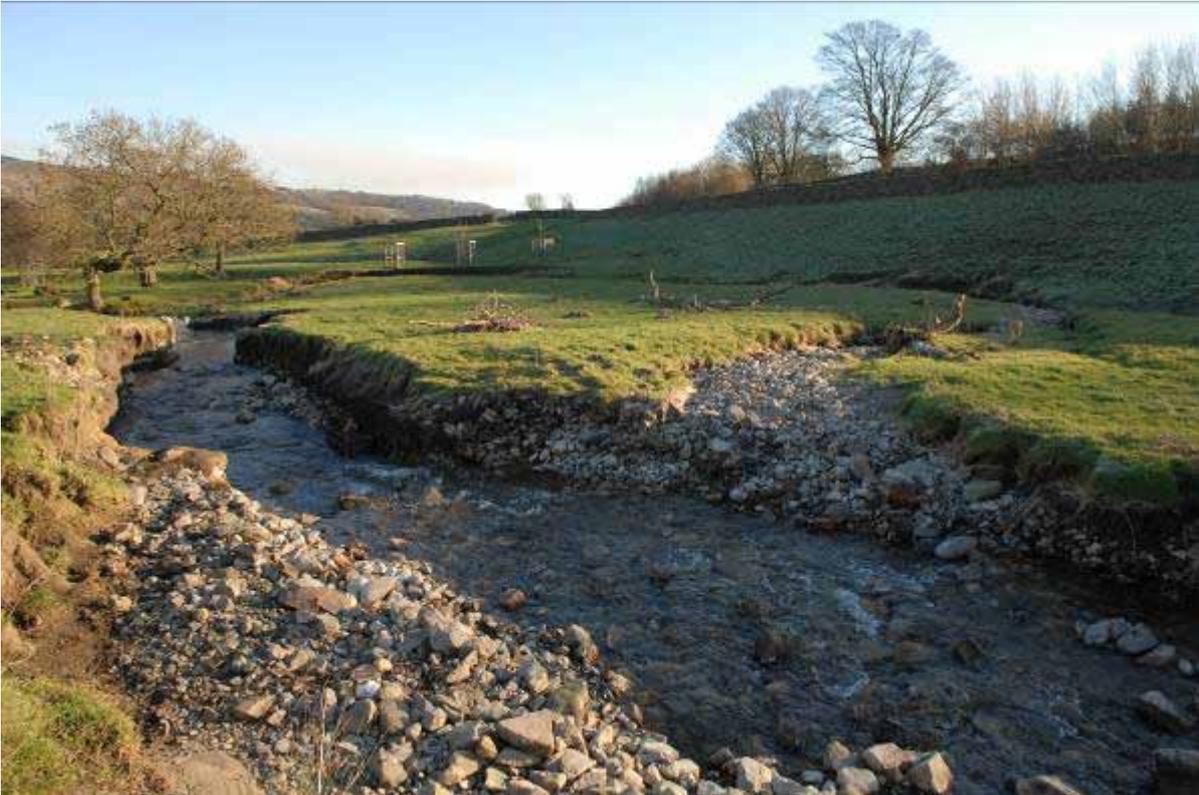
In the last few weeks there appears to have been a 'one-off' flooding event which has caused the river to cut-off a meander loop. The large boulders present on the banks indicate that the flooding event was very high in energy. Although this is probably a rare event it would be worth assessing and changes within the catchment that may have triggered this event, such as changes in land-use.

The 'new' channel and meander loop in the background on the RHB

It would appear that the beck has recently experienced a high energy flooding event which has caused some significant changes to the long profile of the channel. To what extent this event was a natural phenomenon is open to debate, but the heavily grazed banks and absence of riparian trees and shrubs must be a contributing factor to what appears to be accelerated erosion. It is strongly recommended that the estate do an assessment within the Hambleton catchment to look for any gross changes in land use, etc which may have contributed to such a high energy flooding event.

The most practical and cost effective solution would be to completely fence of the river and create a vegetated buffer strip of at least 9m in width. (see above – Wharfe)

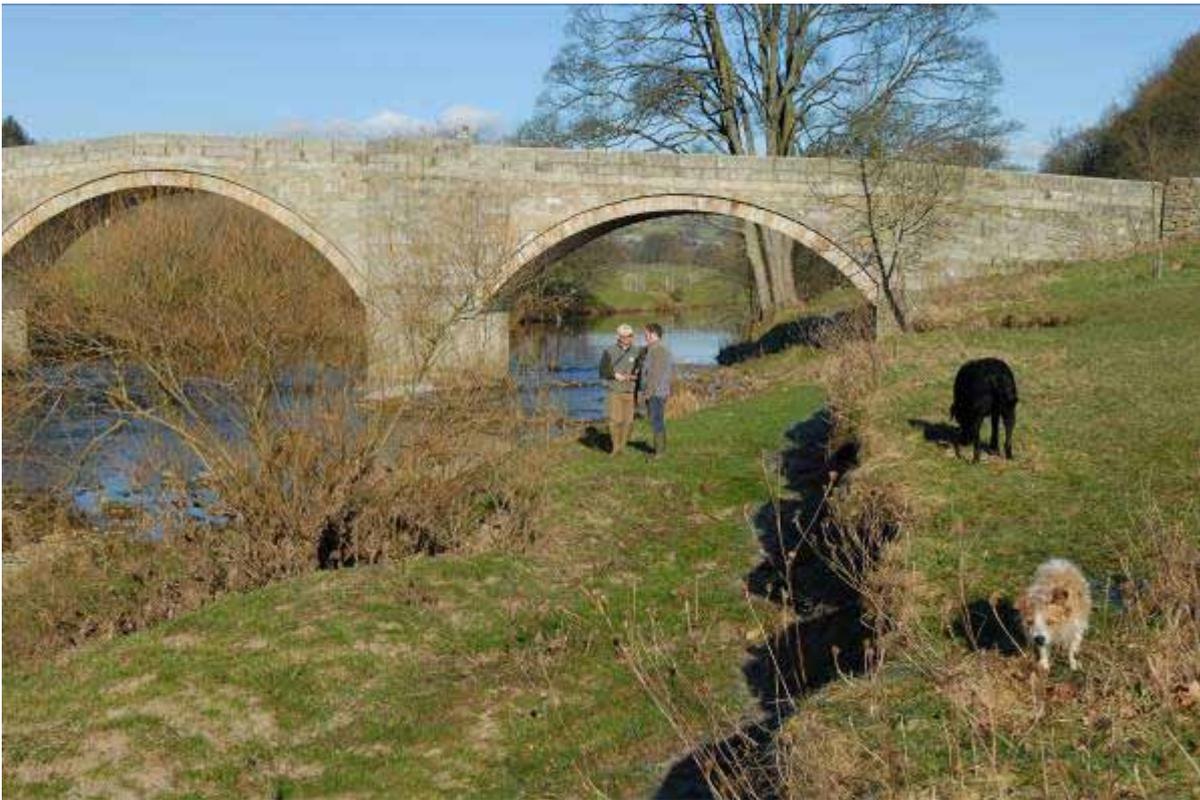
Start of the proposed 'Conservation Area' – fence line and planting should be placed 5-10m from terrace edge (dogs)

The 'conservation area' will have the added benefit of reducing disturbance to both day ticket and syndicate fishermen. The permissive path should be relocated behind the conservation area and in places 'stabilised access points' could be created to provide viewing points. It is recommended that interpretation boards also be installed explaining the reasons for the 'conservation area' perhaps with before and after photographs.

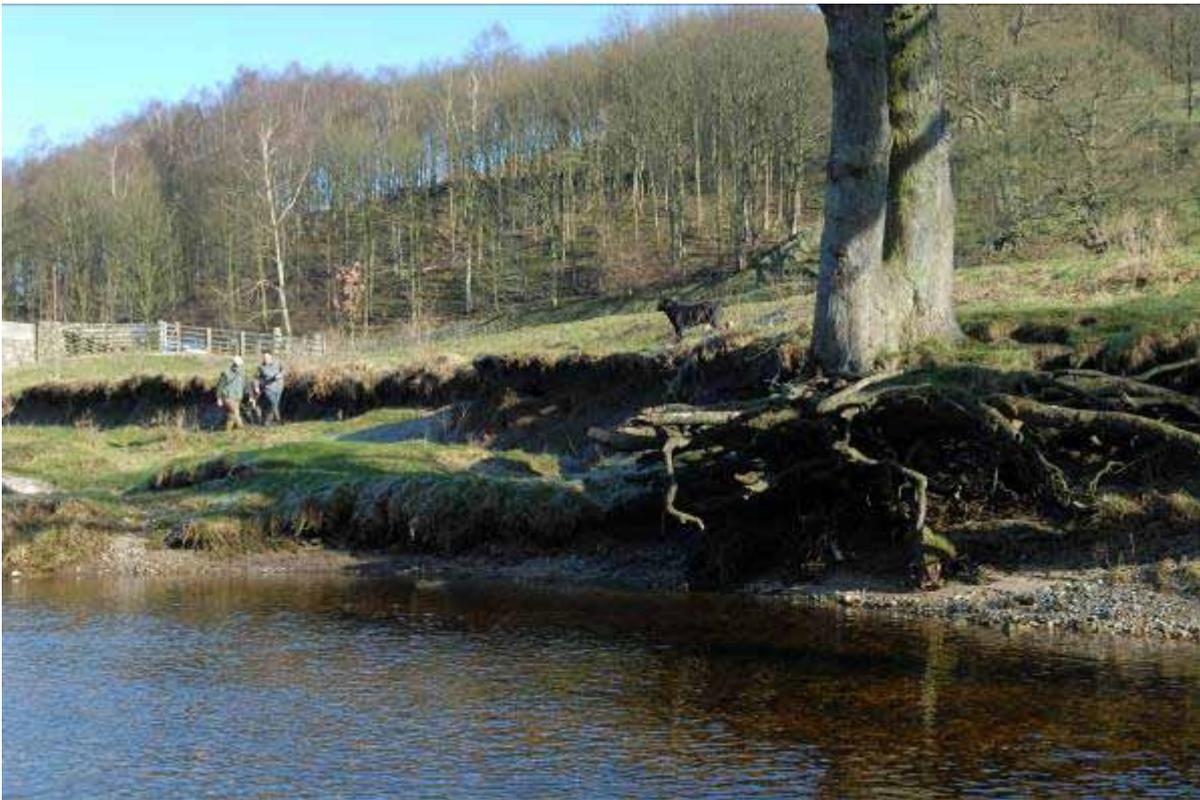
Erosion under the Sycamore root ball.

There are some mature sycamores on the LHB that are having the banks eroded under their root balls. These trees could be pushed over into the river, with their roots balls still attached to the bank to install much needed woody debris. The trees should be placed facing upstream to deflect flow away from the LHB. The rootballs should be enough to secure each tree to the bank, however consideration should be given to pinning them to the riverbed and to establishing erosion protection behind the exposed root ball. Larger boughs from the trimming of the trees (prior to placement) could be placed and pinned into the bank where various erosion 'nick-points' are starting to form. It may also be prudent to leave larger boughs in-tact to act as stabilisers and prevent trunk rolling in the flow.

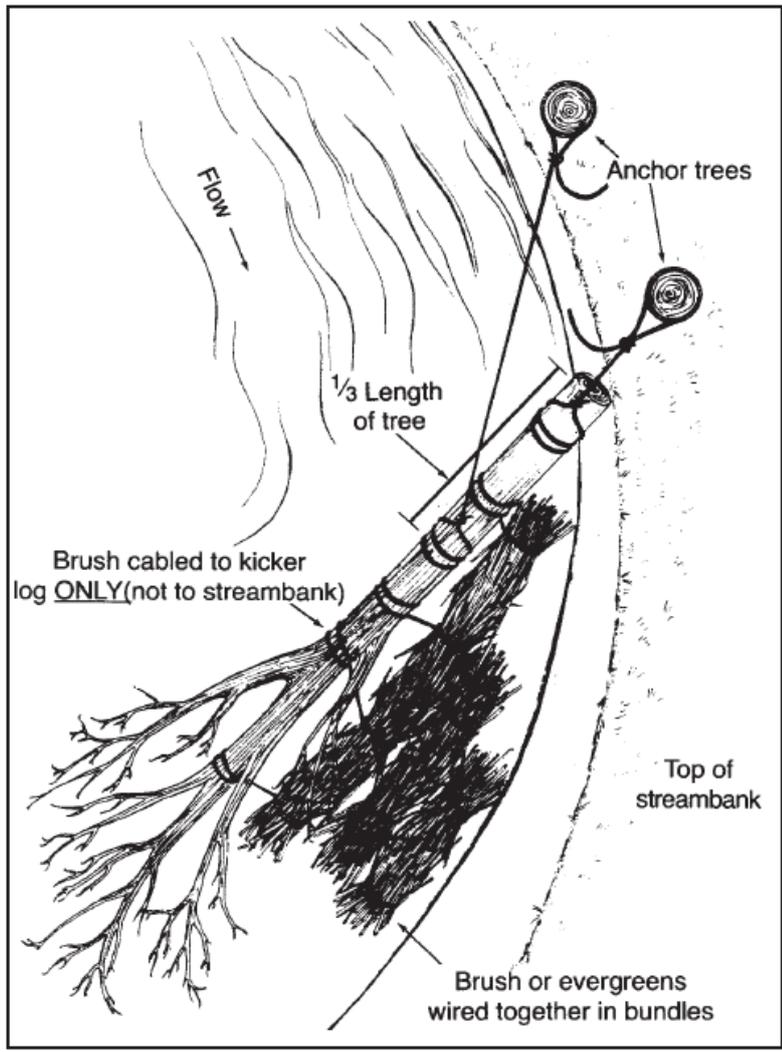
Figure 1. Tree Kicker Construction

Tree "kickers" are hardwood logs which are used to deflect stream flow away from an unstable bank area. One or more logs are anchored to the streambank and placed at an angle to "kick" stream flow away from the bank and towards the middle of the stream. Brush is tied between the log and the bank to prevent scour erosion. Tree kickers are most often used to correct bank undercutting especially where the crest of the cut is 1.5m or more above normal water levels. A kicker deflects the concentration of stream energy away from the bank. In addition, kickers help to re-build the bank by providing an area for sediments to deposit and provide underwater structure for fish and aquatic insects.

The toe of the bank and the bank itself all require protection. It is suggested that 'tree-kickers' are deployed in this section.

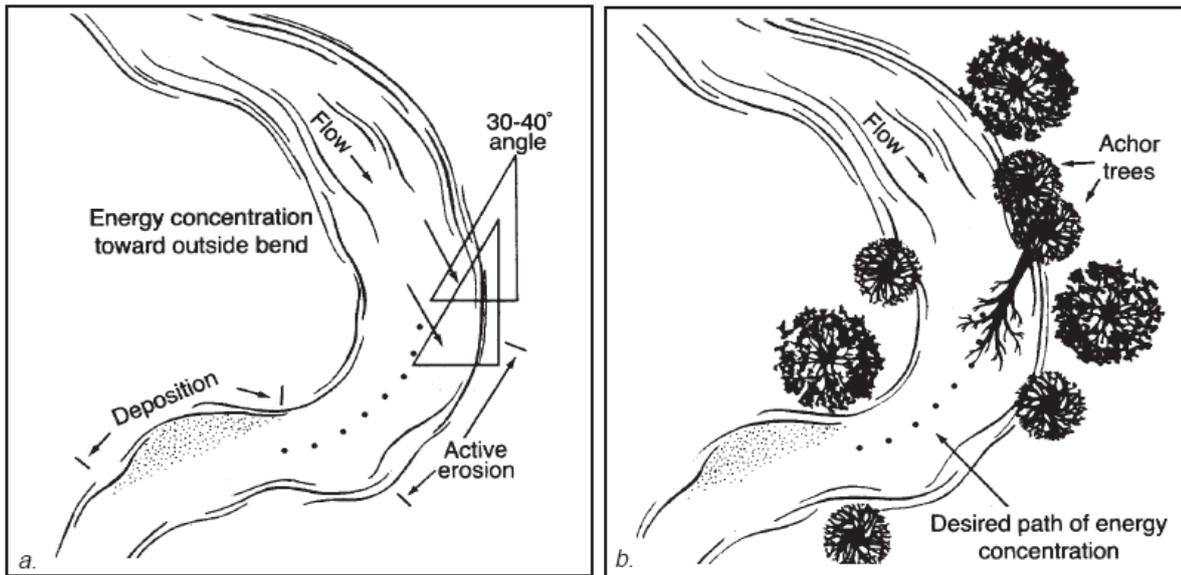
Figure 2. Placement of Kickers

Kickers need to be securely anchored to the streambank. Anchoring it to two live anchor-trees on the bank is best. If no anchor trees are available consideration should be given to installing a deadman anchor. The same angle is used for placing the kicker log. A T-shaped trench will need to be excavated and the kicker will need to be cabled to a large telephone pole or log placed in the crossbar of the 'T'

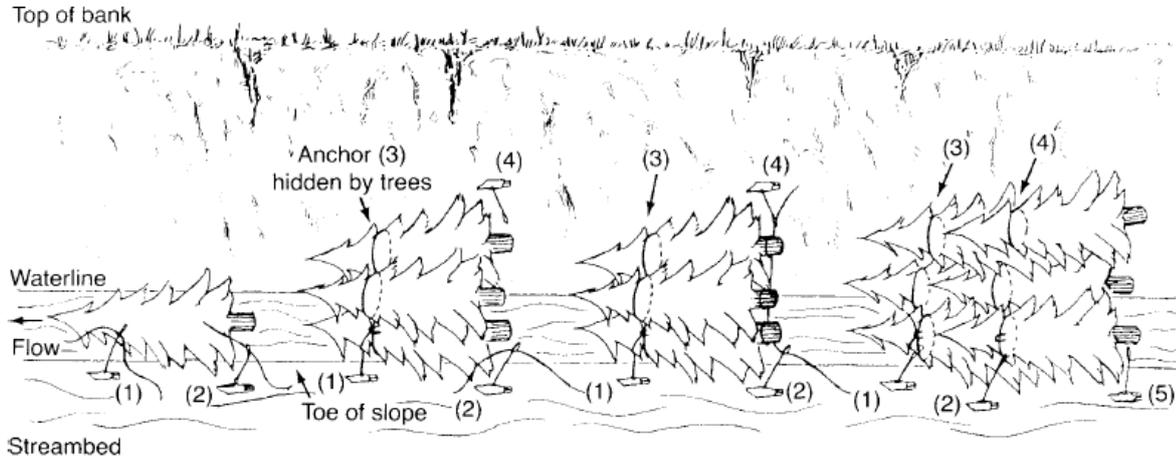
Start downstream of the exposed soil anchoring each tree in place with the butt end of the trunk pointing upstream. Work upstream laying each tree so that it overlaps the previously laid tree by 50% until the revetment extends beyond the exposed soils. The first row of trees needs to be placed so that tree crown (the widest part of the tree) rests on the toe of the bank slope.

Figure 6. Constructing a Multiple-Row Revetment - Figure shows the general placement of cable. Cable should be wrapped around trunks only and not the outside branches. Compress the trees, pull the cable together as tight as possible and clamp tightly.

In conjunction with kickers the problems of slope stability need also to be addressed. This can be undertaken by re-profiling the sheer cliff faces back to a slope of around 30° . Coupled with this it is strongly recommended that the re-profiled slope be stabilised with the sowing of grass seed 'conservation mix' and/or planting of whips (alder / willow). The bank work should be undertaken as early as possible to allow roots to establish and stabilise banks before the winter spate season. An alternative and potentially less expensive approach (machinery / spoil disposal) to re-profiling may be the stabilisation of the banks using an evergreen revetment such as pines, firs or recycled Christmas trees. The more limbs and fine branches a tree has the more it will continue to slow the streams current after the needles are gone, allowing sediments to accumulate within the anchored trees. Anchoring trees to the streambank in a manner that will resist the force of the water is imperative. In order to protect the area of active erosion an evergreen revetment needs to extend beyond the area of exposed soils on the riverbank. The trees need to be fixed to log revetment which has been pinned at the toe of the bank. Logs need to be 3m by 0.25 – 0.3 m diameter secured with two pins (2 m of iron rod, 2 cm diam); each tree nailed to log in at least two places

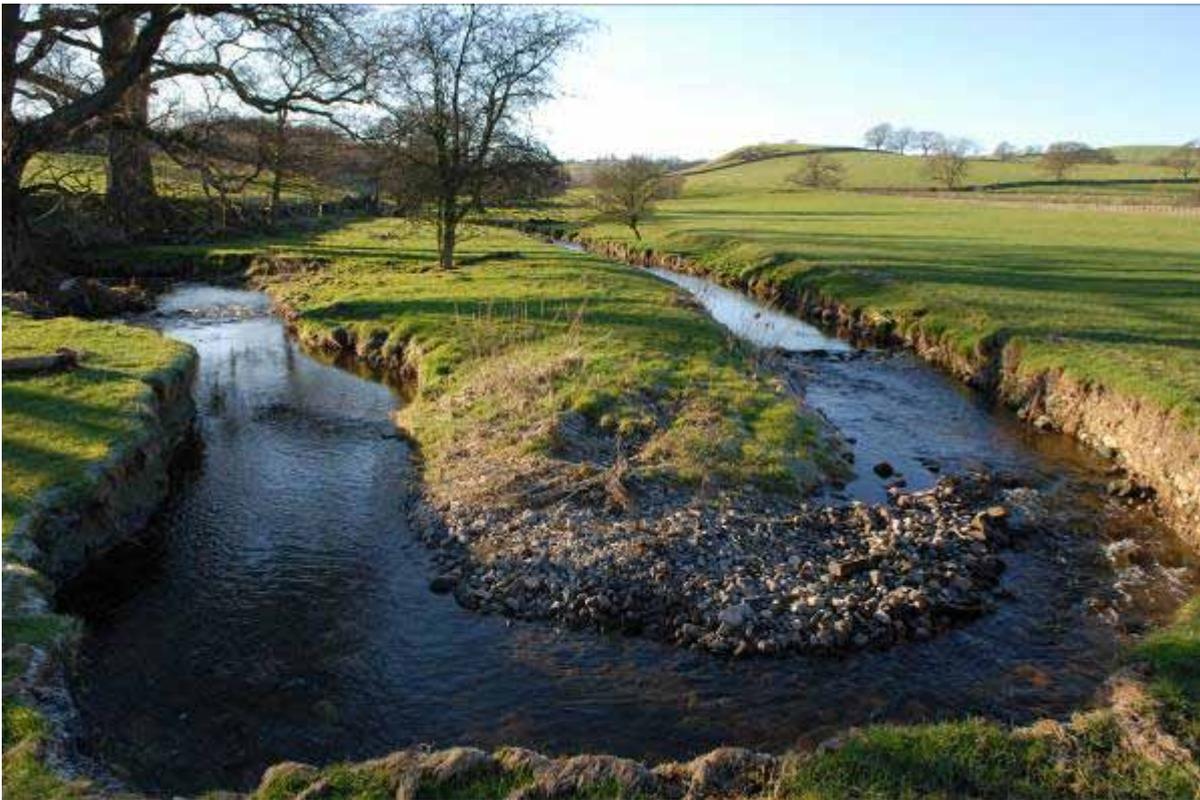
There is a tight S-bend at the bottom of the reach upstream of the health club. It is recommended to undertake some planting of willows on the banks as a priority to reduce the speed of the erosion at this point. The outside of the bend could also be spilled using willow withies.

The 'S' Bend
