**Advisory Visit**

**R. Wharfe, Wetherby & District Angling Club**

**15/06/2017**

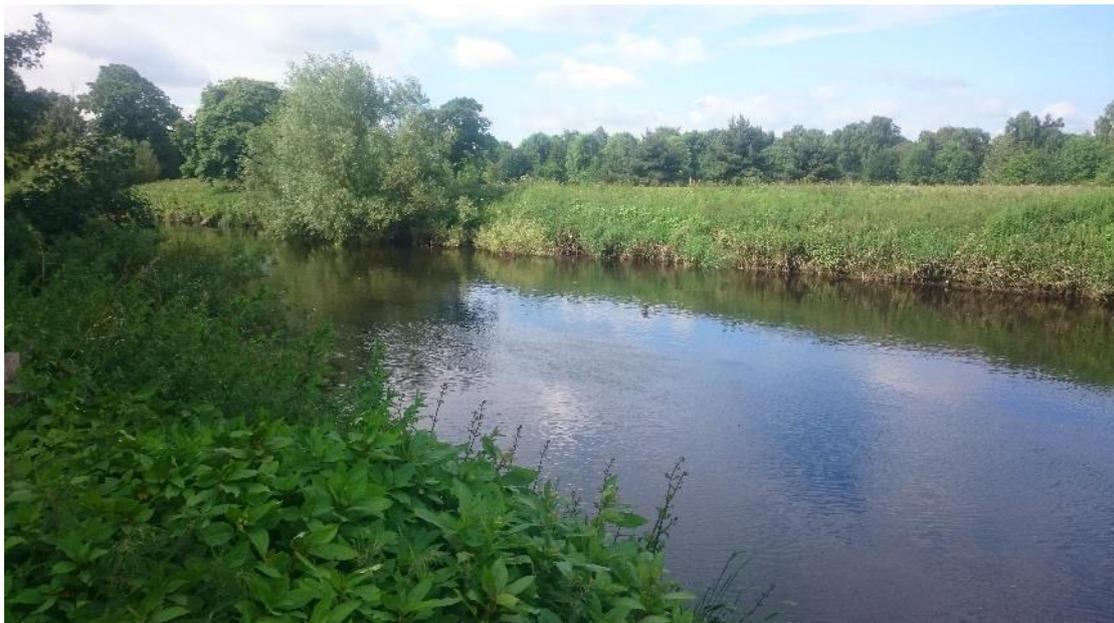
**Fig 2. The banks at Linton Ings are uniform in height and profile which points to historical alignment and revetment to restrict meandering. In places, the boulder reinforcement is more obvious at the bank toe. It creates a typically trapezoidal channel devoid of features and flow variation. Riparian vegetation is generally diverse although riddled with invasive Himalayan balsam in some sections.**

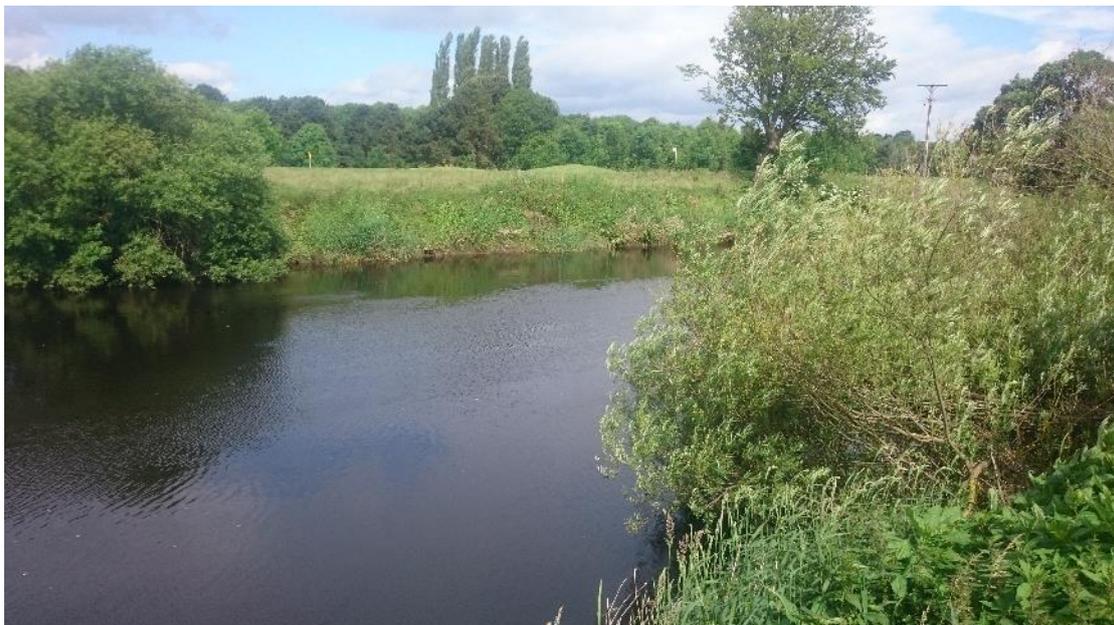
**Fig 3.** The upper reaches of Linton Ings have some low growing willow trees which provide limited shade, and refuge from predators and spates. Diversity and abundance of trees increases d/s on both banks.

- Trailing vegetation on the water surface provides low cover and refugia for fish and invertebrates from predators and spate flow, some shading, egg-laying substrate for river fly species (and some coarse fish), as well as structure to help insects emerge from the water. Submerged and low growing willow branches may diffuse flow to such an extent as to encourage deposition of sediments downstream and hence diversify channel cross-section (Fig 3).

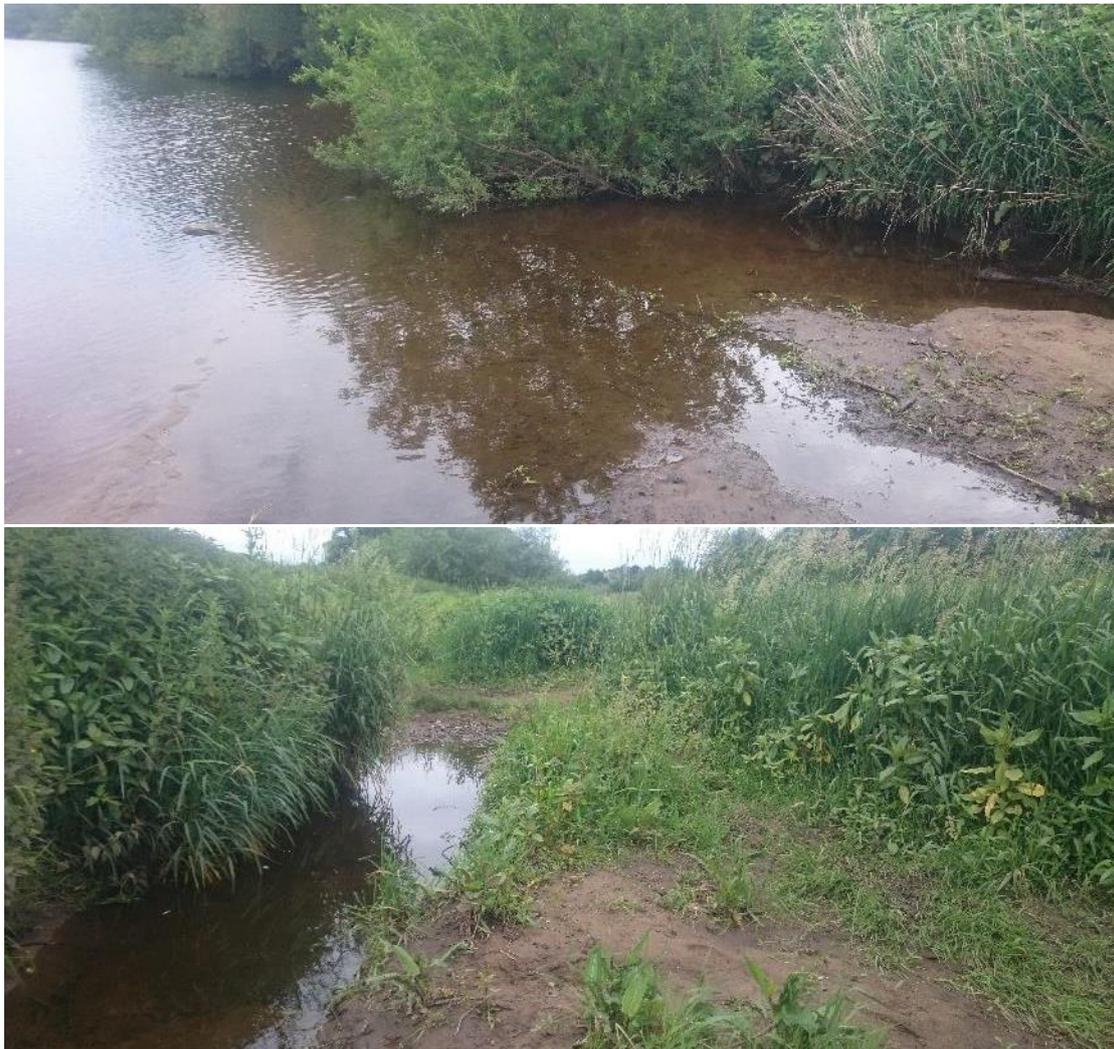
**Fig 4. Looking d/s (upper panel) and u/s (lower panel) at the impact of a deposition bar which has formed in the lee of a mature willow. The low bar is well vegetated and will continue to stabilise and consolidate. Planting of some willow whips will aid this process and provide further low cover. The backwaters make ideal nursery areas for young-of-year fry.**

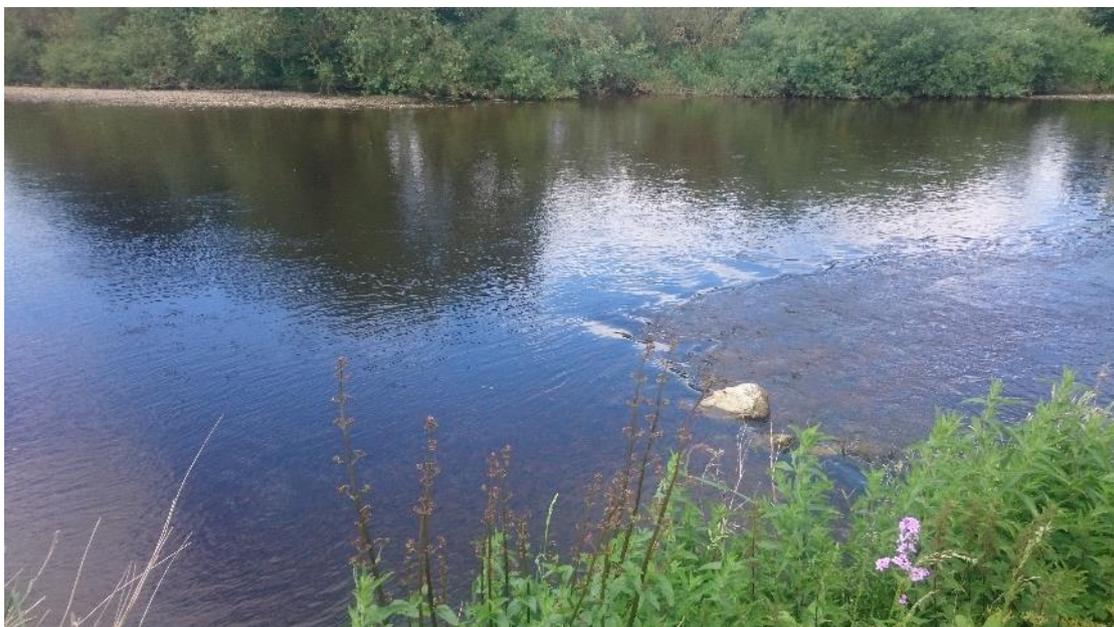
**Fig 5. Evidence of one or two short groyne constructed from local boulders which have been in place for 'a considerable time'. These provide some localised deflection of flow and depth diversity from scour at the point of the groyne in a channel otherwise devoid of features.**

In contrast, on the more exposed sides of the river, deposition of coarser gravels and small cobbles (Figs 5&6) provides habitat for different invertebrate species residing in the gaps between the stones that require a steady stream of oxygen-rich water (e.g. *Gammarus* shrimp and stone flies).

As the Wharfe naturally contains boulders, and some of those have been used to create the short groynes, introduction or relocation of some individual larger boulders towards the head of some of the glides and riffles will create some localised scour and sorting of sediments immediately d/s. These relatively small 'pockets' of deeper water are valuable holding features. Introduction of boulders >0.4m diameter requires EA consent; in a river with the power of the Wharfe, individual boulders of <0.4m would be tossed around like marbles during a spate unless they can be 'interlocked' in groups.

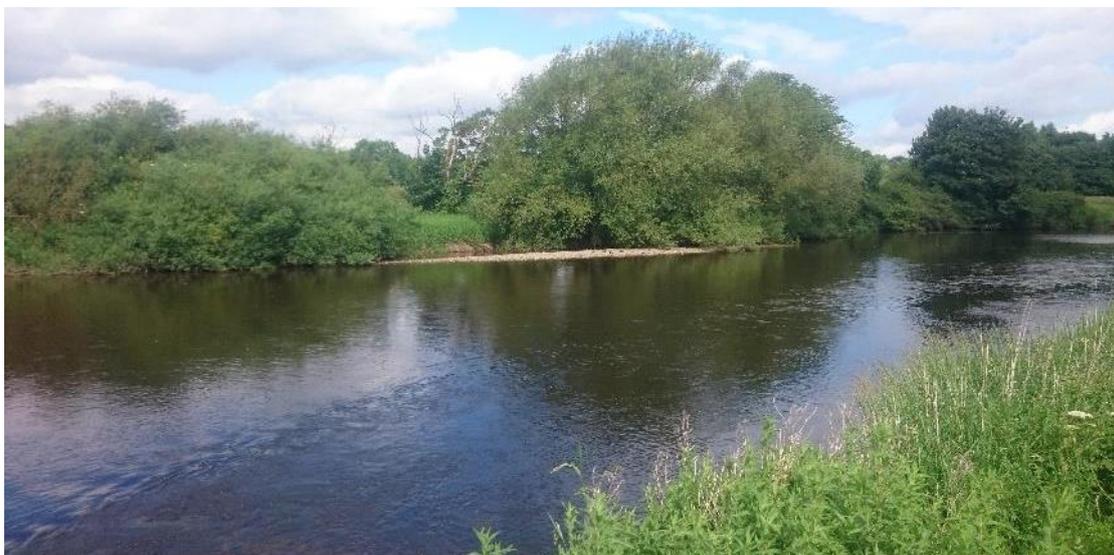
**Fig 6. A shallow gravel deposition bar in the lee of willows on the far (left) bank is evidence that the river is attempting to return to more natural channel width. Note the extent of the seam in the water emanating from the rock groyne (out of shot, bottom left) from Fig 5.**

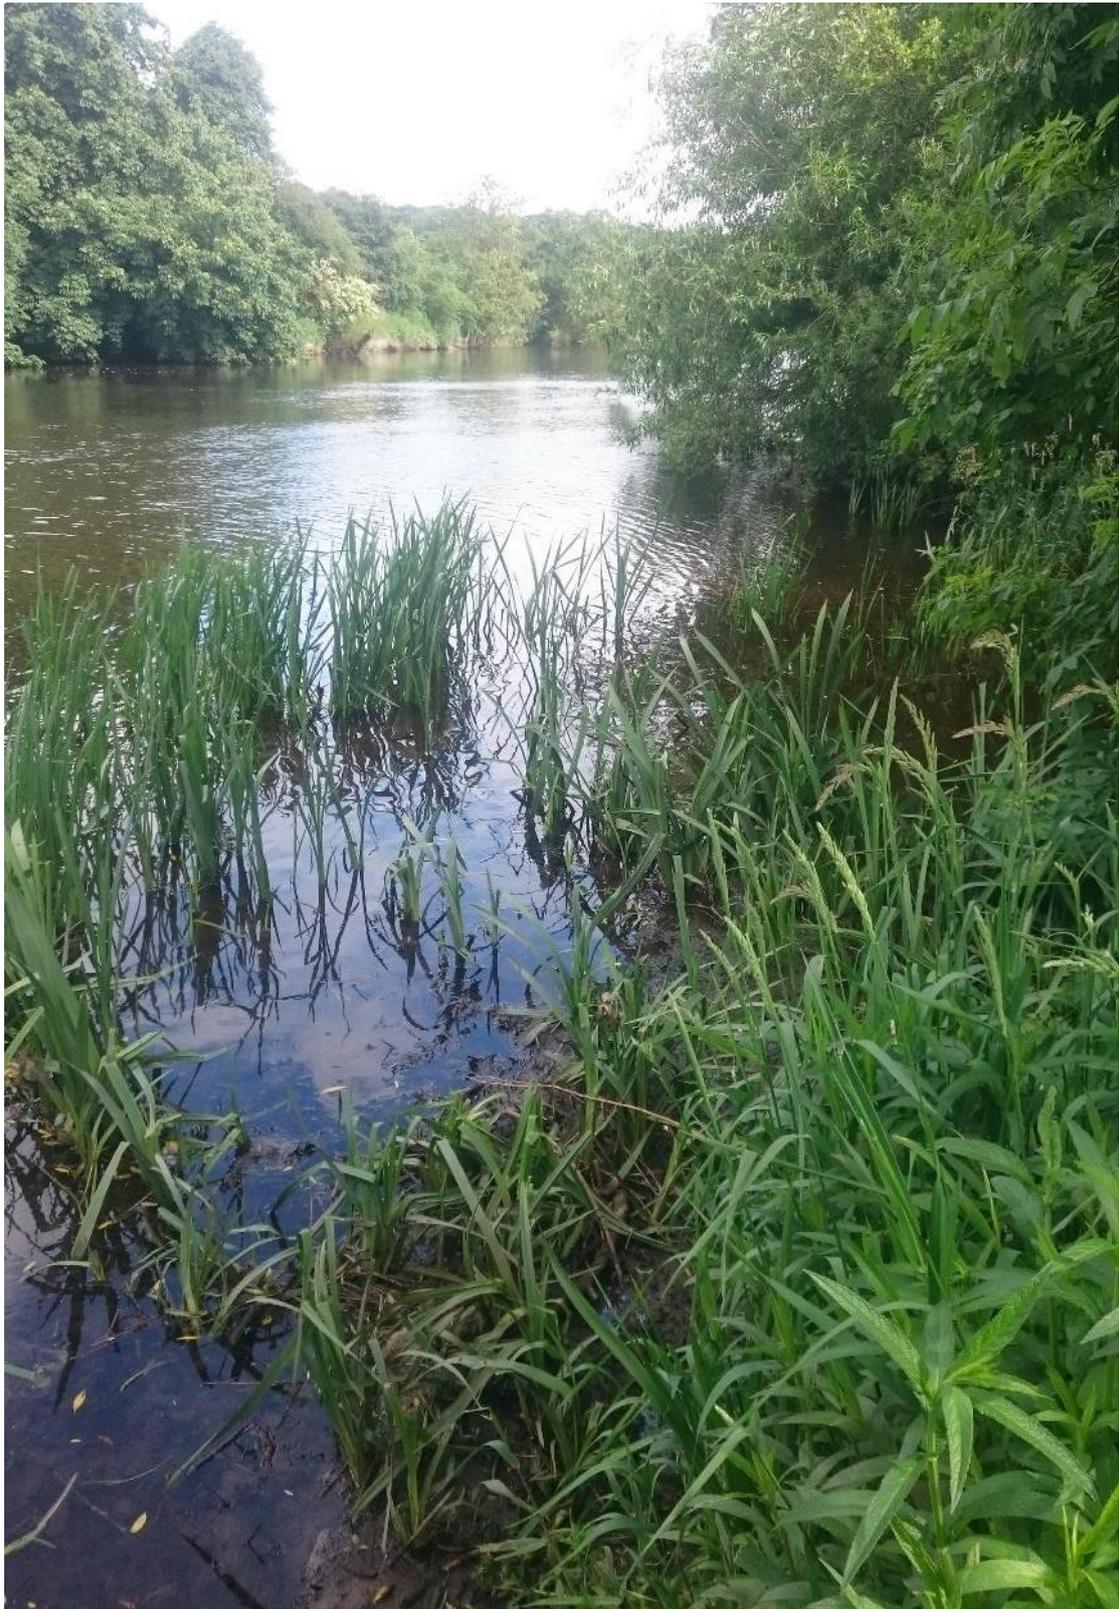
**Fig 7. More valuable refugia for fry, and potentially spawning habitat for some of the coarse fish species, provided by emergent reeds on a silt deposition bar between two outcrops of overhanging willow trees.**

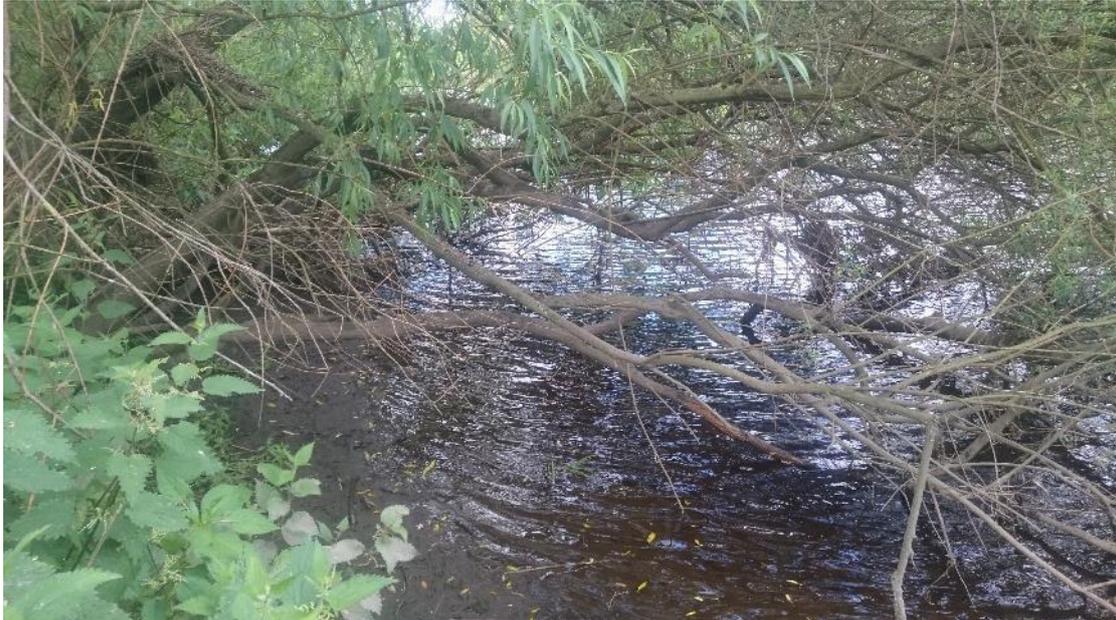
**Fig 8. Lower branches of willow which are frequently submerged. While they may look dead, they provide valuable refuge and spawning habitat for fish, food, shelter and egg deposition substrate for invertebrates, and diffuse spate flow to cause deposition bars d/s. Such structure should be encouraged (e.g. by hinging / laying) and definitely not removed.**

Seemingly dead branches and trunks should be retained wherever possible as they still perform vital functions. The submerged branches in Fig 8 provide the majority of benefits listed in the bullet points above, and the standing trunks (Fig 9) are an important component

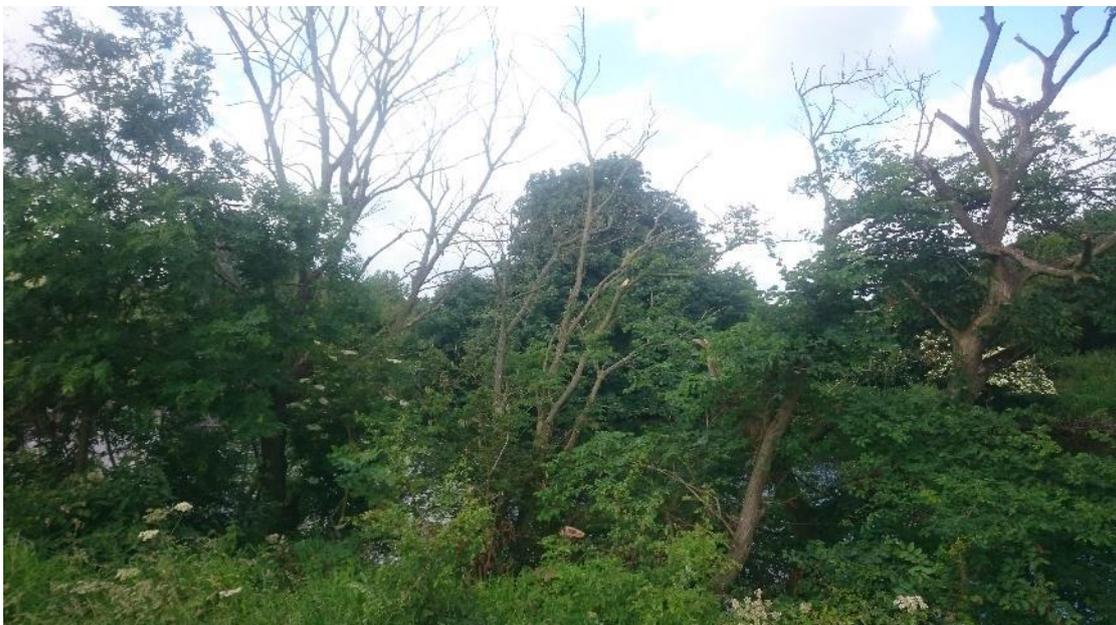
**Fig 9. Dead standing wood should be left rather than tidied up, as it provides food and shelter, and nesting sites for a whole host of species, some of which end up as fish food.**

of the detrital food chain (food for many terrestrial beetle larvae), as well as nesting and/or roosting sites for species of conservation interest (e.g. bats).

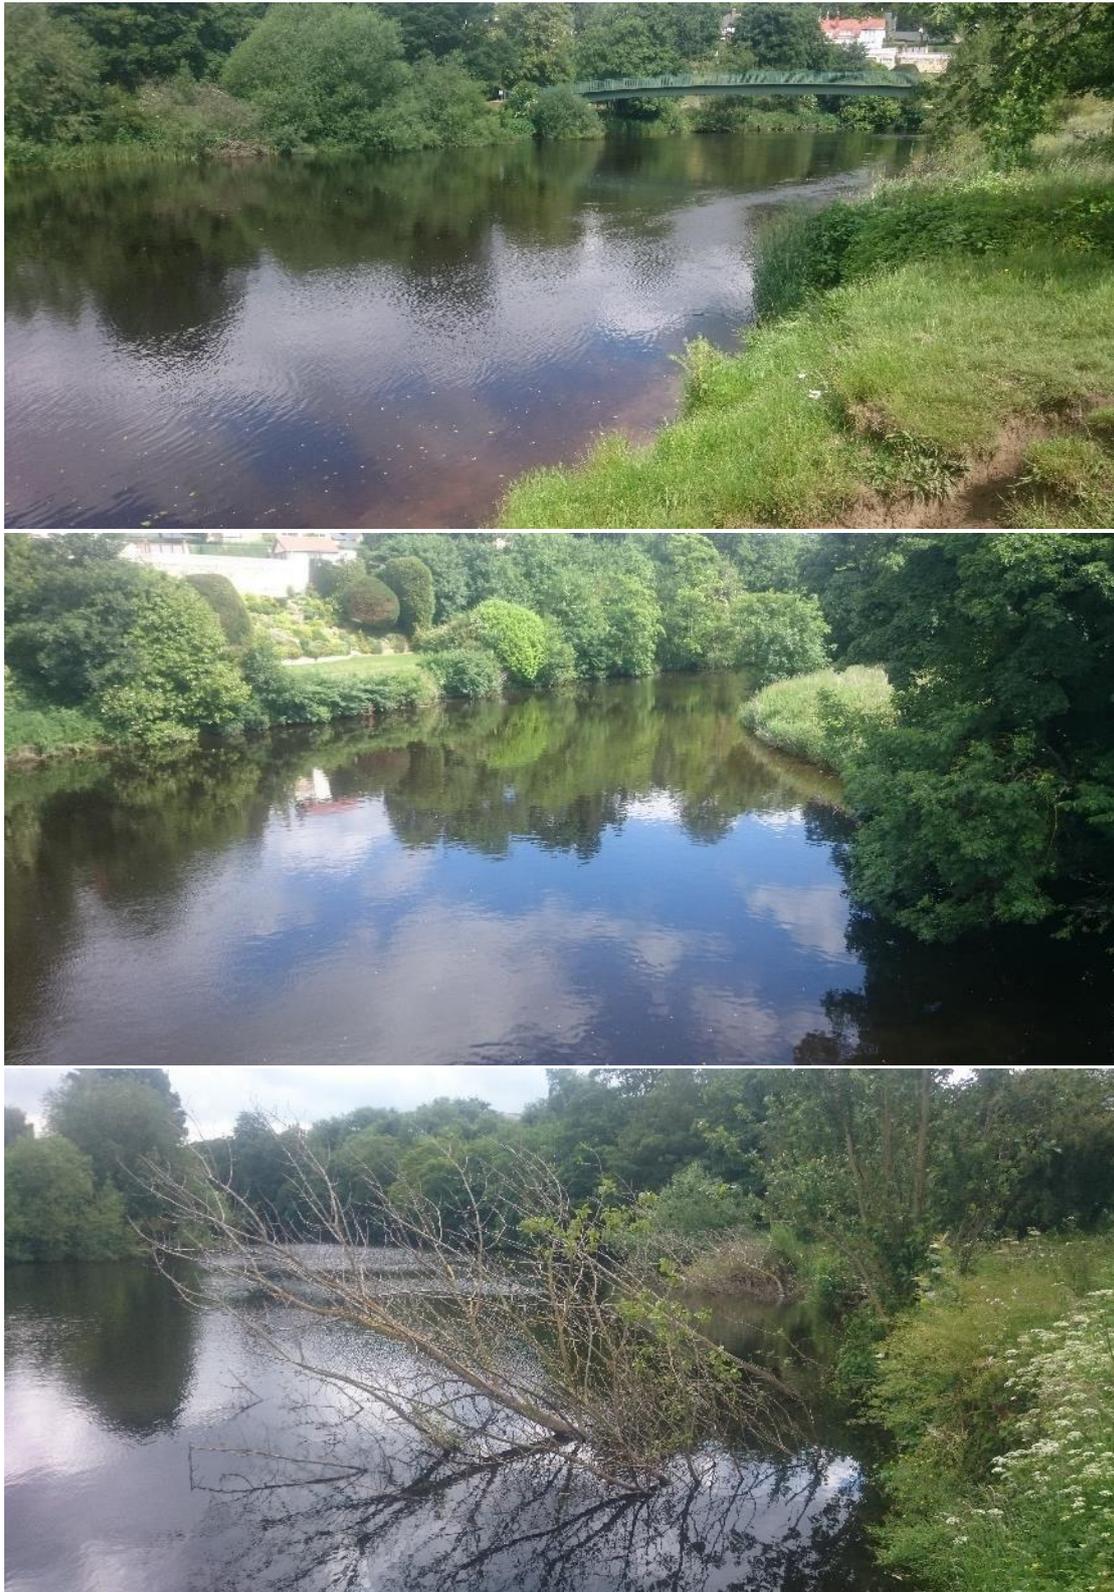
**Fig 10. From the footbridge at Scaur Bank (King George's Field; upper panel), the impoundment effect of the weir can be seen as the river deepens (mid panel) and becomes more canal-like (affectionately known as the 'Dead Zone'). Erosional scour still occurs under spate flow as evidenced by the loss of several trees from the RB (lower panel). Again, removal of these should be resisted as they provide valuable cover and may re-stabilise the bank given time.**

At Scaur Bank, the river has been widened, apparently for bathing and boating; there is a series of wide steps on the LB. Approximately 200m d/s, the river encounters the 'natural' left side of the valley, an outcrop of bedrock which has been developed for (currently) housing. If the river was subject to a natural flow regime, then one might expect a narrower channel with downward scour creating depth on

the outside of the bend (LB) and marked deposition on the inside, but the impounding effect of the weir is already evident (Fig 10).

As a consequence, there is virtually no detectable flow in an overly deep, relatively featureless section. The quality of riparian vegetation is retained on the RB and should be protected and enhanced to introduce some otherwise scarce habitat heterogeneity. The fallen trees (Fig 10: lower panel) contribute multiple benefits as outlined previously and any suggestion to remove these should be contested.

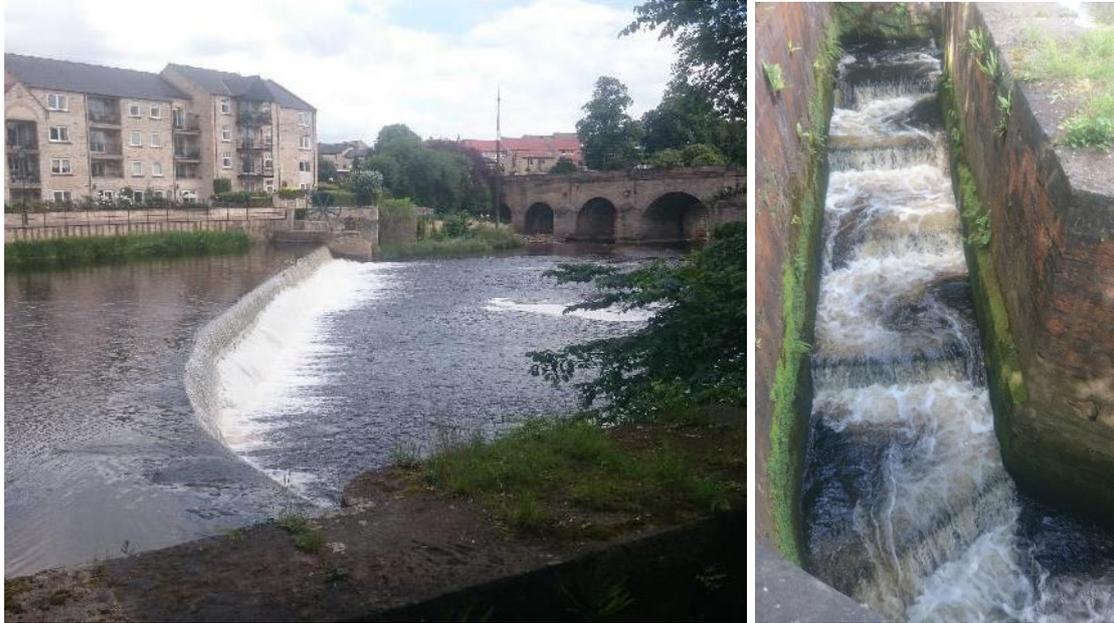
**Fig 11. The weir is a considerable barrier to fish passage in both directions, and geomorphological transport of bed material d/s. A crude fish pass has been installed but efficiency is not monitored; from a cursory observation, it has been designed for salmonids only as the height differential between the pools and flow velocities are likely to be outside the capabilities of many coarse fish, particularly smaller individuals/species.**

The weir is a substantial structure which has fragmented the fish assemblage and interrupted the geomorphology of the river, including starving the river d/s of its natural supply of gravel and cobble substrate (Fig 11). It was repaired in the early 1980s and a fish pass was introduced which only appears to have been designed for salmonids. It is highly unlikely that coarse fish species would be able to ascend. Since the trapezoidal, canalised sections of river u/s of the weir lack fish holding habitat (especially for the weaker swimming coarse species), spate flows are likely to push many fish d/s below the weir where they are essentially trapped. Anecdotally, this appears to have happened to 'silver' species stocked by the EA prior to the 2015/16 floods, further highlighting the futility of stocking fish into waterbodies where there is insufficient suitable habitat for all life-stages.

The magnitude and location of the weir, plus the more recent spread of development around its infrastructure means that it is highly unlikely to ever be removed (the ideal situation to reinstate connectivity for both fish and geomorphology). The current fish pass is not fit for purpose; there are designs that are far better suited (e.g. Larinier) for the various species inhabiting the Wharfe and these should be considered as part of a full appraisal of improving fish passage for salmonid, coarse, eel and lamprey. This is especially pertinent given the improvements elsewhere in the Wharfe catchment (e.g. funding announced in mid-2017 for tackling fish passage d/s at Tadcaster. It is worthwhile initiating a dialogue with the local fisheries officer to investigate this and raise awareness of interests from the Club to improve fish passage.

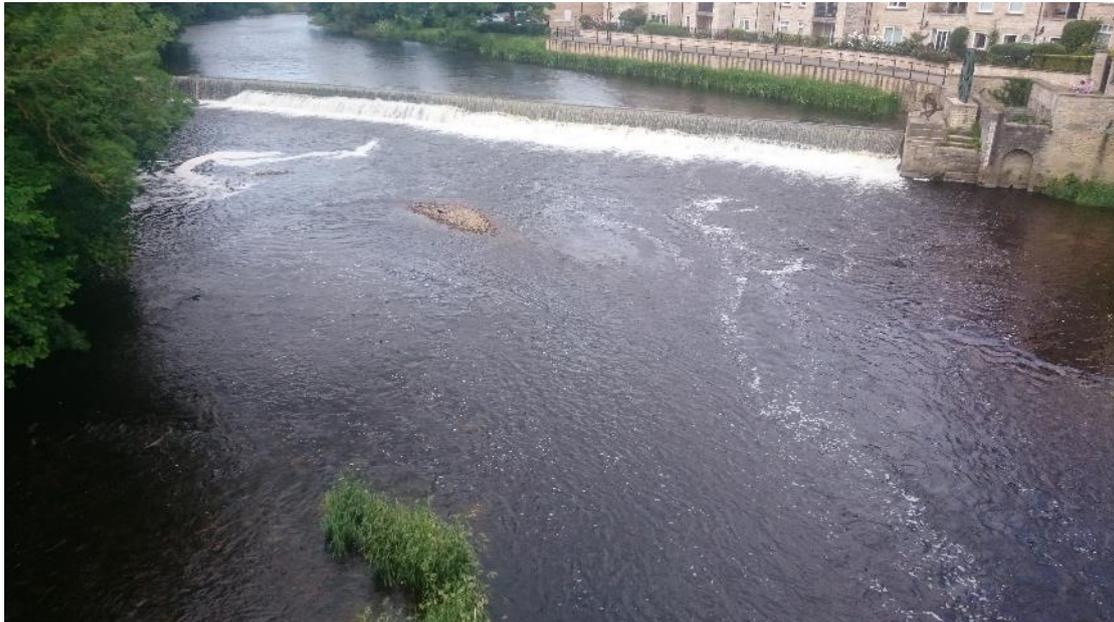
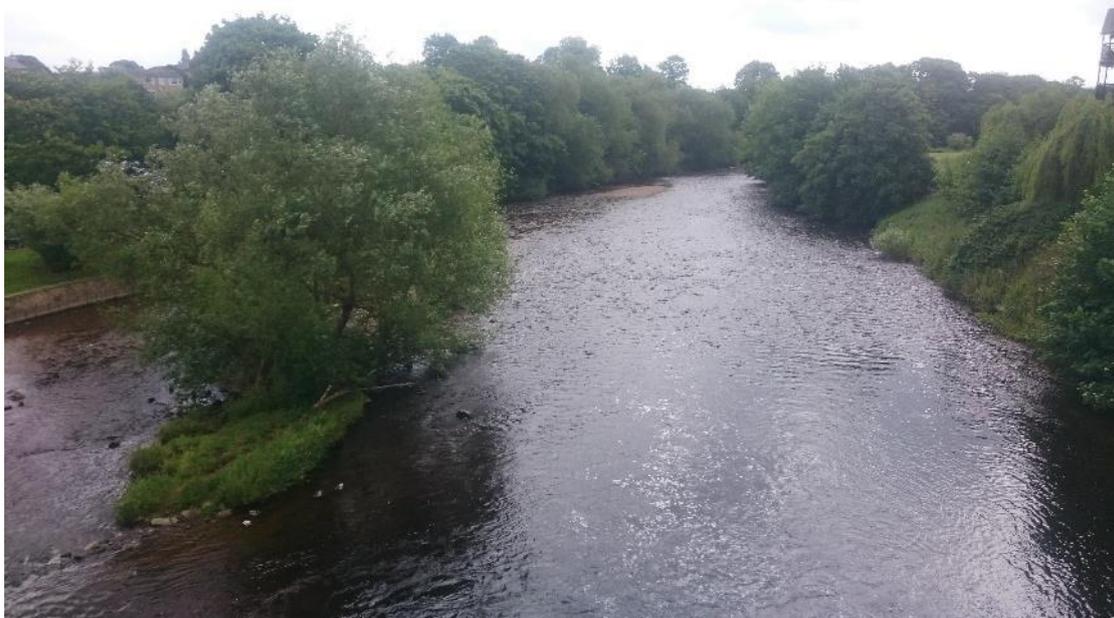
**Fig 12. The close proximity of the weir and the multi-arched Boston Road bridge (from where the photos were taken looking u/s and d/s), cause substantial variety in channel form and flow patterns which remain highly dynamic; depositional features wax and wane in response to different spate and summer flows.**

Immediately d/s of the weir (Fig 12), in an overly wide embayment, the Wharfe has to negotiate a path through the multi-arched Boston Road bridge. As a consequence of the weir 'tripping up' or dissipating the flow of water, and the widened channel available, there is

considerable braiding of the river into multiple channels between deposition bars which are highly dynamic, changing rapidly and often in response to spate flows according to John Smith.

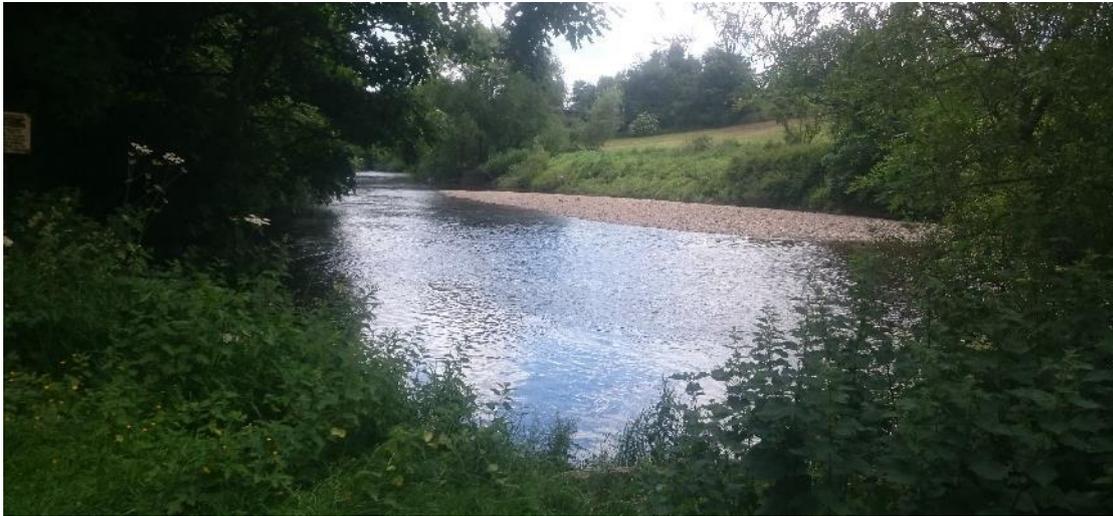
**Fig 13. In a natural pinch to the valley, the river is held tight to bedrock on the LB, so there is more natural pool, riffle, and glide sequence and ample diverse tree cover along the majority of both banks for ~200m between Boston Road and the A168. Note the extensive gravel deposition bar.**

Despite the proximity to the town centre and a large car-park on the LB, the Wharfe is most natural in character for ~200m between Boston Road and the A168 (Fig 13) as the river is pinched by bedrock. Downward scour on the LB as the river butts up to the bedrock, and subsequent extensive deposition of cobbles and gravels in bars along the RB have created much needed pools and riffles to break up the glides. While not inspected closely, the gravels appeared well sorted (deposited according to size with respect to flow velocity), and hence

should provide good quality spawning habitat for various species, not simply the salmonids. Barbel, chub and dace all require clean gravels of various sizes, and even roach and bream will spawn on gravels in relatively fast water in rivers like the Trent (T. Jacklin, pers.comm.).

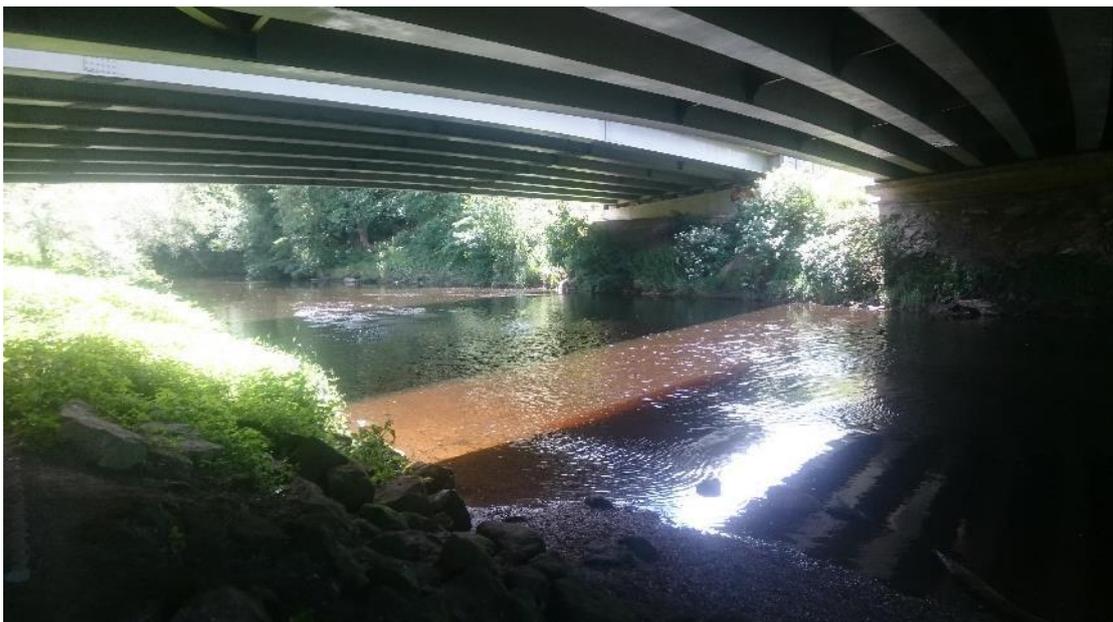
**Fig 14. From the A1M flyover, the channel reverts to trapezoidal shape as the bank reinforcements resume. However, diverse riparian vegetation, from grasses to shrubs and trees is extensive and provide good buffering from agricultural land.**

Downstream from the A1M flyover (Fig 14), the reinstatement of bank alignments reverted the river to the same characteristics as along Linton Ings (beginning of the walkover; see Fig 1). However, the width of the well-vegetated buffer strip and the presence of both mature trees and self-set bushes and saplings regenerating in the gaps is a fabulous asset which needs to be protected.

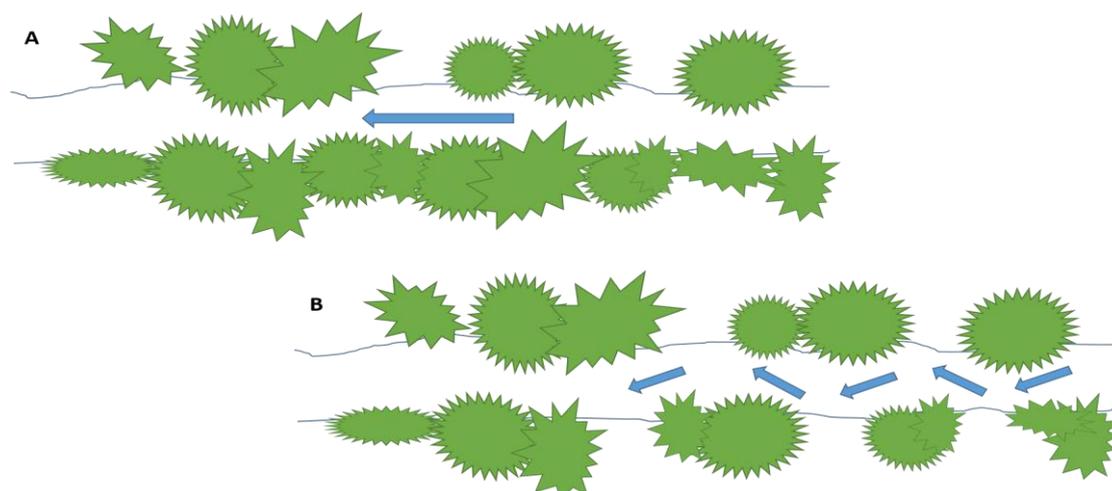
**Fig 15. Schematic of a) mature uninterrupted canopy with relatively linear flow along the edge versus b) coppicing of one or two mature trees to complement existing gaps on opposite bank, and in conjunction with some laying of branches into the water, will encourage more sinuous flow.**

On the lower section of the fishery (Crowcroft Bank), where the age of the tree canopy is more uniform and now quite mature, some judicious rotational coppicing of one or two trees would be beneficial to create a mosaic of cover and essentially increase the quantity of 'edge' – see Fig 15. Coppicing retains the living root, thereby retaining the bank stability function, but also encourages fresh low-level growth.

Insert whips in bunches to (hopefully) form clumps of young trees, especially on bare banks immediately adjacent to where there is sufficient water depth to potentially hold fish. Staggering clumps of willows on alternate banks creates more lies and refugia from predators, ie creating the scenario in Fig 15B. Further advice can be found in the WTT video on tree management:

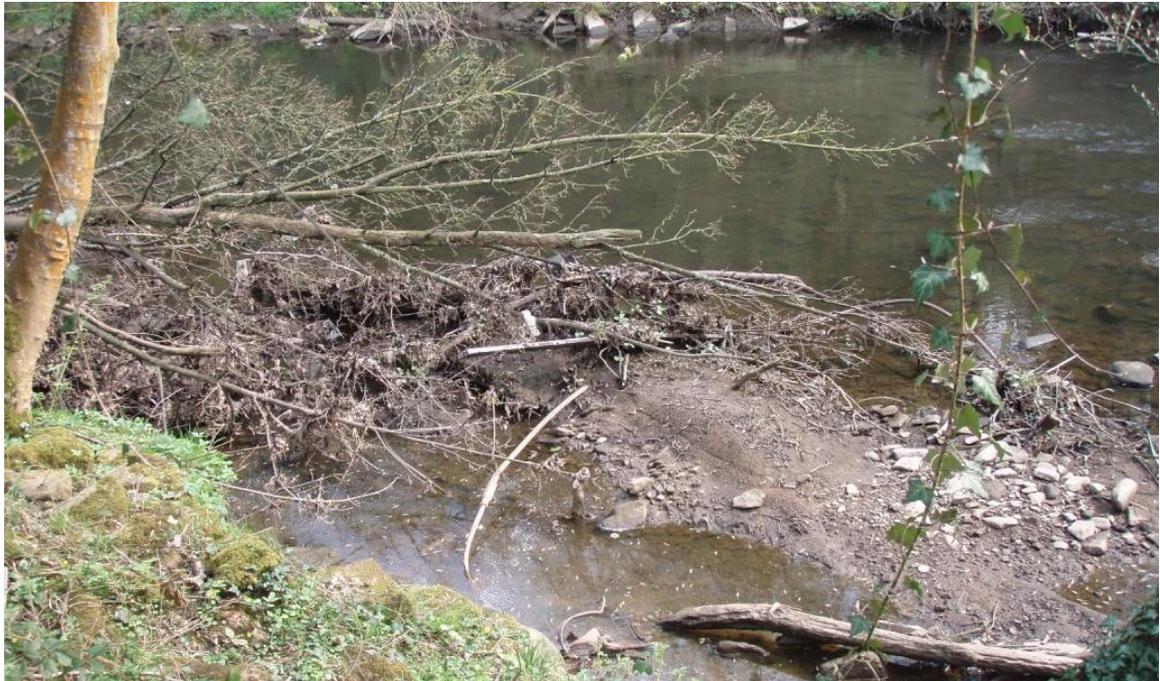
**Fig 16. A tree kicker causes flow to be focussed to the far side of the channel resulting in deposition along the protected, nearside margin.**

A larger scale solution is to use a tree-kicker, to increase flow diversity by creating narrower pinch points where bed scouring and sorting will occur and create areas of slack water immediately d/s to encourage more deposition. A tree kicker secured within a river margin (Fig 16) has accumulated sediment within the crown and in its lee d/s, providing beneficial channel narrowing.

A tree kicker is created by felling a tree to lay in the margins almost parallel to the bank and preferably already in an area of modest deposition to encourage stability of the ensuing structure. However, it must be cabled securely to an appropriate anchor point (usually its own living stump) to prevent any risk of future mobilisation and transport d/s. Installation of tree kickers requires consent under the EA environmental permitting regulations. WTT has produced a video on secure tree kicker installation:
