Advisory Visit

R. Wharfe, Otley Angling Club

July 2019

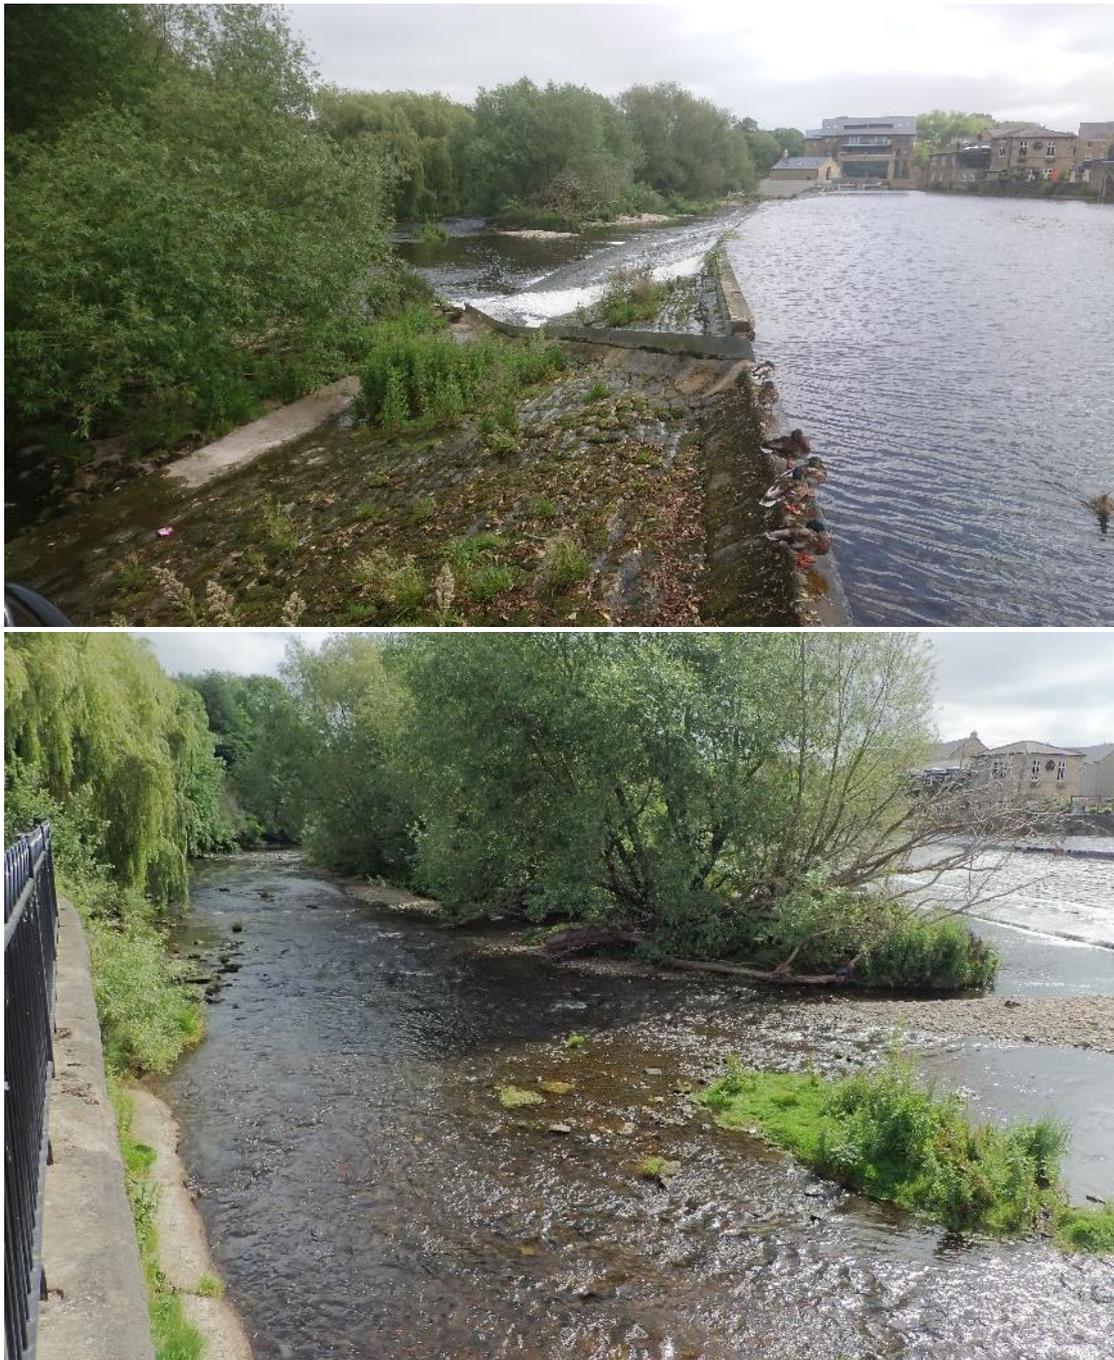
The walk effectively commenced at Otley weir; the heavily impounded section extending u/s to Otley Bridge is overly wide and featureless. The weir was recently refurbished to accommodate a hydro-power scheme to the RB and has two fishways installed: a technical 'Larinier' fish pass co-located next to the hydro output, and a simple baulk pass to the LB (Fig 2).

Fig 2. The weir below Otley Bridge presents a major barrier to sediment and fish passage. It has two fishways installed (baulk pass in the foreground), neither of which are monitored. Islands of various sizes have established immediately downstream of the weir from deposition bars being stabilised by vegetation, and these introduce much needed heterogeneity into the habitat. These features should be retained.

When faced with an obstruction such as a natural cascade or man-made barrier, fish will typically seek the path with the greatest flow ('attraction flow') as this is where the majority of the water will be passing the obstruction. A weir presents a very confusing situation because the flow of water is generally dissipated equally across the breadth of the crest without any focus. With a hydro-scheme in place, requiring a considerable volume of water to be focused through the turbine, the attraction flow essentially draws fish to the outflow of the turbine. Hence, the idea of co-locating the outflow of the technical fish pass in the hope that at least some fish will find the pass and be able to move u/s (Fig 3). At higher flows, the likelihood of fish finding the fish pass decreases and if they swim to the bottom of the weir, they are likely to head to the most u/s point which on Otley weir is to the LB. Then, the baulk pass comes into play but fish have to exert considerable power in a 'burst' to be able to swim up the chute constrained by the baulk.

Fishways are not very efficient and are typically species and life-stage specific in how passable they are. Stronger swimming species capable of leaping are clearly favoured eg the salmonids. Even then, not all individuals make passage and hence the presence of the weir / fishway begins to exert a selection pressure on the population by screening out certain individuals. Most fish passage issues are viewed from an u/s movement perspective but of course individuals and progeny spawned u/s are likely to move d/s at some point. The impounded section on the u/s side of a weir is again a confusing environment as there is typically a lack of focal flow, and the greater depth and lack of cover increases opportunities for predators.

To restore full ecological functionality to a river, weirs should be removed which from a fishery perspective would allow all species and life-stages to move freely u/s and d/s whenever they need to. It must be remembered that all fish species undertake in-river migrations to find food, spawning habitat, or relocate after displacement during spates or pollution events. Clearly the weirs at the top and bottom of the fishery are not going to be removed in the foreseeable future. However, it is important to appreciate the subtle direct and indirect impacts that those weirs will have had on the fish populations within the Otley waters since their establishment.

The magnitude and location of the weirs, plus the substantial investment around hydro-infrastructure especially at Otley weir means that it is highly unlikely they will ever be removed (the ideal situation to reinstate connectivity for both fish and geomorphology). However, with improvements elsewhere in the Wharfe catchment, the Environment Agency should be looking into assessing the efficacy of the fish passes currently *in situ*, expanding the network of passes or removing other defunct weirs, especially to cater for coarse fish and species of conservation concern (i.e. eel and lamprey). It is worthwhile maintaining a dialogue with the local EA Fisheries Officer (as well as the Yorks Dales RT) to keep abreast of developments and raise awareness of interests from the Club to improve fish passage.

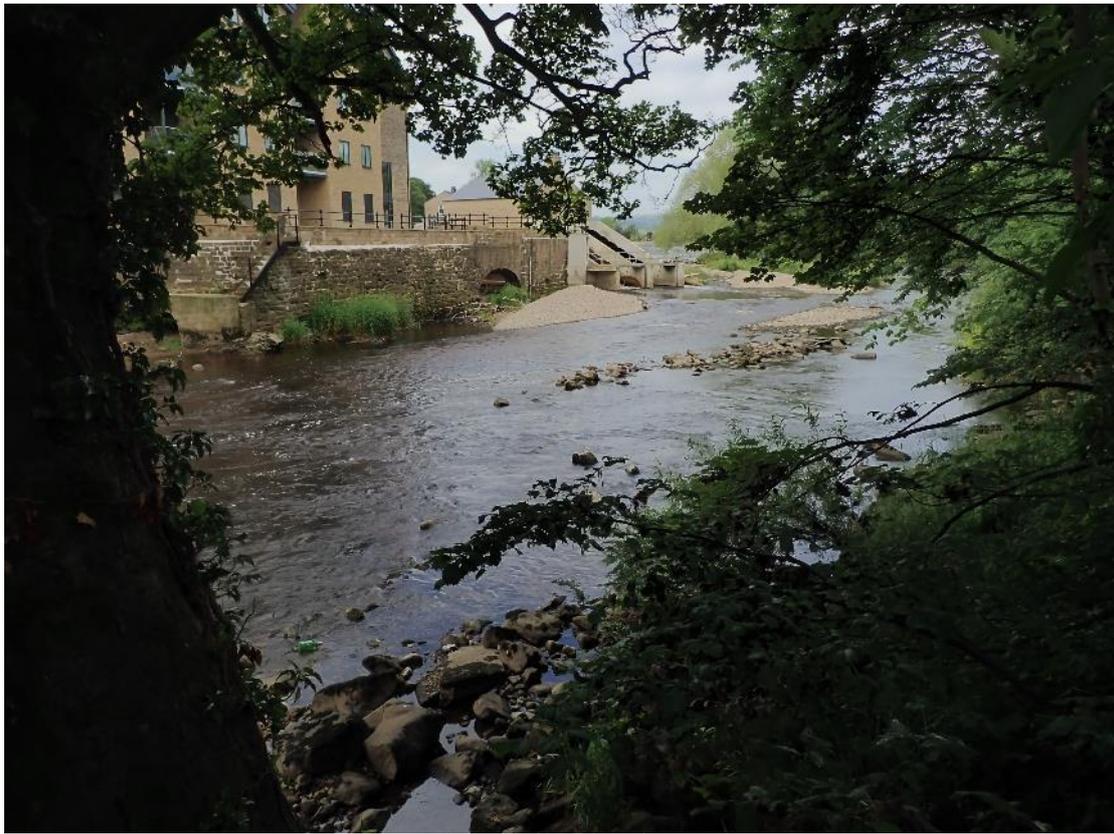
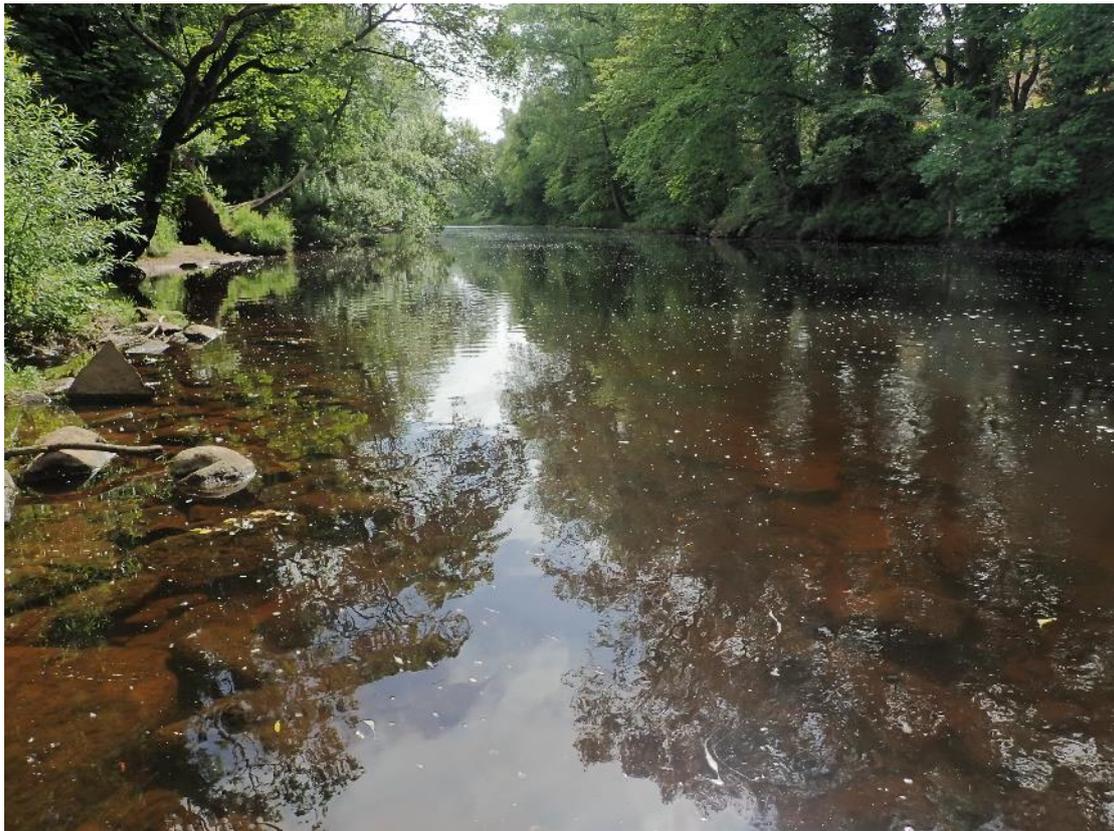
Fig 3. Upper panel: from the LB looking across to the exit of the hydro-scheme and co-located technical fish pass, and some deposition bars indicating varied depth profiles and sediment sorting. Lower panel: Looking d/s, habitat diversity immediately gave way to uniformity with almost uniform depth and little discernible flow along the very straightened channel.

'trapped' against the weir (fish passage issues outlined above) *and* the short stretch of perceived good habitat below the weir is at the expense of a much greater loss of habitat under the impounded

section u/s. Impounded water robs the river of the flow required to sculpt the varied habitat needed by fish and other aquatic wildlife to complete their lifecycles, and essentially creates a sediment trap hence the increasingly shallow water and uniform bed characteristics found u/s.

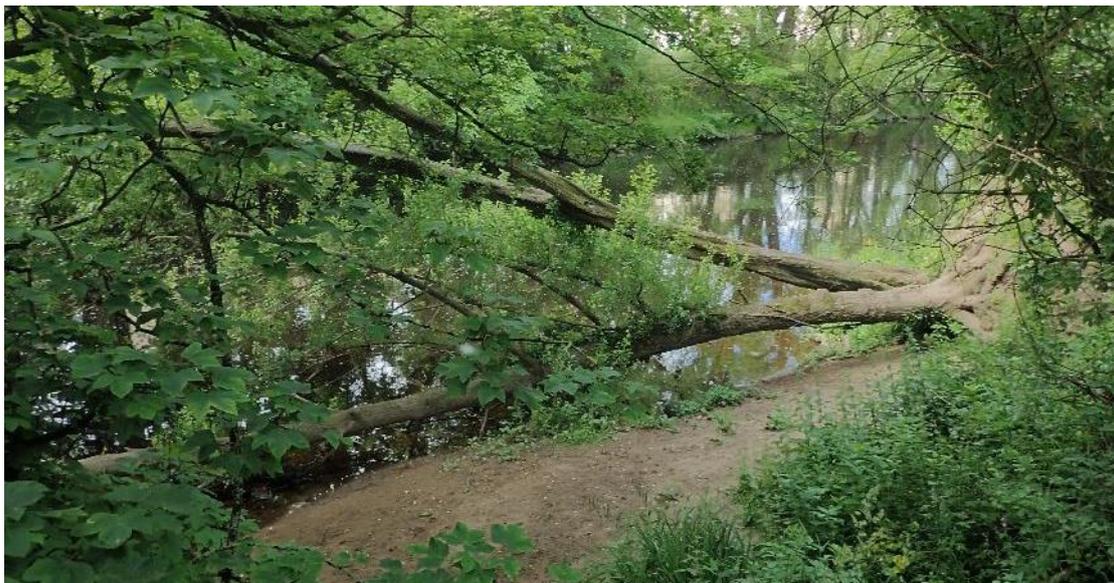
Fig 4. A naturally fallen poplar, which was still rooted and hence living, and has been there for many years. Angled downstream, it has clearly been unaffected by recent high spate flow, and provides multiple ecosystem benefits such as flow and predator refugia, shade and substrate. Any attempt to 'tidy up' such features should be resisted.

It was encouraging to see a large poplar that had fallen naturally into the water but had maintained a living 'hinge' had been left *in situ* for several years (Fig 4). Any attempt to 'tidy up' such a feature should be resisted. Indeed, it would be extremely beneficial to replicate such a feature (a 'tree-kicker') along all the straightened reaches d/s. The ecological benefits of such woody material include flow and predator refugia for fish and invertebrates, egg-laying substrate, a surface for biofilm colonisation (bug food), leaf-litter and shade. Furthermore, water moving around the trunk and branches introduces flow diversity, creating a slightly faster run on the outside edge and deposition in the slacker water in the lee of the structure, thereby 'pinching' the channel and kicking the flow away from the bank.

In conjunction with riparian management above, existing trees can be used to diversify instream habitat and replicate what was seen in Fig 4. Laying or hinging of appropriate pliant species such as goat or crack willow at a downstream angle $<30^\circ$ to the bank retains a living attachment point and reduces undue stress on the hinge during spate flows.

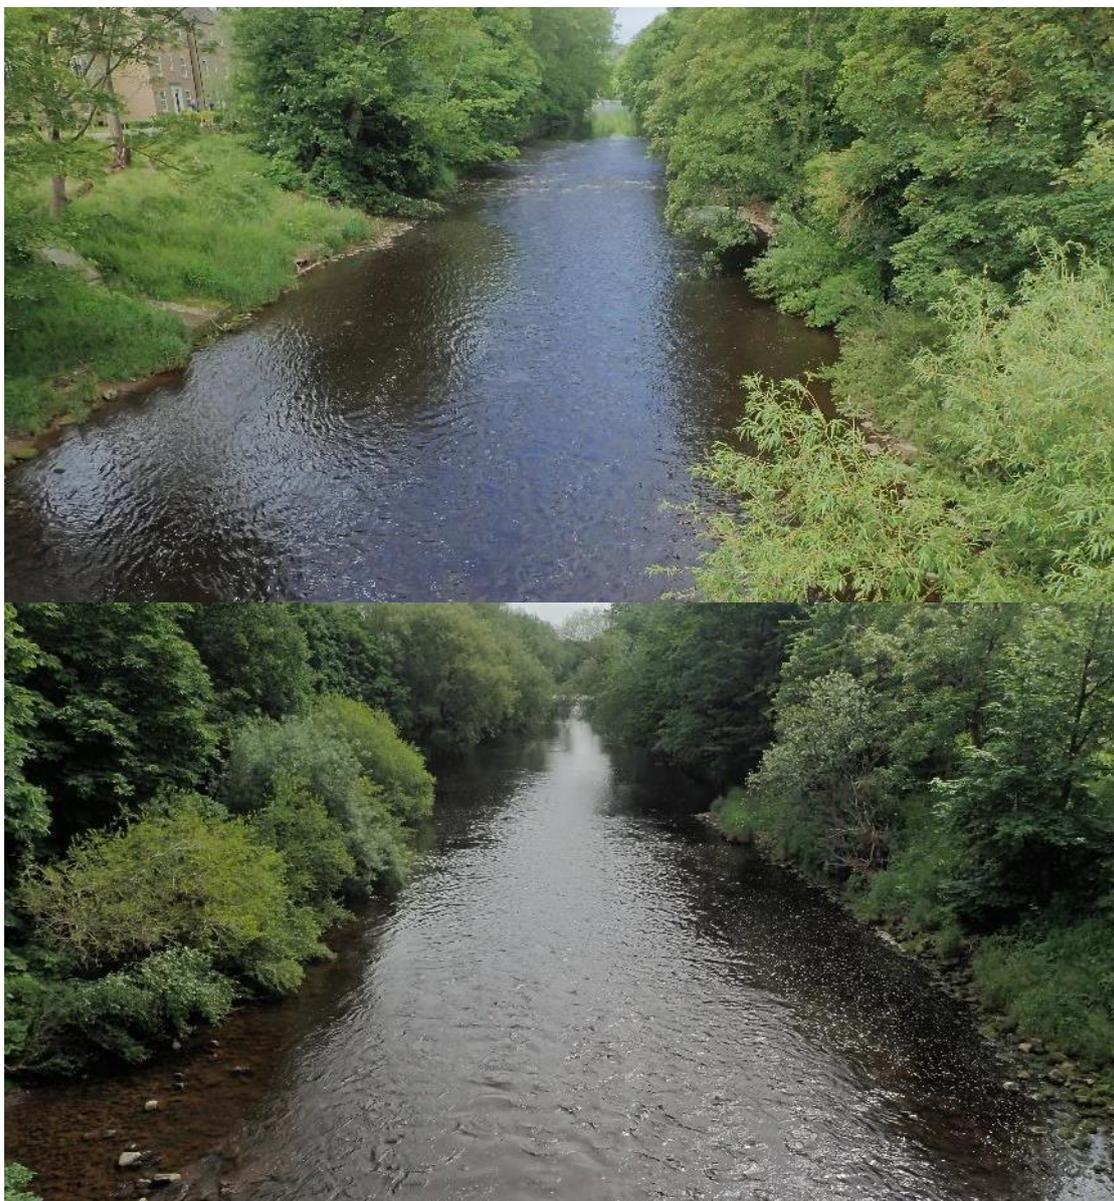
Fig 5. From the White Bridge at SE 20812 46092, it was easy to visualise the straightening of the channel by boulder revetment to both banks. The majority of bank length was covered by trees, dominated by sycamore but with occasional crack willow, poplar, and scrubbier species like goat willow at the bank toe.

The very straightened nature of the channel was evident from the White Bridge (Fig 5), as was the typically mature avenue of trees. Unlike many other Dales' rivers, the tree cover was more than 'one tree deep' along the majority of reaches and there were plenty of self-set saplings generating, albeit struggling to compete for light with the mature canopy. Elsewhere, young trees are generally in short supply because they are browsed by livestock. Make no mistake, the presence of these trees is good, but the uniformity of age structure could be improved by encouraging some gaps (replicating Fig 4) and allowing some of the new growth to come through. Some greater diversity could also be introduced. Sycamore and crack willow tended to dominate. Alder and hazel or hawthorn would be useful to introduce, especially as the former produces extremely nutritious leaf litter that is preferentially fed upon by macroinvertebrates.

Similarly, where low growing, scrubby species like goat willow were lining the toe of the bank (eg Fig 5), one or two trunks of the multiple-stemmed trees could be forced over into the channel in a d/s direction to further roughen the 'edge' of the vegetation.

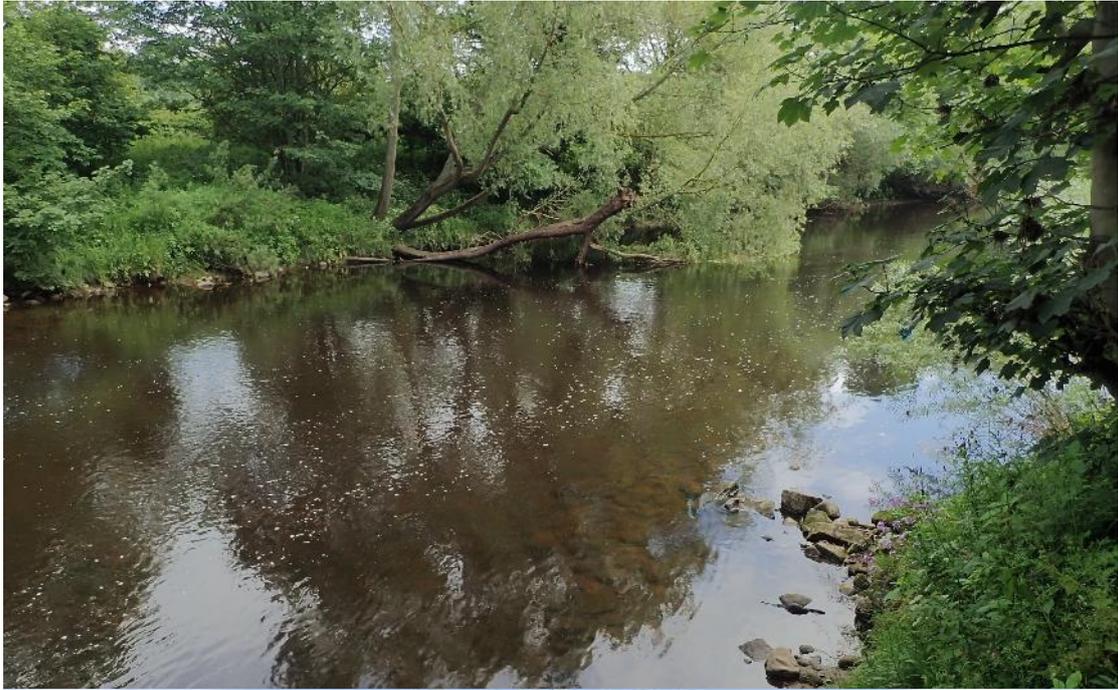
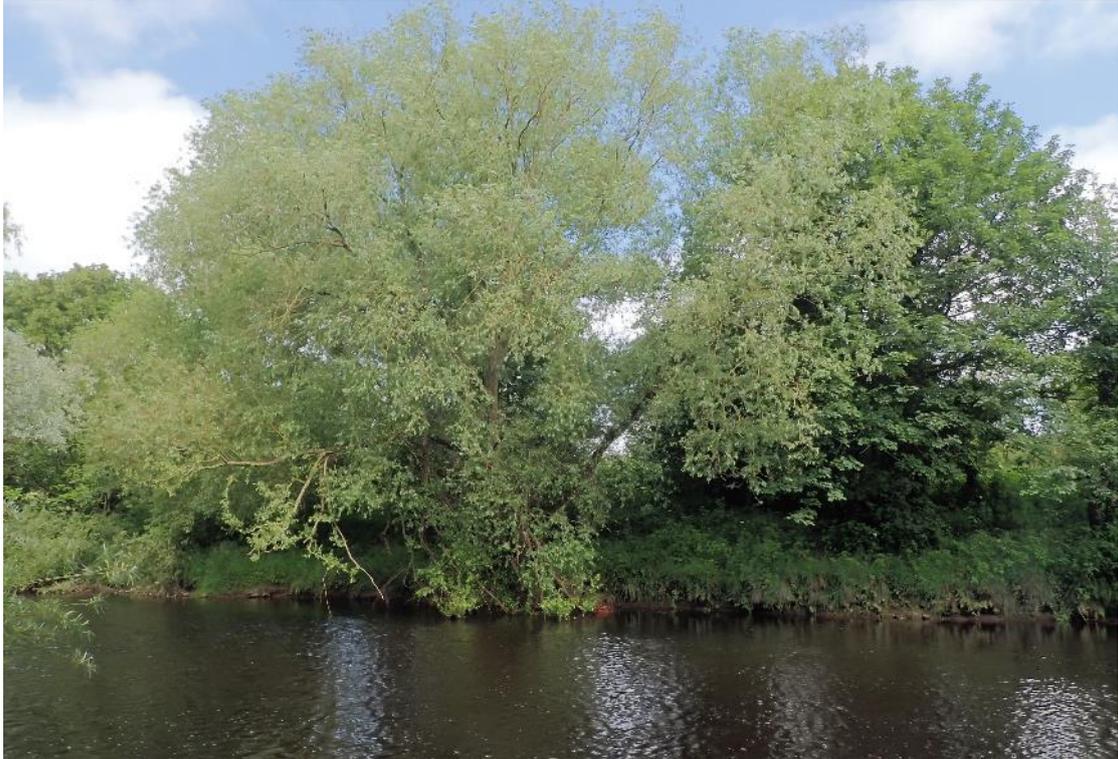
Deposition bars of finer sediments were evident, predominantly downstream from such low-lying willow. Emergent and pioneer (early colonising) plant species were consolidating fine sediment bars, providing good spawning habitat for coarse fish species and nursery habitat for fry. The silt substrate also provides a different habitat for colonisation by burrowing invertebrates like chironomid (non-biting midges) and true mayflies (*Ephemera danica*). Subtle changes to bankside trees (even through modest pruning) can have knock-on effects to these deposition bars, so any planned riparian management should be reviewed carefully to consider the wider environmental ramifications u/s and d/s. However, as already noted, trees can be managed to create and emphasise such features too. There were several examples of leaning limbs of crack willow which could be encouraged to 'lay' in the river to maximise ecological benefits (Fig 6; see Recommendations).

Fig 6. A couple of examples where previously coppiced crack willows (indicated by multiple trunks) would be ideal for laying of at least one trunk into the water to simulate that seen in Fig 4, pinching the flow and thereby locally accrue the ecosystem benefits.

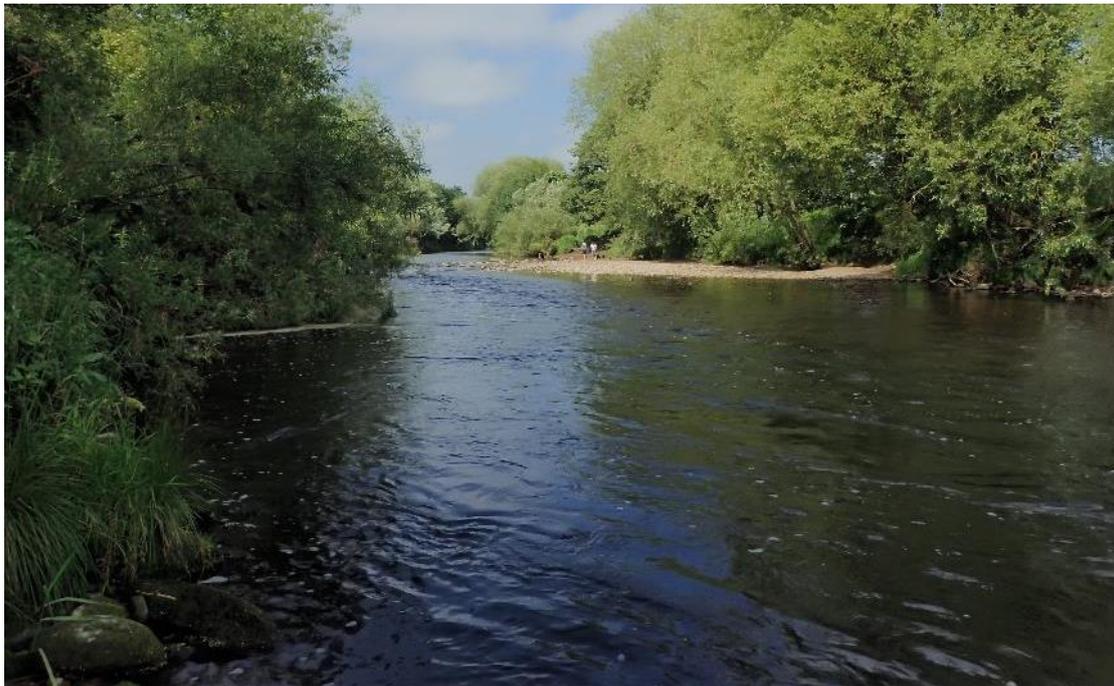
Every 400m or so, there were deposits of sediment that interrupted the relatively featureless long glides and created a more dynamic riffle habitat (Fig 7) and some slight focussing of flow to one side or the other. It would be worth investing some time to improve and thereby extend the habitat mosaic in these areas, capitalising upon the slight revitalisation of flow.

Fig 7. Eventually, the long, straight glides are interrupted (at ~400m) by deposition causing a shallow riffle, and a slight pinch to the flow as depicted above at SE 21193 46079. These are essentially little oases of habitat mosaic interspersed far too infrequently along the modified, relatively barren channel.

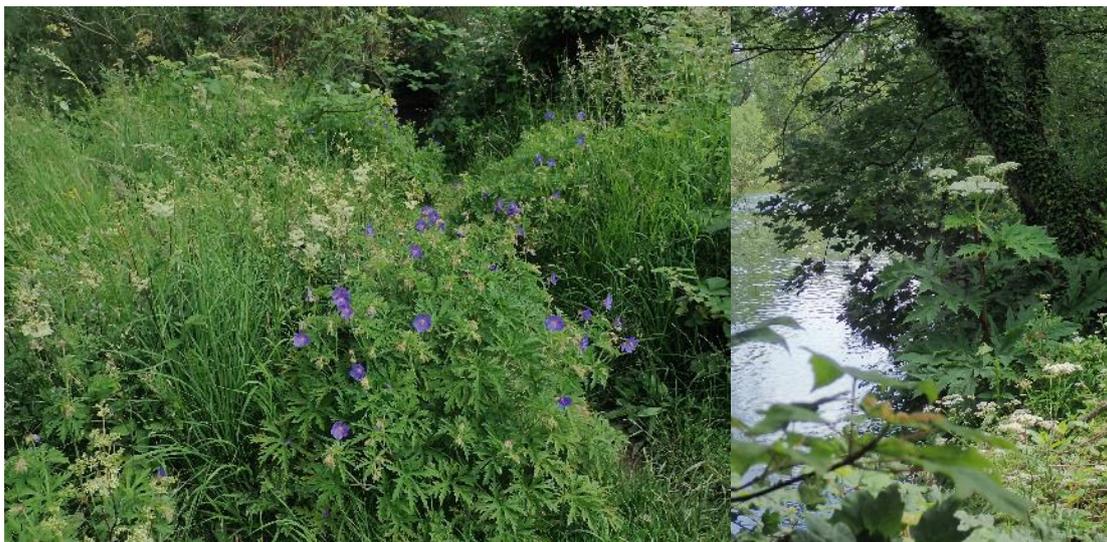
Despite the presence of Himalayan balsam, the riparian buffer strips on either bank were, for the most part, quite rich and diverse in herbaceous vegetation (Fig 8) which imparts multiple ecosystem benefits:-

Fig 8. Where tree cover was missing, or the canopy thinner, the herbaceous community was reasonably diverse with meadowsweet, cranesbill and comfrey all good for pollinators and will provide refuge for emergent 'riverfly' species. Unfortunately, Himalayan balsam was present throughout, and there were 7 or 8 individual giant hogweed plants (RH-panel) noted along the length.

Non-native vegetation such as Himalayan balsam can and should be removed simply by pulling prior to seed-set, making sure to remove certainly to the first node on the stem. The few individual giant hogweed plants and the Japanese knotweed stands were reported via the Yorkshire Invasive Species Forum to inform future management strategies. Giant hogweed requires care when handling as the sap can cause considerable damage to people upon exposure. Plants are typically sprayed early season prior to flower heads forming. If flower heads do form, they can be cut and should be bagged, removed and burnt. Japanese knotweed is treated by stem injection, late summer when the plant is withdrawing nutrients down into the rhizome to

sustain it over winter; it should never be pulled or cut as the smallest fragments can regenerate. More information is available at:

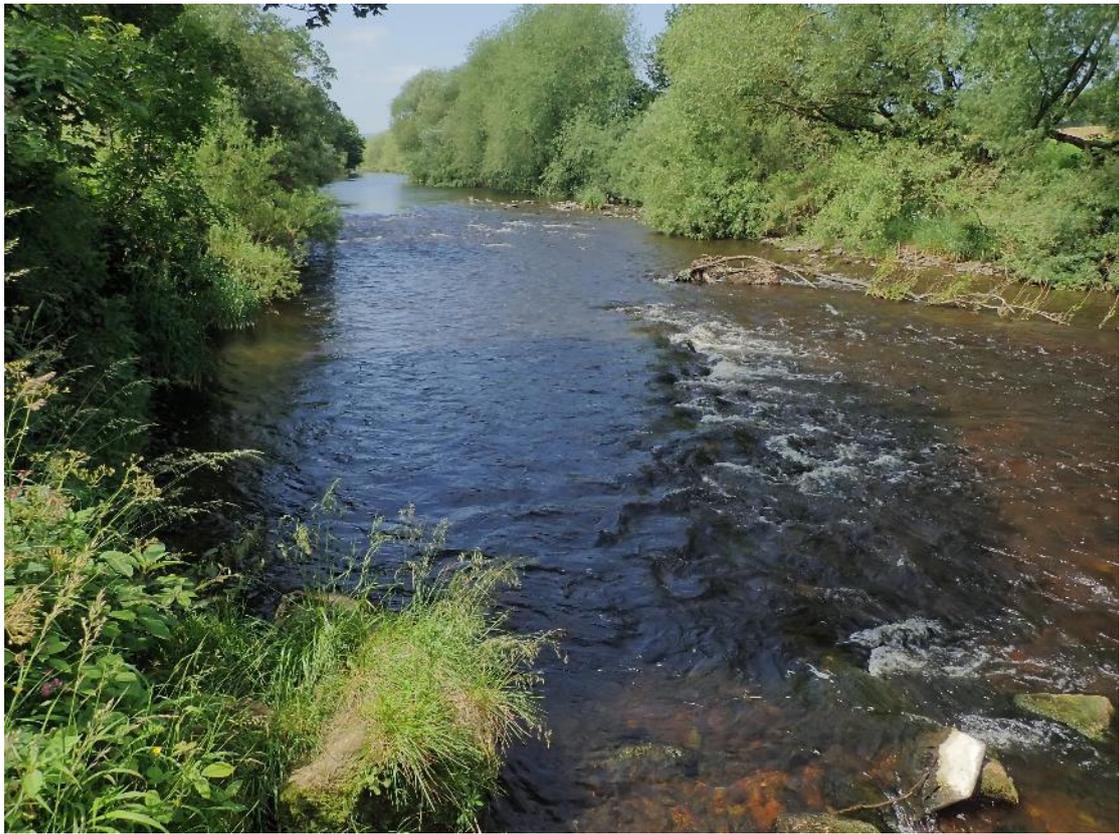
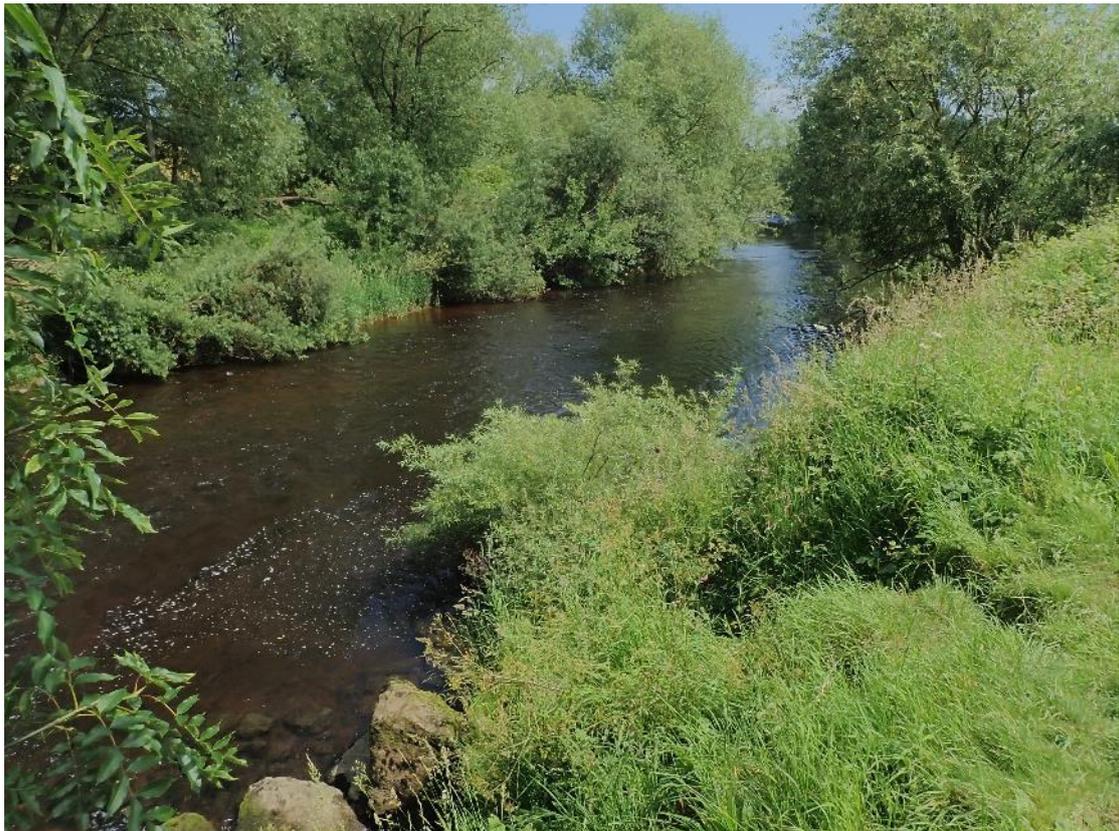
A slight (enforced) bend to the river to circumnavigate the Water Treatment Works and former gravel pit sites has allowed a degree of geomorphological process to alter the otherwise uniform channel dimensions (Fig 9). Deposition on the inside of the bend has been stabilised by vegetation and pinched the channel into a narrower, deeper run, with plenty of low and trailing vegetation; it culminates in a few more natural repeating sequences of pool-riffle-glide (instead of the long glide-short riffle found u/s and d/s). The diversity of habitat in this reach encapsulated many features that would benefit multiple species and life-stages and replicating that 'mosaic' elsewhere in the straightened sections should be an aspiration to improve the fishery.

Fig 9. At one of the few (slight) bends in the river, looking u/s and d/s in upper and lower panels, respectively. The channel was naturally pinched by deposition to the LB which has been stabilised over time by encroaching vegetation, and initiated a more habitat diverse reach of ~400m as the river was diverted around the WTW and (now) Knotford lagoons.

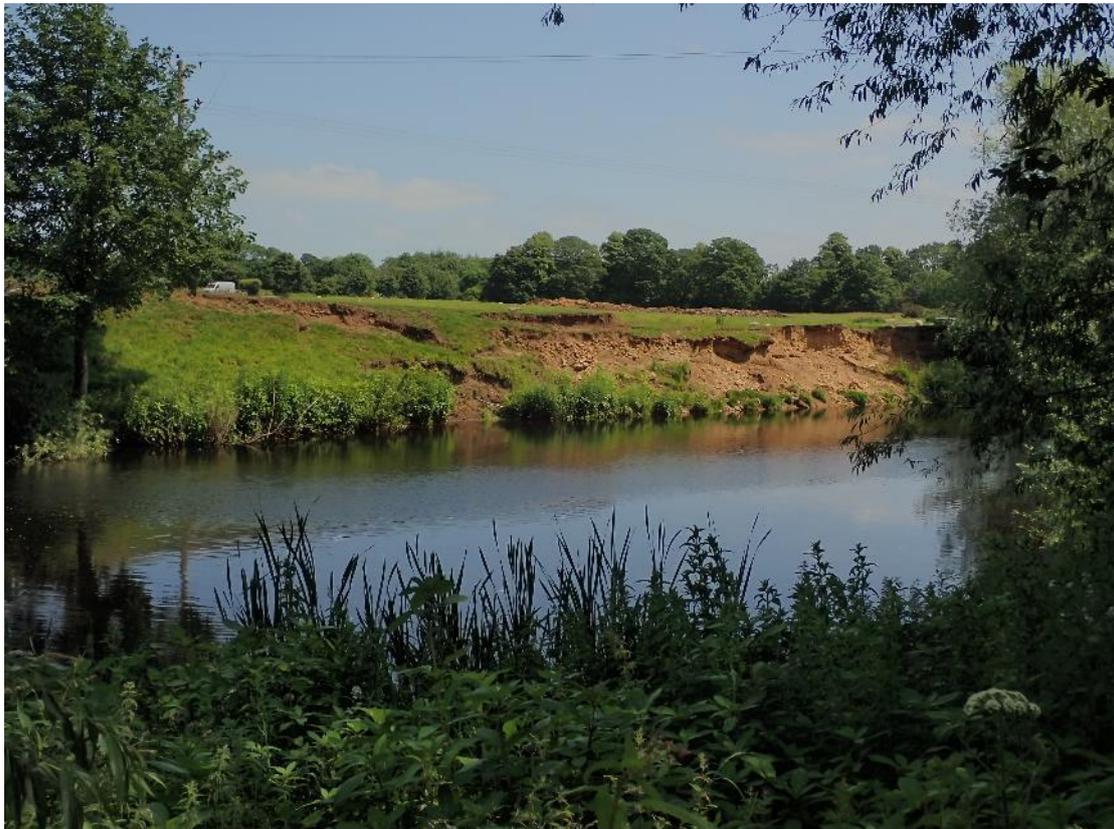
The only sections of bank exhibiting any serious erosion, aside from very focussed points of entry and exit primarily by dogs, was found at SE 22749 46332 (Fig 10). One field on the LB was used for pasture,

and the impact of livestock was immediately evident. Trampling, poaching and grazing by sheep, cattle and horses denudes ground cover, reduces the root matrix which binds soil together (because the grass is continually having to replace cropped shoots), compacts the soil and causes guttering of overland flow (rainfall), thereby contributing to diffuse agricultural pollution via soil running into the river. Weakened banks are more susceptible to spate flow, so while it is the river 'doing' the eroding, it is the activities of livestock which initiates the process. Fines entering the watercourse contribute to the clogging of interstices within the gravel, degrading that microhabitat for invertebrates and also its suitability as fish spawning substrate.

Fig 10. One of the few stretches of bank exposed to livestock was immediately evident from the erosion scars and input of diffuse pollution from bare soil, clearly demonstrating the combined effects of trampling and grazing. LB at SE 22749 46332.

There were no obvious point sources of sewage pollution seen, and little evidence of excess nutrient influxes aside from livestock erosion in one field which could easily be rectified with flood specification fencing. Extensive poaching of the bank by livestock is an offence under the Farming Rules for Water (2018). Any discoloured or malodorous water should immediately be reported via the EA hotline (0800 807060).

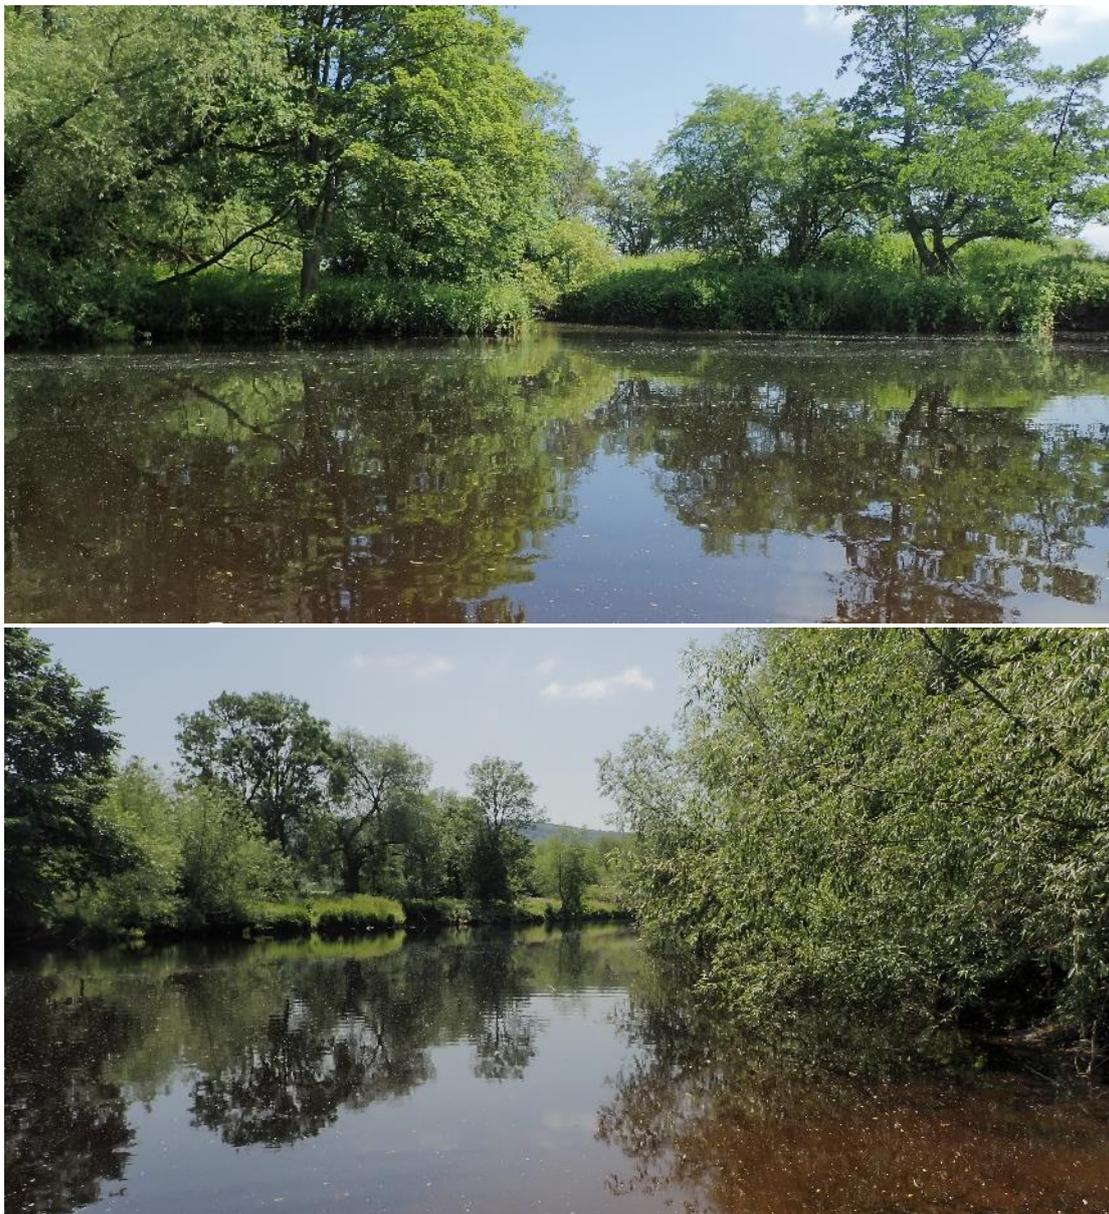
Just u/s from the confluence of the R Washburn entering on the LB, the mainstem Wharfe became notably sluggish as the impounding effects of the weir ~km d/s were detected (Fig 11). The bed of the channel was much siltier and deposition bars comprised finer materials, leading to more emergent vegetation occurring on the inside of the bend (RB). The Washburn could not be viewed from the RB. The confluence appeared to present good access but scrutiny of an Ordnance Survey map since has revealed the presence of a weir <200m u/s. A tributary of that size should be an important nursery for fish migrating from the Wharfe where spawning habitat is in short

supply so the presence of the weir should be investigated further, especially as the Washburn is the only tributary of note between the two weirs effectively demarking the limits of Otley AC.

Fig 11. The confluence of the R Washburn (upper panel) and immediately d/s (lower panel) is within a very sluggish section of the Wharfe, probably impounded from the weir at SE 23251 45591, ~1km d/s. Access to the Washburn appeared good from deeper water on the outside of the bend.

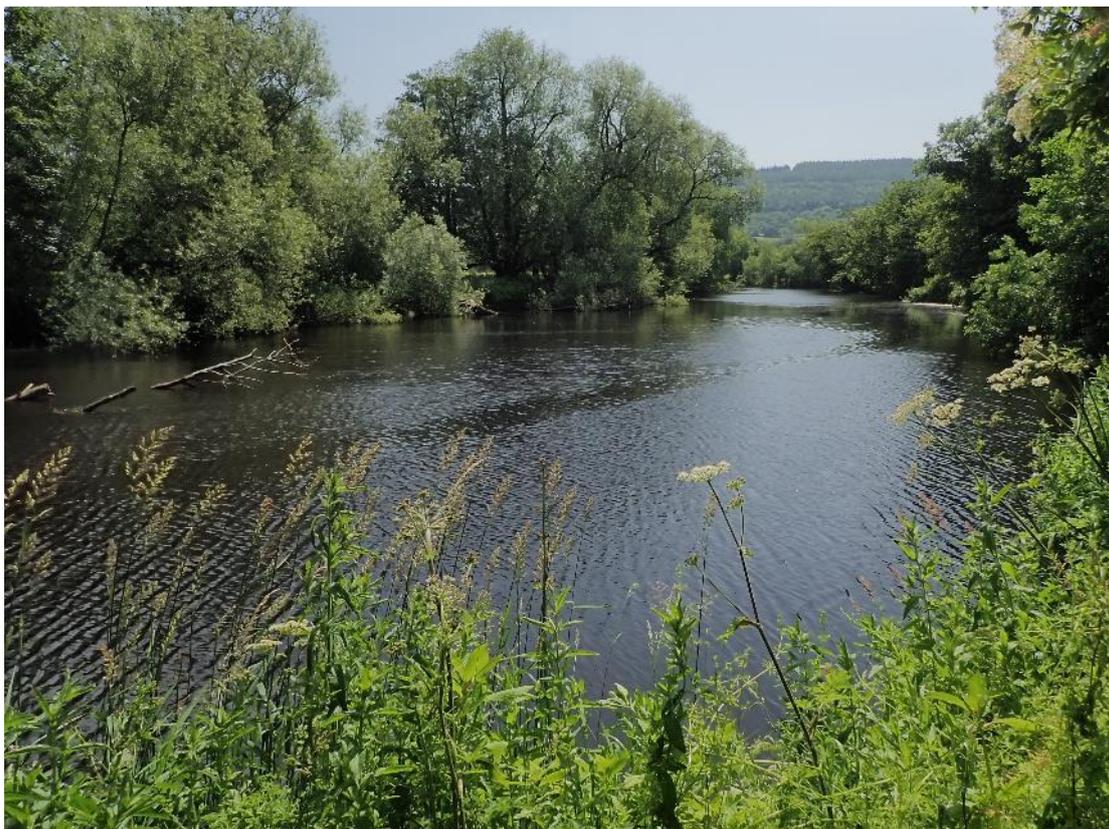
The lowest reach was even broader and sluggish to the extent that one or two whole trees had been deposited mid-channel in the past (Fig 12). While these flow characteristics favour various species of coarse fish, the restriction of cover to the trailing branches along the banks meant precious little refuge from potential predators. Better protection of those fish stocks and more opportunities for spawning substrate would be afforded by dropping some of the bankside trees into the river as 'tree-kickers'.

Fig 12. A broader, sluggish reach with the effects of the impounding weir at SE 23251 45591 evident as deposition and retention of trees within the main channel.

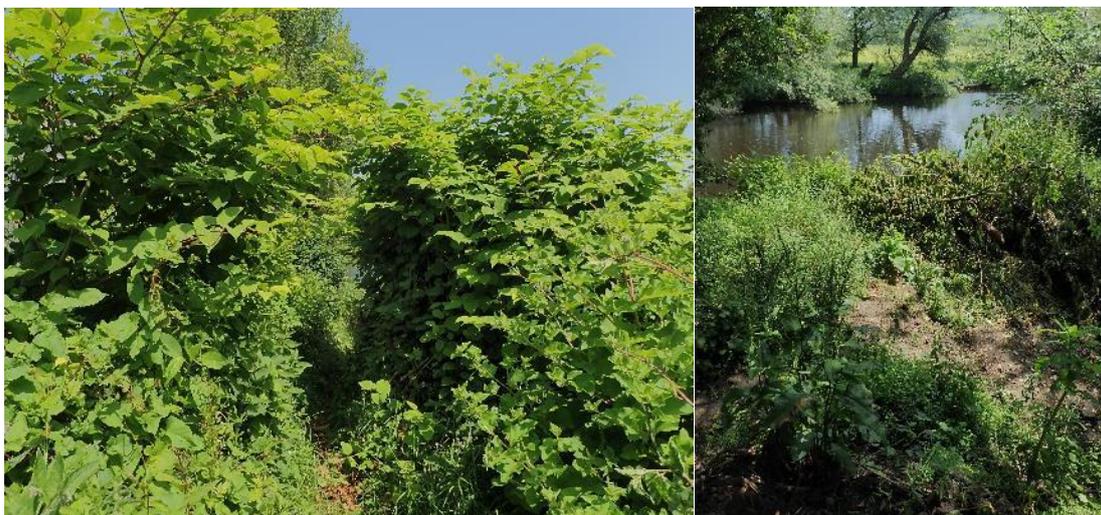
It was disheartening but not unexpected to see large stands of Japanese knotweed on the bank next to a layby / access point where garden waste and other refuse had been fly-tipped (Fig 13).

Fig 13. Of note was a large stand of Japanese knotweed at SE 22796 45946, Knotford Nook Gravel Workings. The right-hand panel depicts fly-tipped garden waste at the end of a short layby, again with knotweed at the bank edge.

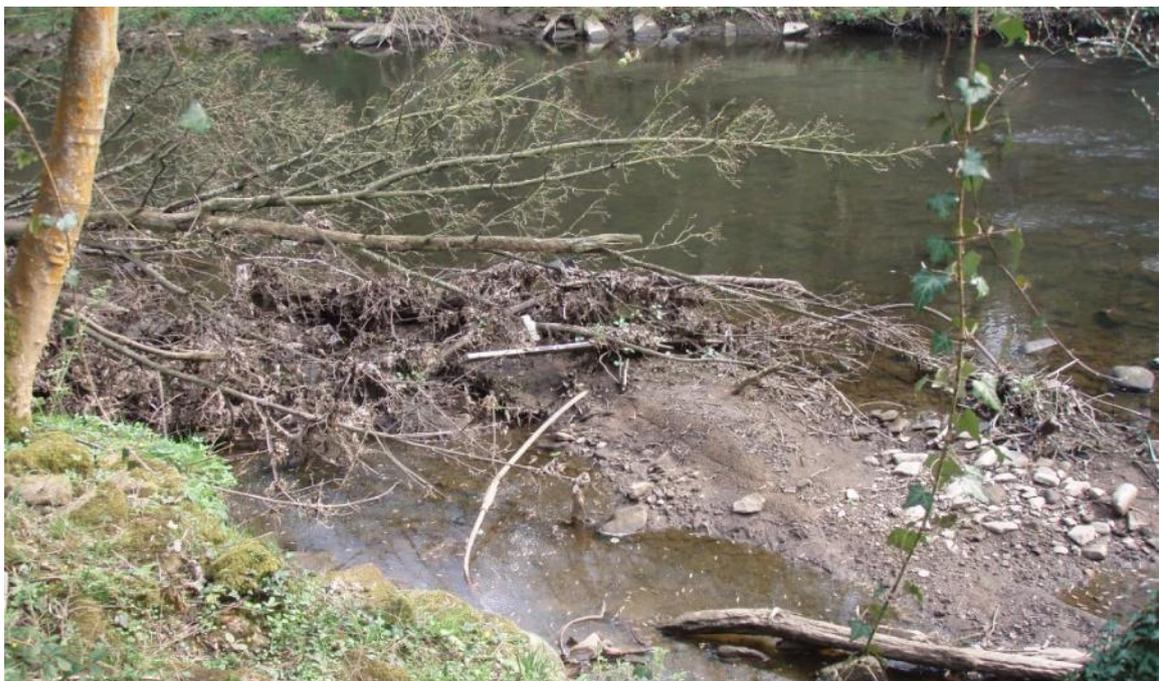
Fig 14. A tree-kicker tethered to its own stump to the left of image causes flow to be focussed away from the near bank resulting in deposition along the protected, nearside margin.

A larger scale solution is to use a tree-kicker, to increase flow diversity by creating narrower pinch points where bed scouring and sorting will occur and create areas of slack water immediately d/s to encourage more deposition. A tree kicker secured within a river margin (Fig 14) has accumulated sediment within the crown and in its lee d/s, providing beneficial channel narrowing.

A tree kicker is created by felling a tree to lay in the margins almost parallel to the bank and preferably already in an area of modest deposition to encourage stability of the ensuing structure. However, it must be cabled securely to an appropriate anchor point (usually its own living stump or another living trunk) to prevent any risk of future mobilisation and transport d/s. Installation of tree kickers requires consent under the EA environmental permitting regulations. WTT has produced a video on secure tree kicker installation:
